# **CHARACTERIZATION OF EPICOR II PREFILTER LINER 3**

**Nancy L. Wynhoff**  
**V. Pasupathi**

**Published April 1983**

**Battelle Columbus Laboratories**  
**505 King Avenue**  
**Columbus, Ohio 43201**

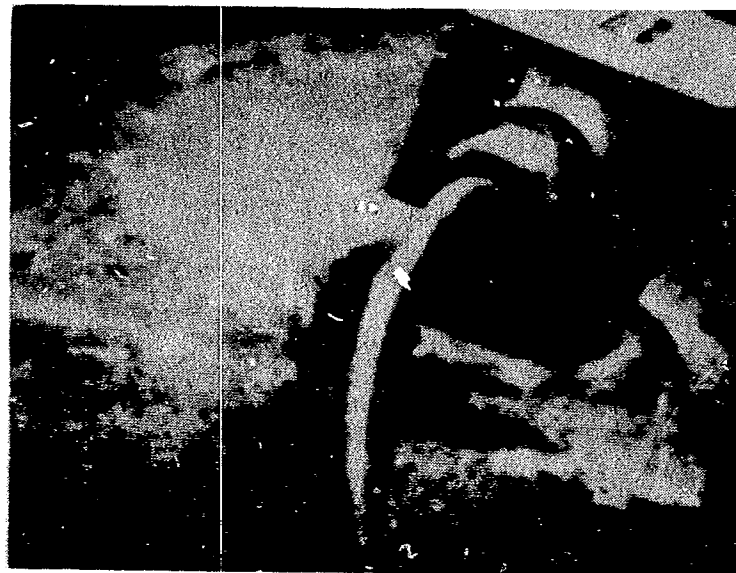
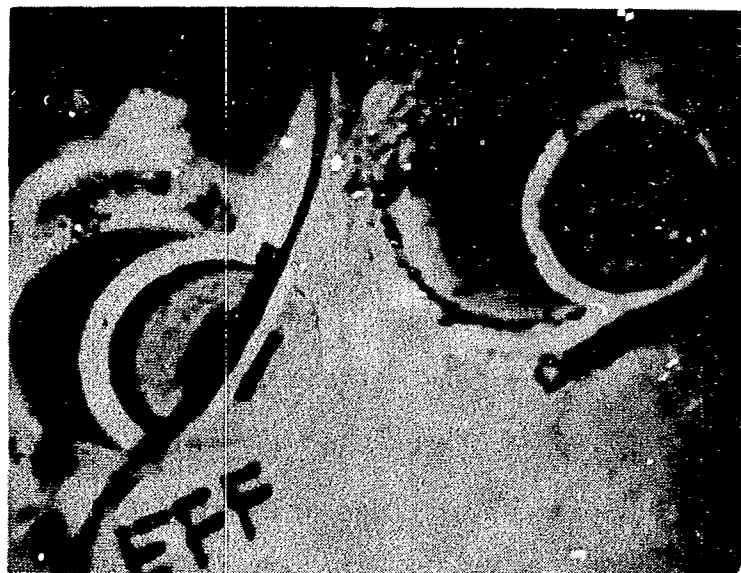
The weld areas at the penetrations contained some black deposits as well as rust spots. The source of the black deposits is not clear. It is possible that these were deposits of dirt and grime collecting around the weld regions. Appearance of this deposit around the weld regions of the conductivity probe and other penetrations is shown in Figure 5.

Figure 5. Appearance of black deposit around the weld regions of the penetrations. (a) conducting probe (b) effluent and off-gas penetrations.

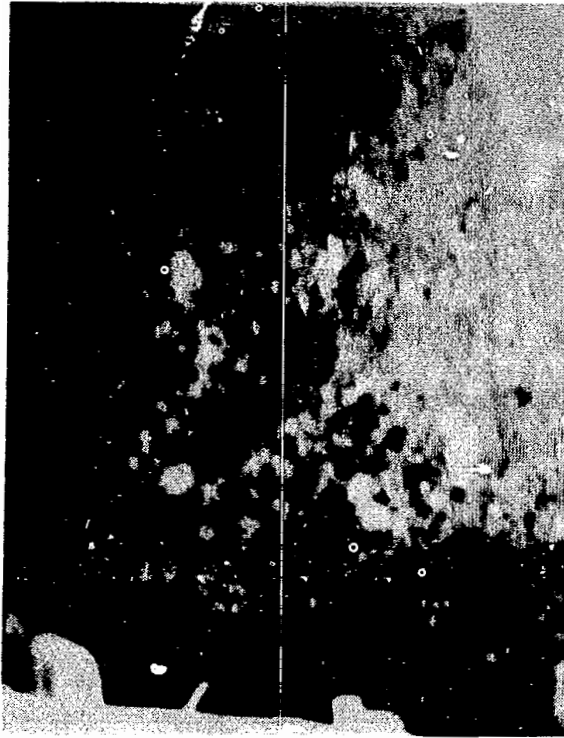
The interior of the liner was examined with an in-cell TV camera and monitor. As a prelude to performing this examination, the liner manway cover was removed and examined. The bottom side of the manway cover showed a significant amount of rusting. The extent of corrosion was about the same as that observed in the case of PF-16. In addition to corrosion, the bottom surface of the cover was also found to be coated with dried up splattered material. The splattered material appeared to contain flaky particles of yellowish brown color presumably from the turbulence of water flow through the ion-exchange media. Figure 6 shows the appearance of the corroded surface.

Figure 6. Appearance of the bottom surface of the manway cover.

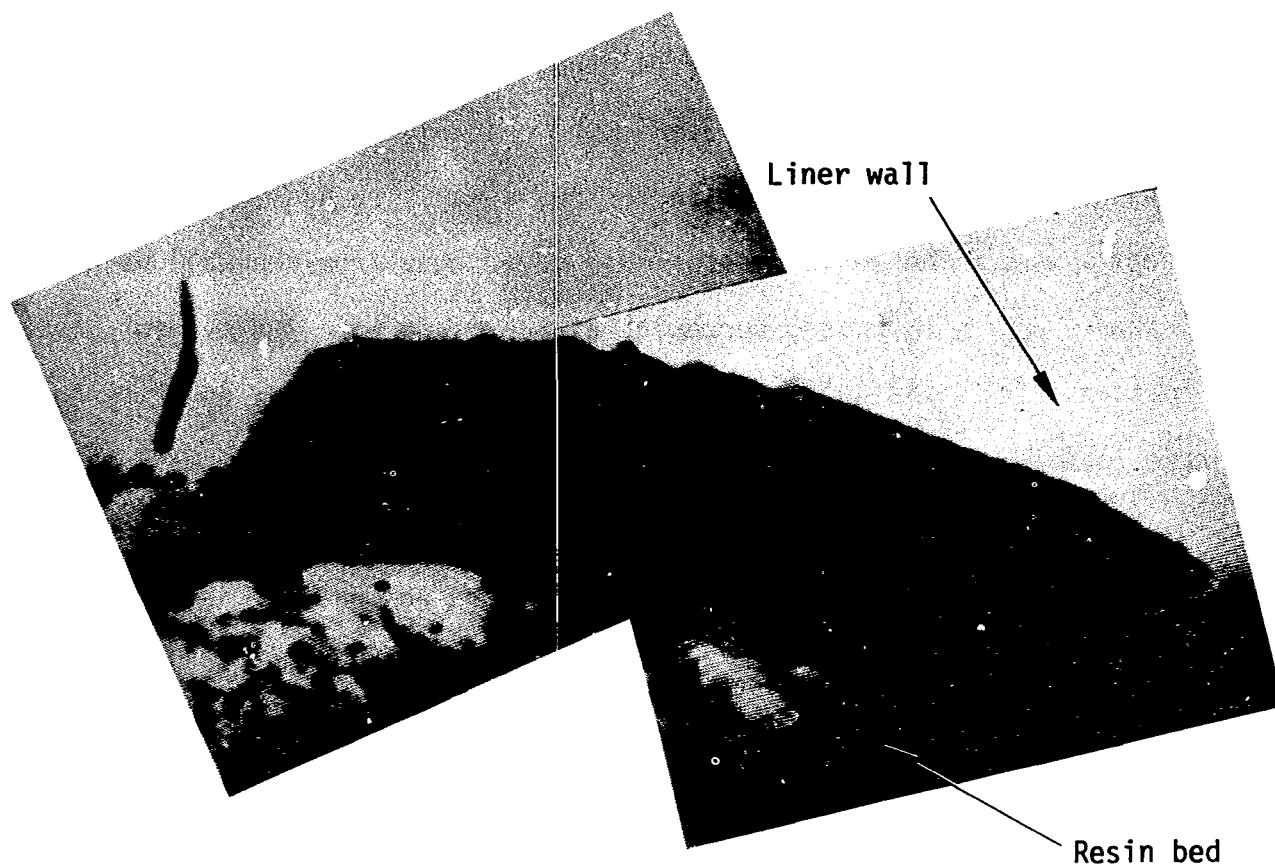
The liner interior wall also contained one large area (approximately 8" by 2" area) where the coating had been scraped off. This area, located just above the resin bed, was presumably intended for the water to make a good ground with the liner so the water level can be determined by the conductivity probe. Significant amount of rusting was evident in this area. Figure 7 shows the appearance of this region.

Figure 7. Appearance of the corroded area just above the resin bed surface. (Coating in this area appeared to be scraped off presumably to provide a contact surface for the conductivity probe).

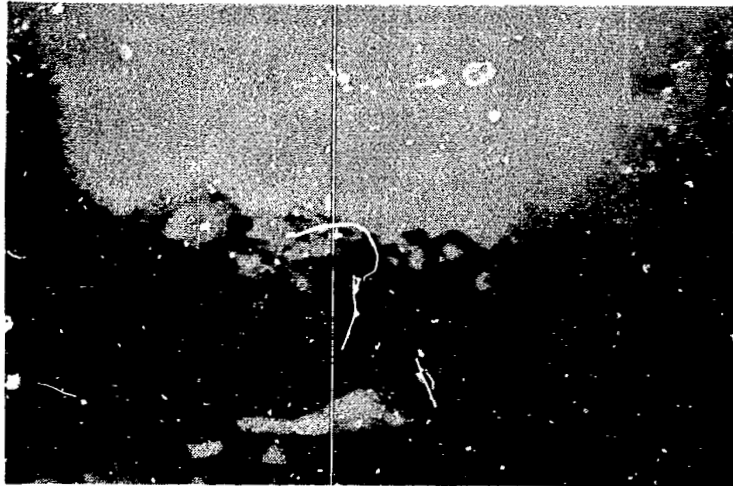
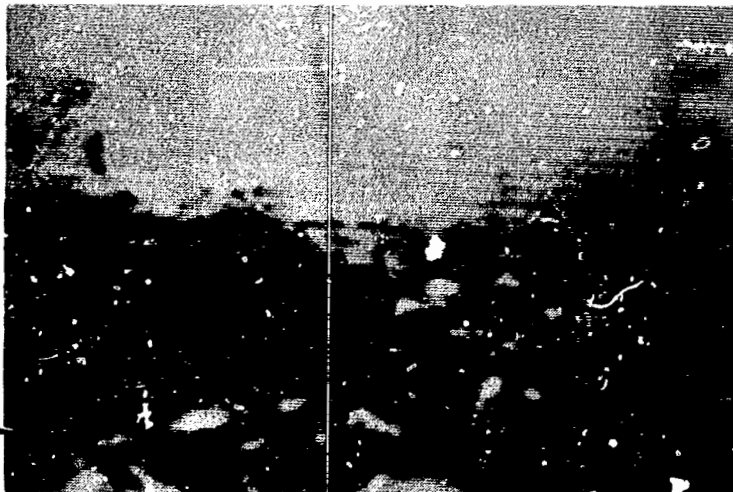
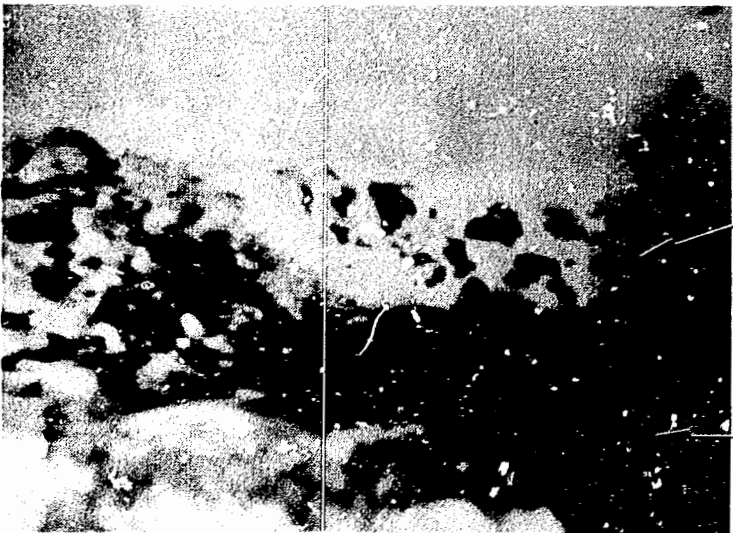
The liner wall in contact with the resin was also examined in two different areas. The resin material was moved away from the wall using a small spade. In both cases, corrosion of the liner wall was evident beneath the coating. The coating was blistered and appeared loosely adherent on the surface (see Figure 9a). It could be removed easily with the small spade. In comparison, PF-16 showed little or no additional corrosion at the interface of liner wall and resin bed. Figure 9 shows the resin-liner interface before, during, and after removal of resin media in contact with the wall.

Corroded  
areas on the  
liner wall

Figure 9. Resin bed liner wall interface (a) before (b) during and (c) after removal of the resin material in contact with the wall.

appeared to corrode more than in liner PF-16. The protective coating appears to be loosely adherent in this area with corrosion of the wall underneath the coating.

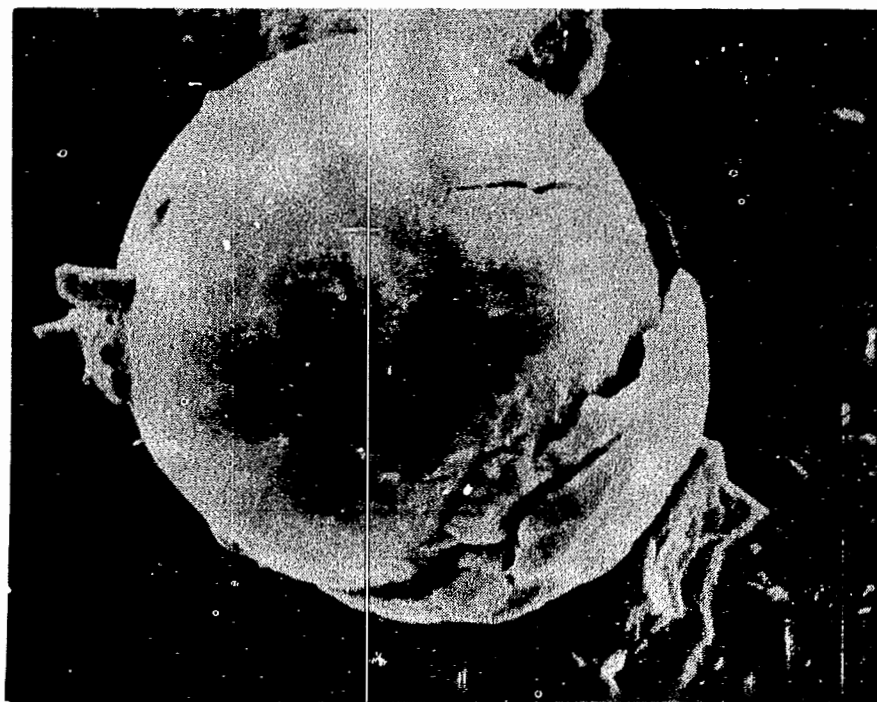
The particles in this region (the lower 16" of the media bed) were all spherical in nature. Many of the particles were fragmented and on all intact particles surface defects were observed. Figure 20 shows the typical distribution of intact particles and particle fragments in this region of the media core sample. Figures 21 through 24 show examples of surface defects and fragmented media particles. EDAX analysis was performed on several particles

Figure 21. SEM photomicrograph detailing fractured media particle, Bottom Region, 0-4" segment, 150X.

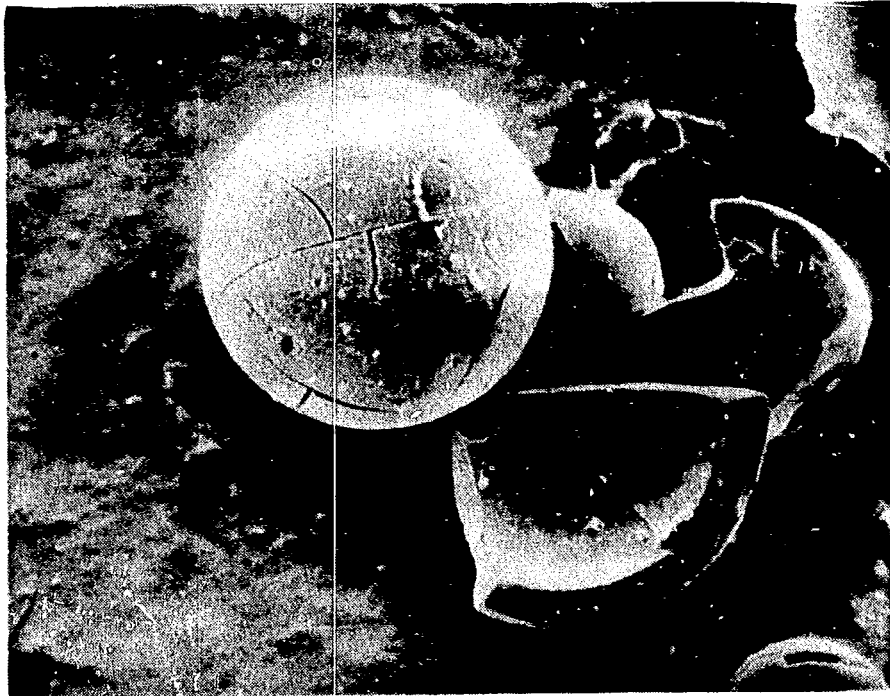
Figure 22. SEM photomicrograph detailing surface defects in media particle, Bottom Region, 4-8" seg,emt. 70X.

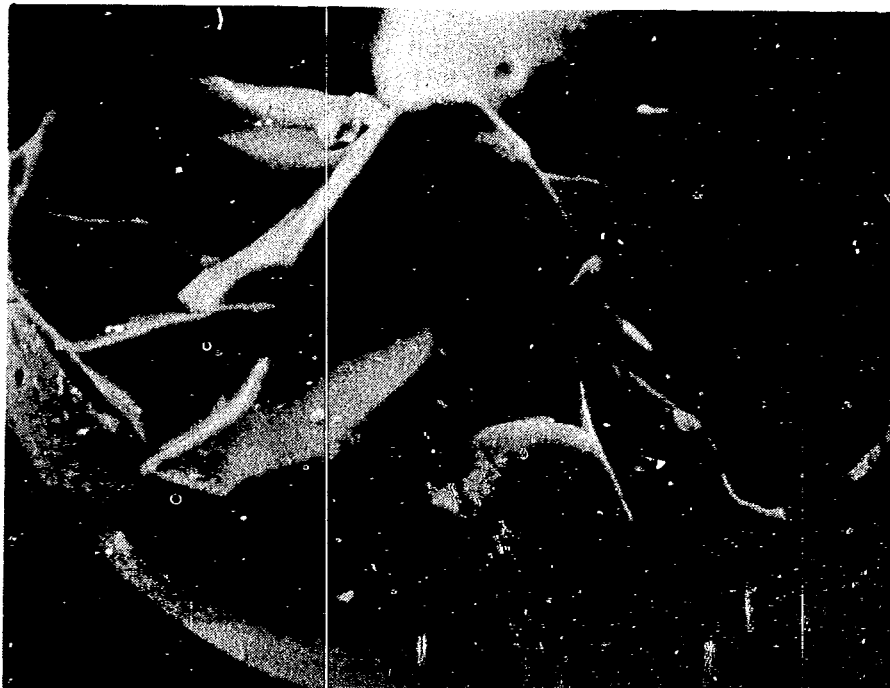
Figure 23. SEM photomicrograph detailing fragmented media particle, Bottom Region, 8-12" segment, 200X.

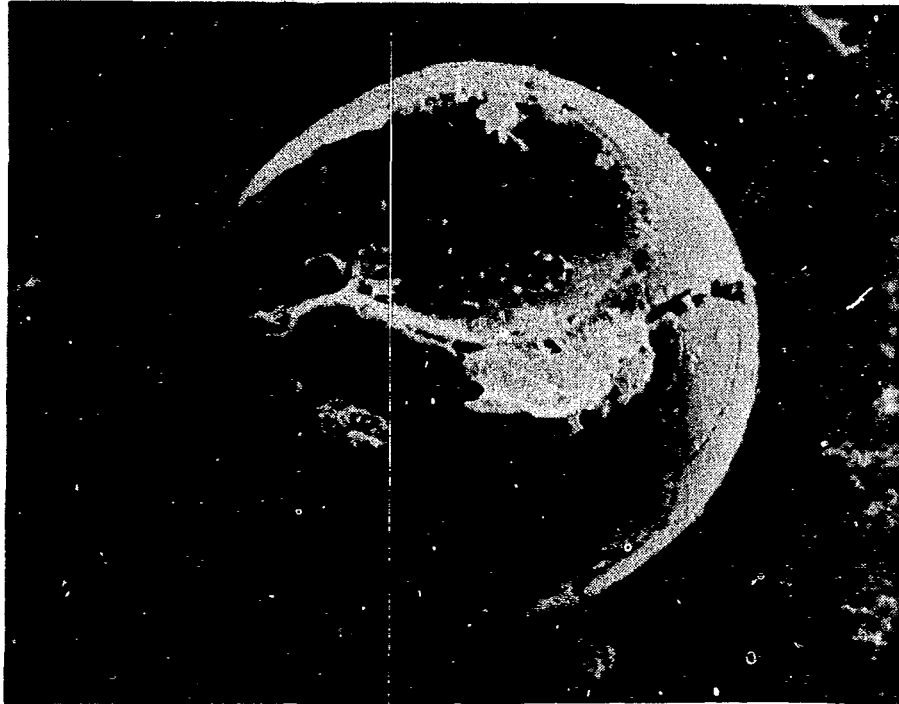
Figure 24. SEM photomicrograph detailing surface defects in media particle, Bottom Region, 12-16" segment, 100X. (White deposits on the media particle are silver mounting material.)

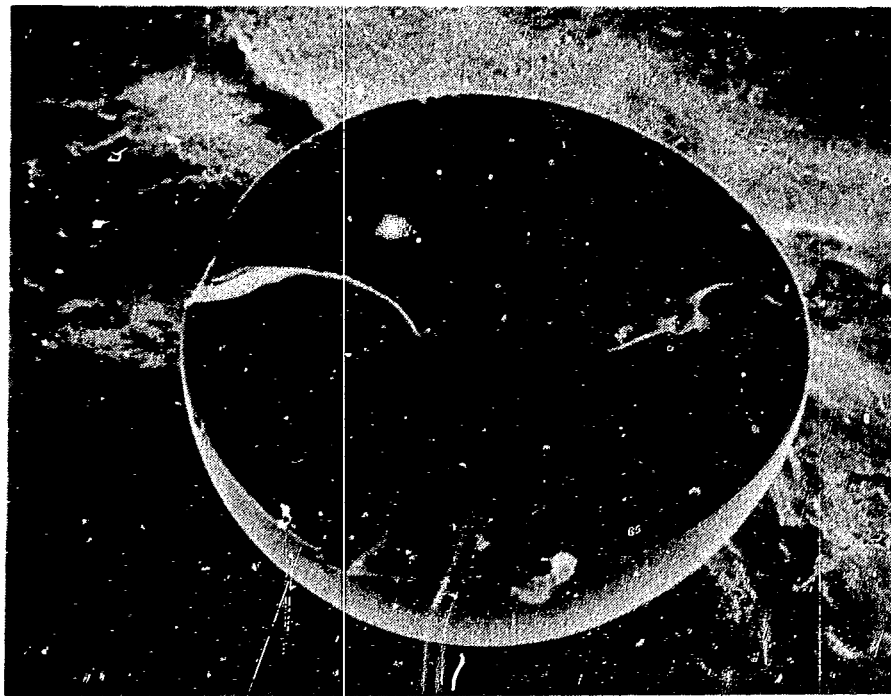
In the top four inches of this region (20-24" from the bottom of the core sample), only spherical particles, showing little or no evidence of surface defects were found. Two particle fragments were found and are shown in Figures 31 and 32. These fragments appear to be from cleanly split particles. Neither fragment showed any evidence of cracking or spalling on its outer face. Figure 33 shows a typical particle from this top layer of the core sample. An EDAX spectrum from a typical particle is shown in Figure 34. Sulfur is again the predominant constituent with smaller amounts of sodium, silicon, and calcium.

Figure 32. SEM photomicrograph detailing surface of fragmented particle, Top Region, 20-22" segment, 100X.
