# **METALLURGICAL EXAMINATION OF, AND RESIN TRANSFER FROM, THREE MILE ISLAND PREFILTER LINERS**

**John W. McConnell, Jr.  
Howard W. Spaletta**

**Published August 1984**

**EG&G Idaho, Inc.  
Idaho Falls, Idaho 83415**

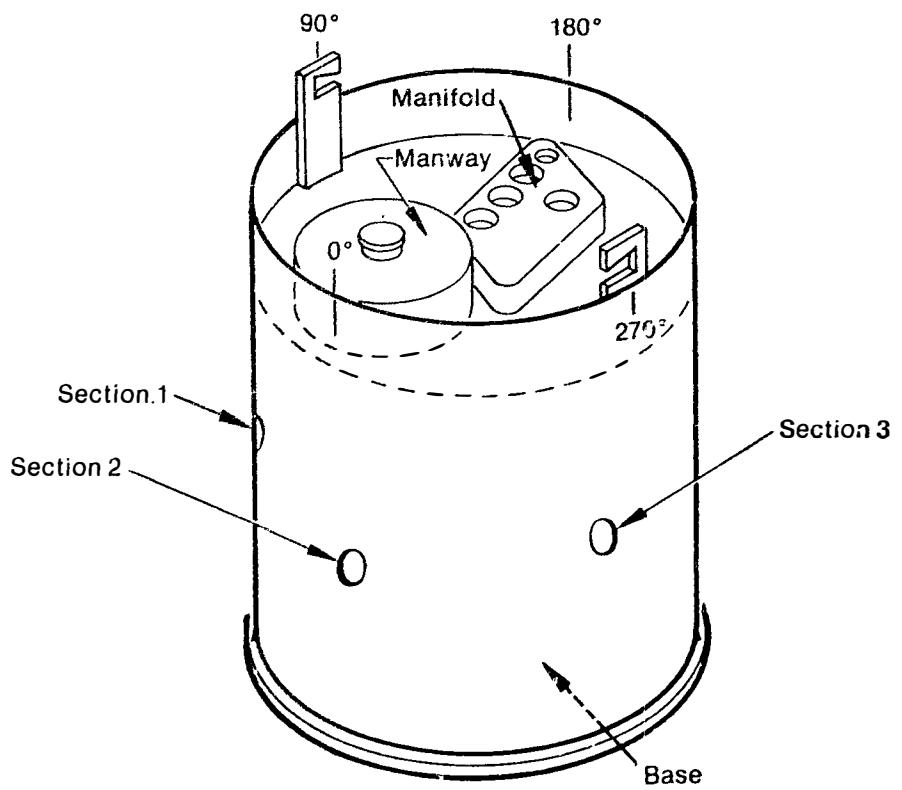
Figure 2. View of liner PF-3 showing locations where metal sections were removed.

Section 1. Section 1 was removed from the center of the grounding area for the conductivity probe, about 30 in. from the bottom of liner PF-3, 45-degrees clockwise from the manway (see Figure 2). The internal coating had been removed mechanically from that area of the liner. After decontamination by rinsing with mineralized water, contact readings of 35 R/h  $\beta$ - $\gamma$  were measured. Visual examination of the interior surface of the section revealed a heavy deposit of corrosion products and residual resin (Figure 12). The high radiation readings required remote examination of this section in the TRA Hot Cells. Some corrosion products were lost while remotely preparing specimens from Section 1.

Section 3. Section 3 was removed from the sidewall of liner PF-3, 90-degrees counterclockwise from the manway, about 30-in. above the bottom of the liner (see Figure 2). That elevation corresponded to the top surface of the resin. Visual examination of the interior surface of Section 3 revealed numerous coating blisters and areas where coating was not adhering to the base metal and had spalled (Figure 15). Light corrosion products under an adherent coating and heavily corroded areas under blisters were observed (Figure 16). The adherent coating is about 0.005-in. thick.

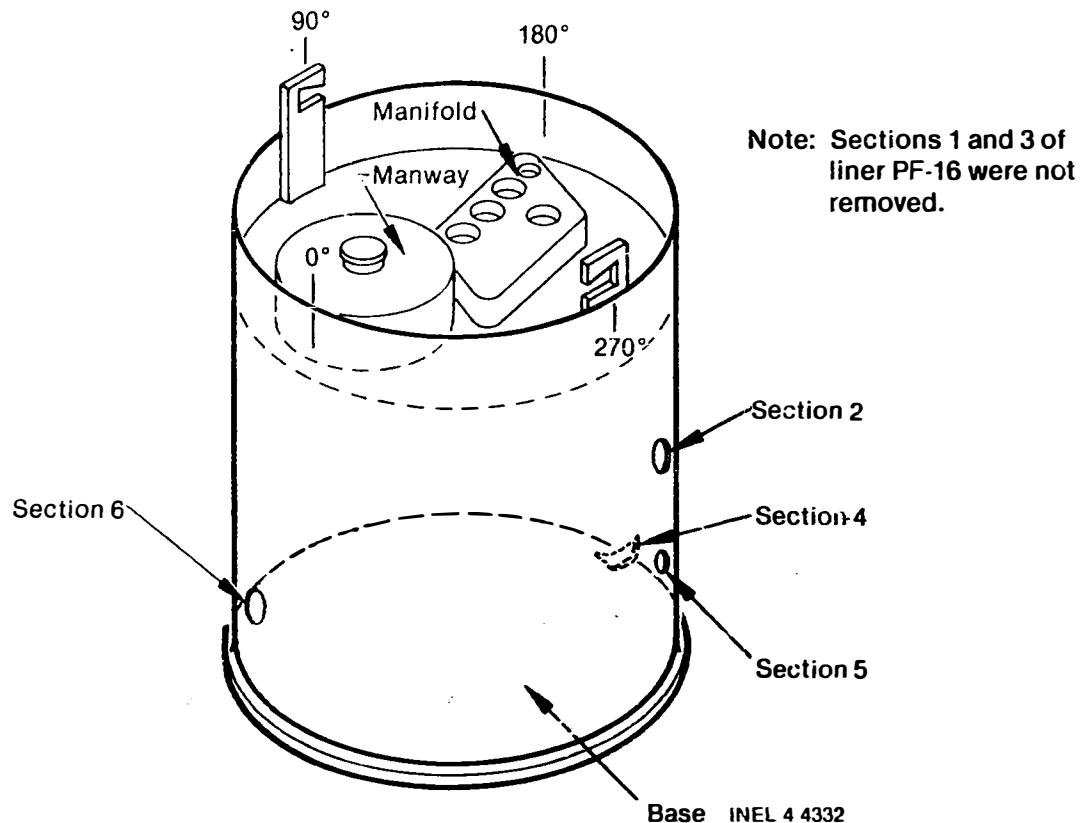
Figure 3. View of liner PF-16 showing locations where metal sections were removed.

Section 4. Section 4 was removed from the junction of the sidewall and bottom of liner PF-16, about 150-degrees counterclockwise from the manway (see Figure 3). Visual examination of the interior surface of Section 4 revealed numerous blisters in the coating on both the interior surface of the bottom plate and cylindrical wall of the liner (Figure 30). Metallographic specimens were prepared from this section at the locations shown in Figure 31. Figure 31 shows the lack of adherence of the coating to both the internal wall of the liner and surfaces of the welds joining the sidewall to bottom plate. Those welds were made in single passes, joint preparations were not machined prior to welding, and there is a gap

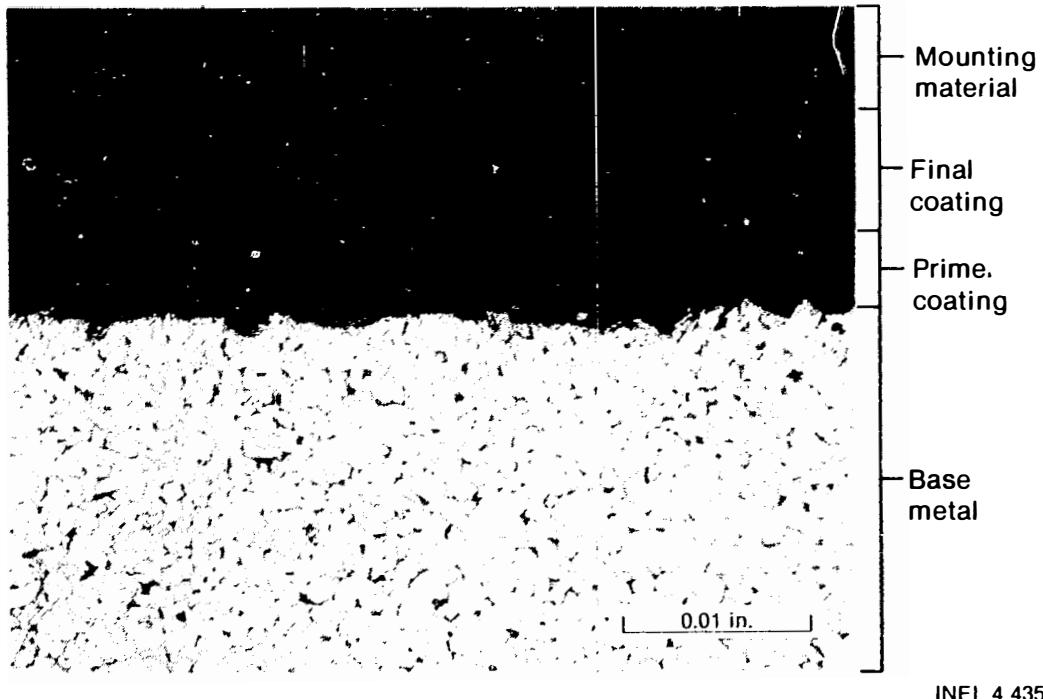
INEL 4 4358

Figure 10. Photomicrograph normal to the coated surface of Test Plate 1.

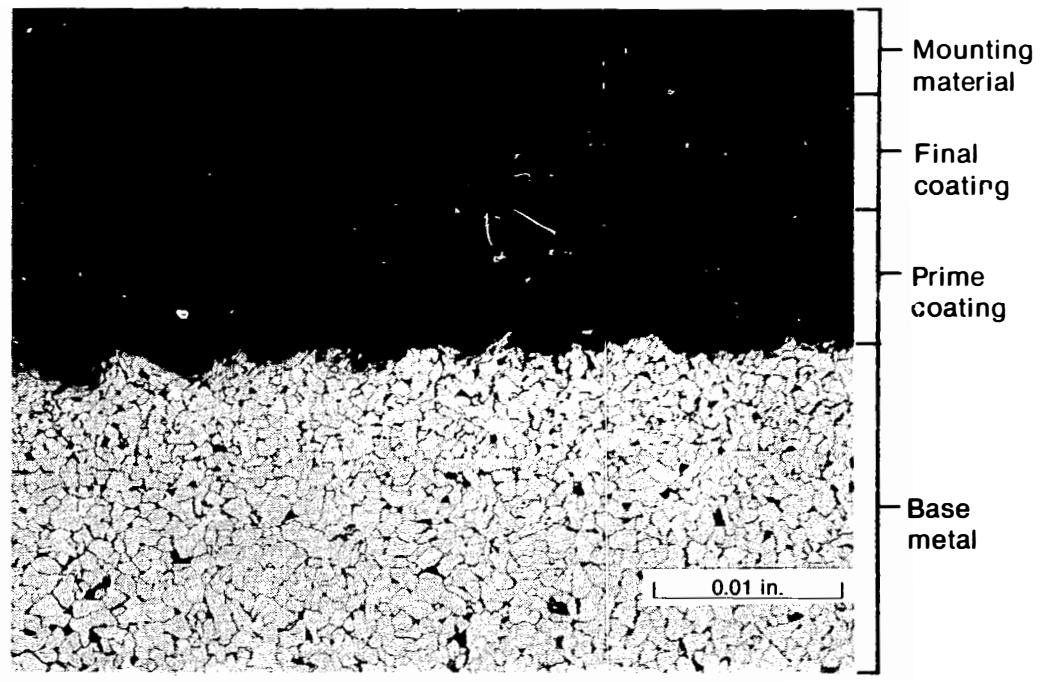
INEL 4 4356

Figure 11. Photomicrograph normal to the coated surface of Test Plate 1A.

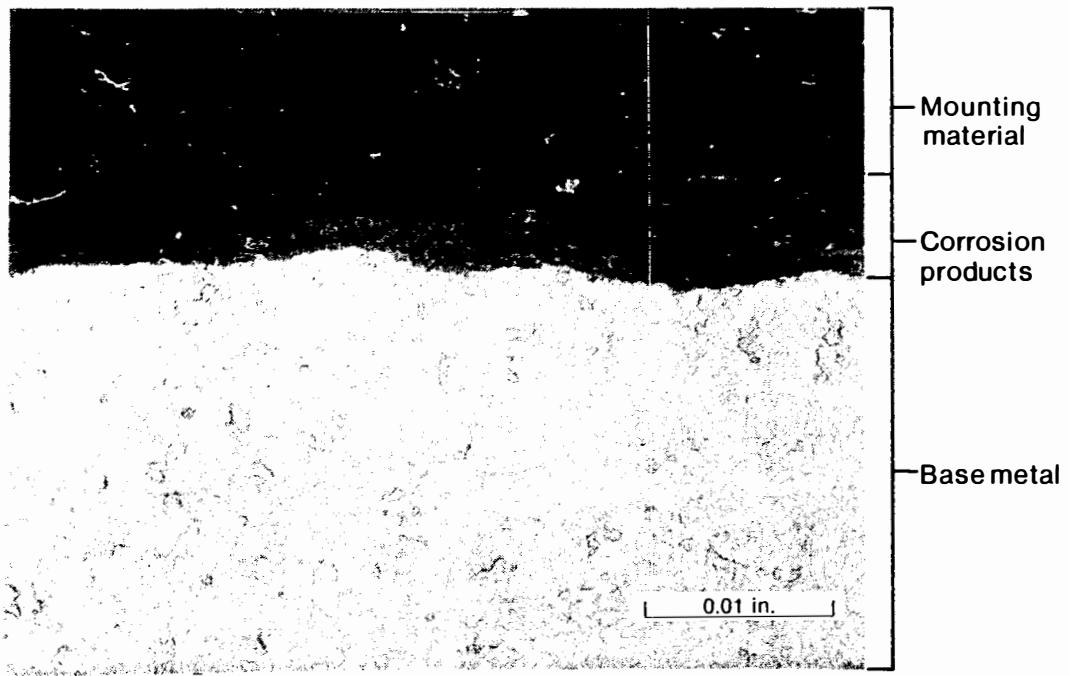
INEL 4 4348

Section 1, Specimen 1-B--Figure 13 is a typical photomicrograph normal to the uniformly corroded interior surface observed for Specimen 1-B. No evidence of pitting or pitting-type corrosion was evident. A normal fine-grained (ASTM grain size No. 8 or finer) structure was observed in the base metal (Figure 14). No interior coating was

Figure 13. Photomicrograph normal to the interior surface of Section 1 from liner PF-3 showing the uniformly corroded surface.

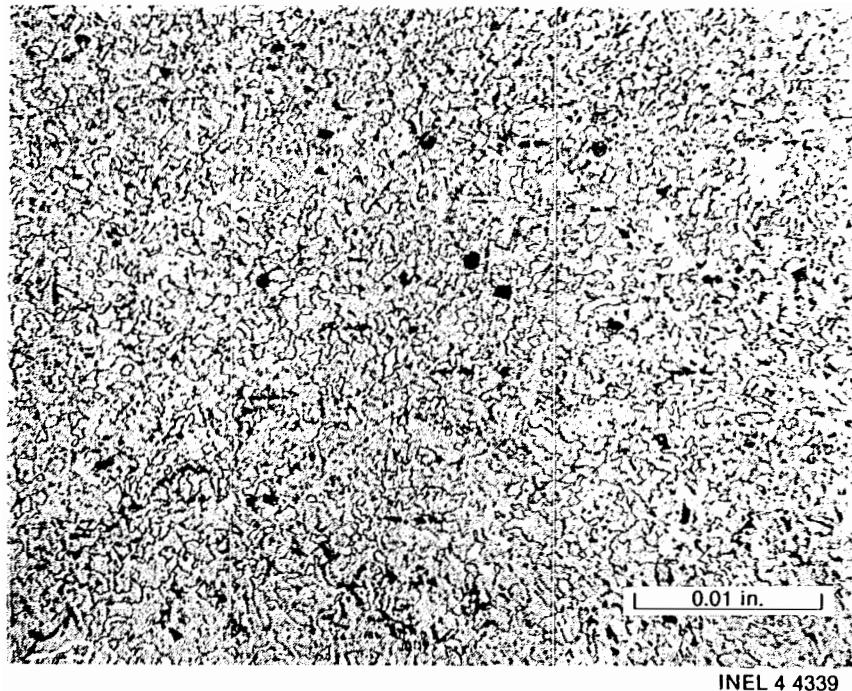
Figure 14. Photomicrograph of Section 1 from liner PF-3 showing a normal fine-grained (ASTM No. 8 or finer) base metal.

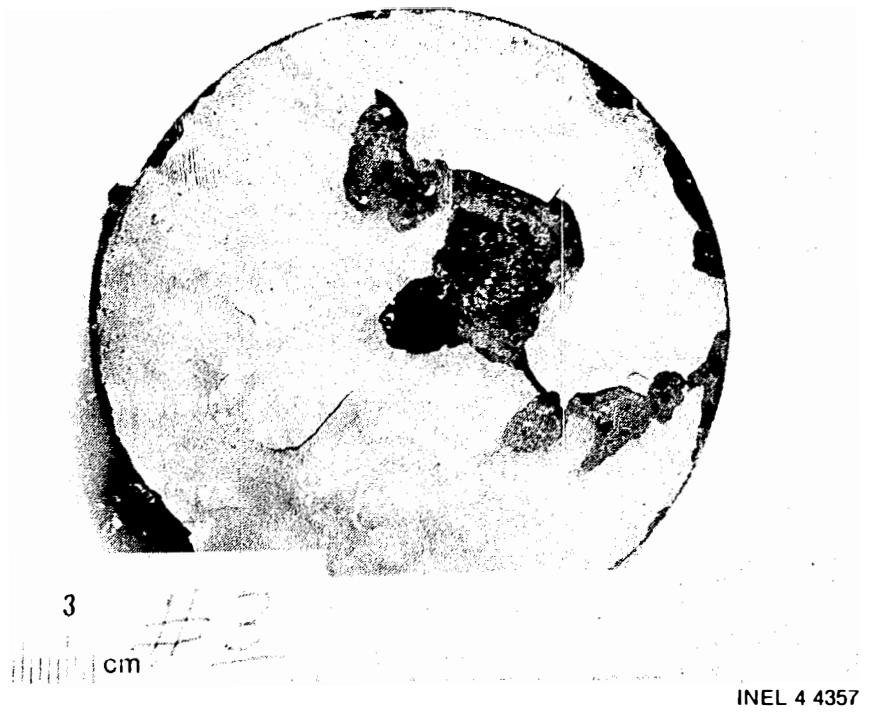
Figure 15. Photograph of the interior surface of Section 3 from liner PF-3 showing coating blisters and areas where coating is missing.

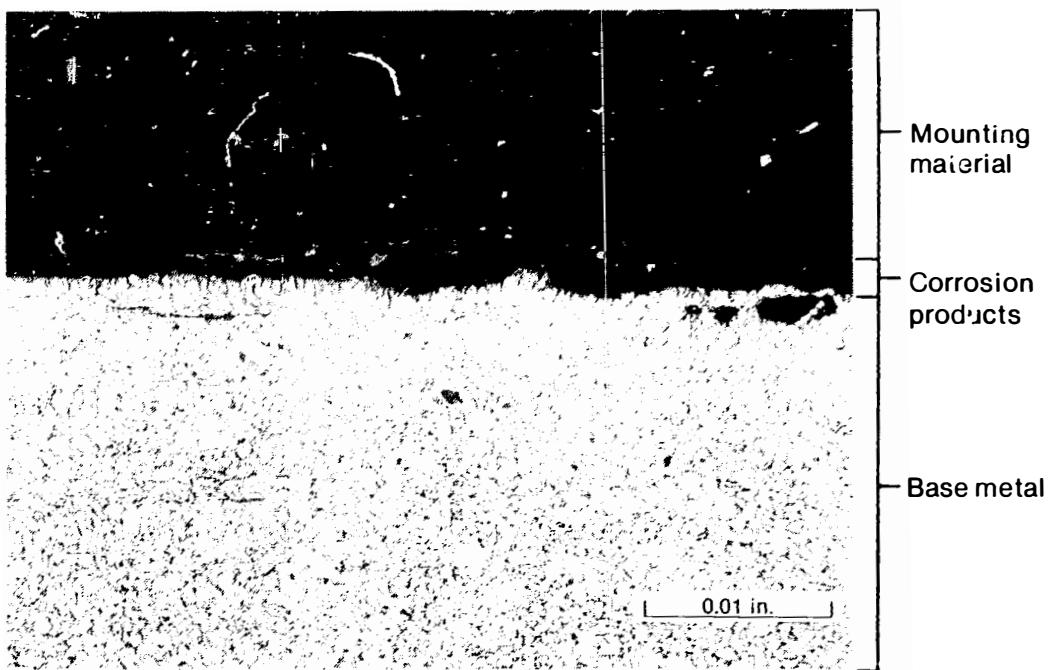
INEL 4 4352

Figure 16. Photomicrograph normal to the interior surface of Section 3 from liner PF-3 showing corrosion products in an area where coating had spalled.

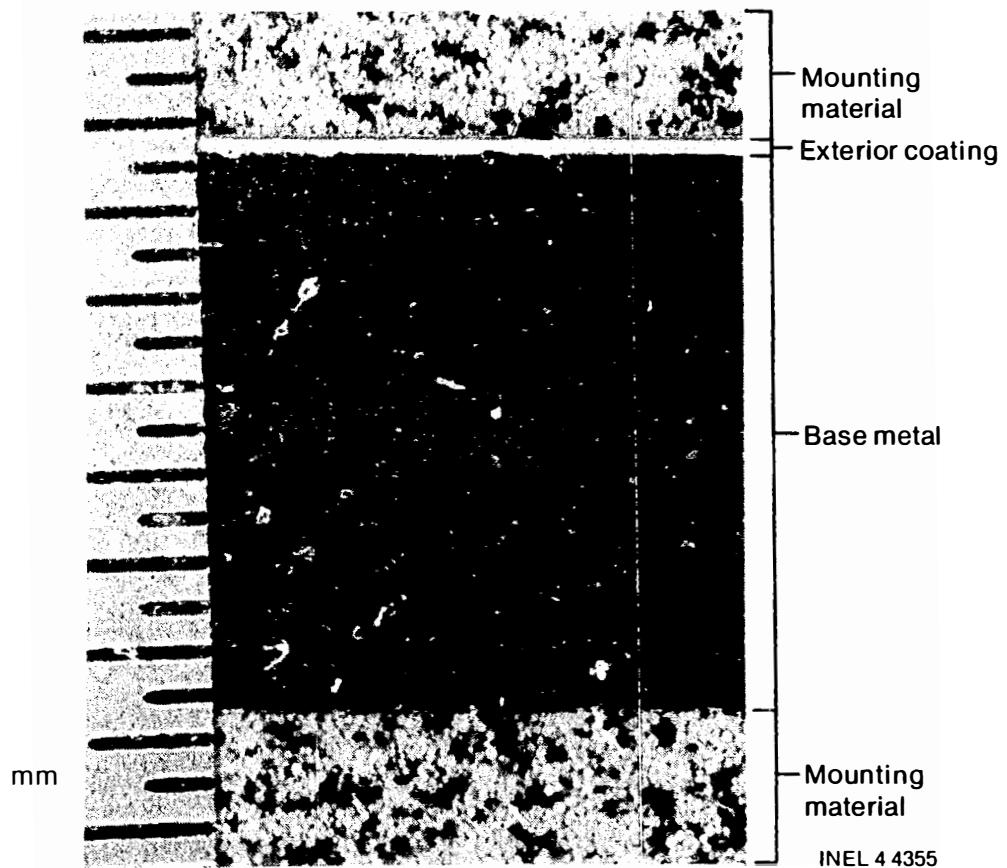
INEL 4 4355

Section 3, Specimen 1-B--The exterior surface of this specimen was examined at 100 magnification (Figure 17), and a heavy exterior phenolic coating of at least three layers was observed. Examination of the exterior surface at higher magnifications revealed corrosion products (about 0.0005-in. thick) between the coating and base metal, with a total coating thickness of about 0.010-in. (Figure 18). Evidence that the coating had been applied over previously present corrosion products is indicated by layers of coating between the base metal and corrosion products (Figure 19).

Figure 17. Photomicrograph normal to the wall of Section 3 from liner PF-3 showing the exterior coating and lack of coating on the interior surface.

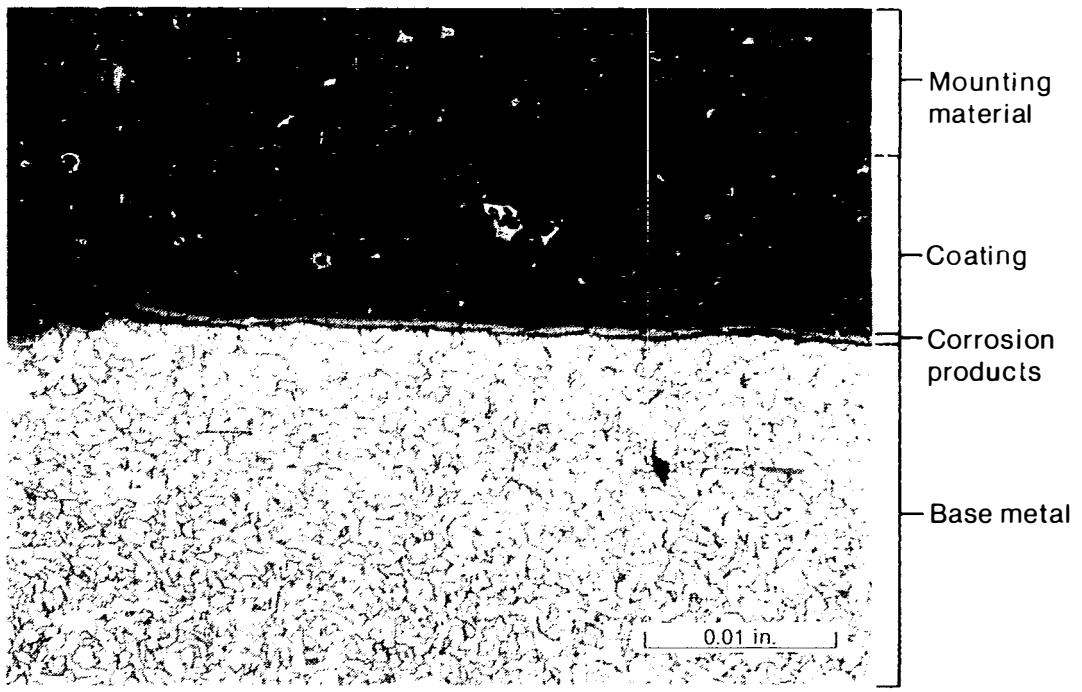
INEL 4 4354

Figure 18. Photomicrograph normal to the exterior surface of Section 3 of liner PF-3 showing corrosion products between the base metal and coating.

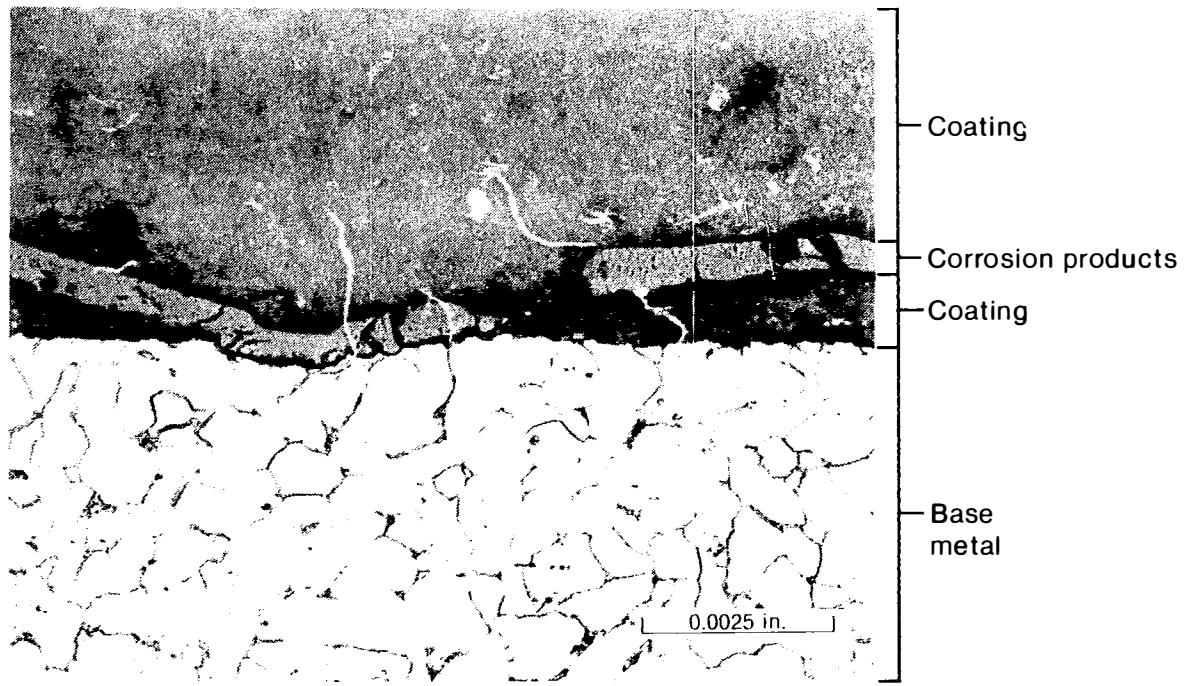
INEL 4 4334

Figure 19. Photomicrograph normal to the exterior surface of Section 3 of liner PF-3 showing coating between the base metal and corrosion products.

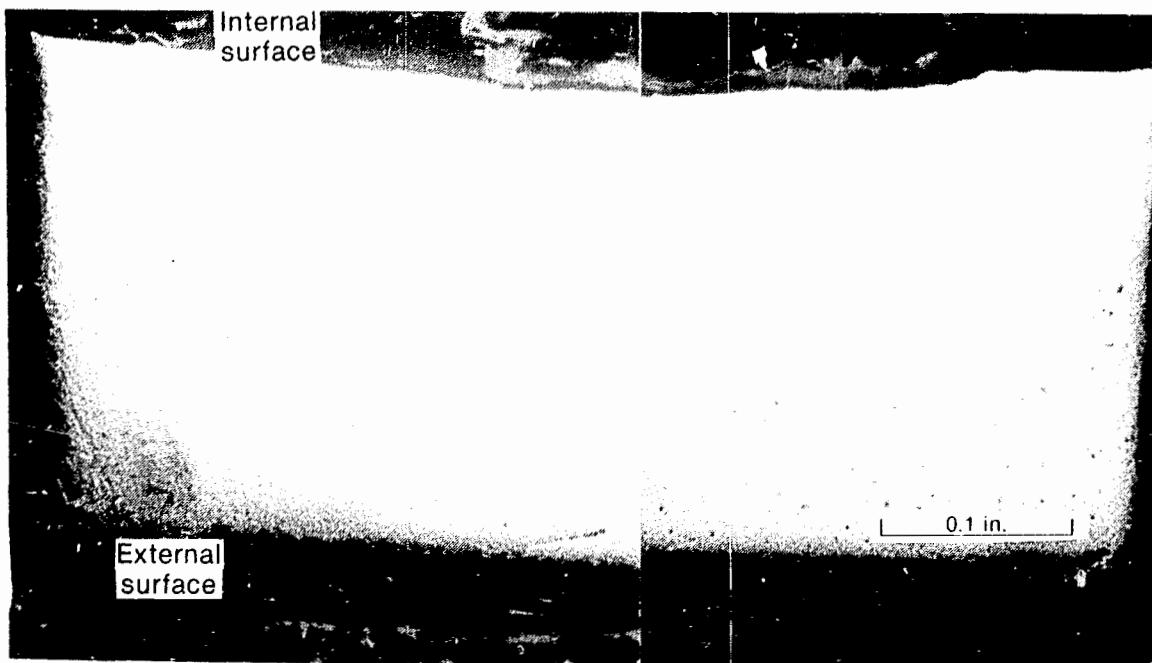
INEL 4 4370

Figure 20. Photomicrograph of Section 1, Specimen 1B (a vertical section from liner PF-3 normal to the grounding area for the conductivity probe) showing the horizontal depression on the internal surface.

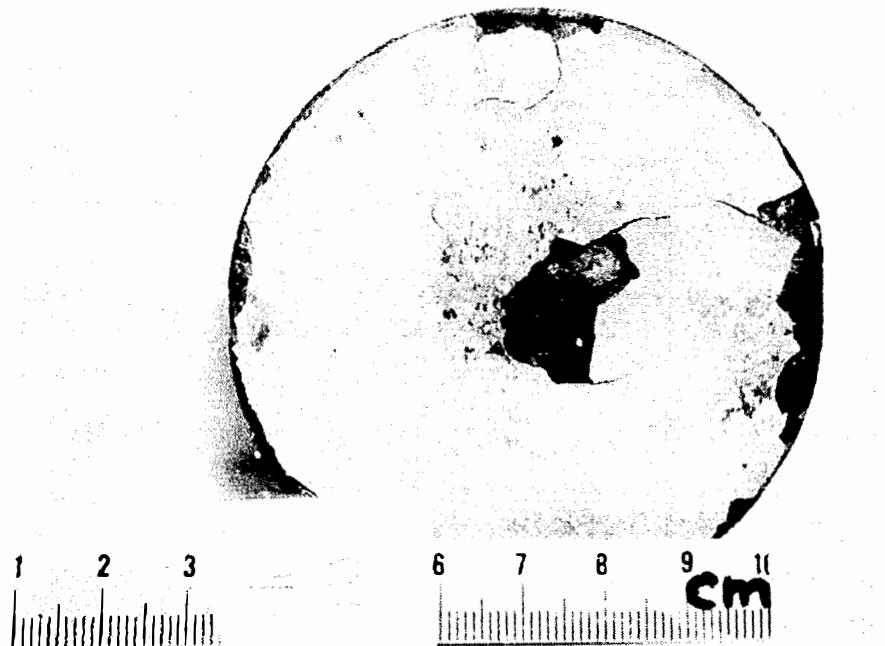
INEL 4 4338

Figure 21. Photograph of the interior surface of Section 2 from liner PF-3 showing coating blisters and areas where the coating is loose.

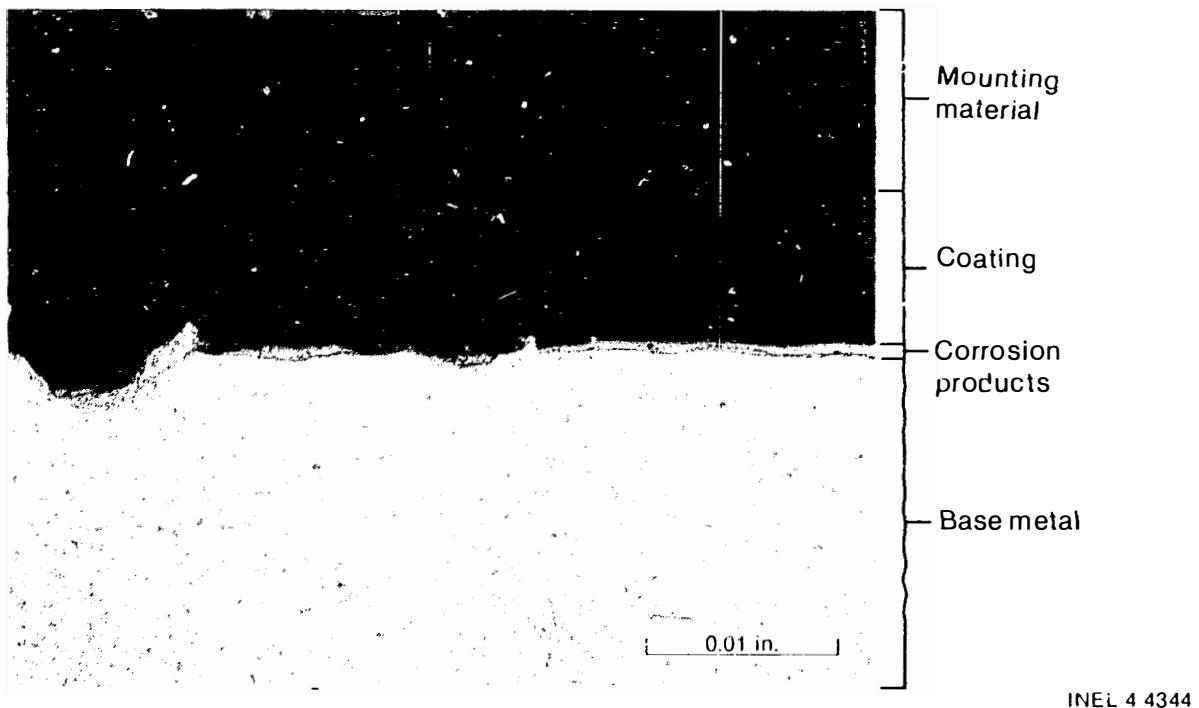
INEL 4 4344

Figure 22. Photomicrograph normal to the interior surface of Section 2 from liner PF-3 showing a surface discontinuity in the base metal.

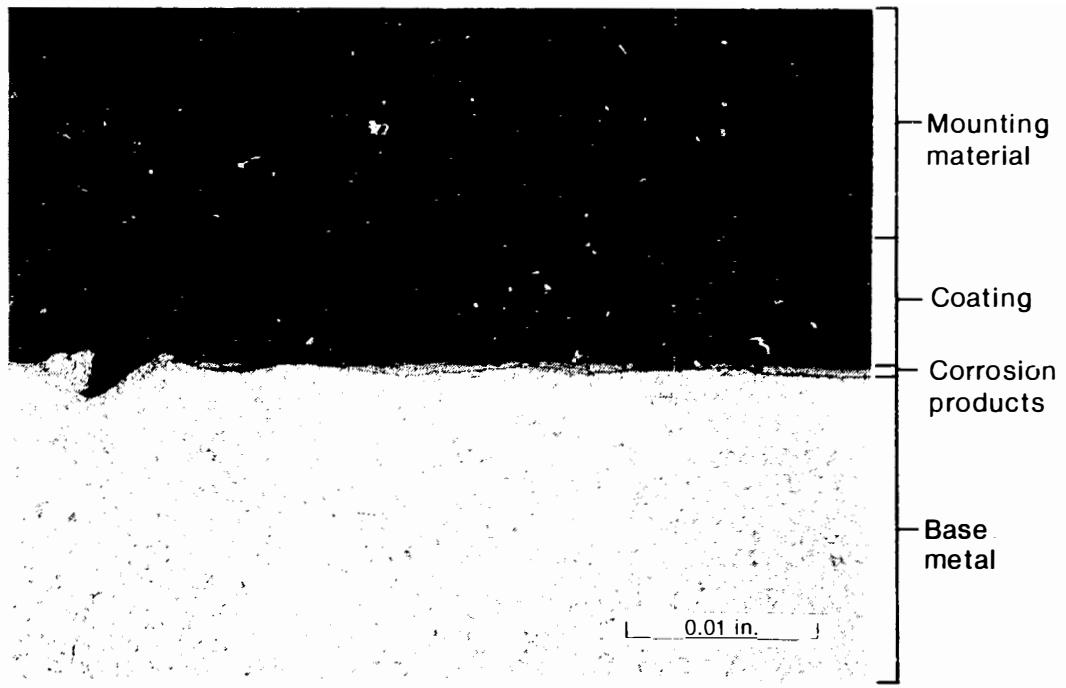
INEL 4 4345

Figure 23. Photomicrograph normal to the interior surface of Section 2 from liner PF-3 showing surface discontinuity in the base metal and an area where the coating is adhering to the base metal with no corrosion products.

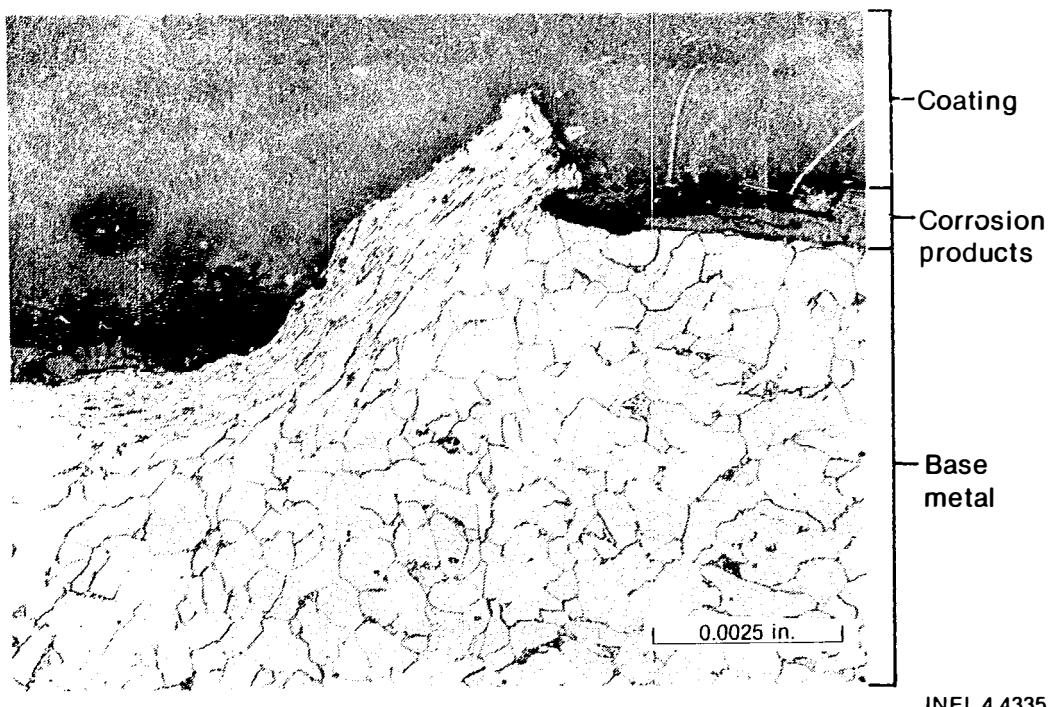
INEL 4 4335

adhering to both the base metal and corrosion products, which indicates the surface had been gouged before application of the coating (Figure 24).

Figure 24. Photomicrograph showing greater detail of discontinuity identified in Figure 22.

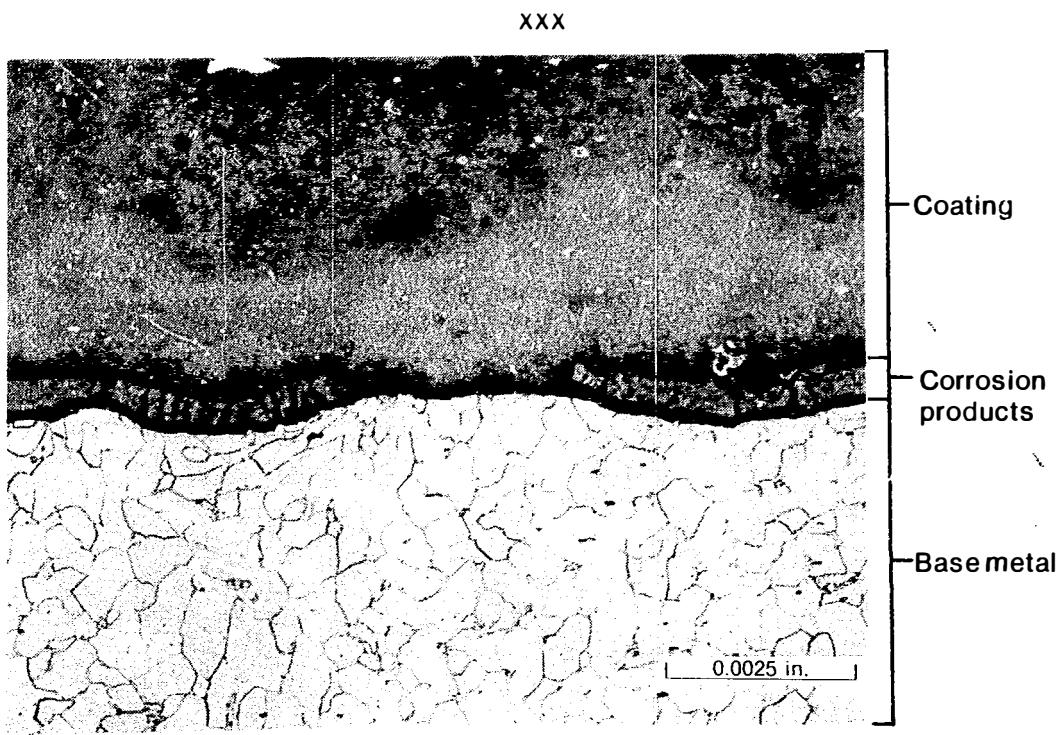
INEL 4 4336

Figure 25. Photomicrograph normal to the interior surface of Section 2 from liner PF-3 showing corrosion products adhering to the base metal and coating and an area where the coating is adhering to the base metal.

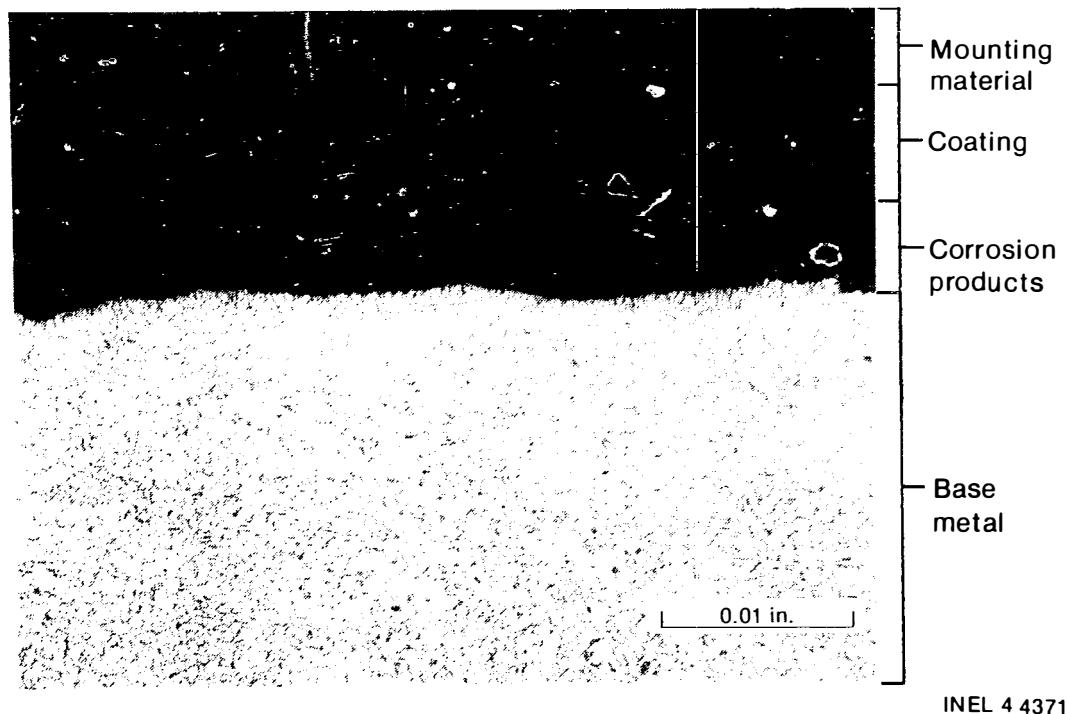
INEL 4 4371

Figure 26. Photomicrograph normal to the interior surface of Section 2 from liner PF-3 showing a cross section through a coating layer.

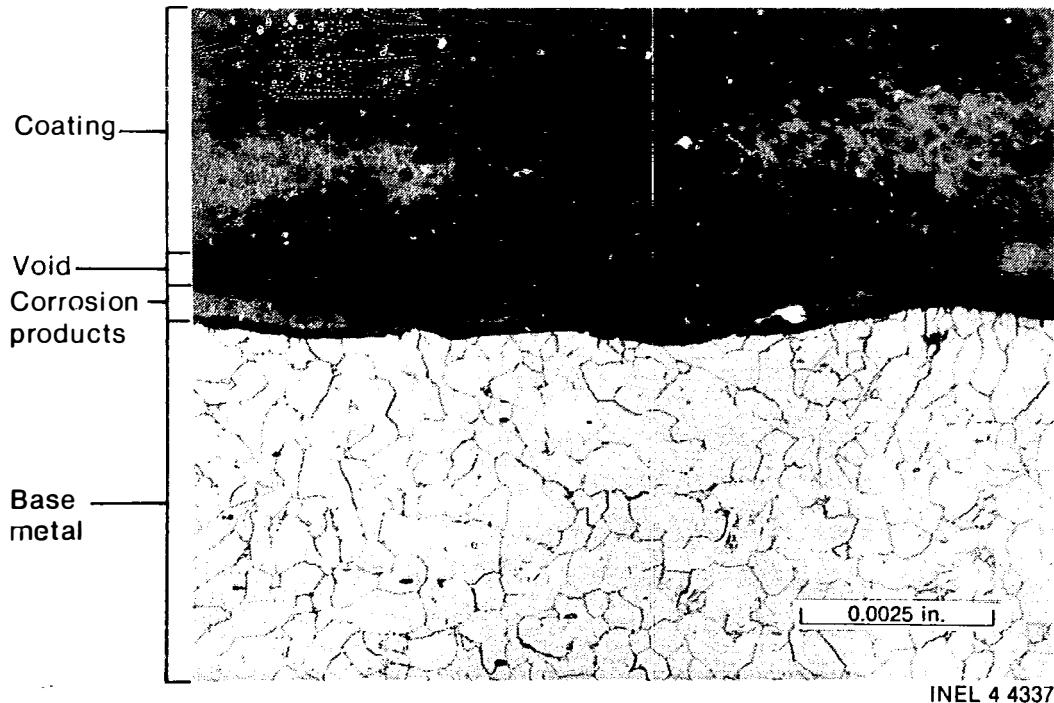
INEL 4 4337

Figure 27. Photomicrograph normal to the interior surface of Section 2 from liner PF-3 showing corrosion products adhering to the base metal and not the coating.

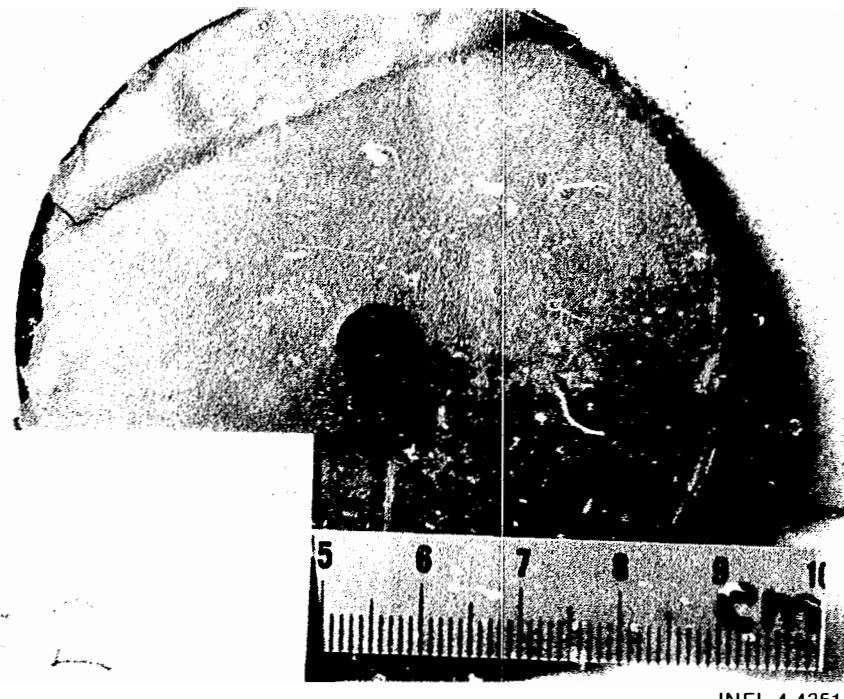
INEL 4 4351

Figure 28. Photograph of the interior surface of Section 2 from liner PF-16 showing a nearly defect-free coating.

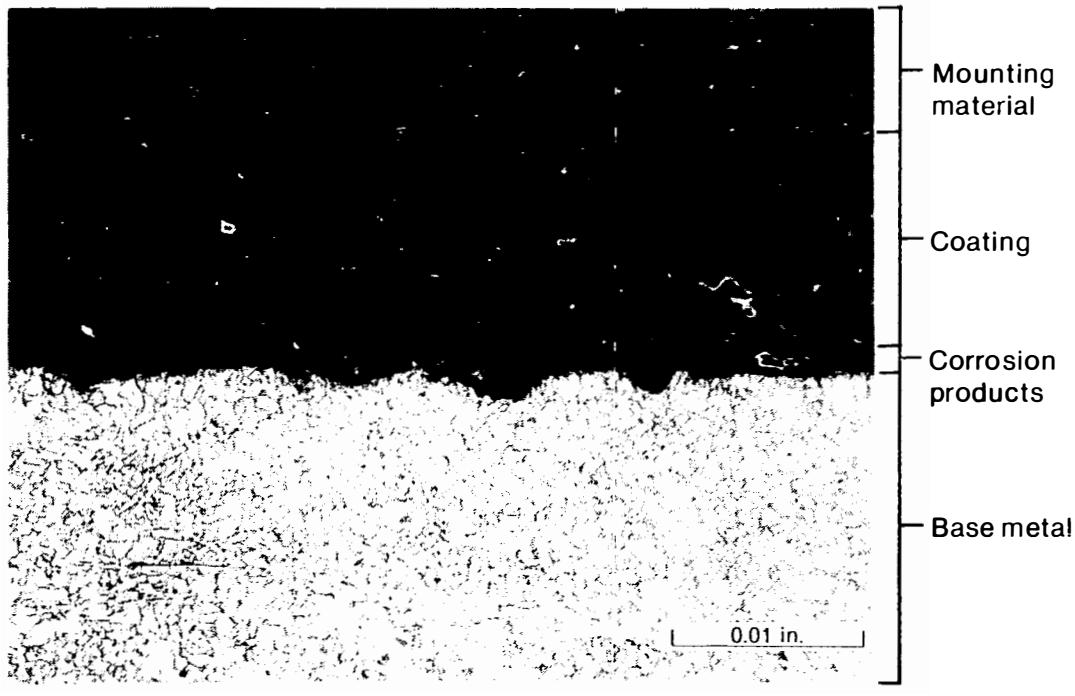
INEL 4 4346

Figure 29. Photomicrograph normal to the interior surface of Section 2 from liner PF-16 showing corrosion products between the coating and base metal.

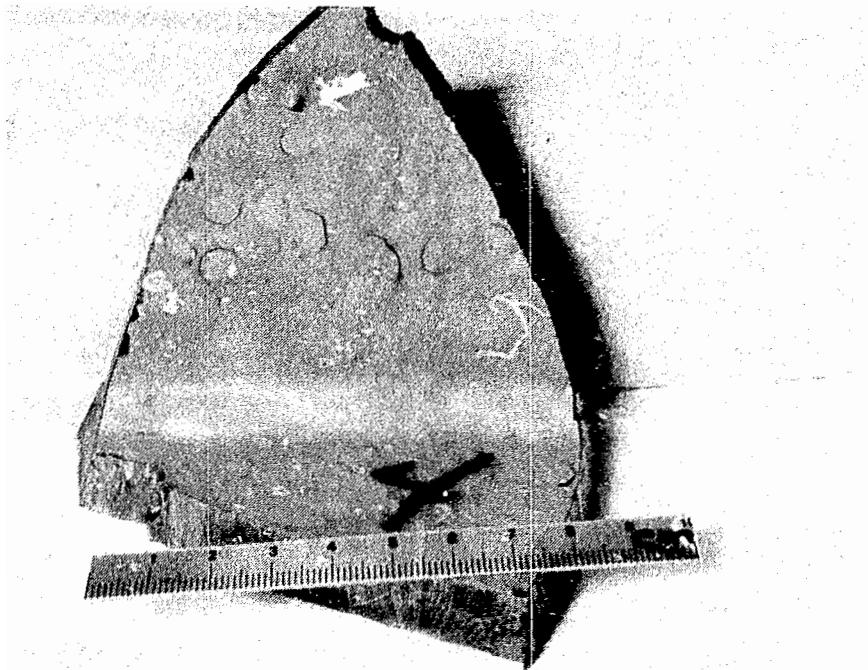
INEL 4 4342

Figure 30. Photograph of Section 4 from liner PF-16 showing blisters on the interior surfaces of both the bottom and sidewall of the liner.

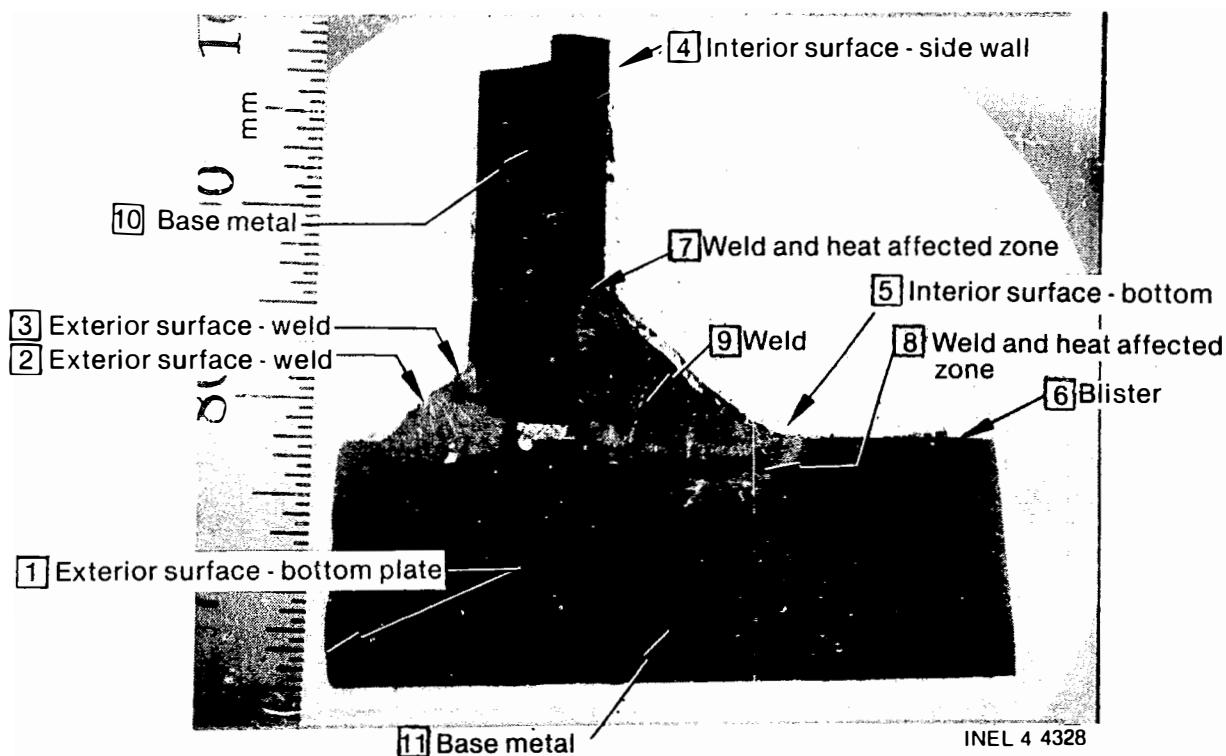
INEL 4 4328

Figure 31. Photograph of vertical section (Section 4 from liner PF-16) through the bottom plate to sidewall joint showing loose coating on the internal wall and surfaces of the welds. Note that the weld joints were not prepared prior to welding, and the welds were made with single passes for both the outside and the inside weld fillets. Location of metallurgical specimens from Section 4 are indicated.

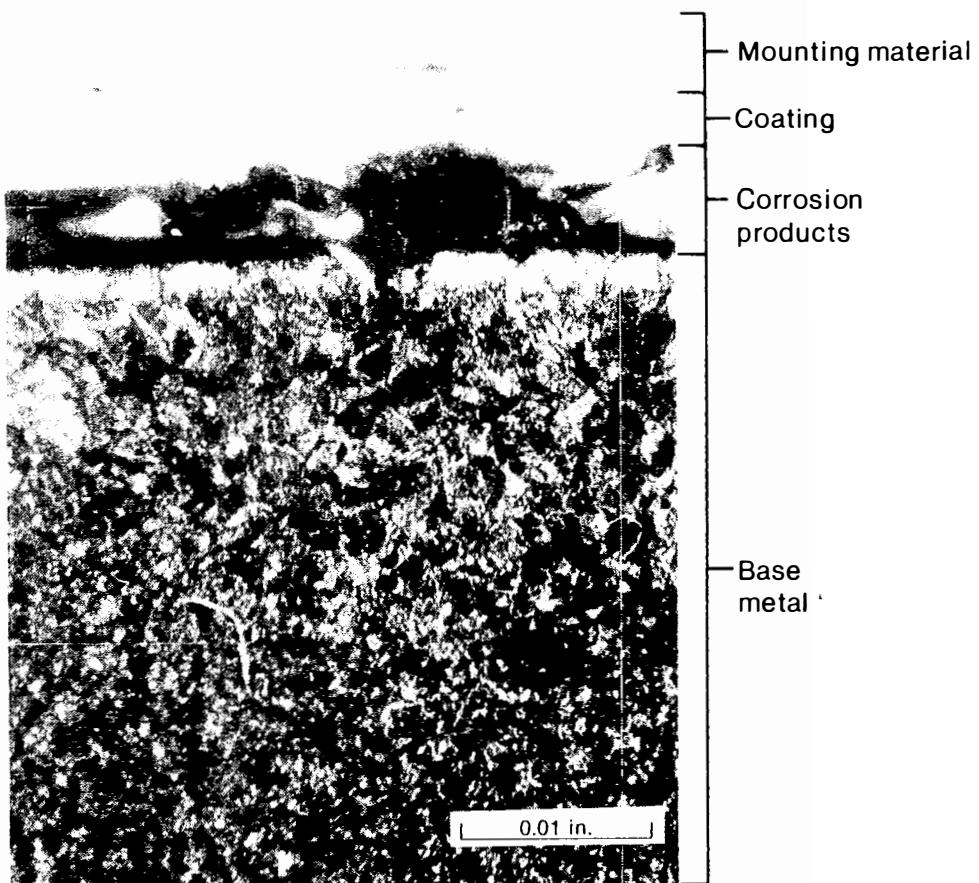
INEL 4 4341

Figure 32. Photomicrograph normal to the exterior of Section 4, Specimen 1 from liner PF-16 showing corrosion products between the coating and base metal (specimen illuminated with polarized light).

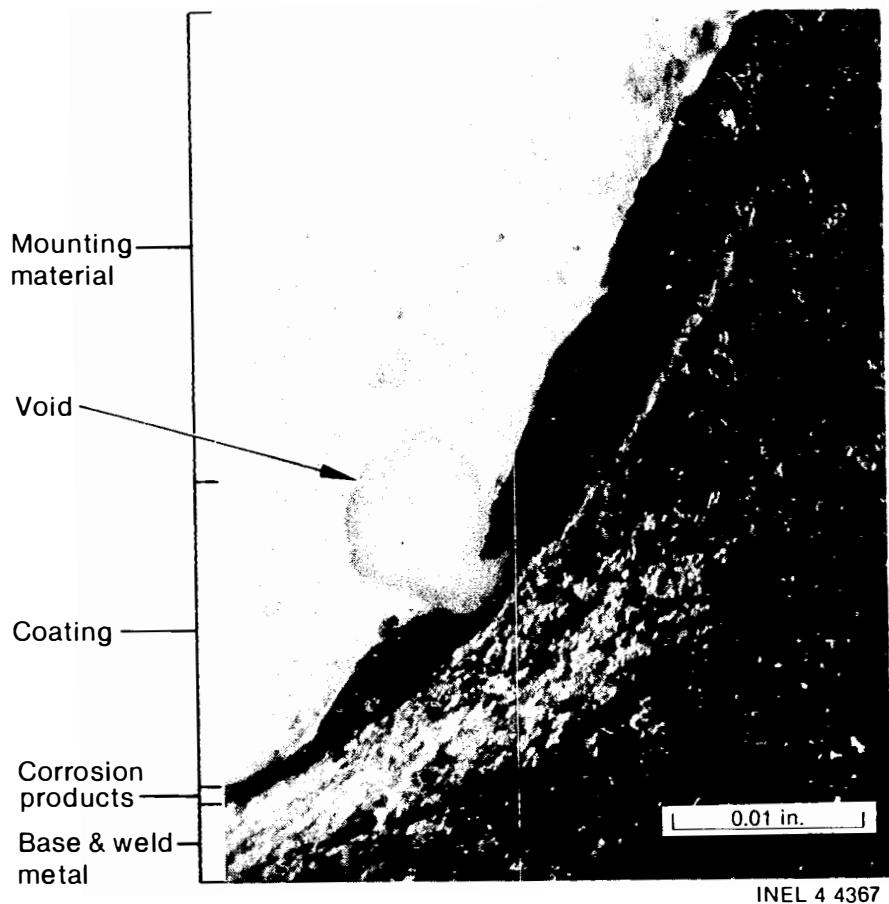
Figure 33. Photomicrograph of Section 4, Specimen 2 from liner PF-16 (made normal to the exterior weld surface) showing corrosion products between the coating and weld fillet and porosity in the coating (specimen illuminated with polarized light).

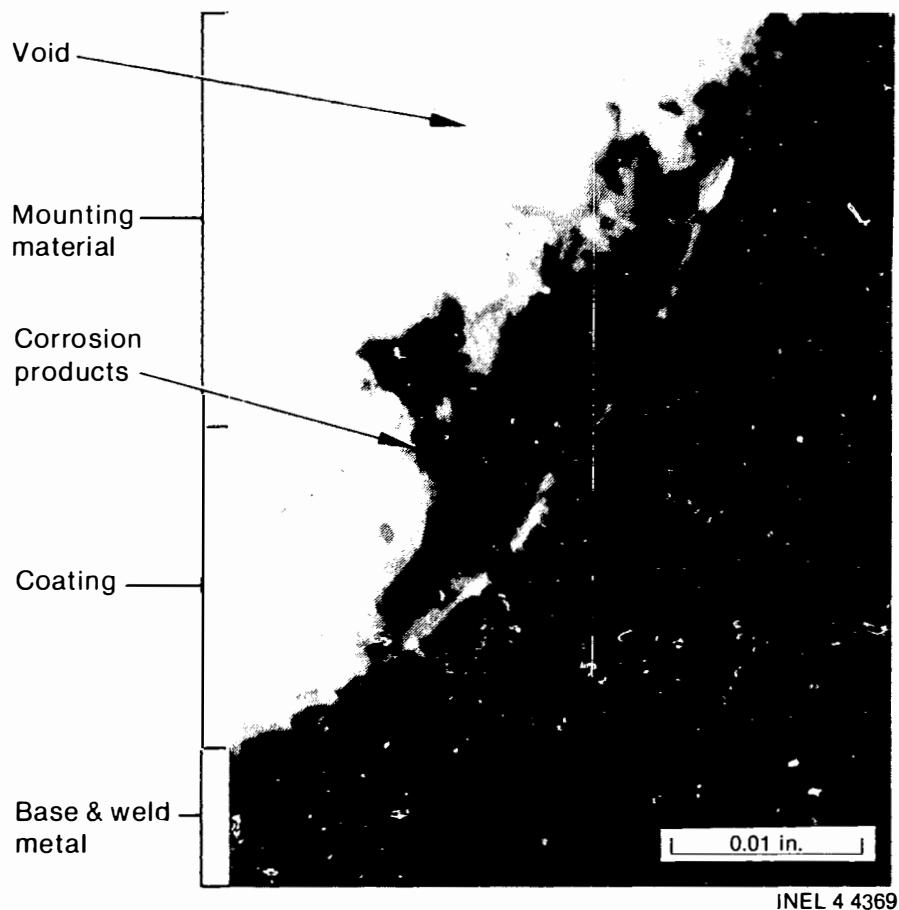
Figure 34. Photomicrograph of Section 4, Specimen 3 from liner PF-16 (made normal to the exterior weld surface) showing corrosion products at the weld surface extending into the coating (specimen illuminated with polarized light).

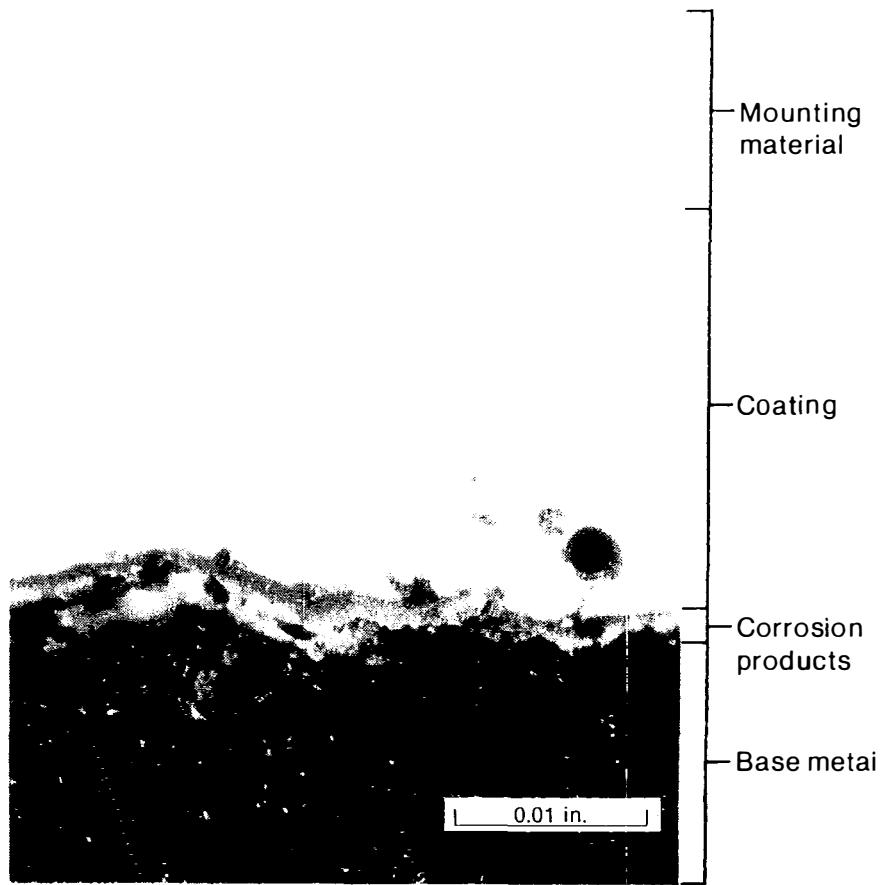
INEL 4 4368

Figure 35. Photomicrograph of Section 4, Specimen 4 from liner PF-16 (made normal to the interior surface of the sidewall) showing a heavy coating, corrosion products between the coating and base metal, and a surface gouge or scratch in the base metal (specimen illuminated with polarized light).
