# **METALLURGICAL EXAMINATION OF, AND RESIN TRANSFER FROM, THREE MILE ISLAND PREFILTER LINERS**

**John W. McConnell, Jr.  
Howard W. Spaletta**

**Published August 1984**

**EG&G Idaho, Inc.  
Idaho Falls, Idaho 83415**

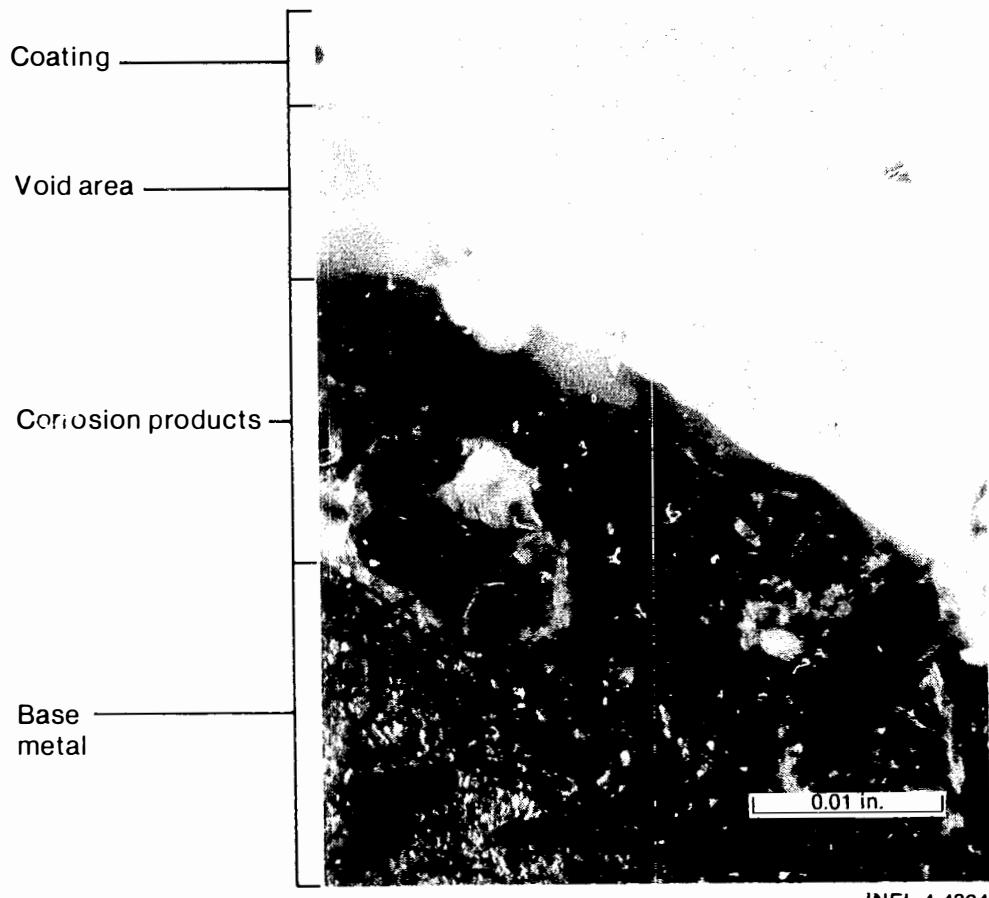
Figure 36. Photomicrograph of Section 4, Specimen 5 from liner PF-16 (made normal to the interior weld surface) showing separation between the coating and surface of the weld. Some corrosion products are evident in the separation (specimen illuminated with polarized light).

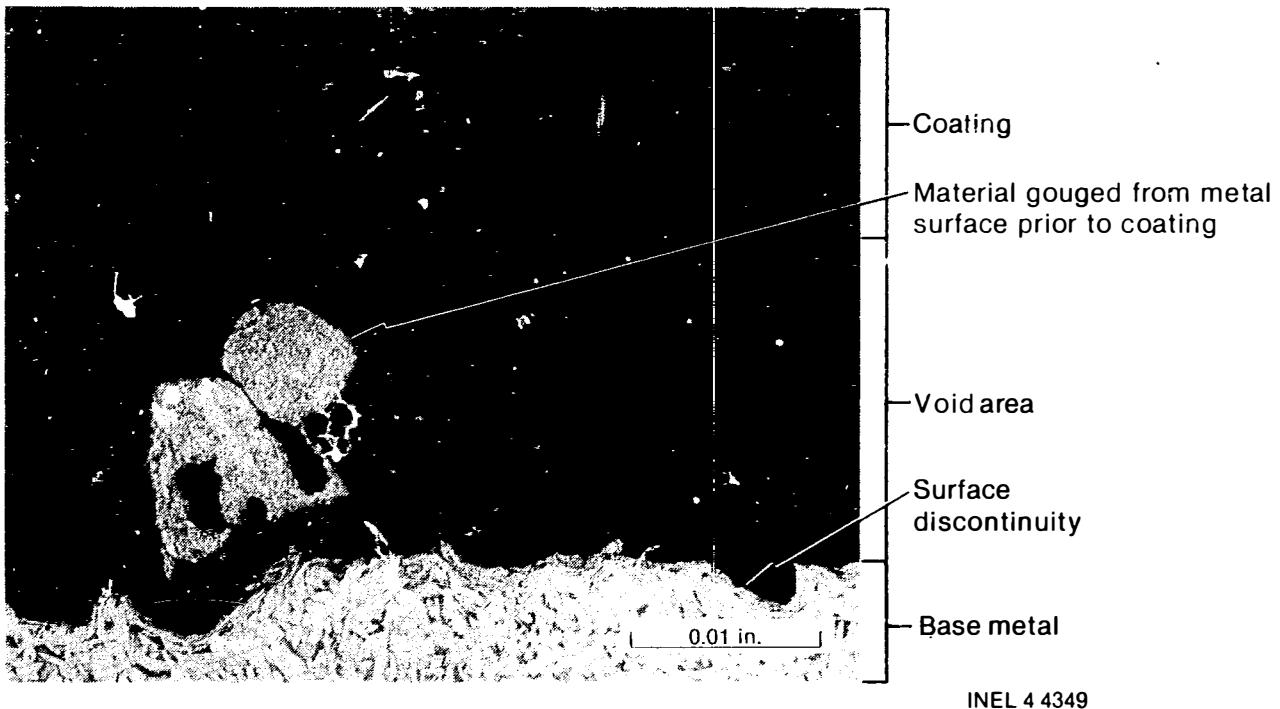
Section 4, Specimen 6--Surface discontinuities and large void areas were observed under the blister on Specimen 6, which was prepared from the inside of the bottom plate (Figure 37). The surface discontinuities indicate that the base metal had been gouged during fabrication.

Figure 37. Photomicrograph of Section 4, Specimen 6 from liner PF-16 (made normal to the interior surface of the bottom plate) showing surface discontinuities and large void areas under the blister between the coating and the base metal.

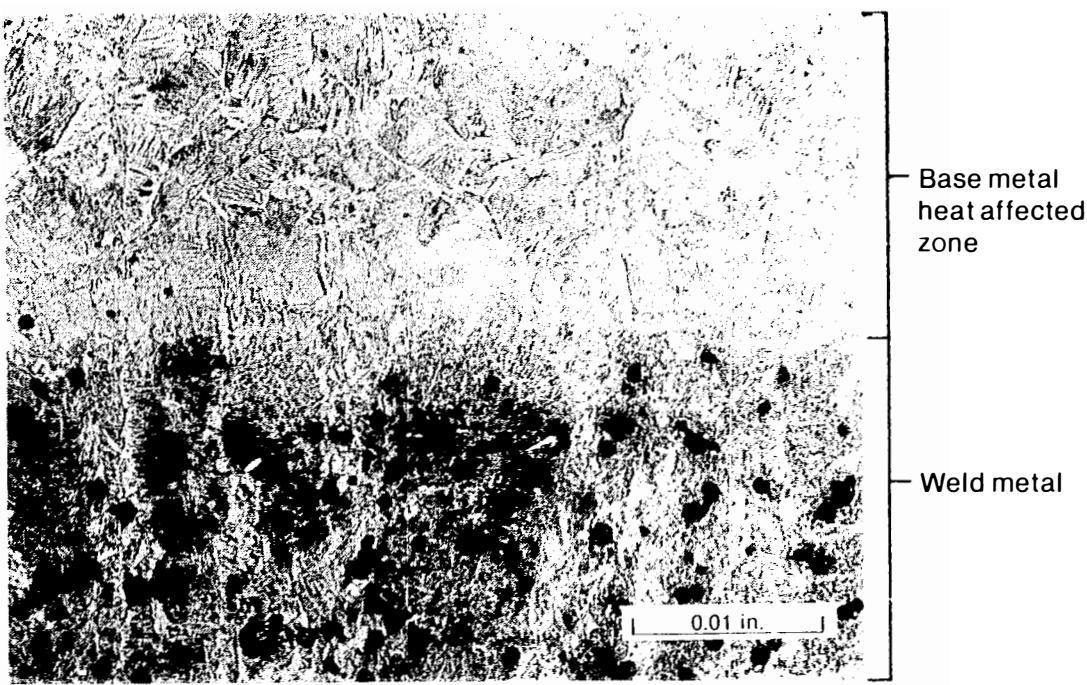
INEL 4 4340

Section 4, Specimens 7 and 8--Examination of specimens from the heat affected zones and weld deposits in the liner wall (Specimen 7, Figure 38) and bottom plate (Specimen 8, Figure 39) revealed dark spheres in the weld deposit, which are voids or nonmetallic inclusions.

Figure 38. Photomicrograph of Section 4, Specimen 7 from liner PF-16 showing the heat affected zone in the liner wall and weld deposit. The dark spheres are voids or nonmetallic inclusions in the weld deposit.

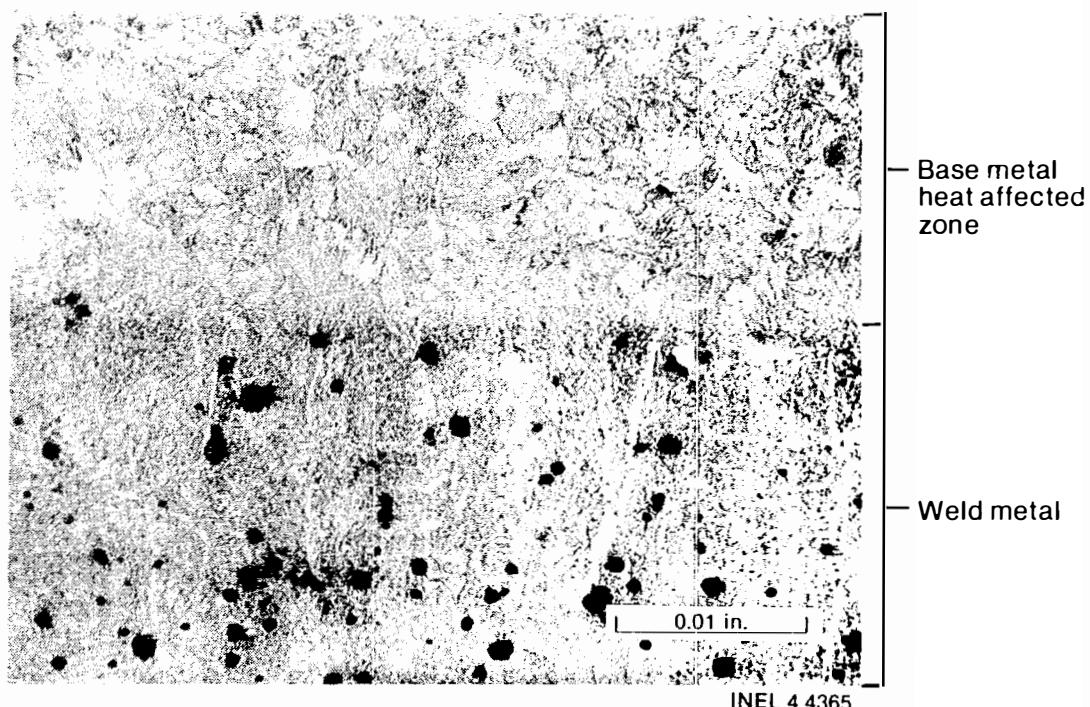
INEL 4 4365

Figure 39. Photomicrograph of Section 4, Specimen 8 from liner PF-16 showing the heat affected zone in the liner bottom plate and weld deposit. The dark spheres are voids or nonmetallic inclusions in the weld deposit.

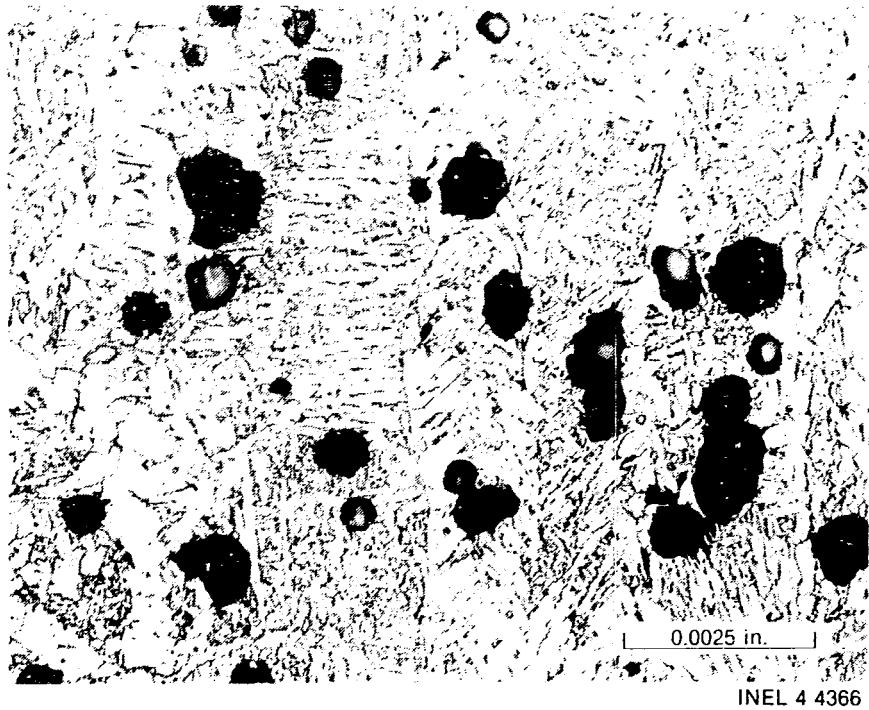
Figure 40. Photomicrograph of Section 4, Specimen 9 from liner PF-16 showing voids and nonmetallic inclusions at the center of the inner weld.

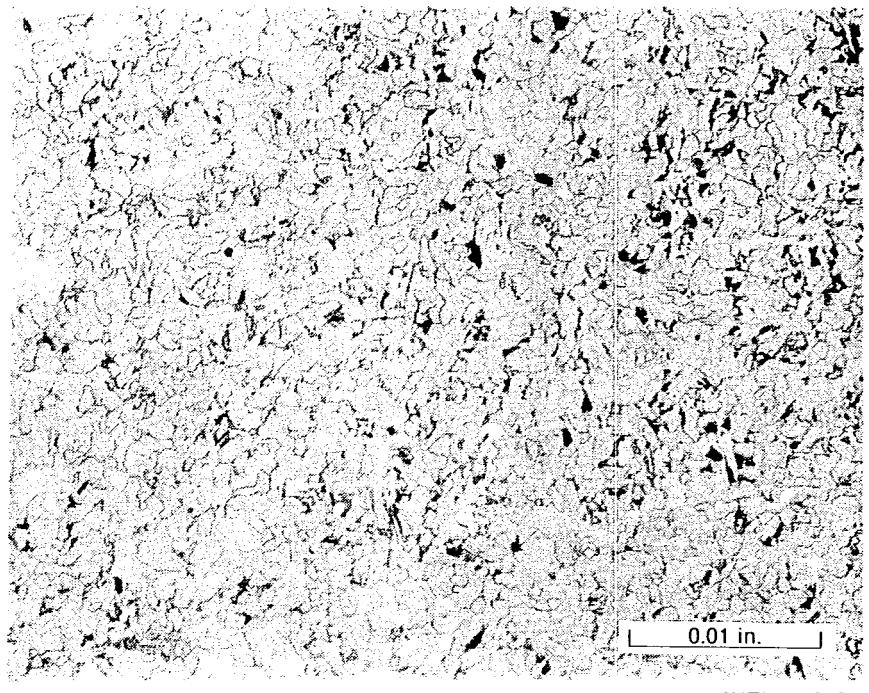
Figure 41. Photomicrograph taken from the liner wall of Section 4, Specimen 10 from liner PF-16 showing a fine-grained (ASTM grain size No. 8 or finer) base metal.

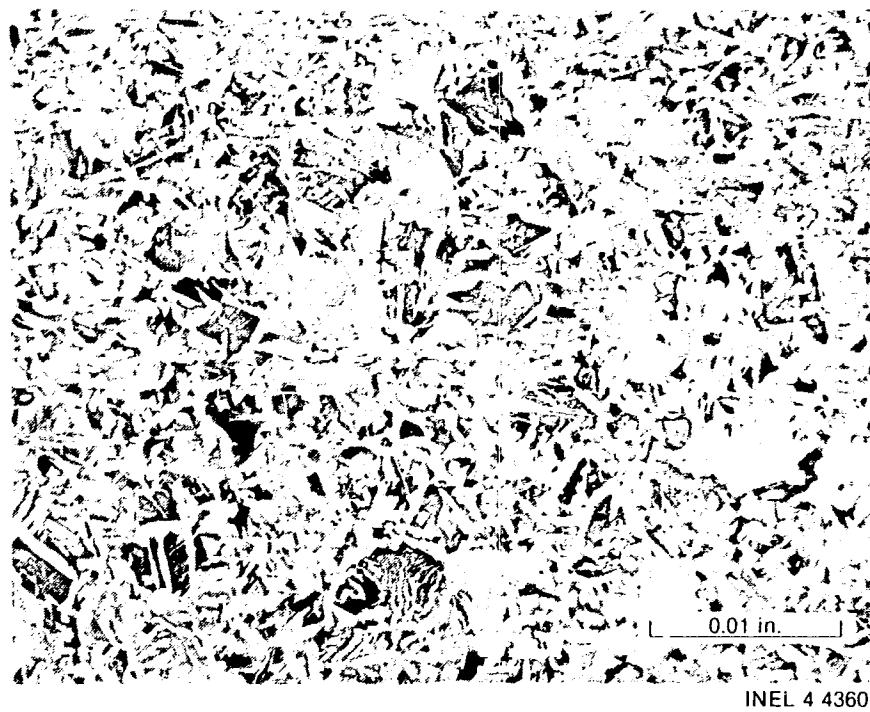
Figure 42. Photomicrograph of the base metal taken from the bottom plate of Section 4, Specimen 11 from liner PF-16 showing pearlitic (black) and ferritic (white) structures (ASTM duplex grain size No. 6 to 8).

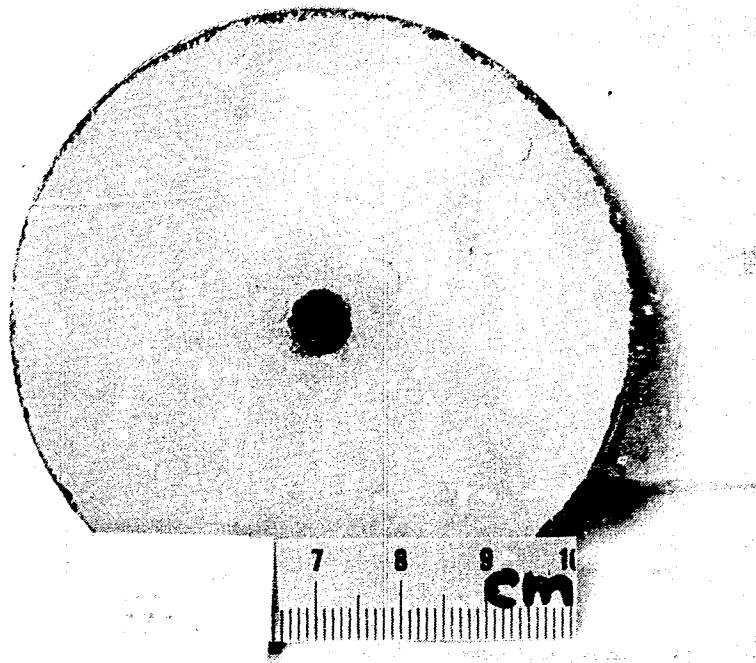
Figure 43. Photograph of the interior surface of Section 5 from liner PF-16 showing an adherent, nearly defect-free coating.

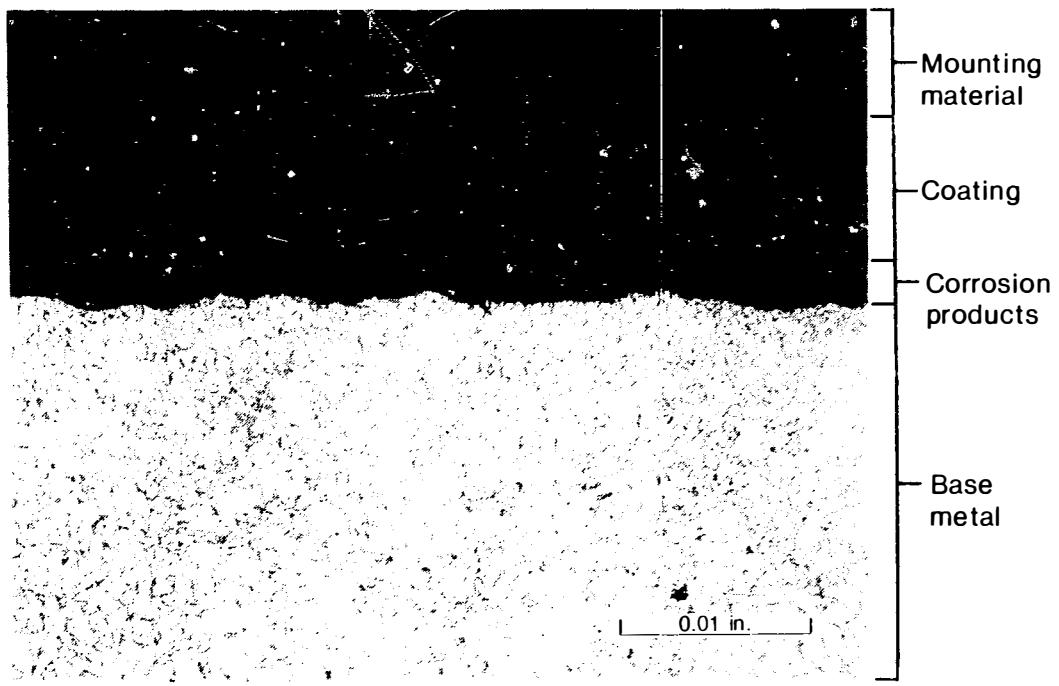
INEL 4 4350

Section 5, Specimen 1--Examination of Specimen 1 revealed some corrosion products (about 0.0015-in. thick) between the coating and base metal and a coating thickness of about 0.010 in. (Figure 44). Further examination using polarized light (Figure 45) revealed coating (light colored material) between the corrosion products (medium dark lines) and base metal (dark granular area), which indicates that the coating had been applied over the corrosion products.

Figure 44. Photomicrograph normal to the internal surface of Section 5 from liner PF-16 showing some corrosion products between the coating and base metal interface.

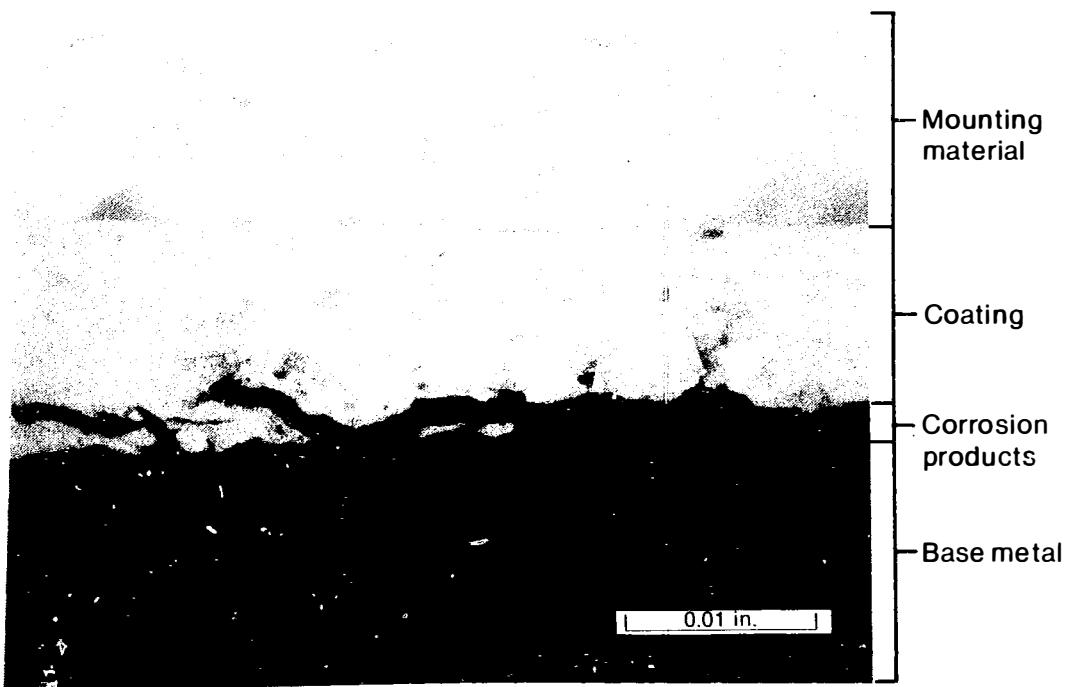
INEL 4 4359

Figure 45. Photomicrograph normal to the internal surface of Section 5 from liner PF-16 showing coating between the base metal and corrosion products (specimen illuminated with polarized light).

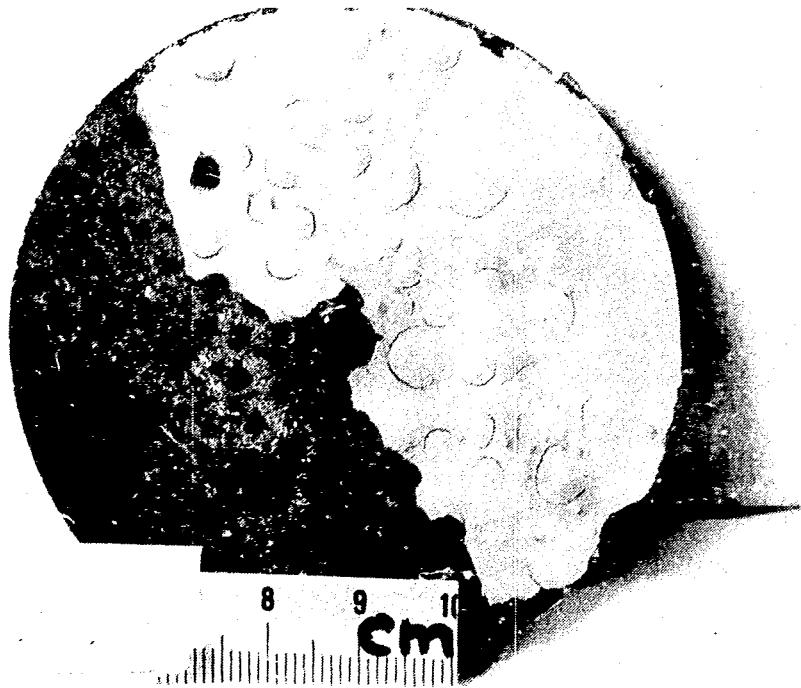
Figure 46. Photograph of the interior surface of Section 6 from liner PF-16 showing blisters and exposed base metal.

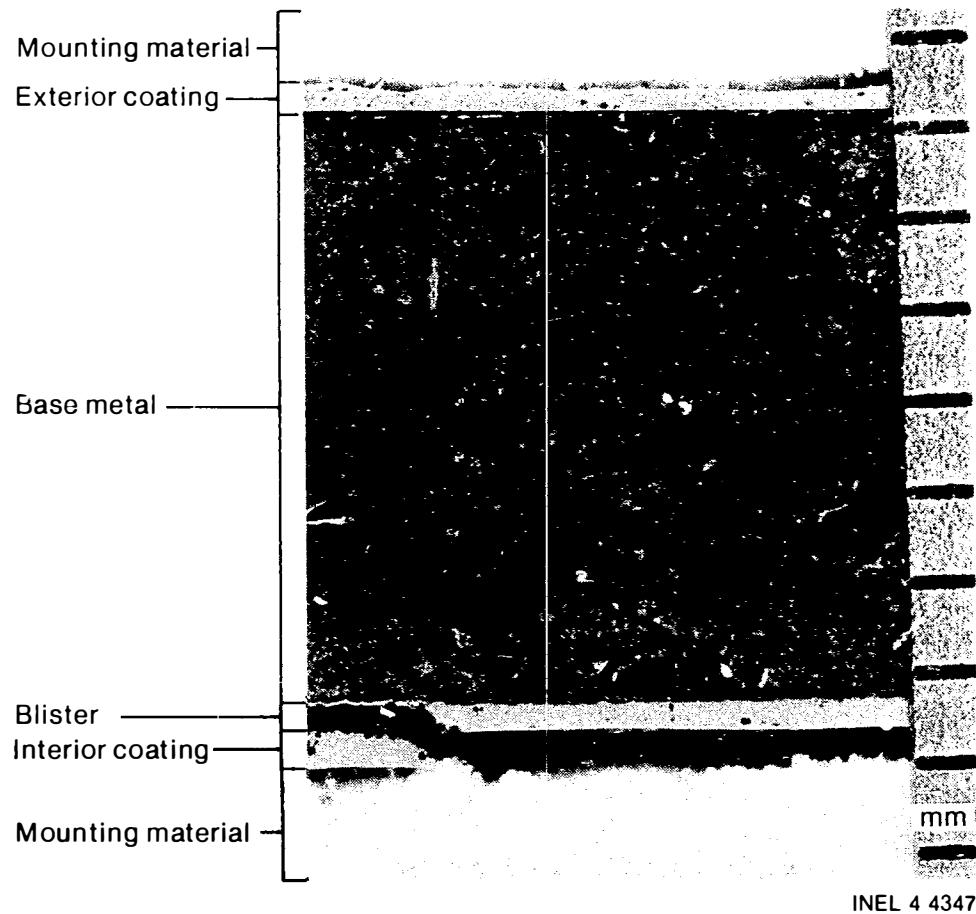
INEL 4 4347

Figure 47. Photomicrograph normal to the wall of Section 6 from liner PF-16 showing coating on the interior surface (bottom) and exterior surface (top). The coating at bottom left is breeched at the edge of a blister.

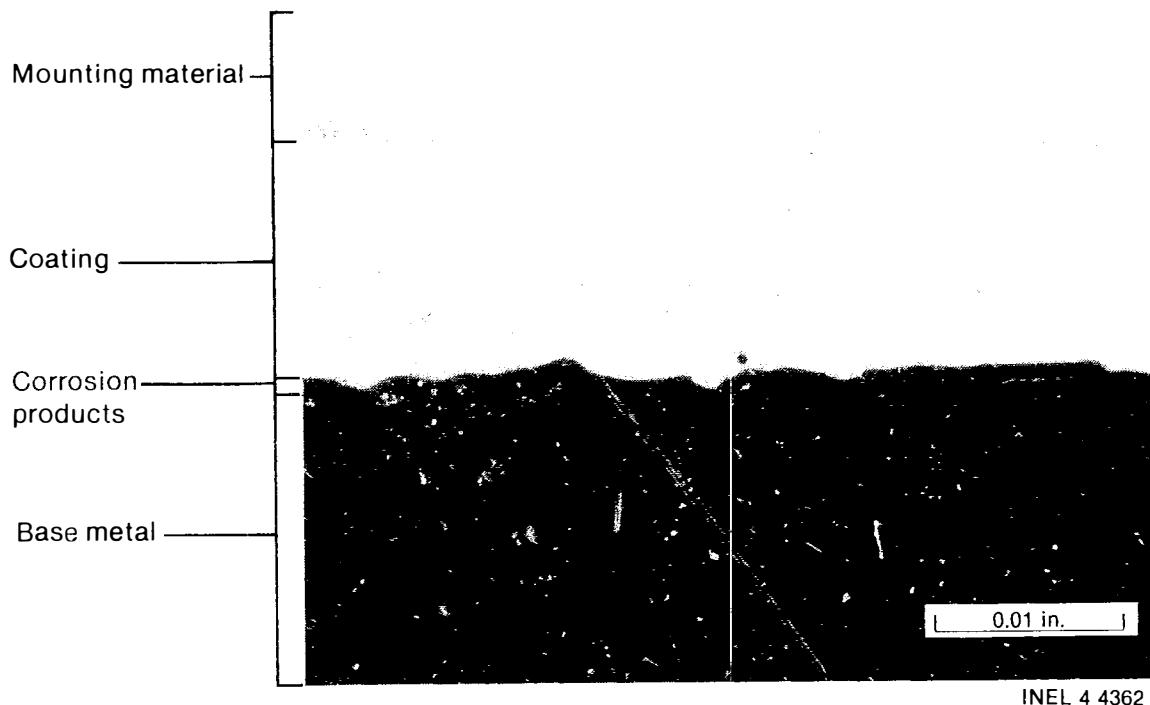
Figure 48. Photomicrograph normal to the internal surface of Section 6 from liner PF-16 showing corrosion products between the coating and base metal (specimen illuminated with polarized light).

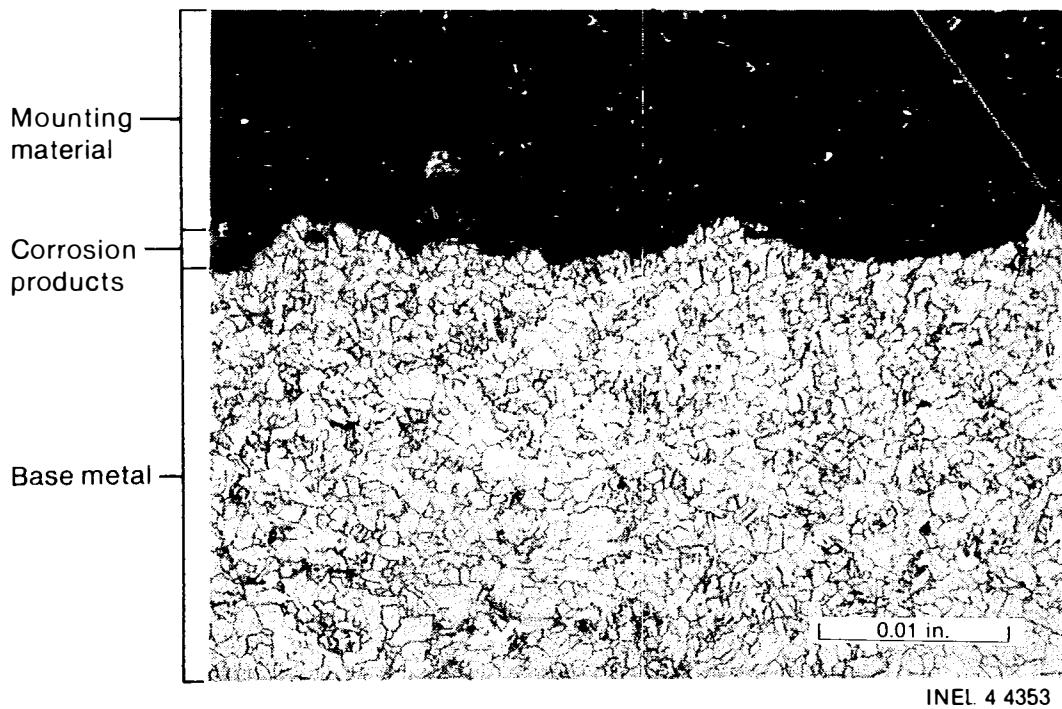
Figure 49. Photomicrograph normal to the internal surface of Section 6 from liner PF-16 showing corrosion products in an area where coating has spalled. Note discontinuity at right edge.

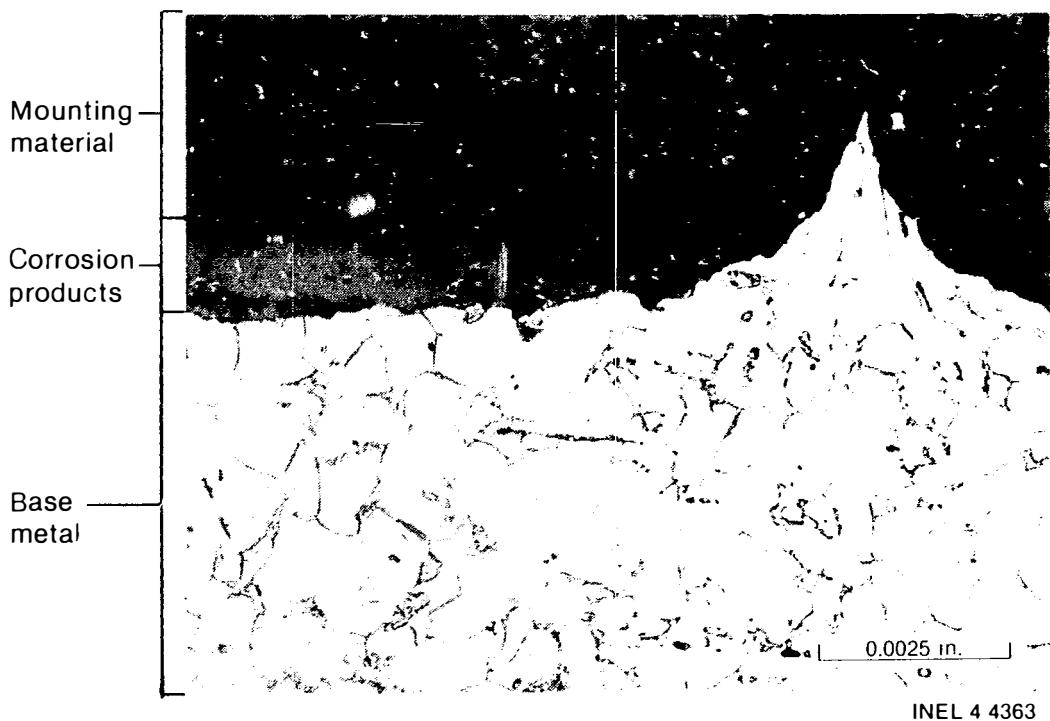
Figure 50. Photomicrograph showing greater detail of the discontinuity identified in Figure 49.
