Docket No. 50-320

Mr. S. K. Kanga, Director  
Three Mile Island Unit 2  
GPU Nuclear Corporation  
P.O. Box 480  
Middletown, PA 17057

Subject: Reactor Building Polar Crane Load Test

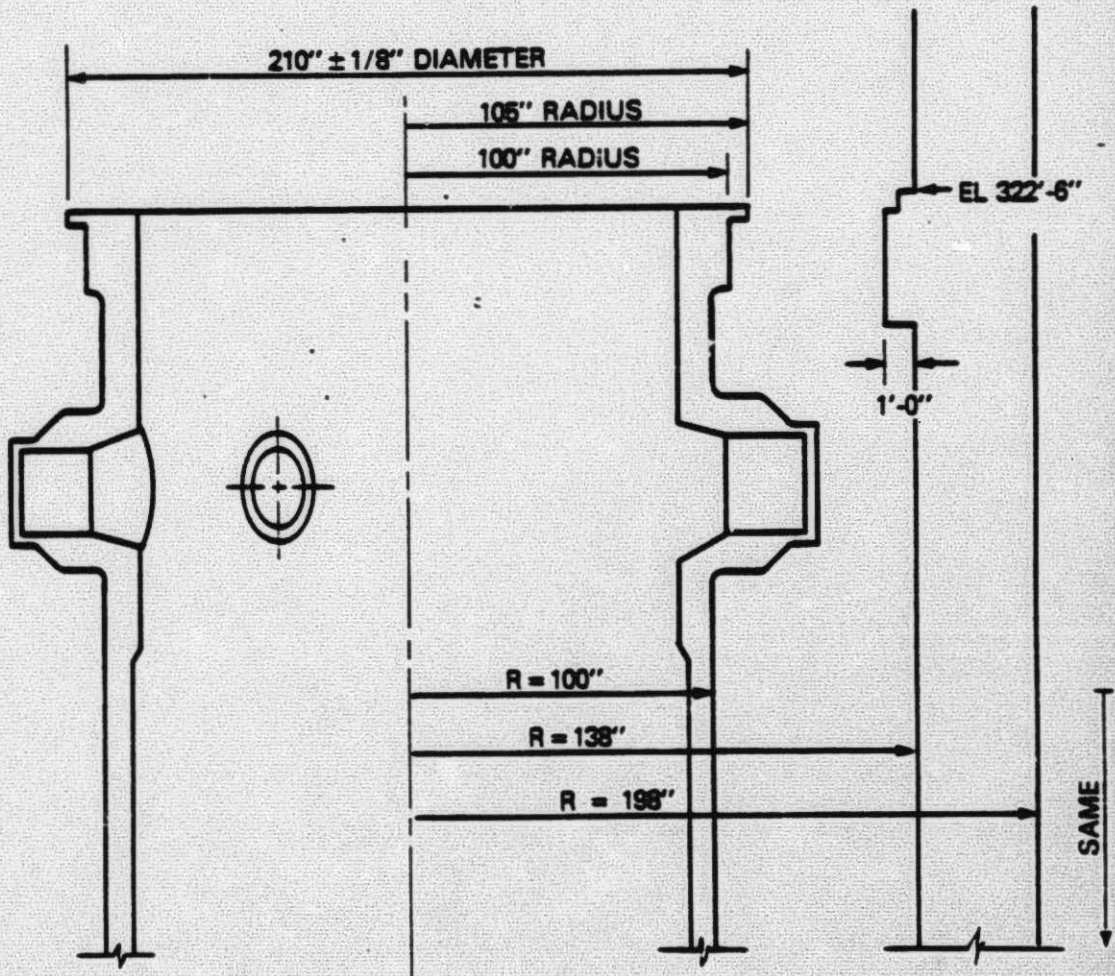
FIGURE 10.2

We have considered the consequences of a missile shield drop on the reactor vessel head and service structure. The worst case credible event would be the fracturing of one of the pipes (e.g., core flood inlet) penetrating the reactor vessel, resulting in the draining of a portion of the reactor coolant. But, even in this case, the reactor coolant would drain down only to the level of the pipe inlet nozzle which is still above the core. Thus, the core would remain covered. The lost reactor coolant would collect in the reactor building basement and would not pose significant radiological risks

AT ELEVATION 322'-6" CLEARANCE =  $138'' - 105'' - 12'' =$   
= 21"  
= 1'-9"

BELOW NOZZLE @ 291'-0" ELEVATION =  $138'' - 100'' = 38''$   
= 3'-2"
