TMI-2 REACTOR VESSEL HEAD REMOVAL

GEND-INF-062

Published December 1984

GPU Nuclear Corporation
Middletown, PA 17057

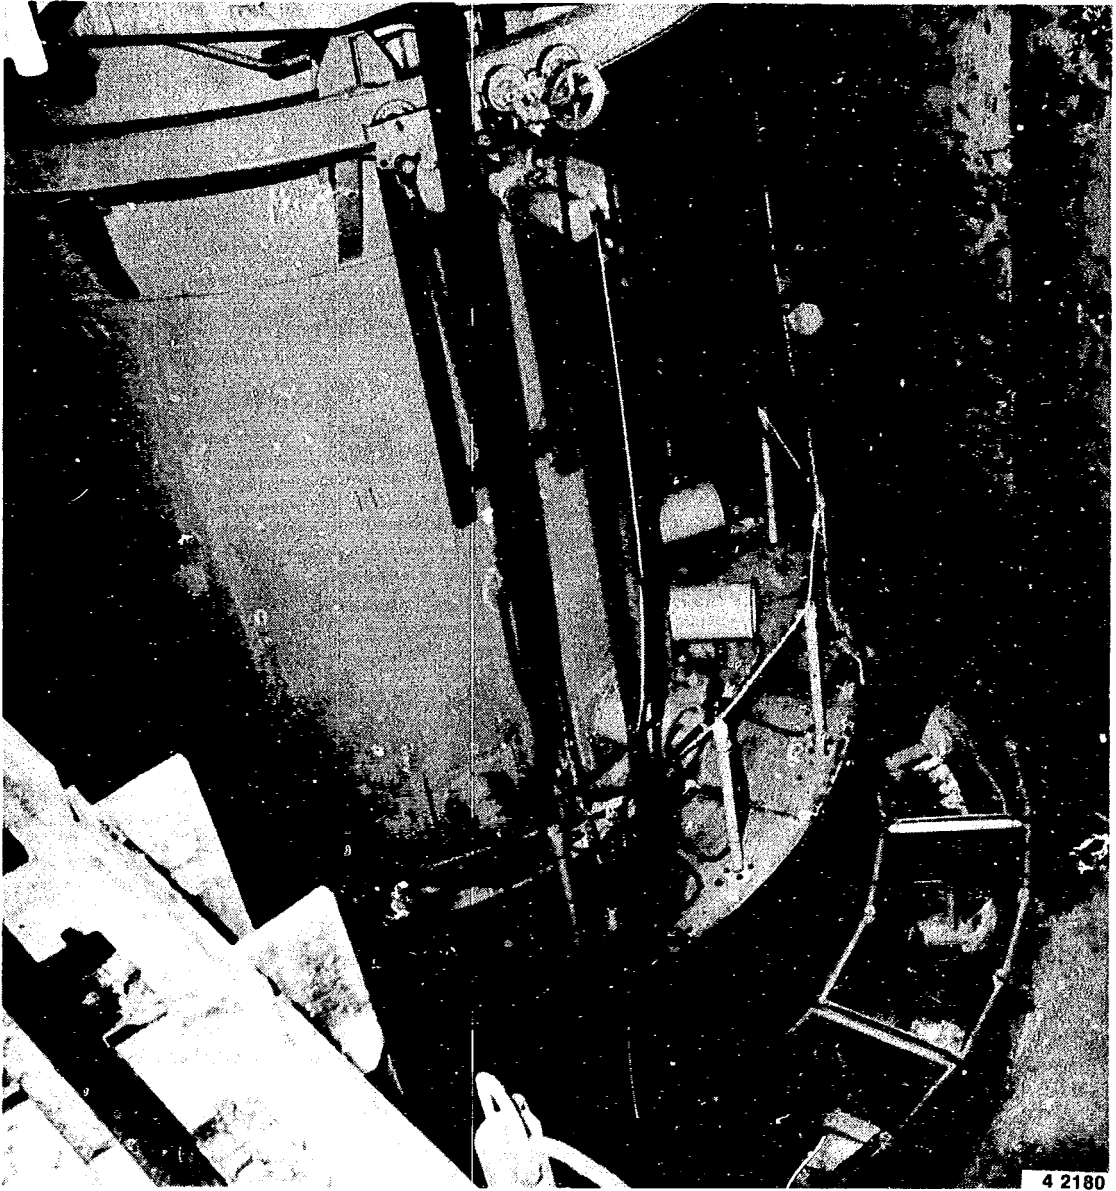
Figure 7. Service structure showing fans and exhaust ports, neutron shield tanks, walkway over reflective insulation, and hoist.

During the accident, the service structure fans became highly contaminated because they were circulating contaminated reactor building air (Figure 7). The service structure was flushed to provide dose rate

reduction in the area of the reactor vessel head flange. The flushing did reduce area dose rates but did not eliminate the dose rate contribution of the fans. After flushing, the 12 fans were removed from the service structure and disposed of as radioactive waste.

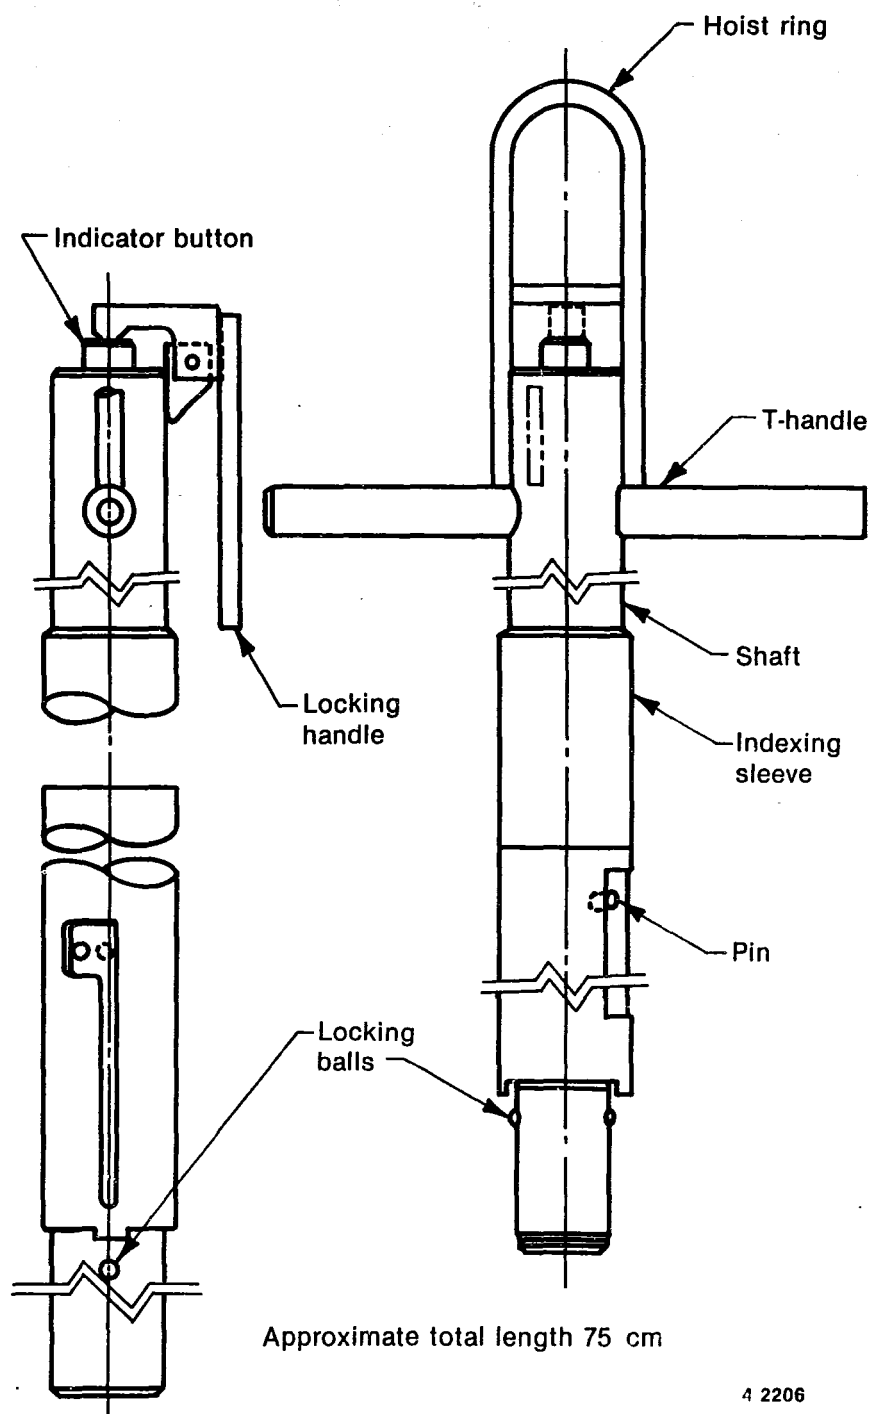
Figure 13. Lead screw lifting tool.

One of the lead screws, while being lifted with the lifting tool, became bound 1/2 m short of the parked position and disengaged from the tool when the binding occurred. However, the binding prevented it from dropping back to the inserted position, so the lifting tool was reengaged. Visual inspections prior to reengagement verified no apparent damage to the

tool or lead screw. After reattaching the lifting tool, the lead screw was parked in the normal manner.

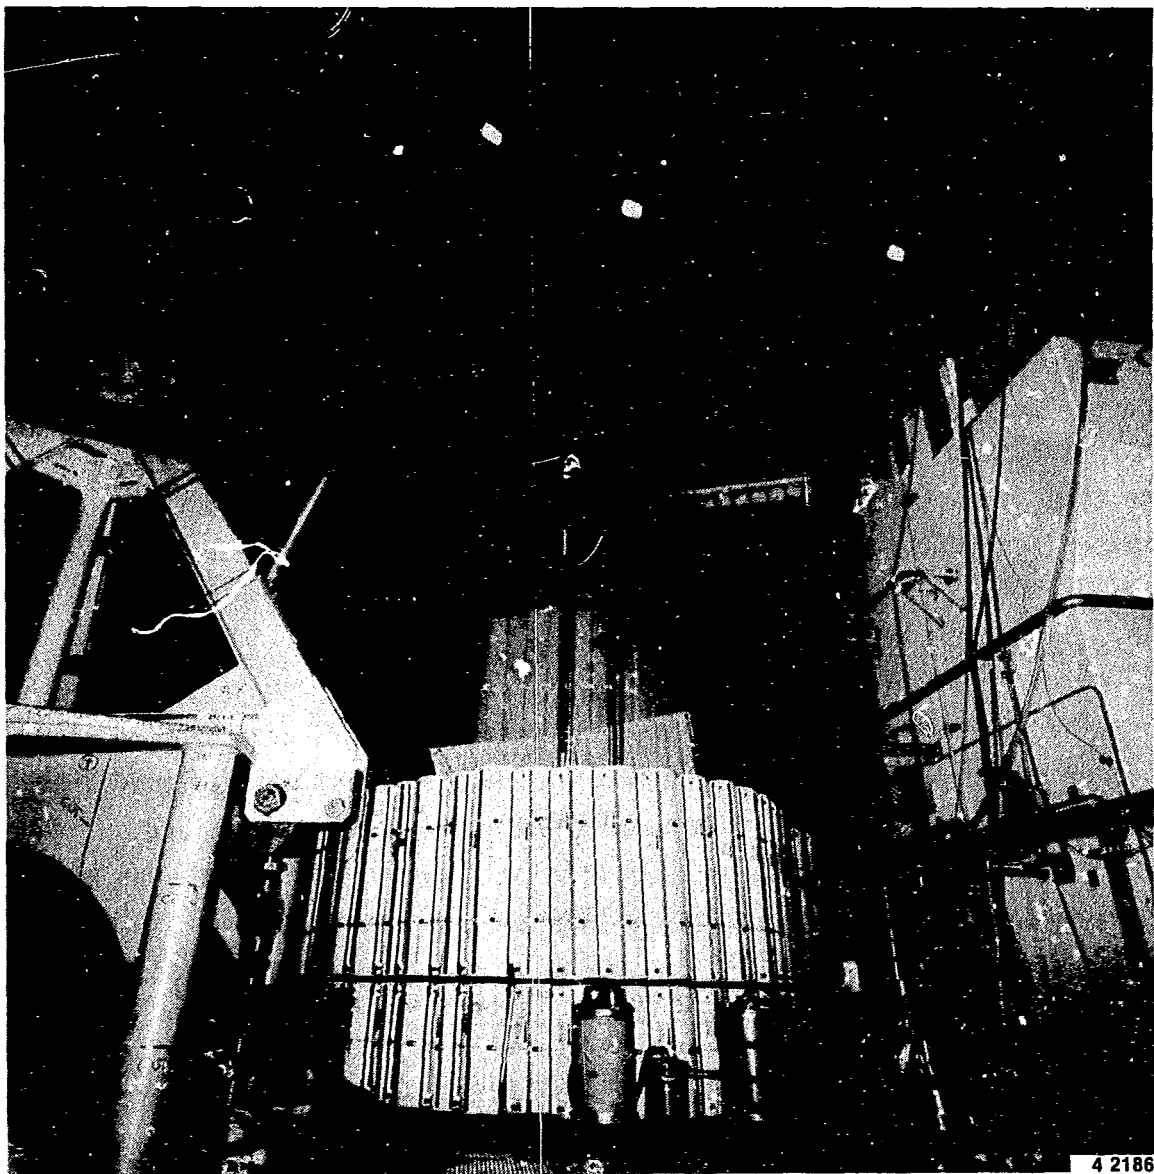
Figure 14. Shielded work station (upper right), walkway to service structure, tripod with turnbuckles (lower left), and 3.5 m sand column shielding.

As part of the lifting assembly inspection, the head lift tripod was cleaned and inspected (magnetic particle inspection) before and after the polar crane load test. Undersize weld lengths, discovered during the initial visual inspection, prompted a thorough reevaluation of the tripod using sophisticated analytical techniques. Additionally, three of the more highly stressed welds were examined before and after the load test by magnetic particle testing and found to be acceptable. Both the analyses and the inspections verified that the tripod was qualified for lifting the head (Figure 14).

The headlift turnbuckles were also examined because of a generic problem with lock welds used to fasten the jam nut to the turnbuckle body. These lock welds tended to crack when placed under a lifting strain. Magnetic particle inspection of the turnbuckles revealed that the lock welds had cracks that had propagated through the weld into the turnbuckle body. The solution to the problem was to use the TMI-1 turnbuckles, which had not been lock welded. These turnbuckles were also subjected to

magnetic particle inspection prior to use. All of the lifting gear were inspected except for the head lift pendants, which were load tested as part of the polar crane load test.

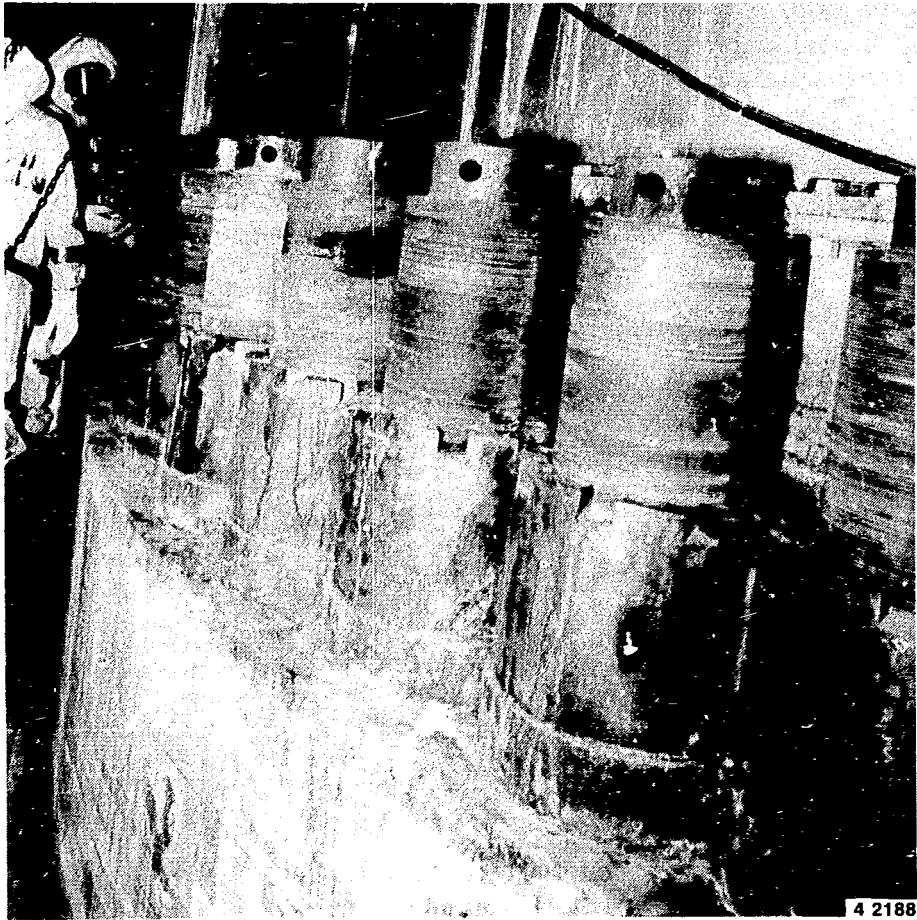
Figure 16. Reactor vessel studs before cleaning.

Reactor vessel stud detensioning requires that the tension on the studs be unloaded incrementally in two steps or passes. Normally, as soon as the first pass is complete, the second pass commences. In this case, the first pass was performed months in advance of the final pass to determine if any of the nuts were stuck. This allowed time to plan corrective action before the final detensioning, which was on the critical path to head removal.
