**THE
ACCIDENT AT
THREE MILE
ISLAND**

Reports Of The Technical
Assessment Task Force, Vol. I

REPORTS OF THE
TECHNICAL ASSESSMENT TASK FORCE

TECHNICAL STAFF ANALYSIS REPORTS SUMMARY

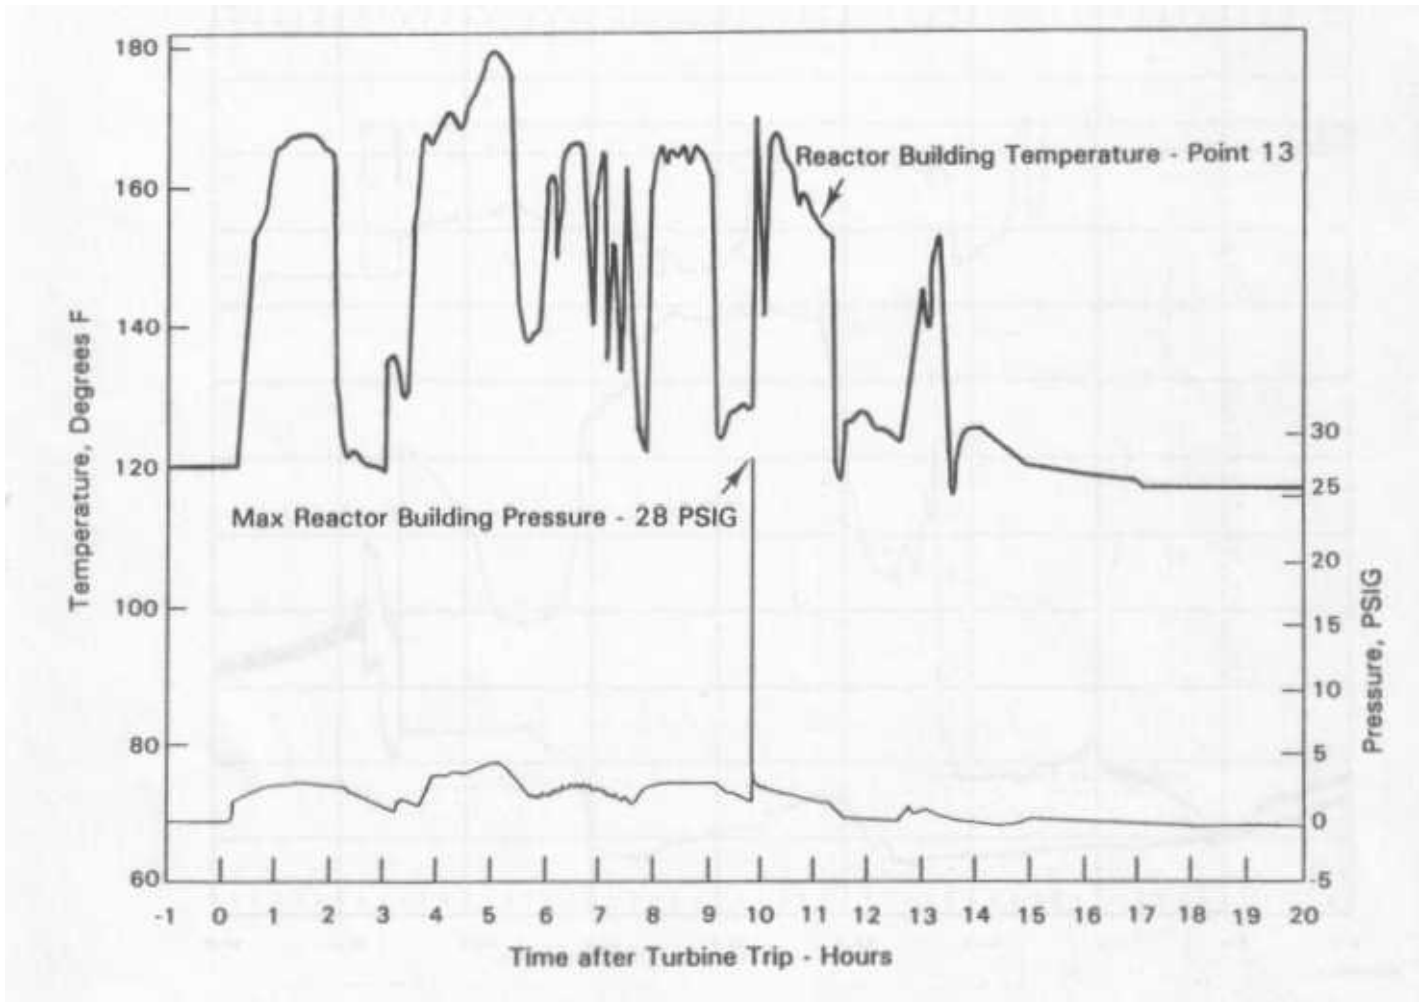
FIGURE 6: TMI-2 Loss-of-Coolant Accident of March 28, 1979, Reactor Building Temperature and Pressure

At 9 hours and 50 minutes into the accident, a 28 psig pressure spike was recorded in the containment building. A calculation of the amount of hydrogen burned in producing such a spike showed it would take 294 pound-moles of hydrogen or 5.9 percent by volume.

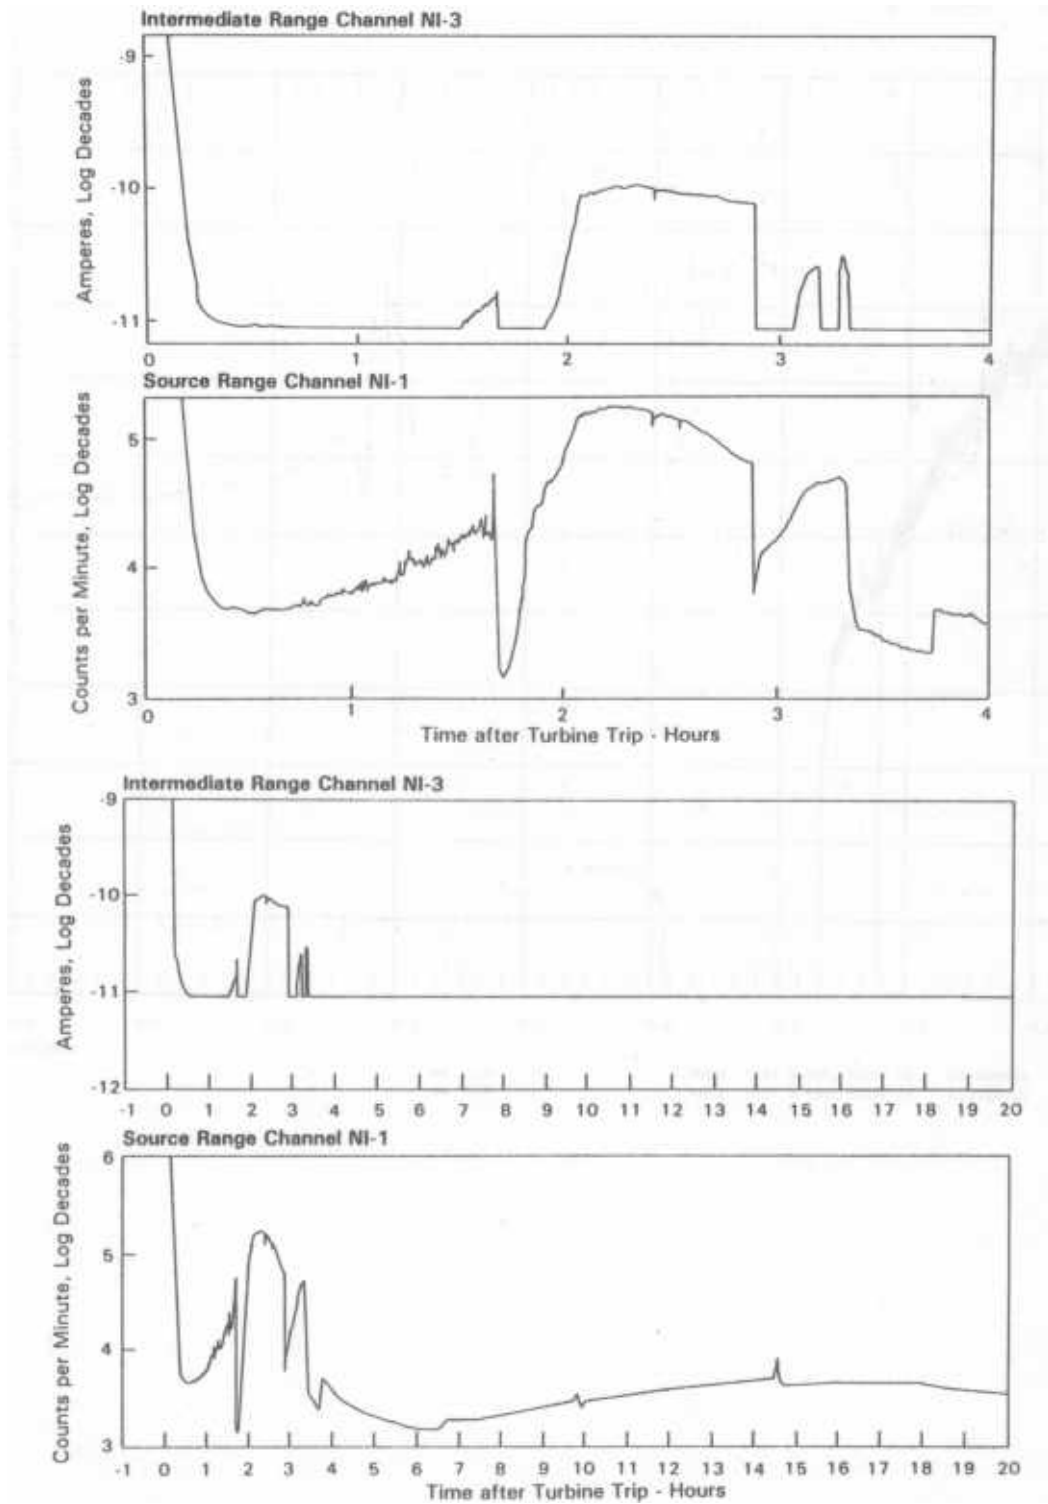
FIGURE 7: TMI Loss-of-Coolant Accident of March 28, 1979, Intermediate and Source Range Nuclear Instrumentation

- Continuing leaching of radioactive products into the cooling water indicates that some of the fuel may be in finely divided form.
- A section of the core probably fell downward at 226 minutes into the event as a consequence of earlier damage. This is indicated by a rapid change in the readings of both incore and excore neutron detectors at that time.
