**THE
ACCIDENT AT
THREE MILE
ISLAND**

*Reports Of The Technical
Assessment Task Force, Vol. IV*

REPORTS OF THE
TECHNICAL ASSESSMENT TASK FORCE

VOLUME IV

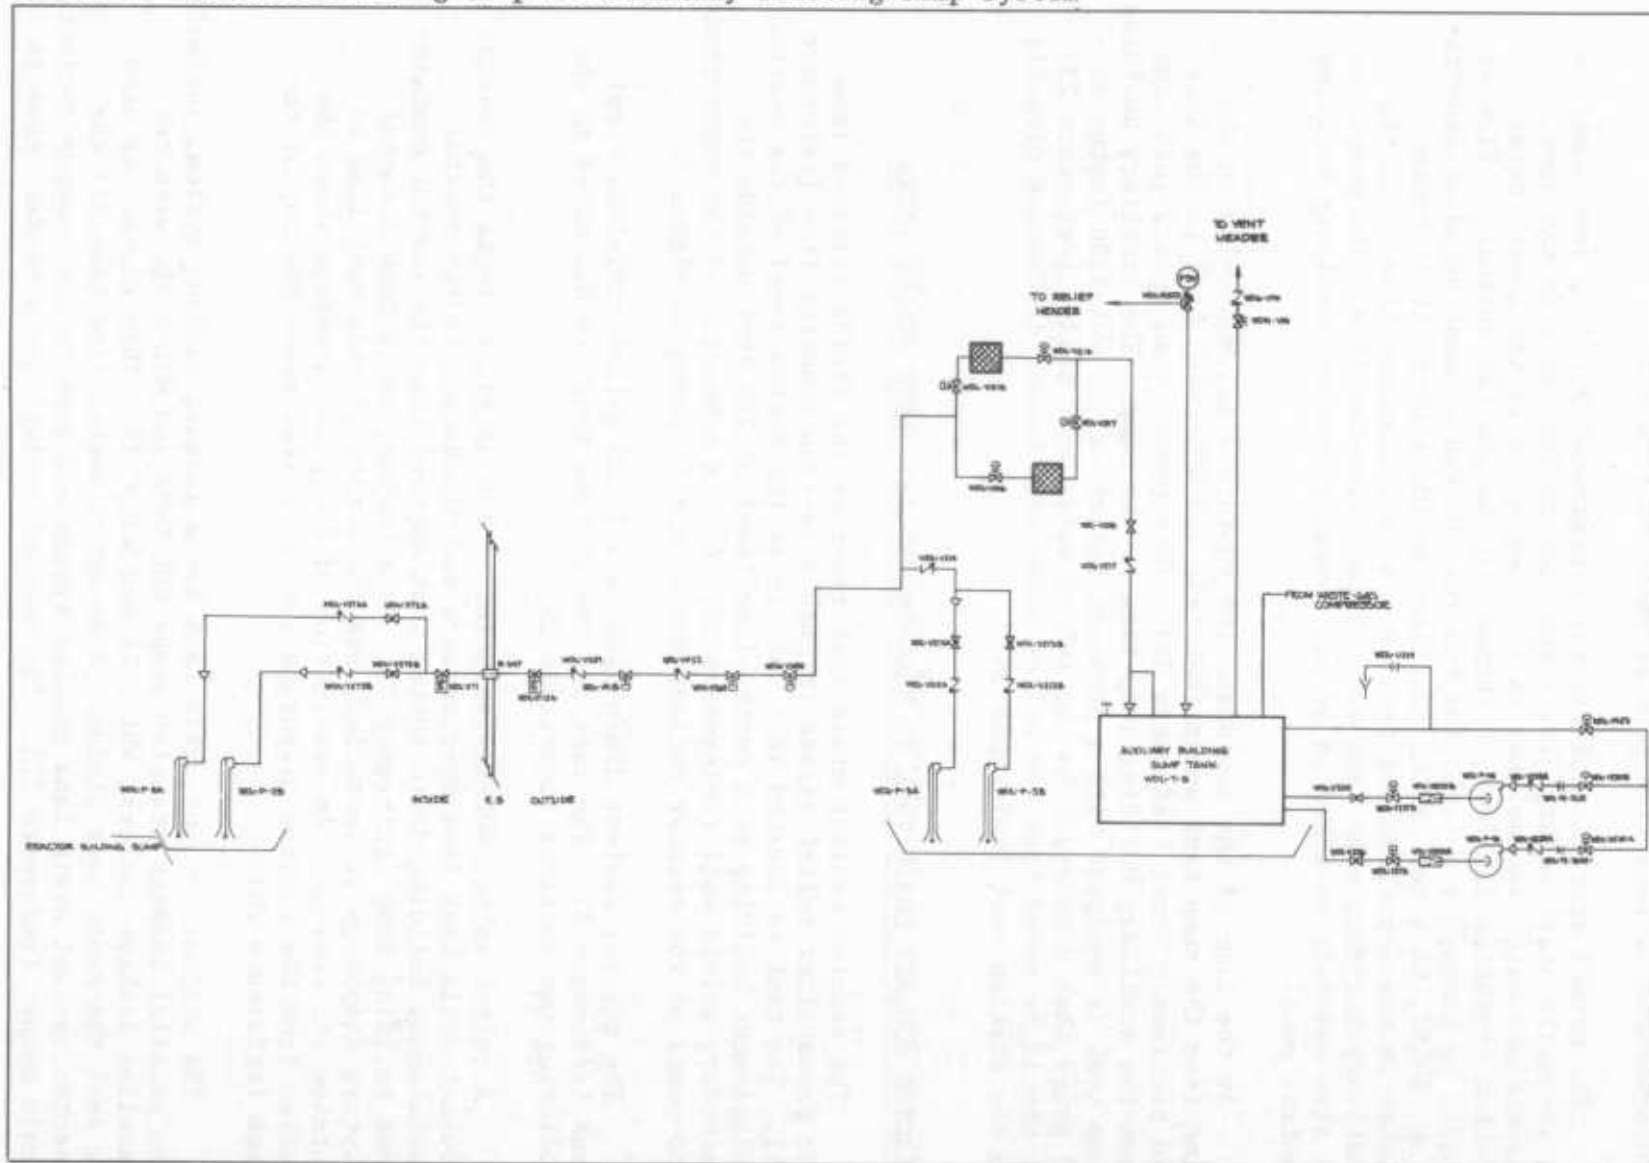
FIGURE 2: Reactor Building Sump to Auxiliary Building Sump System

auxiliary building sump tank. Consensus of operating personnel and level readings of the miscellaneous waste holdup tank before and after the event indicate the valve line-up was to the auxiliary sump tank. The schematic of this flow path is shown in Figure 2.

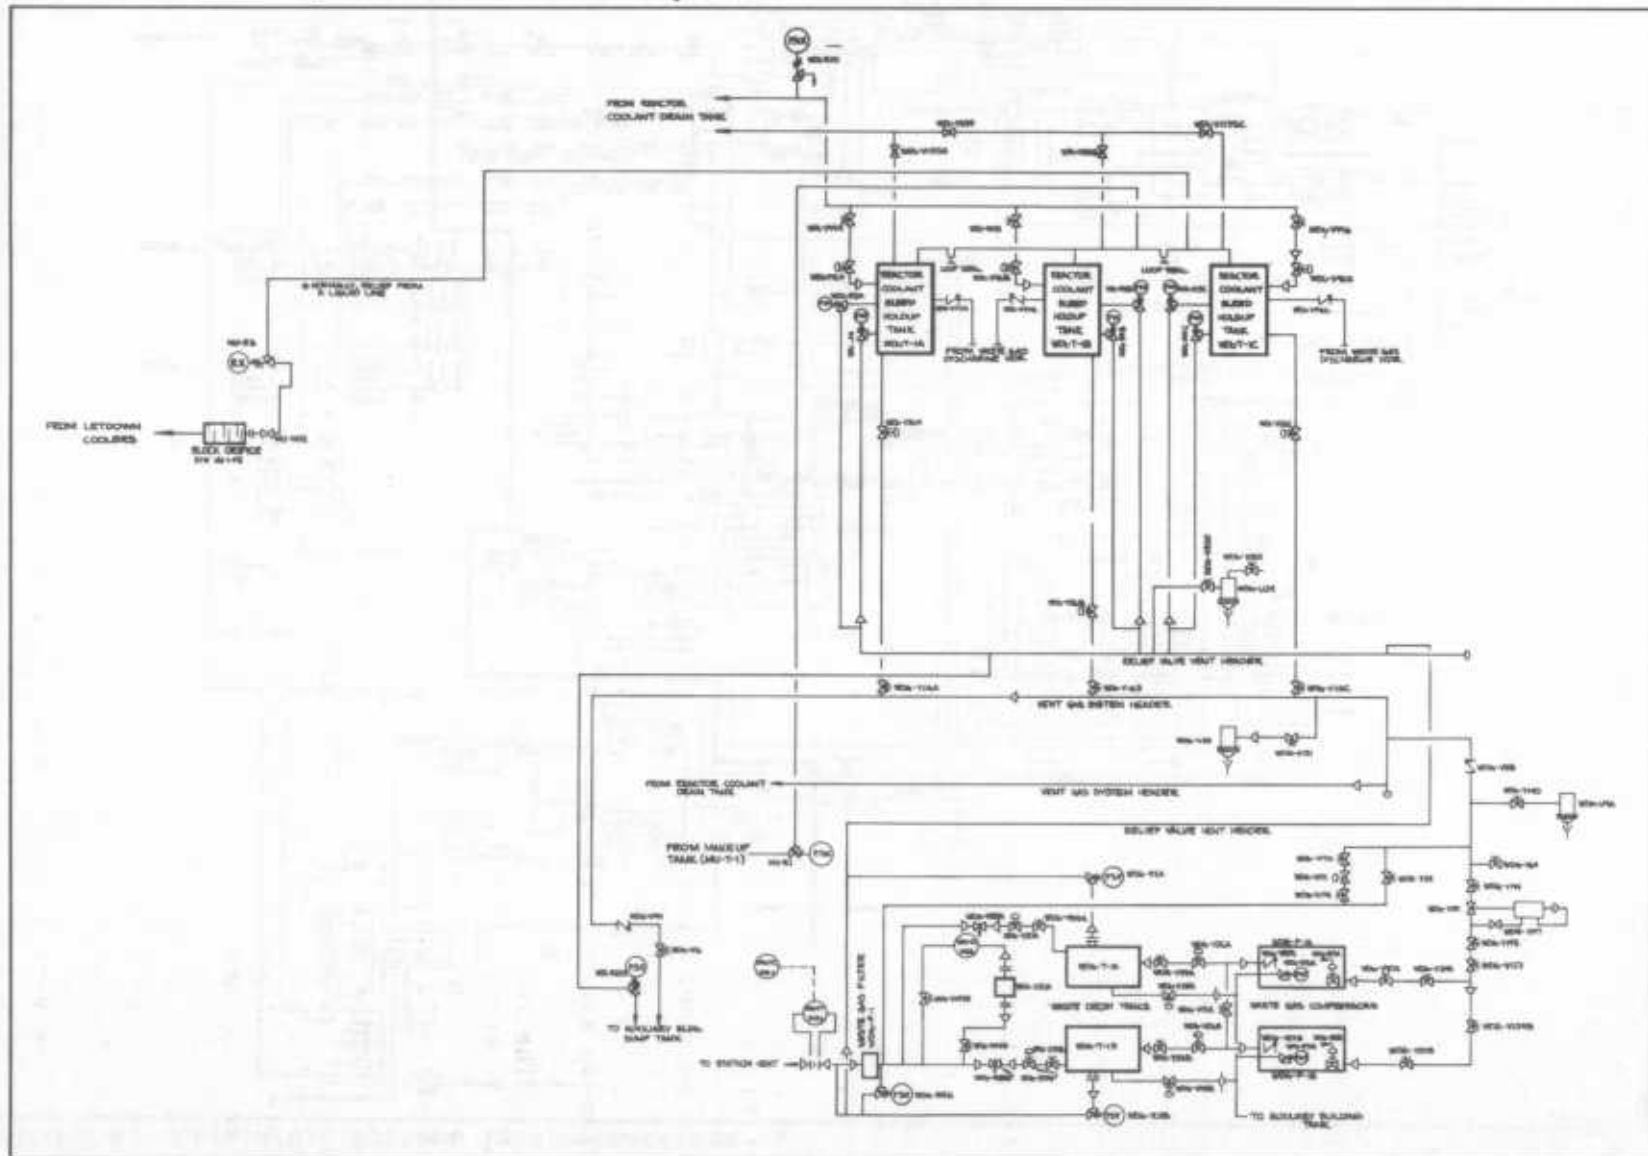
FIGURE 7: Vent Gas/Relief Valve Header System

The vent system is equipped with traps at the low points to drain water that might get into the vent system from lifting of pressure

relief valves. There are at least two of these traps, WDG-U8A and WDG-U9A, in the auxiliary buildings.

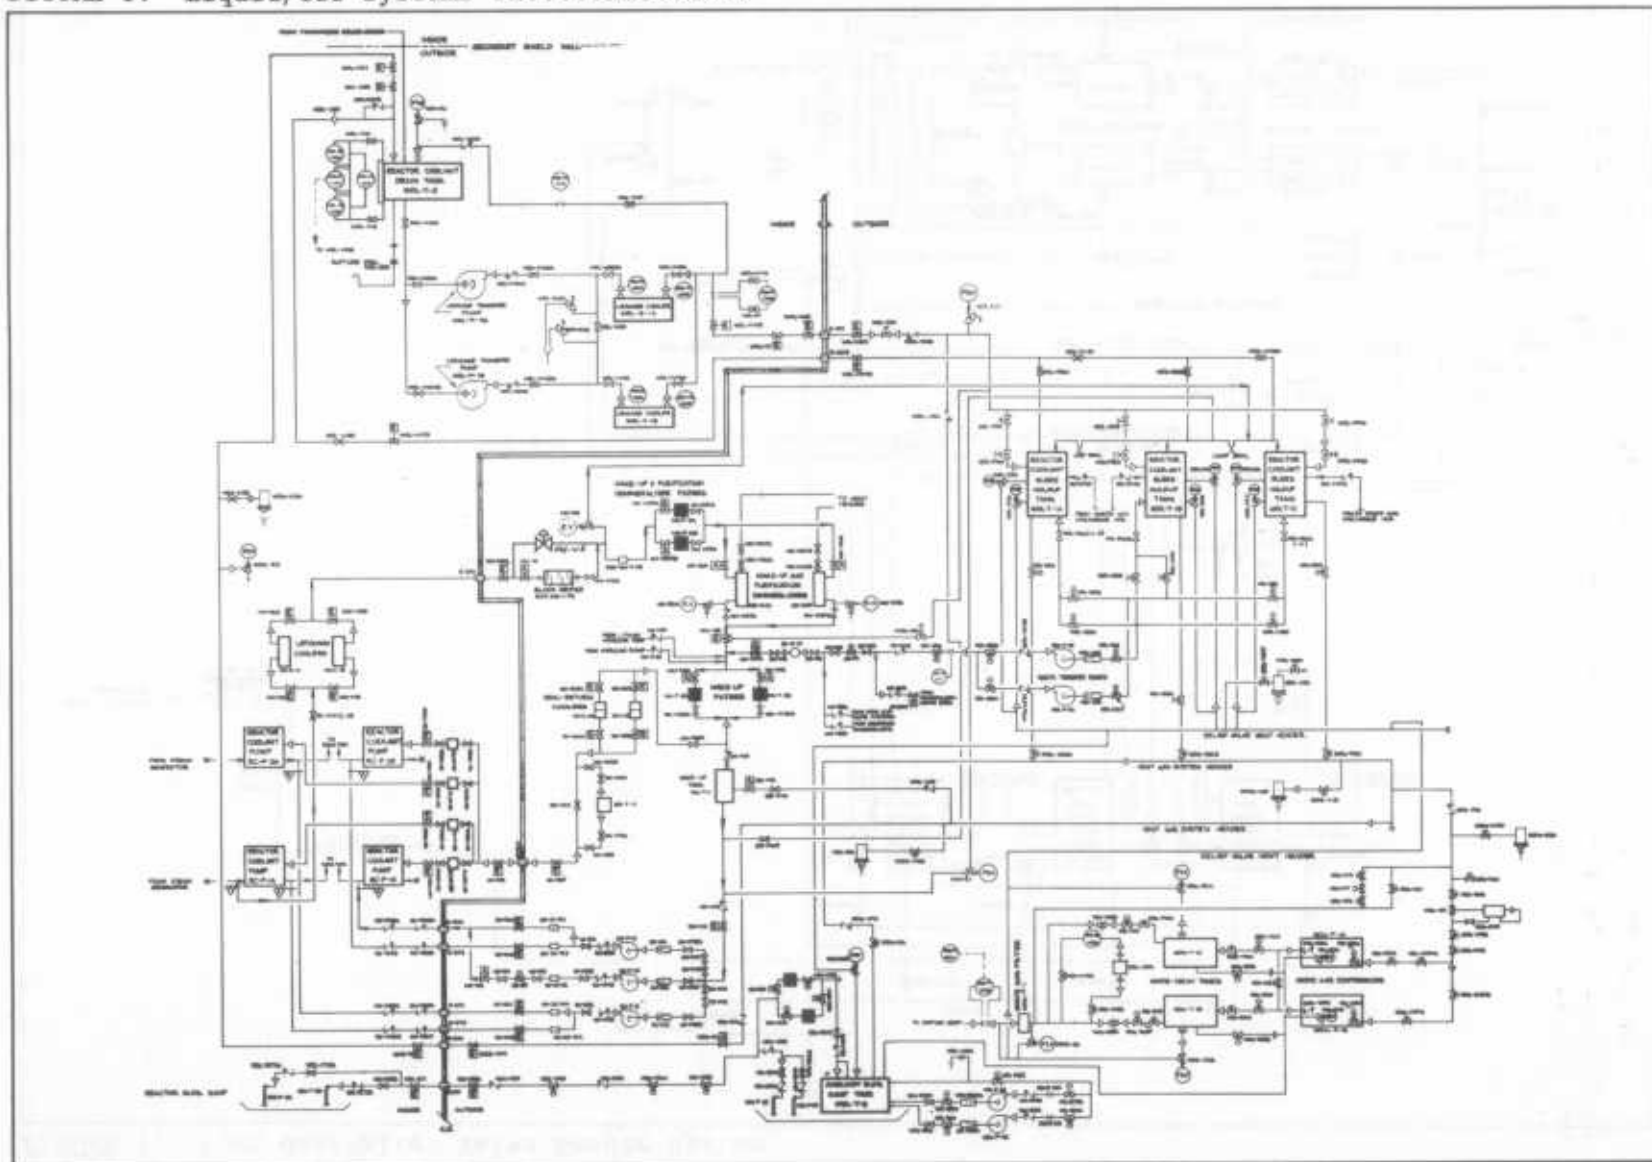
FIGURE 8: Liquid/Gas Systems Interconnections

The interconnections of the liquid system with the gas systems make it difficult to diagnose the release points of the radioactive gas from the auxiliary building.
