NUREG-0600

INVESTIGATION INTO THE MARCH 28, 1979
THREE MILE ISLAND ACCIDENT
BY
OFFICE OF INSPECTION AND ENFORCEMENT

Investigative Report No. 50-320/79-10

Office of Inspection and Enforcement
U. S. Nuclear Regulatory Commission

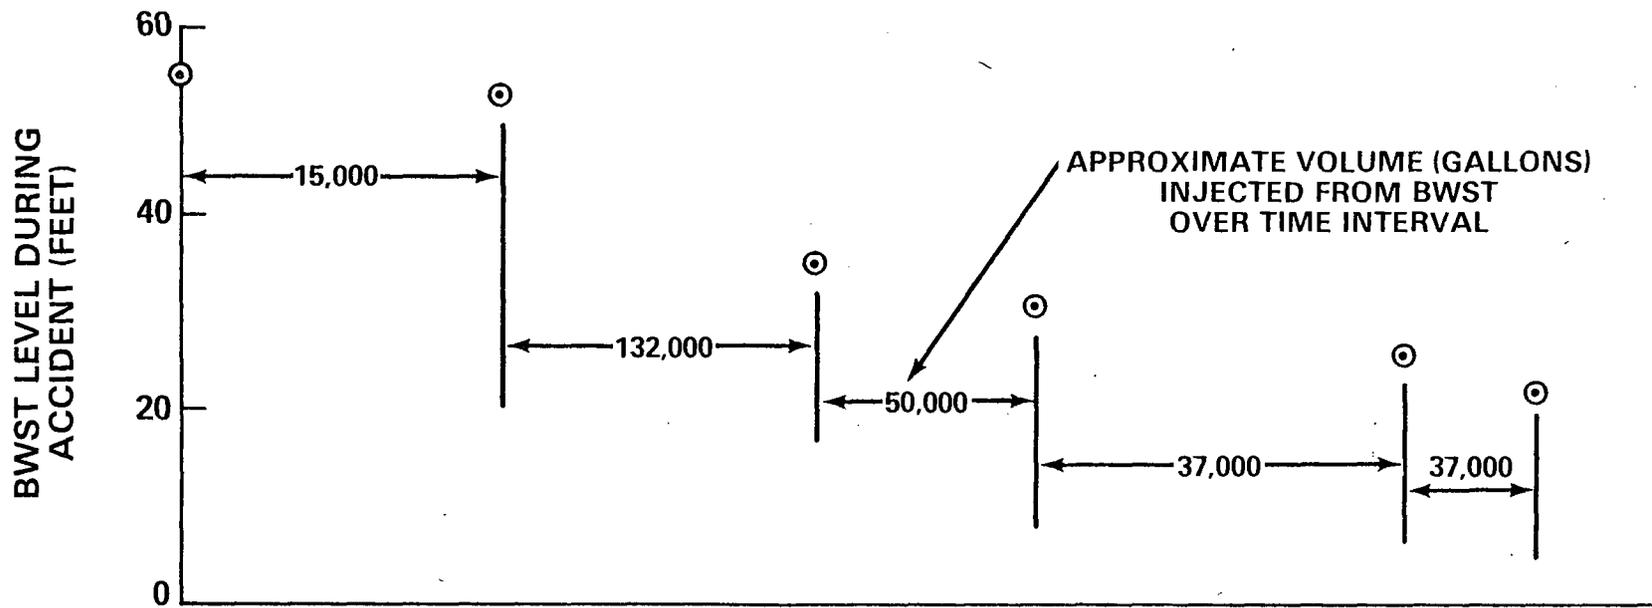
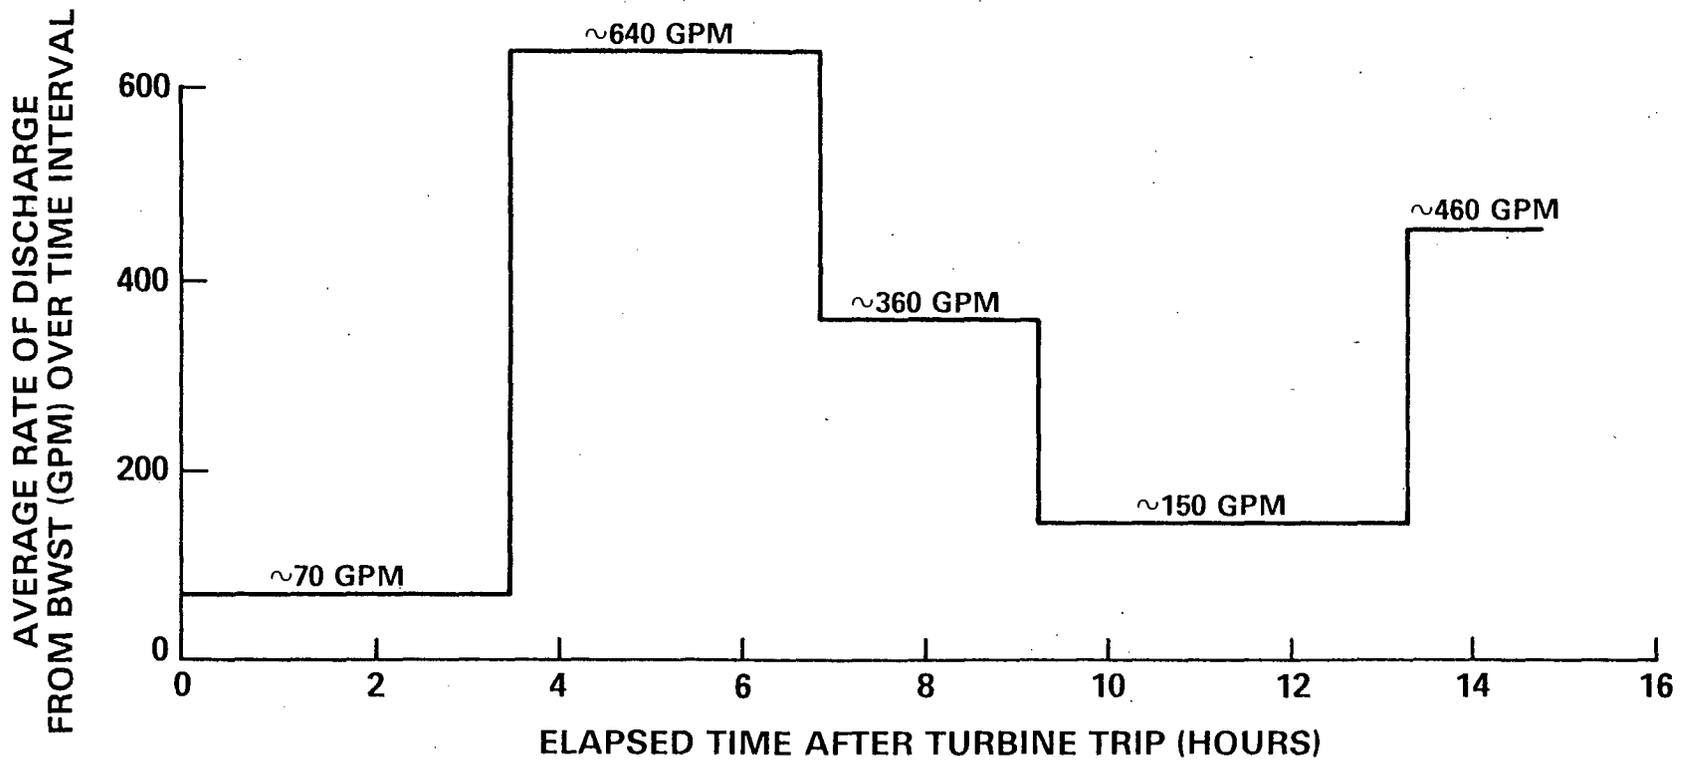
FIG 1.4-2

- . The first 3 1/2 hours of generally very low flow,
- . The following 3 1/2 hours of high flow rates,
- . A 2-hour period of moderate flow rate,
- . An interim 4-hour period of low flow rates,
- . The final repressurization.

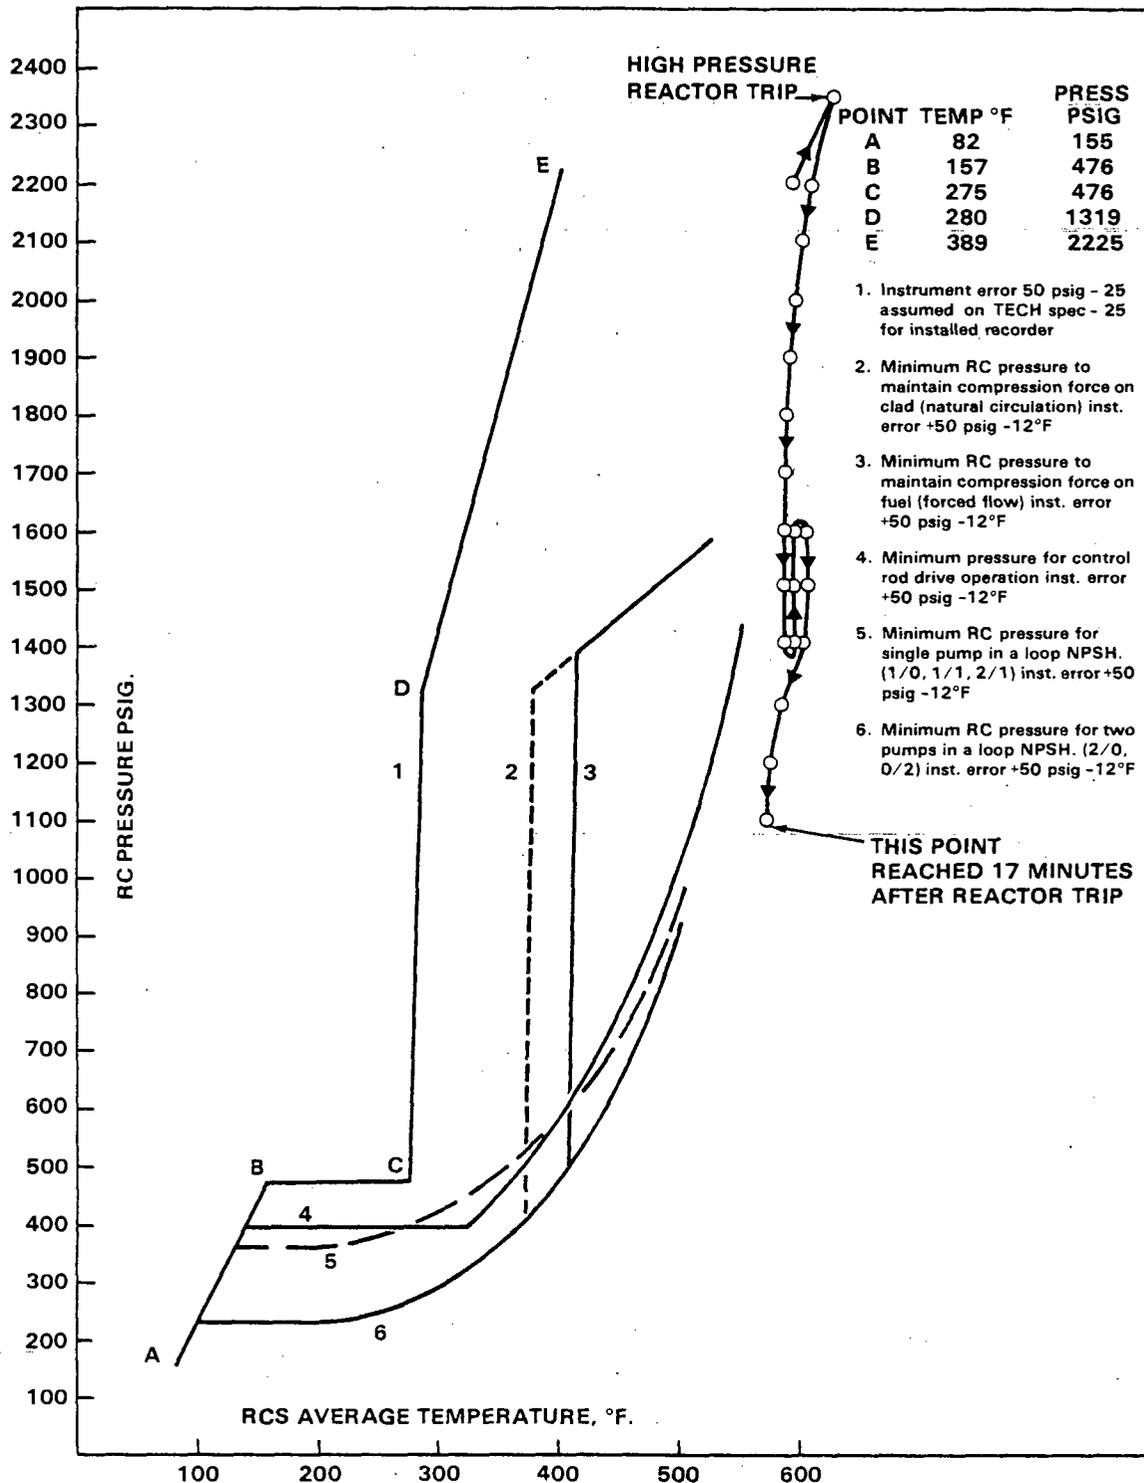
FIG 1.4-4

COMPARISON OF RCS TEMP/PRESS. BEHAVIOR TO LIMITS (1ST 17 MIN.)

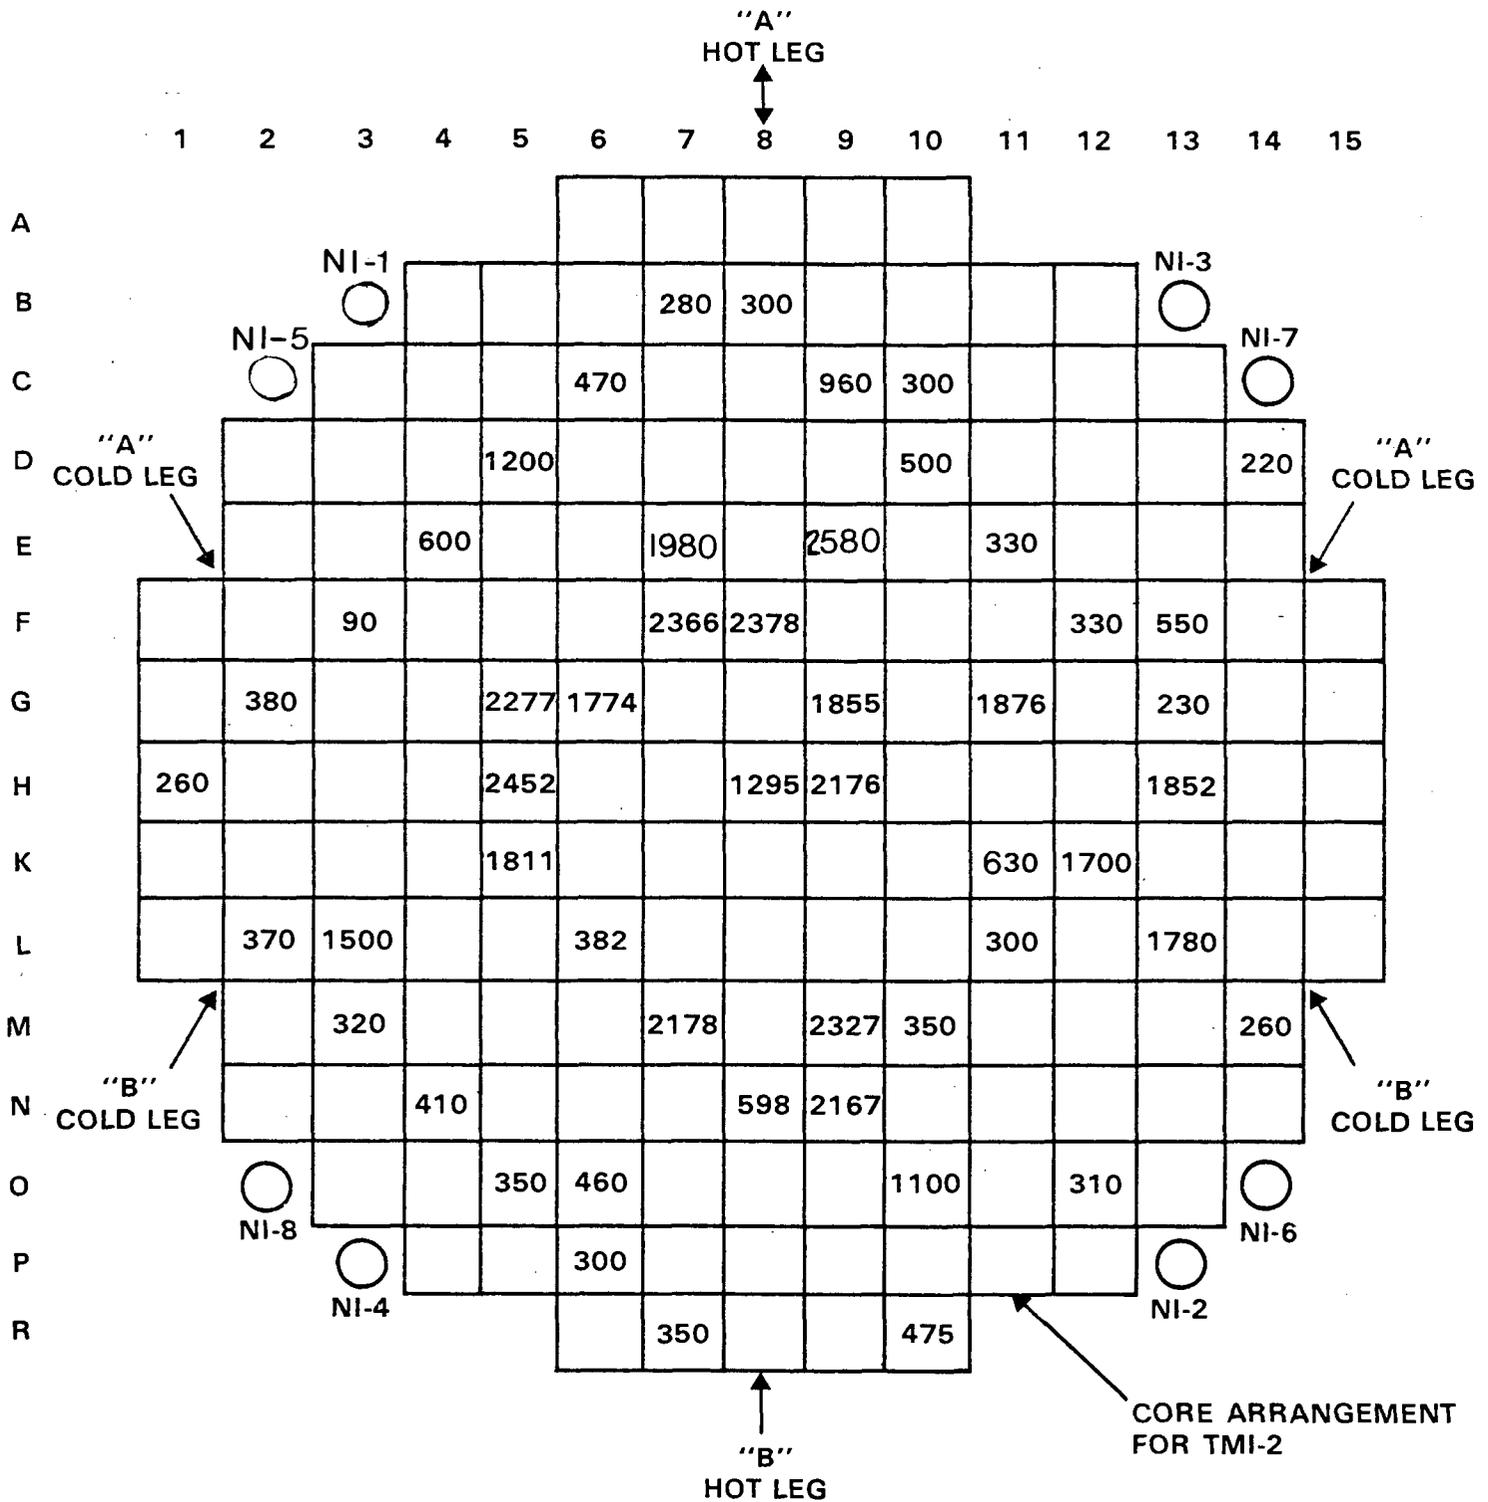
FIG 1.4-11

READINGS OBTAINED FROM INCORE THERMOCOUPLES AT APPROXIMATELY 4-5 HOURS AFTER START OF ACCIDENT

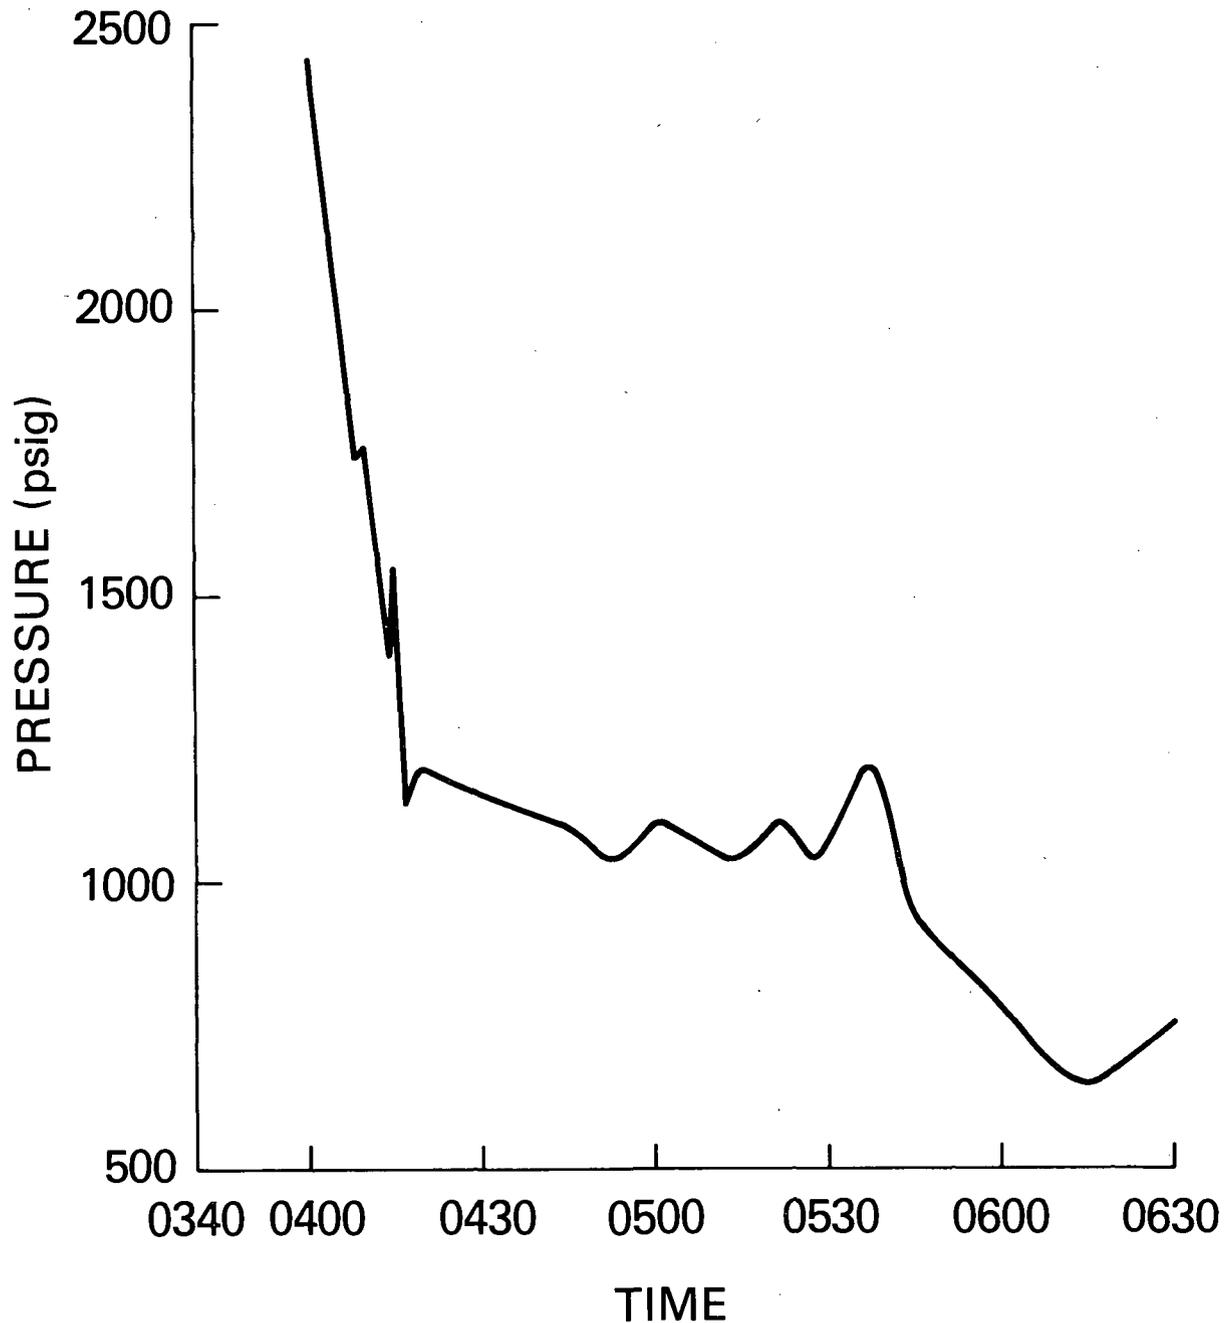
Figure II-2-1

**REACTOR COOLANT PRESSURE VS.
TIME ON MARCH 28, 1979,
AS DISPLAYED ON THE WIDE
RANGE PRESSURE RECORDER**

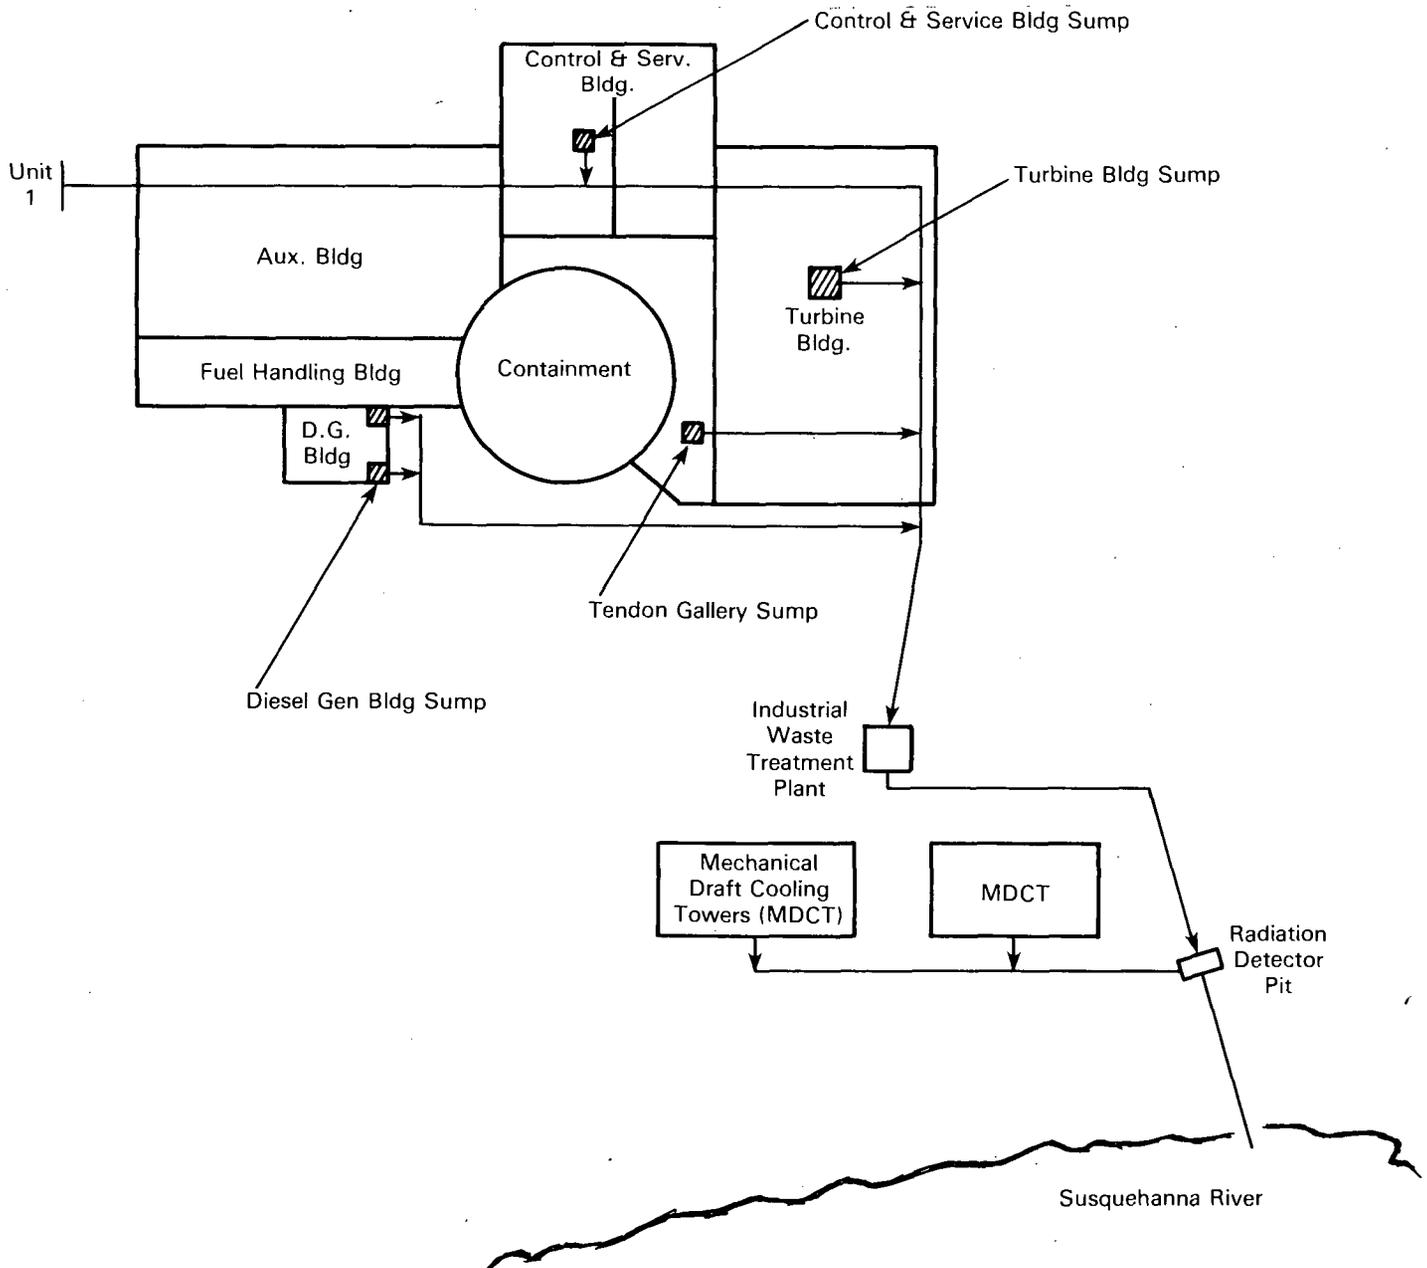
Figure II-3-1

SUMP PUMP DISCHARGES TO THE INDUSTRIAL WASTE TREATMENT SYSTEM

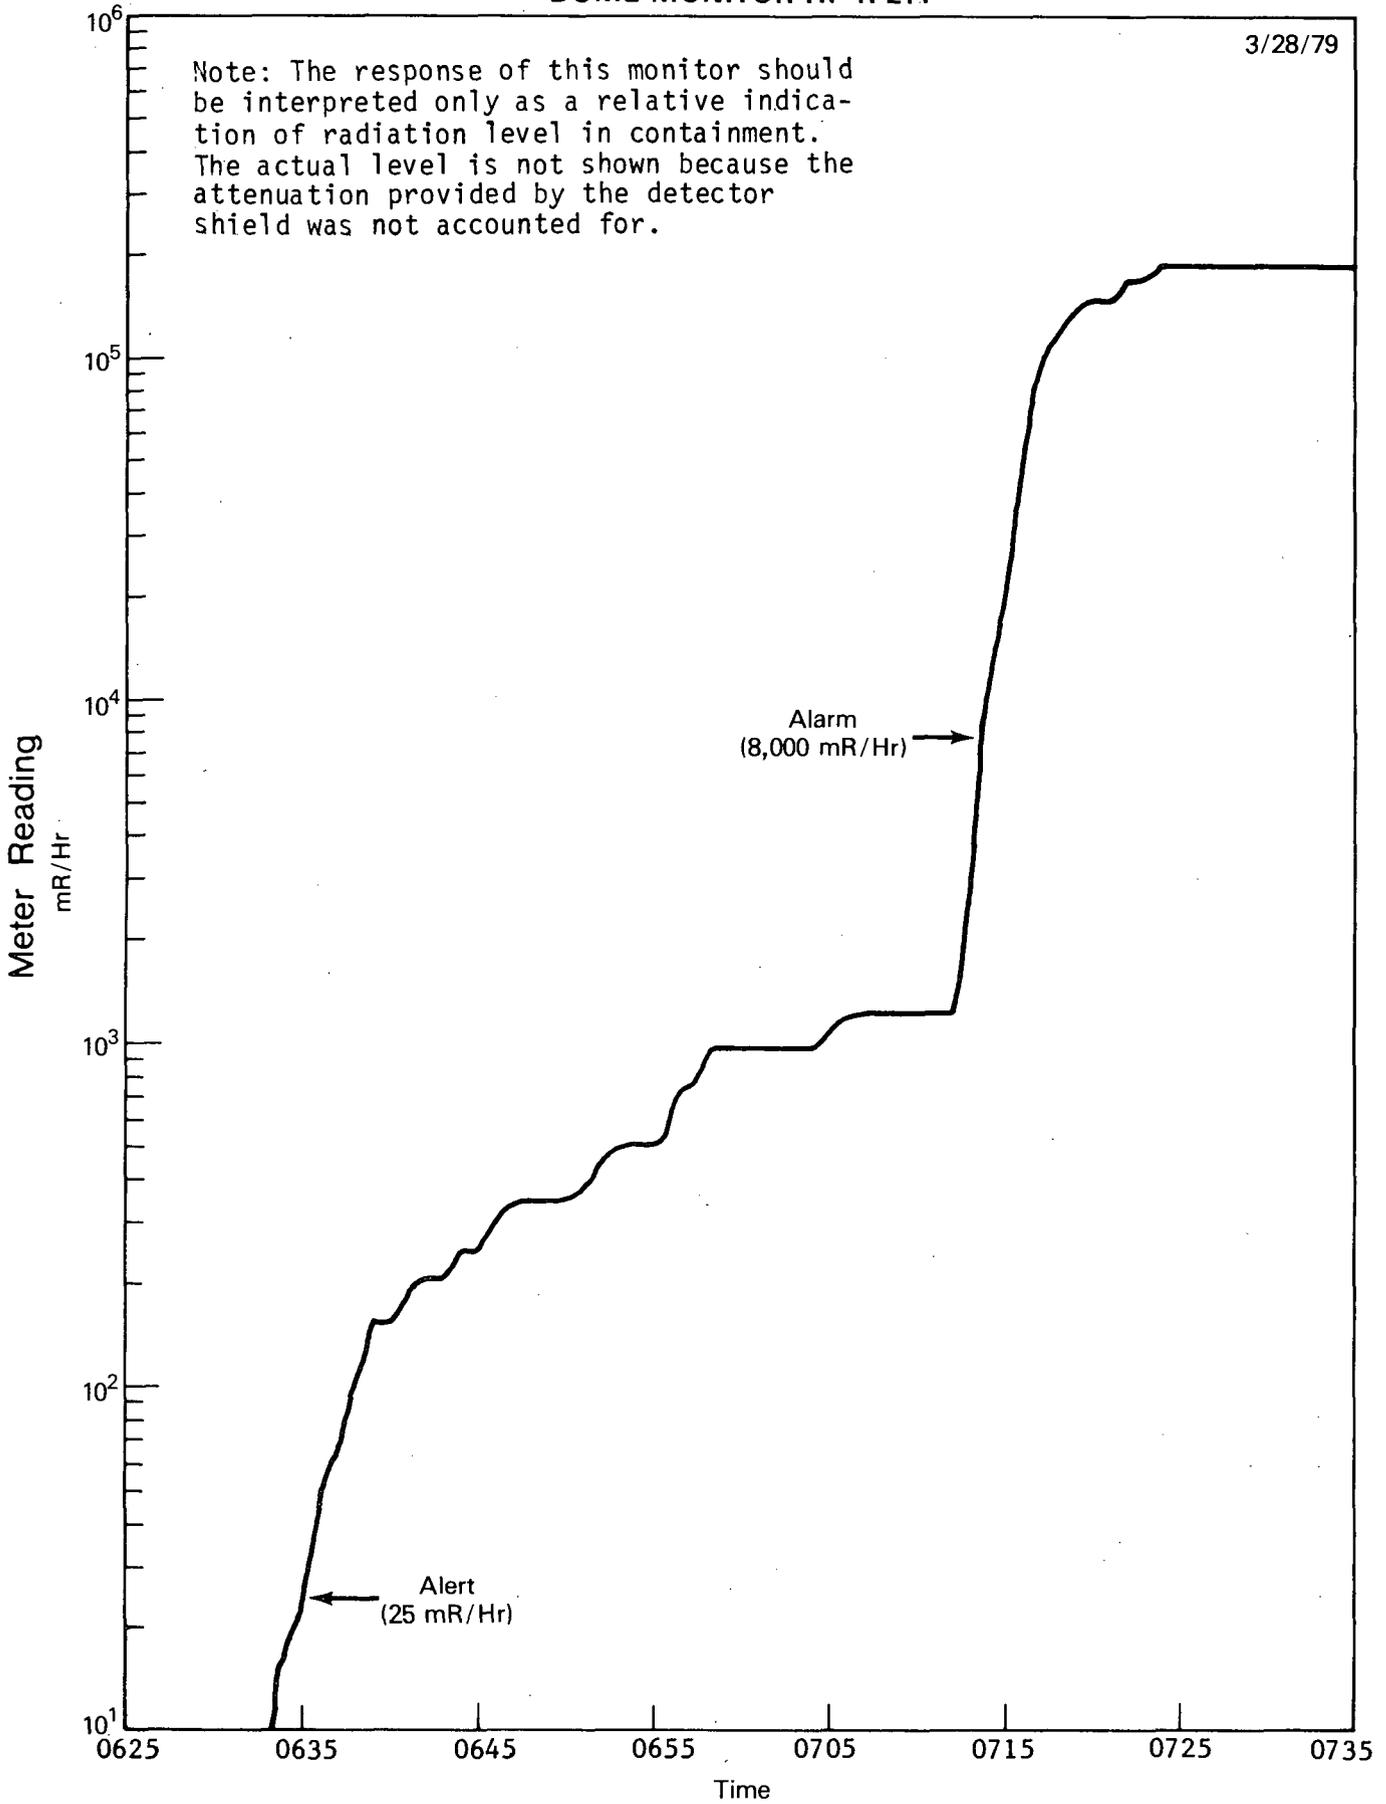
Figure II-3-3

Note: The response of this monitor should be interpreted only as a relative indication of radiation level in containment. The actual level is not shown because the attenuation provided by the detector shield was not accounted for.
