Supplement to Reportable Occurrence NF-32-77-16  
Davis-Besse Nuclear Power Station Unit 1  
Date of Occurrence: September 24, 1977

## SUMMARY

## 2. EVENT DESCRIPTION

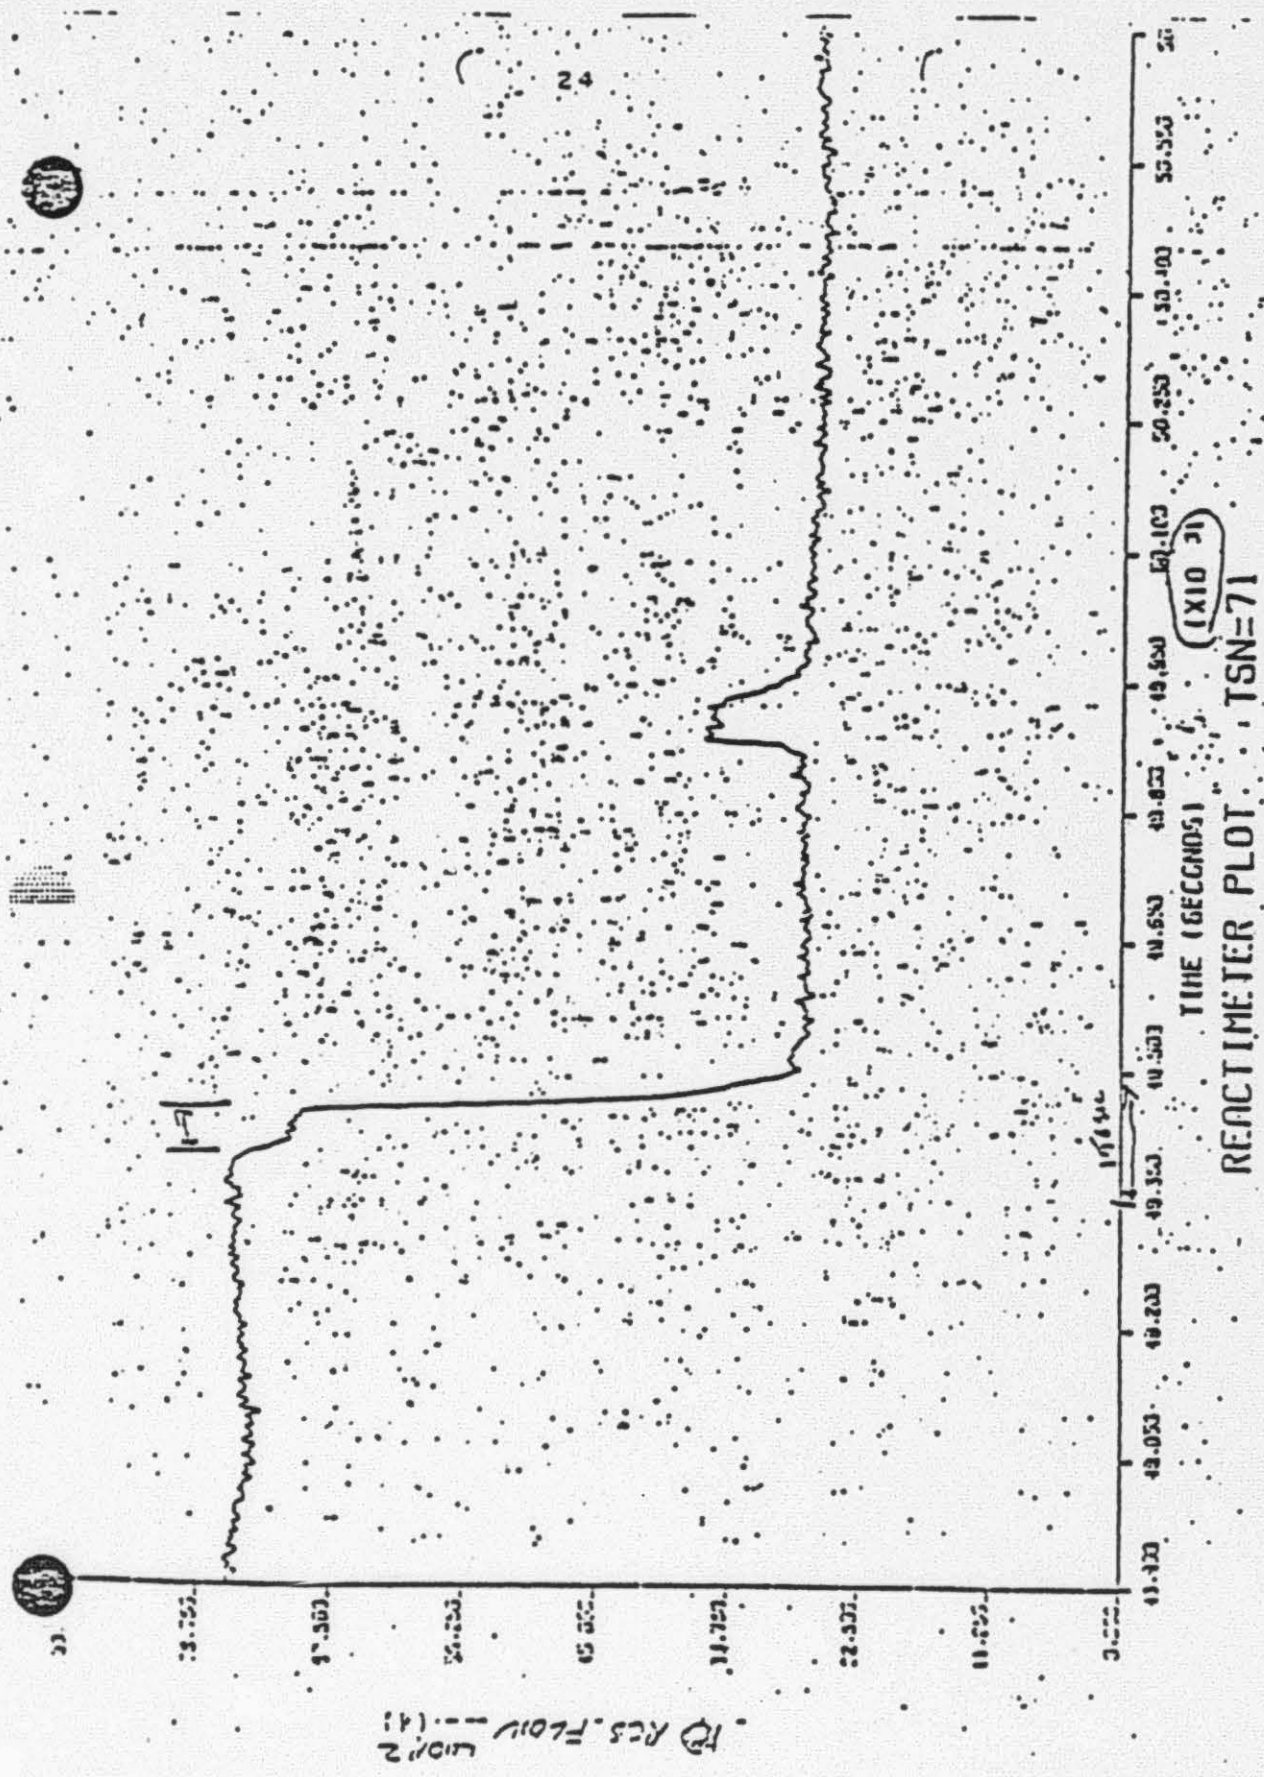
FIGURE 4-8

Assuming a coolant temperature of 337 F and  $150 \times 10^6$  lb/min system flow (per Figures 4-8 and 4-9), the net lift force will be less than 375 lb. The maximum allowable lift force is 472 lb. Therefore, we conclude that fuel assembly lift-off did not occur.

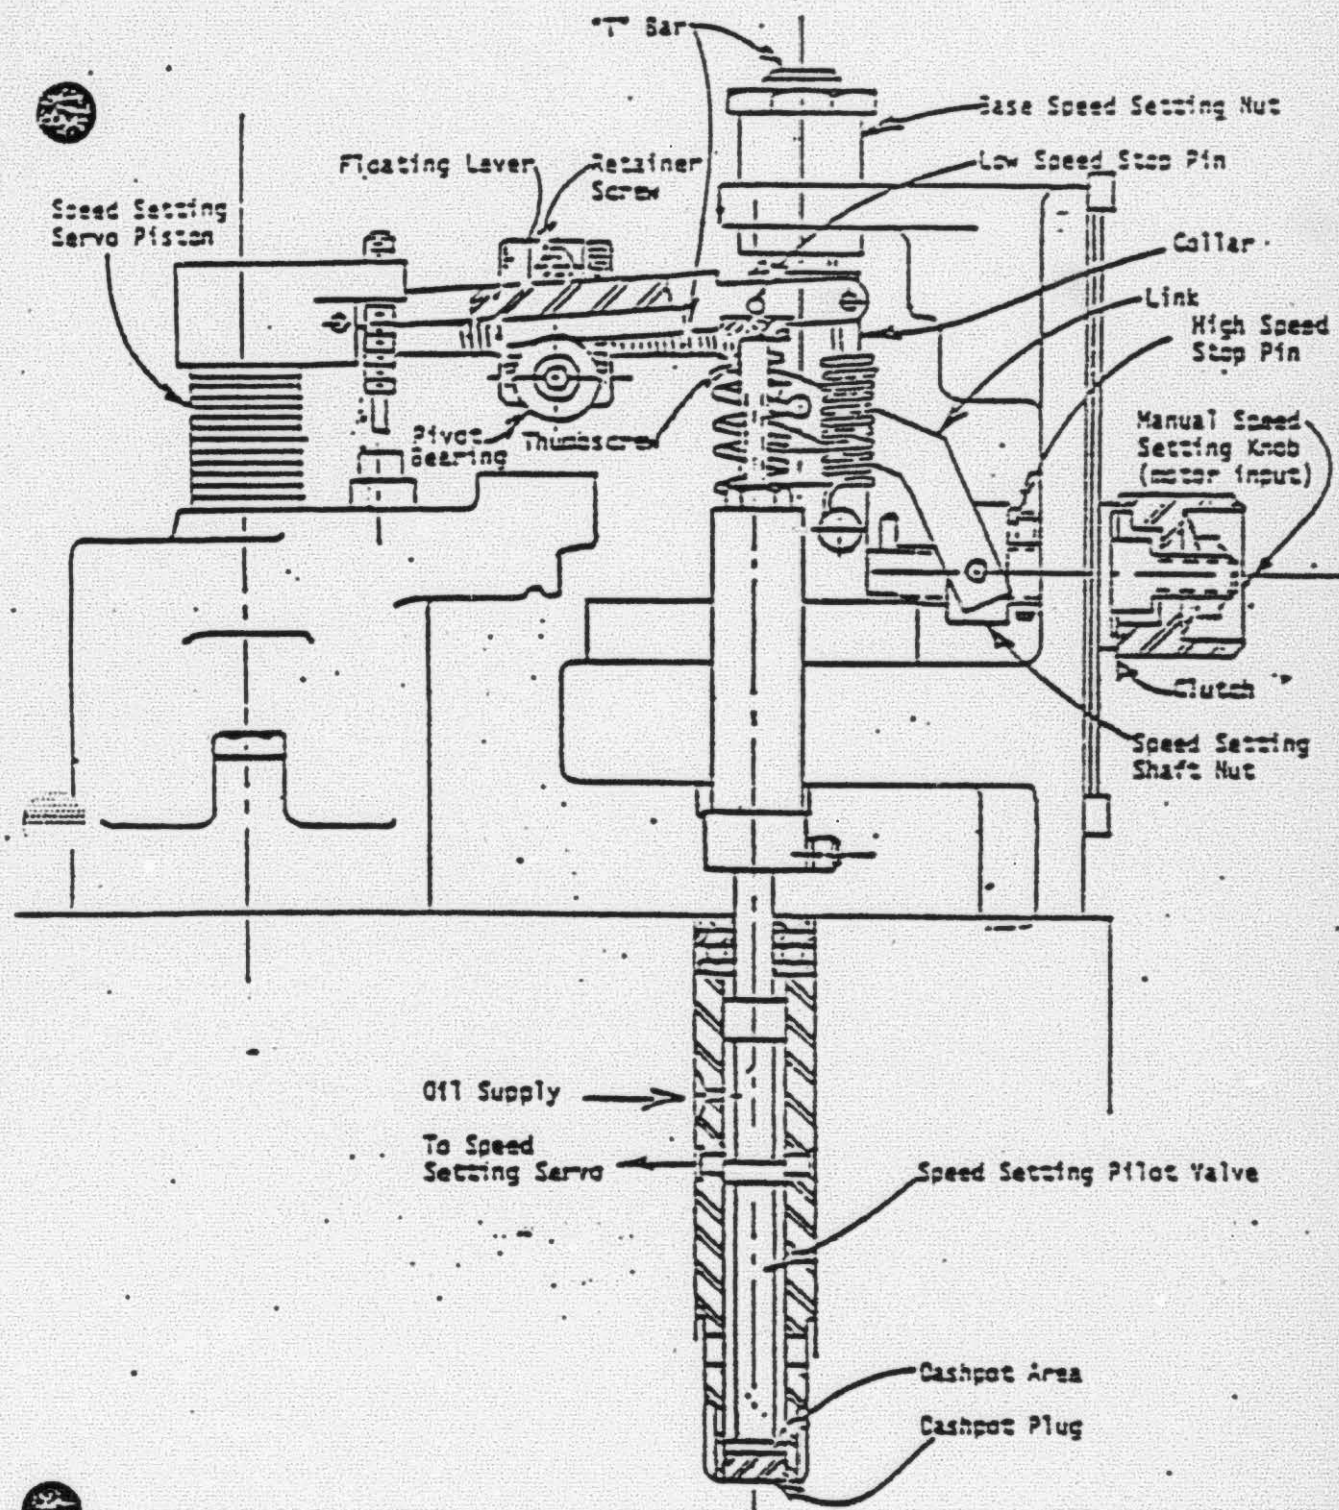
FIGURE 6-1

Before describing the modifications made to the auxiliary feedpump turbine (AFPT) governor, the governor action which resulted in the binding will be described. Figure 6-1 is a drawing of the Woodward Governor PG-21 speed setting mechanism, showing the governor in the bound up condition. The sequence of events creating this condition is as follows:

- 4.9 Because the Bodine motor continues to rotate the manual speed setting knob, slipping the clutch, a torque is placed on the speed setting shaft nut, link and collar. This torque against the "T"-bar causes friction that locks the "T"-bar in place.

8. When the Bodine speed setting motor is backed off from the stop, the "T"-bar falls down to its high speed stop, dropping the pivot bearing. The pilot valve moves downward, increasing oil flow to the speed setting servo until the high speed condition is reached.

The required parts were manufactured, the unneeded parts removed and the governors were reassembled. The governors were tested at the Woodward factory and the tests confirmed that the modifications did remove all possibility of the undesired binding of the governors. Surveillance testing at the station has also confirmed that the auxiliary feedpump turbine governors function properly.

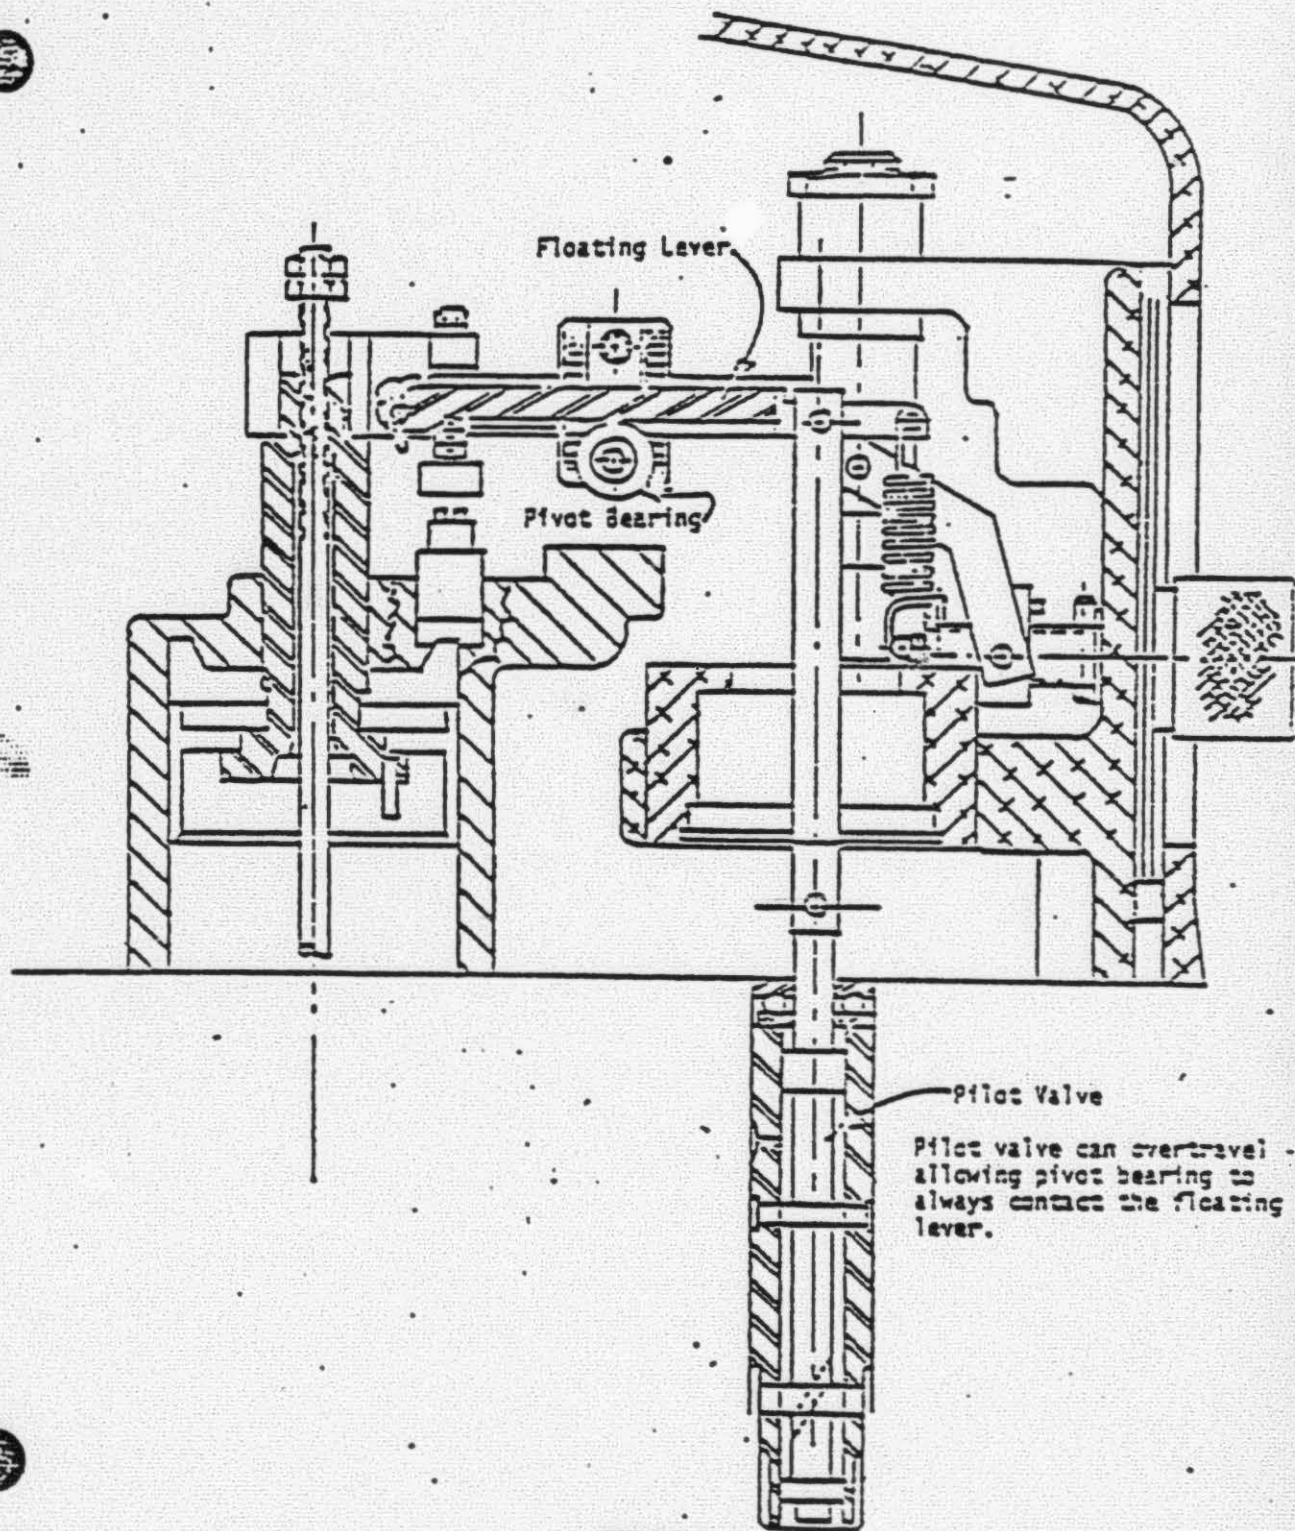
FIGURE 6-3

When the AFT governors arrived at the Woodward Governor Company factory, one of the governors was placed on the test stand. While observing the operation of the speed setting linkage, it became evident that a simple link from the speed setting pilot valve (plunger) to the floating lever would allow removal of the bellows, coupling spring, low speed pin, "C" link and dashpot plug in the speed setting pilot valve sleeve (see Figure 2). This would allow the speed setting pilot valve to overtravel when the motor was set in a high speed condition with the speed setting servo at the minimum position (see Figure 6-3).
