GPU ACCIDENT REVIEW TASK FORCE
FINAL SUMMARY REPORT

December 15, 1980

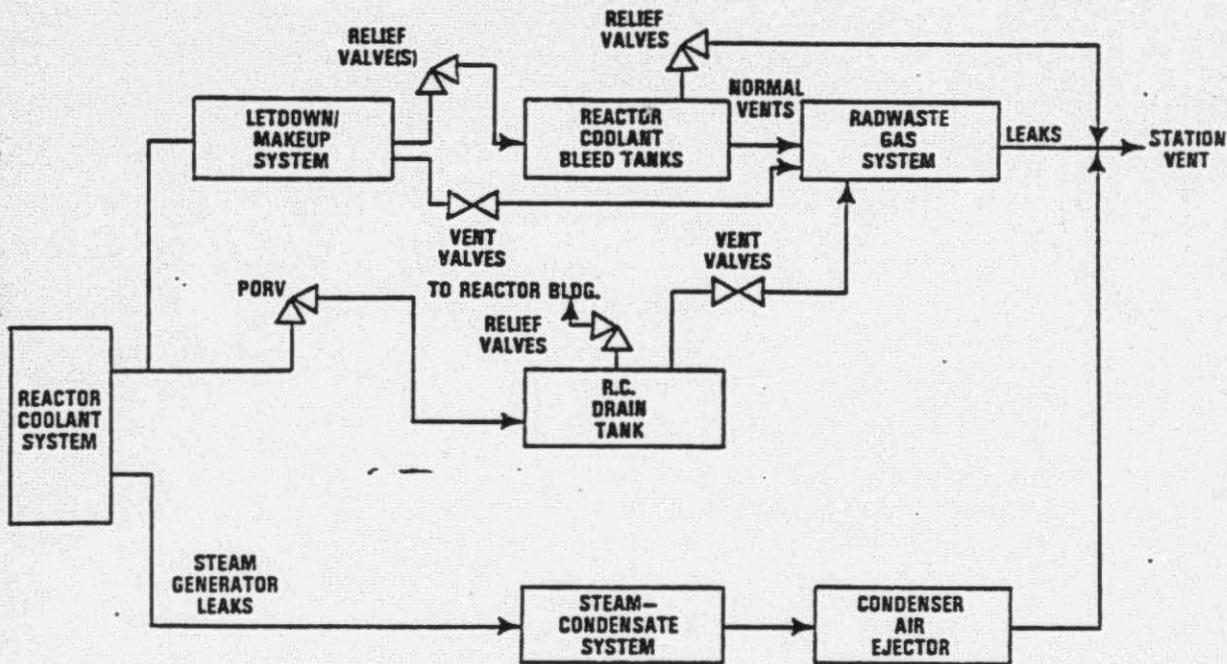
FIGURE I

The reactor coolant bleed holdup tanks are known (from shift logs) to have received increases in inventory on the 28th. In addition, extremely high levels of radiation (1000 R/Hr) existed in the area

PRINCIPAL PATHWAYS FOR RELEASE OF GASEOUS RADIOACTIVITY

of the tanks after the accident. The bleed tanks are normally vented to the vent gas system, which utilizes two parallel compressors to transfer waste gas to the waste gas decay tanks. Since leaks were subsequently found in this system, this appears to be a part of the major release pathway on March 28.
