STAFF REPORT
ON THE GENERIC ASSESSMENT
OF FEEDWATER TRANSIENTS
IN PRESSURIZED WATER REACTORS
DESIGNED BY THE
BABCOCK & WILCOX COMPANY

Office of Nuclear Reactor Regulation
U. S. Nuclear Regulatory Commission

**Manuscript Completed: May 1979
Date Published: May 1979**

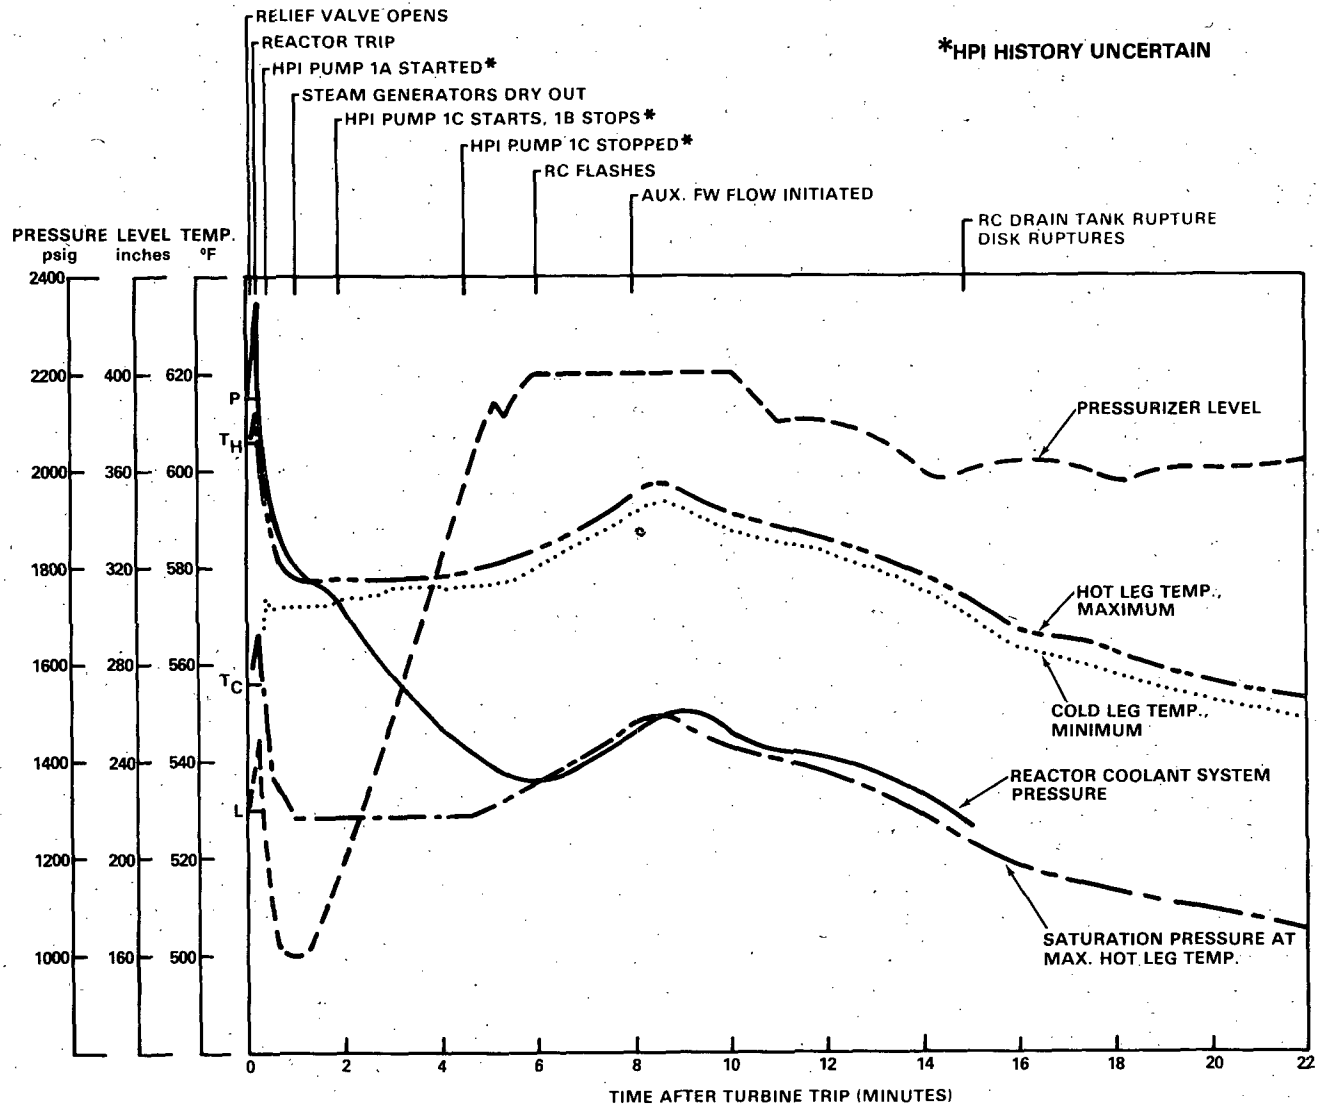
Figure 1. Reactor Coolant System Parameters in Minutes After Turbine Trip at Three Mile Island, Unit 2, March 28, 1979.

The responses of the system parameters in the first several minutes of the accident are shown in Figure 1. In the time period up to about 30 seconds, the sequence at TMI-2 was generally normal for an anticipated feedwater transient and plant response was as expected. The power-operated relief valve (PORV) opened at approximately 3 seconds after turbine trip and the reactor tripped at approximately 8 seconds. The auxiliary feedwater system started up and should have delivered secondary coolant to the plant's two steam generators to remove heat; however, the flow paths were blocked by closed valves. Operator action to open the valves to

start auxiliary feedwater flow occurred approximately 8 minutes later. In addition, the PORV should have closed as reactor pressure decreased; however, it failed to close.

The relief valve apparently remained open and the system temperature and pressure continued to fall while the pressurizer level remained high. After approximately 15 minutes, the reactor coolant drain tank, which receives the discharge from the relief and safety valves, became overpressurized and relieved through its rupture disk. The pressure within the containment then rose to about 2 psig. The containment was not isolated since automatic isolation is initiated at 4 psig, which did not occur until after nearly 4 hours. The reactor building sump pumps started automatically in response to the rising water level in the containment and discharged into tanks in the auxiliary building. These tanks became full and overflowed into the reactor building. The reactor building sump pumps were stopped after approximately 30 minutes.

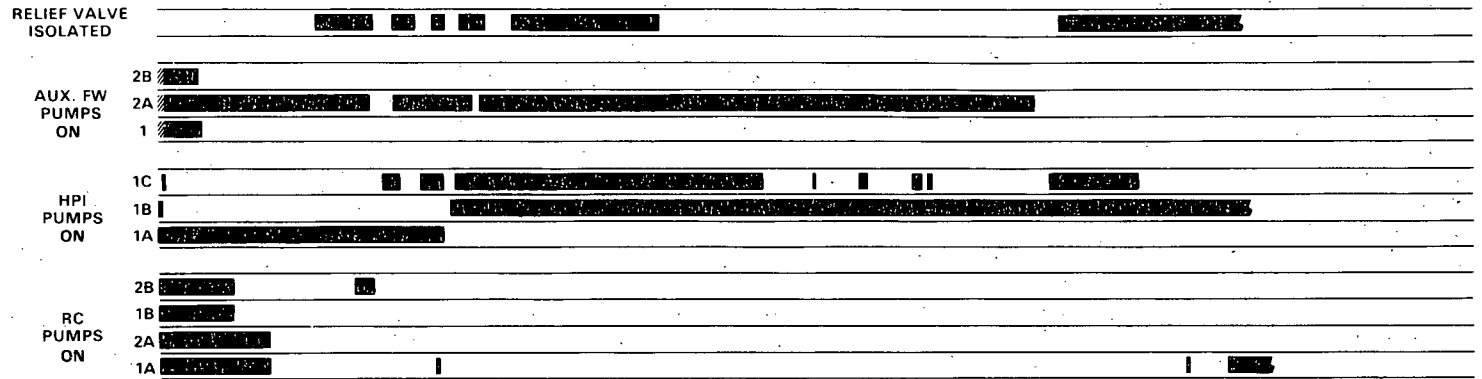
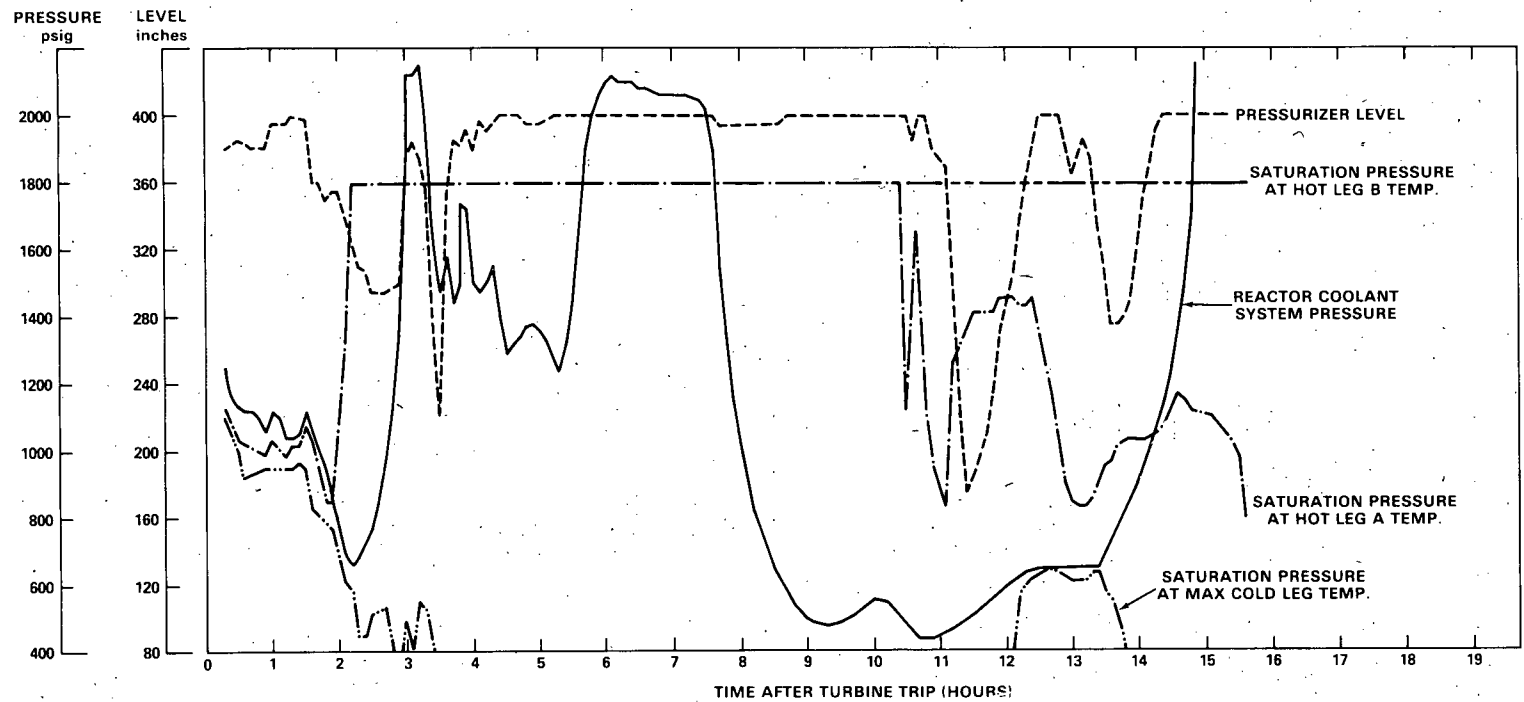
Figure 2. Reactor Coolant System Parameters in Hours After Turbine Trip at Three Mile Island, Unit 2, March 28, 1979.

The sequence of events and system response for the next 15 hours are shown in Figure 2. Two of the three auxiliary feedwater pumps were shut off after 30 minutes. Except for short periods, one auxiliary feedwater pump or normal feedwater and one or two HPI pumps remained turned on from this time on. However, the flow from the HPI pumps was apparently throttled. The pair of reactor coolant pumps in one loop was turned off after approximately 70 minutes, apparently to prevent damage to the pumps. The secondary side of the steam generator in this loop was isolated, and the water level in the other steam generator was raised from 36 inches to approximately 250 inches or about 50 percent of the operating range.

The pair of pumps in the other loop was also shut off after approximately 100 minutes. Within 15 minutes, the reactor coolant system hot leg temperature began to increase rapidly and went off the scale at approximately 620°F. The cold leg temperatures continued to decrease. This large temperature difference continued for over 8 hours and is believed to be the period during which the severe damage to the core occurred.

this block valve was opened and the system was depressurized over the next 4½ hours in an apparent attempt to start the decay heat removal system, which required the pressure to be below 400 psig. For reasons not known at this time, the RHR system was not placed into operation. However, the sequence of events shown in Figure 2 indicate that the pressure was never low enough to go on residual heat removal (RHR). The reactor building isolation and containment spray were actuated at about 9 hours, apparently because of the combustion of hydrogen in the containment.

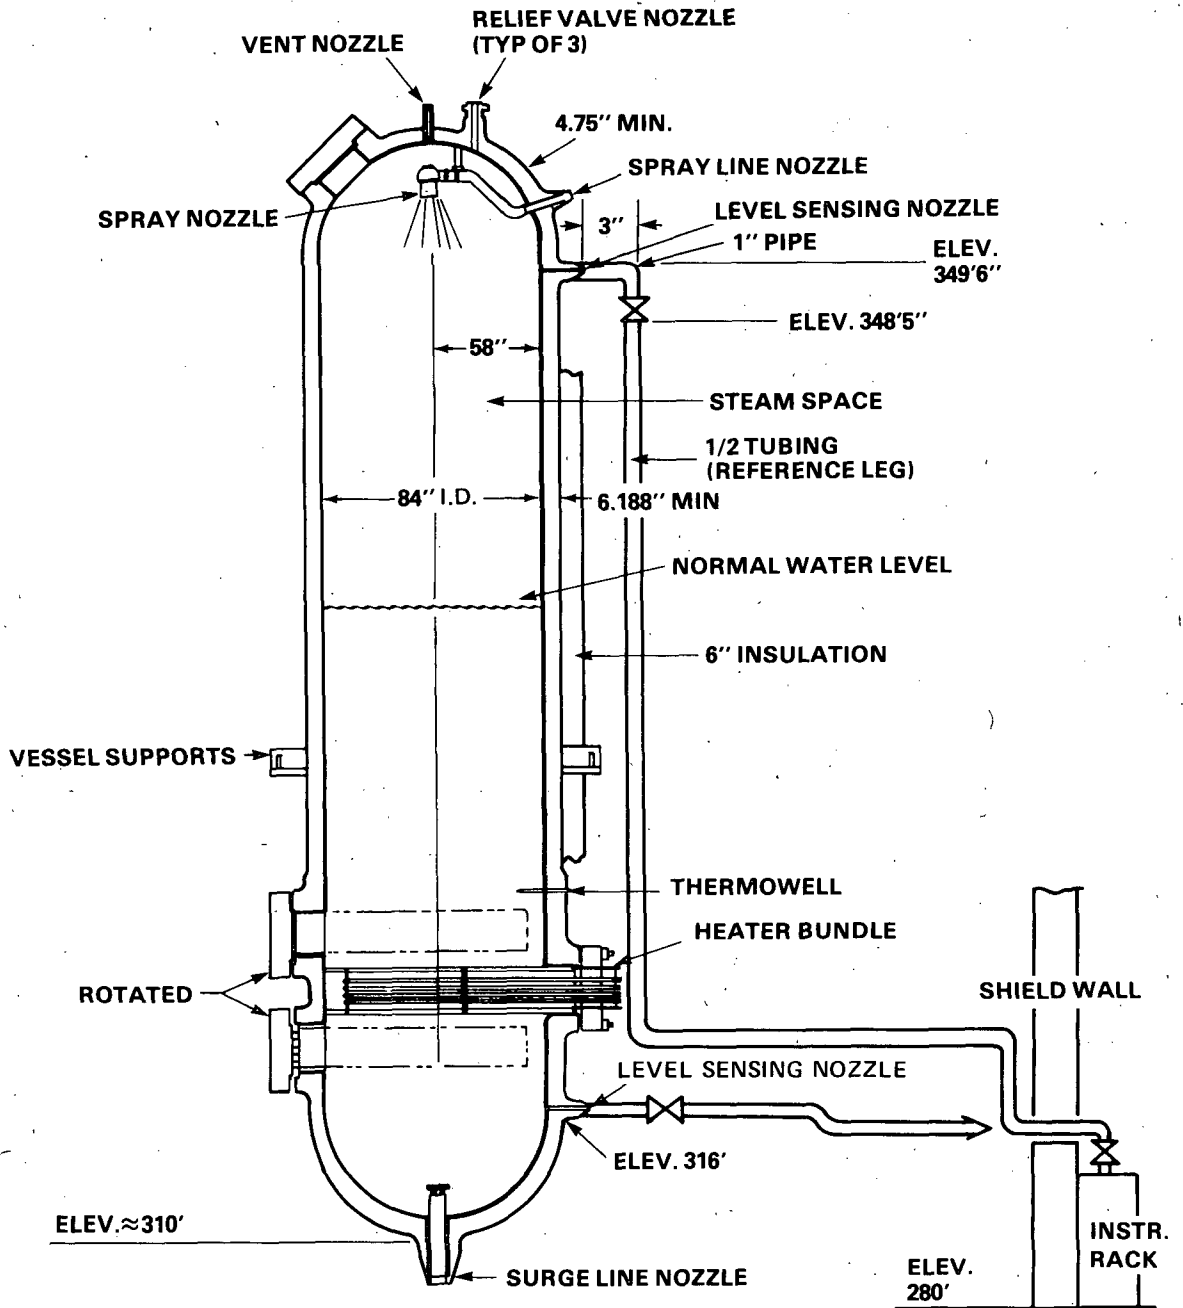
Figure 8. TMI-2 Pressurizer Level Instrument System (typical of all B&W plants).

The importance of each of these effects has been assessed assuming conditions that existed at TMI-2 prior to and during the event. Calculations were performed to estimate the effects of both flashing and degassing. Even though the calculations indicated that some flashing could occur, the reduction in water level in the

reference leg due to flashing is estimated to be less than 1 foot. Because the distance between the taps is about 33 feet, the effect of this reduction would be small. Calculations also indicate that the effect of degassing of liquid in the reference leg is negligible. With regard to the venturi effect, it is estimated that gas velocities at the upper level sensing nozzle are too low to produce any significant effect.

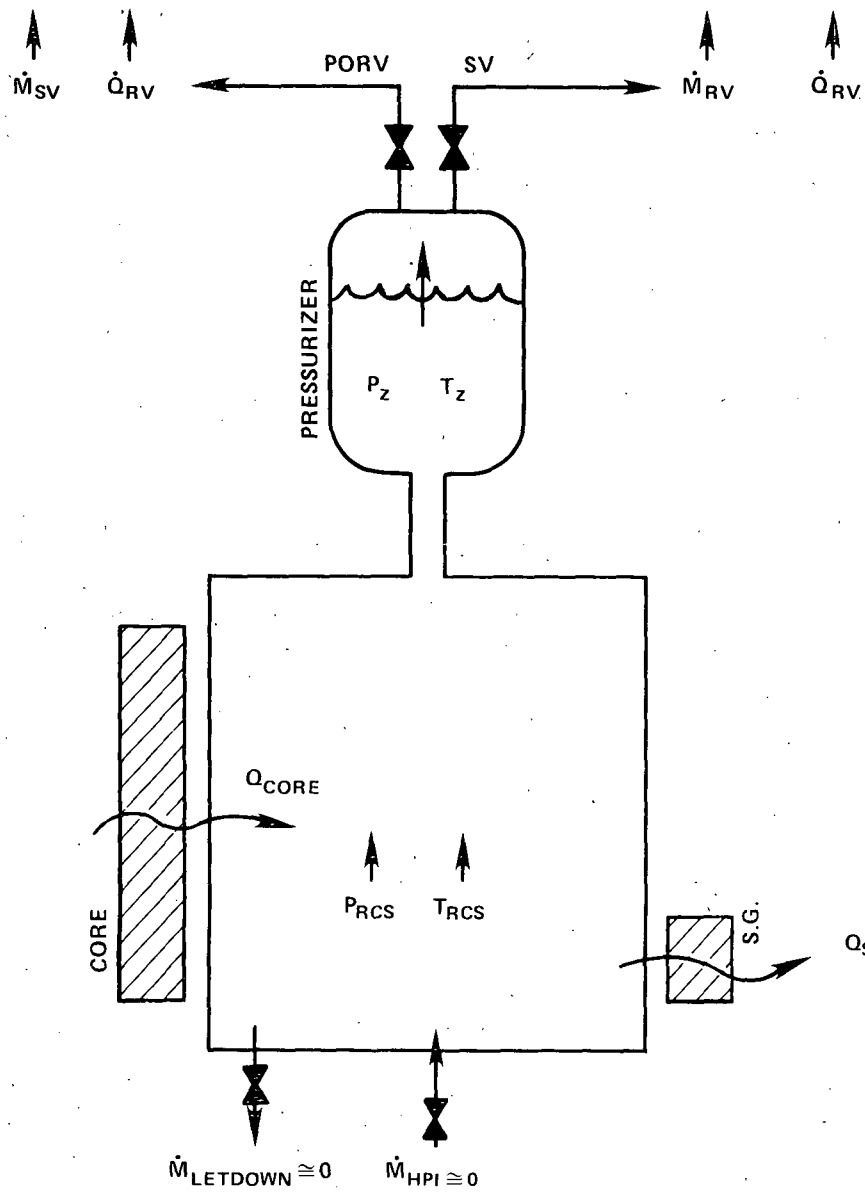
Figure 10. Transient Phase 1: Reactor at Full Power, S.G. Level Drops \rightarrow Heatup and Pressurization (more heat generated than removed).

Once the reactor trips on high RCS pressure, primary system pressure will rapidly drop because the combined system energy removal paths of the still open PORV and the still partially filled steam generator exceeds the energy put into the system by the reactor core. If the PORV recloses when its set point is reached, the continued depressurization or subsequent repressurization will depend on the availability of auxiliary feedwater. With auxiliary feedwater available, the rate of depressurization will depend on the imbalance between the stored and decay heat output of the core together with the steam generator heat removal capabilities dictated by the secondary-side steam generator water level and pressure. The B&W auxiliary feedwater capacity and steam generator level control is such that with the PORV reclosed the primary system will neither be overcooled (thereby draining

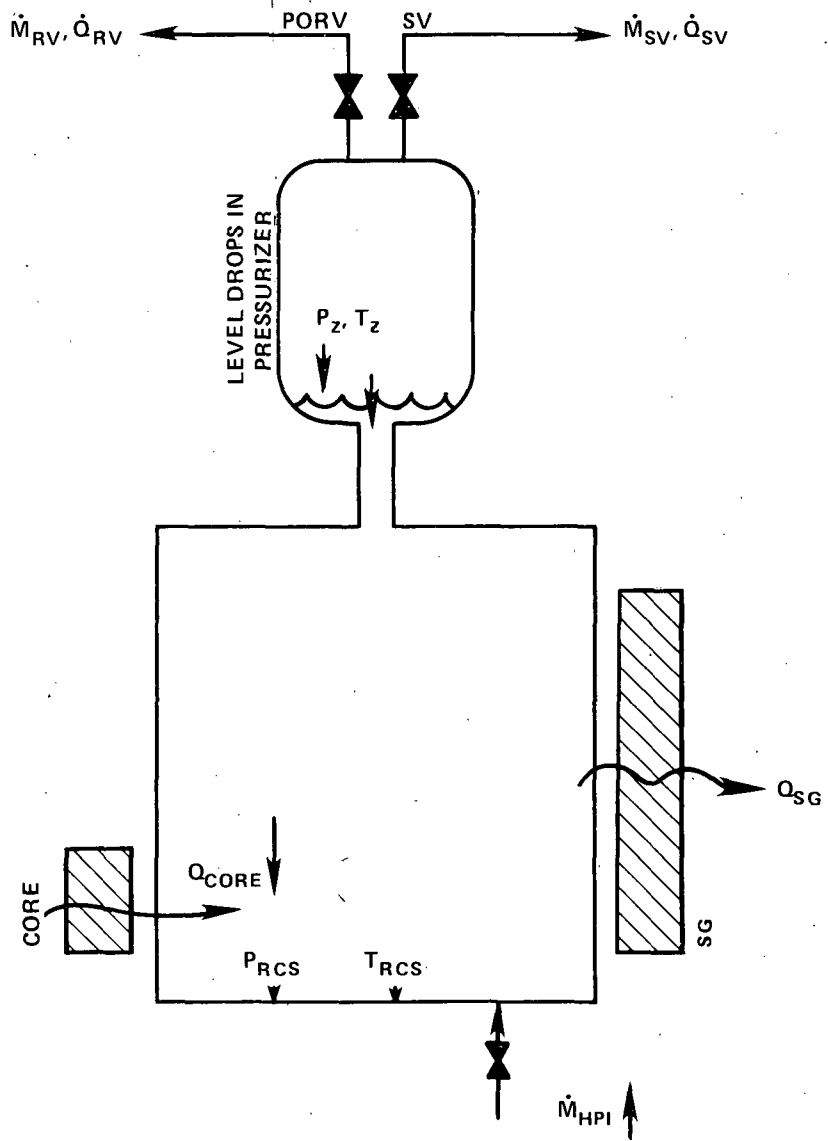
Figure 11. Transient Phase 2: Reactor Trips, S.G. Recovery Level \rightarrow Cooldown and Depressurization (more heat removed than generated).

the pressurizer and inducing voids into the system) nor will it be undercooled (thereby allowing pressures and temperatures to increase sufficiently to relift the PORV). HPI will not come on because its set point would not be reached. Thus, the steam generator level setting will allow the transient decay heat energy to be removed while keeping the RCS adequately but not overly subcooled, thereby keeping system temperatures and pressures within acceptable bounds without high-pressure injection. There are no special actions required of the operator for this case. The reactor coolant system is automatically and adequately recovered and kept within an acceptable thermal-hydraulic condition (properly subcooled) by the auxiliary feedwater system without significant operator actions. The pressurizer pressure and level control systems automatically maintain primary system conditions.
