Three Mile Island Nuclear Station, Unit 2 (TMI-2)
Operating License No. DPR-73
Docket No. 50-320
Licensee Event Report 82-011/01L-1

Attached please find Licensee Event Report 82-011/01L-1 concerning a potential bypass path around several of the ventilation systems filtration units at TMI-2.

LICENSEE EVENT REPORT
NARRATIVE REPORT
TMI-II
LER 82-011/03L-1
EVENT DATE - March 3, 1982

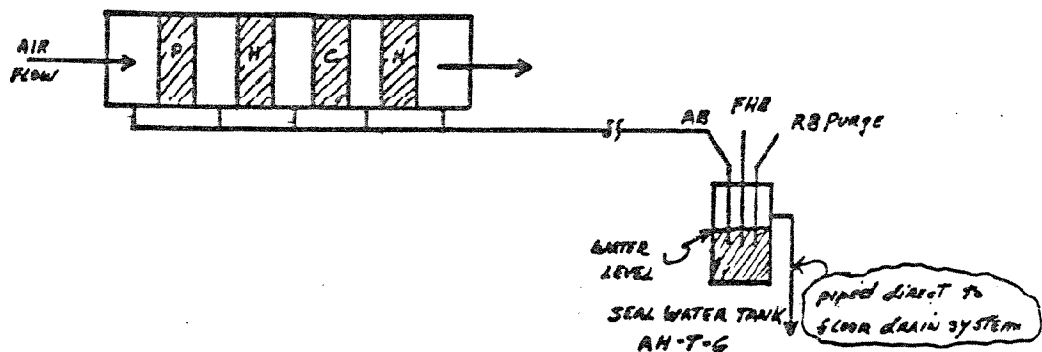
2. Another potential path identified was possible bypass through the floor drain system, into the Filter Cabinet Seal Water Tank (AH-T-6) and then up through the filter cabinet underdrain to the downstream side of the filters. An investigation of the level control system was satisfactorily performed which indicated that there was sufficient water in the drain tank at the time of the January 8, 1982 occurrence to have eliminated this bypass path. This investigation included draining the tank to ensure that the level control valve operated correctly and checking the calibration on the level controller to ensure it operated within its required range.
3. The third potential path was bypass through the underdrains in each HEPA filter bank. Each of the filter cabinets in question have the basic arrangement shown below.

Each filter cabinet has one drain and four cleanouts, all of which tie into a common header. The header in turn runs to the seal water tank.

An investigation of these cleanouts subsequent to the January 8, 1982 event revealed that they had been taped instead of plugged and that the tape was either loose or missing from several of the cleanouts. This could have established a bypass path around the filters via the common header. Smear surveys taken at the drain and cleanout openings inside the downstream filter cabinet showed relatively high contamination as compared with adjacent ductwork, which indicates filter bypassing.

Plant drawings and specifications call for the existence of one (1) open drain and four (4) plugged cleanouts in each of the filter cabinets. However, the existing plant equipment had four (4) unplugged cleanouts in addition to the open drain. The four (4) cleanouts and associated plugs apparently were never installed.

In order to prevent HEPA filter bypass permanent carbon steel plugs have been installed in the four (4) cleanouts located in each of the exhaust filter cabinets. The central floor drain of each exhaust filter cabinet has been left unplugged to allow for drainage of the filter cabinet in the event of an actuation of the cabinet's fire protection system.
