UPDATE

Volume 3, Number 2

August 15, 1983

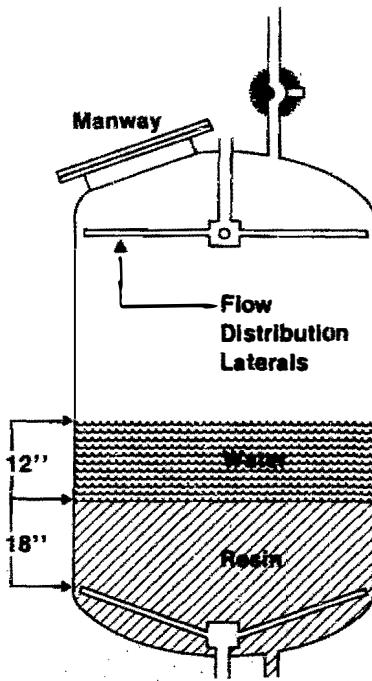
Figure 3. Pathways of fiber optic horescope during examination of demineralizer A vessel internals.

In April 1983, TI&EP engineers completed a successful examination of demineralizer A vessel using a 50-ft long, radiation-tolerant, fiberoptic scope. The scope, inside a polyethylene guide tube, was pushed into the vessel through the resin fill line and passed easily through the resin fill line diaphragm valve. The fiberoptic scope and guide tube paths are detailed in Figure 3. Observations by TI&EP personnel during the fiberscope inspection concluded that the A vessel contains a bed of resin with a crust of boron crystals coating the top of the bed. The center of the bed has a large void that appears to be above the resin shoring outlet line. The resin in the bed is agglomerated and amber colored below the crystalline crust.

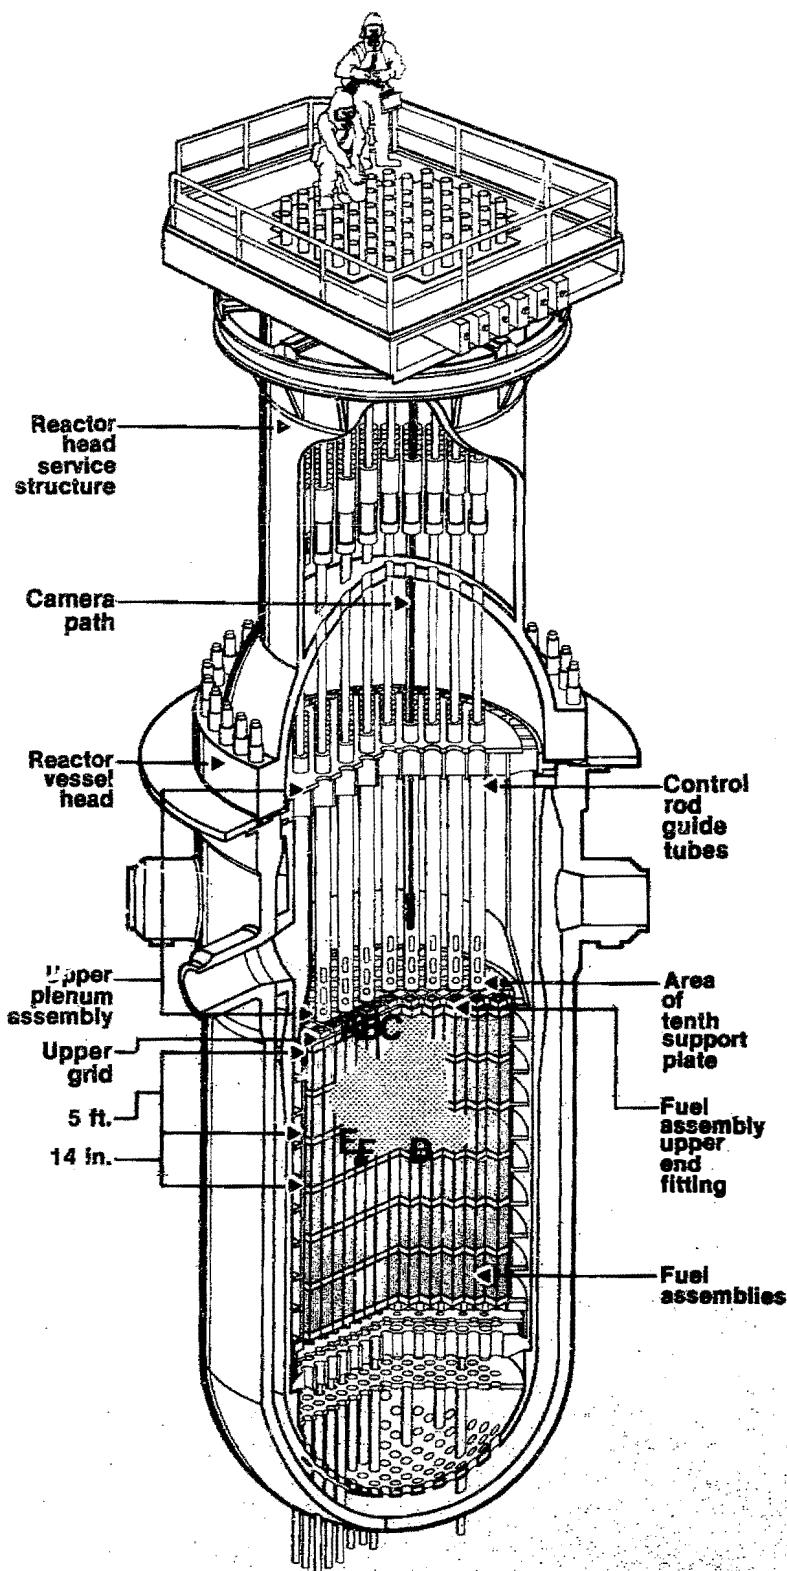
Figure 12. Relative locations and views of damage inside the TMI-2 reactor.

At the core center position, the entire upper end fitting was missing, as were all adjacent end fittings. The grillwork from the midradius upper end fitting was completely missing as was its control rod spider, spring, and spring retainer. The grillwork on each of the other upper end fittings visible from this location was present but partially melted and suspended from the plenum grid plate. One section of grillwork also had other identifiable components, such as a spacer grid, stubs of control elements, and partial fuel rods, suspended from it.

The insides of the midradius upper end fitting were scanned using the camera's right angle lens. The end fitting appeared to be in its normal position with respect to the grid structure. Metal chips and debris were found in the small space between the center tabs on the end fitting and the grid. In addition, some areas of the top portions of this upper end fitting have the appearance of having been cut by a torch, while adjacent areas appear to be in the as-manufactured condition.

A. Metal chips and debris between centering tabs of an upper end fitting.

B. Damage to E-9 upper end fitting looks like metal after it has been cut by a torch.

C. Control rod element stub in upper end fitting grill work.

D. General appearance of the rubble bed at core-center location H-8. Potato-shaped object in center of picture is actually only 0.32-cm in diameter.

E. Unidentified rod on top of rubble bed at location E-9.

F. Pellet hold-down spring on top of rubble bed at location E-9.

formed by the redistribution of fuel from central fuel assemblies. The rubble bed in the central region consists of fine granular particles, angular in shape, and approximately 1/8 in. in size. No recognizable shapes could be identified other than a portion of a control rod spider assembly. Engineers believe that this is the core center spider assembly which fell into the rubble bed when its leadscrew was uncoupled to provide access for the quick look camera. The general appearance of the rubble bed in the midradius region was considerably different than that at the core center location. In the midradius region, the rubble bed was comprised of much larger pieces and numerous recognizable shapes. Stubs of fuel rods were also observed protruding upward from the rubble and a forest of rods could be seen looking radially outward toward the west edge of the core. These rods and stubs were suspended from the remains of the upper end fittings that were still in place.
