**Results of Examinations of Pressure Vessel Samples
and Instrument Nozzles from the TMI-2 Lower Head***

G. E. Korth
Idaho National Engineering Laboratory
EG&G Idaho, Inc.
Idaho Falls, ID 83415

D. R. Diercks and L. A. Neimark
Energy Technology Division
Argonne National Laboratory
Argonne, IL 60439

October 1993

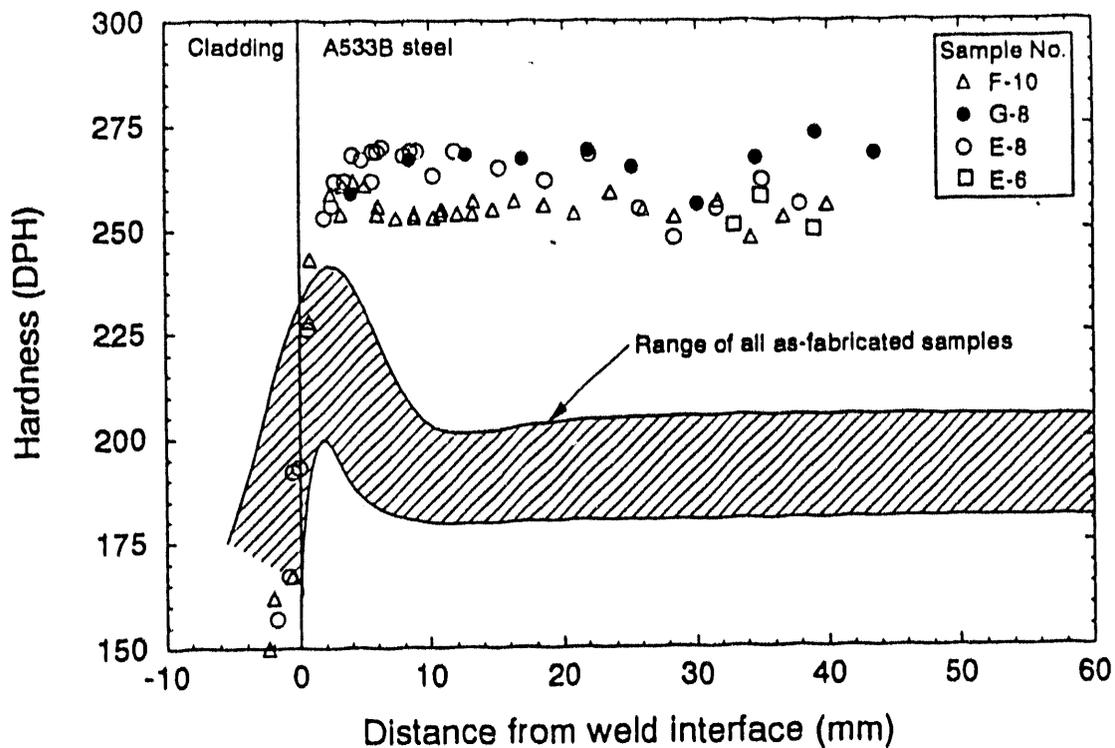
Hardness Measurements. The hardness profiles of most of the TMI-2 samples had the typical characteristic profile of as-fabricated material as shown in Fig. 4, but the hardness profiles from Samples E-6, E-8, F-10, and G-8 were markedly different than all other samples, as shown in Fig. 5. The characteristic hardness profile through the HAZ band had risen sharply in these four samples to much higher levels and was then sustained throughout the full sample depth. Heat-affected bands from the weld cladding were not evident in these four samples, but were completely eliminated by the thermal effects of the accident.

Fig. 5. Hardness profiles of Samples F-10, G-8, E-8 and E-6 compared to the as-fabricated samples.

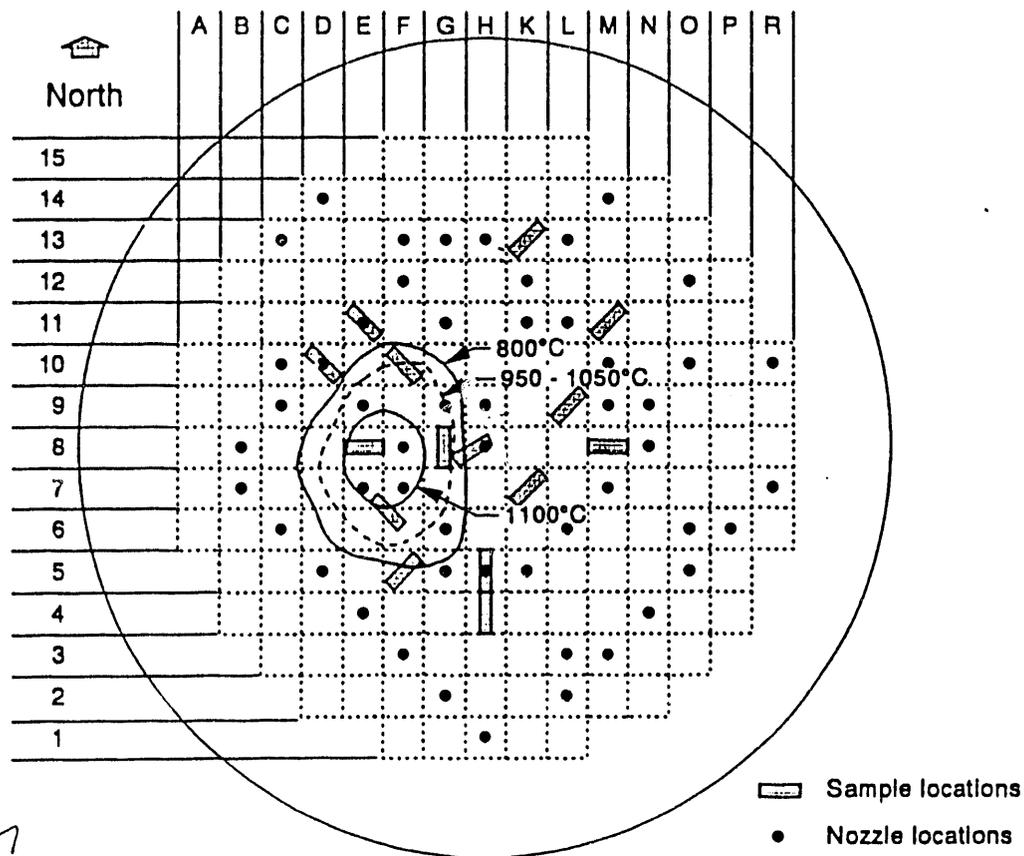
Fig. 7. Thermal contour map of peak temperature constructed as best estimate based on results of the metallographic examinations of the boat samples.

- E-6 and E-8: 1075-1100°C for about 30 minutes
- F-10 and G-8: 1040-1060°C for about 30 minutes.

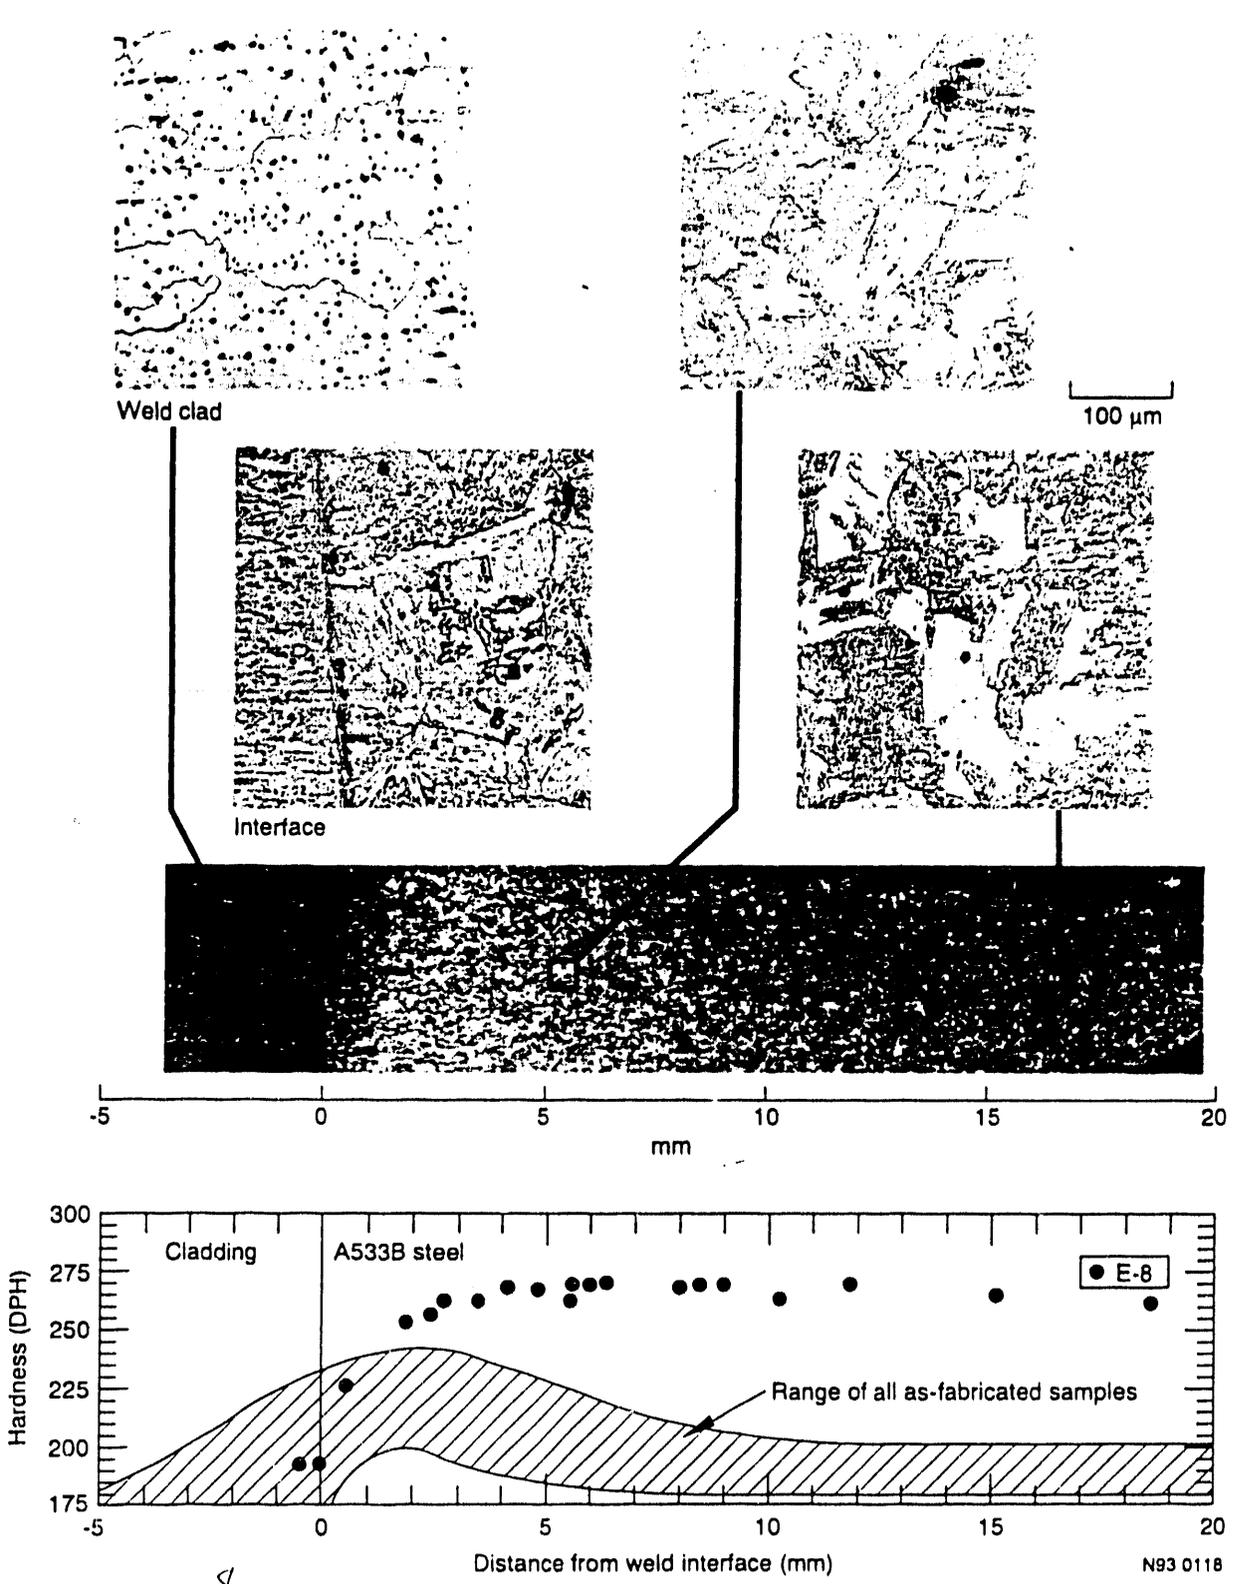
As the standards were prepared and examined, various metallurgical observations revealed a step-wise process that could be used in determining the thermal histories of the TMI-2 samples. A diagram (shown in Fig. 6) was constructed, which illustrates the metallurgical changes with time and temperature of the Midland and TMI-2 lower head A533B steel with a 308L stainless weld clad. Since the vessel was stress relieved at 607°C after the weld cladding, no thermal effects from the accident could be detected at or below this temperature and, therefore, the diagram shows only metallurgical observations for temperatures above this point. The lowest temperature indicator, above the stress relief temperature, was the ferrite-austenite transformation, which starts at 727°C and is complete by ≈830°C. Variations in the typical as-fabricated hardness profile will be evident when this threshold is exceeded. The next indicator is the dissolution or dissipation of a dark feathery band at the interface; this occurs between 800 and 925°C, depending on the time. The next indicator of increasing temperature is the appearance of small equiaxed grains, which formed in the A533B steel adjacent to the interface at temperatures between 850 and 900°C and disappeared between 1025 and 1100°C as they were consumed by grain growth in the low alloy steel. The equiaxed grains, which are not typical for a low alloy steel, appear to be devoid of cementite, probably due to a loss of carbon into the stainless steel. Grain growth in the A533B steel becomes significant above approximately 950 to 1075°C, depending on the time involved. The highest temperature indicator shown on the diagram is the change in morphology of the δ-ferrite islands in the stainless steel cladding. In the approximate range of 975 to 1000°C at 100 minutes or 1100 to 1125°C at 10 minutes, the δ-ferrite islands begin to lose their slender branch-like morphology and become spherical in shape. This spheroidizing of the δ-ferrite islands is believed to be associated with the dissolution of $M_{23}C_6$ carbides, which decorate the ferrite-austenite boundaries and stabilize their shape. When the carbides dissolve, the δ-ferrite becomes more spherical to minimize surface energy. There was also evidence that some of the δ-ferrite was consumed into the austenitic matrix after exposures above 1000°C since there was a net loss of δ-ferrite after cooling. Researchers in the Federal Republic of Germany⁷ and Spain⁹ observed that δ-ferrite in the cladding of non-affected samples was 4-5%, but only 1.4% in E-8.

Fig. 8. Microstructure and hardness profile of Sample E-8.

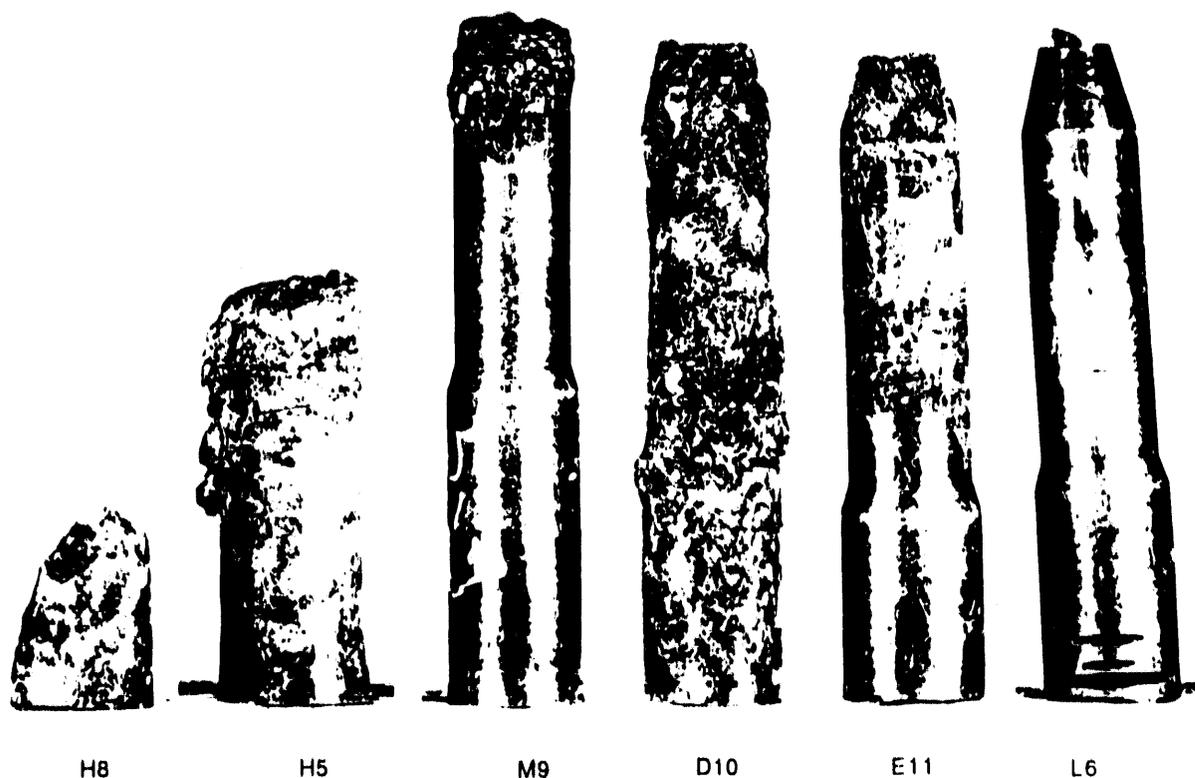
Fig. 11. Appearance of nozzles as removed from the lower head.

Pattern of Nozzle Damage. Figure 11 shows the as-removed appearance of the six ANL nozzles; Table 1 should be used to obtain a true comparison of the elevations at which nozzle damage occurred because the stub lengths remaining on the vessel were different for each nozzle. The tops of nozzles M-9 and H-5 were clearly melted an appreciable amount. The transition zone between the molten region and the unaffected lower part of the nozzles was relatively narrow on M-9 and more extensive on the shorter H-5. These transition zones were typically covered with a thin scale that was basically an iron oxide with entrapped shards of various core debris materials (Fig. 12); the lower areas of the nozzles were clean of adherent scale and showed little, if any, effects of being in contact with very hot core debris.
