**Results of Examinations of Pressure Vessel Samples
and Instrument Nozzles from the TMI-2 Lower Head***

October 1993

**Results of Examinations of Pressure Vessel Samples
and Instrument Tube Nozzles from the TMI-2 Lower Head**

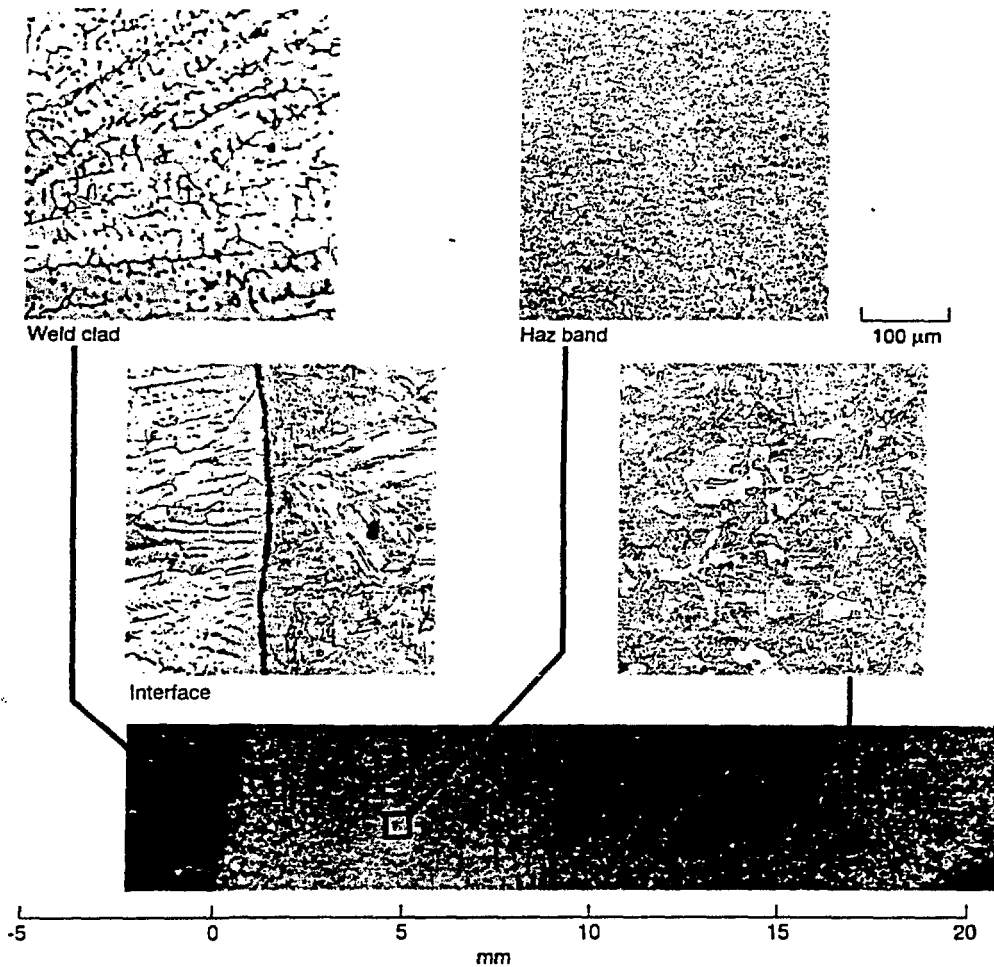
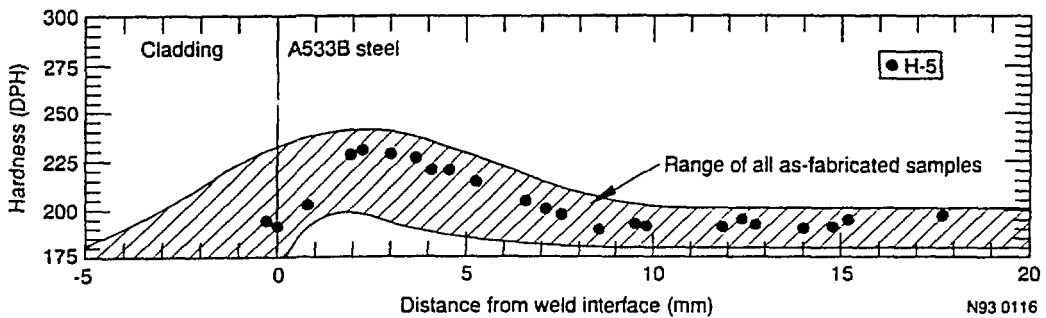
Hardness Measurements. The hardness profiles of most of the TMI-2 samples had the typical characteristic profile of as-fabricated material as shown in Fig. 4, but the hardness profiles from Samples E-6, E-8, F-10, and G-8 were markedly different than all other samples, as shown in Fig. 5. The characteristic hardness profile through the HAZ band had risen sharply in these four samples to much higher levels and was then sustained throughout the full sample depth. Heat-affected bands from the weld cladding were not evident in these four samples, but were completely eliminated by the thermal effects of the accident.

Fig. 4. Typical as-fabricated microstructure and hardness of TMI-2 lower head material (from Sample H-5).

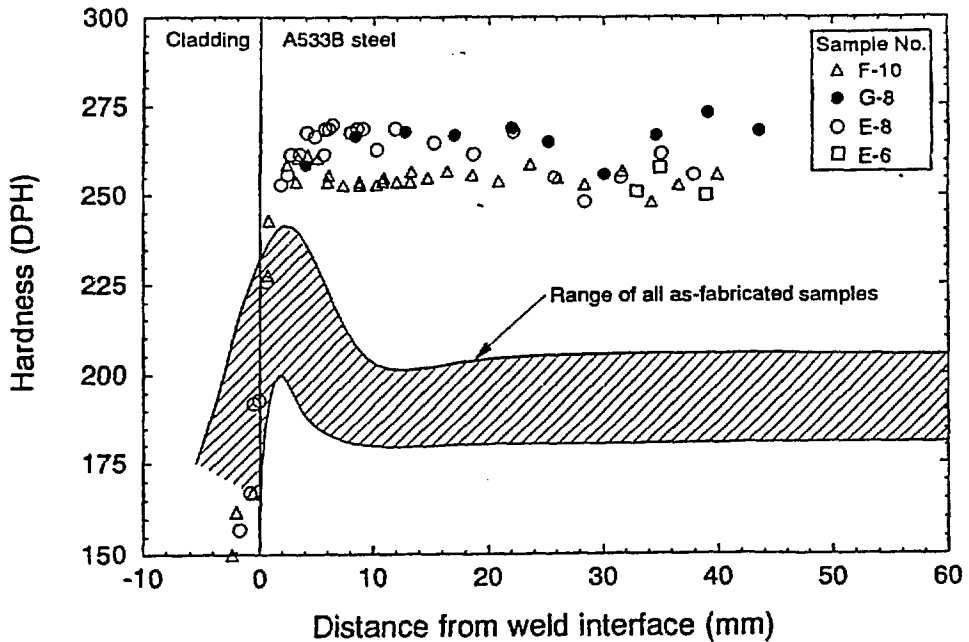
Fig. 5. Hardness profiles of Samples F-10, G-8, E-8 and E-6 compared to the as-fabricated samples.

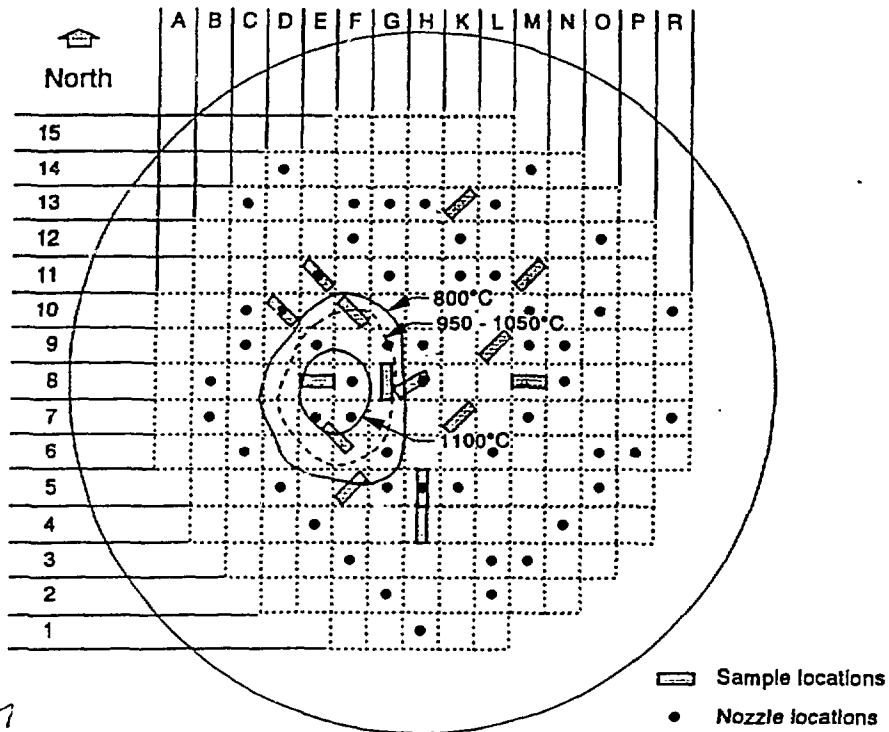
Fig. 7. Thermal contour map of peak temperature constructed as best estimate based on results of the metallographic examinations of the boat samples.

- E-6 and E-8: 1075-1100°C for about 30 minutes
- F-10 and G-8: 1040-1060°C for about 30 minutes.

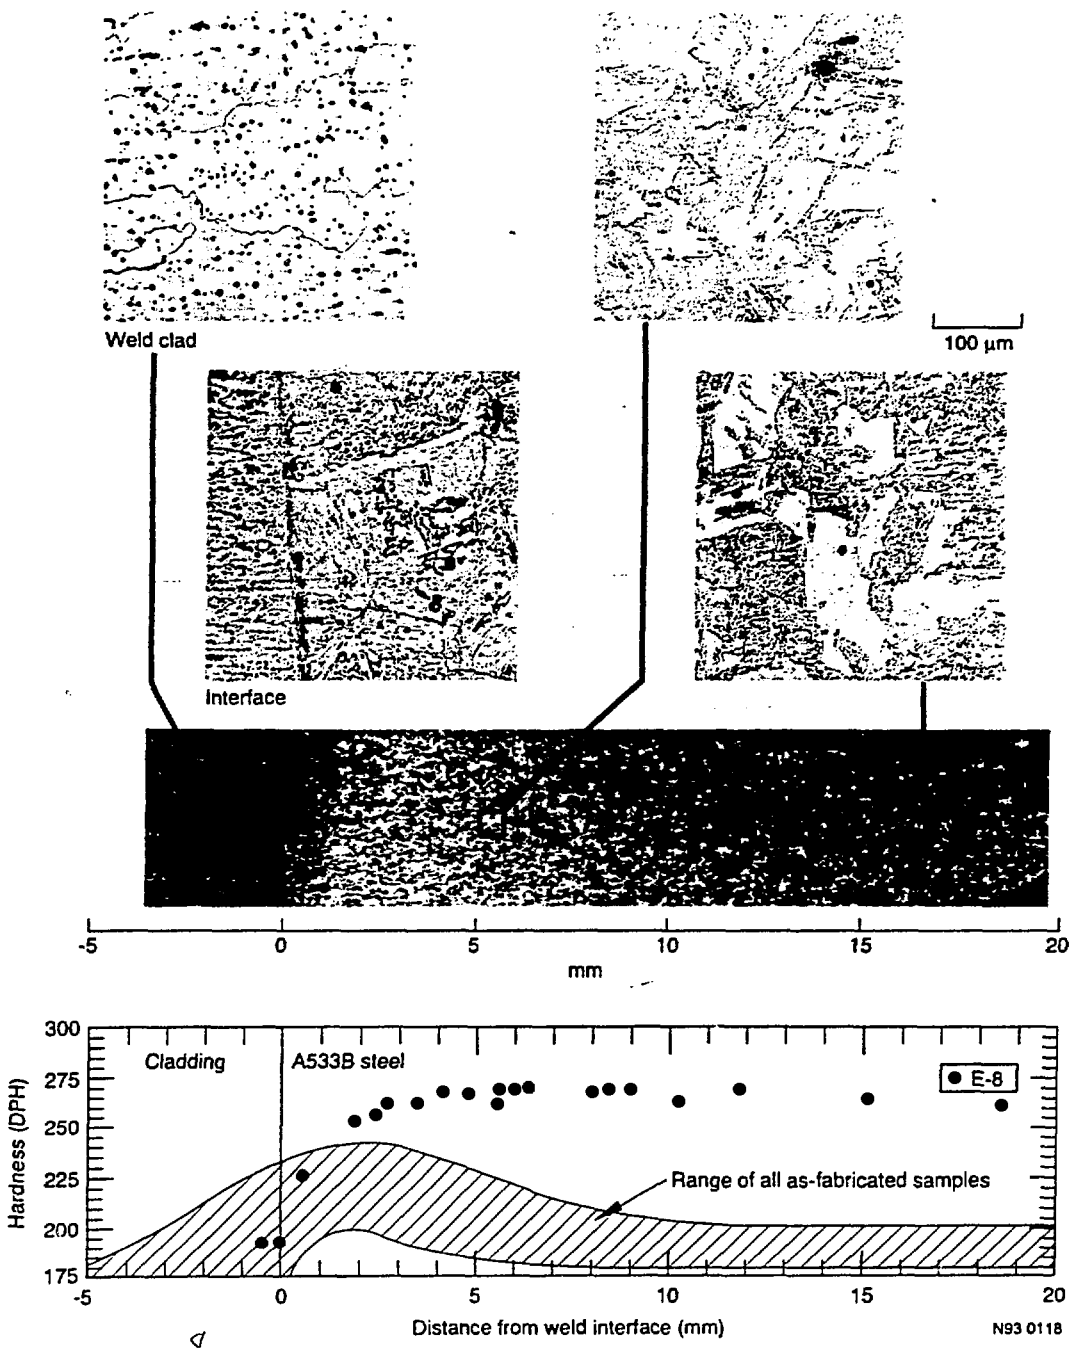
Examinations at ANL and some of the OECD partner laboratories for different sections of these same boat samples are consistent with the INEL conclusions. United Kingdom researchers showed evidence that M-11 also slightly exceeded the 727°C transformation temperature, but that determination was not confirmed by the other five laboratories examining different sections of the M-11 boat sample. Based on the above observations and conclusions, a thermal contour map of peak temperatures was constructed as shown in Fig. 7. The hardness profile and microstructure of one of the thermally altered samples, E-8, is shown in Fig. 8.

Fig. 8. Microstructure and hardness profile of Sample E-8.

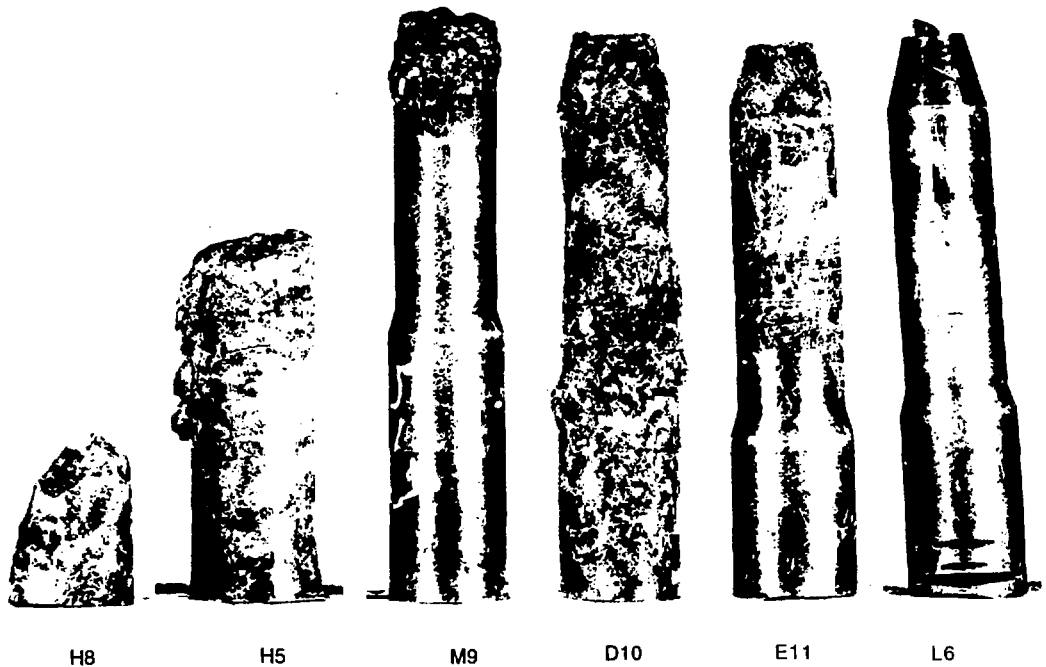
Fig. 11. Appearance of nozzles as removed from the lower head.

Pattern of Nozzle Damage. Figure 11 shows the as-removed appearance of the six ANL nozzles; Table 1 should be used to obtain a true comparison of the elevations at which nozzle damage occurred because the stub lengths remaining on the vessel were different for each nozzle. The tops of nozzles M-9 and H-5 were clearly melted an appreciable amount. The transition zone between the molten region and the unaffected lower part of the nozzles was relatively narrow on M-9 and more extensive on the shorter H-5. These transition zones were typically covered with a thin scale that was basically an iron oxide with entrapped shards of various core debris materials (Fig. 12); the lower areas of the nozzles were clean of adherent scale and showed little, if any, effects of being in contact with very hot core debris.

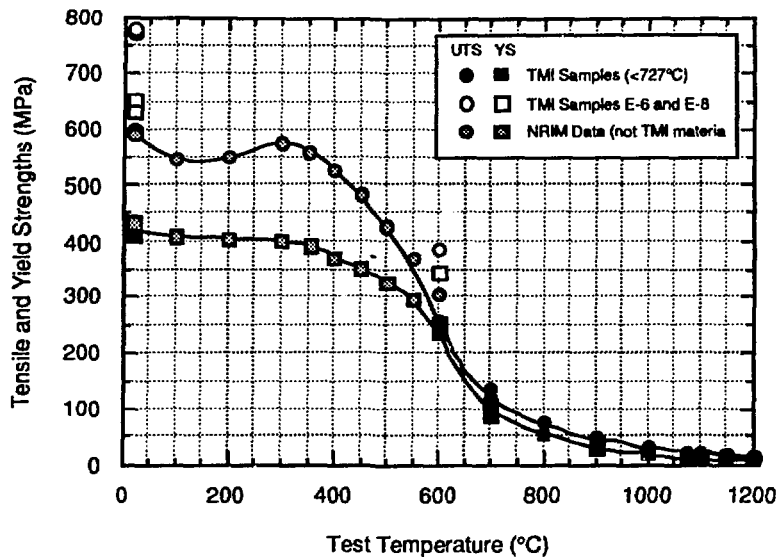
The data for specimens taken from lower head samples E-6 and E-8 are plotted separately in Fig. 14, and these data lie significantly above the best-fit curve to the remaining data. It has been determined that both of these samples were heated to maximum temperatures of ≈ 1000 -1100°C during the accident, followed by a relatively rapidly cooling.² The resulting hardening has produced significant increases in strength at both room temperature and 600°C.

Fig. 14. Tensile and yield strengths of TMI-2 lower head material

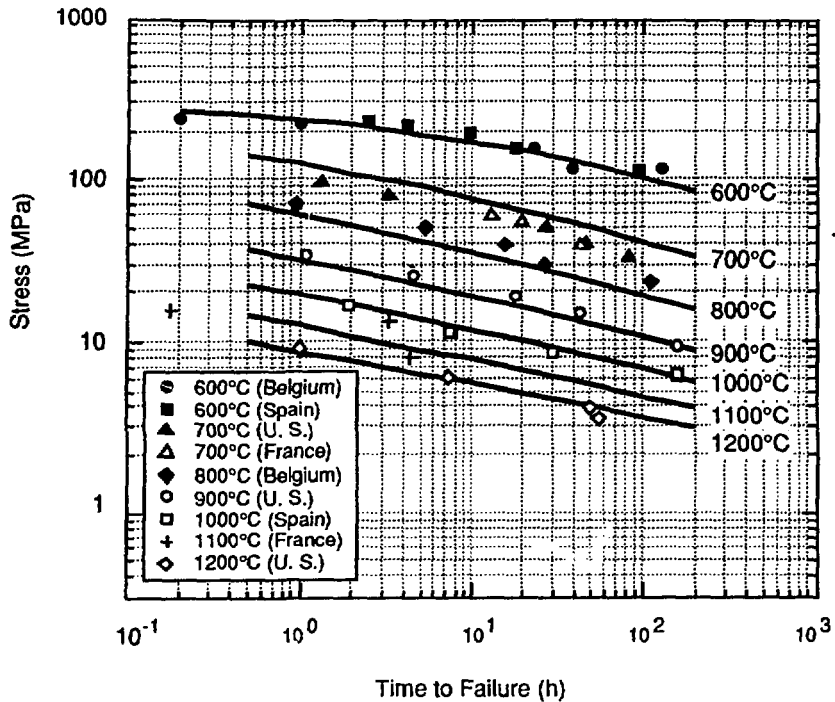
These tests were carried out at ANL and in Belgium, France, and Spain, and the resulting stress-vs.-time-to-failure data are plotted in Fig. 15. The tests were conducted in an Ar or He environment except those conducted by the SCK/CEN in Belgium. All but one of the Belgian tests was conducted in vacuum; a single test at 800°C and 30 MPa was conducted in an Ar environment.

Fig. 15. Stress-rupture data with Manson-Haferd best fit

A comparison of the resulting best fit curves with the actual s vs. t_f data in Fig. 15 shows a reasonably good fit to the data. However, systematic departures from the actual data are noted in the 700-900°C region. This problem may be associated, in part, with the ferrite-to-austenite phase transformation that occurs over the temperature regime from 727 to $\approx 850^\circ\text{C}$.

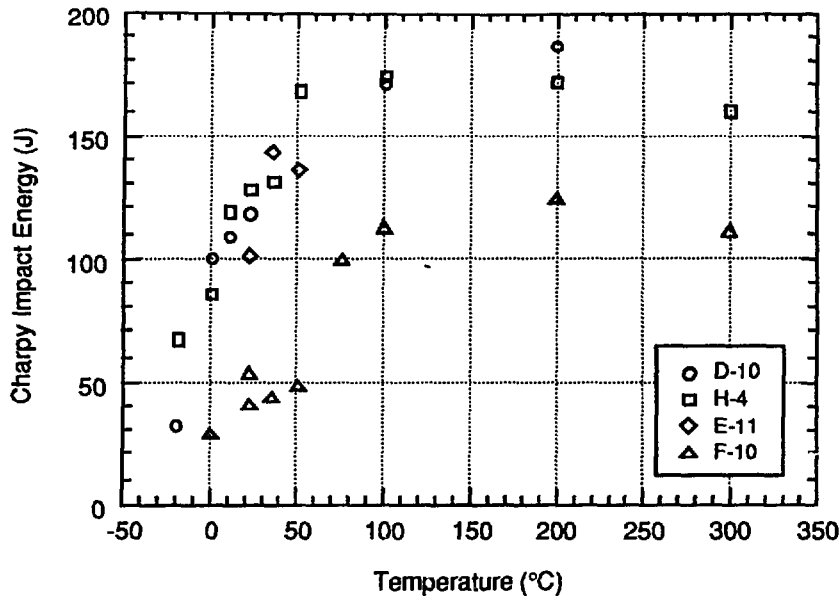
Fig. 16. Absorbed impact energy vs. test temperature

Impact Tests. The impact tests on the lower-head material were conducted in Italy⁸ using the procedure and conventional Charpy V-notch test specimen described in ASTM E23, and the data are summarized in Fig. 16. The three groups of test specimens for which the maximum temperature did not exceed 727°C show similar behavior, with an upper shelf energy of ≈ 170 J and a transition temperature of the order of 20°C. However, the data from specimens of Sample F-10, for which the maximum temperature was as high as $\approx 1050^\circ\text{C}$, stand in marked contrast. The F-10 material shows a significantly higher ductile-to-brittle transition temperature of $\approx 70^\circ\text{C}$, as well as a lower upper-shelf energy of ≈ 120 J. These differences reflect the reduced ductility and impact resistance that is produced in this material by the high temperatures and relatively rapid cooling associated with the accident.

9. Charpy V-notch impact tests conducted on lower head base-metal material noted a substantial difference between specimens from Sample F-10, for which T_{max} was as high as $\approx 1050^{\circ}\text{C}$, as compared with specimens from samples for which T_{max} was $<727^{\circ}\text{C}$. The F-10 material showed a significantly higher ductile-to-brittle transition temperature as well as a lower upper-shelf energy value.
