Investigation of Intergranular Stress Corrosion  
Cracking in the Fuel Pool at Three Mile Island Unit 1

Carl J. Czajkowski  
Brookhaven National Laboratory  
Upton, New York 11973

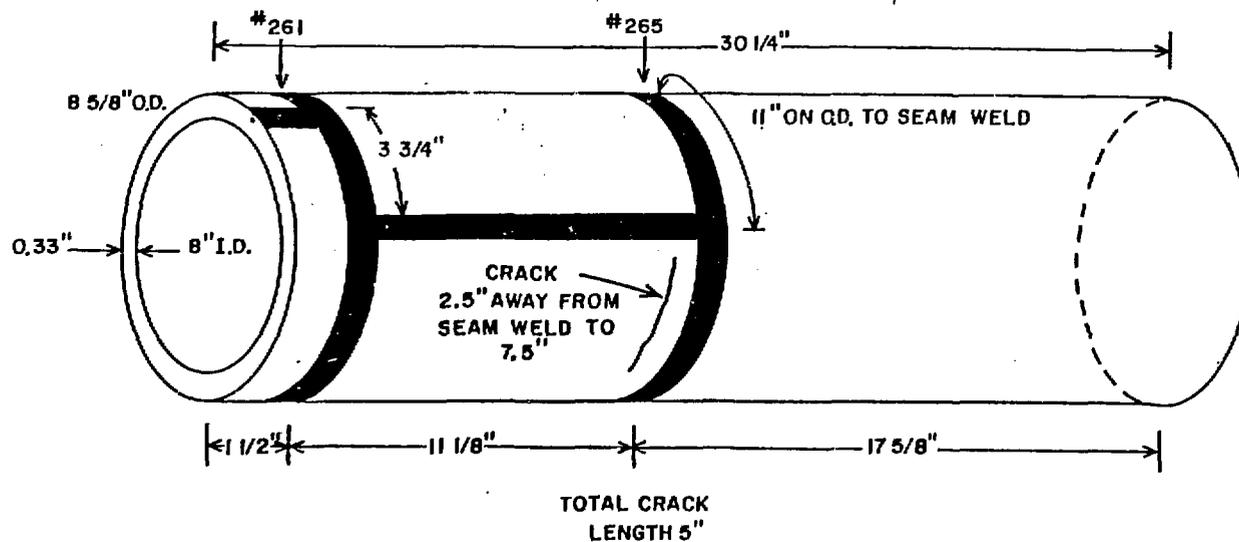
In order to analyze the cracking phenomena in more detail, a section of radioactively contaminated 8" diameter pipe was sent to Brookhaven National Laboratory (BNL). The pipe (H.T. #334165) measured approximately 30" in length and contained two circumferential welds, SF 265 (through wall cracked-field weld), and SF 261 (uncracked-shop weld), as well as three uncracked longitudinal seam shop welds (Figure 1). (Note: Six of the seven through wall cracks were from material of this heat number 334165.)

Figure 1. Location of welds and crack on 30 1/4" piece of 8" stainless steel pipe.

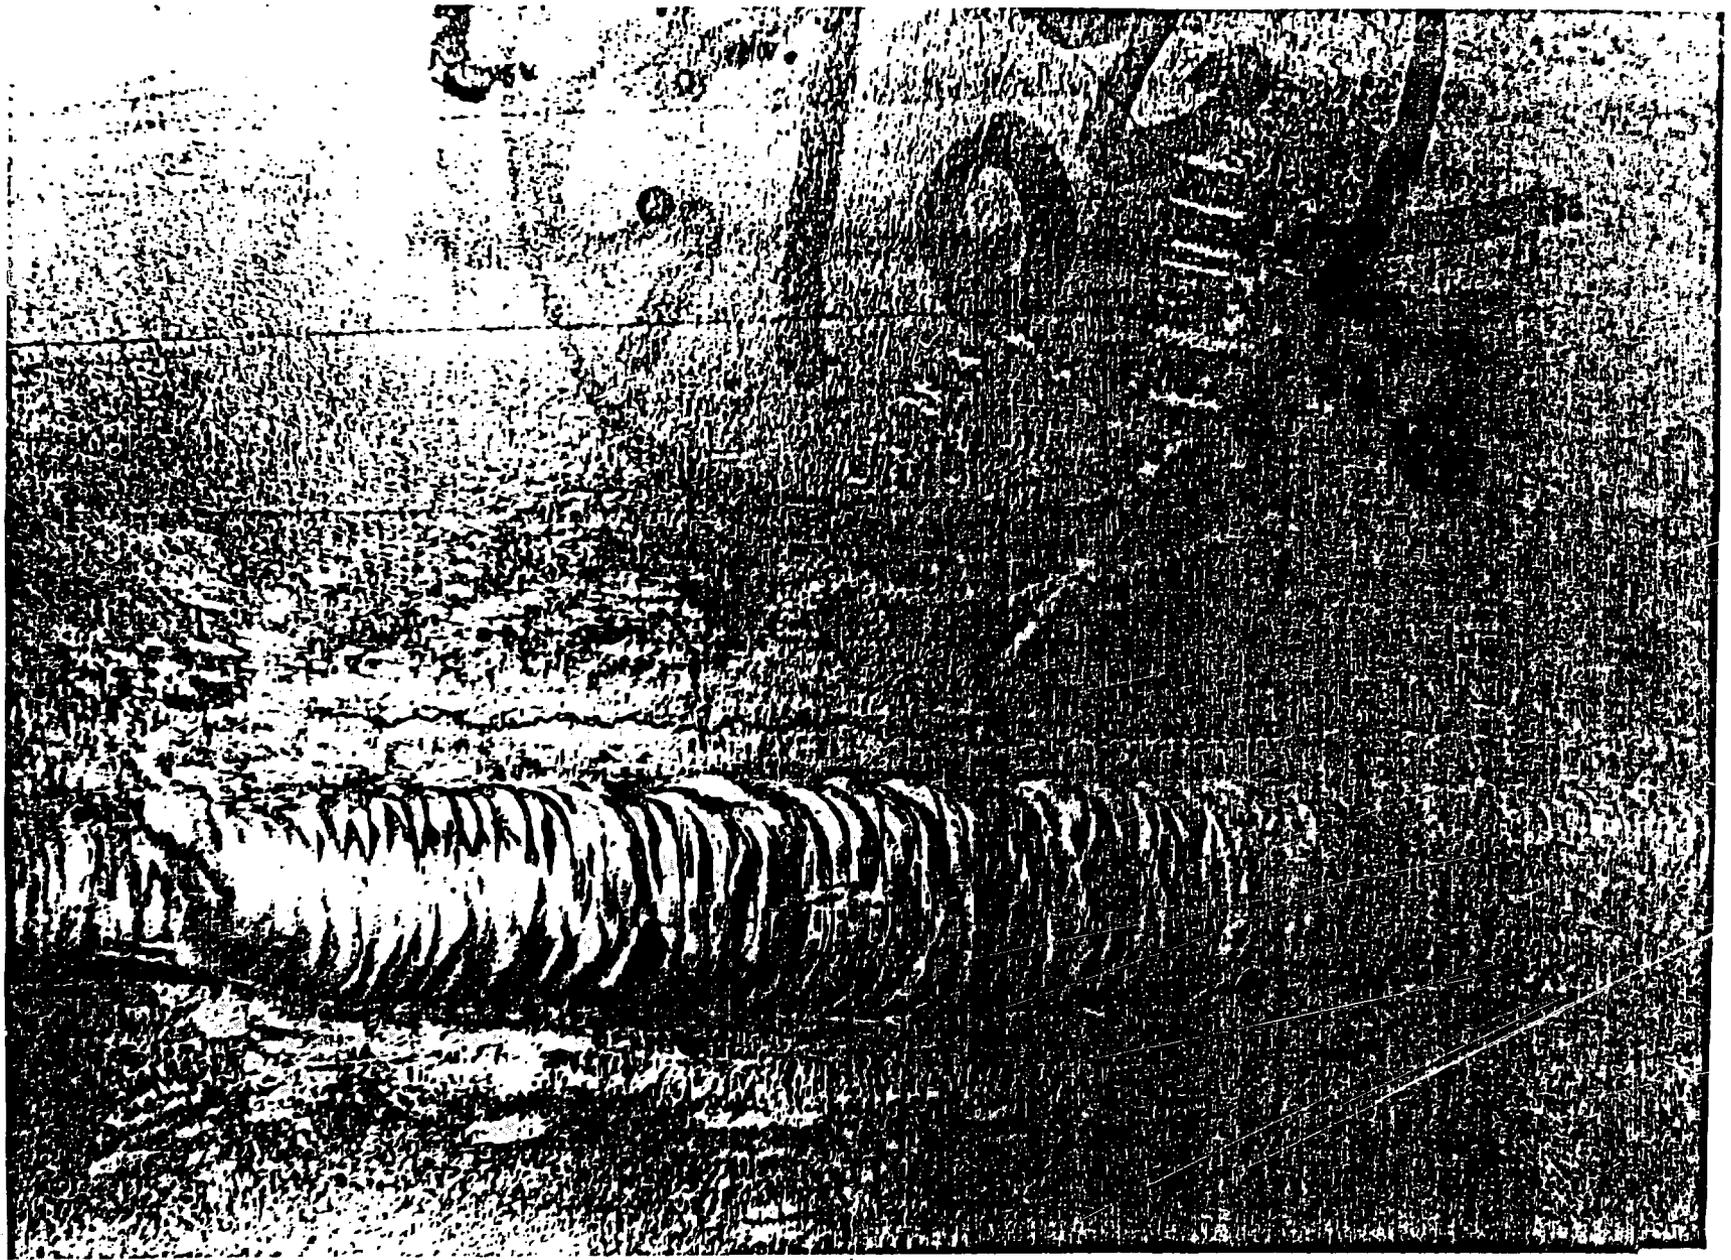
VISUAL/PHOTOGRAPHY - Preliminary visual examination of the pipe disclosed that the crack (near SF 265) was adjacent to what appeared to be a weld repair area. In addition, GPU also communicated that the weld was a single "V" type with a shallow ( $\approx 20^\circ$ ) edge preparation. The filler metal used was an E308 Grinnell Consumable Insert and welded with ER308 electrode (Table 1). The welding process used was GTAW (Gas Tungsten Arc Welding). The repair area was in its R-2 stage (two repairs completed). The pipe had also been counterbored prior to installation for ease in pipe fit-up prior to welding. The crack on the outside surface of the pipe was approximately five inches long, ran parallel to the girth weld and was reasoned to be in the weld heat-affected zone. The pipe was then longitudinally sectioned and the inside surface visually inspected. The inside of the pipe contained a crack 5.5" long running parallel to the girth weld for half its length, with its direction varying into the counterbore at its terminal ends (Figure 2). The inside surface was covered with an oxide film and showed evidence of significant heating during welding. Eight sections were then cut bracketing the crack to facilitate further examinations.

Figure 2. Photograph of crack on 8" diameter pipe outside surface (crack ~5" in length).

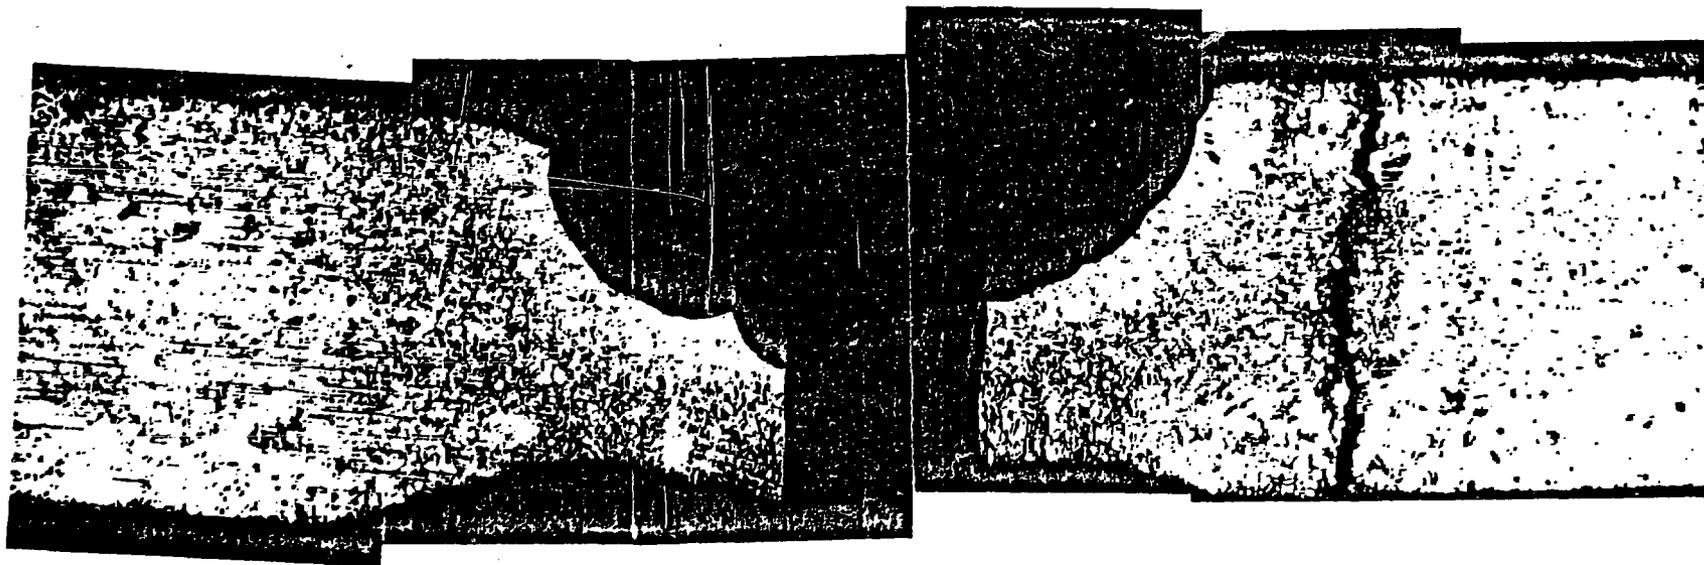
**OPTICAL MICROSCOPY** - One specimen was cut and mounted in epoxy in such a manner that the cross section of the pipe's circumference was perpendicular to the plane of examination. The surface was polished and then electrolytically etched with a 10% oxalic acid etch for macrostructural depiction. The weld insert, weld deposit, crack and counterbore area are well defined showing the through wall crack and a smaller non-through wall crack on the weld side of the main crack (Figure 3). The specimen was then repolished and examined after ASTM A-262 Practice A was performed. As can be seen from the photomicrograph (Figure 4), the crack was intergranular in nature with secondary cracks branching out from the body of the main crack. The microstructure across the face of the specimen showed a fine grained structure in the pipe's central cross section, with increasing grain size outward towards the pipe's outside and inside surfaces. This grain size variance was visible in the specimen outside the weld HAZ, which may be the result of cold working operations prior to the solution annealing heat treatment in the pipe's manufacture. The area surrounding the crack and in the heat-affected zone exhibited a ditched structure (ASTM A262), which is evidence of considerable material sensitization. In view of the above observations, the failure is considered to be intergranular stress corrosion cracking in the sensitized region of the weld repair heat-affected zone.

There were also a few indications of incipient cracking on the inside surface of the weldment in the counterbore area. These indications were visible on the counterbore of both the cracked side of the weld and the uncracked side.

Figure 3 Photomicrograph of specimen showing crack, counterbore and weldment.

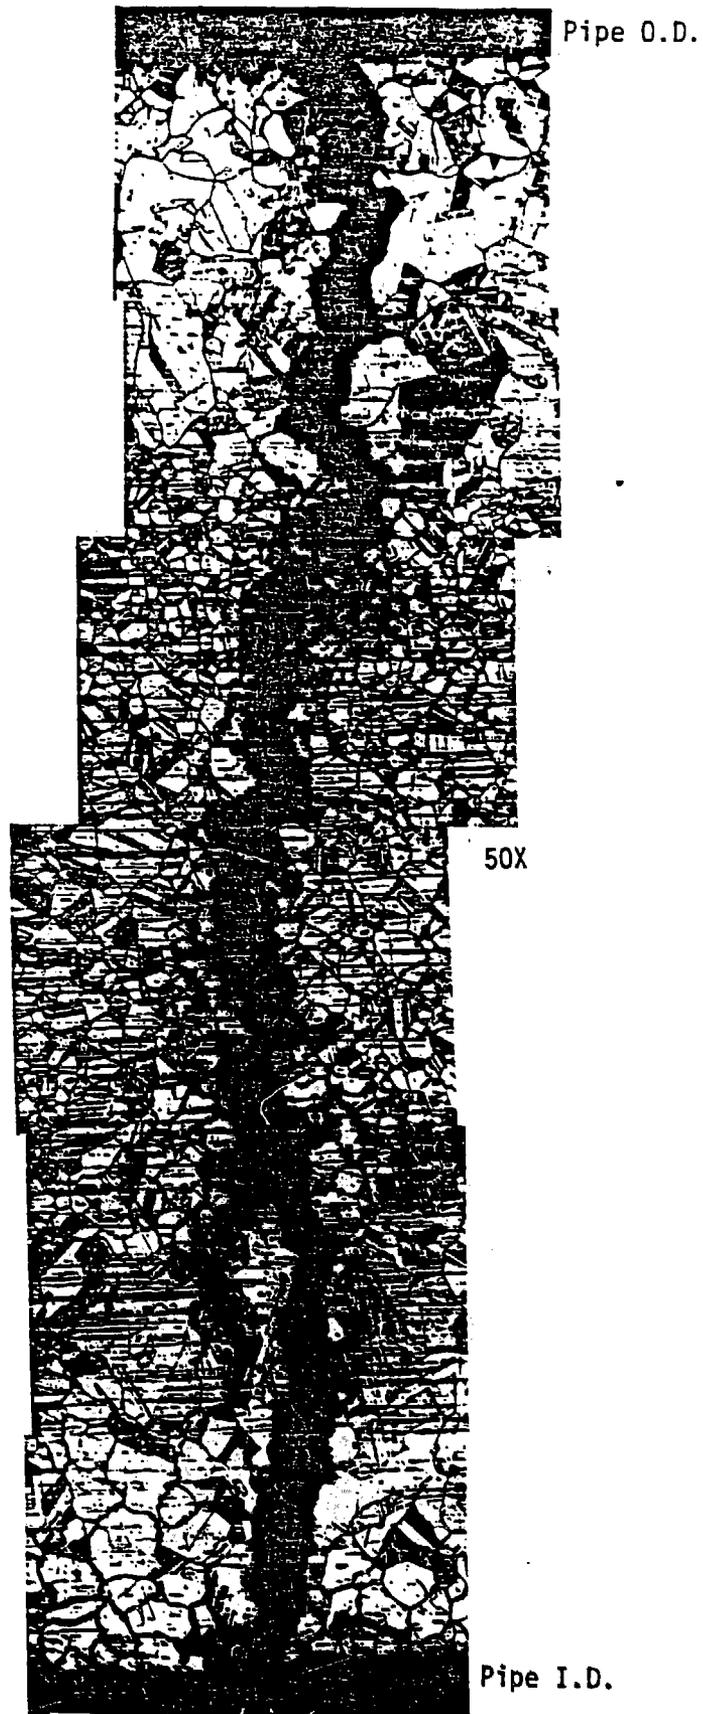
Figure 4 Photomicrograph of crack after ASTM A262 (Practice A) performed.

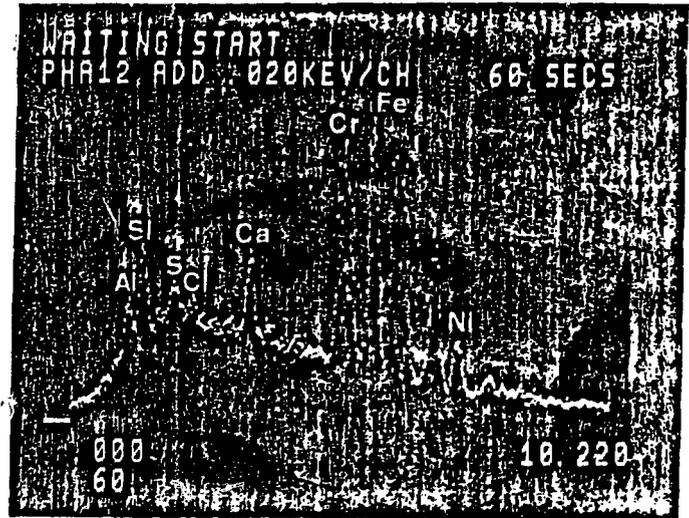
An examination was also made of the inner surface of the pipe where there appeared to be etched grain boundaries (Figure 5). The base metal adjacent to the grain boundary etching showed Al, Si, S, Ca and a trace of Cl in the scan (Figure 6).

Figure 6 EDS scan of surface near "etched" grain boundaries.
