TMI-2 Core Damage: A Summary of Present Knowledge

August 28 - September 1, 1983

International Meeting on LWR Severe Accident Evaluation

## TMI-2 CORE DAMAGE: A SUMMARY OF PRESENT KNOWLEDGE<sup>a</sup>

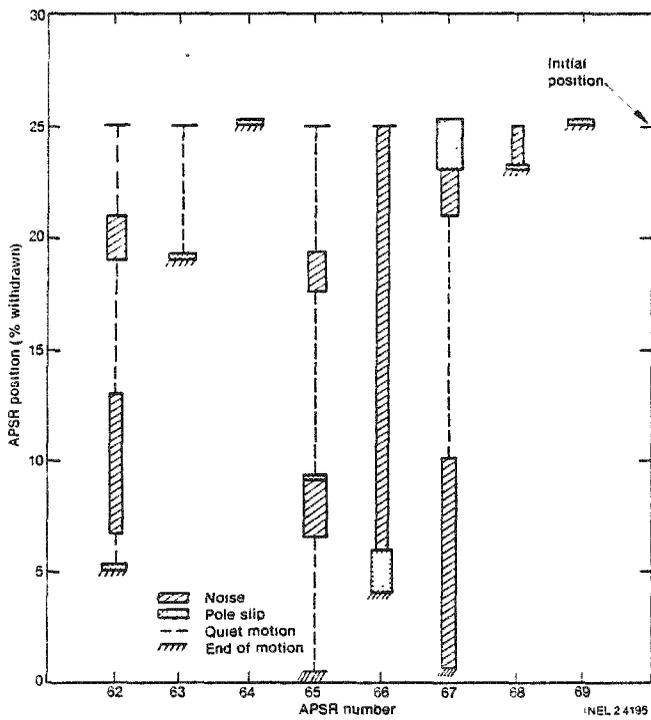
(a) APSR response

The results of the APSR movement test<sup>(1)</sup> are summarized in Figure 1(a). With all eight APSR assemblies starting from their normal shutdown position of 25% withdrawn, two of the APSRs were fully inserted, three were partially inserted, and three were essentially immovable. As Figure 1(a) indicates, APSR movement was generally accompanied by periods of acoustic noise atypical of APSR movement in an undamaged reactor. There were no noises, however, indicative of fuel assembly or plenum damage or disruption during any APSR movement. Examination of Figure 1(a) reveals that, although none of the acoustic profiles are exactly

alike, there are several common areas in the APSR movement path associated with high acoustic noise or APSR obstruction. These zones, at about the 20% withdrawn position and the 5 to 10% withdrawn position, were the subject of additional analysis to determine whether the reasons for APSR motion interference could be identified and correlated with either APSR or drive mechanism damage caused by the accident.

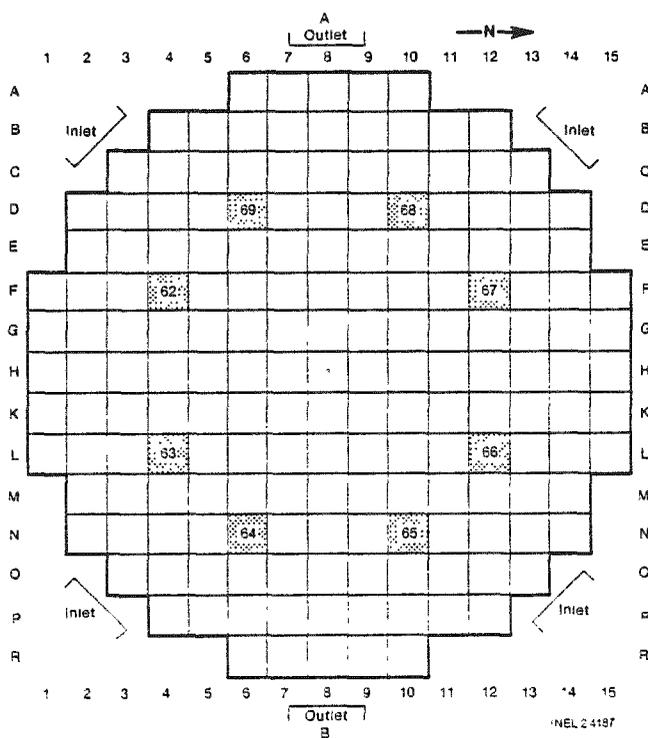
(b) APSR locations in TMI-2 core

Shortly after the TMI-2 APSR movement test, the TMI-2 closed-circuit television camera examination provided a partial answer to the ambiguous interpretation of APSR movement, as well as substantial additional information on specific core damage features. The CCTV examination provided direct observation of TMI-2 core damage by lowering a radiation-resistant TV camera into the core via openings created by the removal of selected control rod drive leadscrews. Core damage was viewed directly at the center of the core and at approximately the one-half core radius position. A third core inspection attempt at a position near the core periphery was blocked by the presence of the control rod assembly spider and, presumably, the underlying fuel assembly. [Specifically, CCTV inspections were made at core locations H8, E9, and B8; see Figure 1(b) for orientation.]

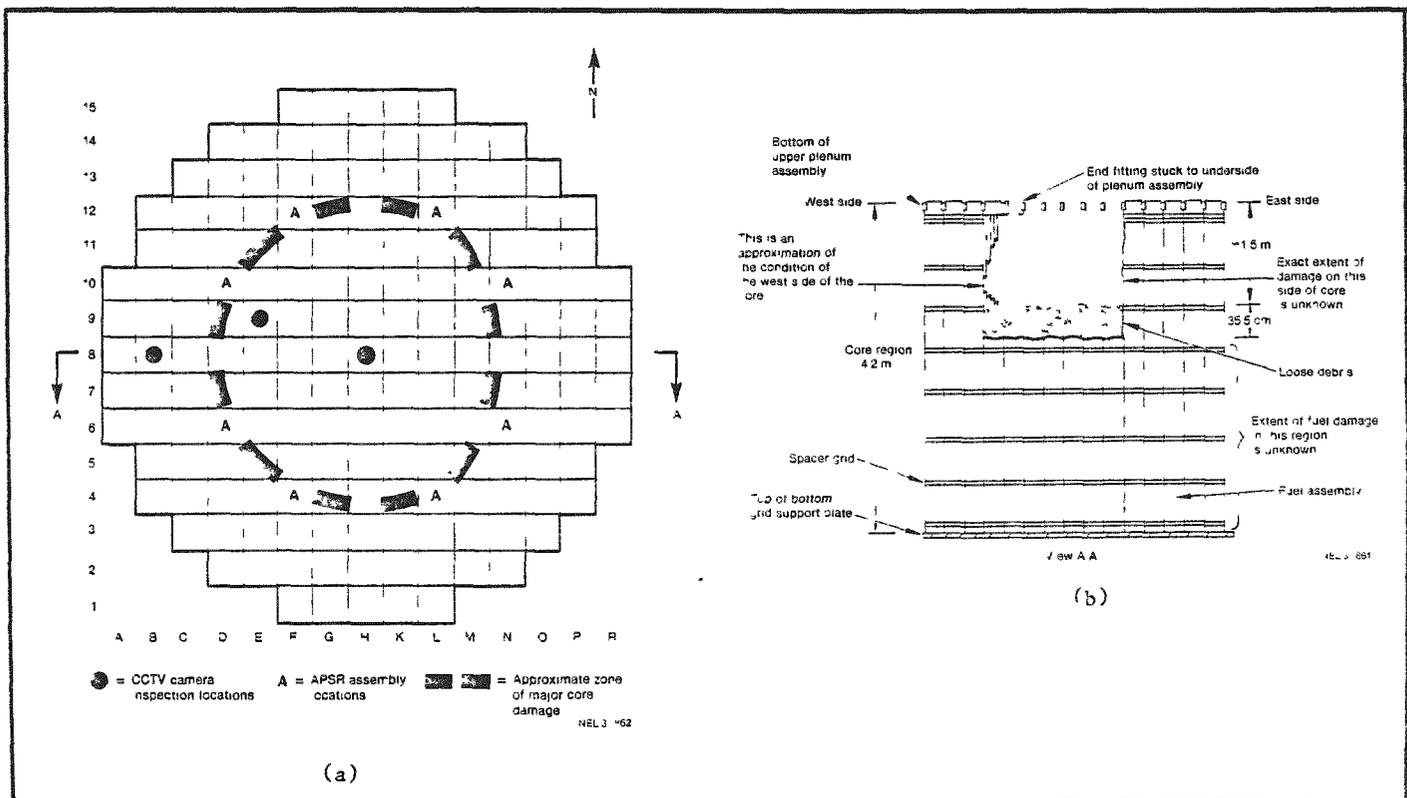
the fuel debris. At the center of the core (position H8), the top 1.60 m of fuel is missing. At the specific half-radius position inspected (position E9), the top 1.52 m of fuel is gone.

- o At the core center location, the debris bed was relatively flat and level and consisted of granular material with an apparent average size of ~0.5 cm. At the half radius location, the surface of the debris bed was irregular and the debris pieces were of larger average size, including cladding shards and fuel rod pieces many centimeters long. At several locations, small (~0.5 cm), apparently once-molten nodules were seen in the loose debris.

- o As determined by probing with a steel rod, the rubble bed at both the center and half radius positions consists of loose, easily penetrated debris to a depth of at least 35.5 cm.

- o At the half-radius location, there are some fuel assembly upper end-fittings hanging unsupported from the underside of the plenum that contain some damaged fuel rods and control rods. There is evidence of some melting of parts of the stainless steel end-fittings.

- o The bottom of the reactor upper plenum assembly, including the control rod and APSR guide tubes and brazements, appears relatively undamaged.

Examination of the top view of Figure 2 provides a partial explanation of the ambiguous nature of the APSR movement test results. The ring of APSR assemblies marks the approximate demarcation between major core damage and relatively intact fuel assemblies. It appears likely that damage to the APSRs was extensive enough that some, if not all, of the rods are missing or severely damaged. It is thus clear that the observed resistance to APSR assembly motion is not the result of rod interference with distorted guide tubes or spacer grids low in the core. Similarly, the observation of generally intact plenum assembly guide tubes implies that neither is the resistance to movement a result of rod stub interference with distorted plenum guide tubes or brazements. At this time, the most likely explanation is that high temperatures at the very

FIGURE 2. CORE DAMAGE AS REVEALED BY CCTV CAMERA INSPECTIONS.

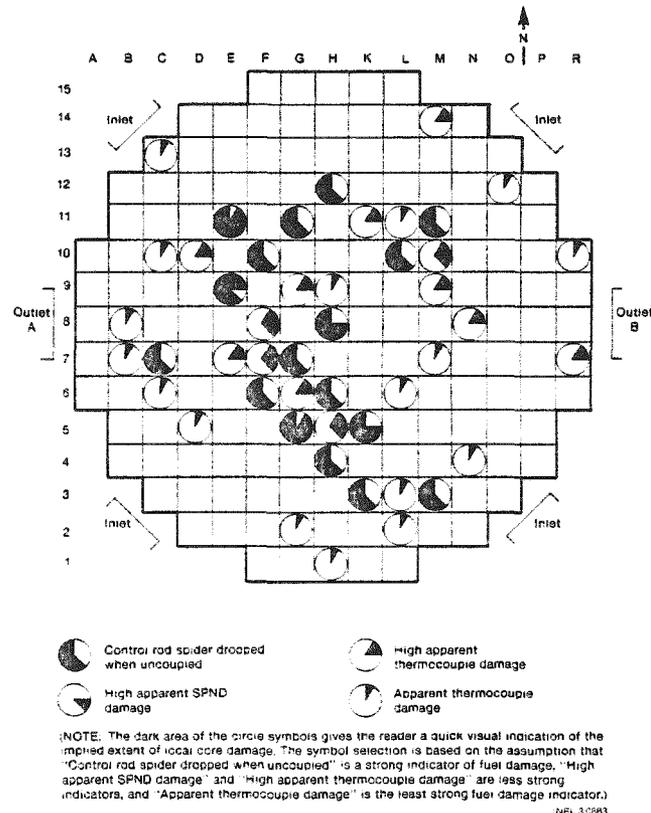
FIGURE 5. INDICATORS OF TMI-2 CORE DAMAGE BASED ON IN-CORE INSTRUMENT AND LEADSREW UNCOUPLING DATA.

the core were damaged, regardless of radial location, implying widespread damage in the upper part of the core. In addition, a sub-group of instrument strings were identified in which all seven of the axially spaced SPNDs appear to be damaged, implying that core damage in these locations extends over essentially the entire fuel assembly length. These locations are shown as "high apparent SPND damage" in Figure 5.

Data with strong core damage implications are also available from the control rod drive leadscrew uncoupling task. This task involved manual uncoupling of the 69 control rod drive mechanism leadscrews and 8 axial power shaping rod leadscrews from the control element spiders to which they were attached. (Such uncoupling of the leadscrews is a prerequisite to reactor vessel head lift.) During the uncoupling process, it was possible to tell the behavior of the control element spider to which the leadscrew was attached. In some instances the spider dropped, indicating that the fuel assembly normally supporting the control element spider was either absent or damaged. If the spider dropped following uncoupling, it was not possible to determine exactly how far it dropped, other than it had to drop at least 5 cm, otherwise it would have been possible to reengage it. In the central region of the core where the CCTV camera revealed a core void, it is likely that the spiders fell down onto the rubble bed; in fact, the spider from the center core position (H8) was observed on the rubble bed during the CCTV camera inspection. At other core locations, it is not known whether the spider fell completely away or whether the underlying fuel assembly was only damaged, not absent, in which case the spider could have dropped only slightly. Regardless, the fact that the spider dropped at all during uncoupling implies significant damage to the underlying fuel assembly. Those control element locations at which the spiders dropped are also shown in Figure 5.

Comparison of Figure 2 (damage directly observed by CCTV camera inspections) with Figure 5 (damage zones implied by the analysis of in-core instruments and control element spider movement) indicates that core damage extends radially and axially beyond the obvious core void. Most accident scenario analyses also predict a gradation of fuel rod damage ranging from zircaloy cladding ballooning and rupture, to various stages of cladding embrittlement and fragmentation, through fuel liquefaction. Unless very sophisticated core debris sampling programs are developed, the full extent of core damage will not be revealed until reactor defueling.
