## PRELIMINARY RESULTS OF THE TMI-2 CORE BORES<sup>a</sup>

Idaho National Engineering Laboratory  
Idaho Falls, Idaho 83415

### ABSTRACT

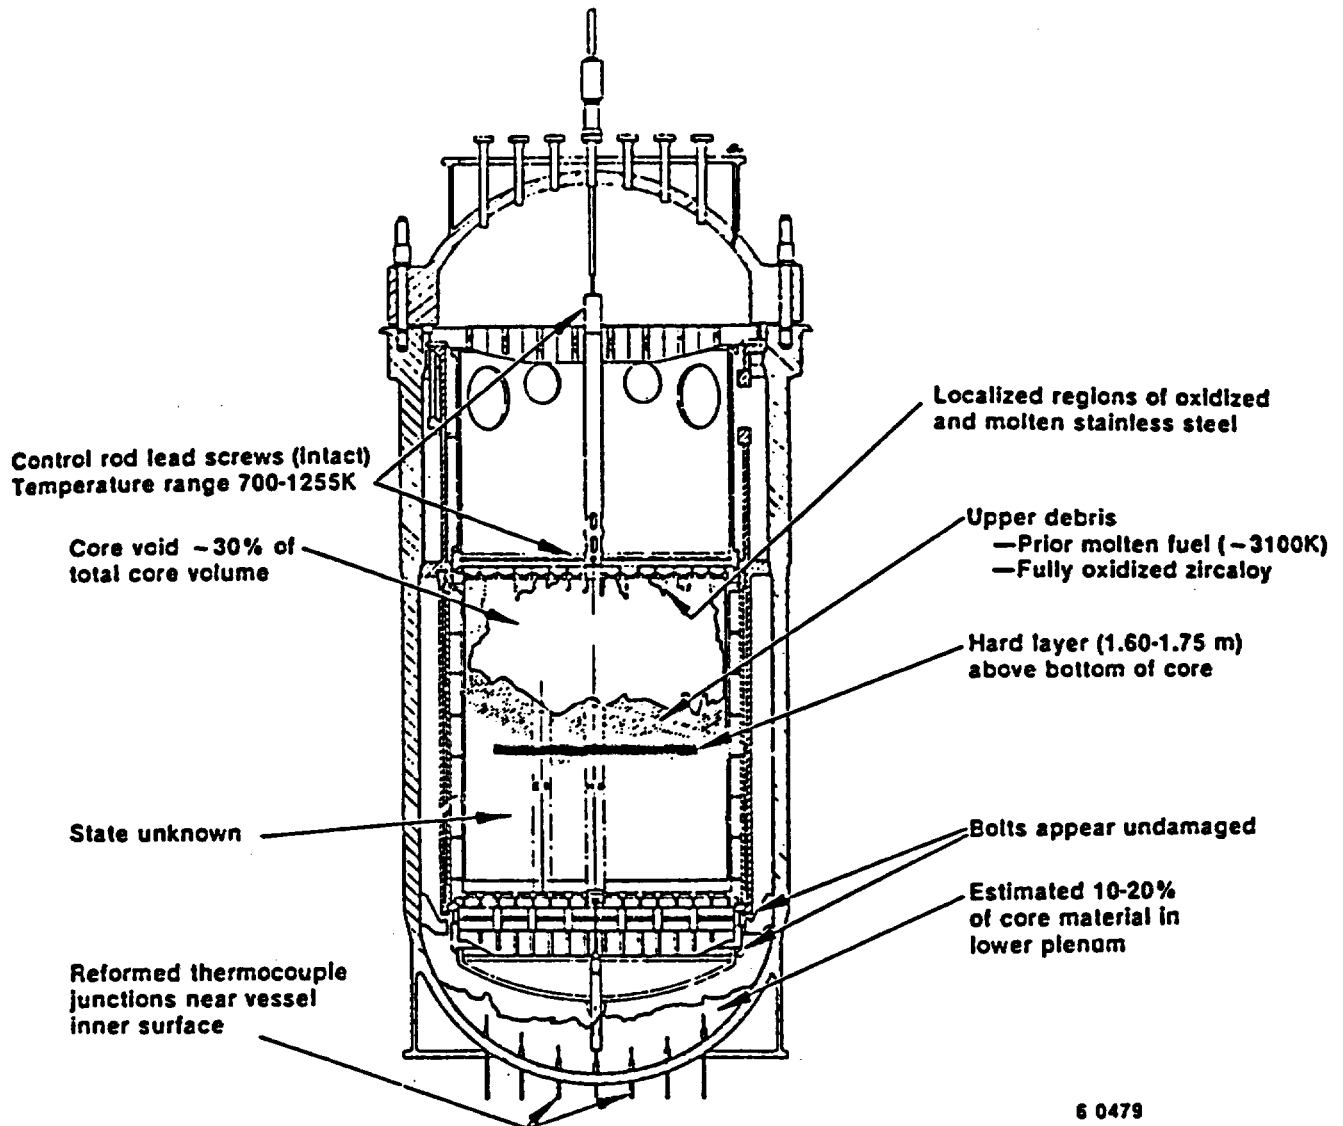
Prior to core boring, it was known that the upper core consisted of an upper void region almost entirely surrounded by standing peripheral assemblies, and a region of loose debris resting on a hard crust, as illustrated in Figure 1. Conditions within the confines of the core boundary but beneath the hard crust were unknown. It was estimated that the RV lower plenum contained 10 to 20 tons of core debris. Based on examination of loose debris from the lower plenum, it was known that the materials were primarily ceramic fuel and cladding, and that UO<sub>2</sub> melting temperatures had been reached.

Figure 1. Known core and reactor vessel conditions prior to core bore acquisition.

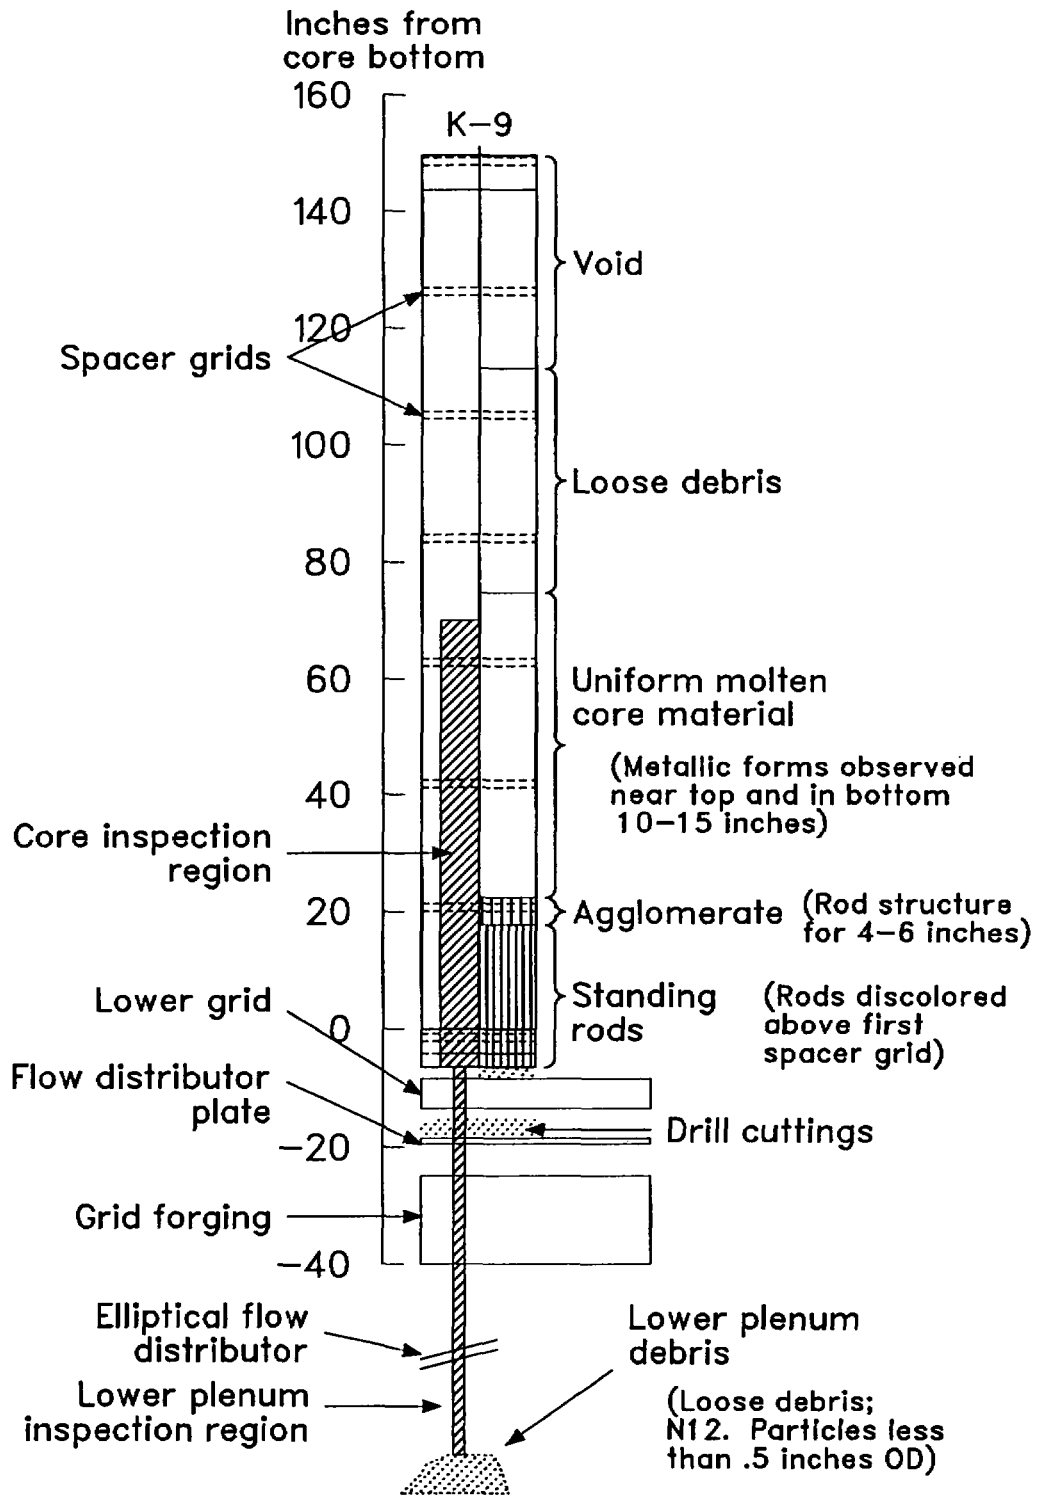
LN86060-1

A summary of the observations from central core bore location K9 is shown in Figure 3. As shown in the figure, homogeneous previously molten core material extends from the top of the core bore hole down to near the top of the second spacer grid, a distance of almost 50 in. (the greatest depth observed in the core bores). The previously molten homogeneous core material is about 40-in. thick at core location G8 and about 30-in. thick at location K6. A 4- to 6-in.-thick region of agglomerate material separates the previously molten homogeneous material from standing fuel rods in the lower regions of the core in core bore location K9. A large metallic-appearing structure that has been partially, or perhaps fully,

molten was observed near the top of the drill hole. A possibly metallic form was observed to be embedded in the homogeneous ceramic material 30 in. above the bottom of the core, and what appeared to be a partially melted spacer grid in the homogeneous ceramic material was observed 26 in. above the bottom of the core.

Figure 3. Summary of observations from central core bore location K9.

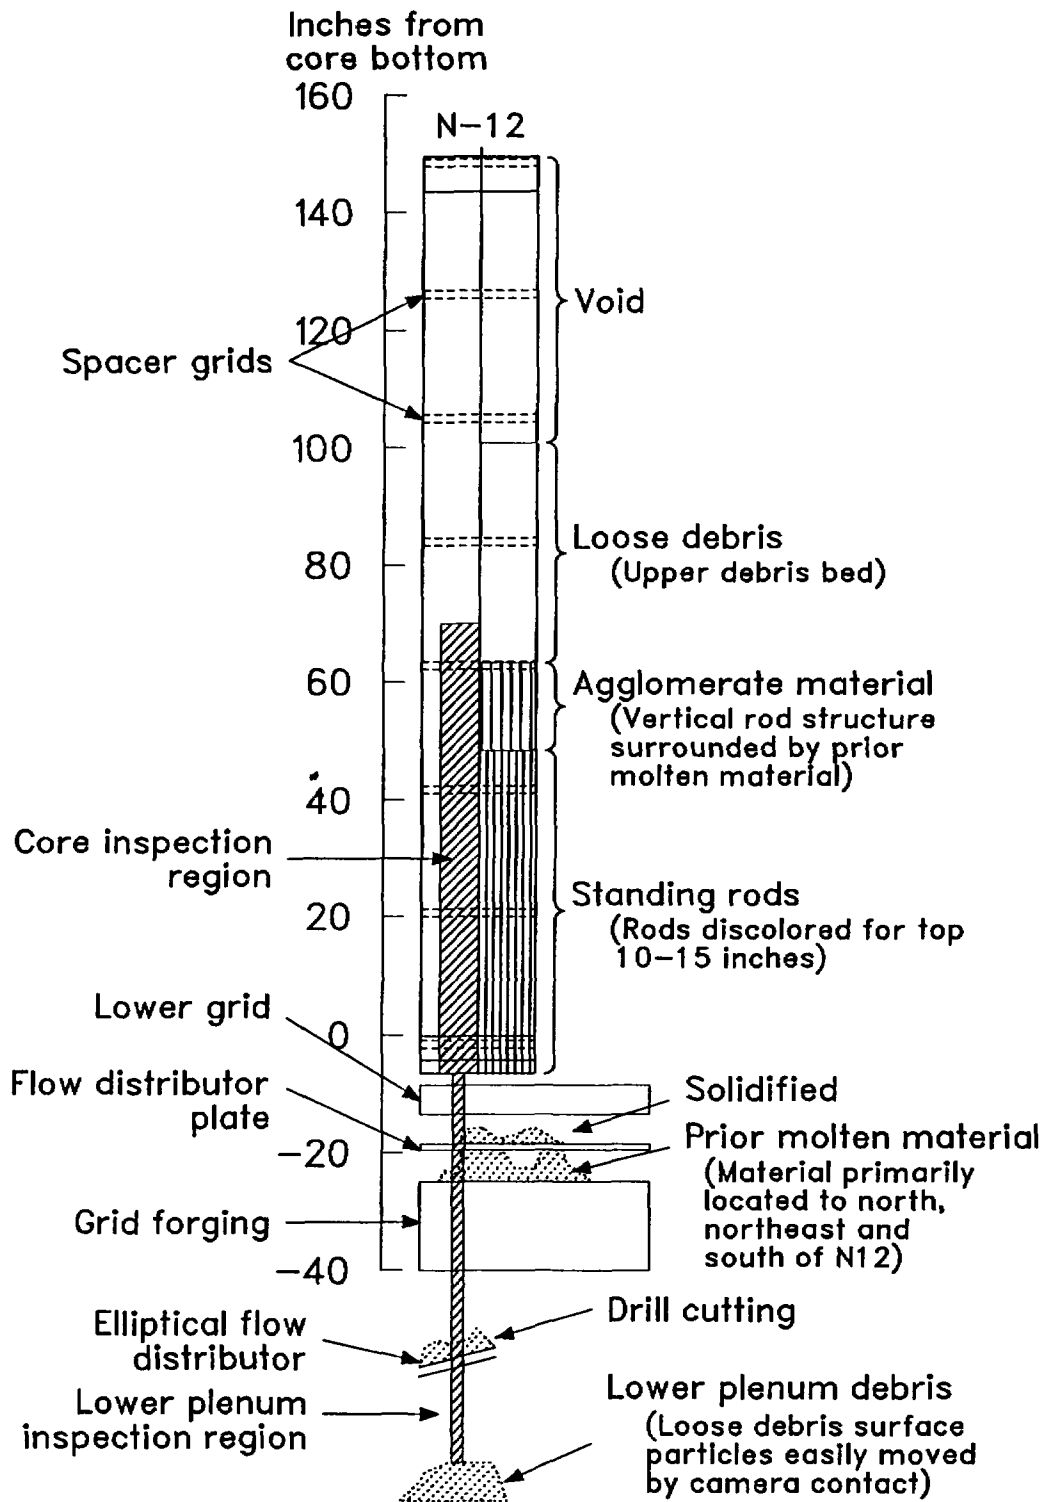
LN86060-3

A summary of observations from peripheral core bore location N12 is shown in Figure 4. Agglomerate material with vertical fuel rod structure extends from the top of the core bore hole to the transition region between agglomerate material and standing fuel rods. The agglomerate material is only about 14-in. thick, and standing fuel rods extend 48 in. above the core bottom. Previously molten homogeneous ceramic material was not observed in any of the peripheral core bore holes (D4, D8, N5, N12, O7, O9).

Figure 4. Summary of observations from peripheral core bore location N12.

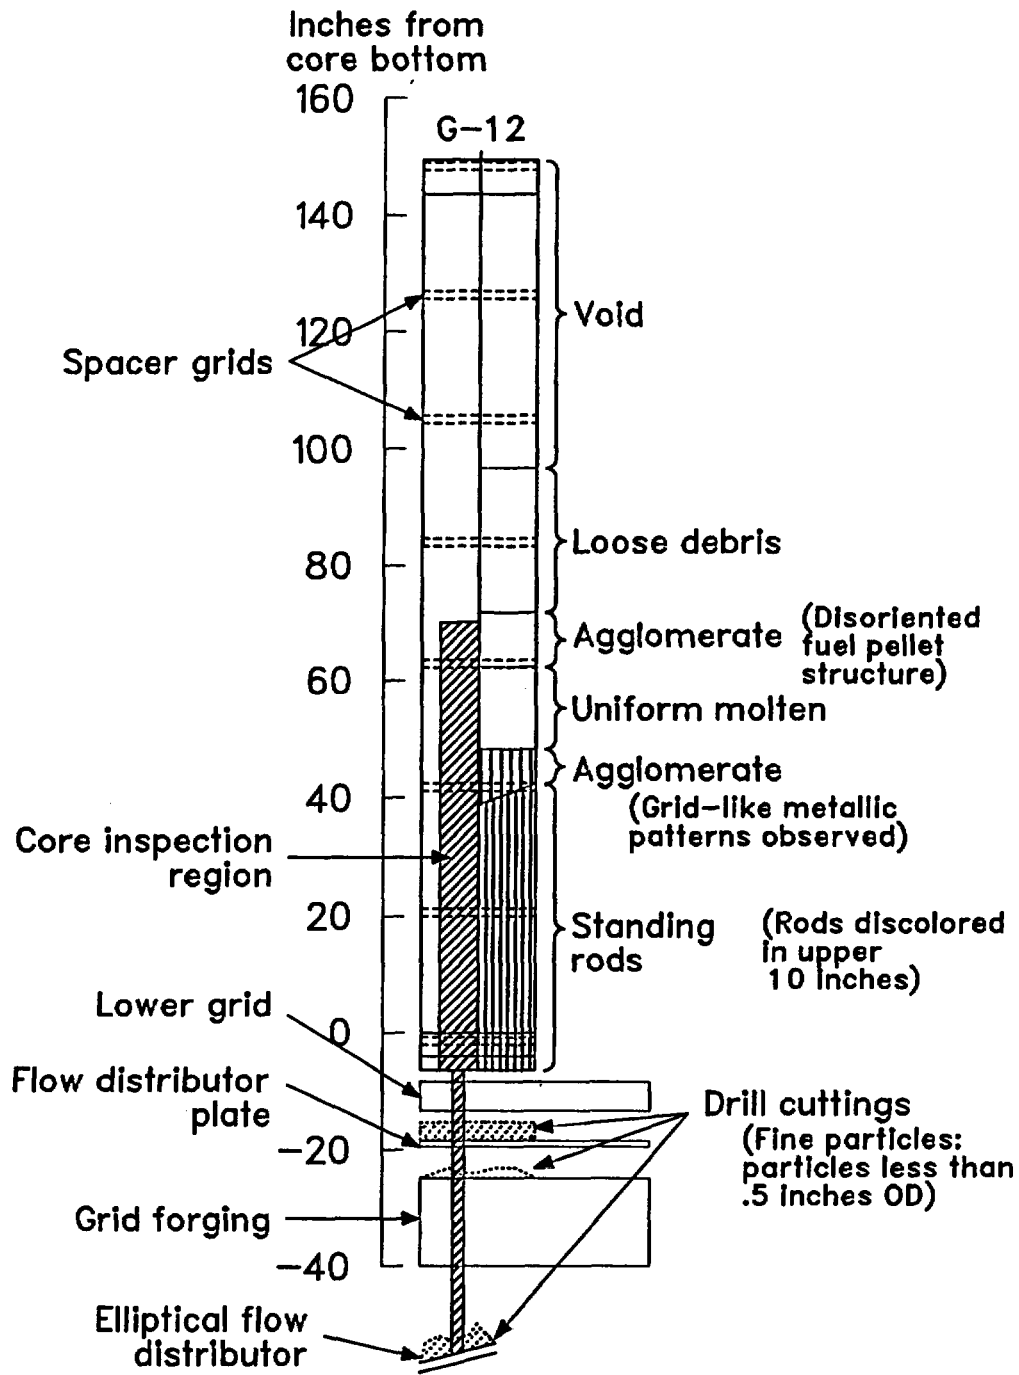
LN86060-2

At location G12, a thin region of previously molten homogeneous core material is bounded by a region of agglomerate material with randomly oriented fuel pellets on the top and a zone of agglomerate material with vertical, intact fuel pellets on the bottom. The standing fuel rods extend about 42 in. above core bottom, as illustrated in Figure 5.

Figure 5. Summary of observations from core bore location G12.

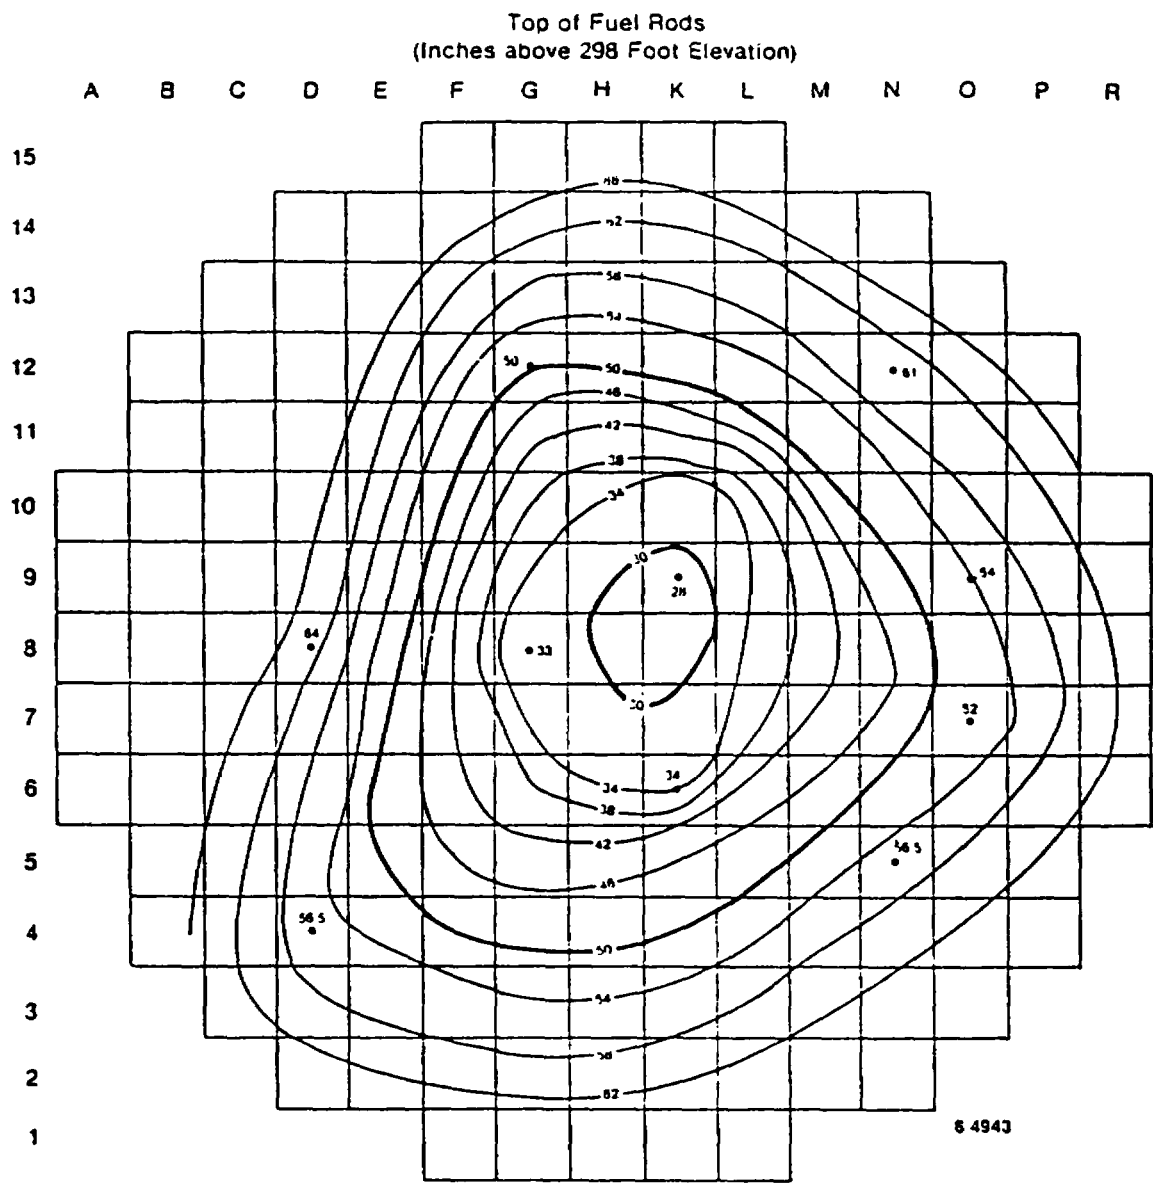
The homogeneous, previously molten core region, agglomerate region, standing fuel rod region, and upper core debris bed are spatially defined by contour mapping the interfaces between these regions. The contour map of the transition region between the standing fuel rod stubs and the agglomerate material (as determined from the core bore visual data) is shown in Figure 6, and illustrates that the height of standing fuel rods from the bottom of the core varies from about 30 in. at the core center to between 50 and 60 in. at the core periphery. Data from References 4 (core probe data) and 5 (acoustic topography data) were used to construct contour maps defining the lower supporting surface of the debris bed (upper surface of the molten core region) and the upper surface of the debris bed. These contour data are shown in Figures 7 and 8, respectively. Using these three contour maps, regions defining the lower standing fuel rods, the previously molten core zone, and the upper debris bed can be estimated through any row of core fuel assemblies.

Figure 6. Contour map of the lower, intact fuel rods and molten core interface.

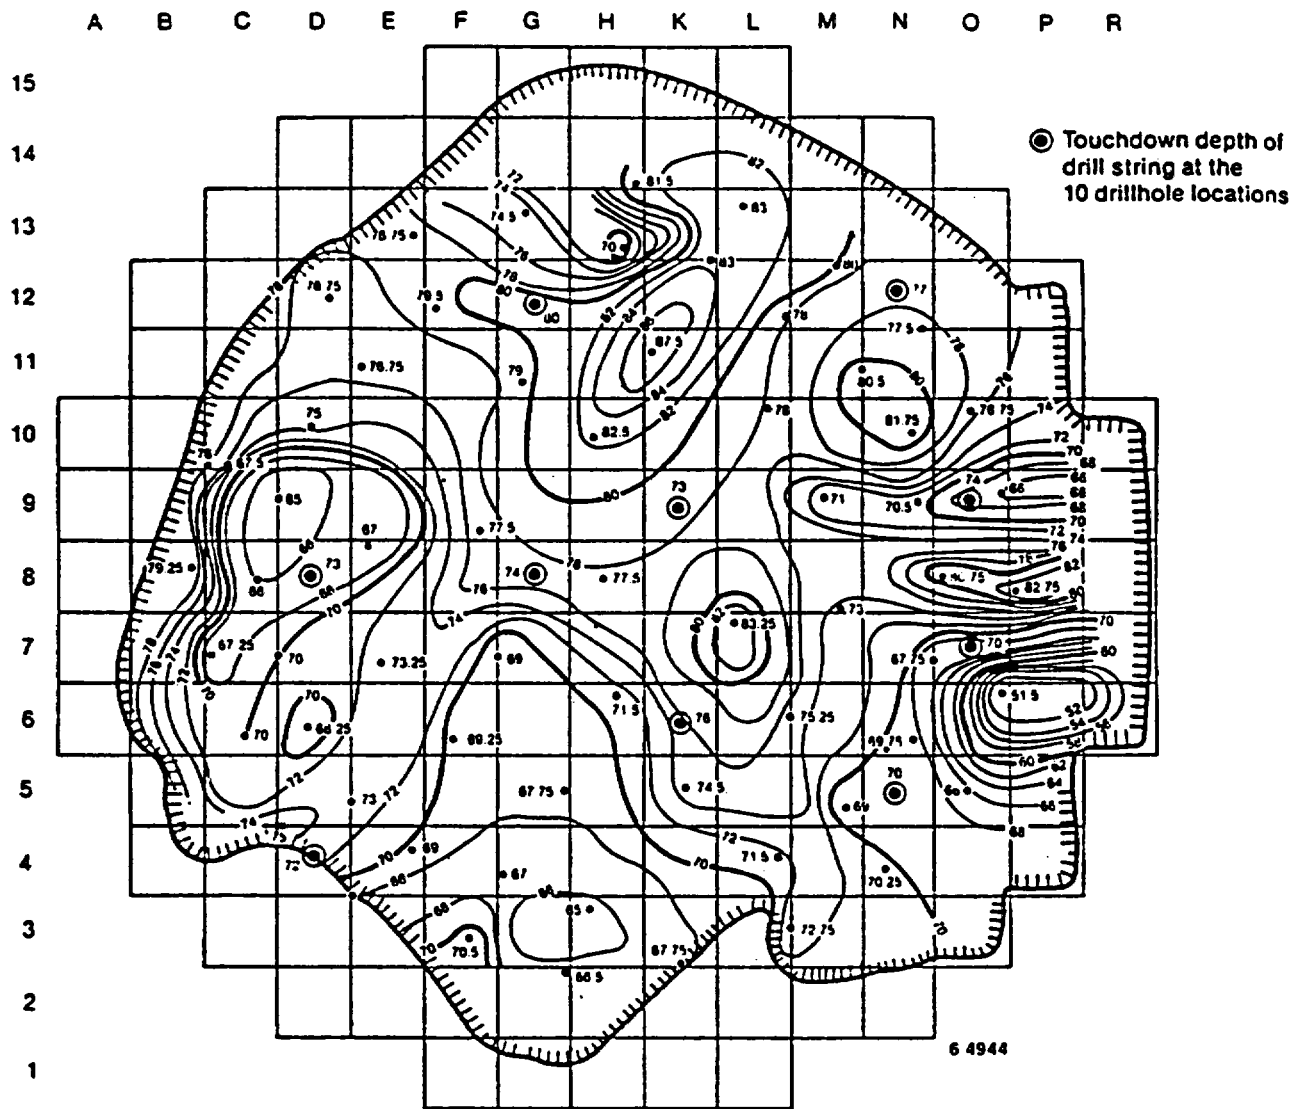
Figure 7. Contour map of the molten core upper surface region developed from hard stop data of rod probe.

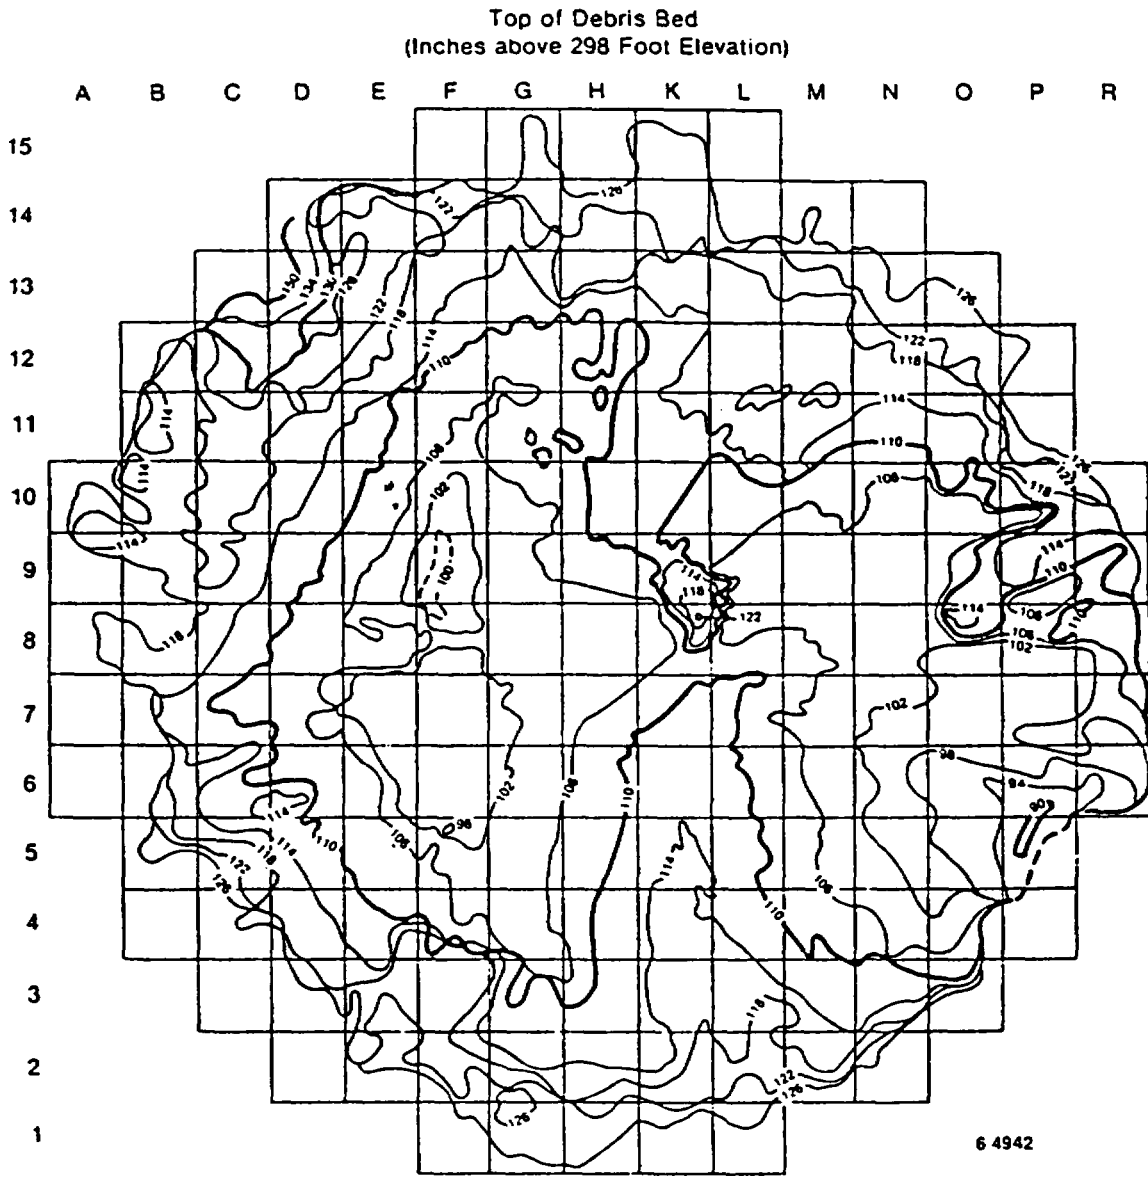
Figure 8. Contour map of core debris upper surface.

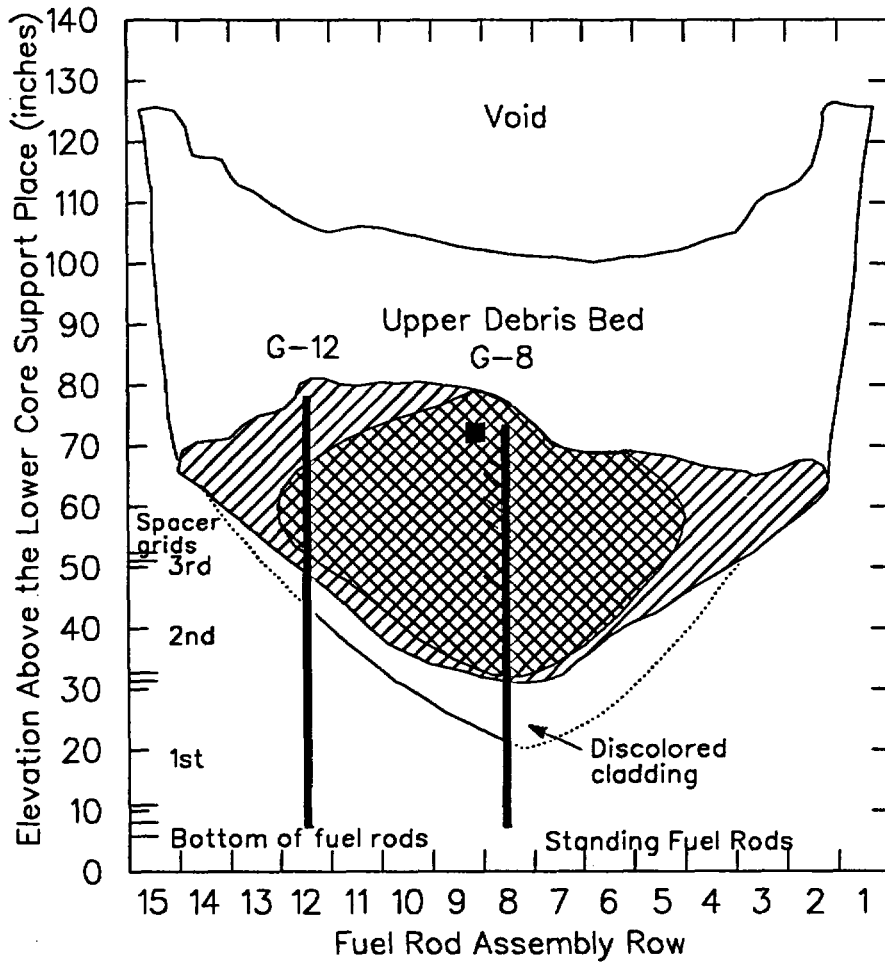
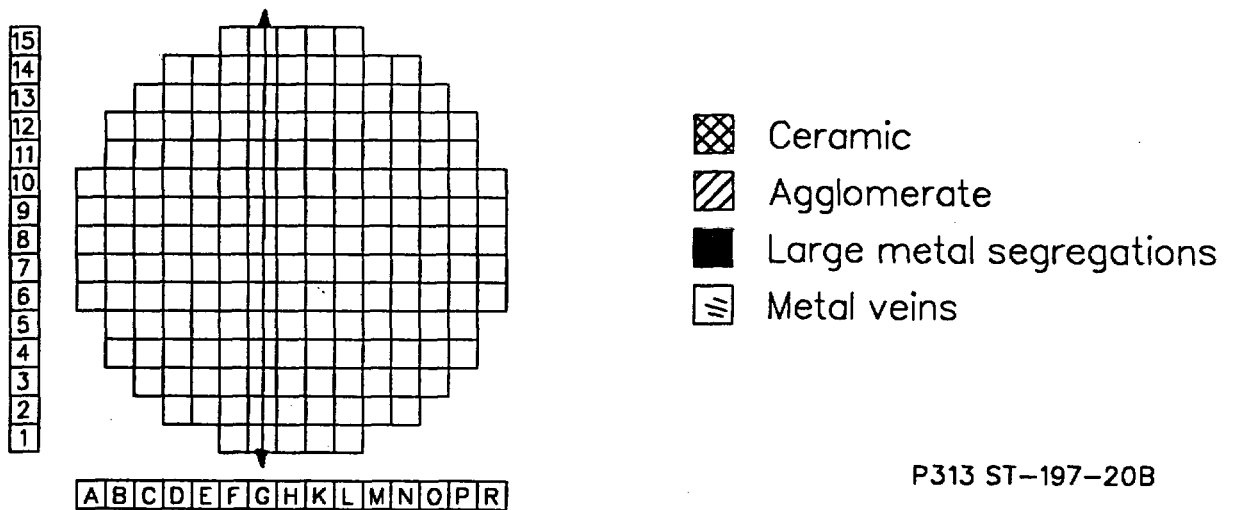
P313 ST-197-20B

Figure 9 shows these regions as they extend through the G row of fuel assemblies. The standing fuel rod stubs at the core bottom support the agglomerate and molten ceramic regions. The agglomerate region forms a shell surrounding the central zone of previously molten ceramic material. The shell is relatively thin under the previously molten ceramic in the central core region but increases in thickness toward the outer regions and forms all of the degraded core material above the standing fuel rods in the outer fuel assemblies. As noted earlier, the agglomerate in the lower central region of the core appears to be composed of previously molten material surrounding intact vertical rod stubs. The rod pellet boundaries are discernible inside the rods (axial interfaces between pellets) but are not generally well-defined at the outer radial surfaces of the rods, which are in contact with the interstitial, solidified melt material.

Figure 9. Core cross section across G row of fuel assemblies.

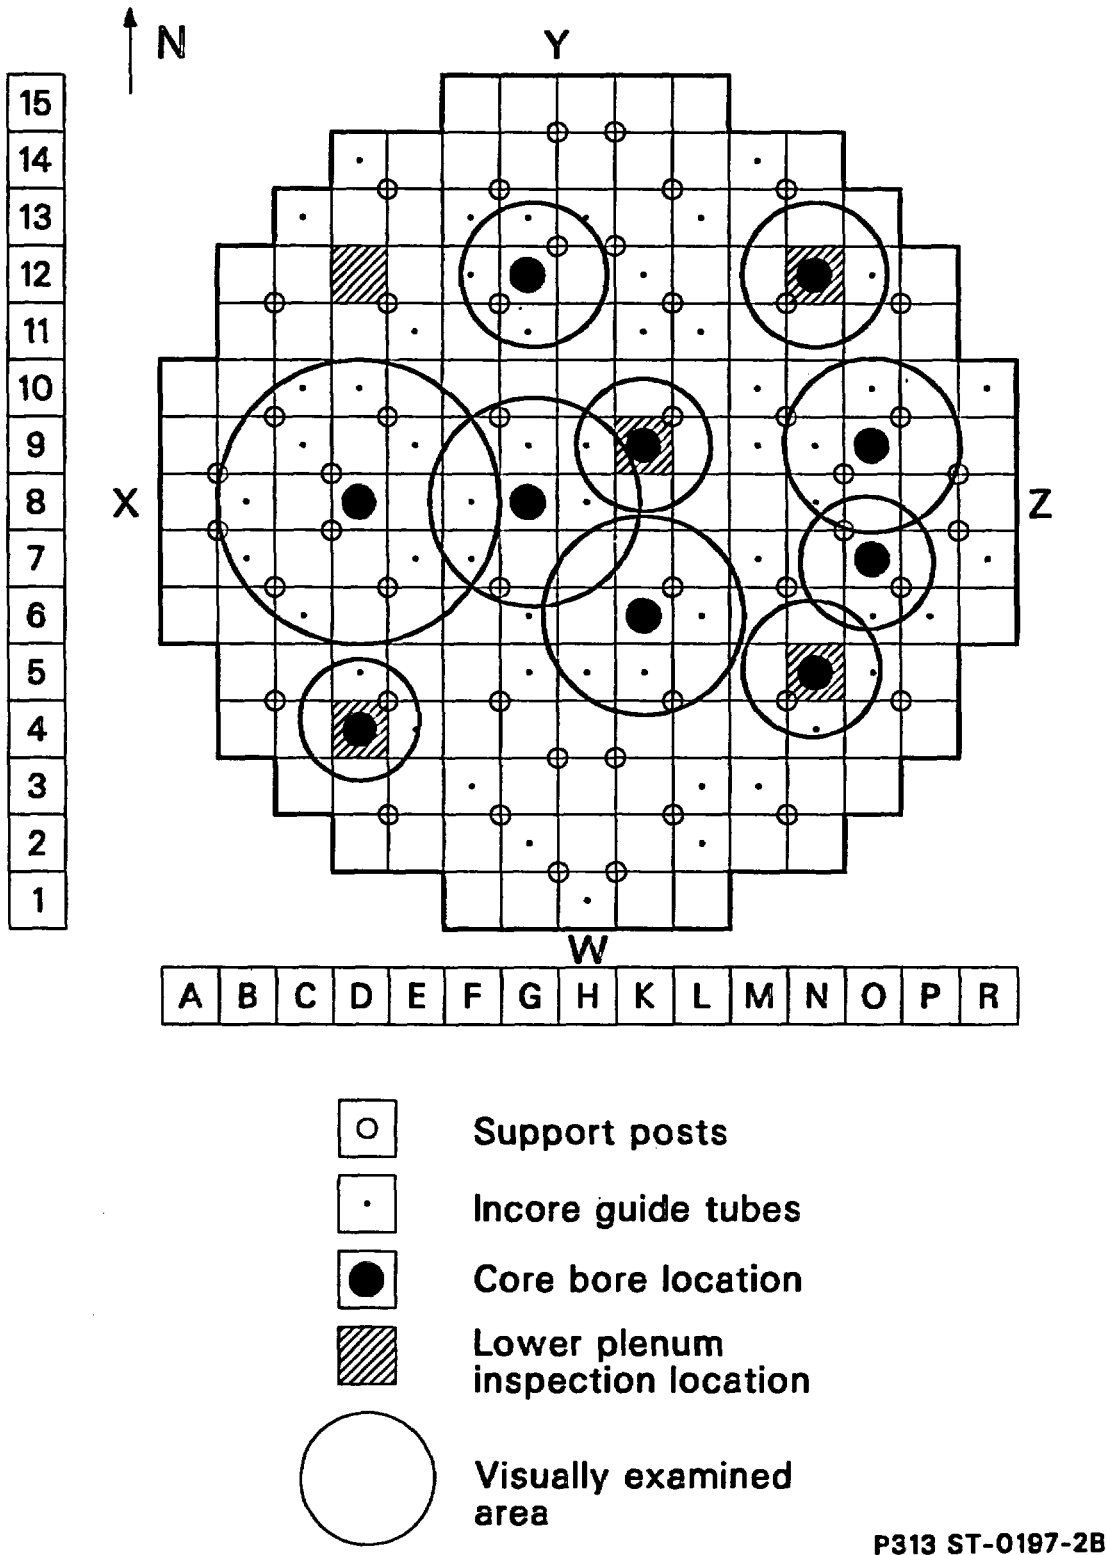
Video inspection of the core support assembly (CSA) at each core bore location allowed evaluation of CSA damage and identification of the locations where the core material flowed from the core into the lower plenum. Figure 10 summarizes the regions of the CSA that were discernible from the visual inspections and indicates that approximately half of the CSA regions were characterized.

Figure 10. Approximate core support assembly regions discernible in the video data.

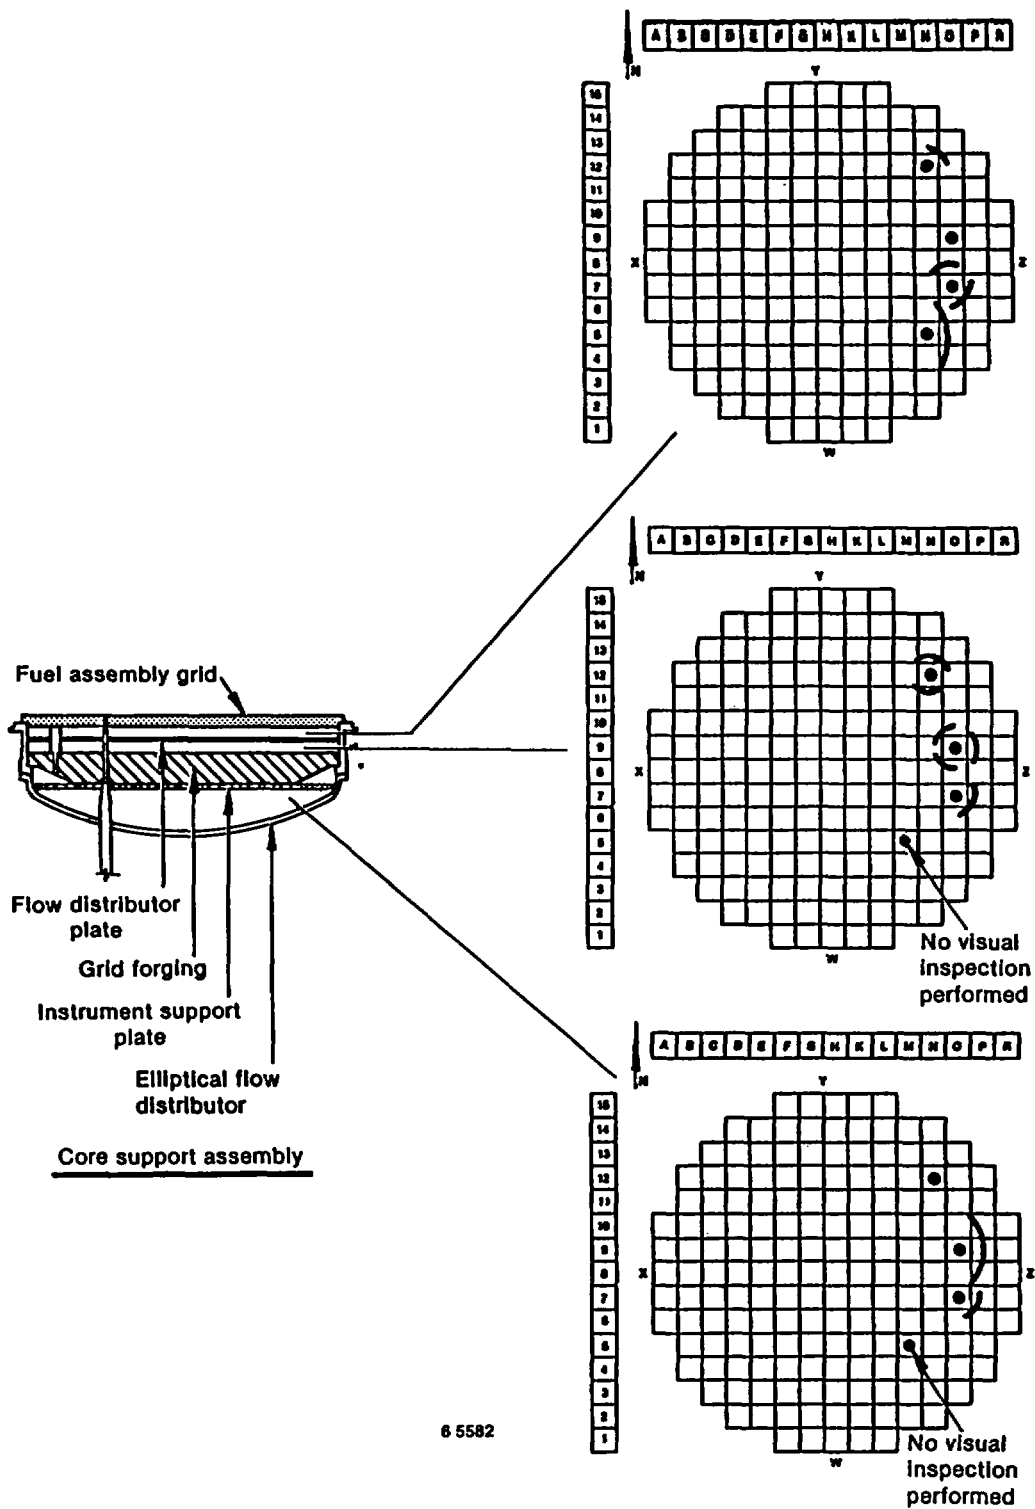
Visual inspection confirms that no damage to the CSA occurred below the central region of the core. Some fine, sandy material, most likely drilling debris, was observed at each of the central drill locations. The only locations that indicated significant core material relocation into the CSA were N5, N12, O7, and O9, all located on the east side of the core near the periphery. The approximate locations in which significant molten, relocated core material was observed in the CSA are shown in Figure 11. The material resembles the molten material observed in the core region and looks like it froze in the CSA regions as it flowed downward, thus resembling a cascade or curtain.

Figure 11. Approximate regions of significant fuel relocation in the core support assembly.

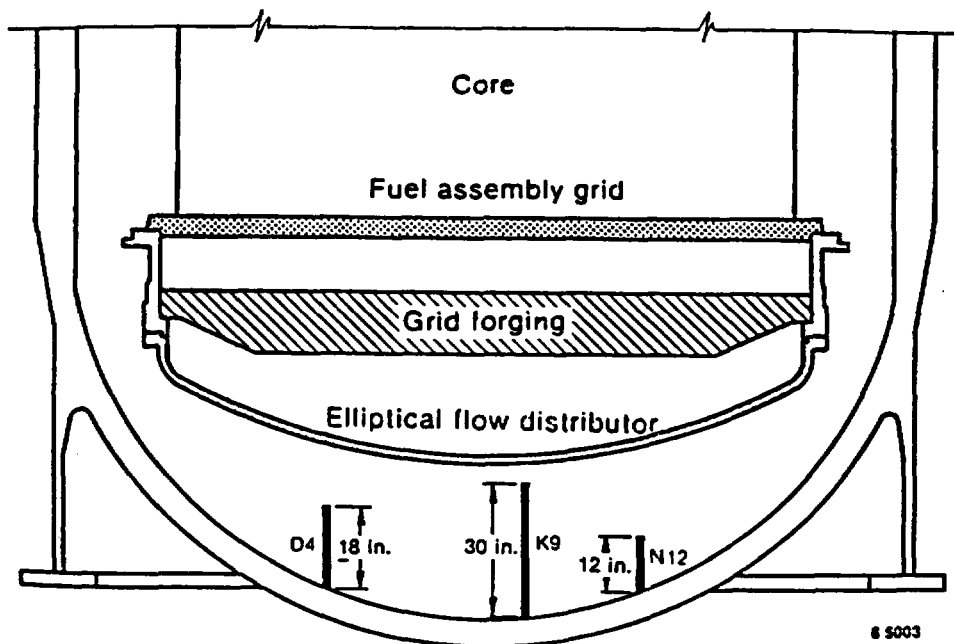
Sampling of the debris material was attempted at locations K9 and D4 by drilling into the debris bed to within approximately 8 in. of the RV lower head. After removal of the sample casing, the debris apparently collapsed into the drill hole. Because the debris was relatively fine, it is doubtful that a significant sample was obtained from either drill location. The estimated heights of the debris bed at each inspection location are illustrated in Figure 12.

Figure 12. Estimated heights of the debris bed.

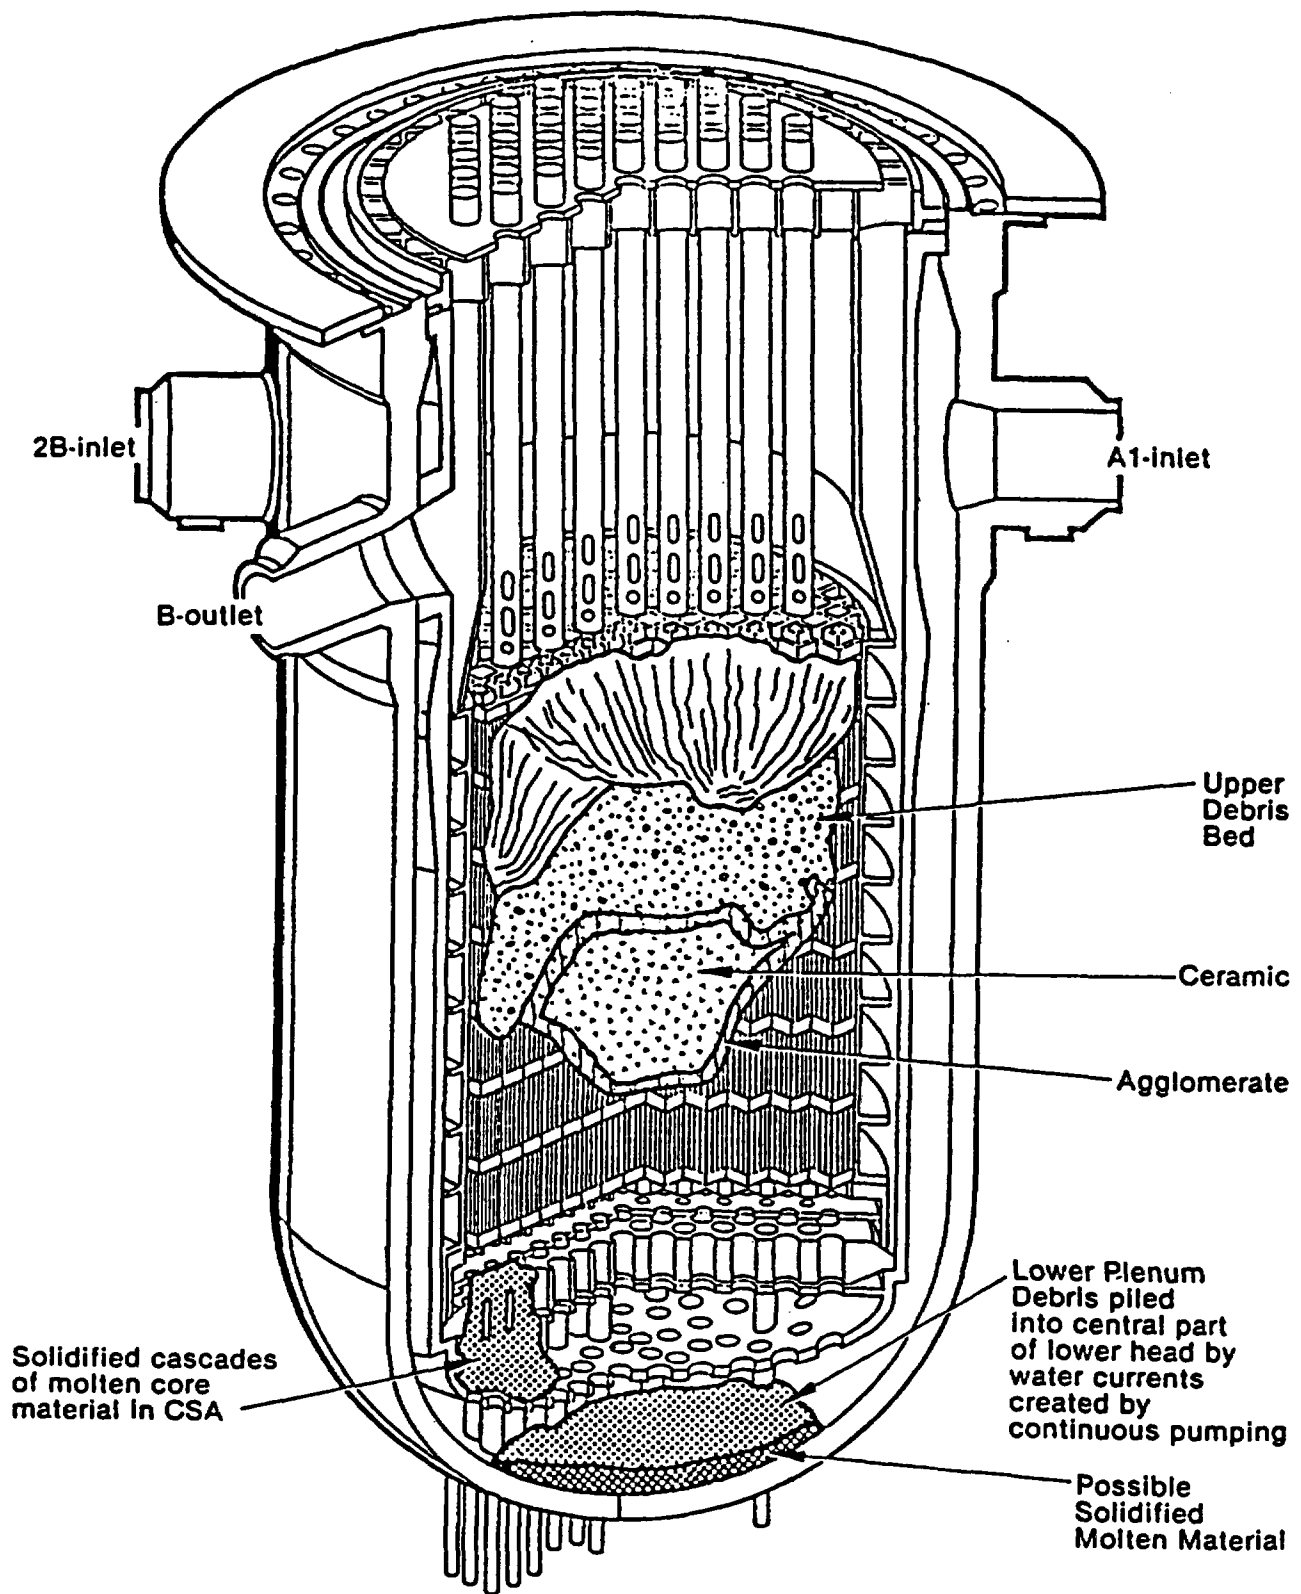
6 4911

A revised end-state condition of the TMI-2 core immediately following the accident is shown in Figure 13. This figure was constructed using the cross sections of the upper debris bed region, molten core region (agglomerate and previously molten, homogeneous ceramic), and standing fuel rods for the B through P assembly rows. The different material structures that currently exist within the core are illustrated approximately to scale.

Figure 13. Updated end-state core conditions.
