TMI-2 ACCIDENT SCENARIO UPDATE^a

E. L. Tolman, P. Kuan, J. M. Broughton
Idaho National Engineering Laboratory
EG&G Idaho, Inc.
Idaho Falls, Idaho 83415

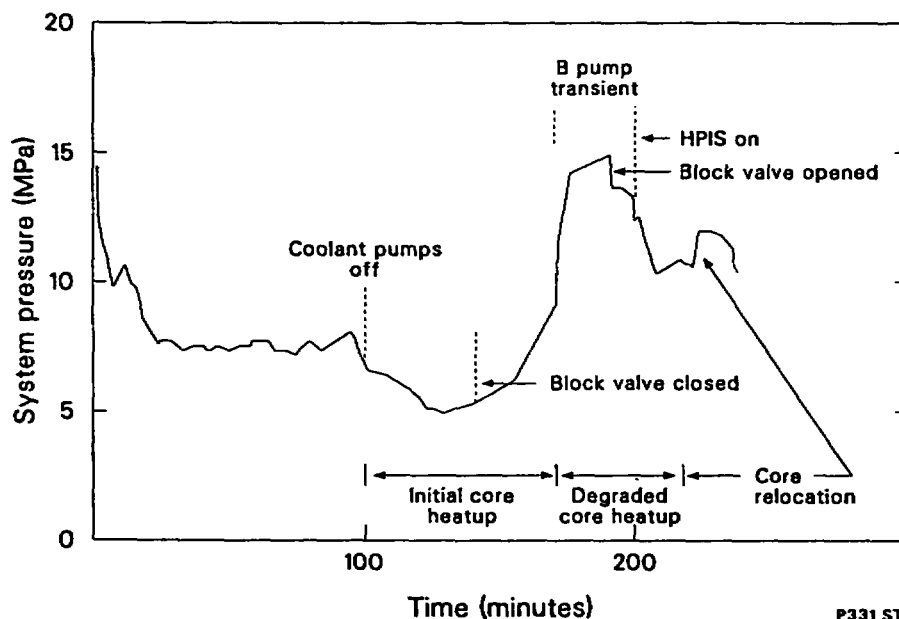
Figure 1 shows the measured reactor system pressure and provides a timeline perspective of the accident during the first 4 h. Important mechanisms controlling the core damage progression during each of these time periods are discussed with emphasis on the impact of the recent core inspection data.

Figure 1. Measured reactor system pressure during the first 4 h hours of the TMI-2 accident, showing the major core damage progression time periods discussed in the paper.

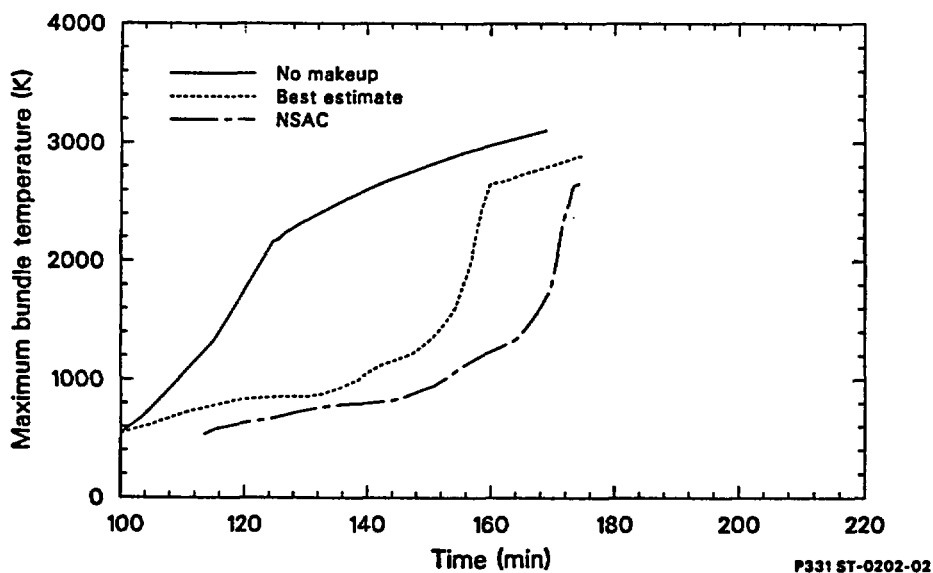
Figure 2. SCDAP predicted mid-core temperatures during initial core heatup period (100-174 min) for assumed lower and upper bounds and best-estimate cases of core liquid level.

responses for assumed bounding and best-estimate cases of core liquid level. The lower-bound core heatup case assumes the core liquid levels from early NSAC analyses.⁸ The upper-bound core heatup case assumes no coolant addition to the reactor vessel after 100 min. The best-estimate case uses the NSAC-predicted core liquid levels shifted in time by about 10 min, resulting in earlier core uncover and calculated core temperatures more consistent with the above data sources.

The best-estimate core heatup calculations suggest that by 150 min the predicted core temperatures have increased sufficiently to result in rapid cladding oxidation and melting. The molten zircaloy cladding dissolves some fuel, and the U-Zr mixture flows downward and solidifies in the lower, cooler regions of the core near the coolant interface. The relocated core material fills the coolant channels surrounding the fuel rods and forms a crust, as shown in Figure 3. From 150 to 174 min, the core temperatures are predicted to increase further from oxidation and decay heat. By 174 min (just prior to the pump transient), core temperatures near the core midplane may have exceeded 2400 K, sufficient to melt the U-Zr-O ternary material. The estimated extent of core material relocation at 174 min is shown in Figure 4; the relocated core material likely formed a region from 1 to 2 m in height extending radially outward as far as 1 to 1.5 m. The damage to the upper fuel assembly grid may have occurred by this time, caused by hot gas exiting the core during the initial core rapid oxidation; the damage to the grid structure was highly localized, as shown in Figure 5.

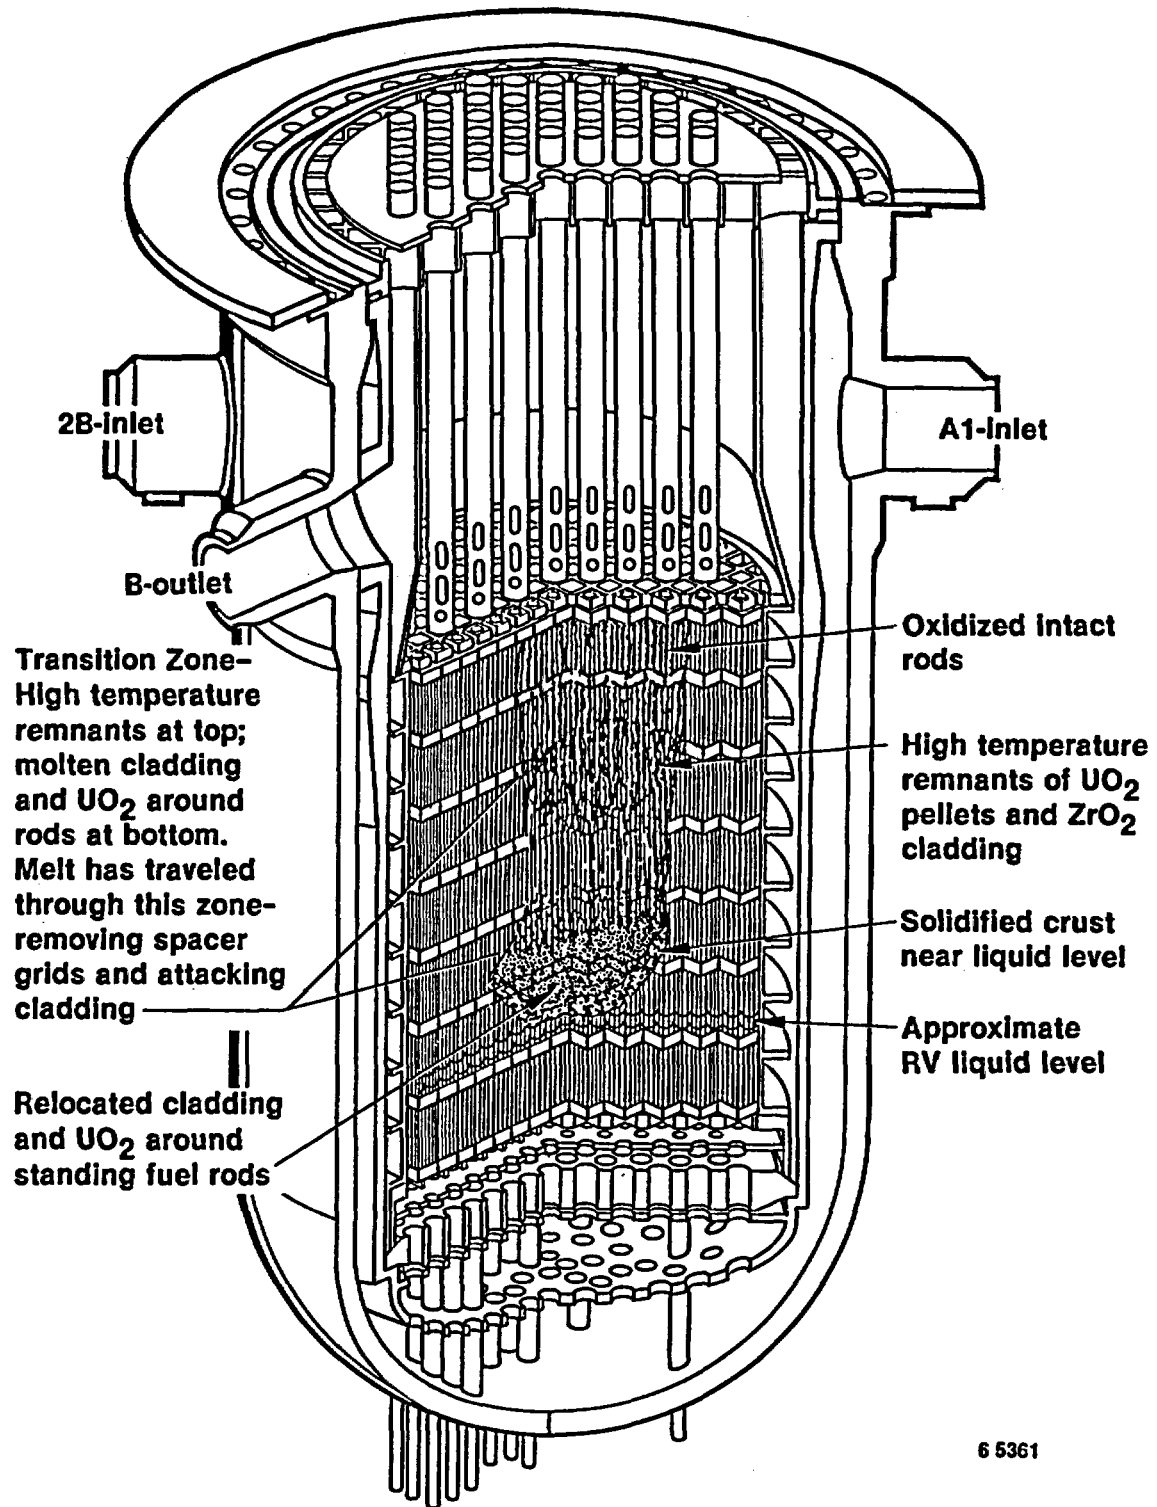
Figure 3. Estimated core configuration at 150 min showing the initial relocation of core materials.

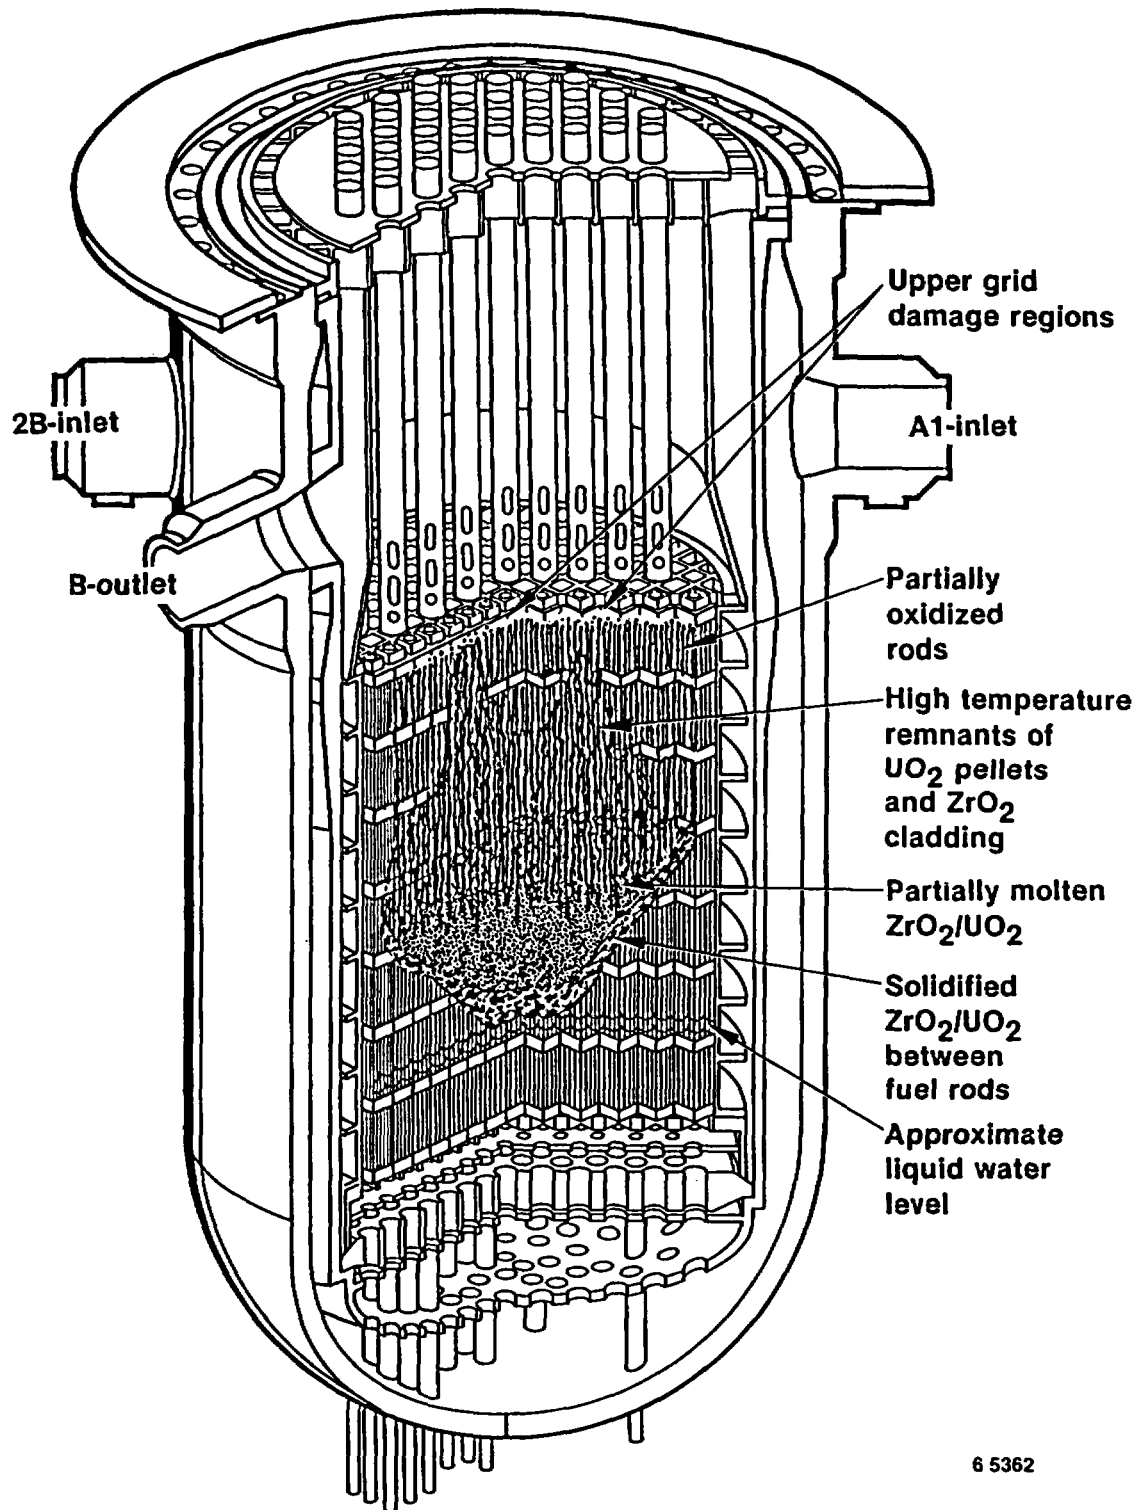
The end-state core configuration based on the core bore inspection data indicates that the bottom crust of relocated core materials is funnel shaped with the lowest point at about 0.5 m. Intact rods below 0.5 m suggest that the coolant level was maintained near this elevation. Coolant injection into the reactor vessel at 174 min suggests that the minimum coolant level likely occurred just prior to 174 min.

Figure 4. Estimated core configuration at 174 min, just prior to the pump transient, showing extensive core material relocation.

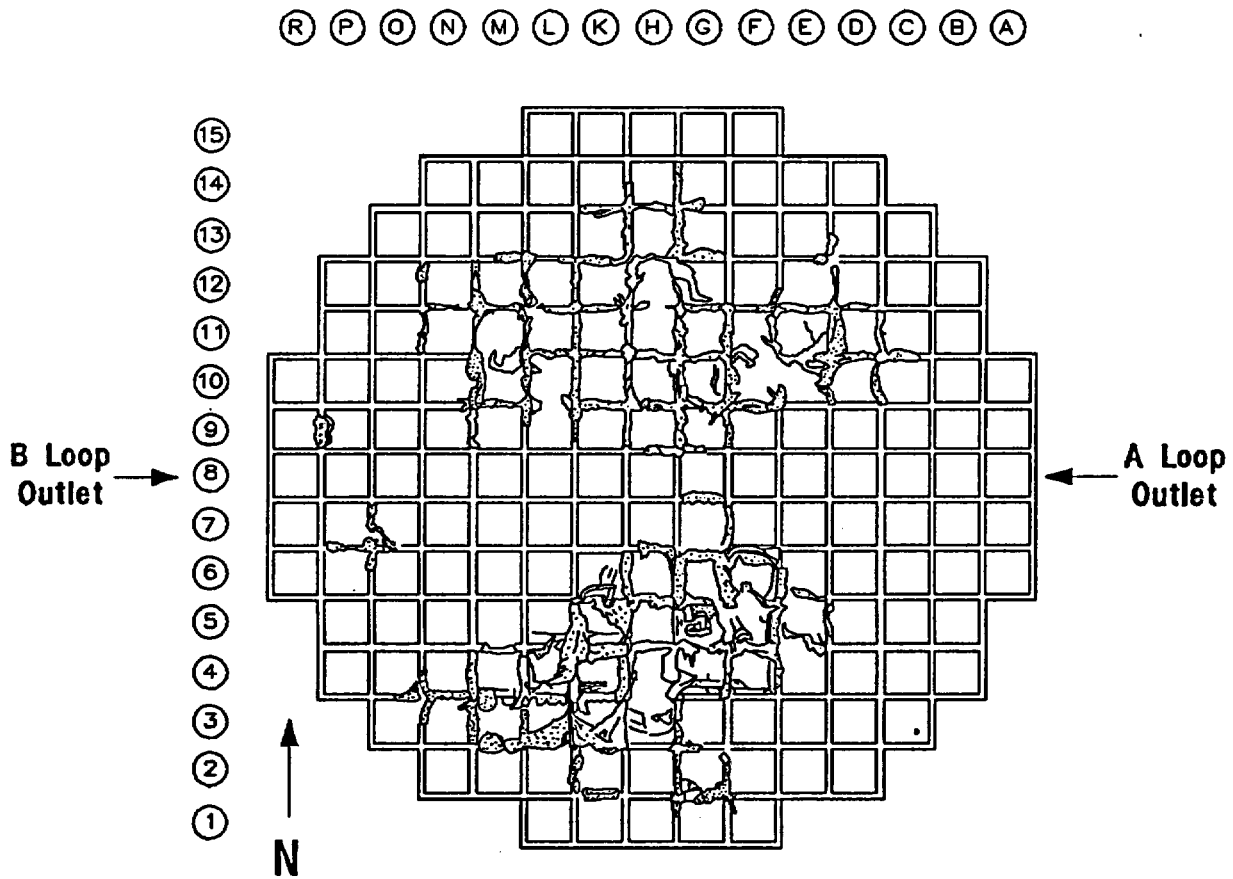
Figure 5. Damage zones to the lower surface of the upper fuel assembly grid structure.

contributed to the observed damage to the underside of the upper fuel assembly grid. The debris bed cooling process may have mixed the debris bed and resulted in some molten ceramic material from the top of the molten core zone being mixed into the upper debris bed. Examination of the upper core debris particles indicate some molten material on selected particles.

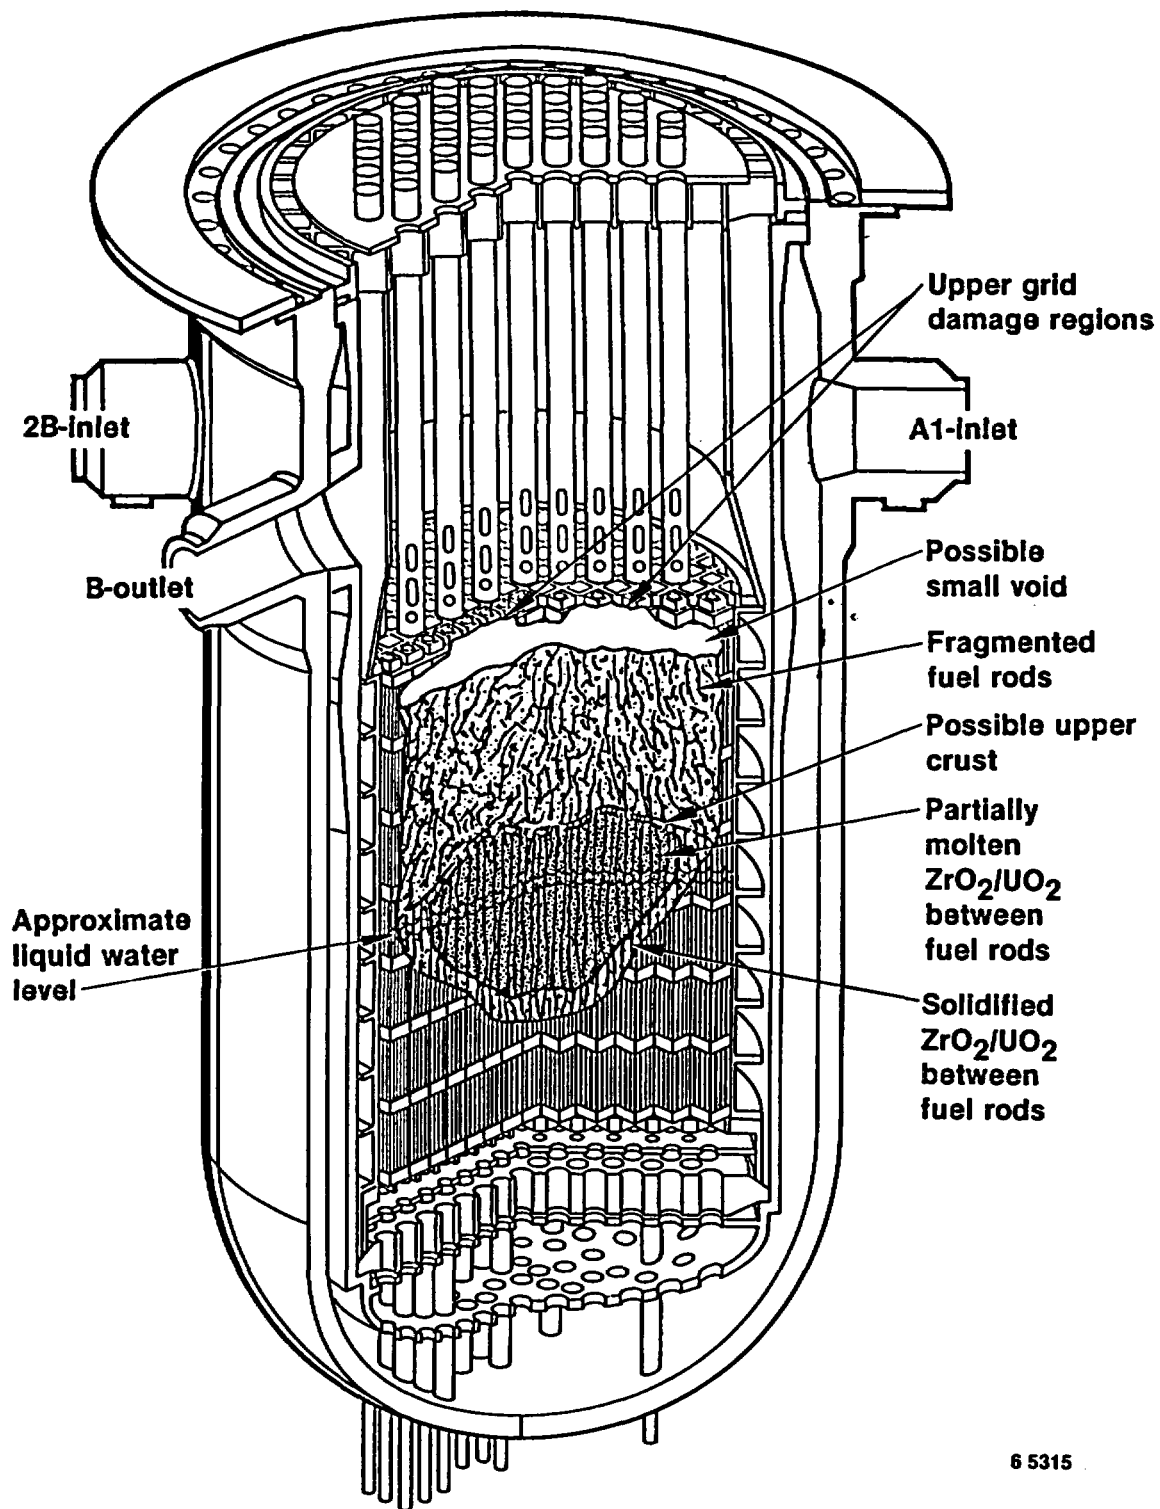
The first significant coolant addition to the reactor vessel occurred at 174 min when the 2B coolant pump was turned on. The coolant delivery to the reactor vessel rapidly pressurized the reactor system (Figure 1). The resulting thermal/mechanical forces would fragment the highly oxidized fuel rod remnants in the upper core region, thus forming a rubble bed on top of the relocated core materials in the center region of the core. This configuration is shown in Figure 6.

Figure 6. Estimated core configuration at 175 to 180 min showing the upper rods fragmented, forming a debris bed.

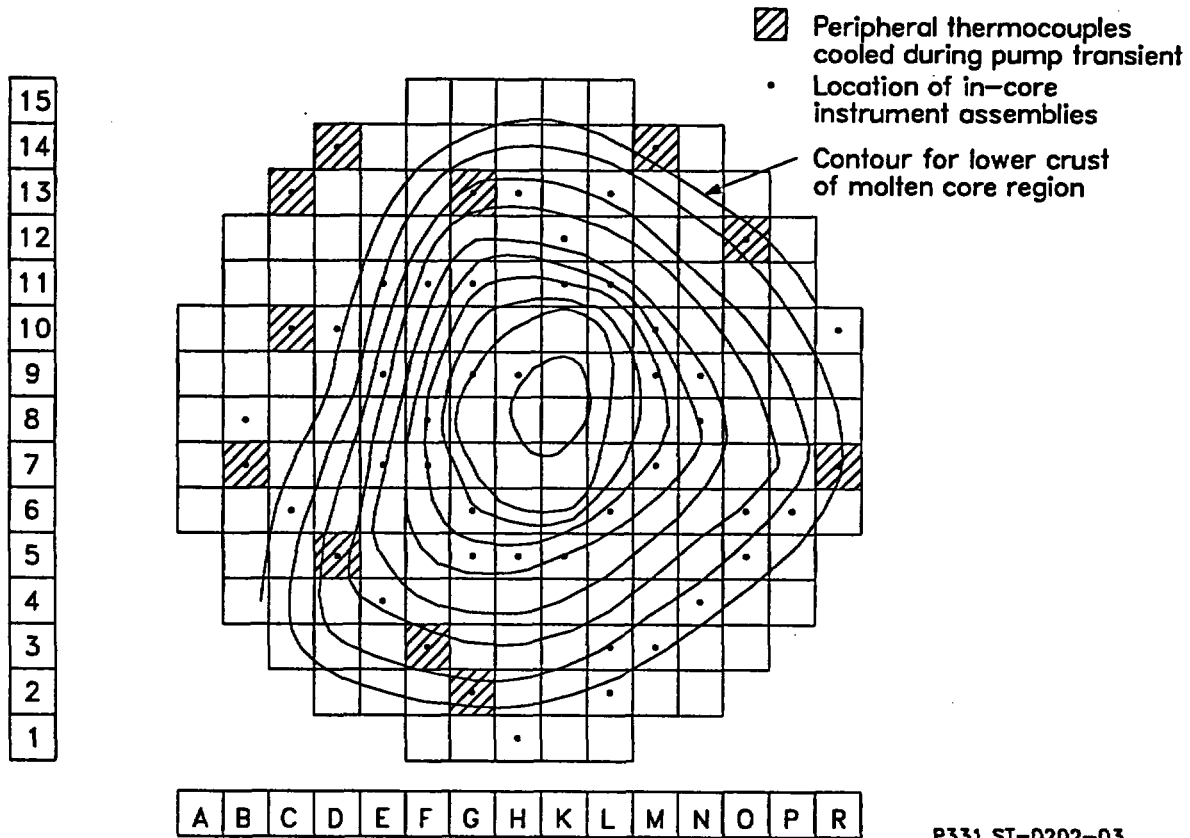
response. Those core thermocouples that were cooled as a result of the pump transient are shown in Figure 7. Note that only those thermocouples generally on the periphery of the degraded core were cooled. These data suggest that formation of the degraded core and lower core crust occurred prior to 174 min, as depicted in Figures 3 through 5. Subsequent alarm data show that all thermocouples cooled by the pump transient again alarmed off-scale (heated up) prior to emergency core coolant injection at 200 min, indicating concurrent reduction in the reactor vessel liquid level during the 174- to 200-min time period.

Figure 7. Overlay of the in-core thermocouple positions that were cooled by the pump transient and the end-state contour of the lower molten zone crust.

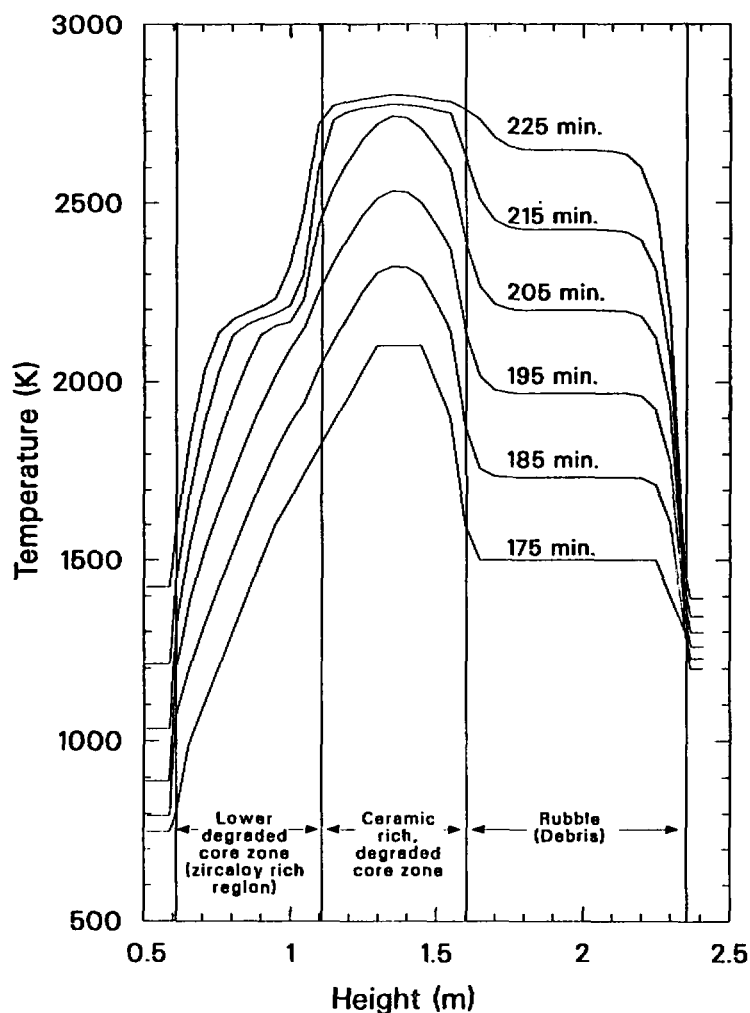
Calculations⁹ to estimate the thermal response of the degraded TMI-2 core configuration generally represented in Figures 4 and 5 indicate that the central core regions will continue to heat up independently of any cooling at the surface of the degraded core region, as shown in Figure 8.

Figure 8. Estimated degraded core thermal response from 175 to 225 min.

Notice that during the 174- to 224-min time period the center regions of the degraded core material are predicted to reach temperatures above 2500 K.

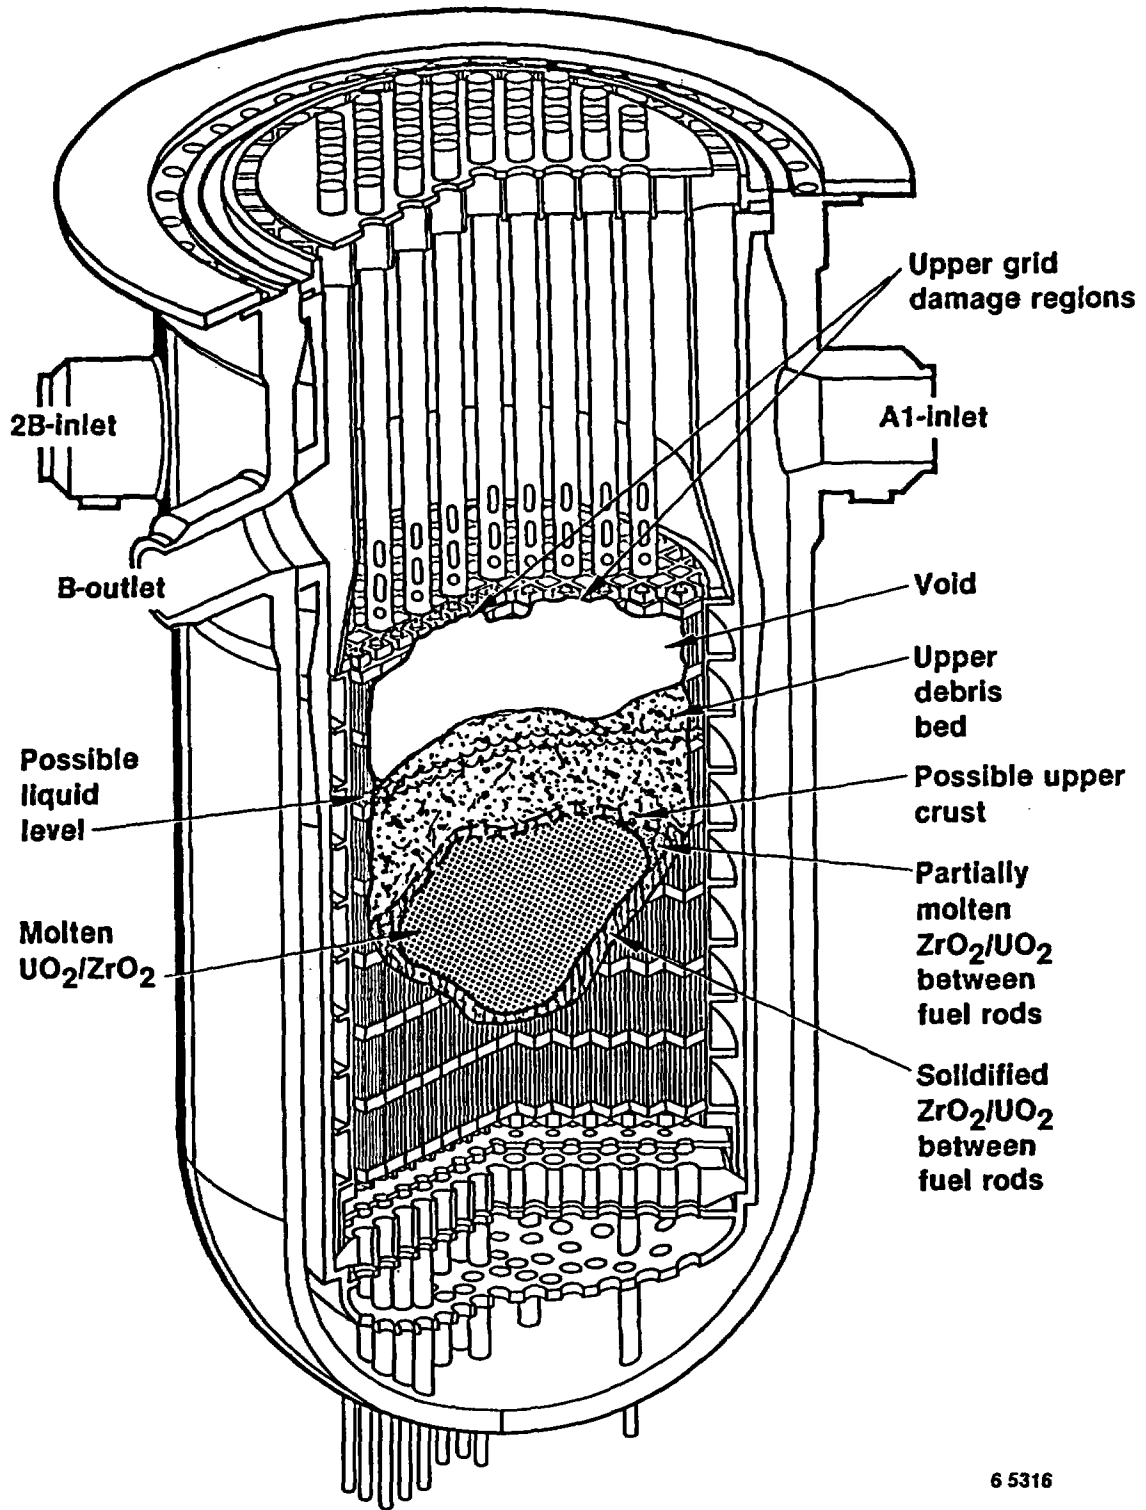
Thus, the estimated core configuration just prior to the core failure and migration of core material to the lower plenum at 224 min is shown in Figure 9. The central regions of the degraded core are predicted to be molten. Cooling of the lower crust was maintained by water in the reactor vessel. However, the configuration and cooling of the upper crusts are much less understood due to (a) uncertainty in the growth rate of the molten zone, which is predominantly in the upward direction due to the convective heat transfer, and (b) uncertainty in the coolability of the upper debris bed.

Figure 9. Estimated core configuration just before core failure and relocation at 224 min.

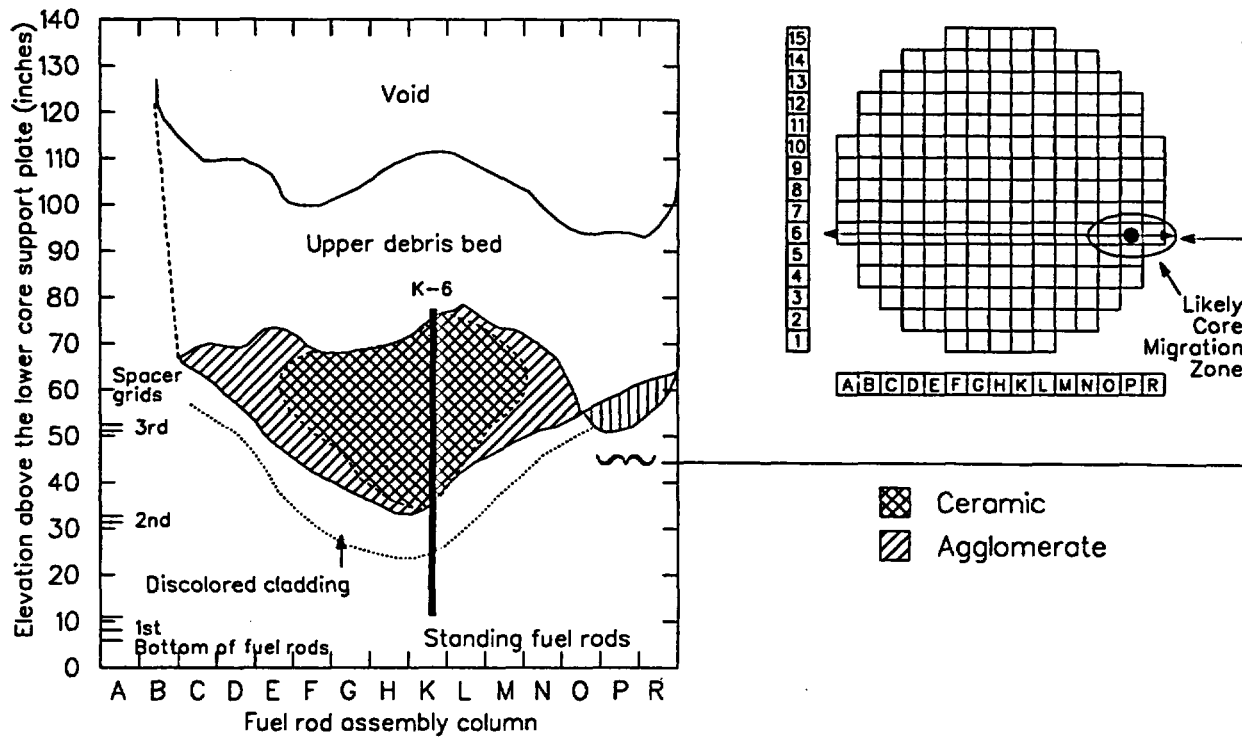
The core bore inspection data summarized in the previous paper provides information for estimating the location of core failure and the flow path of molten material to the lower plenum. The end-state core configuration cross sections as described in the previous paper suggest that failure of the core support crusts likely occurred, at least initially, in the southeast quadrant of the core. Figure 10 shows the core cross sections through the Row 6 fuel assemblies. At the core periphery in fuel assemblies O, P and R, the upper crust of the molten core zone is below the projected bottom crust (based on the core bore contour data). This apparent discrepancy was also observed in the core cross section through the P row of fuel assemblies and can be explained by localized failure of the core crusts in these regions.

The core bore inspection data also showed that significant molten material in the core support assembly regions was limited to only the east quadrant of the reactor vessel, consistent with the inferred core failure locations shown in Figure 10.

Figure 10. End-state core cross section (through the Row 6 fuel assemblies) showing inconsistency in the upper and lower surfaces of the molten core zone (failure location) near the core periphery in the east quadrant.

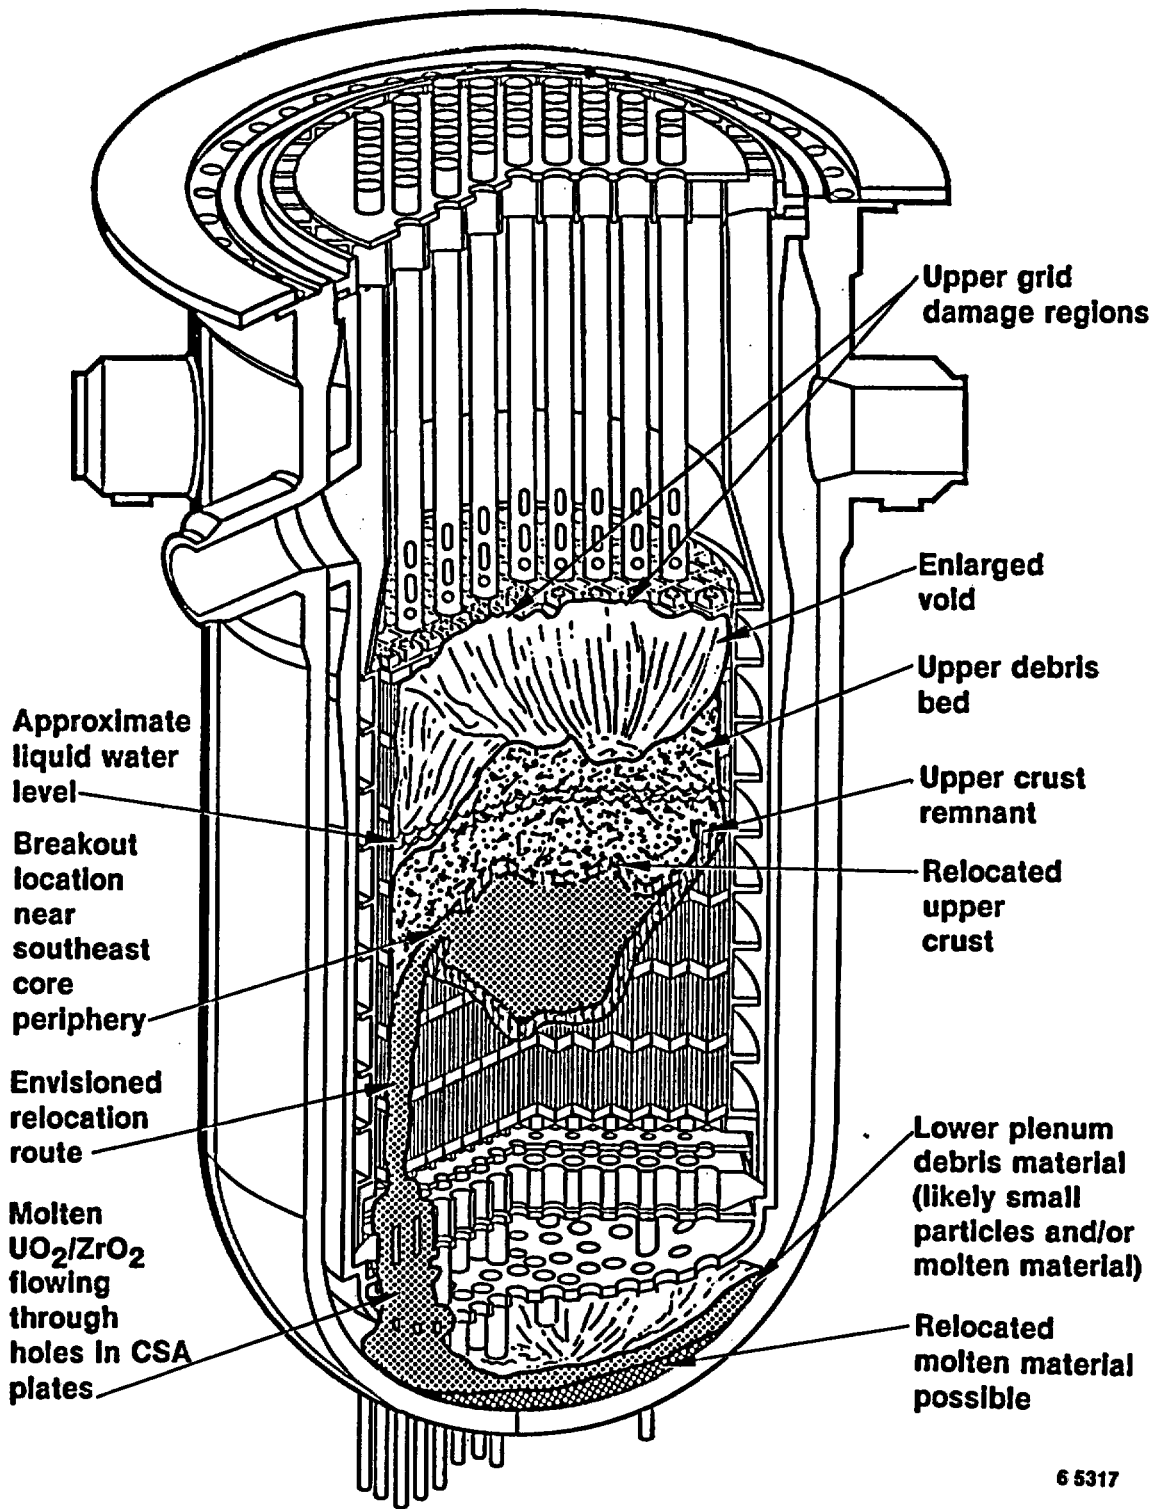
Thus, at 224 min, failure of the supporting core crusts occurred, followed by a rapid fuel migration into the lower plenum region as depicted in Figure 11. Several core failure mechanisms have been hypothesized. These include (a) melting of the upper crust as the degraded core materials continue to heatup, (b) mechanical stress on the crust due to pressure differences between the molten interior and exterior of the degraded core region, and (c) possible interactions between the degraded core materials and the core former wall at the core periphery. Further core characterization and supporting analysis work will be required to converge on a best-estimate core failure mechanism. This work will be essential to complete our understanding of the extent of damage to the CSA and lower vessel head and instrument tube penetrations.

Figure 11. Estimated core configuration at time of core failure (224 min) showing the failure location and migration path to the lower plenum.
