Instrumentation Performance During the TMI-2 Accident

ANIMMA 2013

Instrumentation Performance during the TMI-2 Accident

Joy L. Rempe, *Senior Member, IEEE*, and Darrell L. Knudson

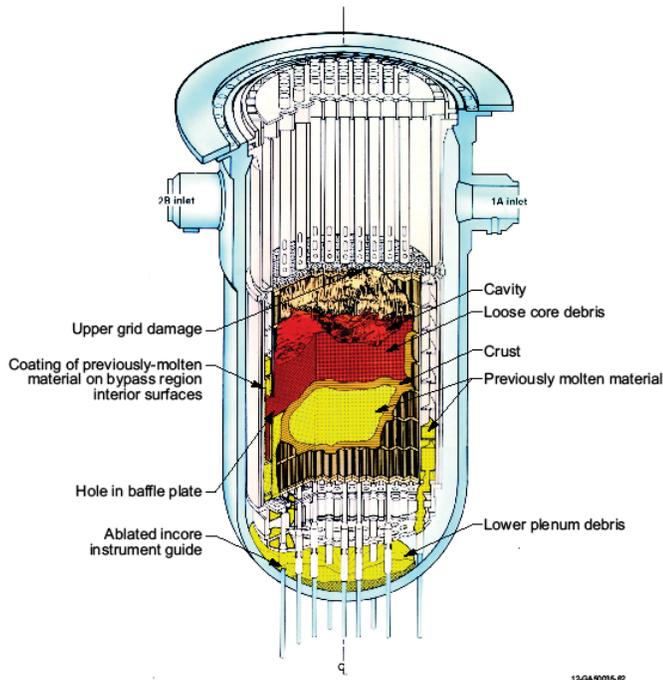
- All TMI-2 fuel assemblies were damaged. Large regions of the core exceeded the melting temperature of the cladding (~ 1900 $^{\circ}$ C). Significant fuel liquefaction by melted Zircaloy and some fuel melting occurred (corresponding to peak temperatures of at least 2800 $^{\circ}$ C).
- Approximately 20% of liquefied core materials escaped from the core as a liquid phase and solidified in the core bypass region, the Core Support Assembly (CSA) region, and the vessel lower head region.
- Based on the end-state core and CSA configuration and supporting analysis of core heatup, it is believed that the crust (or resolidified molten material) surrounding the relocated core material failed near the top of the molten core region in the southeast quadrant of the reactor vessel.

Limited damage to the CSA occurred as core material flowed to the lower plenum. Fig. 4 illustrates the currently-postulated final state of materials within the TMI-2 vessel based on integrated Fig. 3 evaluations.

Fig. 4. Postulated final state of materials within the TMI-2 vessel.[5]

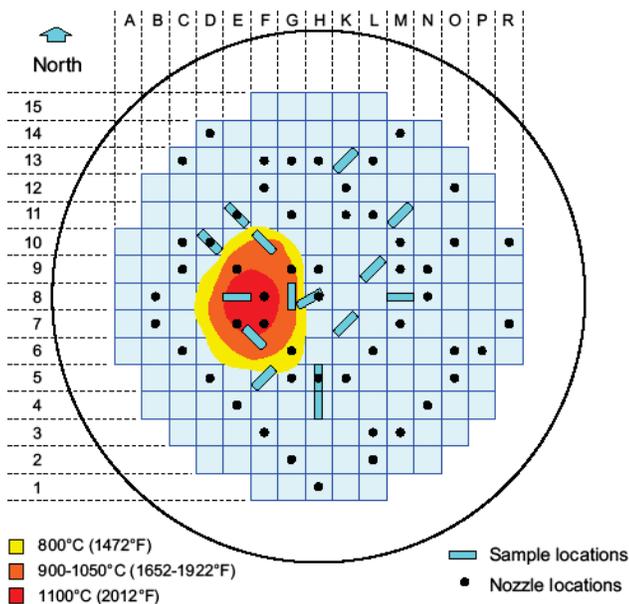
- Metallurgical examinations of the vessel steel samples in conjunction with visual observations suggest that an elliptical region of the vessel, approximately 0.8 m by 1.0 m, reached peak temperatures of 1100 °C during the accident (see Fig. 5). At locations away from this “hot spot”, there is no evidence to indicate that vessel steel temperatures exceeded 727 °C.

Fig. 5. Location of TMI-2 lower head vessel steel samples and “hot spot”[5].

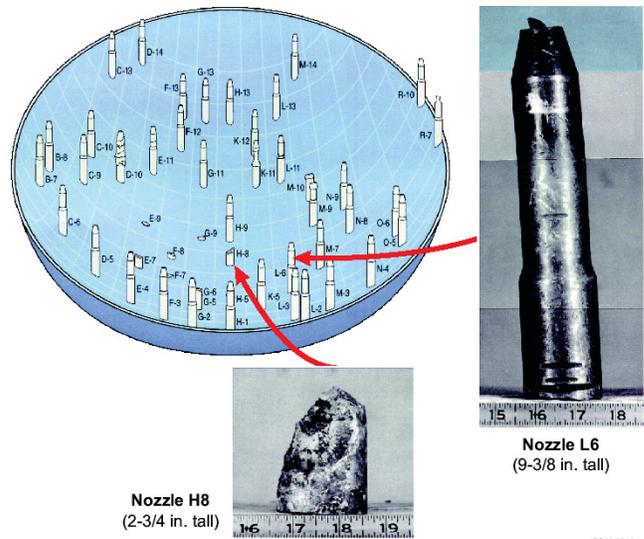
- Instrumentation nozzle damage (see Fig. 6) was caused by molten core material relocating to the lower head. The most severe damage was observed in nozzles located within the “hot spot” region of the vessel and was not related to the embedded debris height (e.g., nozzle L6 was submerged in debris, but remained undamaged).

Fig. 6. End-state of nozzles on the TMI-2 vessel lower head.[5]

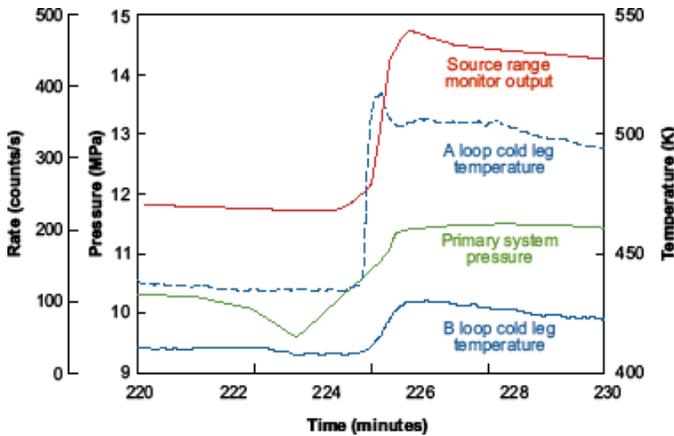
- The simultaneous increase in SRM count rate, RCS pressure, and cold leg temperatures, provided confidence about the timing of a major relocation of materials from the reactor core to the lower head (see Fig. 7).

Fig. 7. Overlay of SRM count rate, RCS pressure measurements, and cold leg temperatures.

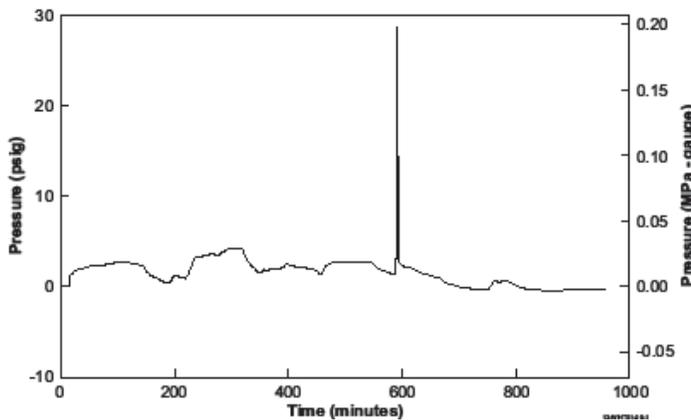
- Peak values for containment building temperature would not have been obtained without considering data from other sensors such as the containment building pressure transmitters. Calculations assuming peak containment pressures (see Fig. 8) yielded peak containment temperatures of 650 °C, which are much higher than the measured 93 °C peak temperature data (Fig. 9). Recognizing that the TMI-2 containment temperature data had a limited sampling rate, experts qualified the containment pressure and a modified set of containment temperature data.

Fig. 8. Containment building pressure.

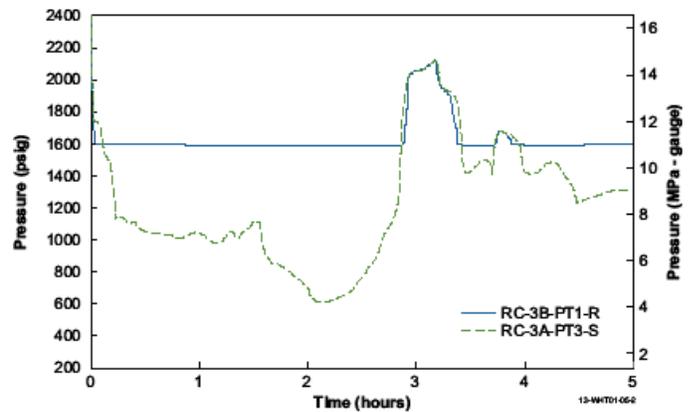
- Data unavailability was often due to computational limits, such as storage memory, inadequate paper or ink, insufficient sampling rates, and ‘preset’ limits associated with anticipated operating ranges (rather than sensor operating limits as illustrated by the RCS pressure data shown in Fig. 10). A wider range of limits and enhanced computational capabilities, with easy-to-read graphical displays, could alleviate such issues, as occurred with TMI-2 building resistance temperature detector (RTD) temperature and steam generator reference pressure transmitter sampling.

Fig. 10. RCS pressures at selected locations.

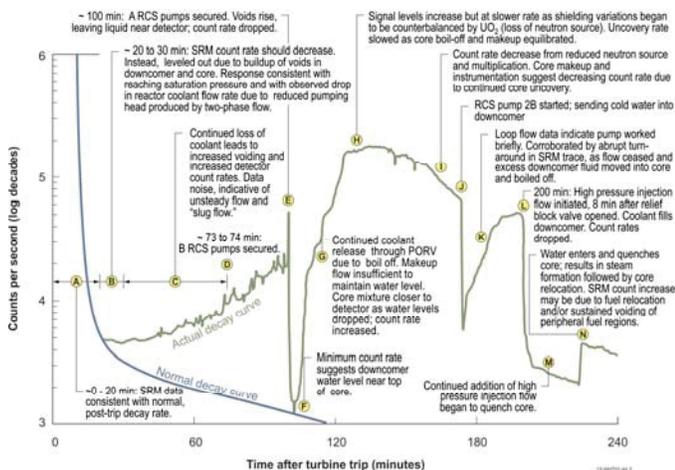
- Qualitative insights can be obtained by considering sensor response for alternate applications, e.g., ex-core source-range detector signals provide insights about RCS water levels, in-core SPNDs provide insights about RCS temperature and water levels. However, such interpretations often require detailed analyses and assumptions related to the status of the core, the RCS and containment (as evidenced from efforts to interpret SRM data in Fig. 11).

Fig. 11. TMI-2 SRM response during the first 4 hours of the accident.

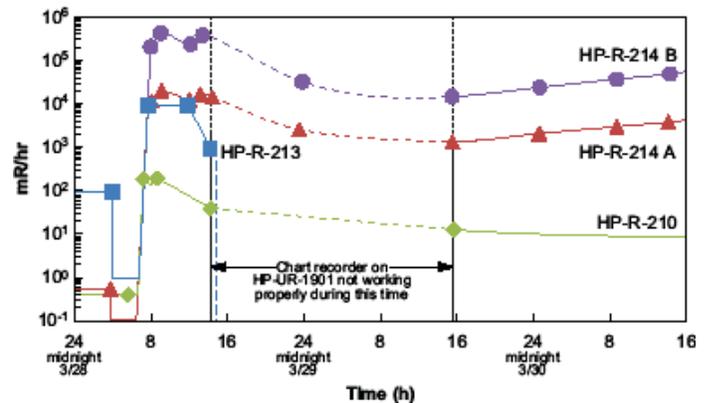
- Post-accident evaluations emphasized the need for more accurate containment radiation measurements. Identified Dome Monitor failures and data uncertainties (see Fig. 12) led to several recommendations for design improvements, such as better seals that are periodically leak tested, the use of moisture and radiation resistant components and cabling, and relocating electronics outside the containment so that the lead shield could be removed.

Fig. 12. Containment radiation monitor response (Two curves are provided for HP-R-214 to reflect upper and lower bounds associated with uncertainties in recording scale).
