EMERGENCY ACTIONS CONCERNED WITH EFFLUENT
CONTROL AT TMI

R. E. Brooksbank, D. O. Campbell, J. W. Snider, O. O. Yarbrow

Chemical Technology Division
Oak Ridge National Laboratory*
Post Office Box X
Oak Ridge, Tennessee 37830

For presentation at the ANS Session on The Public Safety Aspects of Three Mile Island - ANS Annual Meeting, Las Vegas, Nev., June 8-19, 1980.

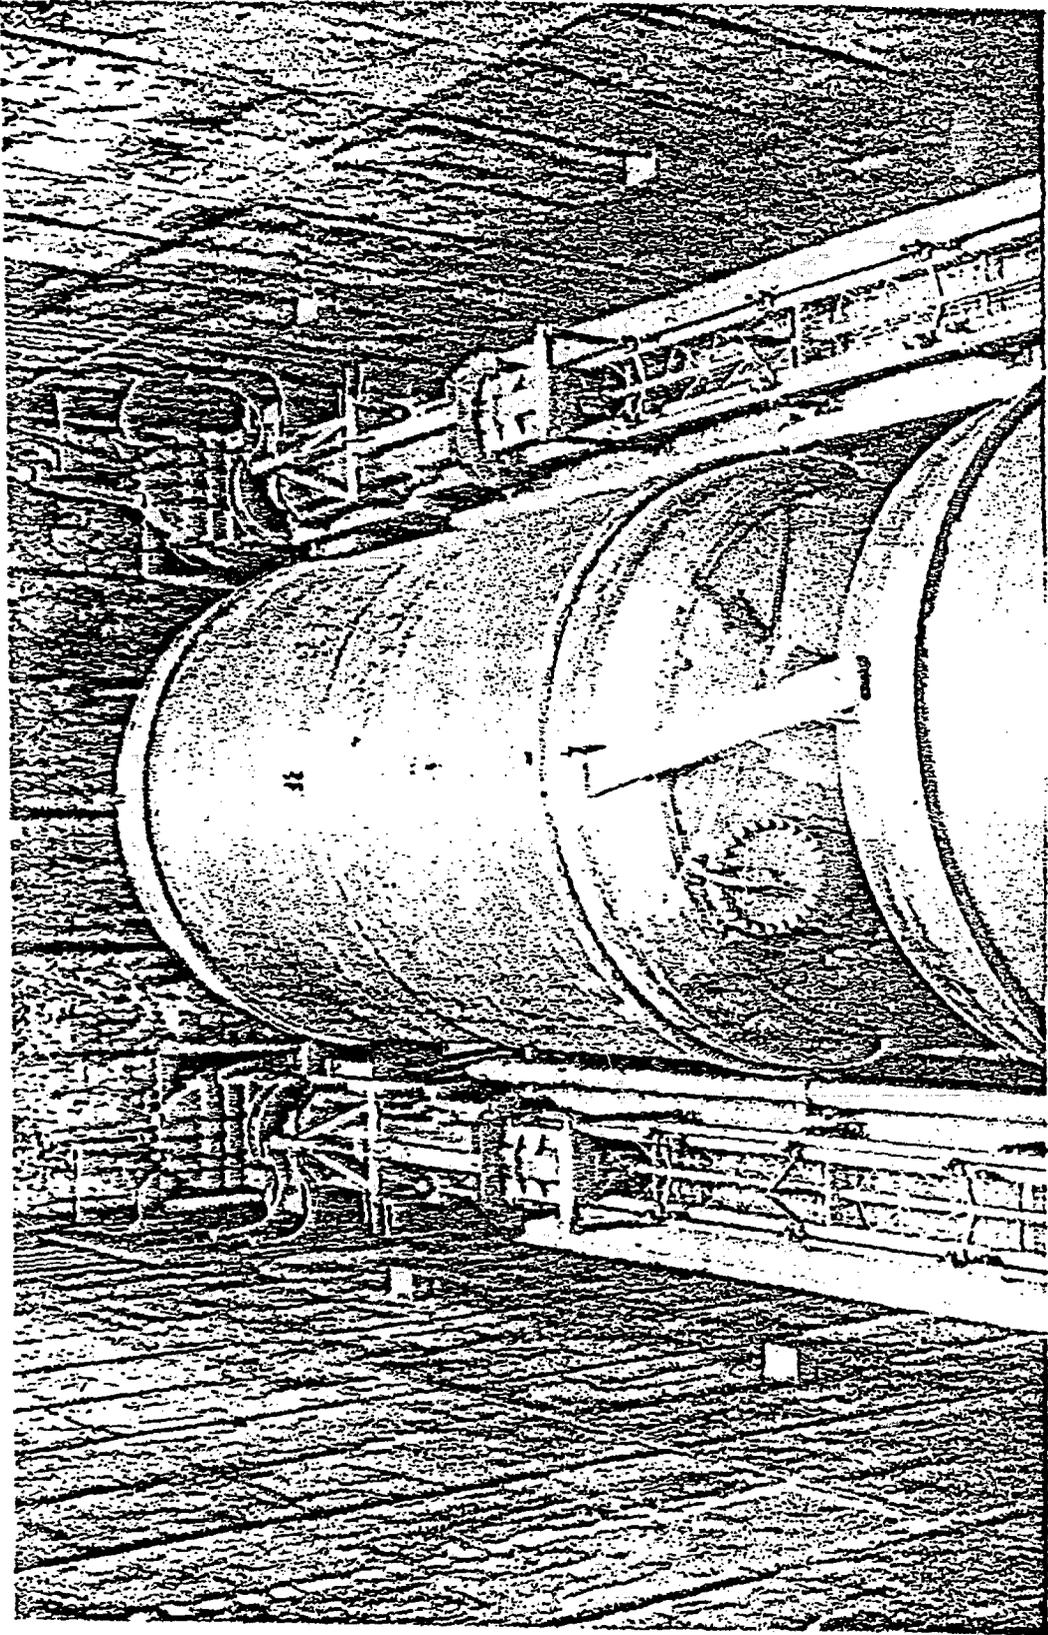
Fig. 11. Emergency tank farm at TMI Unit 2.

Water inventories in both auxiliary buildings were increasing. There was an urgent need for additional storage and/or water treatment facilities. In accordance with this requirement, an emergency tank farm system was designed and installed in an unused fuel storage basin to provide an additional 110,000 gallons of storage capacity. Figure 10 presents an equipment schematic and Fig. 11 is a photograph of the lower tanks during installation.
