OPERATOR/INSTRUMENTATION INTERACTIONS DURING THE THREE MILE ISLAND INCIDENT

GARTH E. CUMMINGS

OCTOBER 1979

THIS PAPER WAS PREPARED FOR SUBMISSION TO IEEE - SYMPOSIUM ON NUCLEAR POWER SYSTEMS, October 19, 1979, San Jose, California

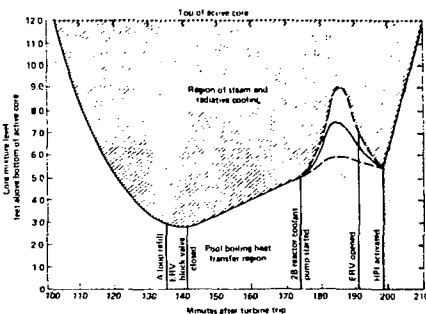
Figure 2. Core Mixture Level

A review of the water level in the reactor core is given in Fig. 2. As can be seen, the level continued to decrease for two hours until the ERV block valve was closed. The high pressure injection system makeup into the reactor then caused the reactor water level to rise. A reactor coolant pump was started at approximately 175 min. after the incident started. Saturated conditions prevented the continued operation of this pump but it delivered a surge of water into the core which is believed to have caused a certain amount of damage. As can be seen, the core was uncovered for a considerable length of time.
