Assessment of Thermal Damage to Polymeric Materials by Hydrogen
Deflagration in the Three Mile Island Unit 2 Reactor Building*

N. J. Alvares**
Lawrence Livermore National Laboratory

UCRL--92721

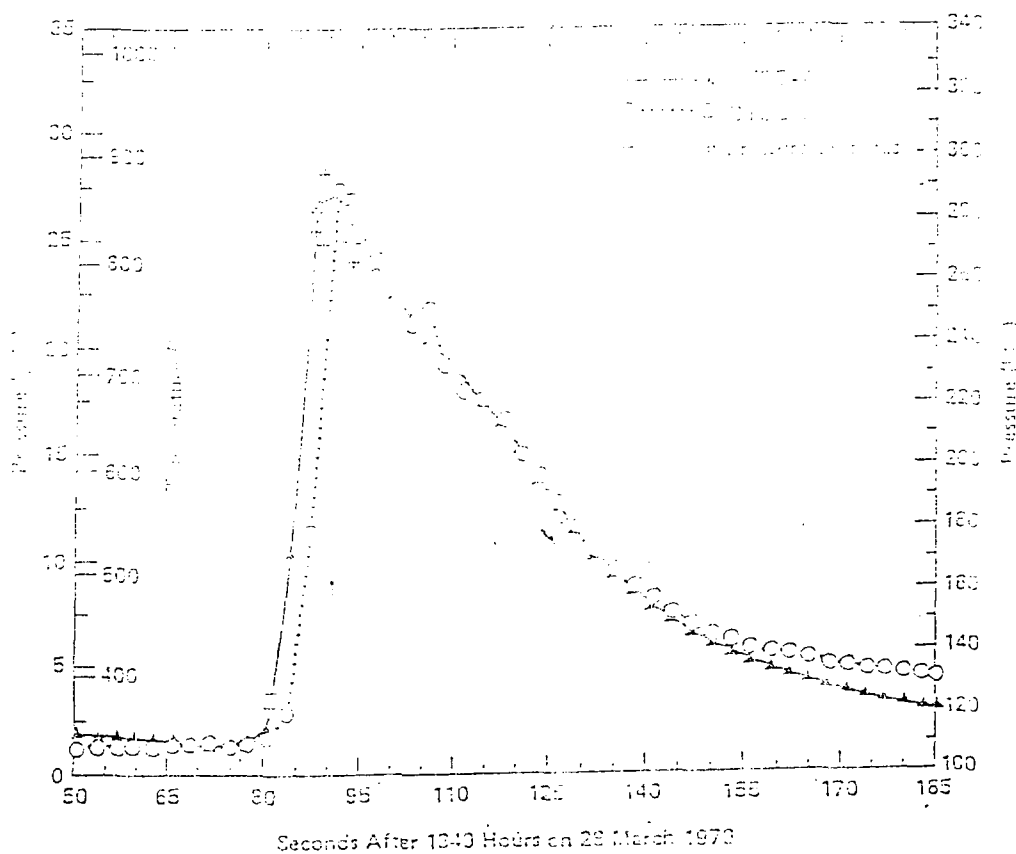
Activation of the building spray system is defined by inflection and increase in the negative slope of interior-pressure-reduction curves (Figure 5). Also indicated is a pressure increase of about 28 psig achieved in a period of about 12 s.(3) Experimental confirmation of the pressure response of hydrogen combustion in constant volume chambers is indicated in Figure 6. Note that the act of causing turbulent conditions in the test chamber causes greater pressure rise at lower hydrogen concentration.

Fig. 5. Pressures recorded during the burn from OTSC pressure transmitters and pressure switch actuation times. Corresponding average temperature via procedure described in Ref. 1 added to psig scale.

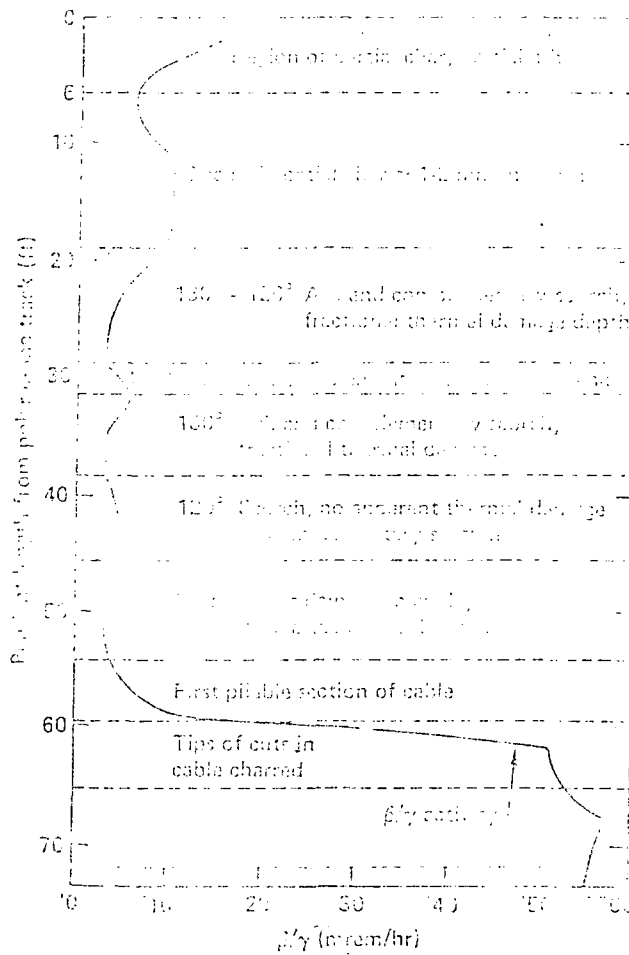
Fig. 16

Maximum thermal damage occurs in the region from 6 to 10 ft below the polar crane girder (from about the 440-ft level down to about the 406-ft level). This region shows locally high β/γ activity, which may correlate to physical absorption by porous, charred insulation. Thermal damage is severe and circumferentially equal in this region. Char depth on the polymer surface averages 1 to 2 mm.

From the 406-ft level to the top of the D-ring (the 367-ft level), thermal damage is progressively less and becomes more directional, i.e., half of the insulation circumference exhibited a heavier degree of damage, ranging from char at the 406-ft level to no perceptible insulation degradation just above the D-ring plane. The pattern of asymmetric thermal damage along the pendant below the 406-ft level (a distance approximately 14 ft below polar crane girder bottom) indicates exposure from a westerly direction.(10) The extent of thermal damage to other available polymers at about the 347-ft level indicates intense thermal exposure in southerly areas of the reactor building. Moreover, since all containment gases above the 347-ft level were convected to the air-cooler intake plenums in the southern sector just below the 347-ft level, some preferential ventilation pattern may have influenced fire propagation path. However, because of fewer thermally susceptible materials in the north reactor building regions, we cannot confidently compare the south and north experience to define sources of non-uniform heat flux. Had there been either minimal thermal experience or other patterns in susceptible polymers in any other region, we may have had better opportunity to define fire geometry. One cause for asymmetry of the burn pattern below the 406-ft level can be conjectured: the cable at this height was

exposed to radiation and convection resulting from hydrogen combustion originating from one side (logically the southwest side) of the reactor building. The exposed surface would sustain thermal damage more readily than the shadowed surface, thus producing the observed pattern.

Figure 16. Thermal damage pattern and β/γ activity along the Du Pont Hypalon and ethylene propylene covered polar crane pendant.
