ADDITIONAL ADDENDA TO THIRD REPORT OF TAAG - Hmb-581-82

TO: File FILE NO. TMI  
FOR: Information DATE July 16, 1982  
FROM: G. W. Tucker and C. M. Ball  
SUBJECT: Three Mile Island Unit No. 2 500-Ton Polar Crane - NNS Comments and Recommendations for Reactivation

**TO** E. J. Wagner  
**FROM** *R. Oakes / H. Young*  
 R. Oakes/H. Young  
**SUBJECT** W.O. 3680-01  
 Technical Assistance & Advisory Group  
 TMI-2 Recovery  
 Closure Head and Fuel Removal Containment

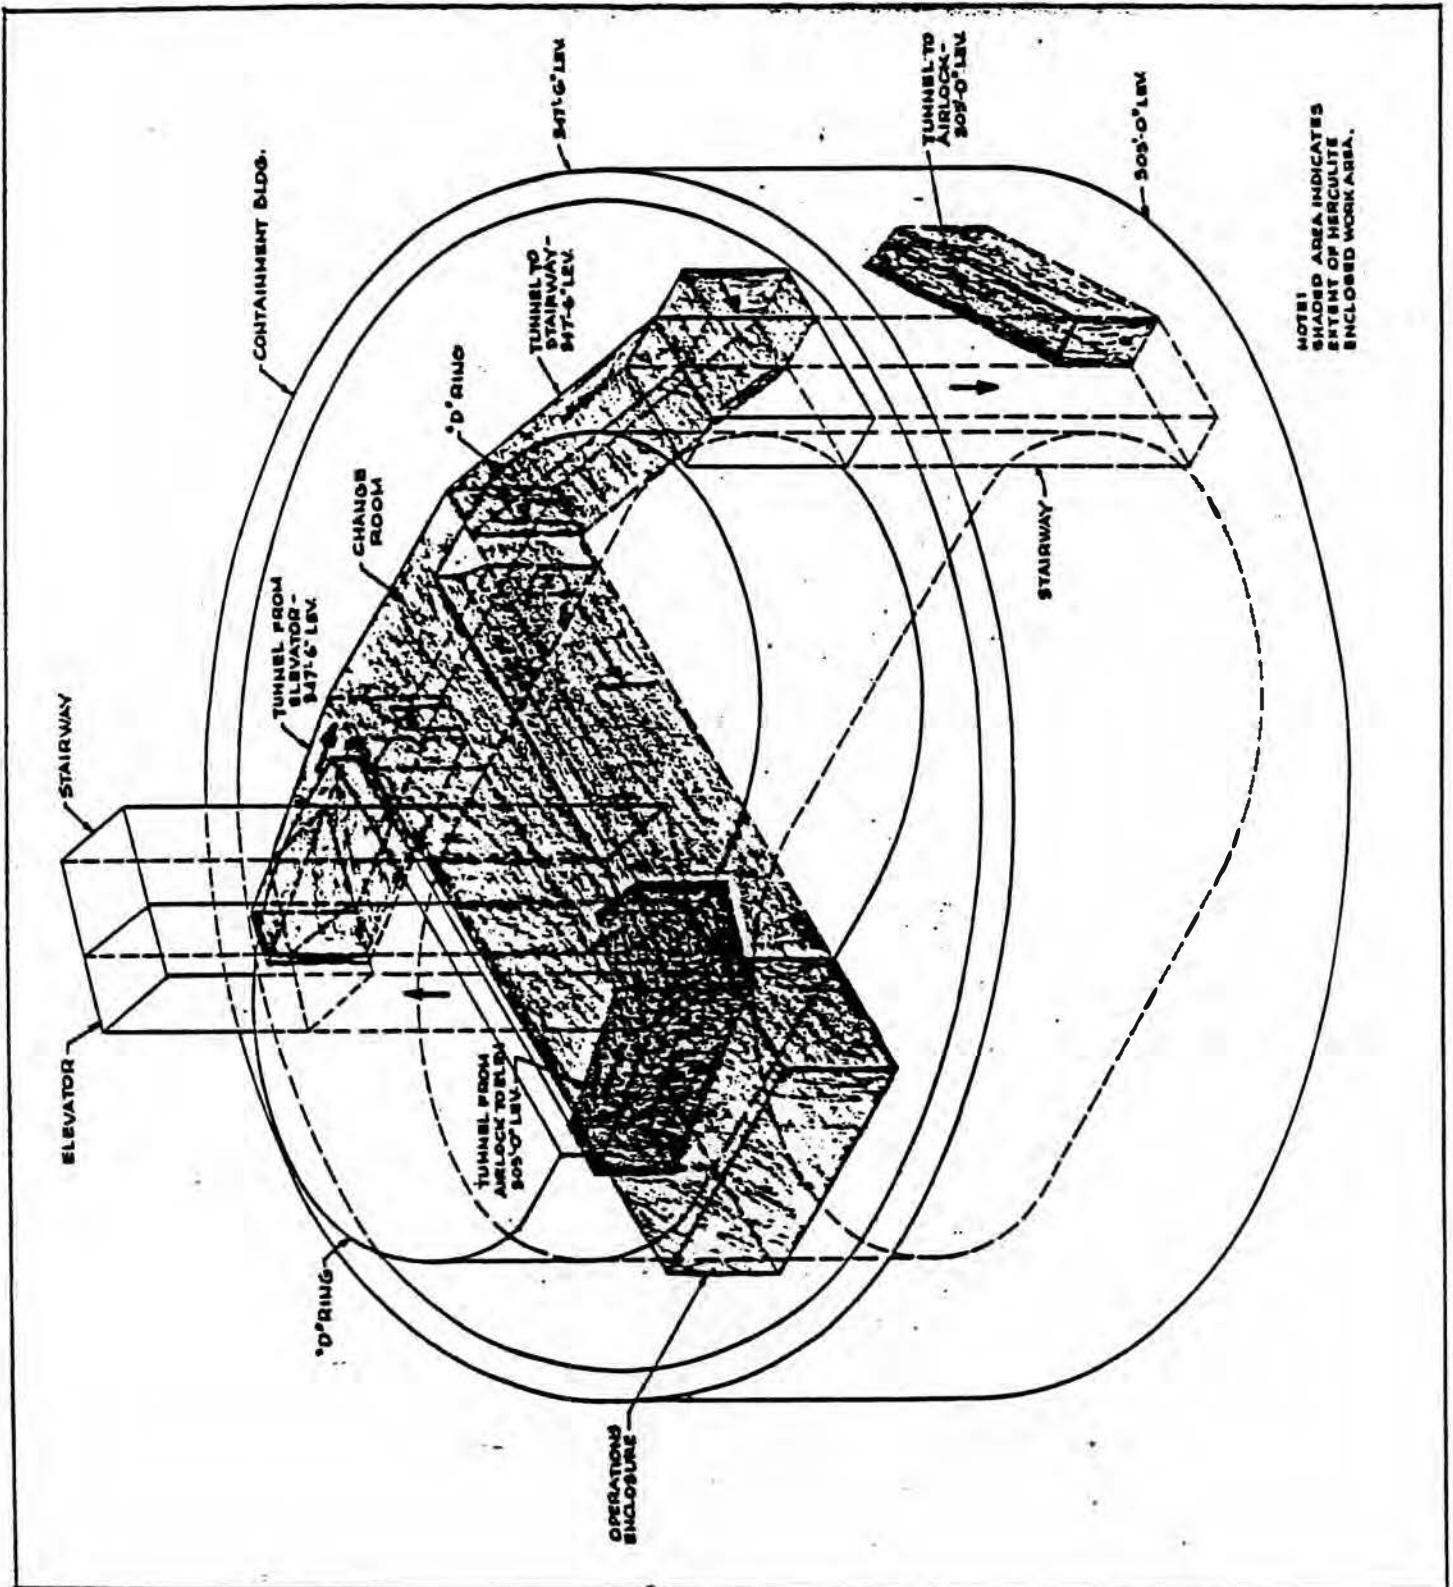
NOTE: SHADED AREA INDICATES EXTENT OF HERCULITE ENCLOSED WORK AREA.

The layout of the tent on the 347'6" elevation on the Attachment (a) sketch has the following deficiencies: it routes personnel into areas of higher radiation, it places the change room on or near the covered hatch, and it does not show the open stairway being enclosed.

The actual layout of the tents are shown on Attachments c & d. All aisleways should be ventilated with about 10 air changes per hour. For the entrance tent to the elevator shown on Attachment c, approximately 300 CFM supply would be required. The elevator would be a unique situation. Since it is mobile, a small fan and HEPA unit of 200 CFM would be required to keep the elevator clean. The unit would be located in the elevator and would take air from the elevator shaft. Power for the fan would be from the elevator lighting circuit. The entrance tent would dump the supply air out of the tent into containment through a backdraft damper. The elevator supply air would exfiltrate out into the elevator shaft.

On elevation 347'-0" the aisleway tent from the elevator to the fuel handling canal requires a supply of about 1000 CFM. This air will be transferred to the fuel canal through a controlled opening at the entrance to the canal. The canal exit corridor extends to the stairway, down the stairway to elevation 305'-0" and out to the equipment airlock. This entire area requires approximately 2000 CFM, which must be supplied near the airlock. The air will travel through the corridor on elevation 305', up the stairway, through the corridor on elevation 347' and into the fuel canal through a controlled opening.

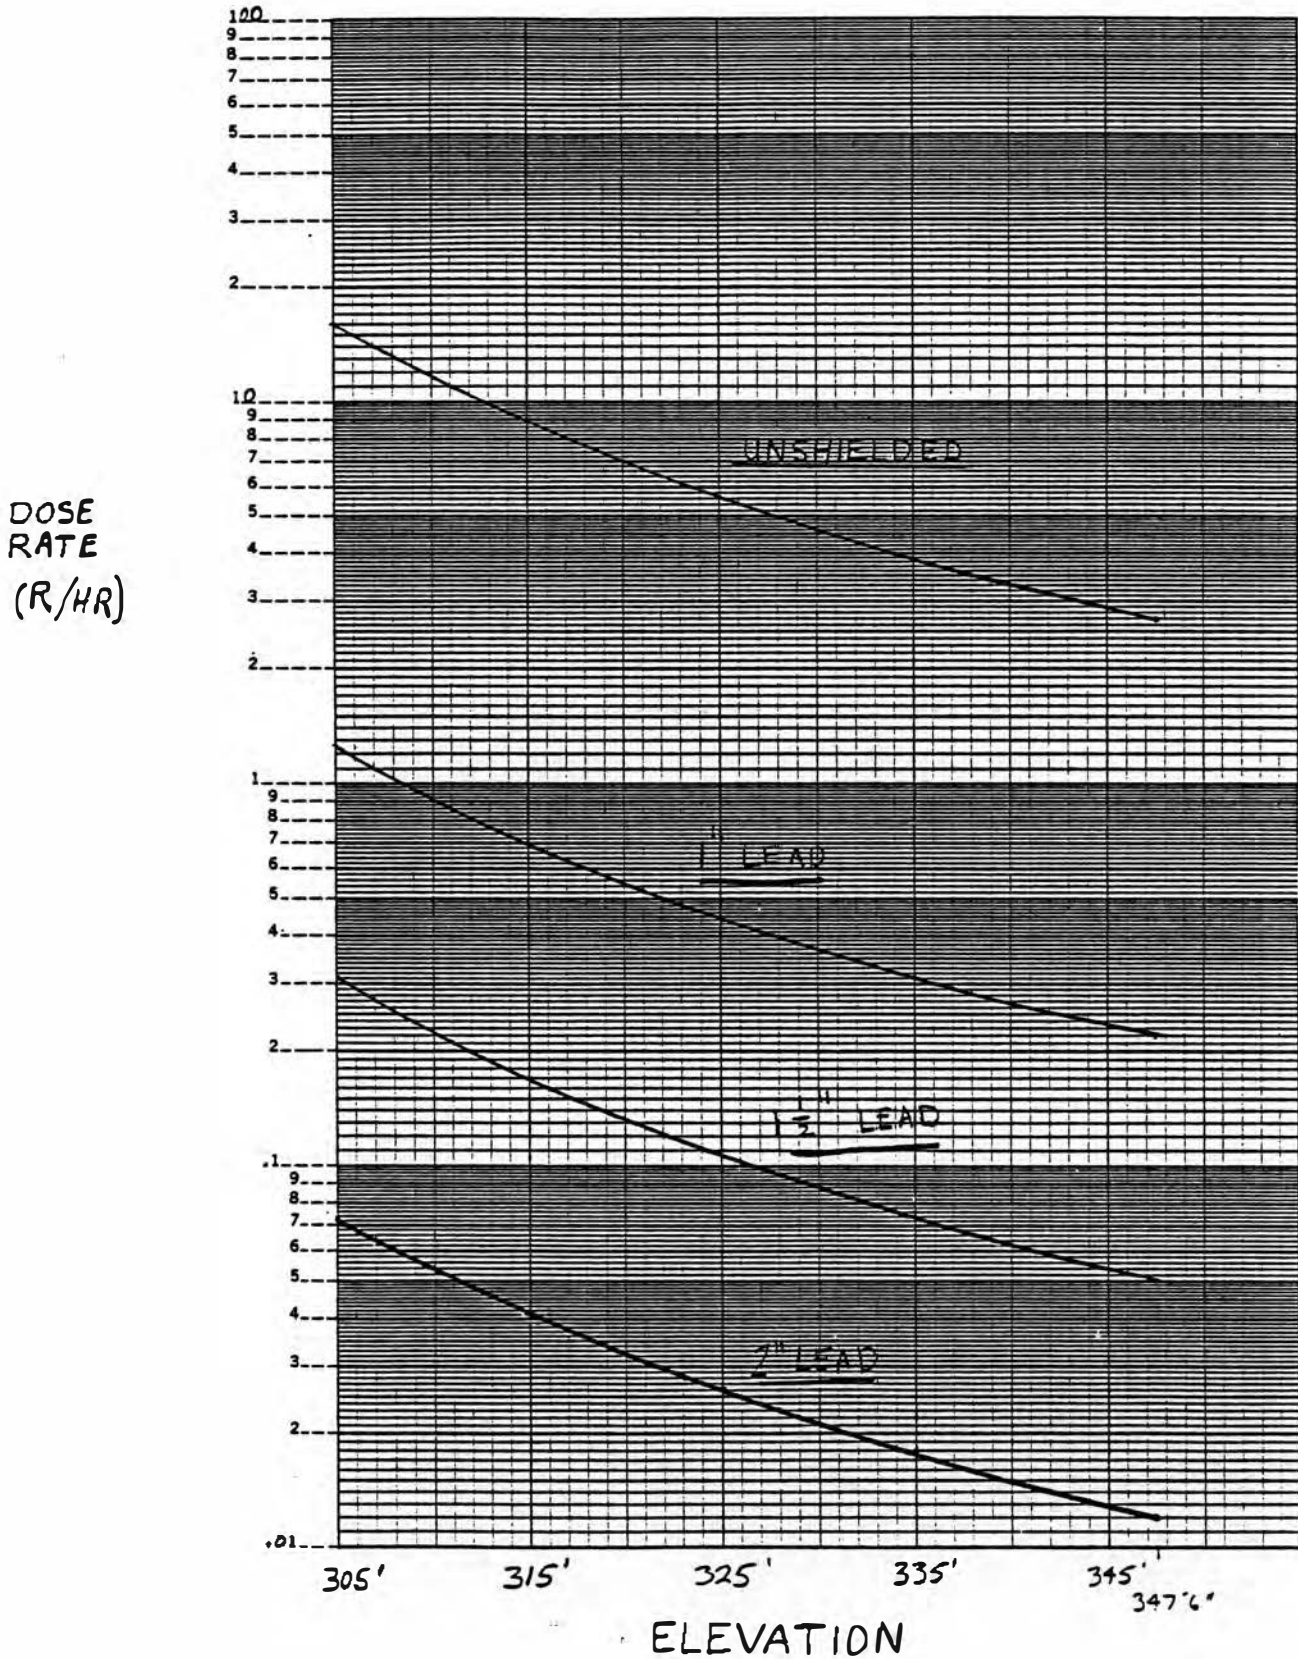
Estimated Dose Rates Inside Reactor Building Elevator Shaft

Therefore, shielding must be inserted into the elevator shaft to reduce the dose rates. The elevator shaft is a 2 hour fire rated structure so it has no exposed structural steel to facilitate supporting shield material. The shielding will have to be supported on structural beams inserted through the open doors and through the block wall at the back of the elevator shaft. Metal decking will be laid over the beams and 2" of lead will be placed on the decking. Modifications to the elevator controls will be necessary to prevent damage to the shield.
