December 15, 1980
TLL 657

Three Mile Island Nuclear Station, Unit 2 (TMI-2)
Operation License No. DPR-73
Docket No. 50-320
Cork Seal Contamination Report

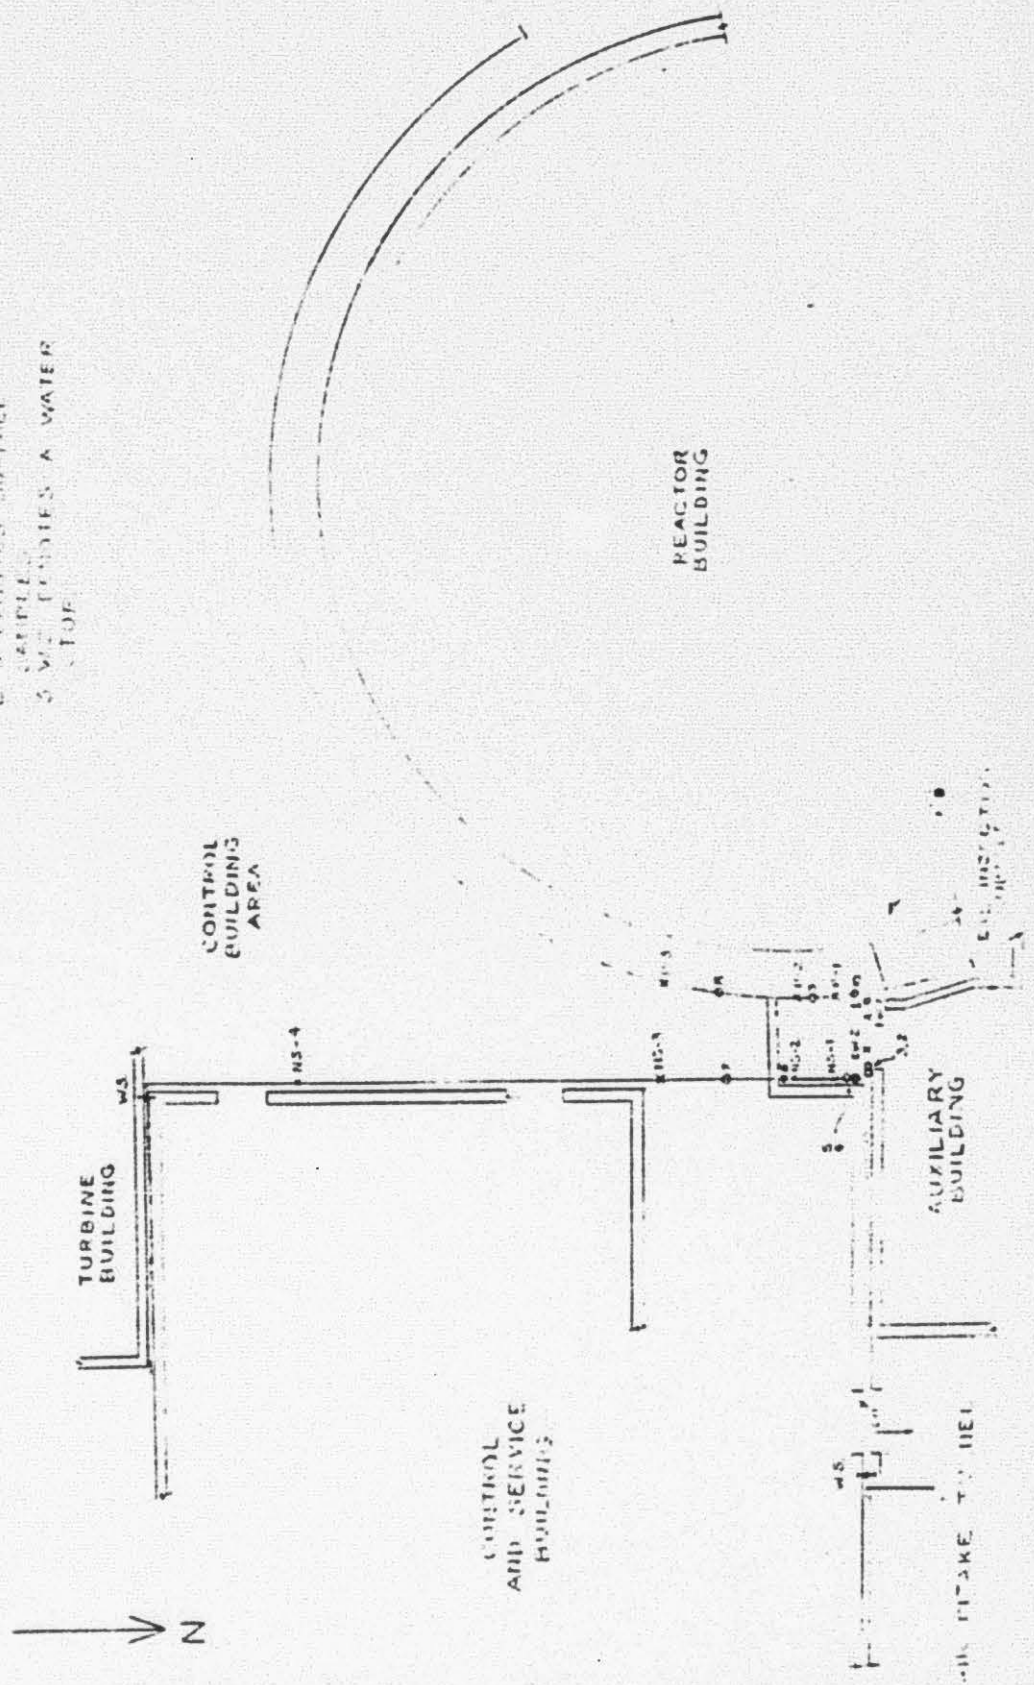
2. A total of 64 cork samples have been analyzed, the results of which are presented in Table 1. Conclusions drawn from these analyses are as follows:
 - a. Cesium concentration is highest along the east-west building seam. (See attached drawing for location)

- b. The contamination is highest near the corner of the seal injection valve room and decreases with distance.
 - c. The radioactive contamination is uniformly distributed over depth except that the samples taken near the corner of the seal injection valve room, showed a trend for cesium specific activity to increase with depth. The cause of this relatively even distribution may be due to cesium being readily soluble and therefore easily transported by water.

The origin of the contamination has not been determined by the samples analyzed thus far but a likely source appears to be leakage from the auxiliary building into the east-west seam approximately 3 feet from the reactor building peripheral seam. This seam is adjacent to areas flooded during the accident and walls which received a gross washdown during decontamination of the auxiliary building.

Samples of cork have been sent to an independent laboratory to chemically separate the cesium and perform detailed analyses in order to study less soluble isotopes. In addition, samples of the water which is underneath the cork will be taken and analyzed. To determine if the water stops are functional, core samples of cork in the Air Intake Tunnel and the Fuel Handling Building/Reactor Building interface will be taken.

Several methods to isolate and contain the cork contamination are being studied. These include cork excavation, desiccant drying agents and the use of sealants and strippable coatings.
