Metropolitan Edison Company
Post Office Box 480
Middletown, Pennsylvania 17057

February 27, 1981
LL2-81-0025

Three Mile Island Nuclear Station, Unit 2 (TMI-2)
Operating License No. DPR-73
Docket No. 50-320
Cork Seal Contamination Report

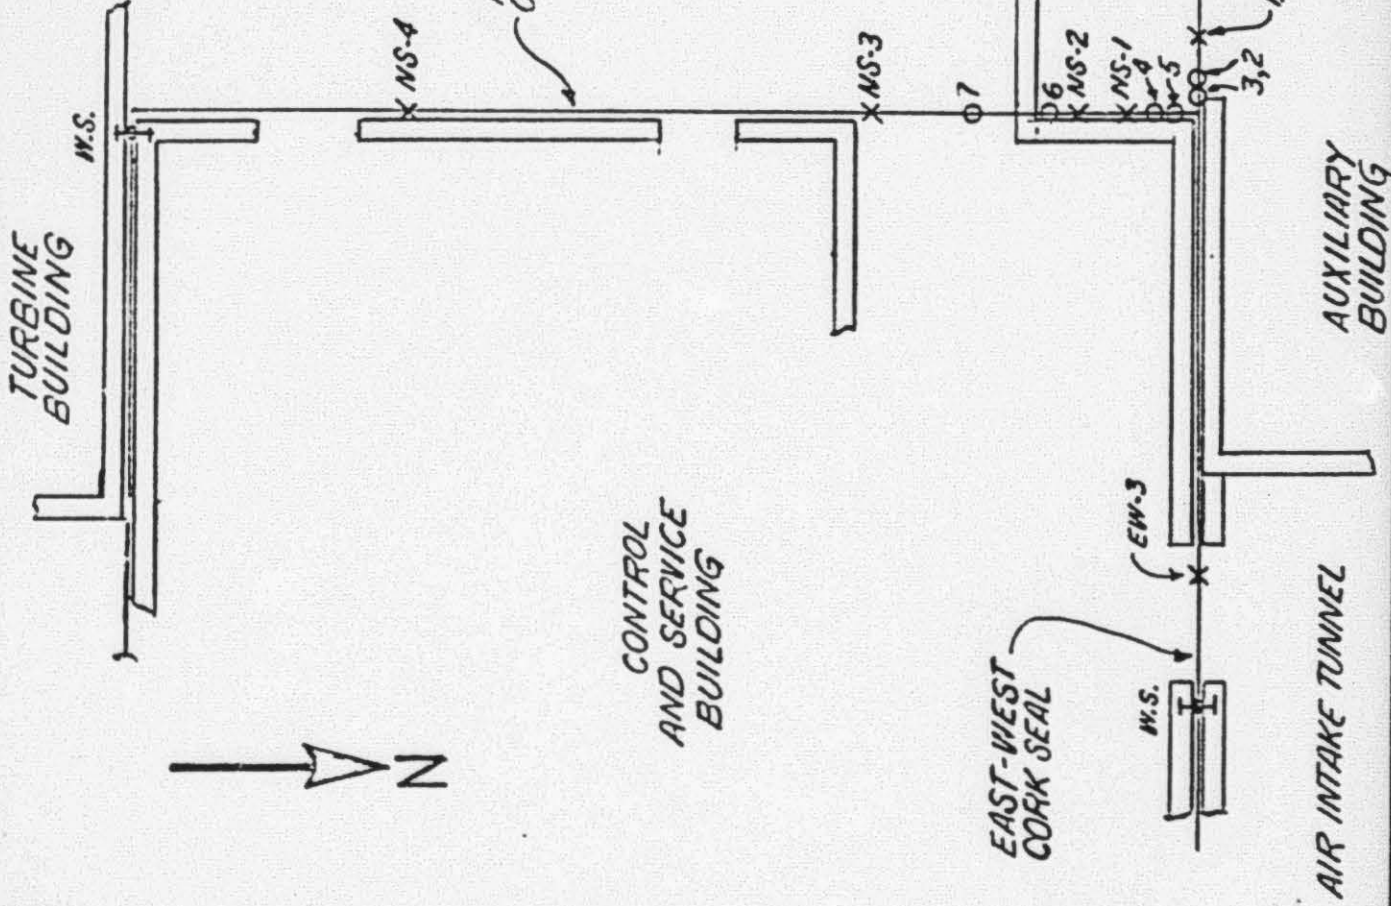
CORK SEAL SAMPLING LOCATIONS

The following table shows gamma analysis data for boring samples taken from the cork seal between the Control & Service Building and the Air Intake Tunnel (location EW-3 on the attached drawing). These are the only boring samples where the low solubility Ce-144 was measured. The cerium was either masked by the cesium or not measured in the other boring samples.

Sample 52982 was one of the initial samples taken. The remaining samples were taken from increasing depths into the cork seal and contained approximately the same volume. Therefore, the concentration of the low solubility Cerium-144 decreases with increasing depth into the cork seal which shows that the source of contamination was from the top.

In addition, contact readings on the cork seals show that radiation levels decrease with increasing distance from the seal injection cubicle, e.g., approximately 700 mR/hr outside the cubicle to approximately 25 mR/hr at the doorway from the Control & Service Building to the Air Intake Tunnel. General area radiation levels also decrease with increasing distance from the cubicle, e.g., 3-10 R/hr in the cubicle, 5 mR/hr outside the cubicle, and 0.2 mR/hr at the doorway between the Control & Service Building and the Air Intake Tunnel.

The foregoing indicates that the seal injection cubicle is the most probable source of the cork seal contamination.
