Three Mile Island Nuclear Station Unit 2 (TMI-2)
License No. DPR-73
Docket No. 50-320
TMI-2 Cork Seam

TMI-2 CORK SEAM

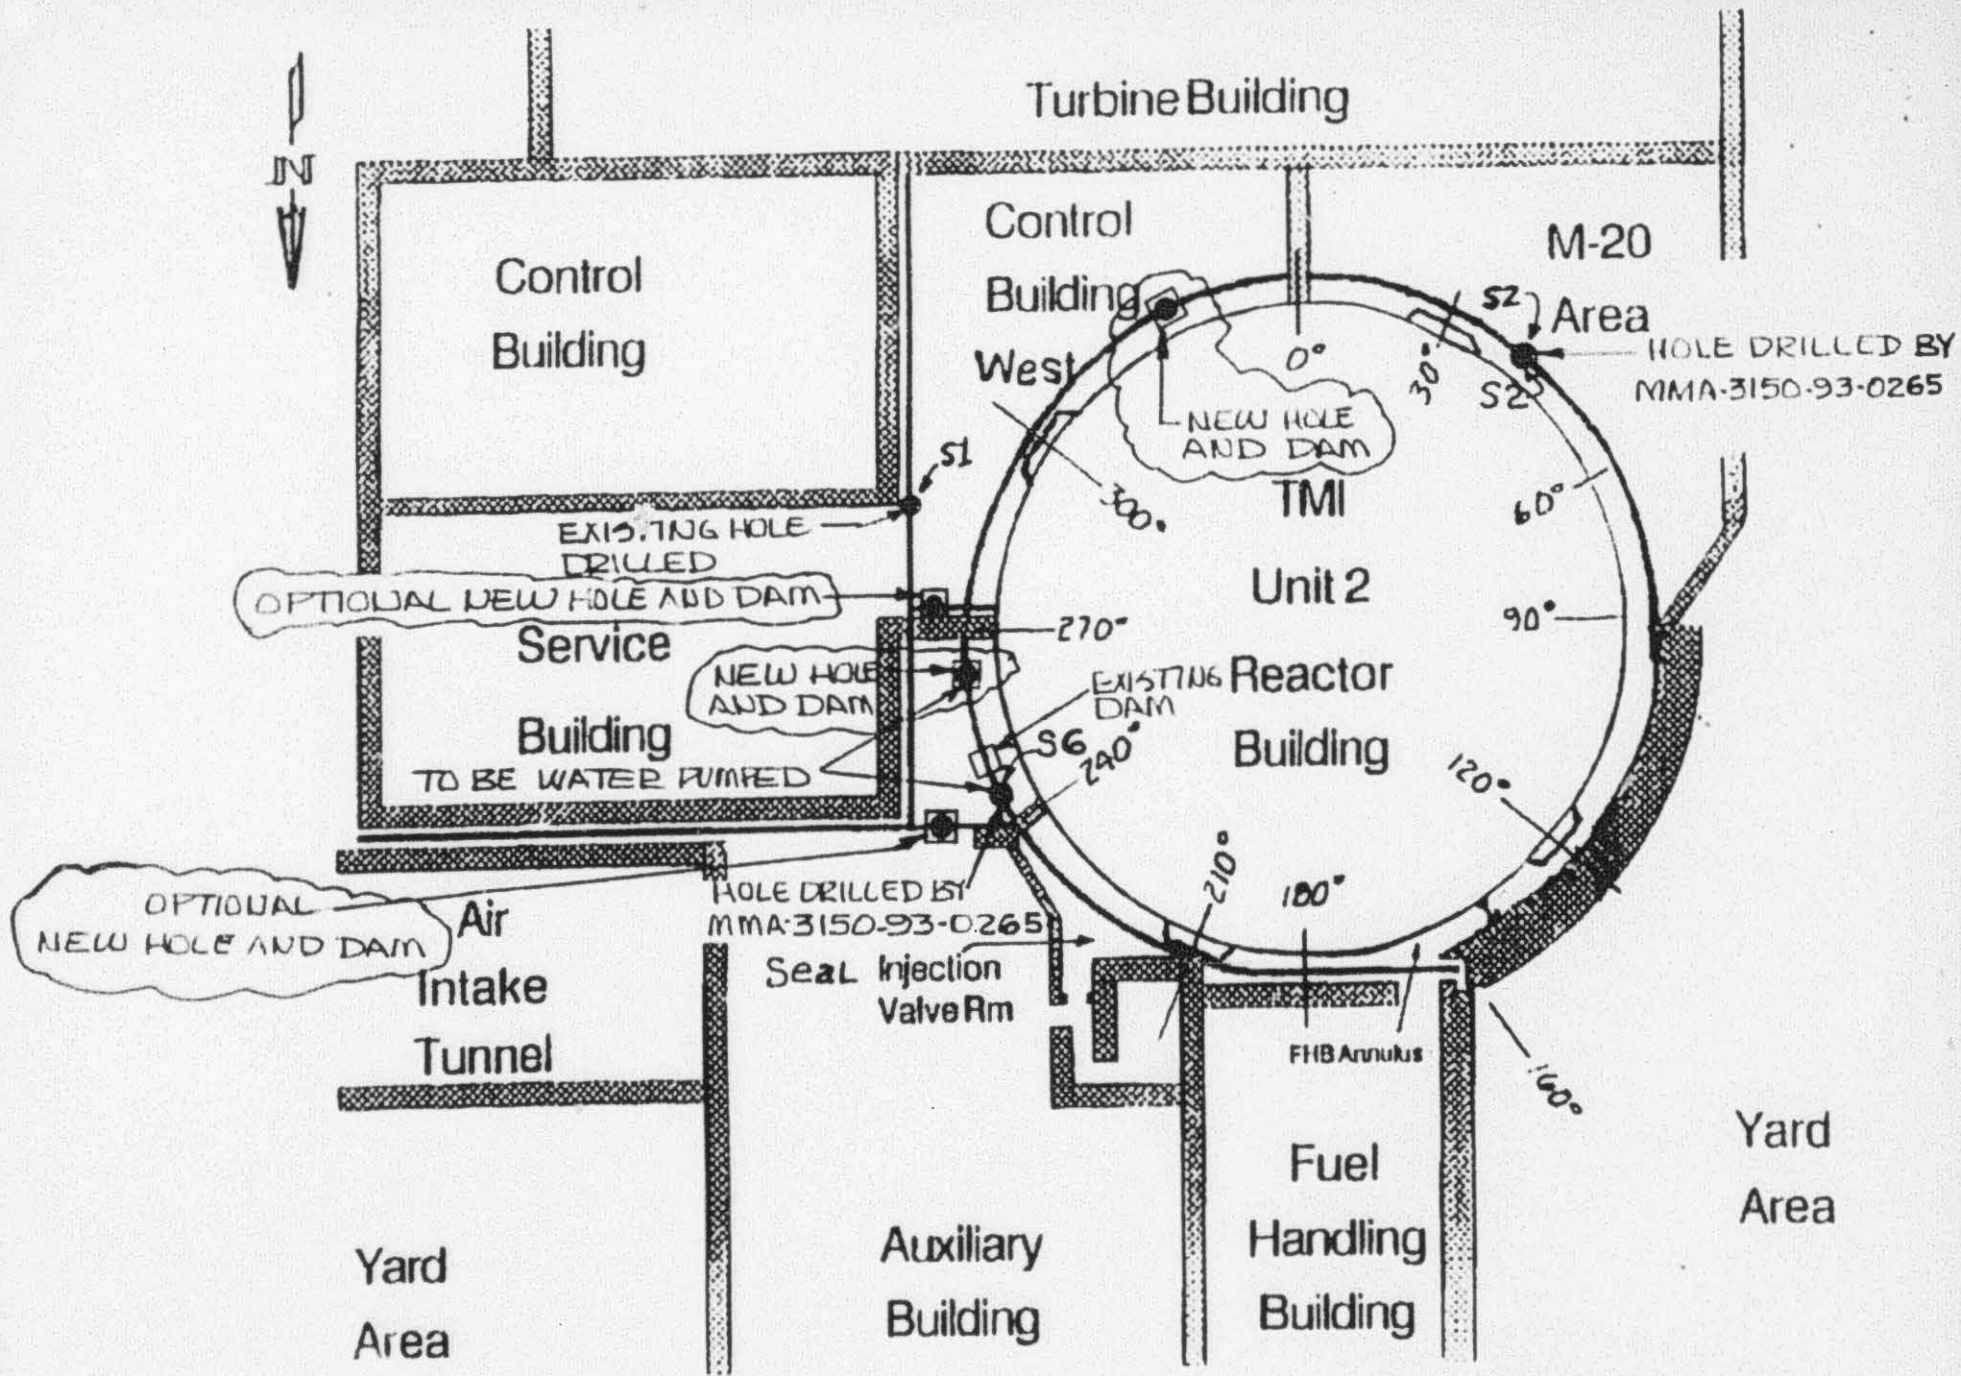
FIGURE 1

The TMI-2 cork seam is a cork-filled construction joint located between the various major structures at TMI-2 (See Figure 1). Its purpose is to accommodate differential expansion between the buildings and to attenuate any vibration/wave motions that may occur.

Core boring holes were made in the M-20 and Auxiliary Building areas of the seam (Figure 1, Holes S2 and S6); cork and water samples were extracted from these holes. The M-20 area was found not to be contaminated. The data retrieved from the Auxiliary Building hole (S6) was analyzed; it was determined that the 40-year Total Integrated Dose (TID) to the PVC waterstop in this area would be $6.4E5$ rads. This is less than 5% of the dose that would cause degradation of the material.

1. A 4" diameter core bore will be drilled in the cork seam in the Control Building-West area and a dam installed to prevent contamination in the seam from spreading into the M-20 area, which is presently not contaminated.
2. In 1986, a dam was installed just south of the S6 hole. It is not known whether it is working or not. Therefore, a 4" diameter core bore will be drilled in the cork seam in the Auxiliary Building between the existing dam and the Auxiliary/Service Building wall. Another dam will be installed to prevent further contamination spread into the Service/Control Building-West area. Prior to installing the new dam at this location, the contaminated water in the seam will be pumped out into a barrel, sampled, and then transferred to the plants' Radioactive Water Storage System, pending future processing

The need for further drilling and dam installation at the two locations noted on Figure 1 will then be determined. In addition, there is the possibility for further removal of cork material and subsequent capping of the cork seam.

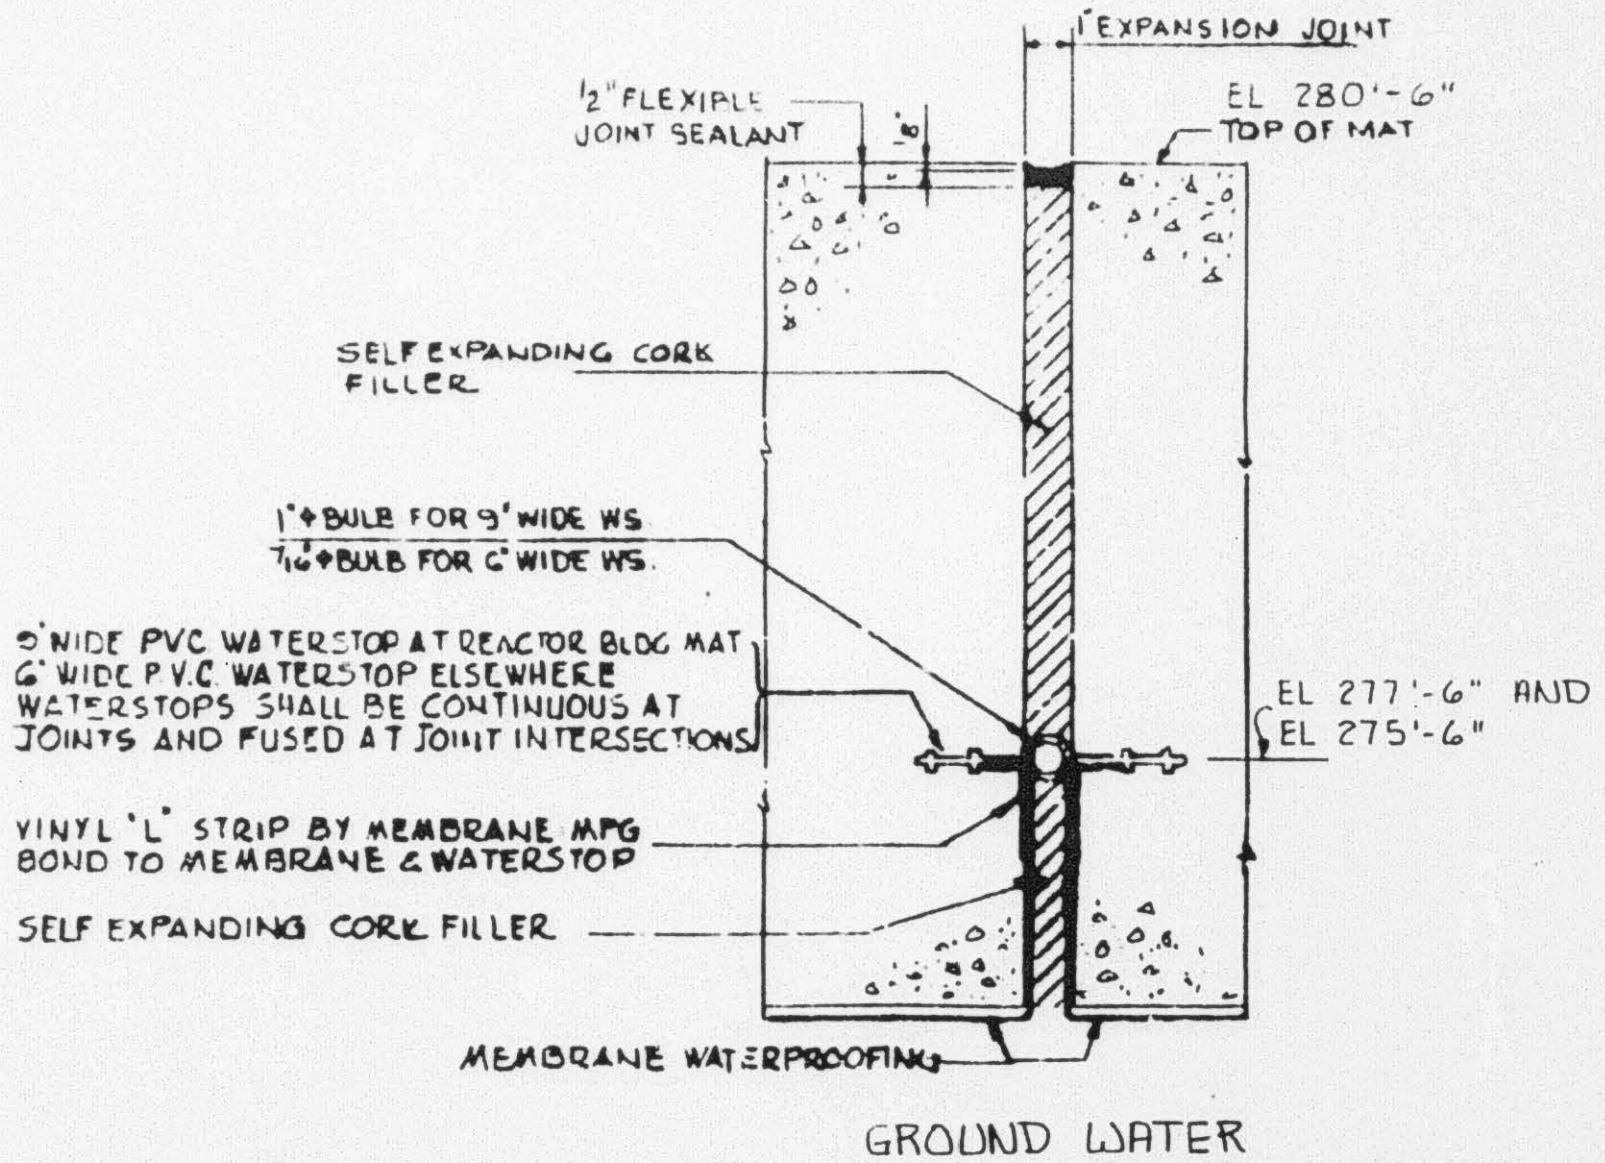
FIGURE 2

During the TMI-2 accident, the cork seam located in the Auxiliary Building Seal Injection Valve Room (SIVR) was contaminated with radioactive water. Attempts to contain the contamination within the room have been unsuccessful. During the past 14 years, radioactive material has spread along the joint in one direction into the Annulus, and in the other direction into the Auxiliary Building, Service Building and Control Building-West. The contamination has not reached the M-20 area at this point. The radioactive contamination is prevented from entering the ground water table by a PVC waterstop (See Figure 2) and thus represents no threat to the health and safety of the public.
