Three Mile Island Nuclear Station Unit 2 (TMI-2)
Operating License No. DPR-73
Docket No. 50-320
TMI-2 Additional Information of Cork Seam

RESPONSE TO REQUEST FOR ADDITIONAL INFORMATION ON TMI-2 CORK SEAM CONTAMINATION

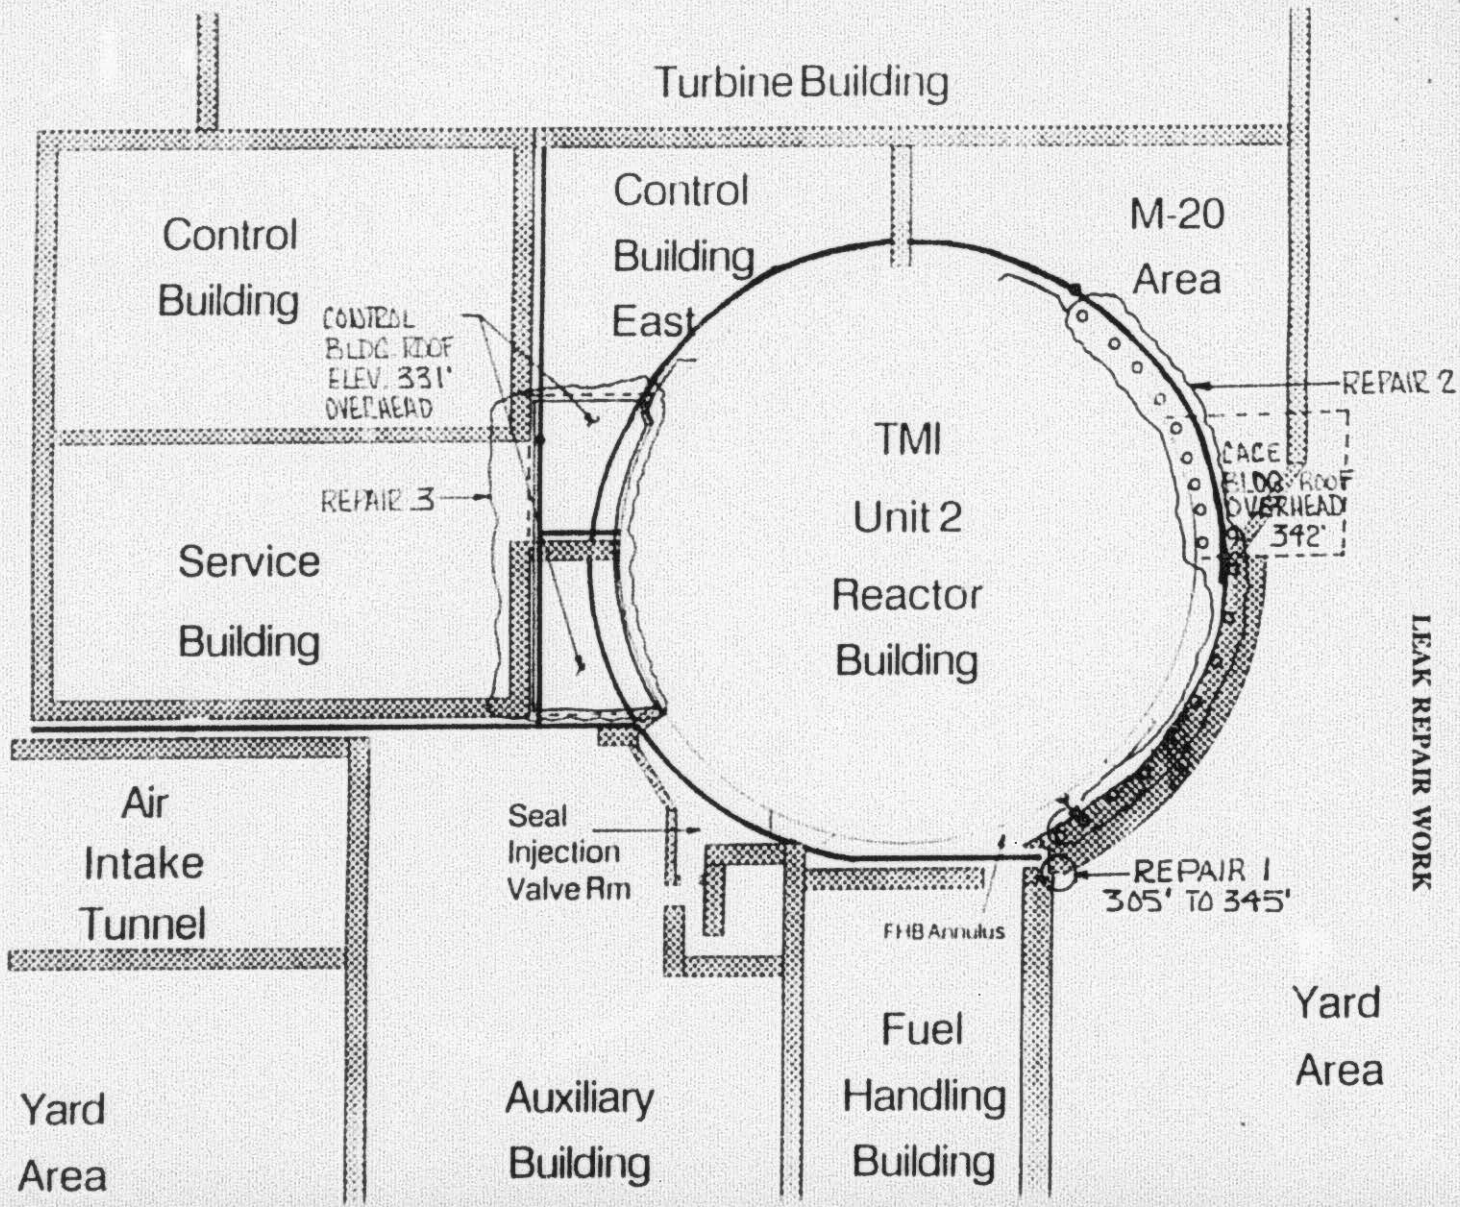
FIGURE 1

RESPONSE: Leak repair work is proceeding in three areas at TMI-2 (See Figure 1). Repair 1 repaired the outside vertical seam at the corner of the Fuel Handling Building (FHB) and the Reactor Building, elevation 305' to 345'. This work was completed on November 19, 1993; the water leakage into the FHB Annulus 280' area following a heavy rain has been practically eliminated.

LEAK REPAIR WORK

Repair 2 will mitigate water leakage into the M-20 area via the reactor wall corridor, elevation 305', and the CACE/Equipment Hatch Building roof, elevation 342'. This work is expected to be completed by December 15, 1993.

Repair 3 will mitigate the water leakage into the Control Building East area via the roof over the Personnel Hatch/Hot Instrument Shop, elevation 331'-6". This work is expected to be completed by December 31, 1993.

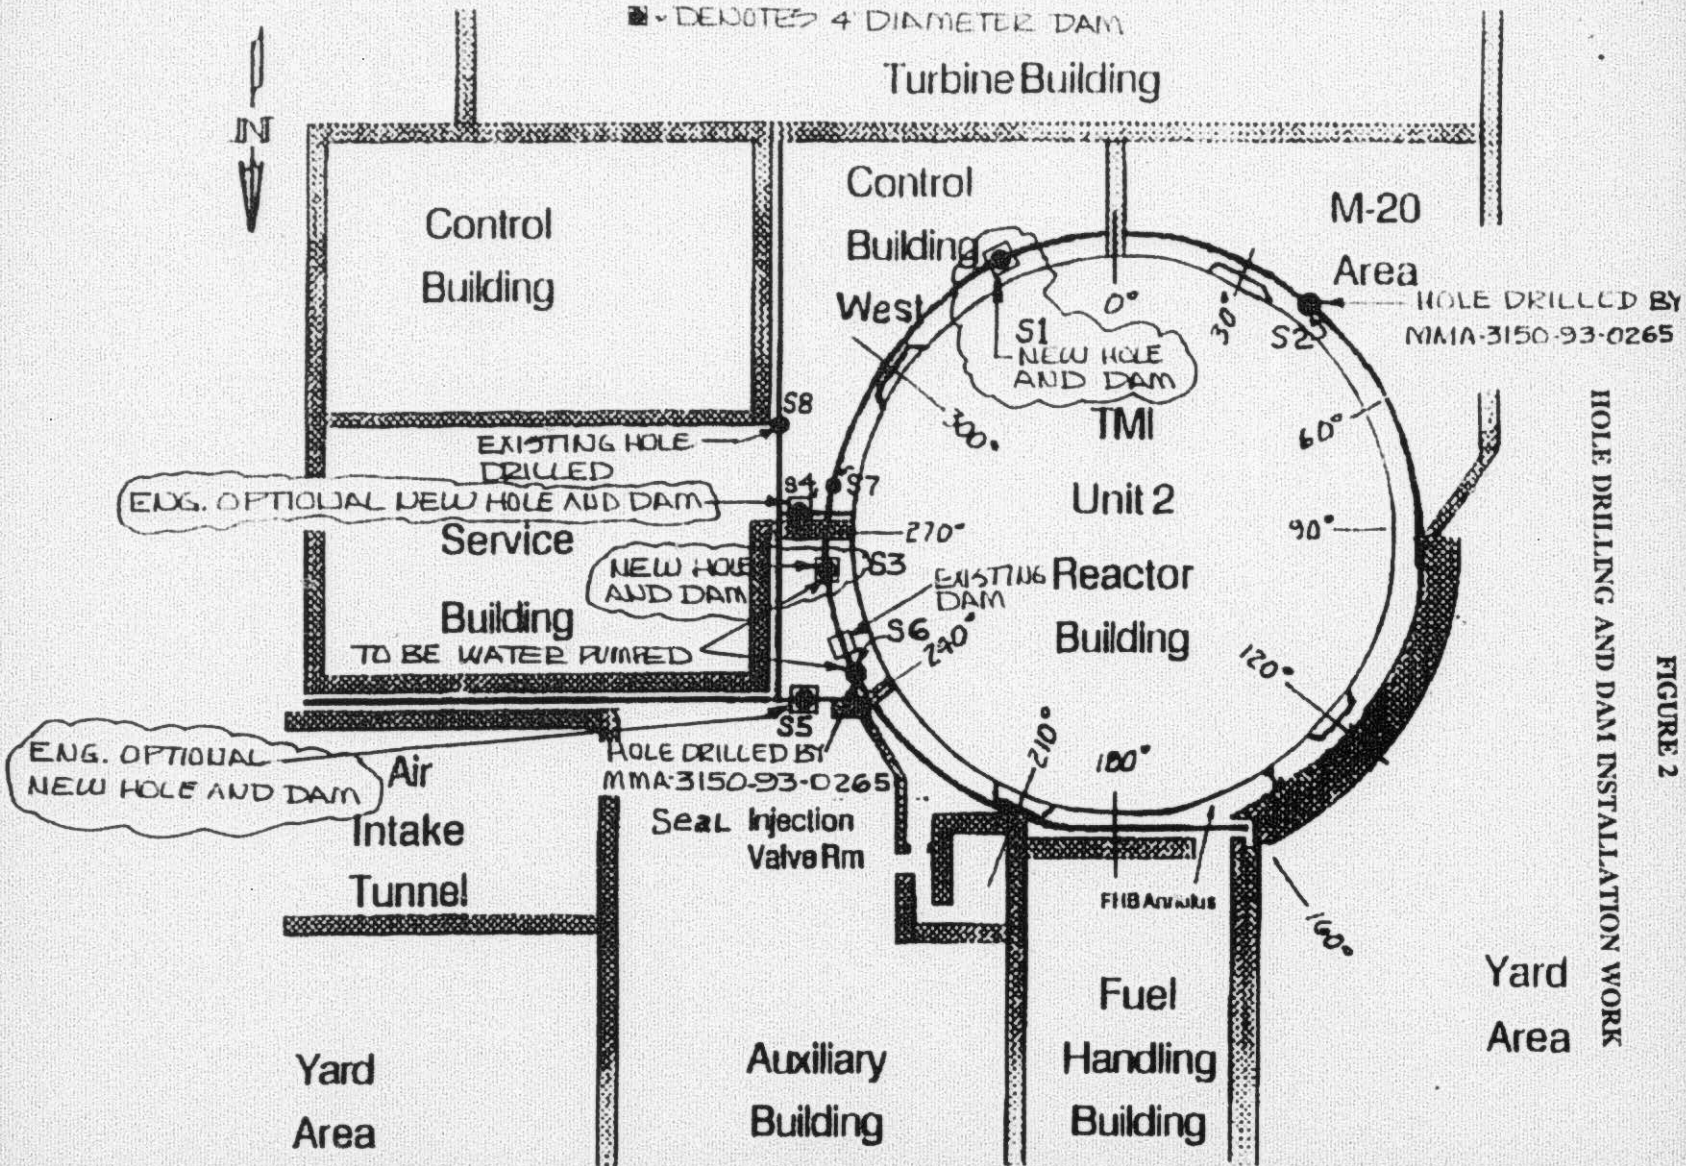
FIGURE 2

HOLE DRILLING AND DAM INSTALLATION WORK

RESPONSE: During the removal of water from the cork seam, four four-inch diameter dams will be installed to prevent contamination from spreading and to provide monitoring locations, and two additional one-inch diameter holes (2 currently exist) will be drilled for pumping (See Figure 2). The dams will be made from an injectable polyurethane grout. This material adheres to wet surfaces and expands to form a closed cell foam that will fill any gaps in the concrete adjacent to the cork seam. In addition, after the dams and pumping/monitoring holes are installed and the water is removed, GPU Nuclear will evaluate whether additional actions are required, i.e., removal of cork material or capping of the cork seam.

After the water removal process has been completed, a liquid level monitoring device will be inserted in each of the four sections in the one-inch diameter holes. At least monthly, for a period of one year, these holes will be monitored for water entering the seam. The monitoring program will be reevaluated after the initial one year period.
