Subject: Three Mile Island Nuclear Station, Unit 2 (TMI-2)
Operating License No. DPR-73
Docket No. 50-320
TMI-2 Cork Seam

TMI-2 CORK SEAM MODIFICATIONS

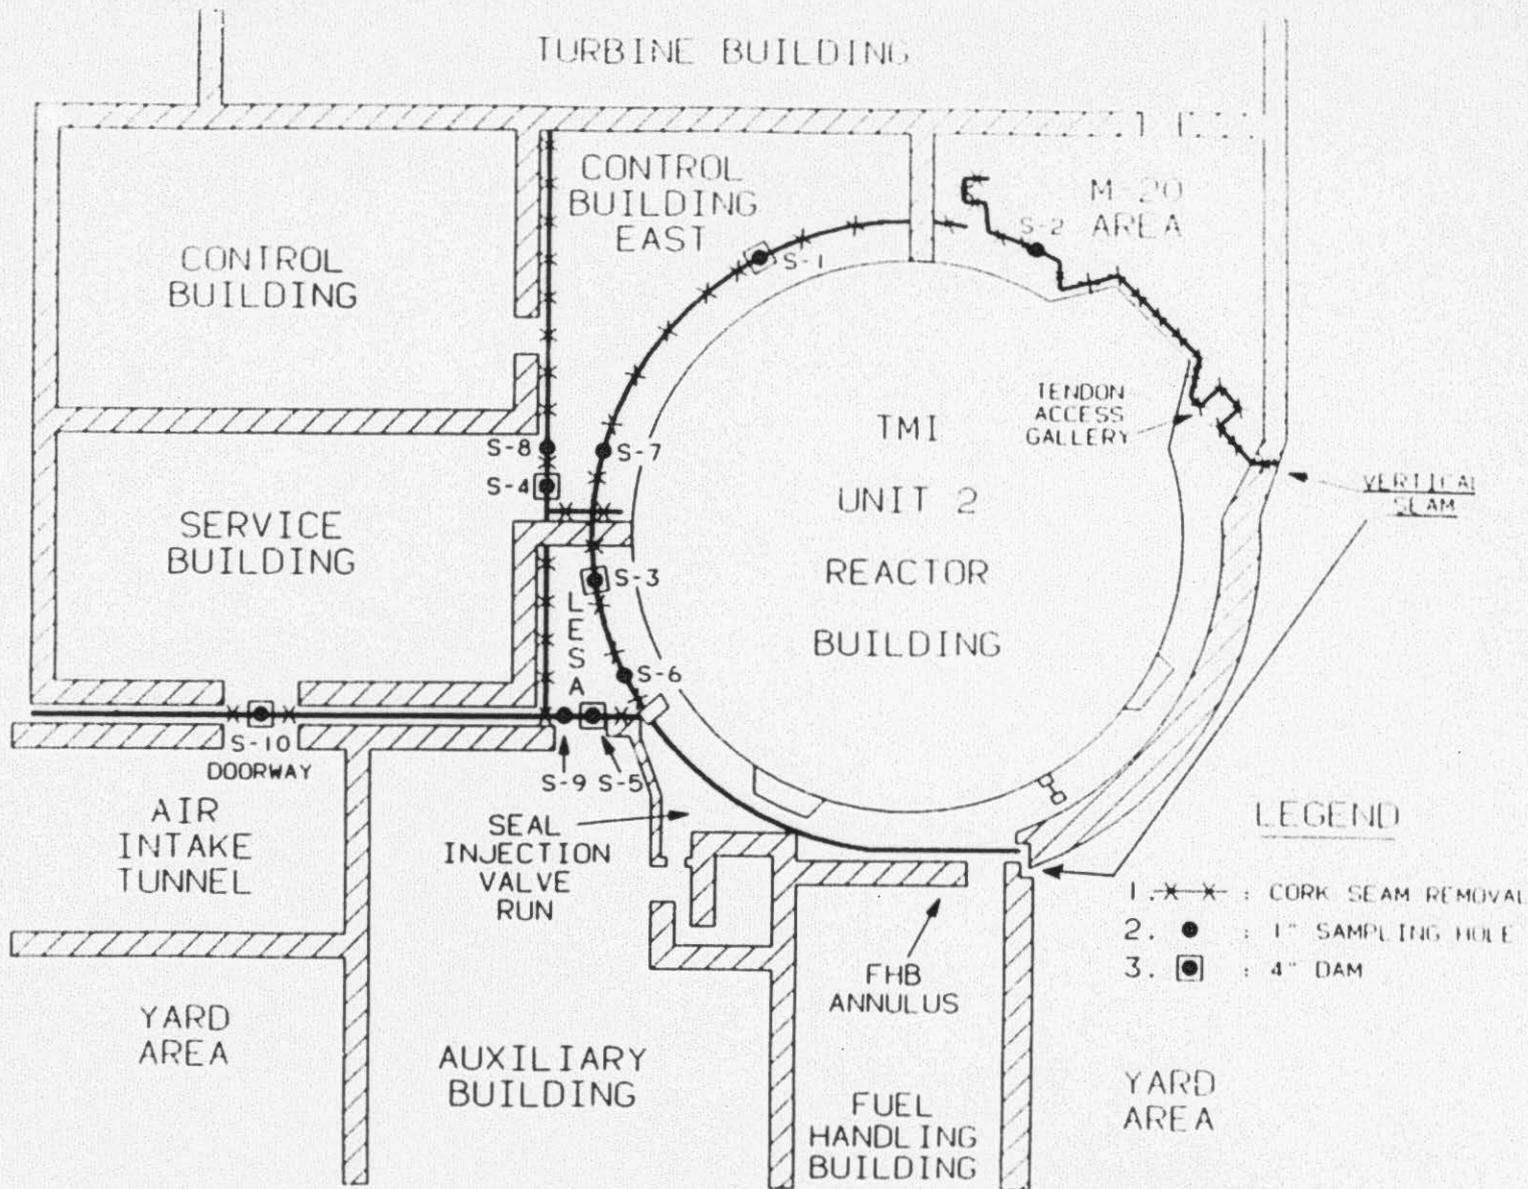
FIG 1: GENERAL ARRANGEMENT OF THE CORK SEAM AREA

Modifications have been made to the cork seam to allow periodic monitoring of the water levels in the joint, to permit periodic water removal, and to prevent water and contamination migration within the cork filled joint. Figure 1 shows the locations where the cork seam was penetrated and modifications performed. At locations S-2, S-6, S-7, S-8, and S-9, 1 inch diameter holes were drilled into the cork seam to a depth of about 1 inch above the PVC water stop. A perforated tube was inserted into these monitoring holes and acts much like a conventional well-point in providing a means of pumping accumulated water out of the seam in the vicinity. Also, the monitor pipes have been fitted with bubbler devices that allow measuring of the water level in the holes.

At locations S-1, S-3, S-4, S-5, and S-10, a 4 inch diameter hole was core bored to penetrate the cork and the adjacent concrete slab on both sides of the seam. These holes extend down to the surface of the PVC water stop. When these holes were drilled, the bottom was carefully probed with a blunt instrument to verify that the hole had actually reached the water stop and to verify that the water stop had not been breached and the material was still pliable. Where possible, the water stop was visually inspected. The hole was then filled with a moisture activated expandable polyurethane foam material that will bond well with both the concrete and the water stop material. These locations serve as dams that will block water migration within the cork seam.

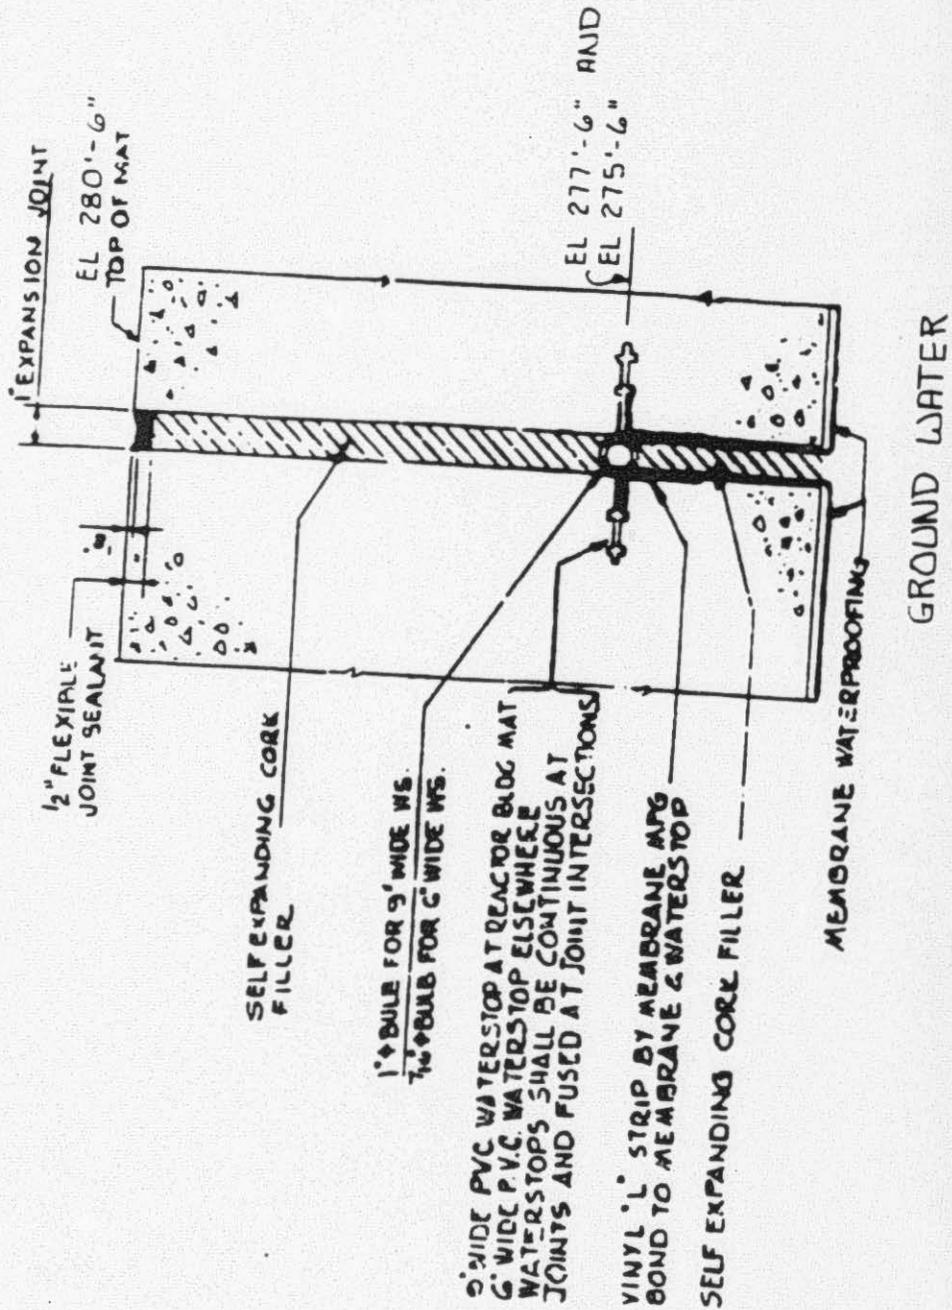
FIGURE 2

The TMI-2 cork seam is a construction joint between the various major facility structures. Its purpose is to allow for differential expansion between the adjoining building structures and to attenuate any vibration or movement that may occur during a seismic event. The seam consists of a 1 to 2 inch space between adjacent concrete floor/base mat slabs. The gap is filled with a sheet cork material that was placed in position during the concrete pour. The bottom of the seam is sealed to prevent groundwater intrusion from below by a PVC plastic water stop that bridges the adjacent slabs at a depth of about 60 inches below the top of the slab (42 inches in some areas). A plan view showing the extent of the cork seam is in the attached Figure 1, and a cross-section showing the details of a typical portion of the cork seam is in Figure 2.

To prevent any additional spread of contamination from the cork seam in the future, work is presently in progress to install a seal over the top of the cork filled joint. The work involved excavating about 3 inches of cork from the top of the joint along all accessible areas of the full length of the seam. The concrete edges will be surface prepped and primed where required, an open cell polyurethane foam backer bar will be packed into the joint, and the top 1 inch of the joint will be filled with a pourable polysulfide sealant. The materials chosen for this modification are expected to provide a very tight bond with the concrete and provide a good pliable contamination barrier over the surface of the cork seam. The installation of this modification is expected to be complete by the July 1994.
