**Color Photographs
Of The Three Mile Island Unit 2
Reactor Containment Building:
Volume 1—Entries 1, 2, 4, 5, 6**

October 1981

**EG&G Idaho, Inc.
Idaho Falls, Idaho 83415**

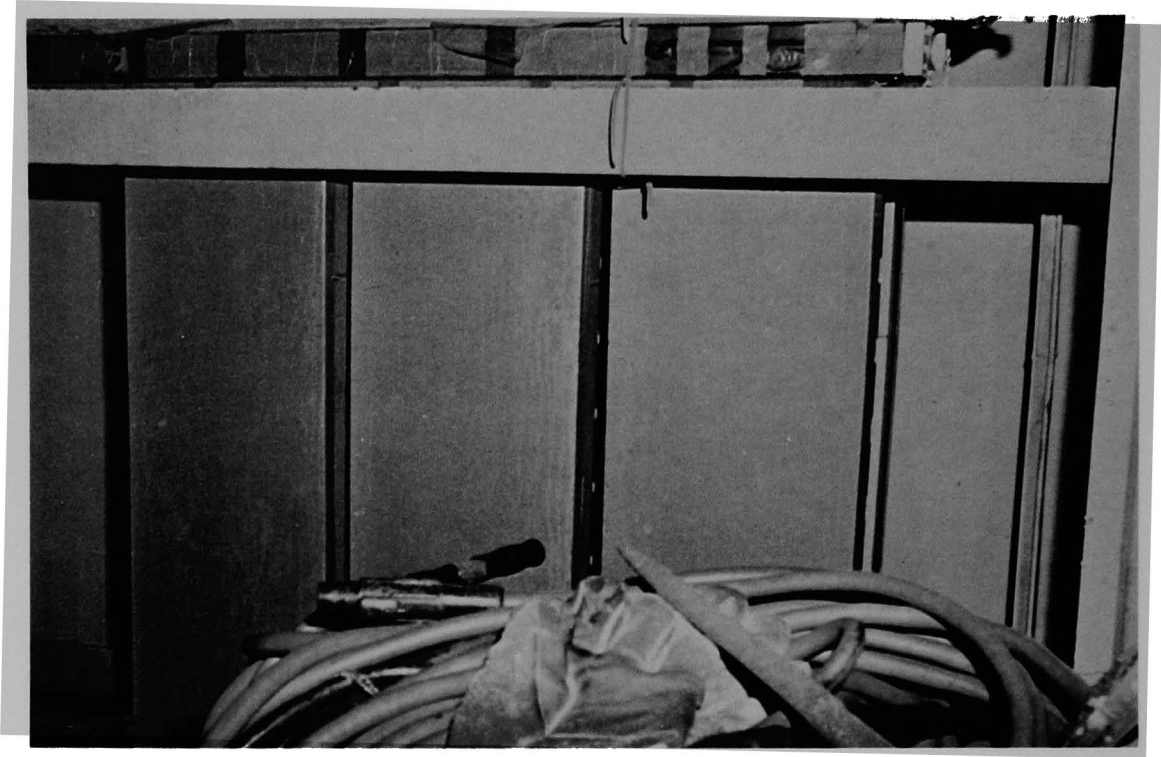
Figure 7 (1A). Gloves and coiled hose on cart just north of personnel air lock 2.

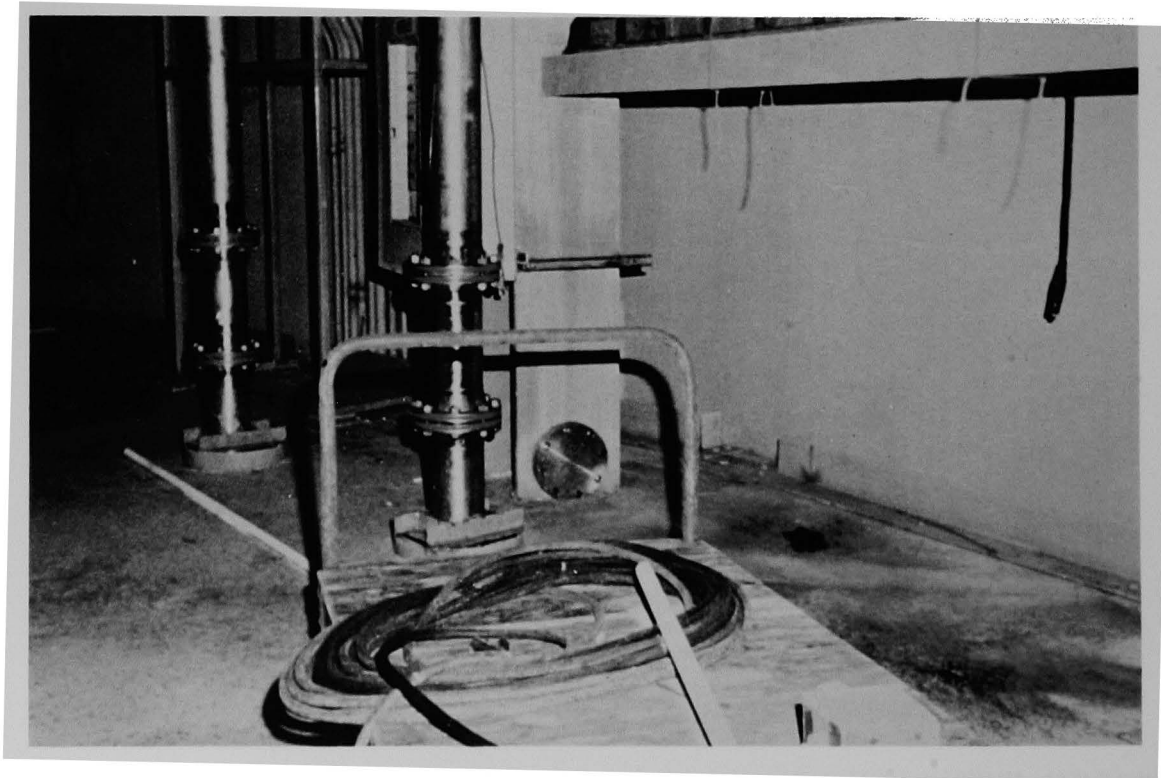
Figure 8 (1A). Coiled hose on north end of card; reactor building spray lines in background.

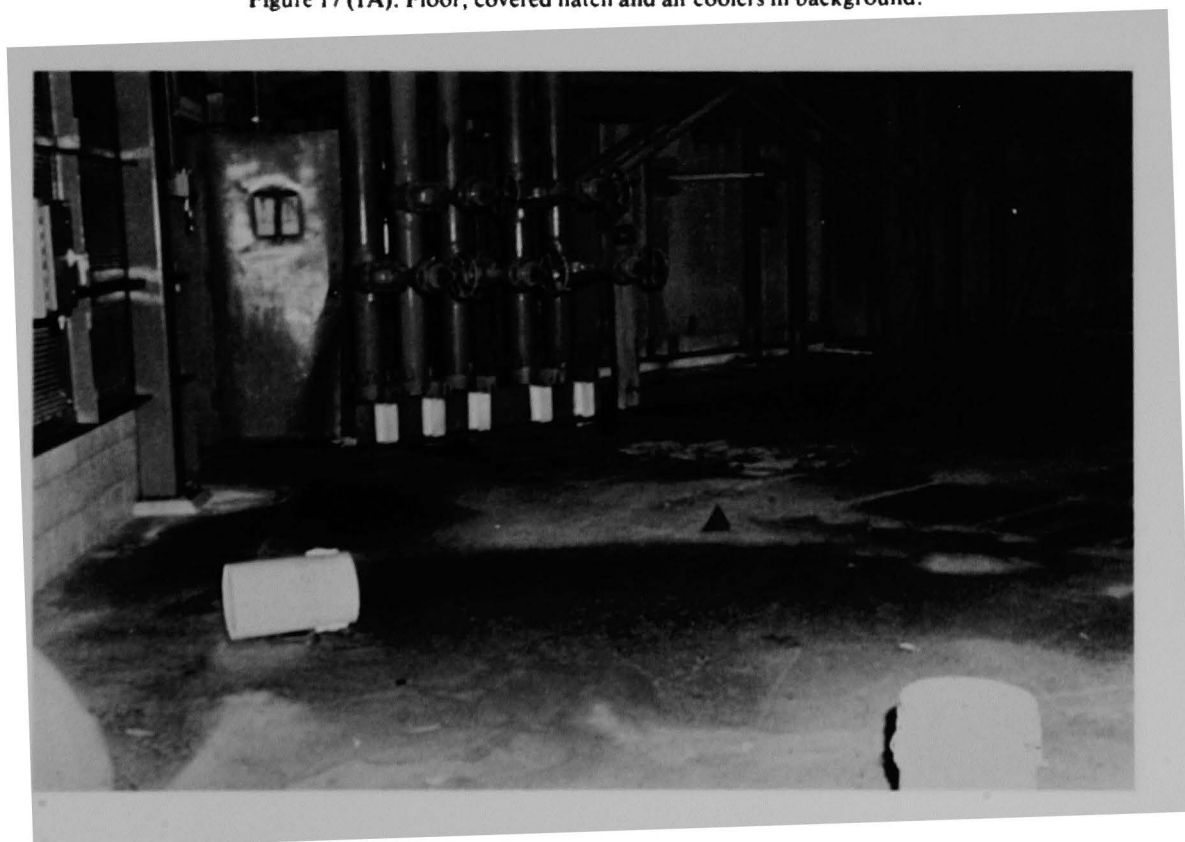
Figure 18 (1A). Floor; enclosed stairway door left, air coolers background right.

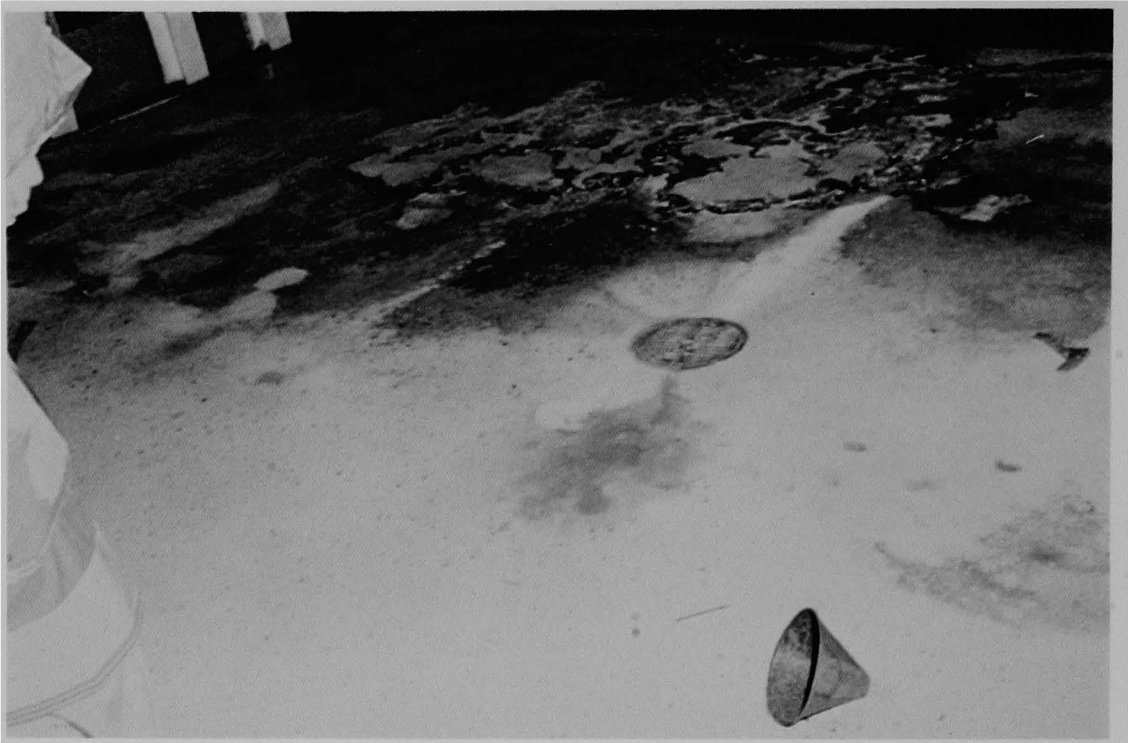
Figure 19 (1A). Floor drain and rusted funnel (center detail of Figure 18).

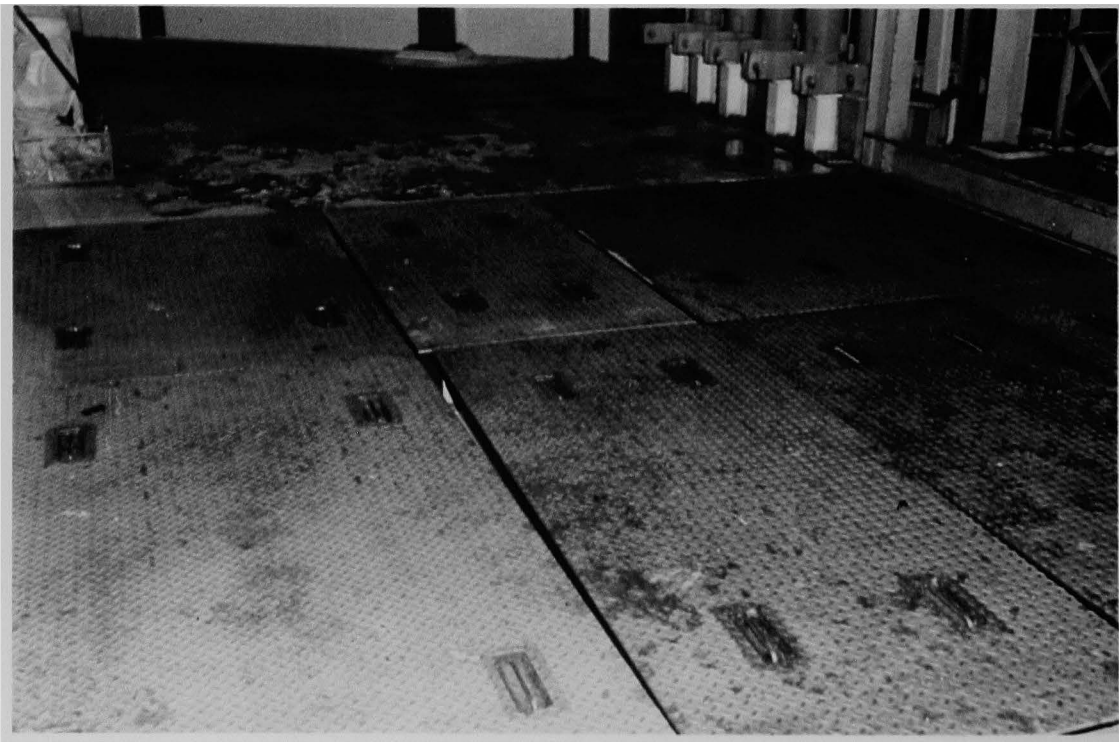
Figure 20 (2A). Covered hatch; air coolers right.

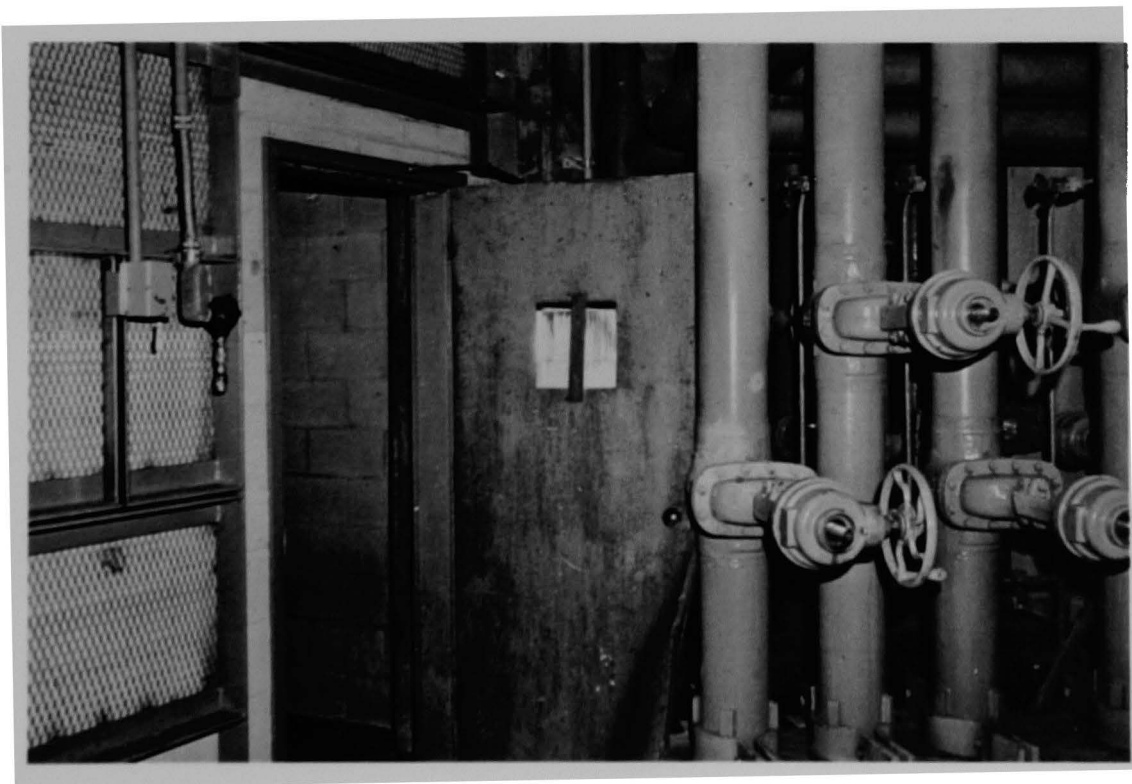
Figure 22 (4A). Door to enclosed stairway, thrust open against the river water piping associated with the air coolers.

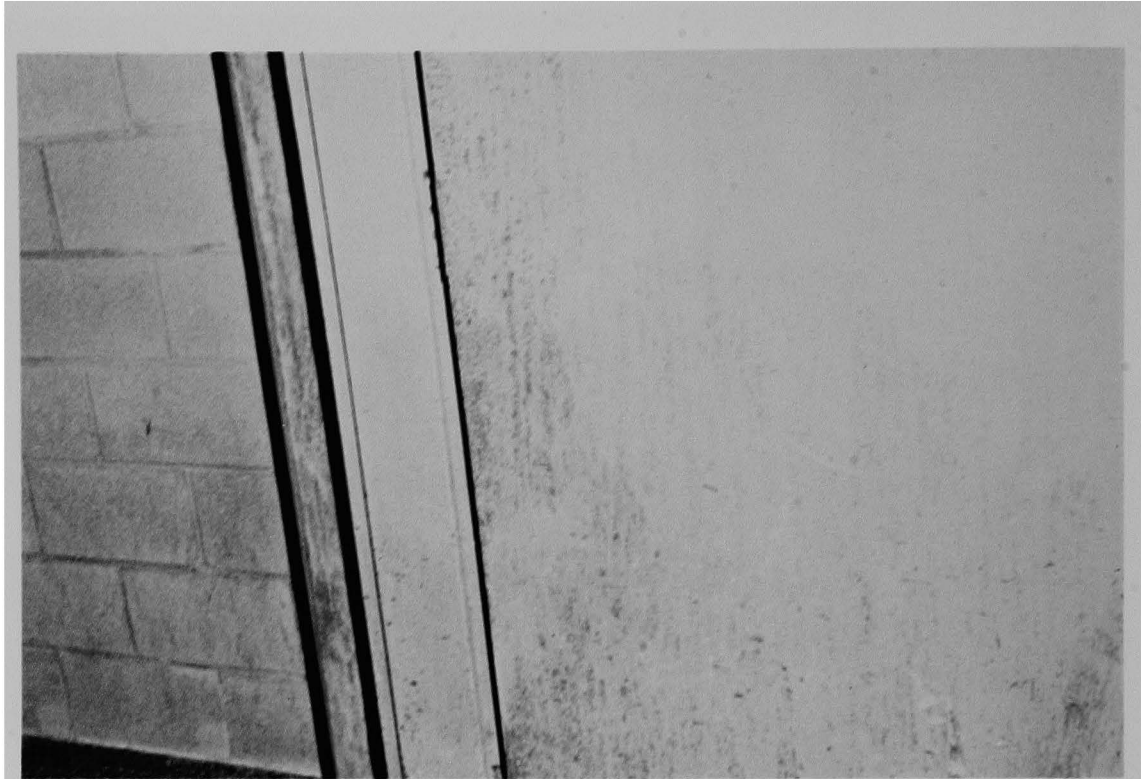
Figure 27 (1A). Surface of door to enclosed stairway.

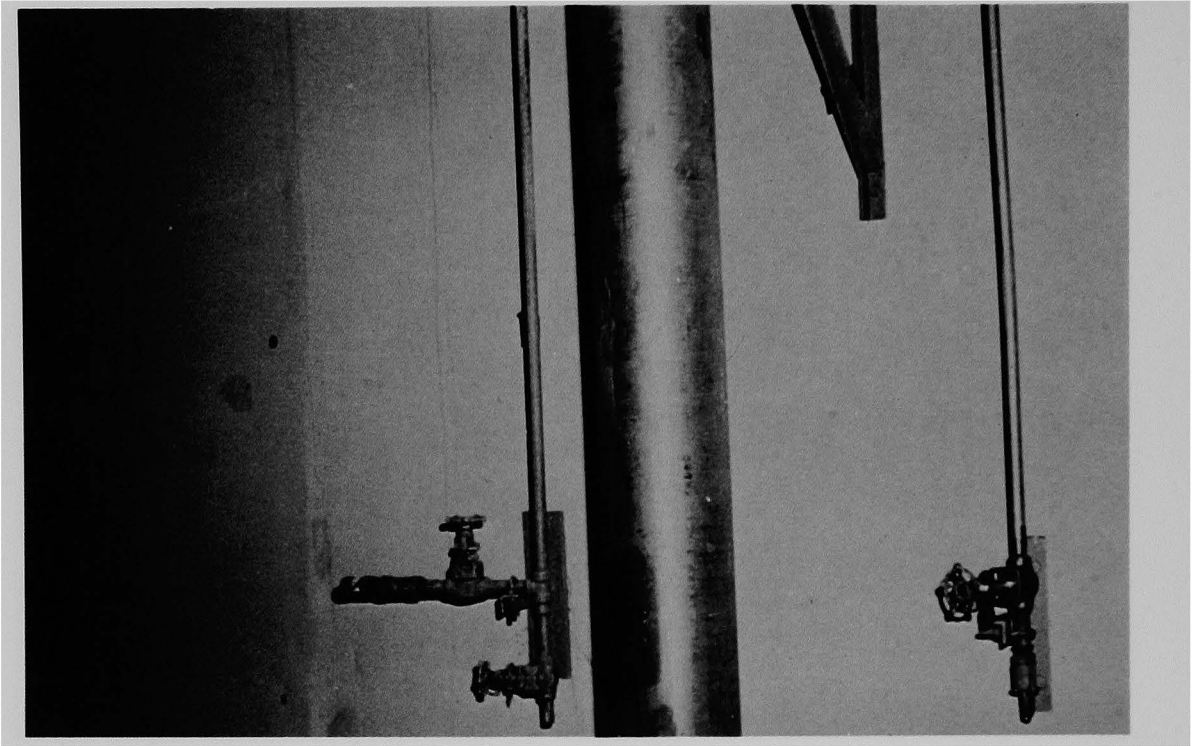
Figure 43 (1A). Pipe on D-ring wall.

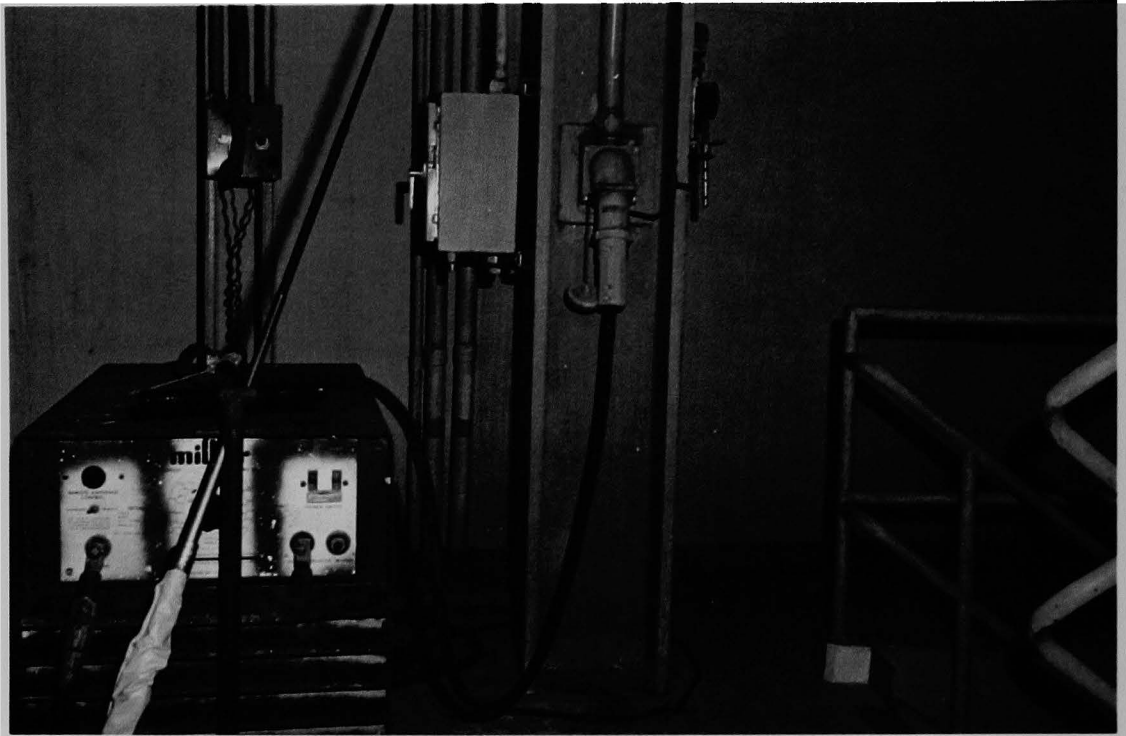
Figure 54 (2A). Rusted welding box; Gai-tronic phone in background, open stairway at right.

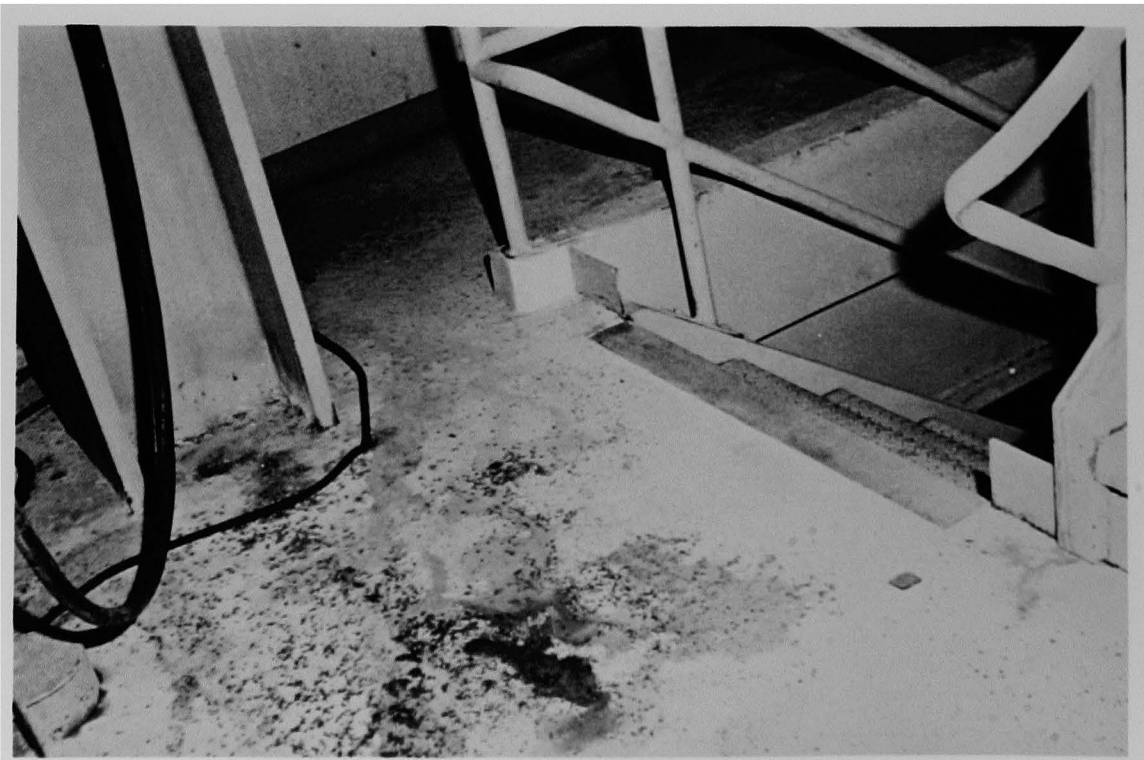
Figure 55 (1A). Stains on floor at entrance to open stairway.

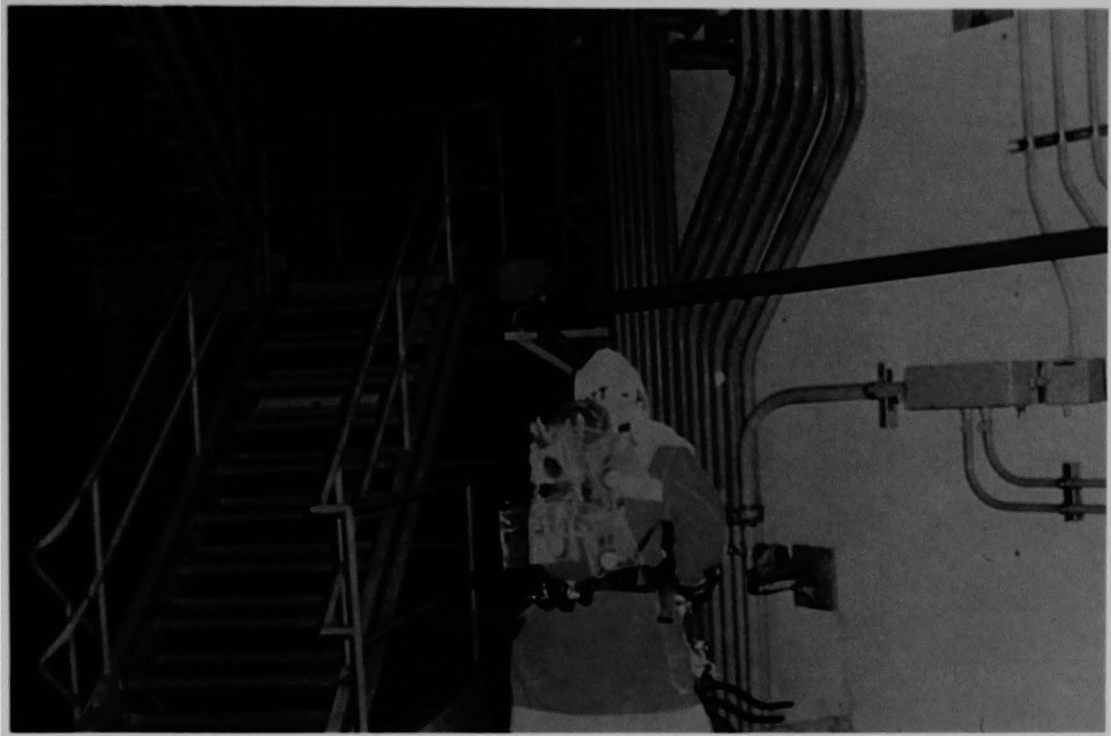
Figure 56 (1A). Open stairway, HP technician taking radiation surveys.

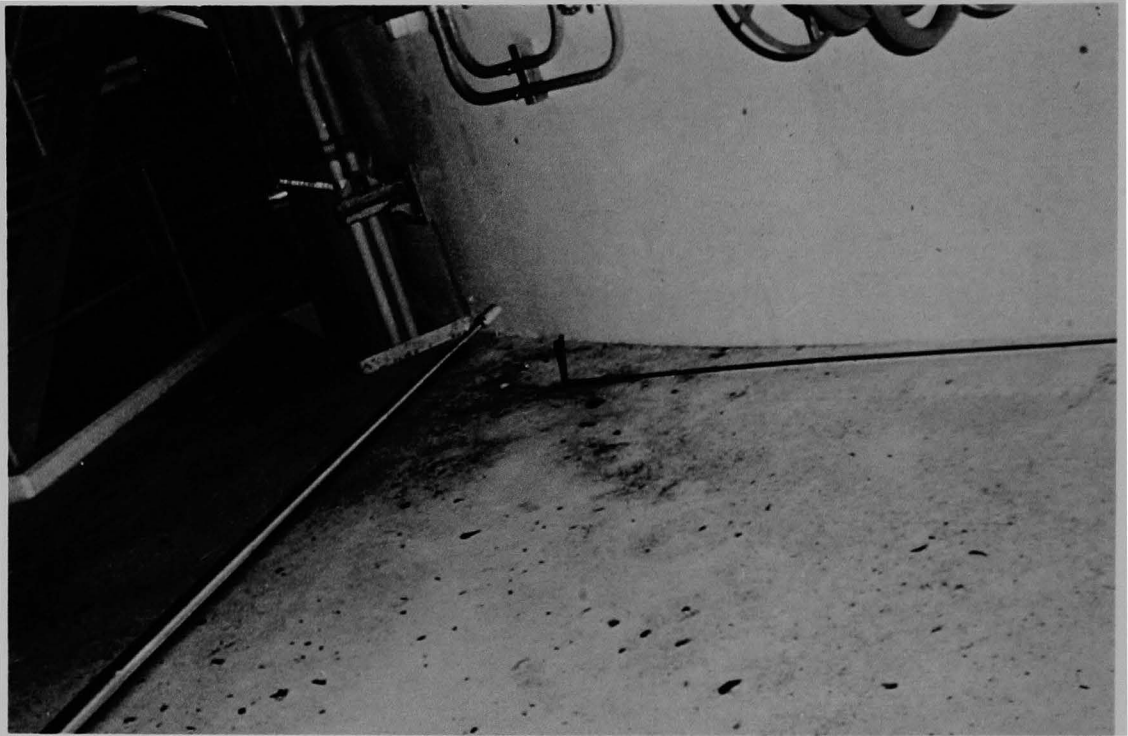
Figure 58 (1A). Broken glass on floor (teletector probe appearing from left corner of photograph).

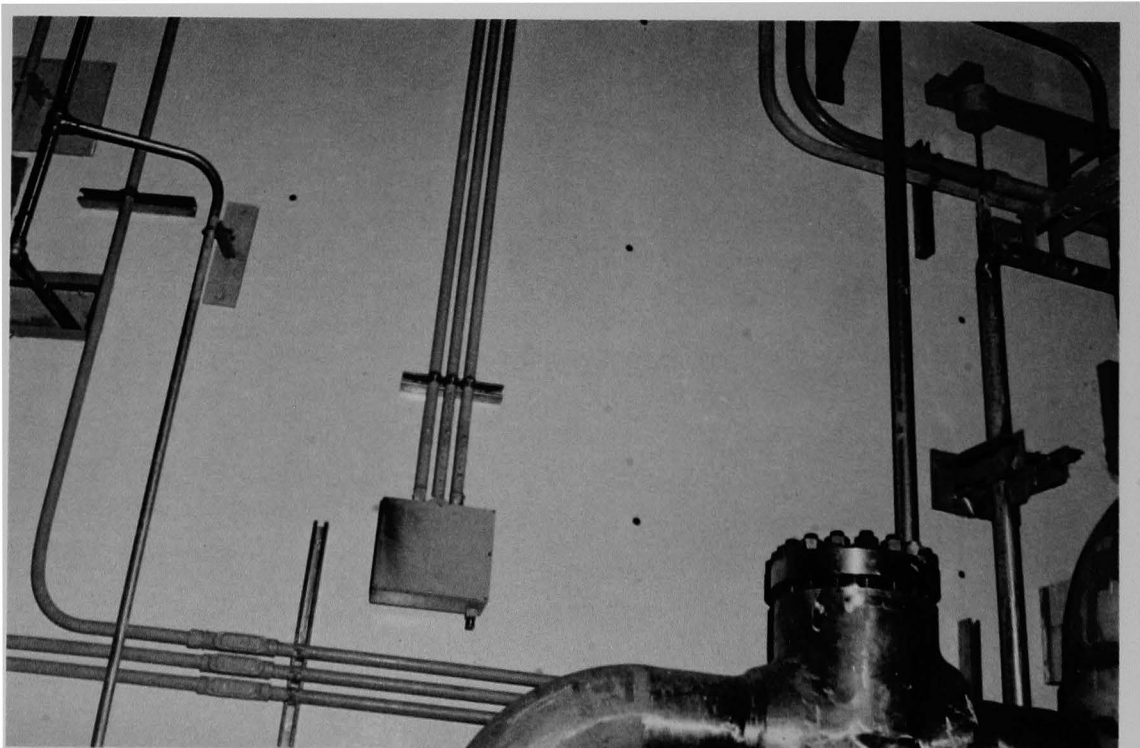
Figure 59 (2A). Circuit box, core flood B check valve, and piping along D-ring wall.

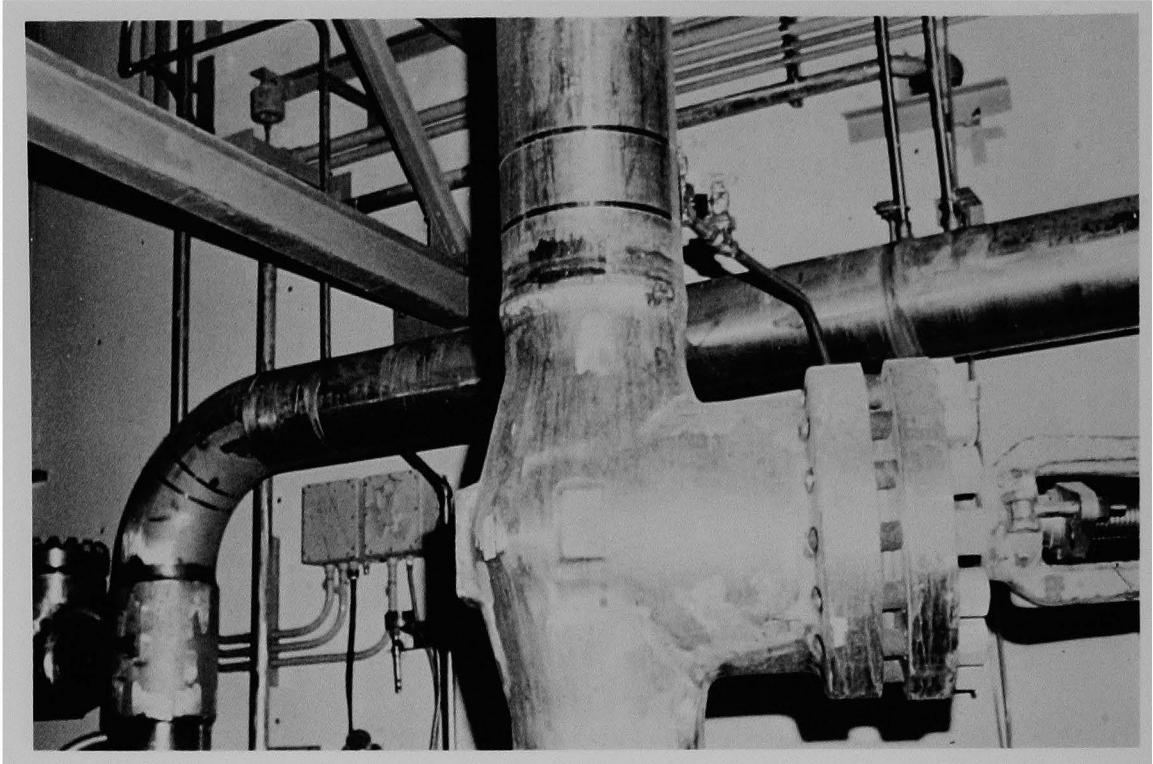
Figure 62 (1A). Check valve directly under core flood tank B.

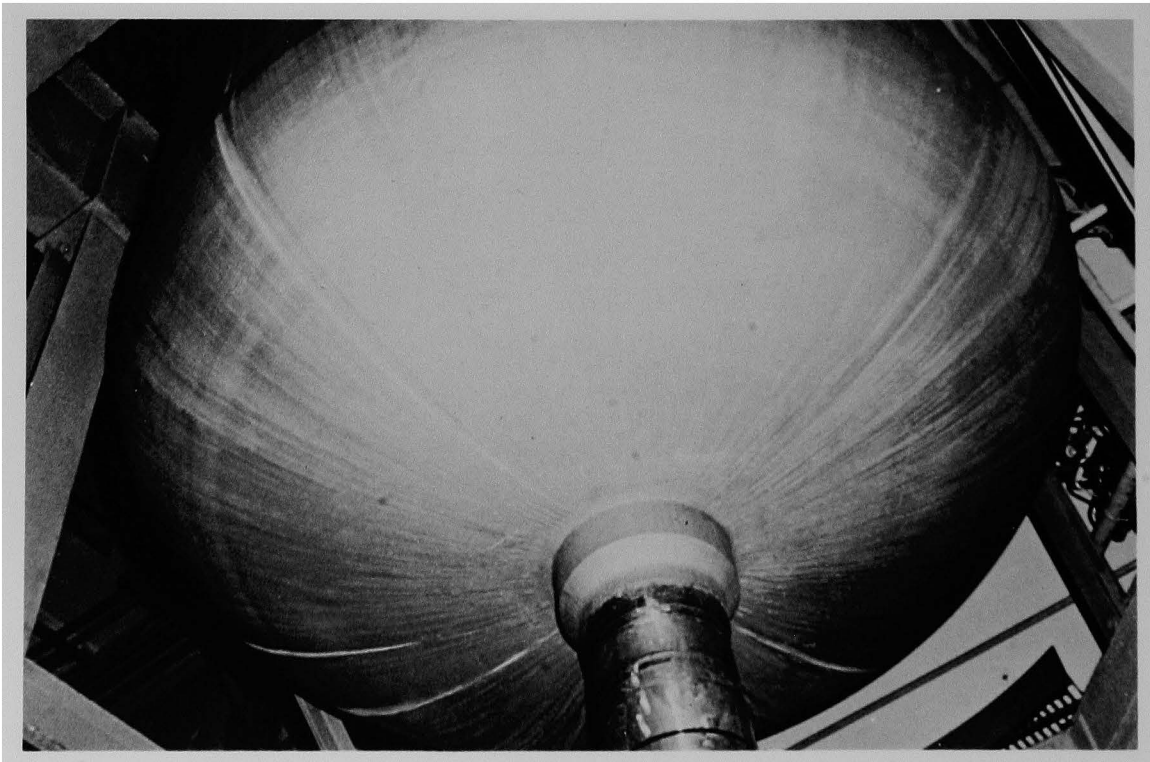
Figure 63 (1A). Bottom view of core flood tank B.

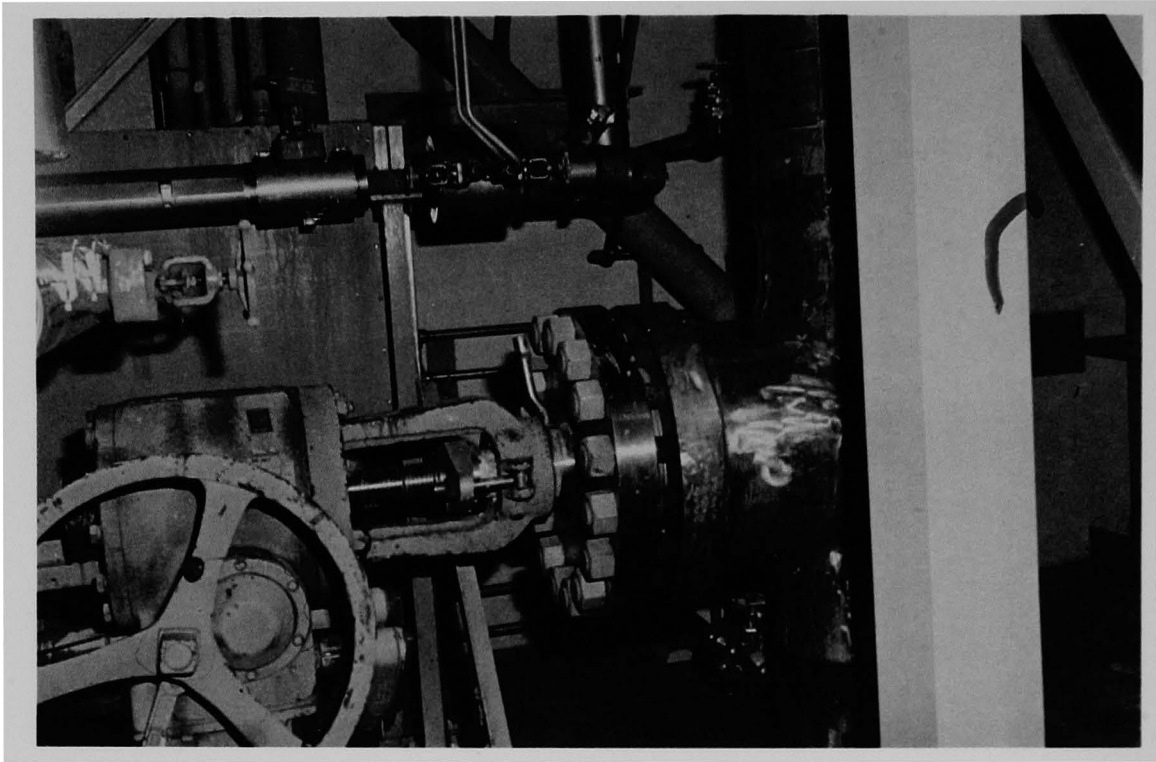
Figure 92 (6A). Stainless steel piping and valve under core flood tank A.

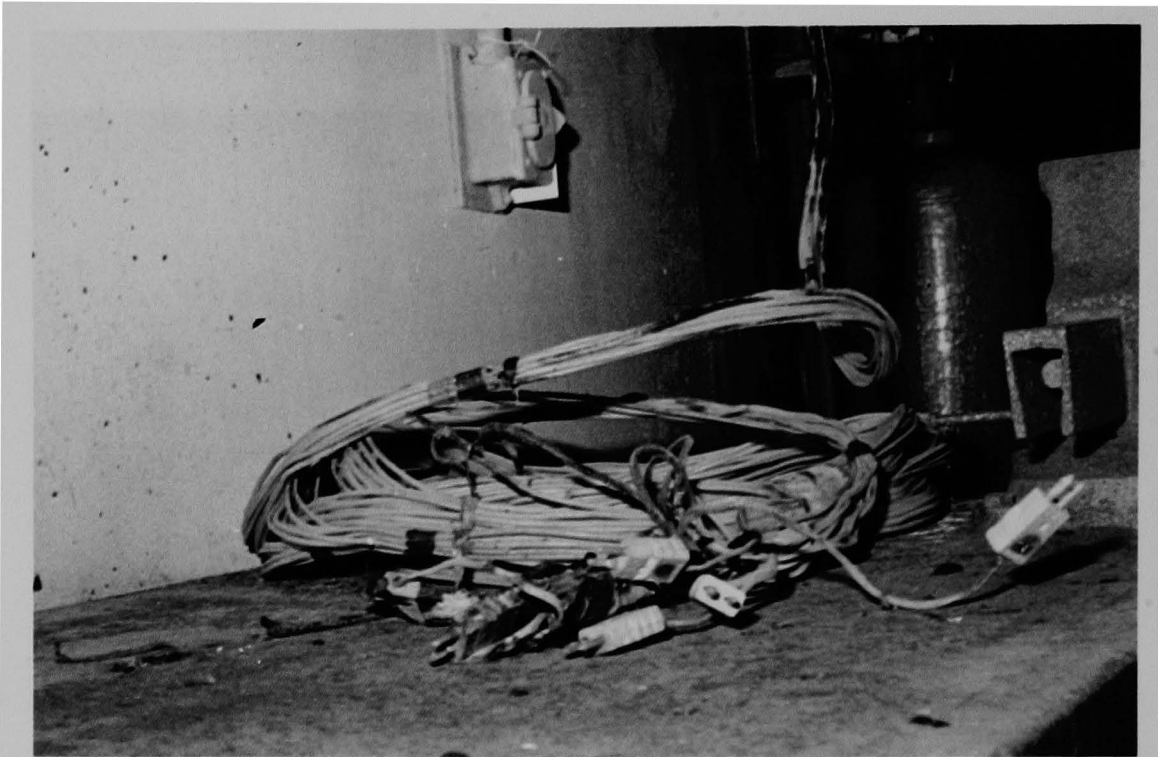
Figure 186 (4). Coil of electrical cord on work bench (see Figure 207); note blackened card and tape.

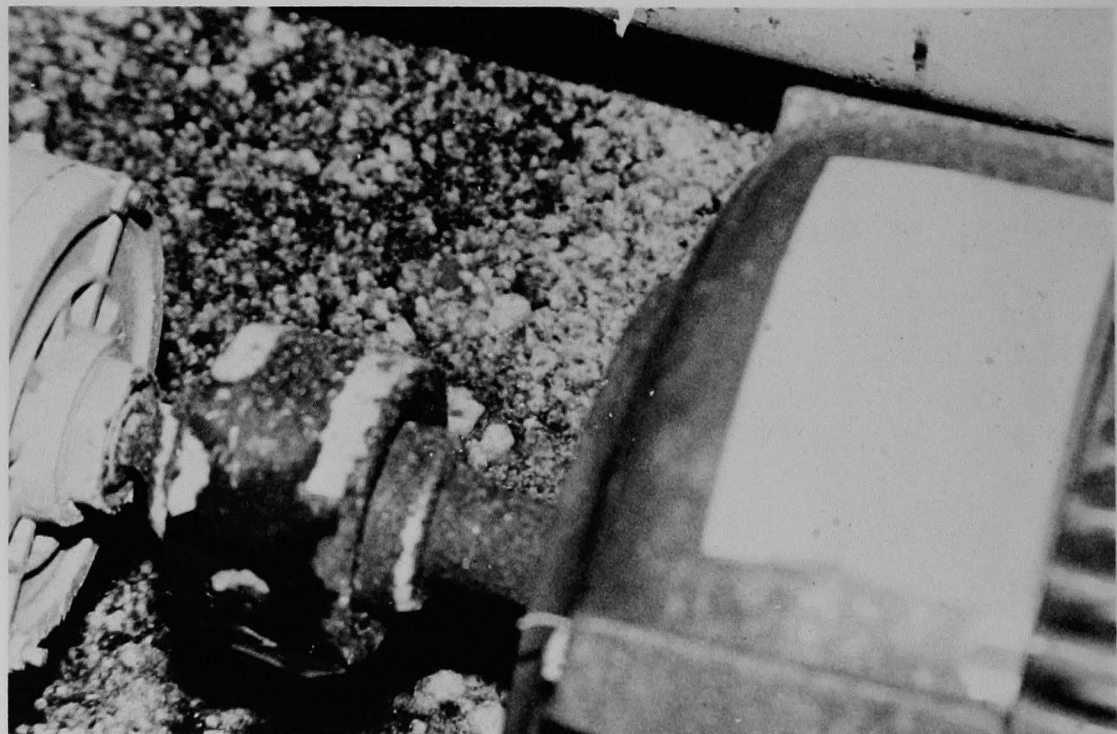
Figure 224 (5B). Rusted coupling and motor on auxiliary fuel handling bridge (see Figure 222).

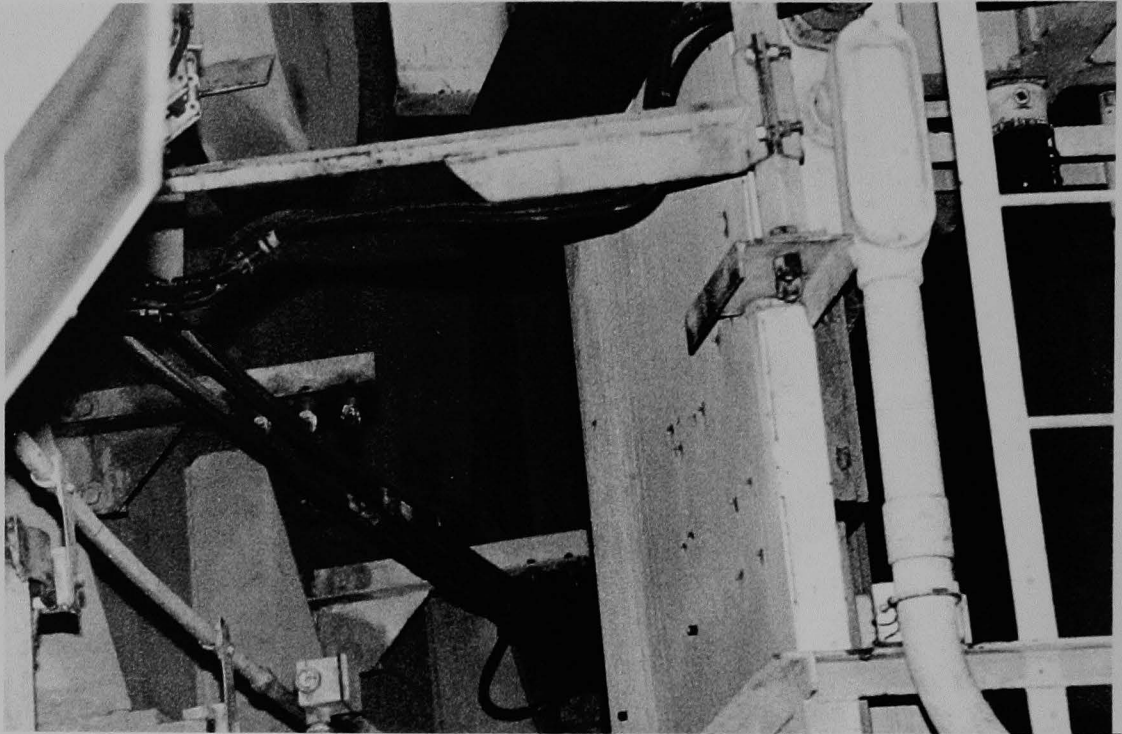
Figure 278 (5B). Polar crane power buss bars (note that one is missing, having dropped to operating deck).

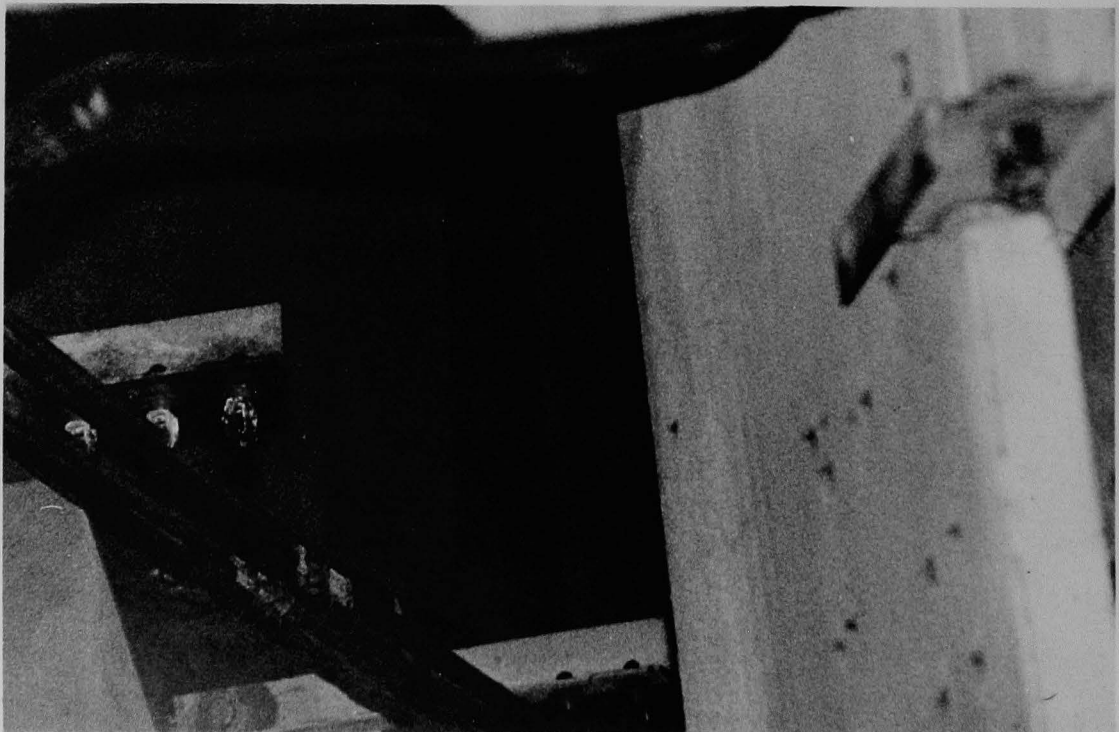
Figure 279 (5B). Closer view of the power buss bars (cf. Figure 278).

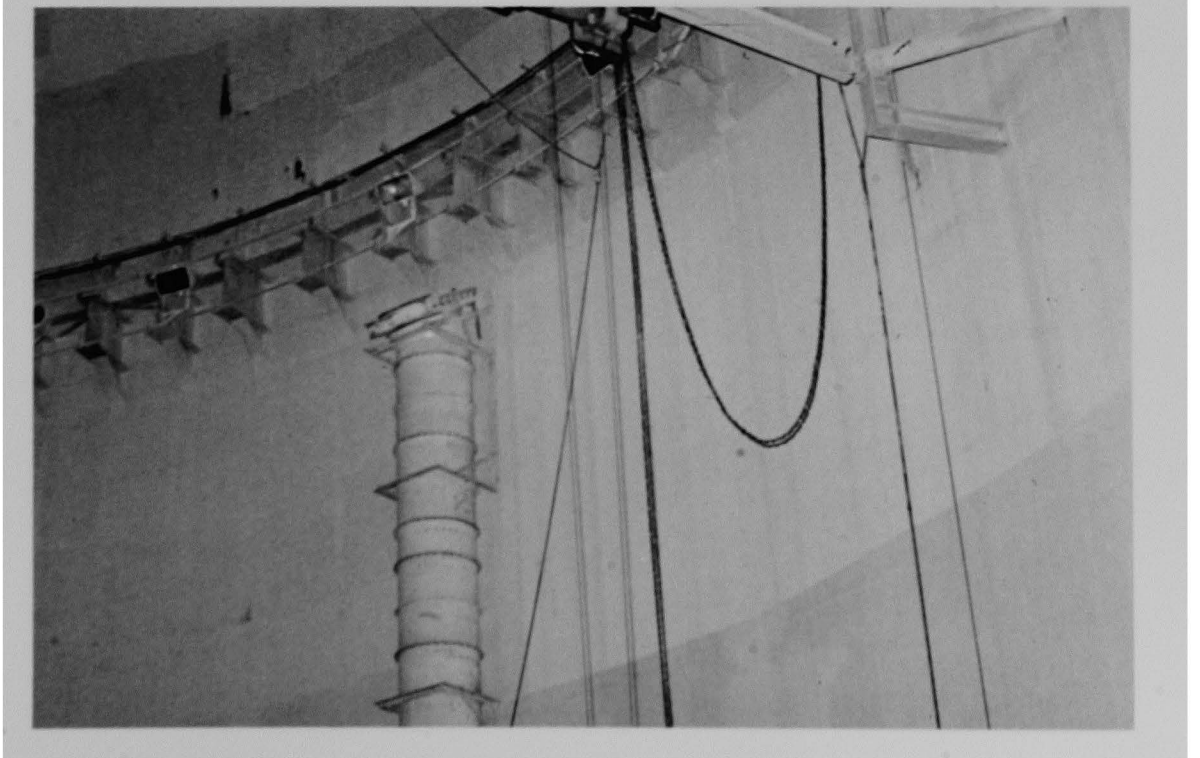
Figure 285 (4). Top of the ventilation duct; job crane right. (Note that not all lights circling the containment are on.)
