QUICK LOOK REPORT
ENTRY 3
THREE MILE ISLAND UNIT 2
OCTOBER 16, 1980

Bechtel Northern Corporation/
General Public Utilities Nuclear Corporation

This report summarizes tasks performed during the third entry at Three Mile Island Unit 2. During the entry into containment, which was made on October 16, 1980, additional beta, gamma, and neutron surveys were performed to supplement data obtained on previous entries. In addition, several maintenance tasks were completed including testing the operation of both equipment hatch doors, replacing a loose parts monitor system pre-amplifier, and removing a source range monitor. The five-man entry team accomplished these tasks in about 1-1/2 hours.

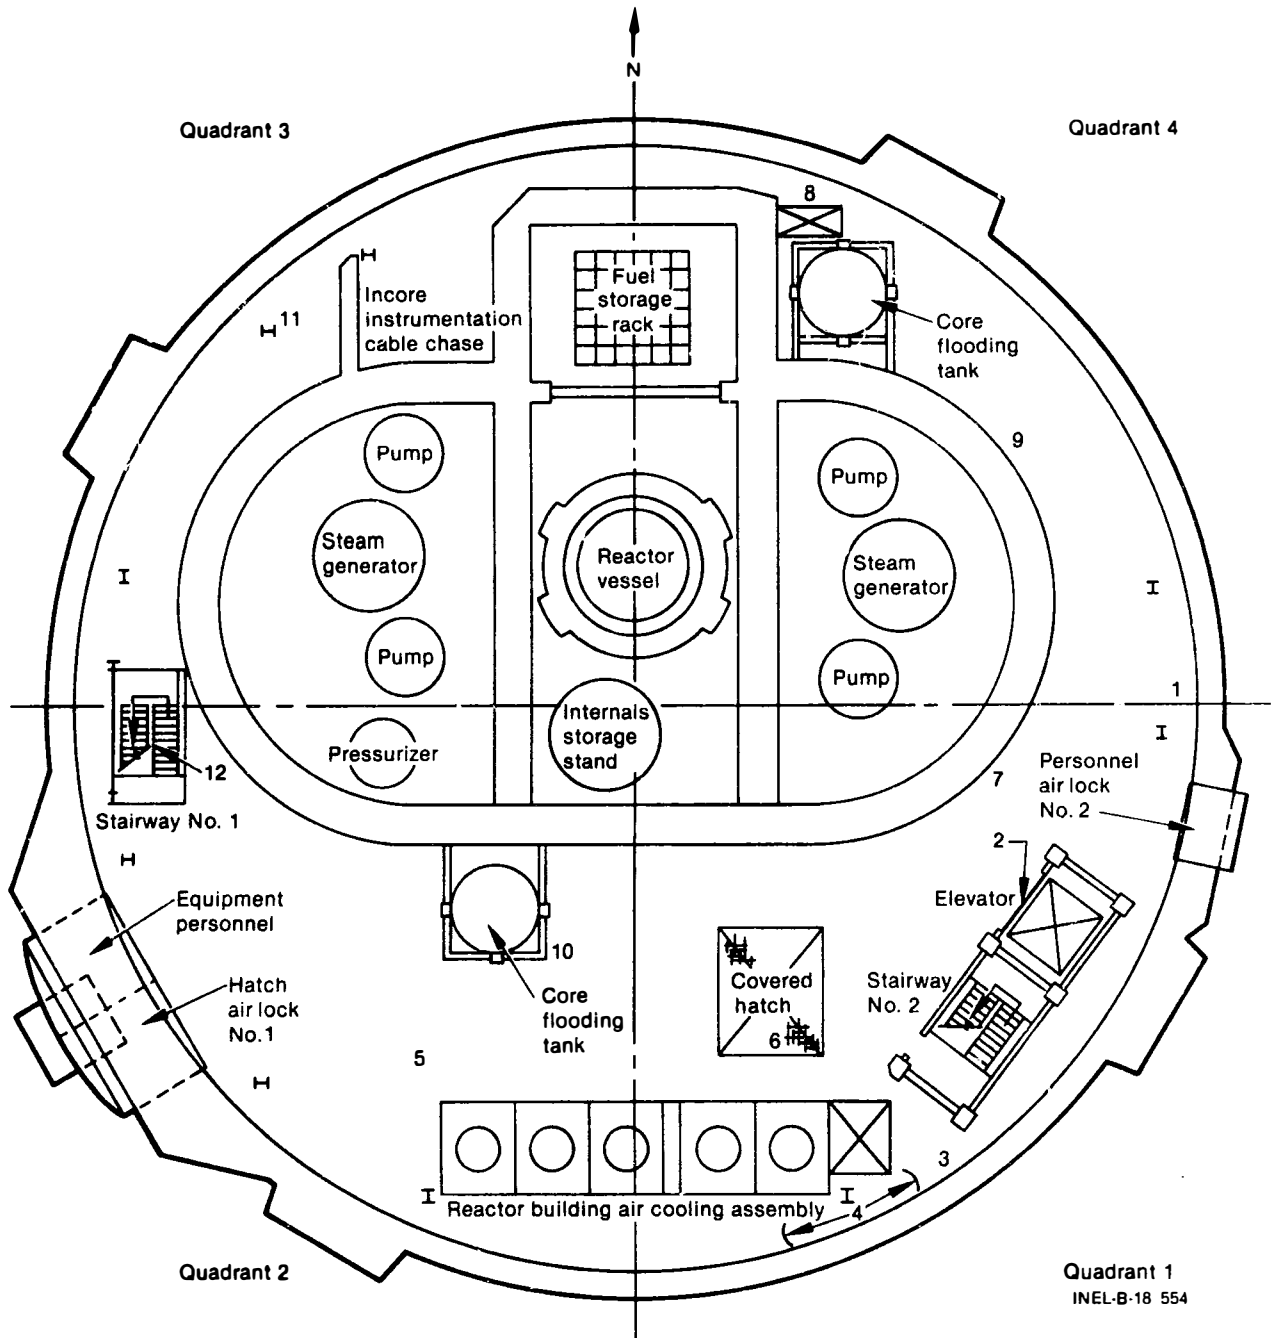
Figure 1. Elevation 305, Entry 3 task locations described by William (Sam) Griffith.

My name is Sam Griffith. Today five of us went inside the Unit 2 Reactor Building. We went down the ramp to the northwest side (1)^a and removed some cabling from a dolly which was on a cart. We put herculite down on it and set equipment on top. We noticed that the upper portion of the elevator on Elevation 305 was bowed out approximately 6 inches from the lower door (2). Pete Keegan and I conducted a survey behind the elevator shaft and air coolers. At first, it seemed like we weren't going to get back there (3), but we were able to get there by crawling. When we got to the other side (4), we found out we needed to retrace our path to exit because the other passage out was too narrow. We went back by crawling through all the angle iron (4). It was just large enough for us to pass.

There was no detectable beta radiation that I could find on any of the floor drains behind the air coolers. The floor area from about the B to the E fans was covered with mud. It looked like river mud. There was a lot of water there as well. We came back (5) and proceeded to climb the front side of the air coolers. Right between the A and B fan, the gamma reading jumped to 2 rem/hr. I believe it was from the covered hatch (6). At the other end, the readings were much lower, but I don't remember the levels. It is recorded on the survey.

At this point, Larry Eberly looked like he was completing work on the source range box. I came down the ladder (5) and Pete Keegan remained to do his swipe survey. Larry and I went over to the first vibration monitor pre-amp box (7). He began work while I went around to do the pictures of the A Core Flood Tank. I wanted to get rid of the camera as soon as possible. Continuing to survey, I crawled back behind the CRD cable chase and over in the direction of the transfer chute tubes (8). There were no significant dose rates over there. I did notice that at different points around the steel liner, the gap in the floor varies from 4 to 12 inches wide on both sides. The reading there is 1.5 rem/hr gamma and no beta. The A Core Flood Tank is very dark and contact readings on the core flood piping and make-up lines are the same as the general area readings. That is not the case with the B tank which was much higher at 5 rem/hr. There is a lot of dirt and scale underneath the A tank.

Larry came over and opened up the second vibration monitor pre-amp box. I took a swipe on the inside of the box. Larry went back to the personnel hatch. In the meantime, Pete had come over and scaled to the top of the A Core Flood Tank. When he came back down, we went around to meet Richard (Rick) Croll (10). Pete tried to climb to the top of the B tank and I went towards the incore instrumentation cable chase. The dose rates in this area from what I have seen so far are the lowest on Elevation 305 (11).

It measured somewhere around 100 mrem/hr back here at the chase itself. Direct shine from the water is anywhere from 8 to 10 rem/hr 5 feet from the open stairwell as it shoots past the landings (12).

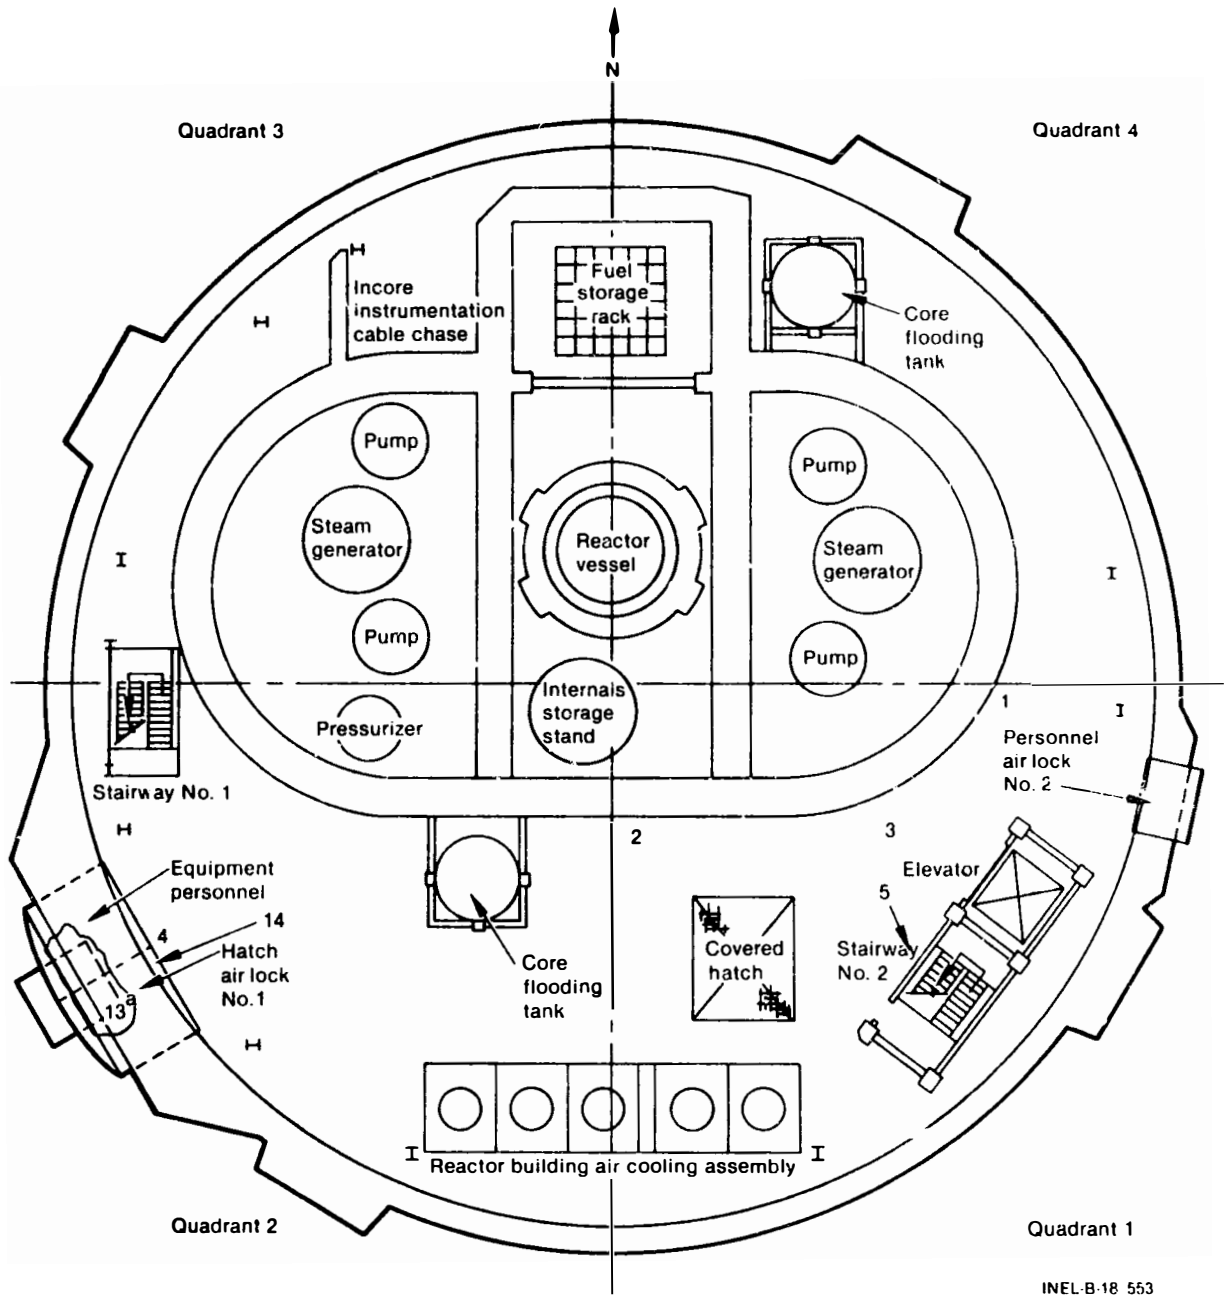
Figure 3. Elevation 305, Entry 3 task locations described by Richard Croll.

I am Rick Croll. Today I entered the Unit 2 Reactor Building as one of the party of five. Initially Larry Eberly and I walked over to the vibration detector to verify it (1)^a was in sight of the air handling equipment. Then we both walked over to the source range monitor (2), swiped the outside, did a radiation survey around it, and Larry opened it up. I walked part of the way back over to the personnel airlock (3), motioned to Guy Wise to follow me, and we went over to the equipment airlock (4). While he was working on that, I discovered my camera would not work. I spent a lot of time trying to make it work and still don't know what is wrong with it. By then Guy had opened the door. I went in to do a survey carrying the oxygen monitor. Initially it alarmed and we both came out. We notified the command center and waited a couple of minutes while it cleared. Then Guy went back in, and I worked on the camera some more, but still didn't get it to work. Having thought that the equipment airlock was fixed, we both came over to the personnel airlock. When we were informed by radio that it wasn't fixed, we both went back over again. Then Guy went in the airlock, shut the inner door, and I surveyed around it and in between the stairs and the air cooling assembly. Then Guy came out of the airlock. The first time he was in, when the door was open, I wiped of the door seal. As he said, it wiped clean. Then when he came out the second time, we both went over to the personnel airlock. Larry was already there.

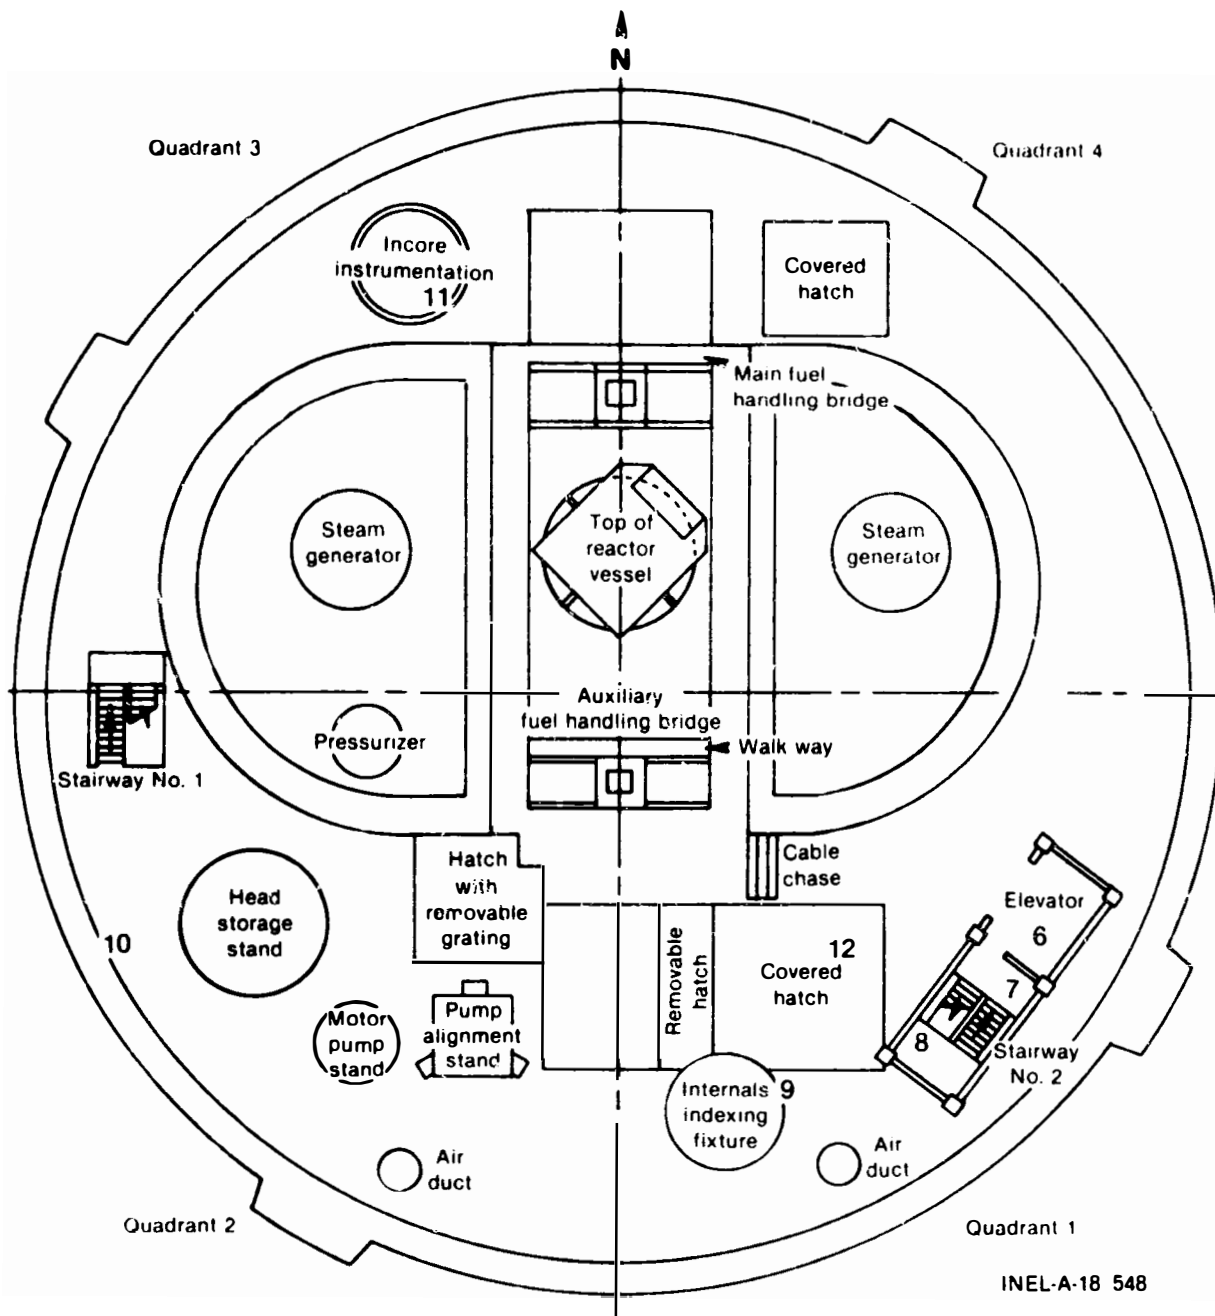
Figure 4. Elevation 347, Entry 3 task locations described by Richard Croll.

I dropped off the camera and oxygen monitor. Sam Griffith and I went up to Elevation 347 taking the PNC-4 detector (5). When we got to the top of the stairwell, we went in the elevator machine room (6).^b Like Sam had previously said, it looked clean in there. There was a small partially

melted yellow bag in the corner. I couldn't tell what it was. It looked like there was an air duct up along the top where the blackened grating was on the outside.

We then left the room and climbed the ladder (7) over to the roof of the elevator. We looked around, but couldn't tell where this wire came from. It's pretty dark all the way up to the top of the dome. The dose rate over in this general area of HP-R-214 (8) was about 200 mrem/hr. Then we went down to Elevation 347. What we thought were cable laying over here were tandem copper bars (9) from the top of the dome. It looked like there was some kind of insulation that had been burned off. Over here by the jib crane boom support (10) was a piece of cable. There is cable thruway about 15 feet high with a piece of cable running through it and dangling to the floor. The penetration was marked S-20. I couldn't see anyplace where the other end of it may have come from. It was just hanging there. We then walked around the rest of the Elevation 347. The only high reading I got was in the southeast part of the incore instrumentation area (11). It was 2 rem/hr gamma and greater than 20 rad/hr beta. I am not sure of the number exactly anymore.

Other than that, there was just some miscellaneous items here and there that we picked up. There were no other survey readings that were out of the ordinary. After we collected the items, we came back over here to the stairwell and took a reading with the PNC-4 (12). It was less than 50 counts per minute. We went downstairs and out the personnel airlock. During the equipment hatch (13).^a Again, I am not sure of the reading exactly, but I think I remember it was about 100 mrem/hr gamma, 400 mrad/hr beta. Further out away from the pit (14), it was about 200 mrem/hr gamma indicating at least part of that was background. I did not check a beta reading further out.

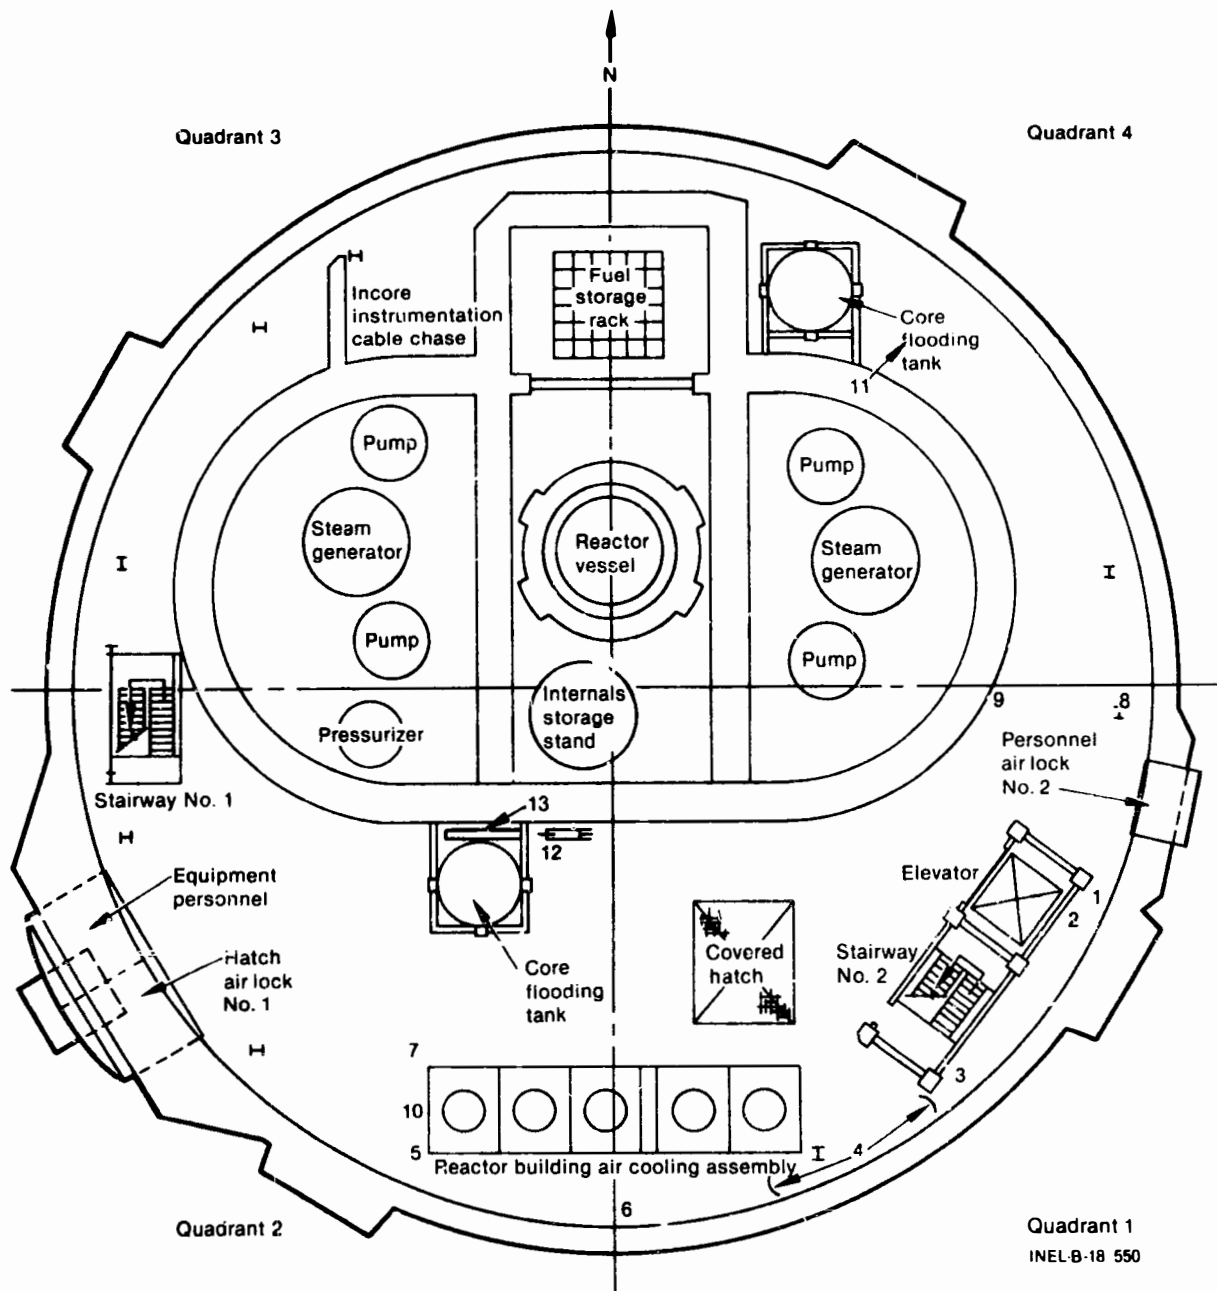
Figure 5. Elevation 305, Entry 3 task locations described by Peter Keegan.

My name is Peter Keegan. I went into the Unit 2 Reactor Building today. Initially upon entry, Sam Griffith layed down the herculite on the dolly and I was supposed to put down the E-530-N, but it was strapped underneath my airhose so it couldn't be removed. I was going to lay down the spotlight, but it was also strapped underneath my airhose so I couldn't put that down. I took the teletector from Sam Griffith and went behind the elevator shaft to start surveying (1).^a The general area is about 200 mrem/hr right behind the elevator shaft (2). The first drain back there is reading about 2 rem/hr about six inches off the floor. I went down to the end of the elevator shaft and the stair number 2 (3), and it was just about 200 mrem/hr all the way along back there. It was so congested there (4) that I decided to come back out and go around and see if I could find an easier entrance to get behind the air handling units, before we decided to go back that way. While Sam was still out setting up his equipment, I walked out around in front of the elevators and looked in between the stairwell and the air handling unit A. It looked even tighter than location (4). I walked around to the end of the air handling unit E. There is another piece equipment on the end there not in this diagram (5). That piece of equipment comes within 6 inches of the wall, and it was impossible to get in back that way. So that time I tried to radio in that it didn't look like we were going to be able to get through back there, but my radio wasn't functioning very well. I tried to get that word to Sam Griffith, and about that time we decided to go back behind the stairs again and try to get through to the maze of angle irons. Then we did go around the round ducting (4) as Sam Griffith said and went back behind the air handling units, and took measurements along there (6). The space along the wall almost from the air handling unit A through air handling unit D is reading just about general area (about 200 mrem/hr). At the end of air handling unit E, the crack reading goes up to about 2 rem/hr. I assume there is

something underneath that is blocking the shine that is coming up from air handling unit A through D, then you have an open shot down to the water down and around E. The general area down there also goes up about 100 mrem/hr. The general area down towards E is 300 to 500 mrem/hr, and it is 200 to 300 mrem/hr the rest of the way around. We couldn't get out that way so we came back out around the elevators and did our lower survey along the front of the air handling units. Sam Griffith went up onto the top and commenced his survey (7), and I went back and got the two smears from the dolly (8). About that time Larry Eberly was ready for Sam, so Sam left and went over to help Larry (9). I went up onto the catwalk with the teletector and the general area readings up there are from 300 mrem/hr at E, up to about 2 rem/hr down around A, and up. I extended the teletector as high as it would reach, but I could just get the teletector up over the top of the air handling units. It is 1200 mrem/hr constant all the way down all five units. Around the end of E, this unit (10) just goes up to that catwalk level, allowing you to step over there physically. There is no walkway or anything built, but it would be physically possible to get over there where the general area is about 1100 mrem/hr.

Next I climbed over the handrails and took the two smears on air handling units B and D. Then I came down with Sam Griffith and we went around to Core Flood Tank A, and climbed up to the short ladder. I performed radiation surveys with the E-530-N. Contact readings on the Core Flood Tank down 3 to 5 feet from the bottom of the tank were 5 to 10 mrem/hr contact facing the tank and 50 to 70 mrem/hr contact with the probe turned. Then I proceeded up the ladder, crossed over on to the long ladder that went up to the next landing, taking contact readings there. The contact readings were 15 to 17 mrem/hr facing the tank and 50 mrem/hr turned around. I went all the way up to the top of the tank, and the general area measured almost constant using the E-530-N at 50 mrem/hr. Most general area contact readings on everything were 50 mrem/hr.

I think the valve numbers WDG-168 and -169, a double isolation valve, had tygon tubing coming out. It looked like it had had a yellow poly sleeving over it. This had come out from the near the top of the Core Flood Tank A, run across the grating and down the long ladder. This was

melted and there was just blobs of it on each of the ladder steps. It had just partially melted off of the valves and it was laying there melted across the grating. I came on down the Core Flood Tank (11), went back around with Sam Griffith to Core Flood Tank B and climbed up the two ladders of Core Flood Tank B (12). The readings at the first ladder landing were around 300 mrem/hr general area on the first landing and 150 mrem/hr general area on the second landing. The contact readings facing the tank were 10 to 15 mrem/hr and facing away from the tank were 90 to 100 mrem/hr. At the top of the second landing on the Core Flood Tank 1B, there was tygon tubing coming down the wall of the D-ring (13). It had been taped about every 10 feet. In between the tapings it had been melted off and bent over until it was hanging there. I came down, went back over to the personnel hatch.

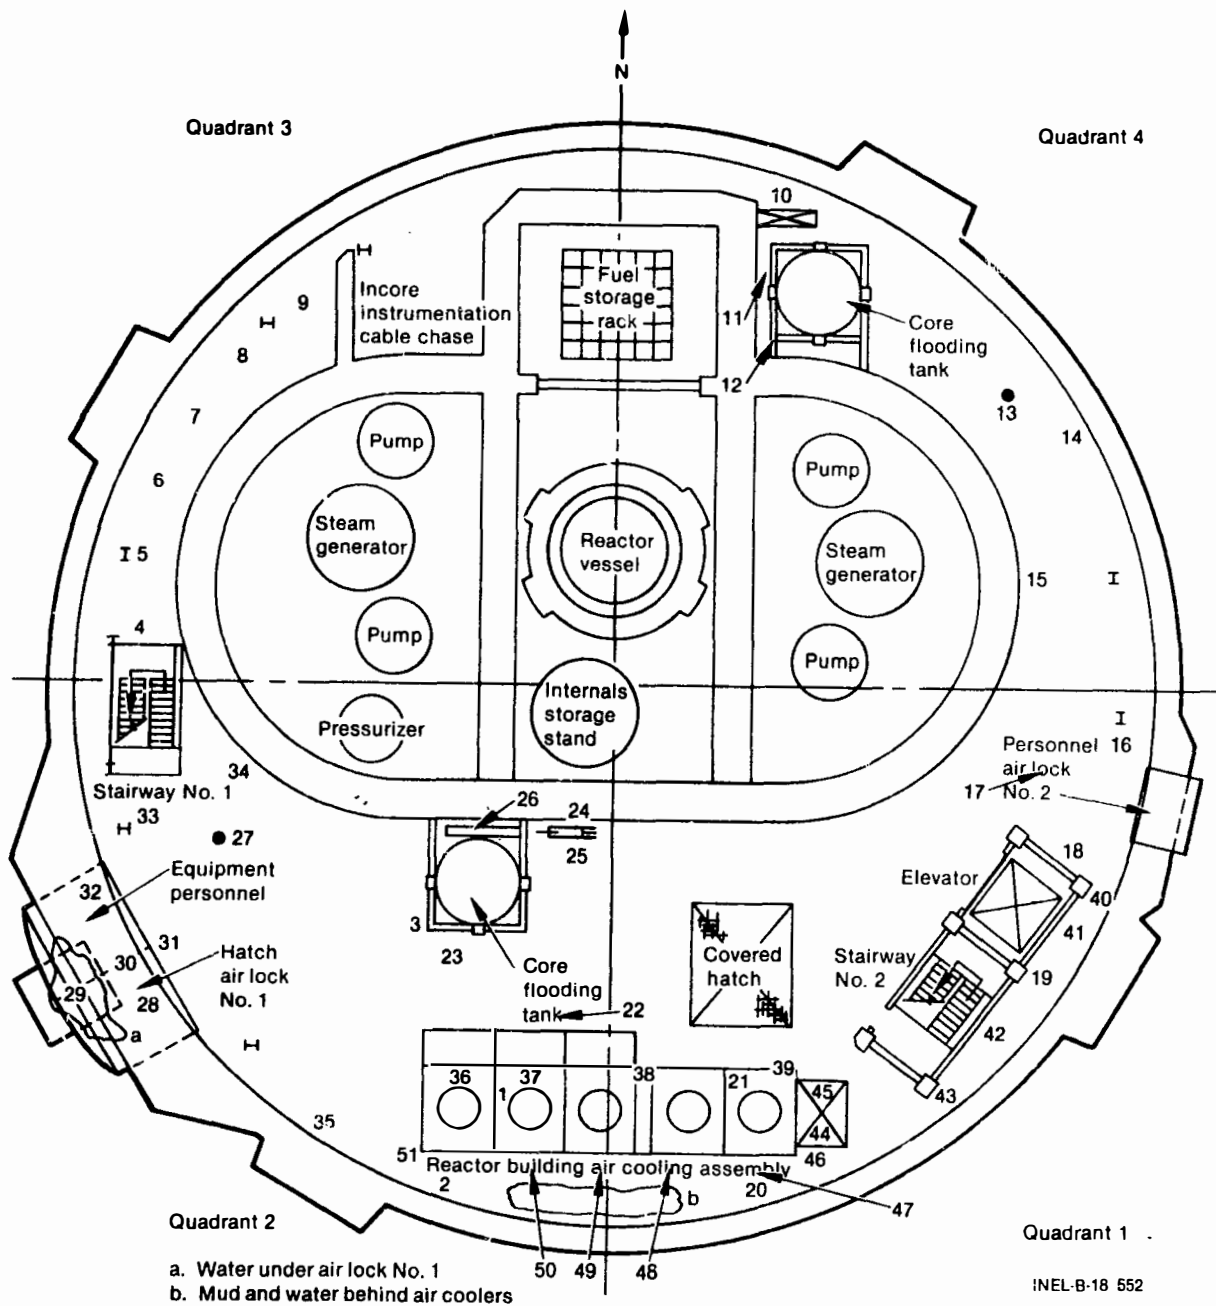
Figure 6. Elevation 305, Entry 3 radiation survey locations (see Table 2).

<u>Data Acquisition Task Number</u>	<u>Location^a</u>	<u>Instrument</u>	<u>Gamma Dose Rate (mrem/hr)</u>	<u>Beta Dose Rate (mrad/hr)</u>	<u>Location</u>
1	(1)	RO-2A	700	--	Air coolers inboard
1	(2)	RO-2A	100	--	Behind air cooler E
1	(3)	RO-2A	5000	--	CFT B piping
1	(4)	RO-2A	1800	--	Stair No. 1, directed at sump
1	(5)	RO-2A	1200	--	Stair No. 1, directed at sump
1	(6)	RO-2A	500	400	Open area, northwest corner
1	(7)	RO-2A	400	400	Open area, northwest corner
1	(8)	RO-2A	300	--	Open area, northwest corner
1	(9)	RO-2A	200	--	West of incore instrumentation cable chase
1	(10)	RO-2A	400	800	Behind CFT 1A
1	(11)	RO-2A	1000	--	CFT 1A make-up lines
1	(12)	RO-2A	800	--	CFT 1A piping
1	(13)	RO-2A	400	800	Floor drain
1	(14)	RO-2A	400	400	Open area, northeast corner

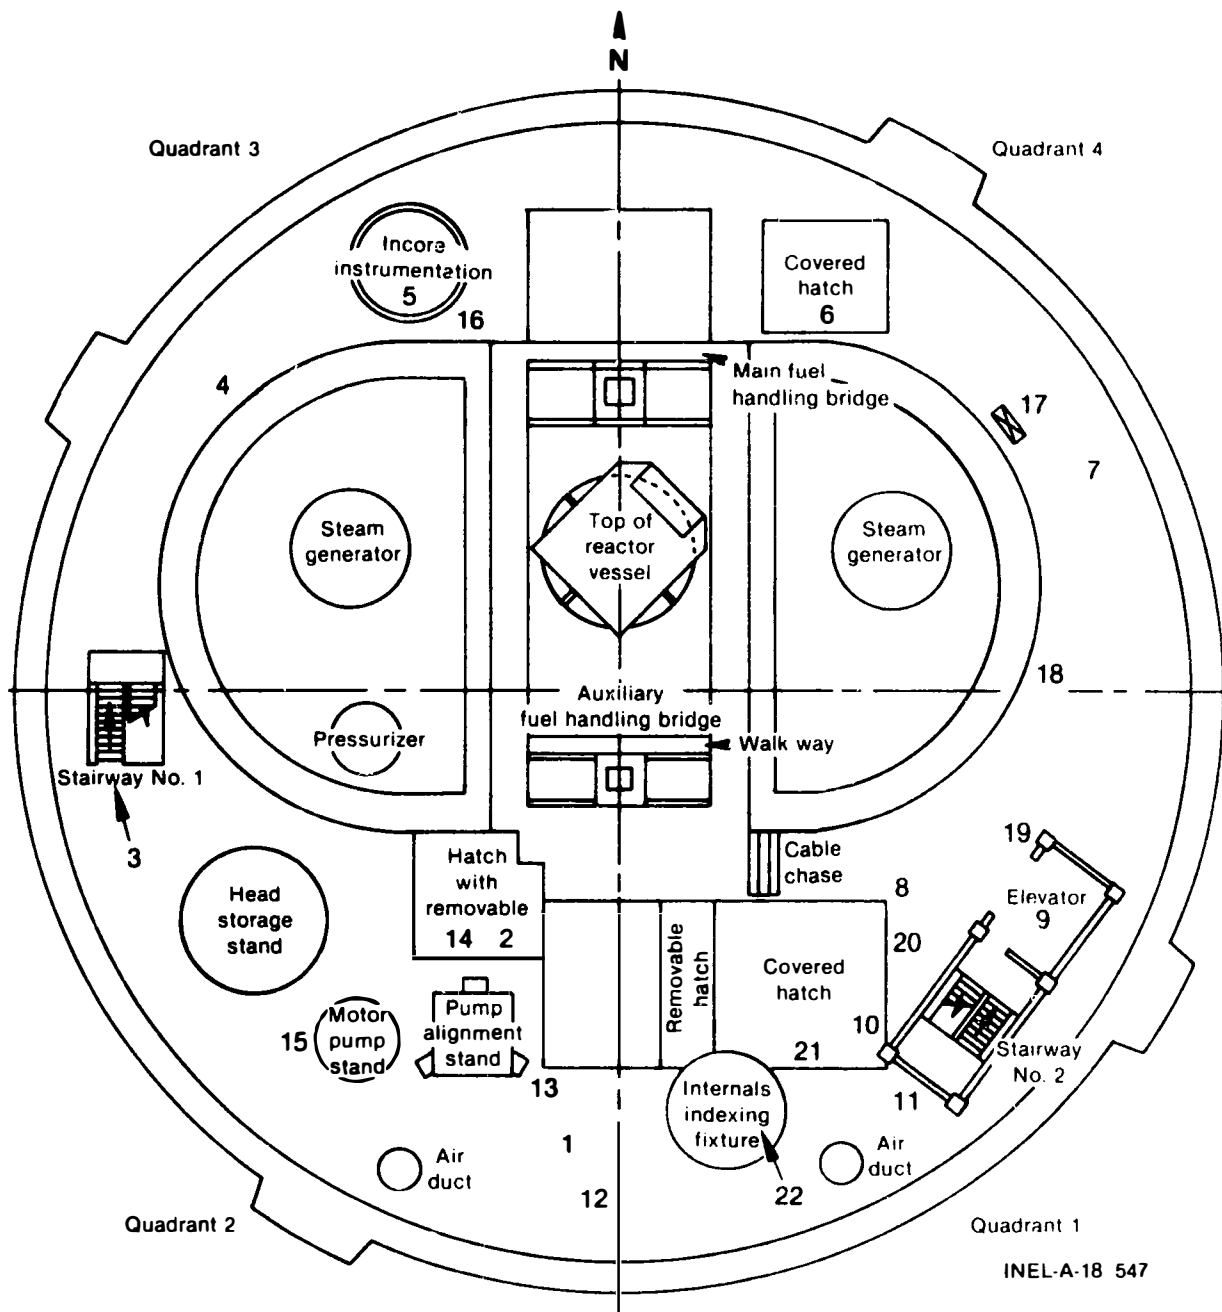
Figure 7. Elevation 347, Entry 3 radiation survey locations (see Table 3).

Data Acquisition Task Number	Location ^a	Instrument	Gamma Dose Rate (mrem/hr)	Beta Dose Rate (mrad/hr)	Neutron Reading (CPM)	Location
22A	(1)	RO-2A	150	--	--	South side
22A	(2)	RO-2A	150	--	--	At hatch with removable grating
22A	(3)	RO-2A	400	--	--	Stair No. 1
22A	(4)	RO-2A	100	--	--	Open area northwest corner
22H	(5)	RO-2A	2000	--	--	Incore instrument service area
22A	(6)	RO-2A	100	--	--	Covered hatch northeast corner
22A	(7)	RO-2A	100	--	--	Open area northeast corner
22A	(8)	RO-2A	125	--	--	Between elevator and CRD cable chase
22A	(9)	RO-2A	280	--	--	Top of elevator No. 2
22A	(10)	RO-2A	100	--	--	Covered hatch southeast corner
22H	(11)	RO-2A	200	--	--	5 feet from HP-R-214
22A	(12)	RO-2A	125	--	--	Open area, south side

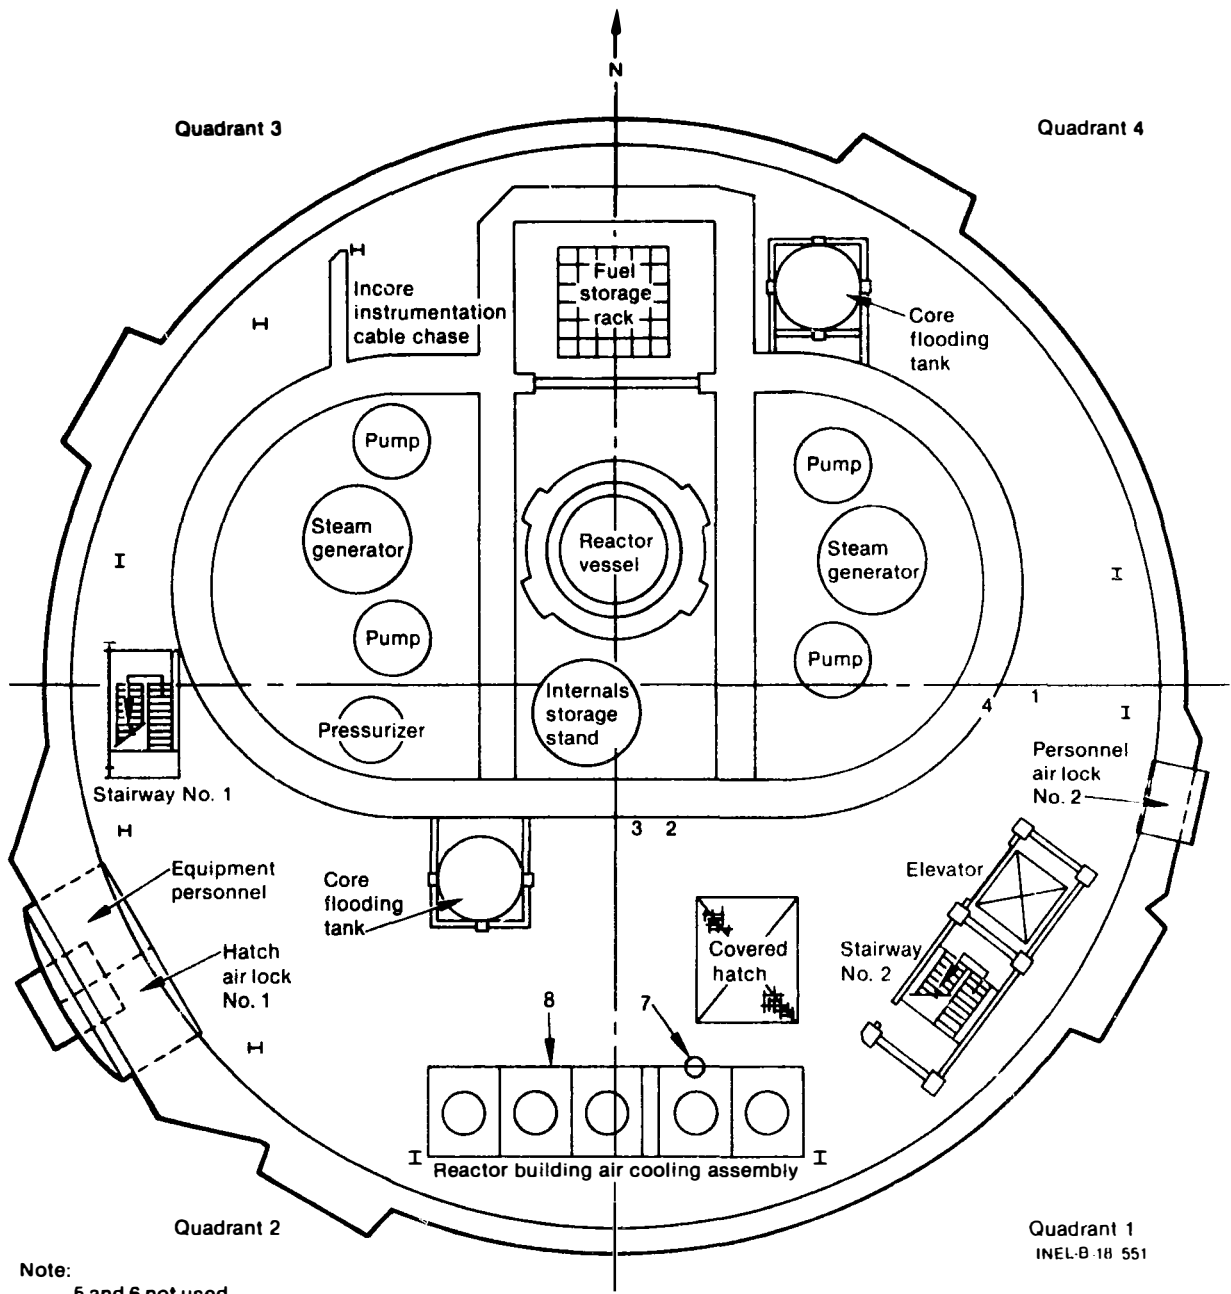
Figure 8. Elevation 305, Entry 3 surface contamination locations (see Table 4).

Data Acquisition Task Number	Specimen ^a	Sample Number	Location	Gross ^{a b} (μCi)	Gross β/γ (μCi)	$\text{Sr}^{90}/\text{Y}^{90}$ (μCi)	Cs^{134} (μCi)	$\text{Cs}^{137\text{C}}$ (μCi)	$\text{Cs}^{137}/\text{Sr}^{90}$ Ratio ^c
7D	(1)	51068	Vibration detector	<7.4-7	1.5-2	1.8-3	/1.9-3	/1.5-2	8.33
7D	(2)	51069	SR monitor	<7.4-7	2.9-2	5.2-3	/3.8-3	/2.8-2	5.3
7D	(3)	51070	SR monitor	<7.4-7	2.6-3	4.5-5	5.4-4/ 4.2-4	3.2-3/ 3.5-3	77.7
7D	(4)	51071	Vibration detector	--	--	7.0-2	/2.5-2	/1.8-1	2.57

(5)	Not used		--	--	--	--	--	--
	(6)	Not used		--	--	--	--	--	--
7G	(7)	51072	Air cooler B	--	--	2.7-1	/1.7-1	/1.2	4.44
7G	(8)	51073	Air cooler D	--	--	5.9-2	/2.8-2	/2.1-1	3.56
7C	(9)	51074	Core flood piping	--	--	5.8-2	/9.3-2	/6.9-2	1.19
7C	(10)	51075	Core flood piping	<7.4-7	2.0-2	5.6-4	3.7-3/ 3.4-3	2.5-2/ 2.6-2	46.4
7C	(11)	51076	Valve in CFT line	--	--	1.2-1	/1.7-1	/1.2	10.0
7C	(12)	51077	RC make-up line	<7.4-7	5.9-2	3.7-3	9.7-3/	7.0-2/	21.35
7C	(13)	51078	RC make-up line	--	--	3.3-2	/1.1-1	/8.2-1	7.45
7B	(14)	51079	Floor under CFT A	--	--	1.8-1	/2.3-1	/1.7	9.44
7B	(15)	51080	Stained area under CFT A	--	--	5.5-2	1/6-1/ 1.1-1	1.1/ 8.0-1	14.55
7B	(16)	51081	Stained area under CFT A	--	--	1.0-1	1.5-1/ 1.0-1	9.3-1/ 7.5-1	7.5

Note:
 5 and 6 not used
 9 and 10 - core floor piping
 11 - valve in CFT line
 12 and 13 - RC make-up line
 14 - floor under tank
 15 and 16 - stained area
