Quick Look Report Entry 4 Three Mile Island Unit 2 November 13, 1980

QUICK LOOK REPORT ENTRY 4 THREE MILE ISLAND UNIT 2. NOVEMBER 13, 1980

This report summarizes tasks performed during entry 4 at Three Mile Island Unit 2. During the entry into containment, which was made on November 13, 1980, additional beta and gamma surveys were conducted to supplement data acquired on previous entries. A decontamination test was completed on Elevation 305. Power receptables tested on Elevation 305 were deenergized, but receptacles on Elevation 347 were energized.

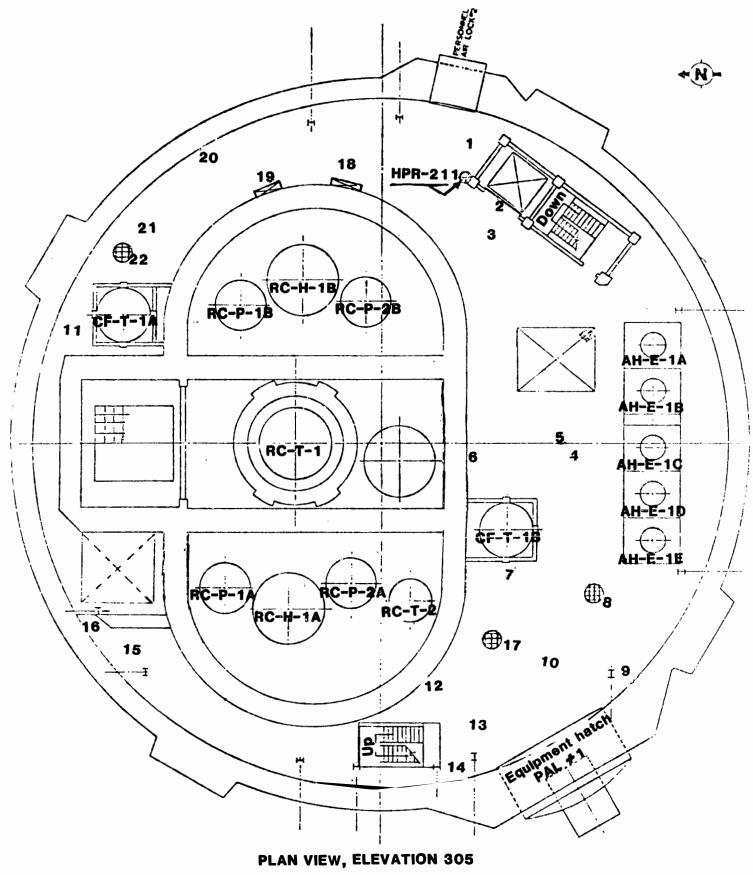
Figure 1. Radiation survey locations on Elevation 305 for Entry 4, November 13, 1980. (Refer to Table 2.)

Data Acquisition Task Number	Location Figure 1 <sup>a</sup>	Instrument	Gamma Dose Rate (mrem/hr)	Beta Dose Rate (rad/hr)	Location
1	1	RO-2A	450*Ե	C	South of PAL #2
1	?	RO-2A	1200		Elevator door
1	3	RO-2A	500*		In front of elevator
1	4	RO-2A	600*		In front of air coolers
1	5	RO-2A	800	9.2	Floor in front of air coolers
1	6	RO-2A	620		South side of D-ring wall
4	7	RO-2A	3800		B-core flood tank piping
6	8	R0-2A	2000	9.9	Floor drain
1	9	RO-2A	600		Near PAL #1
1	10	RO-2A	500	3.3	Floor in front of PAL #1
1 ,	11	RO-2A	600*		North side of A-core flood tank
1	12	RO-2A	400		D-ring near open stairwell
1	13	RO-2A	3000	16.5	Chains on floor near open stairwell
1	14	R0-2A	1000		Near open stairwell
1	15	RO-2A	300*		Northwest section of reactor building
1	16	RO-2A	200-390	~~	Access fence to in-core chase

Data Acquisition Task Number	Location Figure 1 <sup>a</sup>	Instrument	Gamma Dose Rate (mrem/hr)	Beta Dose Rate (rad/hr)	Location
6	17	RO-2A	2000	26.4	Floor drain
1	18	RO-2A	1400	C	Floor penetration on west side of D-ring
1	19	R0-2A	1200		Floor penetration on west side of D-ring
1	20	R0-2A	*008		Seismic gap on east side of reactor building
1	21	RO-2A	200*		Northeast section of reactor building
5	22	RO-2A	600	4.6	Floor drain

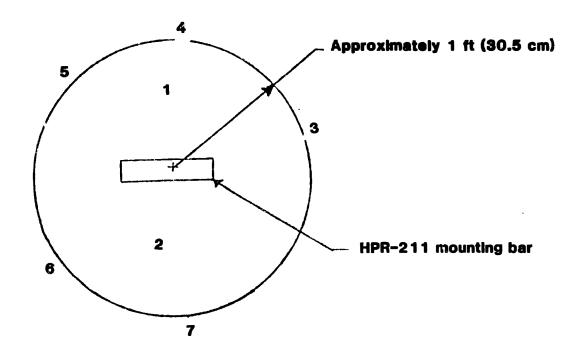
Figure 2. Radiation survey location on Elevation 305 for Entry 4, November 13, 1980. This is the HPR-211 area survey, located on the enclosed stairwell wall, as indicated in Figure 1. (Refer to Table 3.)

Data Acquisition Task Number	Location Figure 2 <sup>a</sup>	Instrument	Gamma Dose Rate (mrem/hr)	Beta Dose Rate (rad/hr)	Location
1	1	RO-2A	250	0.165	Just above HPR-211 mounting bar (contact)
1	2	RO-2A	250	0.033	Just below HPR-211 mounting bar (contact)
1	3	RO-2A	400	b	Area around HPR-211 at 1-ft (approximately 30.5 cm) radius and 1 ft from wall
1	4	RO-2A	280		Area around HPR-211 at 1-ft (approximately 30.5 cm) radius and 1 ft from wall
1	5	RO-2A	350		Area around HPR-211 at 1-ft (approximately 30.5 cm) radius and 1 ft from wall
1	6	RO-2A	480		Area around HPR-211 at 1-ft (approximately 30.5 cm) radius and 1 ft from wal?
1	7	RO-2A	400		Area around HPR-211 at 1-ft (approximately 30.5 cm) radius and 1 ft from wall

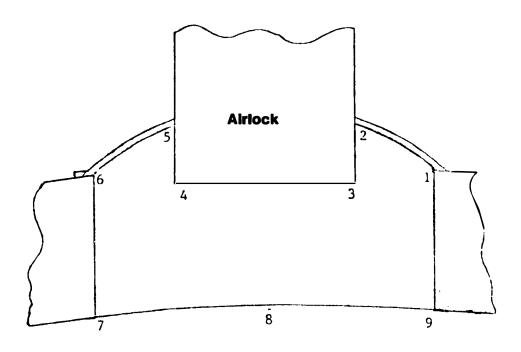
Figure 3. Radiation survey locations on Elevation 305 for Entry 4, November 13, 1980. These survey locations are indicated on the plan view of the reactor building equipment hatch. (Refer to Table 4.)

Data Acquisition Task Number	Location Figure 3 <sup>a</sup>	Instrument	Gamma Dose Rate (mrem/hr) <sup>b</sup>	Beta Dose Rate (rad/hr) <sup>b</sup>
42	1	RO-2A	200	No B
42	2	RO-2A	200	0.76
42	3	RO-2A	400	No B
42	4	RO-2A	200	No ß
42	5	RO-2A	150	1.1
42	6	RO-2A	200	1.1
42	7	RO-2A	500	No B
42	8	RO-2A	500	7.2
42	9	RO-2A	1200	14.4

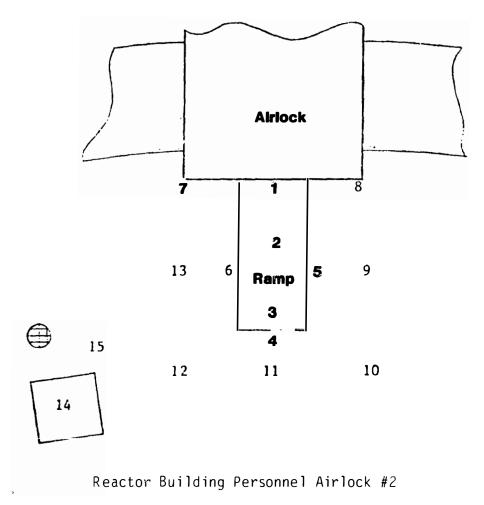
Figure 4. Radiation survey locations on Elevation 305 for Entry 4, November 13,1980. These survey points are indicated on the plan view of the reactor building Personnel Airlock (PAL) #2. (Refer to Table 5.)

Data Acquisition Task Number	Location Figure 4 <sup>a</sup>	Instrument	Gamma Dose Rate (mrem/hr) <sup>b</sup>	Beta Dose Rate (rad/hr)	Location_
42	1	RO-2A	200	3.8	See Figure 4
42	2	RO-2A	200	3.8	See Figure 4
42	3	RO-2A	500	3.8	See Figure 4
42	4	RO-2A	500	4.5	See Figure 4
42	5	RO-2A	500	4.9	See Figure 4
42	6	R0-2A	400	4.2	See Figure 4
42	7	RO-2A	300	3.4	See Figure 4
42	8	RO-2A	200	1.1	See Figure 4
42	9	RO-2A	500	3.9	See Figure 4
42	10	RO-2A	200	5.3	See Figure 4
42	11	RO-2A	300	4.6	See Figure 4
42	12	RO-2A	500	5.7	See Figure 4
42	13	RO-2A	400	3.8	See Figure 4
42	14	R0-2A	500	3.8	Prior to decontamination test operations
42	14	R0-2A	400	2.3	After water wash
42	14	RO-2A	400	2.3	After Radiac wash

Data Acquisition Task Number	Location Figure 4 <sup>a</sup>	Instrument	Gamma Dose Rate (mrem/hr) <sup>b</sup>	Beta Dose Rate (rad/hr)	Location
42	14	RO-2A	400	1.1	After Radiac scrub
42	15	RO-2A	C	2.3	See Figure 4: Contact reading taken before placing rubber matopen window only
42	15	RO-2A		0.5	See Figure 4: Conwact reading taken after placing rubber mat (thickness approximately 3/8 in., or just less than 1 cm)open window only

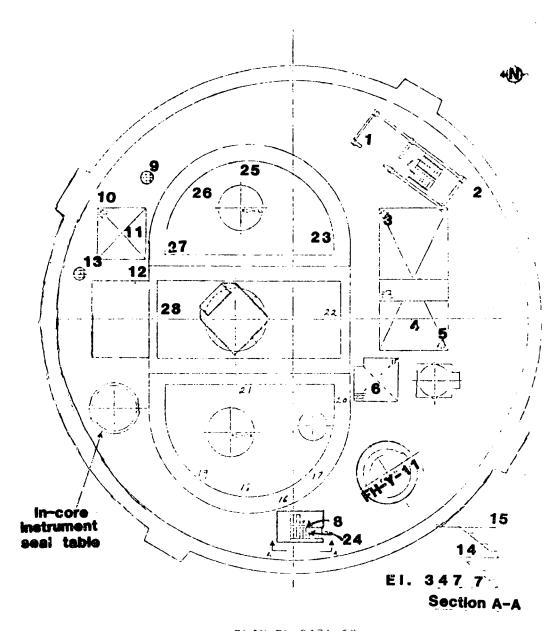
Figure 5. Radiation survey location on Elevation 305 (data points 16-28 are at Elevation 367) for Entry 4, November 13, 1980. (Refer to Table 6.)

Data Acquisition Task Number	Location Figure 5 <sup>a</sup>	Instrument	Gamma Dose Rate (mrem/hr)	Beta Dose Rate (rad/hr)	Location
22A	1	Teletector	200*b	C	Inside of elevator shaft
22A	2	R0-2A	500*		Southside of enclosed stairwell
22A	3	R0-2A	500*		Northeast corner of equipment hatch deck plate
22A	4	R0-2A	500*		West side of equipment hatch deck plate
22A	5	RO-2A	500*		Southwest corner of equipment hatch deck plate
22A	6	R0-2A	500*		B-core flood tank grating
22A	7	R0-2A	350*		First landing of open stairwell
22A	8	R0-2A	300	5.6*	Gap between stairs of open stairwell
22H	9	R0-2A	1000	9.9	Floor drain
22A	10	R0-2A	100*		Near deck plate for A-core flood tank
22A	11	RO-2A	150*		Deck plate over A-core flood tank
22A	12	R0-2A	200*		East of A-core flood tank
22H	13	RO-2A	350*	2.2	Floor drain
22A	14	R0-2A	150*		Second landing of open stairwell

Data Acquisition Task Number	Location Figure 5 <sup>a</sup>	Instrument	Gamma Dose Rate (mrem/hr)	Beta Dose Rate (rad/hr)	Location
22A	15	R0-2A	100*		Top landing of open stairwell (Elevation 367)
22A	16	R0-2A	100*	0.594*	Top of east D-ring (Elevation 367)
22A	17	R0-2A	100*	0.594*	Top of east D-ring (Elevation 367)
22A	18	RC-2A	200*	0.825*	Arm's reach into east D-ring (Elevation 367)
22A	19	RO-2A	300	8.9	Top of steel support beam (Elevation 367)
22A	20	R0-2A	100*	0.594*	Top of D-ring on south side (Elevation 367)
22A	21	RO-2A	600*	1.650*	Arm's reach into east D-ring (Elevation 367)
22A	22	RO-2A	150*	0.165*	South walkway between D-rings (Elevation 367)
22A	23	RO-2A	700*	0.330*	Arm's reach into west D-ring (Elevation 367)
22A	24	RO-2A	250	9	Top of steel support ring (Elevation 367)
22A	25	RO-2A	500*	No β*	Arm's reach into west D-ring (Elevation 367)

Data Acquisition Task Number	Location Figure 5 <sup>a</sup>	<u>Instrument</u>	Camma Dcse Rate (mrem/hr)	Beta Dose Rate (rad/hr)	Location
22A	26	R0-2A	300	8.9	Top of steel support ring (Elevation 367)
22A	27	RO-2A	1500*	No β*	Arm's reach into west D-ring (Elevation 367)
22A	28	R0-2A	200*	660	North walkway between D-rings (Elevation 367)

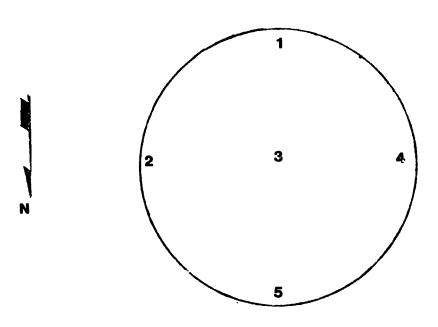
Figure 6. Radiation survey locations at Elevation 347 for Entry 4, November 13,1980. These survey points are on the in-core instrumentation seal tabel. (Refer to Table 7.)

Data AcquisitionTask Number	Location Figure 6 <sup>a</sup>	Instrument	Gamma Dose Rate (mrem/h	Beta Dose Rate (rad/hr)
22H	1	RO-2A	5,000*b	4.95*
22H		RO-2A	5,000	>149
22H	2	RO-2A	1,500*	11.95*
22H		RO-2A	10,000	>132
22H	3	RO-2A	10,000*	16.5*
22H		RO-2A	15,000	>115.5
22H	4	RO-2A	1,800*	10.5*
22H		RO-2A	2,000	9.9
22H	5	R0-2A	10,000*	13.5*
22H		R0-2A	3,500	>153.4

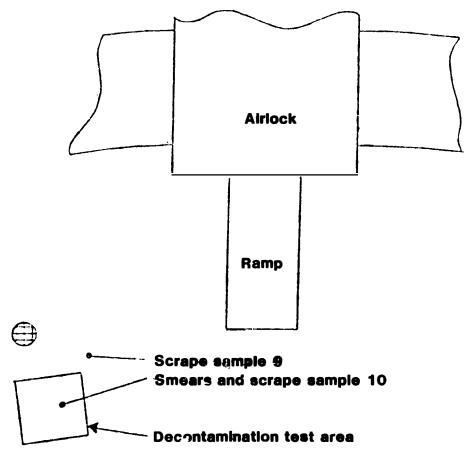
Figure 7. Location of decontamination test area on Elevation 305 made during Entry 4, November 13,1980. The airlock in the figure is #2 PAL.

Smear samples 1 through 8 were taken in the center of a test area of approximately  $3700 \text{ cm}^2$  (4 ft<sup>2</sup>). This area is located on Elevation 305 between the #2 PAL entry ramp and the D-ring as shown in Figure 7. Sequence of the smears was as follows:

- Radiation levels were higher on the B steam generator side than on the A steam generator side.
- Gamma radiation appears to be coming through the floor of Elevation 305. During the decontamination test, the gamma radiation dropped significantly after the initial wash, but the Radiac wash and scrub brought no further reduction.
