QUICK LOOK REPORT
ENTRY 5
THREE MILE ISLAND UNIT 2
December 11, 1980

GEND-INF-005
TIO-QLR

This report summarizes the raw data obtained during Entry 5 at Three Mile Island Unit 2. During the entry into containment, which was made on December 11, 1980, beta/gamma surveys were performed on Elevation 305 and 347, and on the reactor head-fuel pool area and the polar crane access ladder and platform.

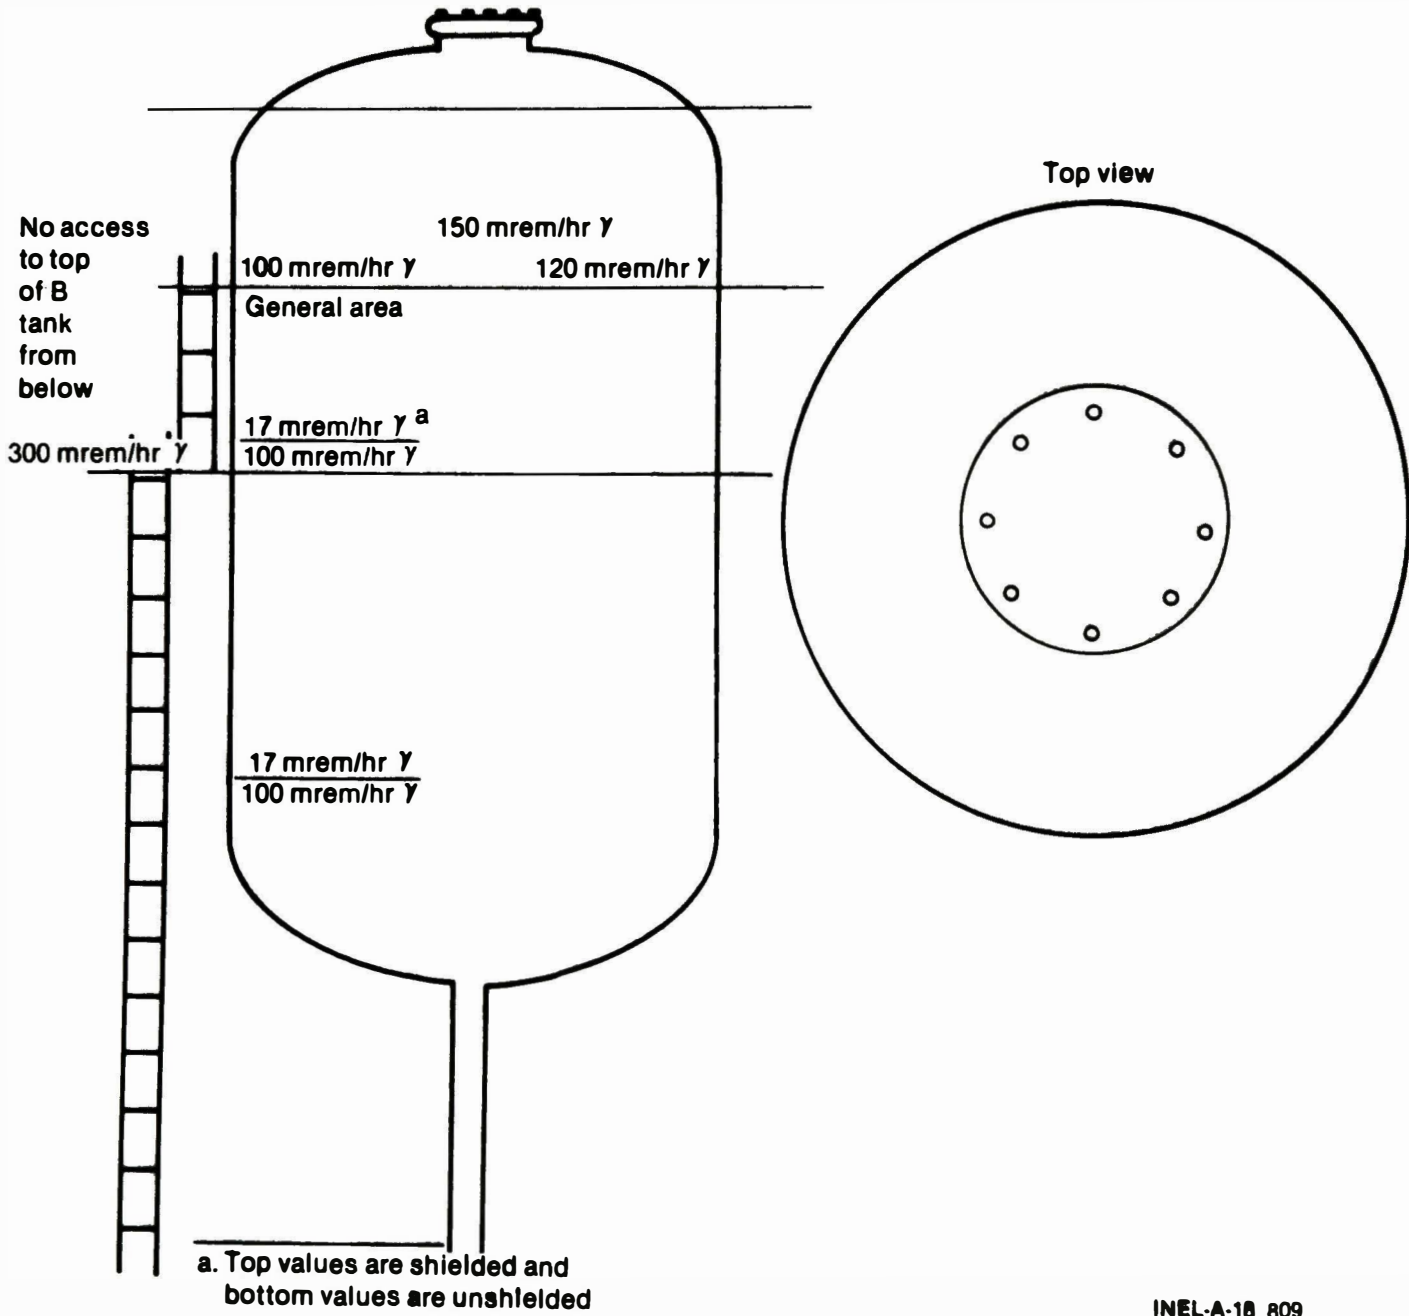
Figure 4. Core Flood Tank B radiation survey looking south.

Piping upstream of check valve under Core Flood Tank B is hot (high radiation).

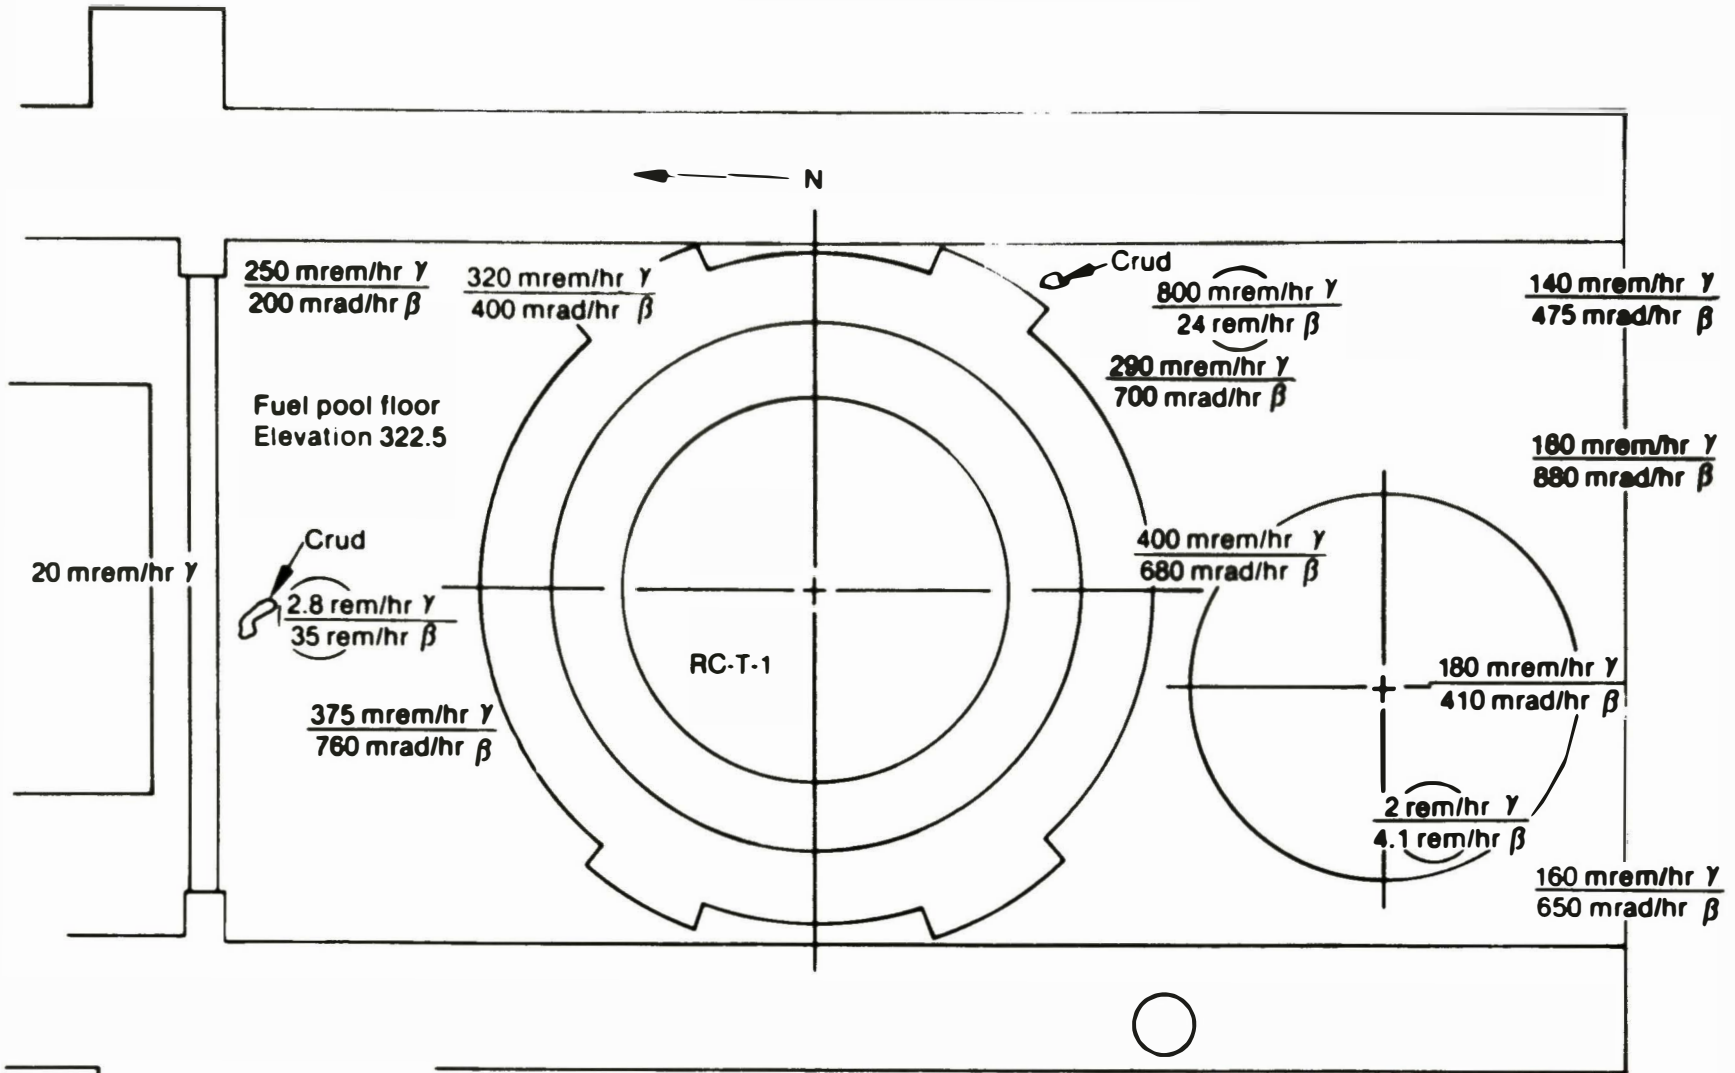
Figure 8. Fuel pool radiation survey.

Large pile of crud on north side of pool

- 2.5 rem/hr γ , 40 rad/hr β on contact.

Pile of crud on north side is about two feet square, looks like boric acid crystals mixed with sawdust, greenish in color

Pile is very distinct and is approximately 1/4 inch thick. Nothing directly overhead, so it's hard to explain how it got there.

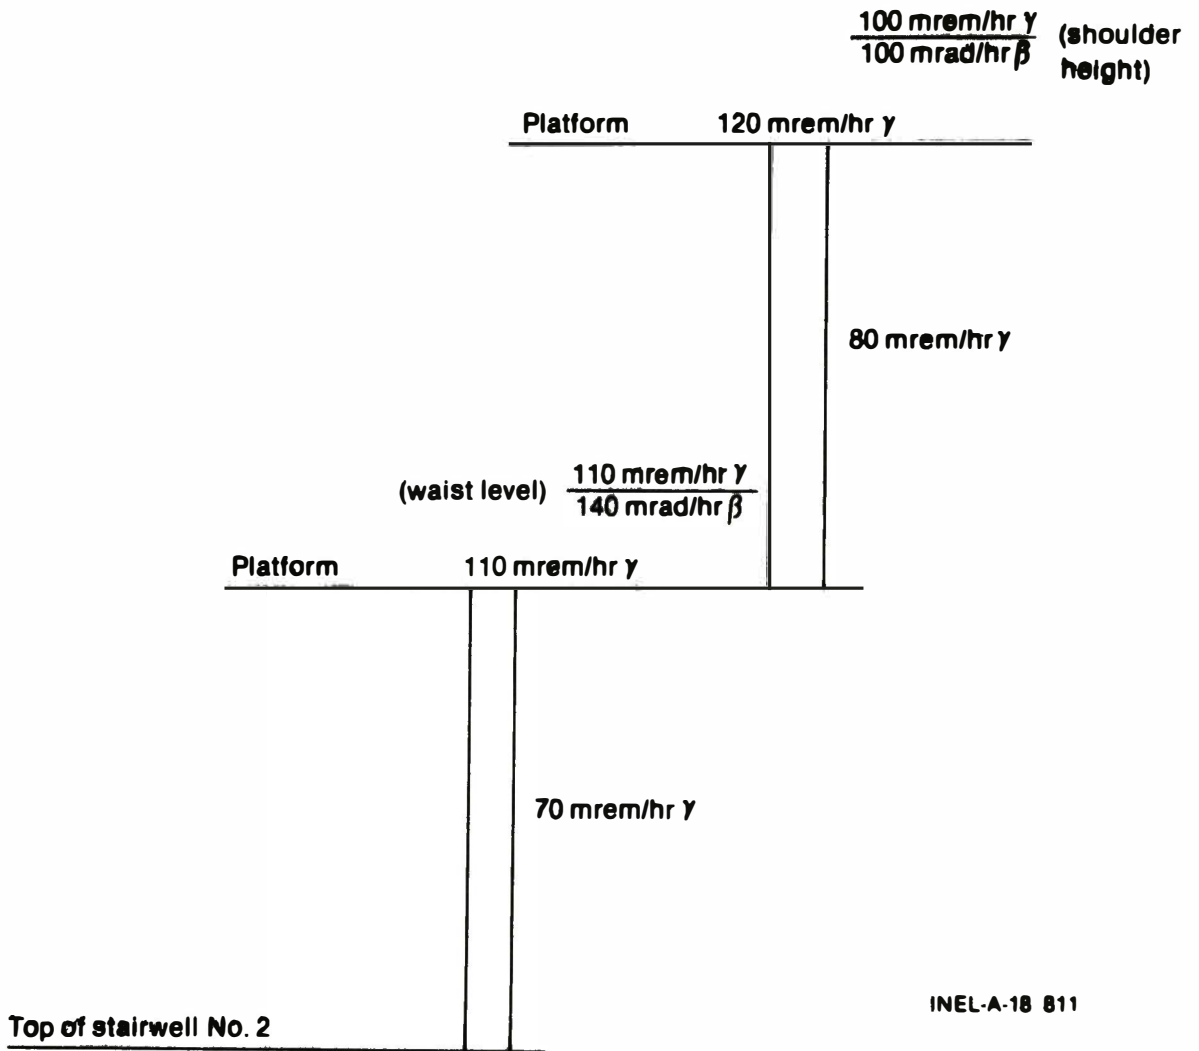
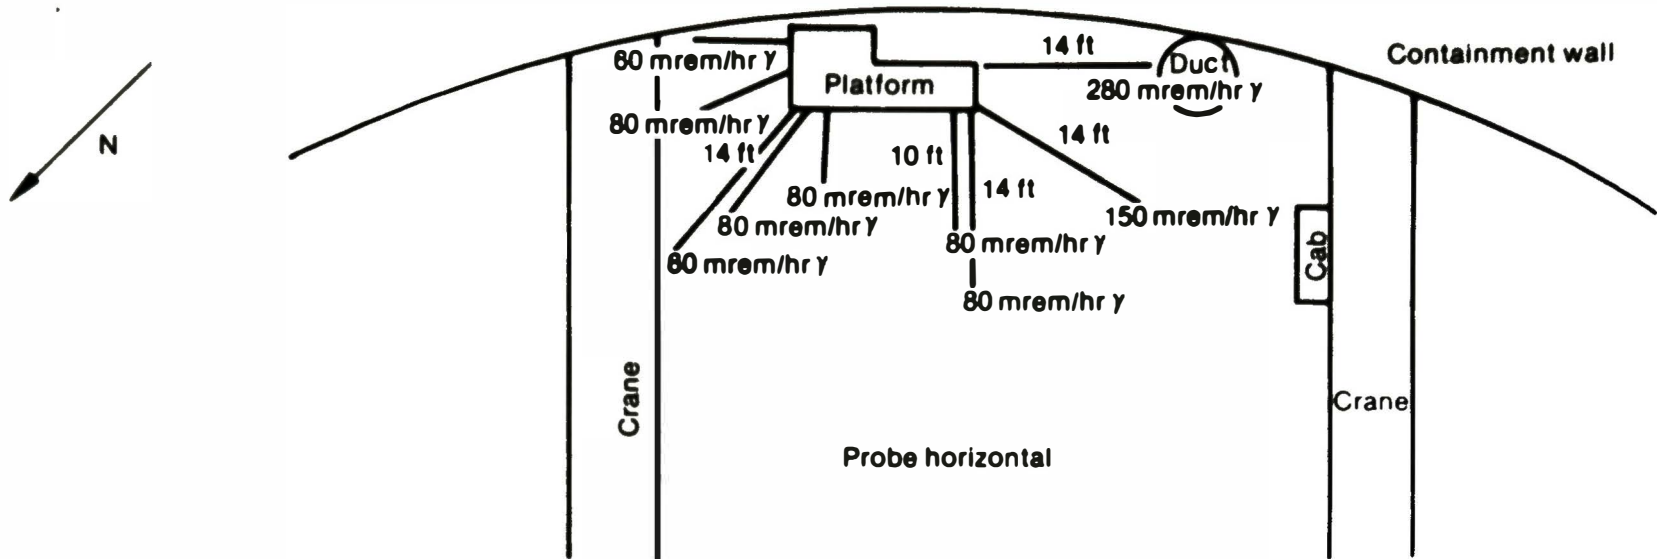
Figure 9. Polar crane access ladder radiation survey.

~ 8 ft straight up - close to wall - 50 mrem/hr γ
 ~ 8 ft straight up - 3 ft from wall - 100 mrem/hr γ
