August 1981

QUICK LOOK REPORT
ENTRY 6
THREE MILE ISLAND UNIT 2

**QUICK LOOK REPORT
ENTRY 6
THREE MILE ISLAND UNIT 2
February 3 and 5, 1981**

**Bechtel Northern Corporation/
General Public Utilities Nuclear Corporation**

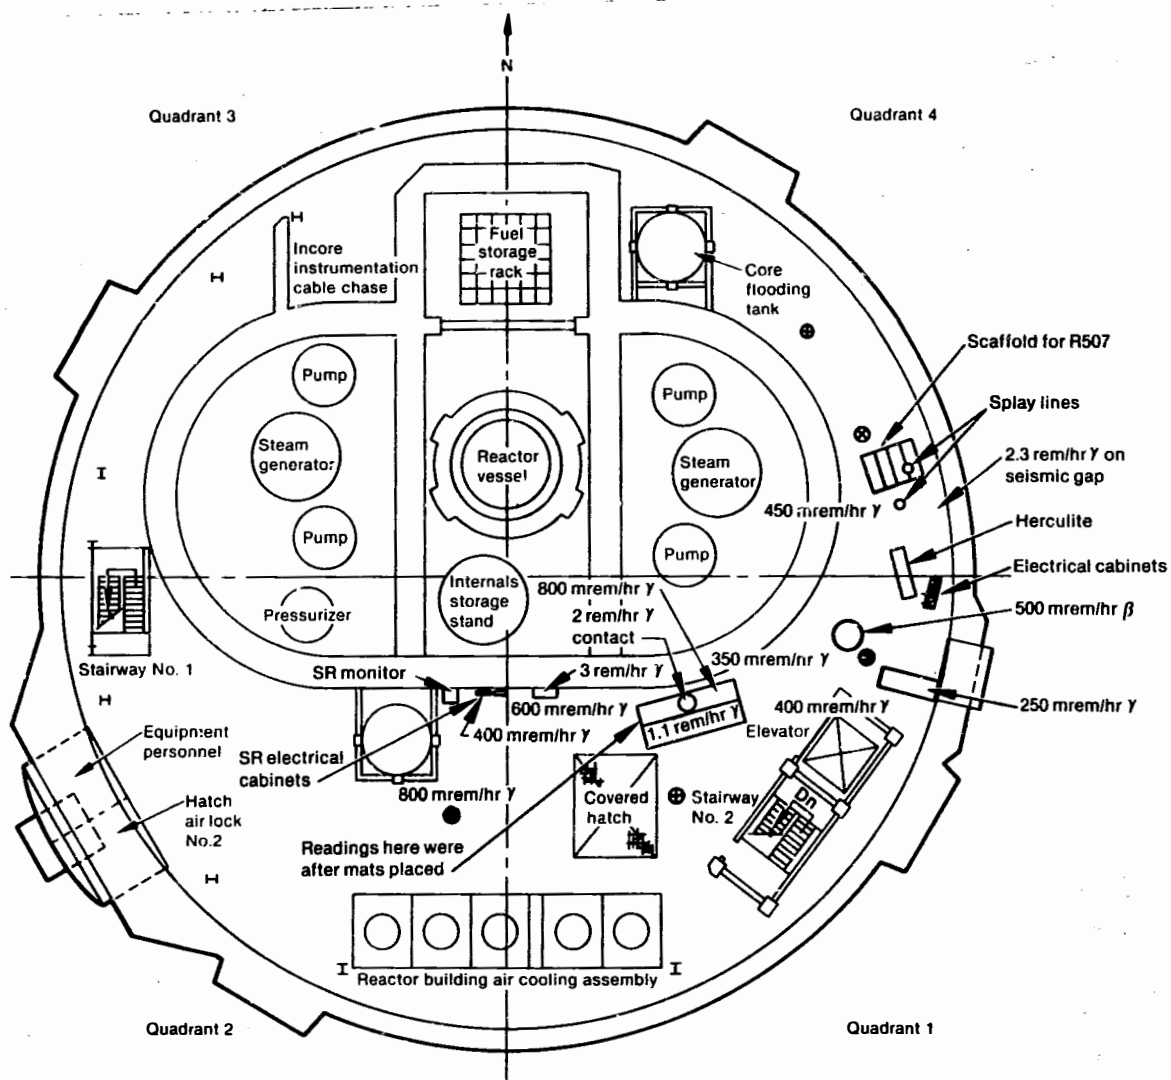
Figure 1. Entry 6, Elevation 305 radiation survey.

Data Acquisition Task Number	Instrument	Gamma Dose Rate (mrem/hr)	Beta Dose Rate ^a (mrad/hr)	Location on Figure 1
6	R0-2A	800	--b	Drain cover between air cooler C and CFT B
1	R0-2A	400	--	SR Monitor
6	R0-2A	3000	--	Penetration East of SR Monitor
6	R0-2A	1100	--	Rubber mat by elevator
6	R0-2A	2000	800	Rubber mat contact
1	R0-2A	600	--	General area between hatch and D-ring
1	R0-2A	400	--	Elevator
1	R0-2A	250	--	Ramp
1	R0-2A	350	--	Between ramp and D-ring
6	R0-2A	--c	500	Drain cover by ramp
1	R0-2A	300	--	Ramp staging area
6	R0-2A	2300	--	Seismic gap under penetration
1	R0-2A	450	--	Scaffold assembly area near R507
1	R0-2A	200	--	General area up on staging under R507
1	R0-2A	250 to 300	--	General area on staging

Note: Rust on floor has bled through paint.
Dose rate after drain covers were placed
was only slightly lower.
A total of five drains were covered.

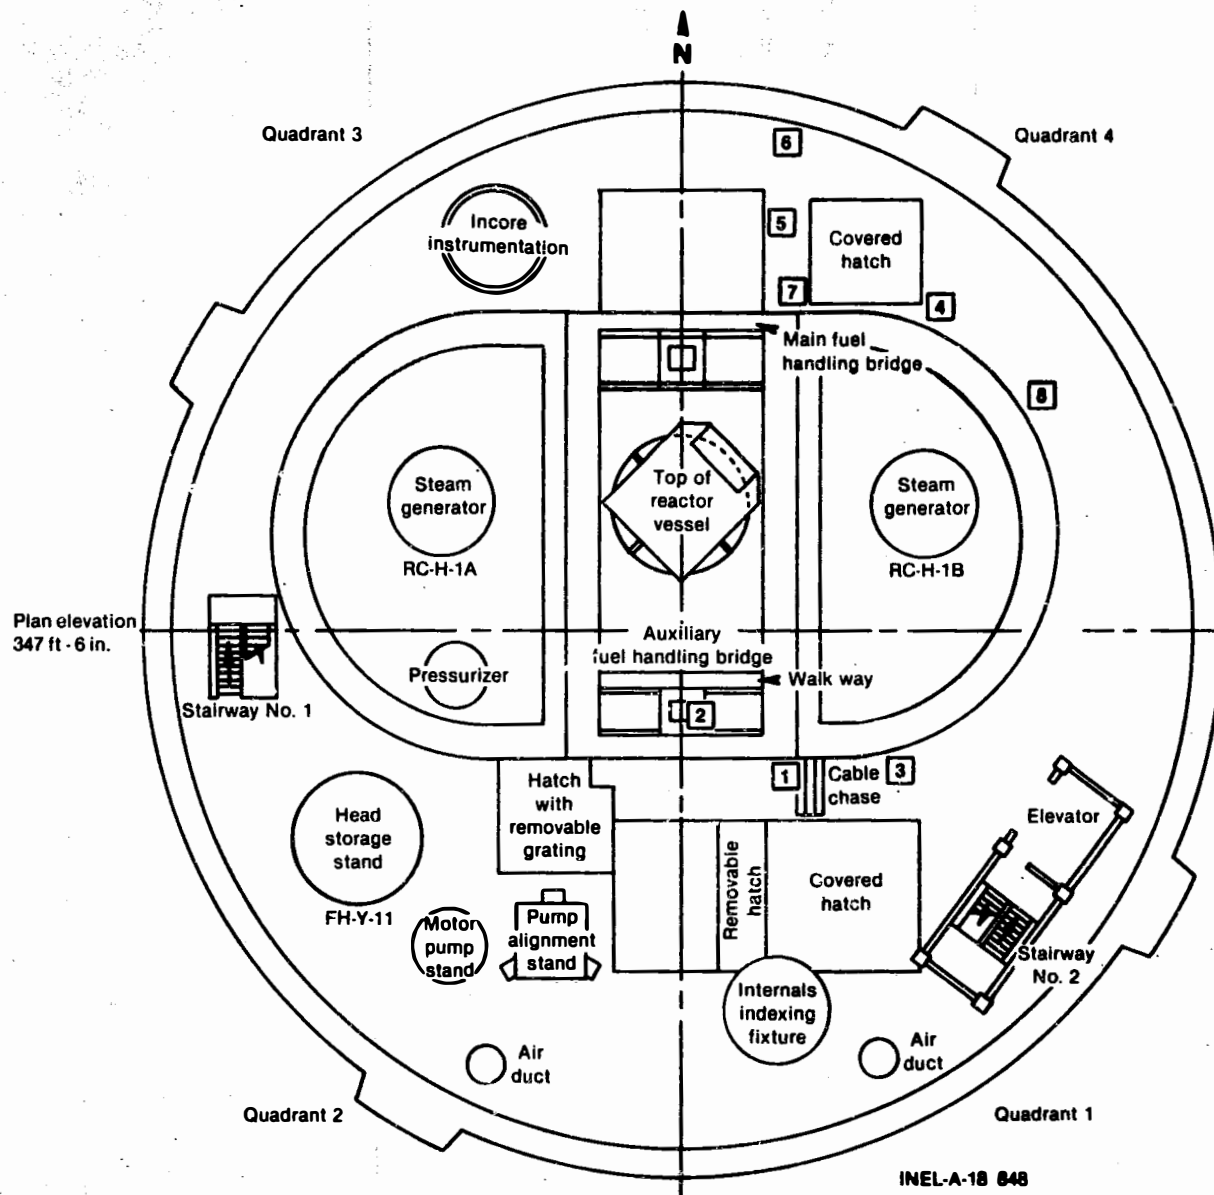
Figure 2. Entry 6, Elevation 346 smears.

The smears taken (shown on Table 5 and Figure 2) not relating to decontamination techniques testing were performed to indicate the amount of contamination present on vital equipment, such as electrical cable and the fuel handling bridge. This data will be used to aid in the assessment of radiation damage to this equipment. These smears were all taken on Elevation 347 at the locations indicated.

Data Acquisition Task Number	Specimen	Sample Number	Location ^a	Cs-134 ($\mu\text{Ci}/100 \text{ cm}^2$) ^b	Cs-137 ($\mu\text{Ci}/100 \text{ cm}^2$) ^b	Cs-60 ($\mu\text{Ci}/100 \text{ cm}^2$) ^b	Comments
27(C)	6-143	56543	1	1.3	9.1	<4.1 ^{-3c}	CRD cable chase--top
27(C)	6-144	56544	1	1.3	9.7	<1.4 ⁻³	CRD cable chase--middle
27(C)	6-145	56545	1	1.3	9.3	<6.9 ⁻⁴	CRD cable chase--bottom
27(O)	6-146	56546	2	2.0 ⁻⁴	1.7 ⁻³	<1.8 ⁻⁵	Aux fuel handling bridge
27(O)	6-147	56547	2	1.9 ⁻⁴	1.6 ⁻³	<2.9 ⁻⁵	Aux fuel handling bridge
27(C)	6-148	56548	3	2.3 ⁻¹	1.7	<6.0 ⁻⁴	Communications box
27(C)	6-149	56549	3	2.8 ⁻¹	2.1	<6.0 ⁻⁴	Communications box
27(C)	6-150	56550	3	1.0 ⁻¹	7.6 ⁻¹	<6.0 ⁻⁴	Communications conduit
