QUICK LOOK REPORT ENTRY 7 THREE MILE ISLAND UNIT 2

Bechtel Northern Corporation/ General Public Utilities Nuclear Corporation

This report summarizes tasks performed during Entry 7 at Three Mile Island Unit 2. During the entry into containment, which was made on March 17, 19, and 20, 1981, samples of sump water were collected, water was processed via the resin column test equipment, the LPR-3B contactor was jumpered for additional floor lighting on Elevation 347, large purge valves were surveyed, the in-core tunnel area was surveyed and photographed, the CRDM service structure was surveyed, CCTV cables between cameras were rerouted, and a high volume air sample was taken on E¹evation 305.

QUICK LOOK REPORT ENTRY 7 THREE MILE ISLAND UNIT 2 MARCH 17, 19, AND 20, 1981

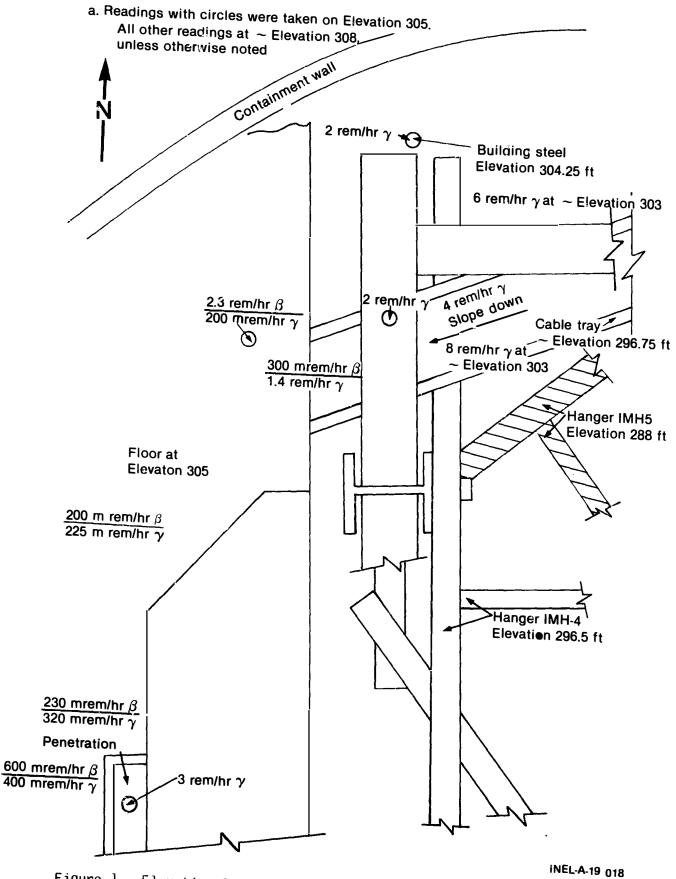
Figure 1. Elevation 305, reactor building in-core instrumentation cable cnase--structural design.

Data Acquisition Task_Number	Location Figure 1 Instrument	Gamma Beta Dose Rate Dose Rate	<u>Location</u>
45	As Noted on Figure 1	As Noted on Figure 1	
20	As Noted on Figure 2	As Noted on Figure 2

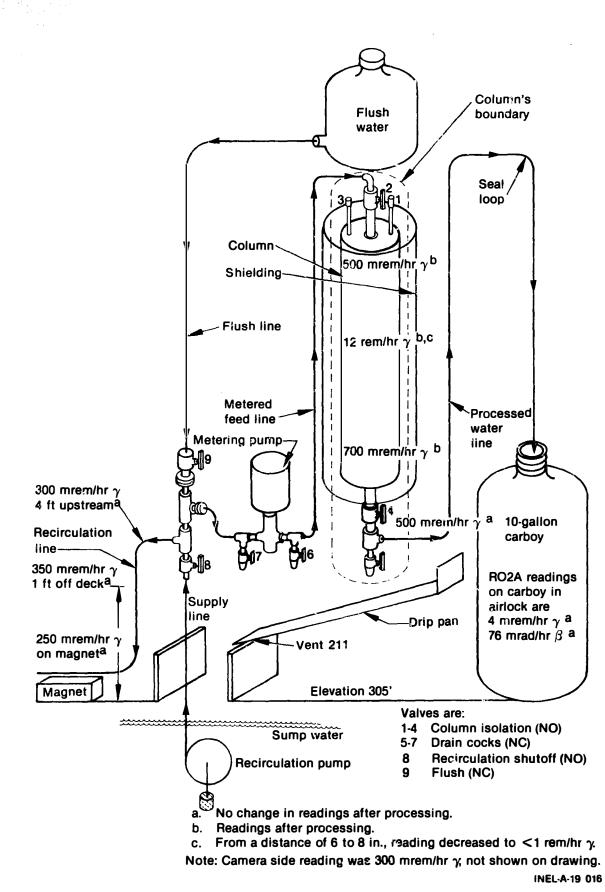
Figure 2. Reactor building sumpwater resin column experiment--system flow diagram.

Data Acquisition Task Number	Task Description	Task Accomplished	Problems Encountered	Comments/ Significant Findings
			Nikonas camera was inadver- tently set with too high a shutter speed causing pictures to be 1/2 frame; pictures slightly fogged.	
42B	Decontamination test control smears and acetate pads	Completed	None	Control smears were taken by removing the smear and acetate pads from their protective bags and rebagging them without being used.
25, 26	Survey and smears inside inside A D-rirg	Not performed	Due to heat stress problems encountered on March 17, 1981, this task was not performed.	None
20	Resin column test	5 gallons of pro- cessed water were obtained	On March 17, 1981, attempts sump pump into sump failed;	Radiation measurements follow- ing test are given in Figure 2.

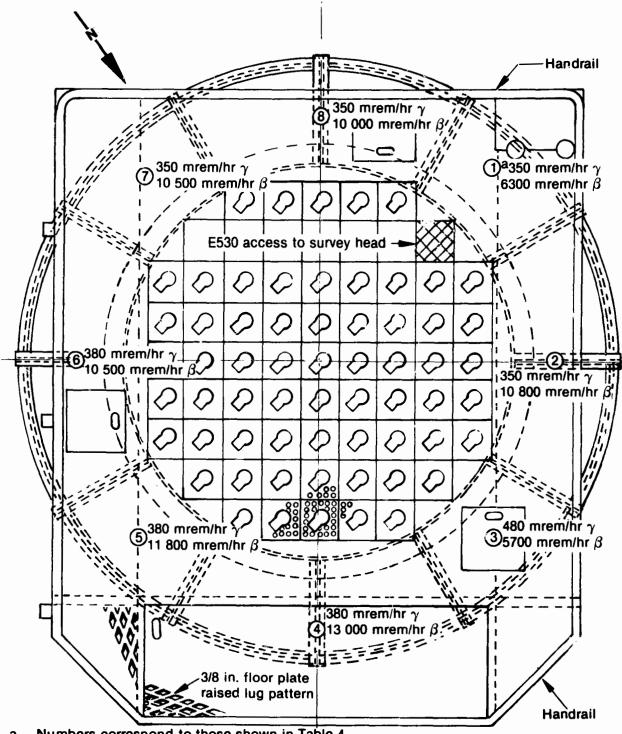
Figure 3. Reactor vessel service structure control rod drive mechanism.

Data Acquisition Task Number	Location Figure 2	Instrument	Gamma Dose Rate	Beta Dose <u>Rate</u>	Neutron Keading	Location
23, 27	As noted or	ı Figure 3 and	Figure 4	As No Figur	ted on Figu e 4	ire 3 and

a. Numbers correspond to those shown in Table 4. All readings were taken with an RO2A on contact.

b. Numbers correspond to those shown in Figure 3.
