EGG-TMI-7385, Rev. 1
February 1987

TMI-2 CORE BORE ACQUISITION SUMMARY REPORT

Published February 1987

EG&G Idaho, Inc.
Idaho Falls, Idaho 83415

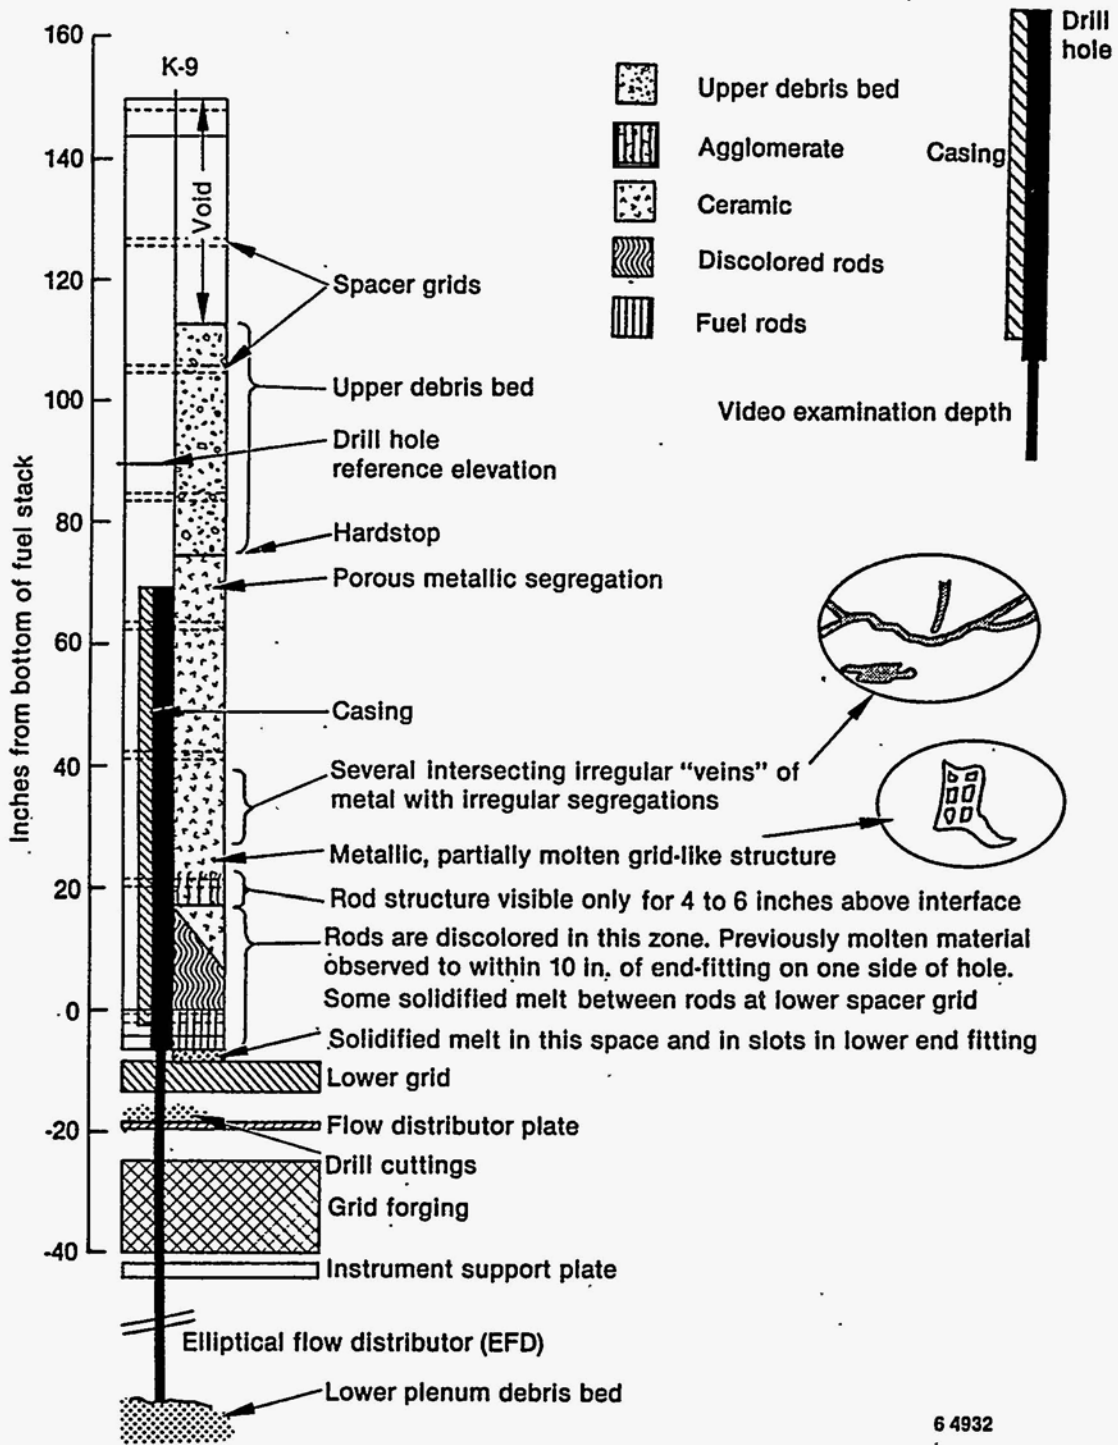
A summary of the observations from a central core location (K9) is shown in Figure 5. As shown in the sketch, homogeneous previously molten ceramic material extends from the top of the core bore hole down to near the top of the second spacer grid, a distance of almost 50 in. Compared with other core bore locations, the previously molten homogeneous material extended to its greatest depth at location K9. The previously molten homogeneous ceramic material was about 40-in. thick at position G8 and about 30-in. thick at position K6. A 4- to 6-in.-thick region of agglomerate material separates the previously molten homogeneous material from standing fuel rods that extend to the bottom of the core in core bore location K9. A metallic-appearing structure that has been partially or perhaps fully molten was observed near the top few inches of the drill hole. A possible metallic form embedded in the homogeneous ceramic material 30 in. above the bottom of the core is shown in Figure 6, and what

Figure 5. Observation summary from central core bore location (K9).

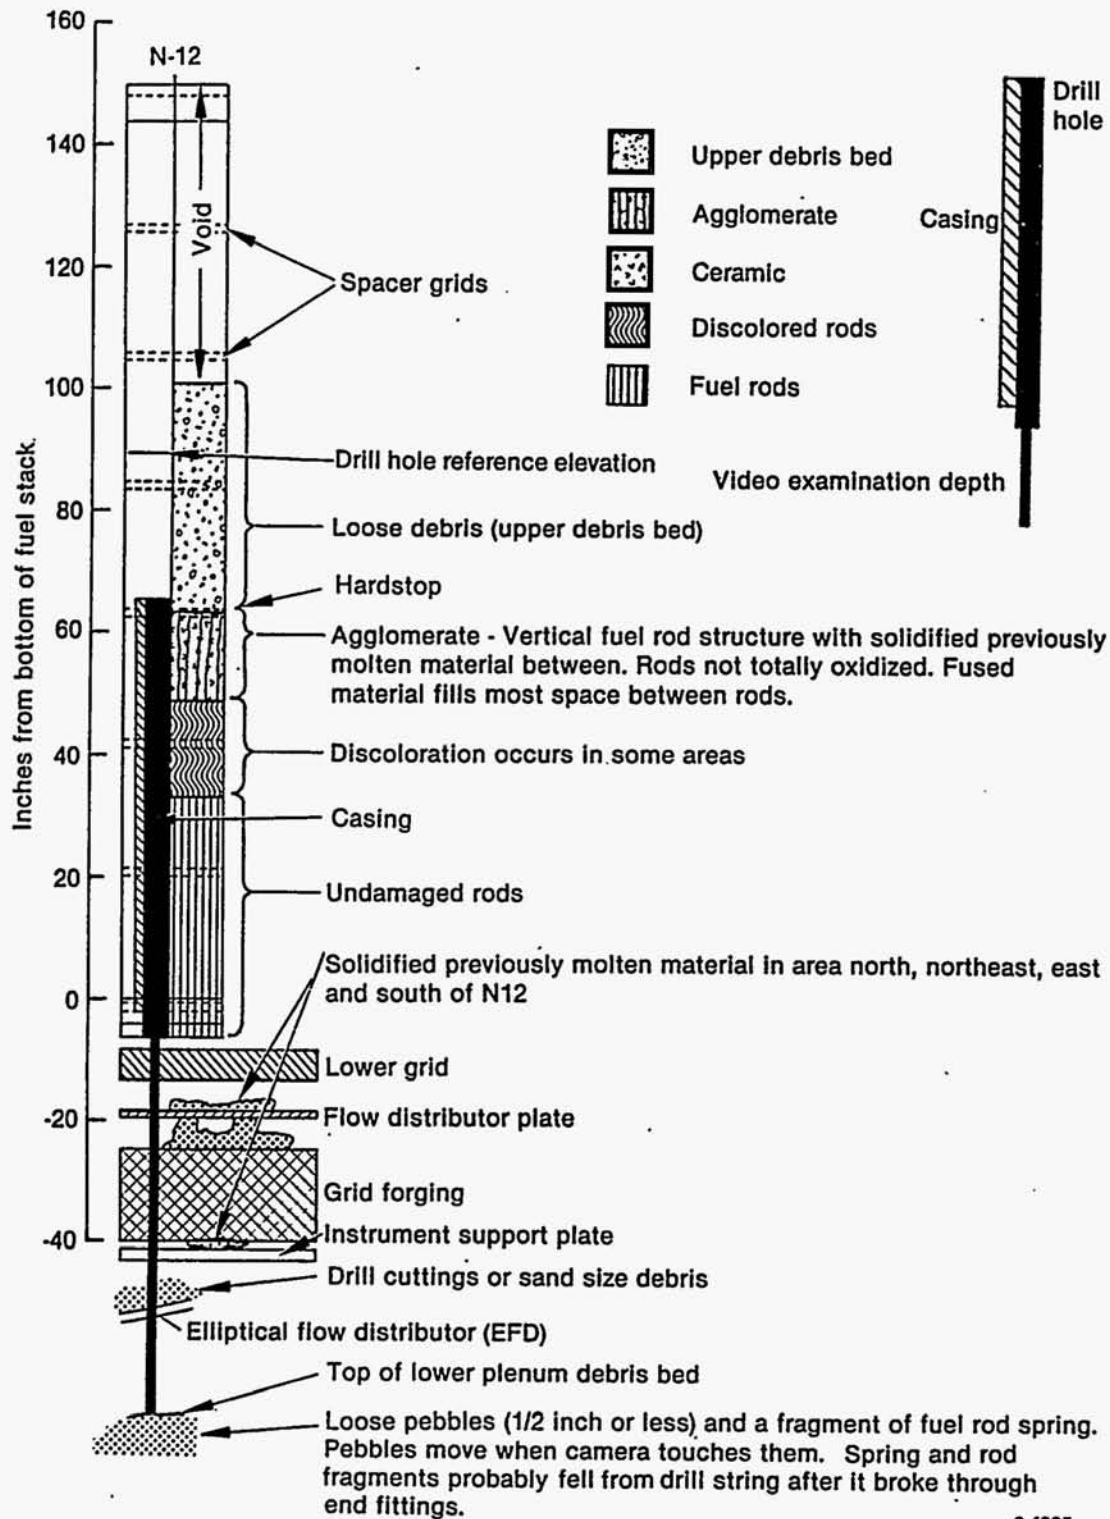
Figure 10. Observation summary from peripheral core bore location (N12).

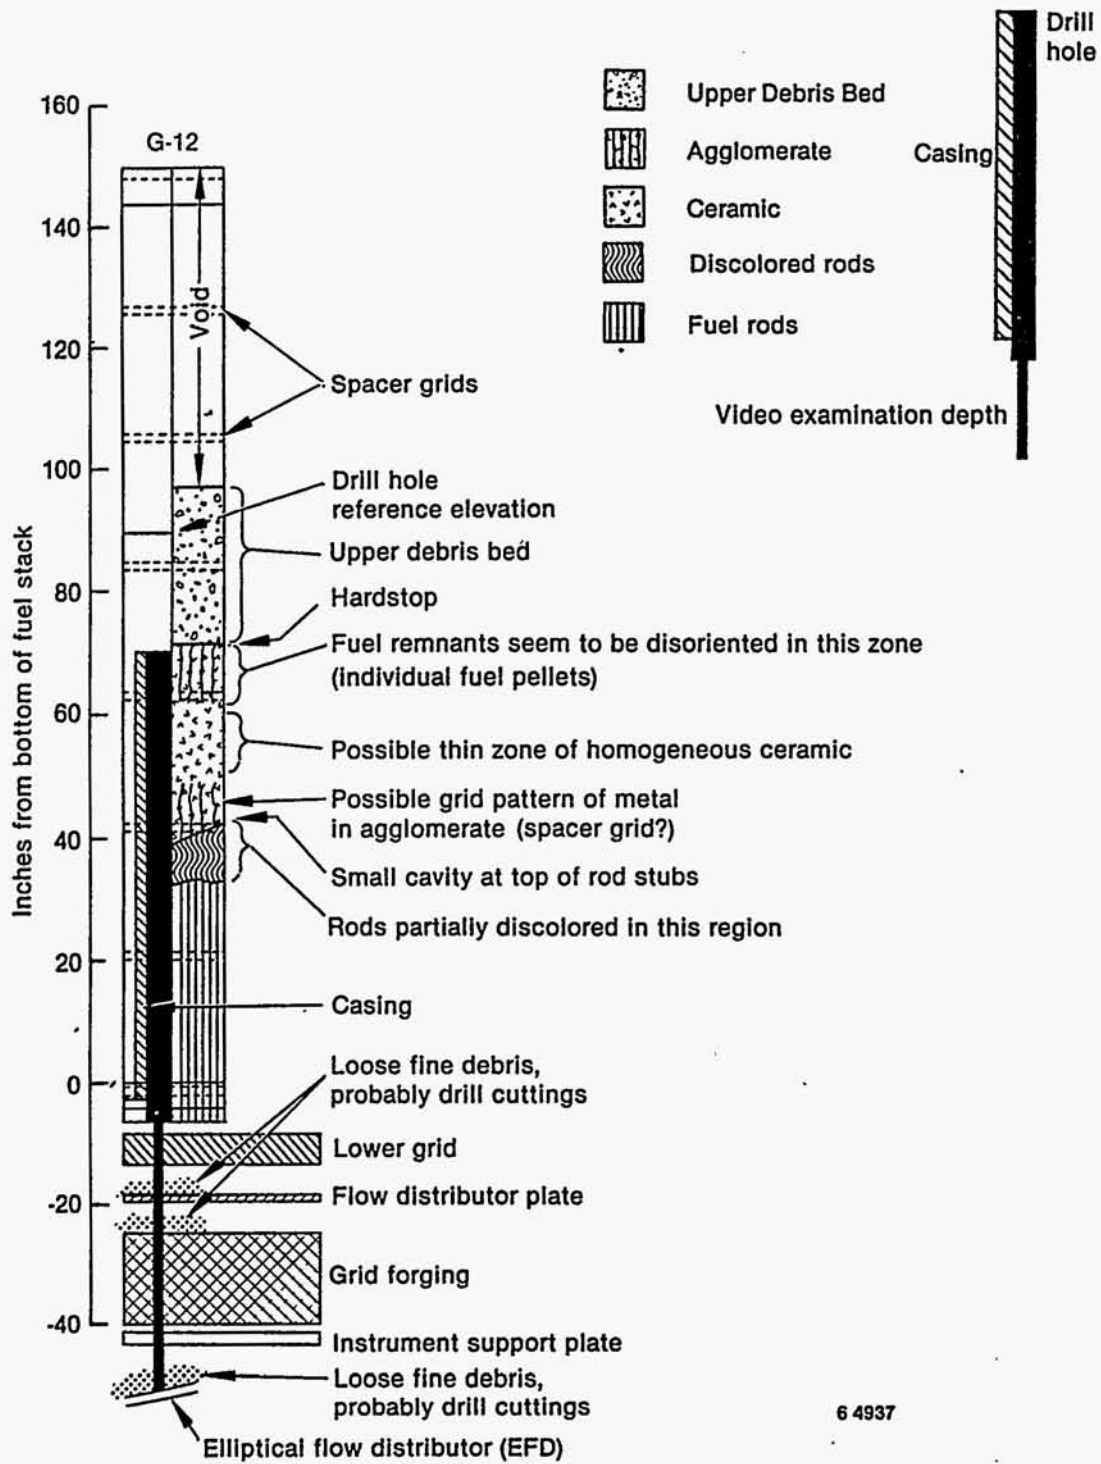
Figure 13. Observation summary from core bore location G12.

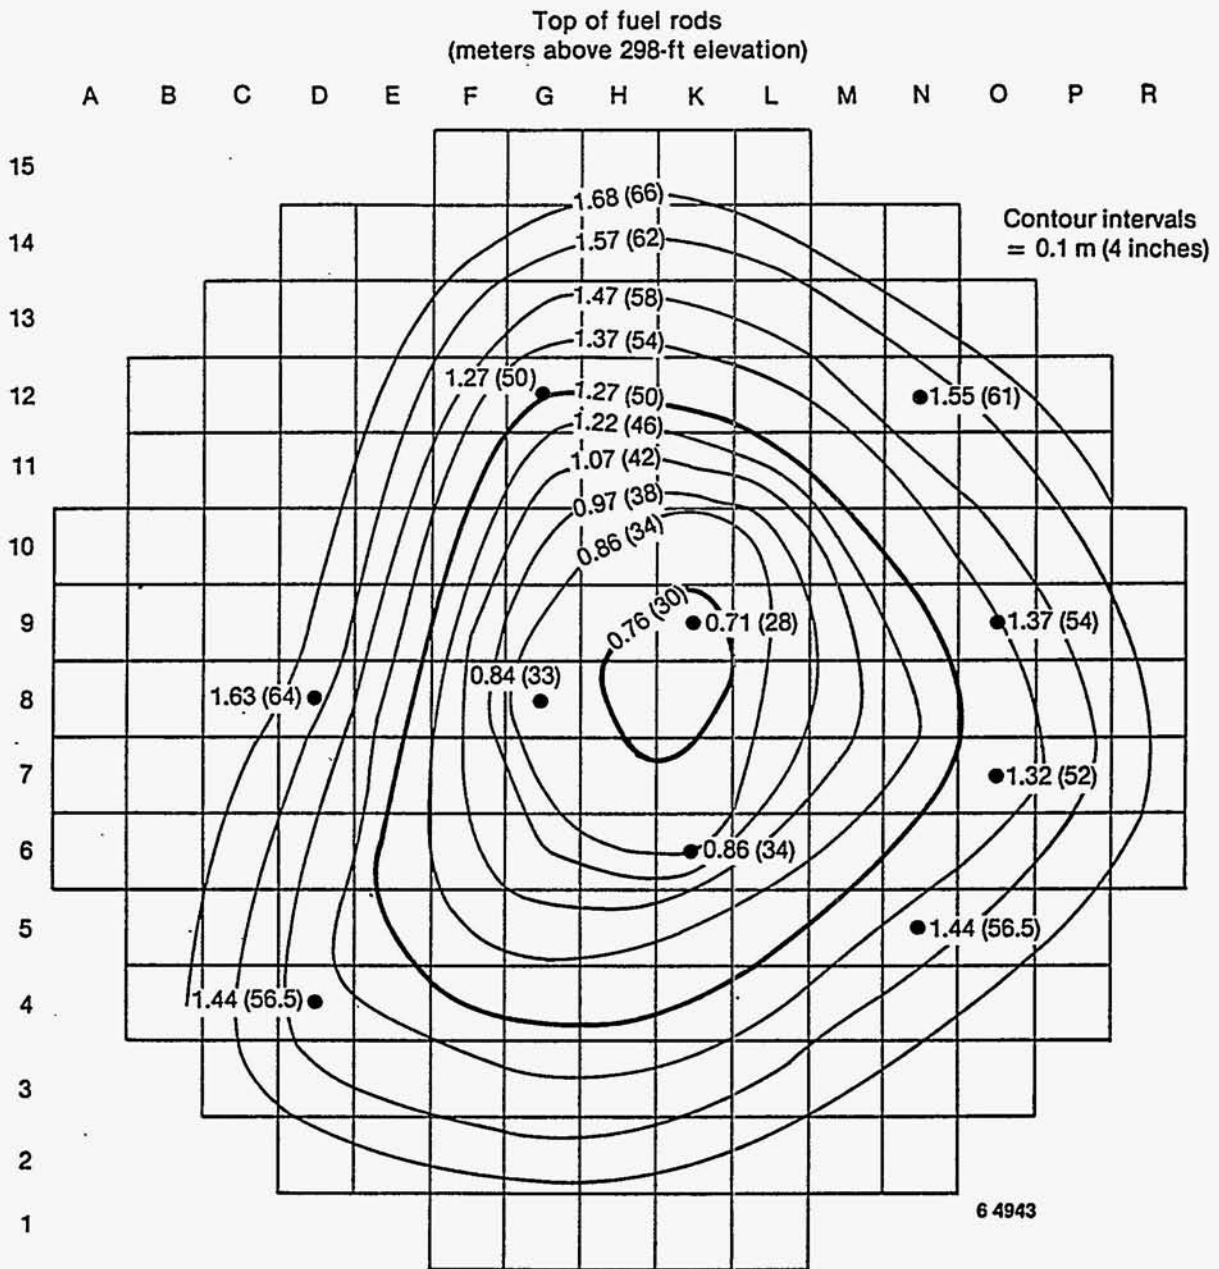
Note: The bottom of the active fuel is approximately 12 inches above the 298-ft elevation.

Figure 15. Contour map of the lower, intact fuel rods and molten core interface.

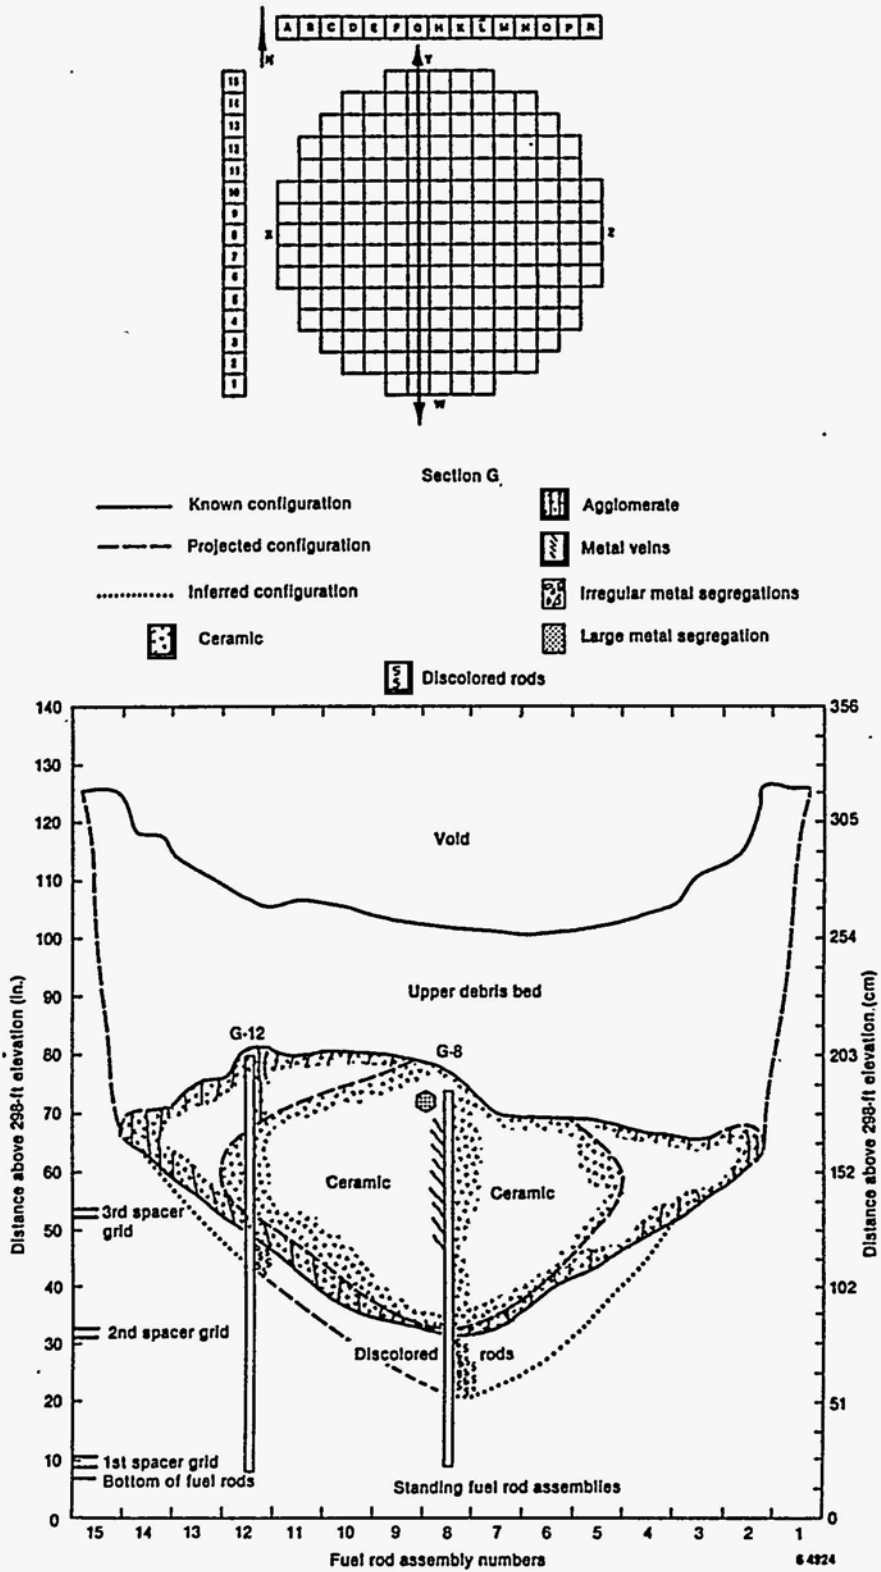
Figure 16. Core cross section across G row of fuel assemblies.

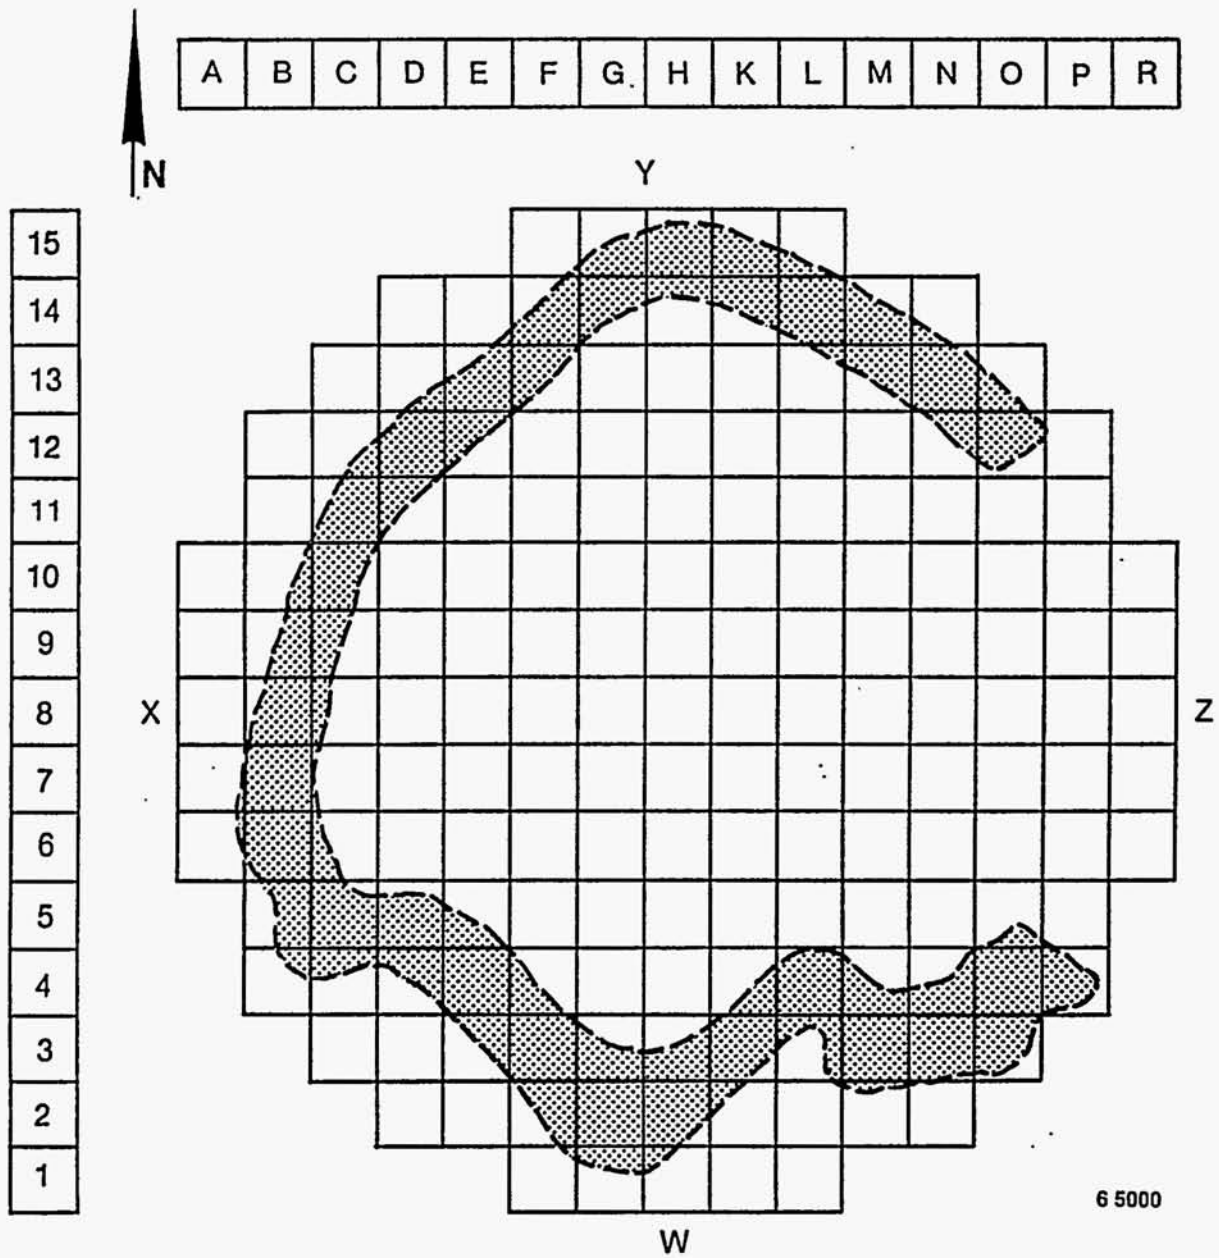
Figure 17. Estimated radial configuration of the upper ridge of agglomerate core material.

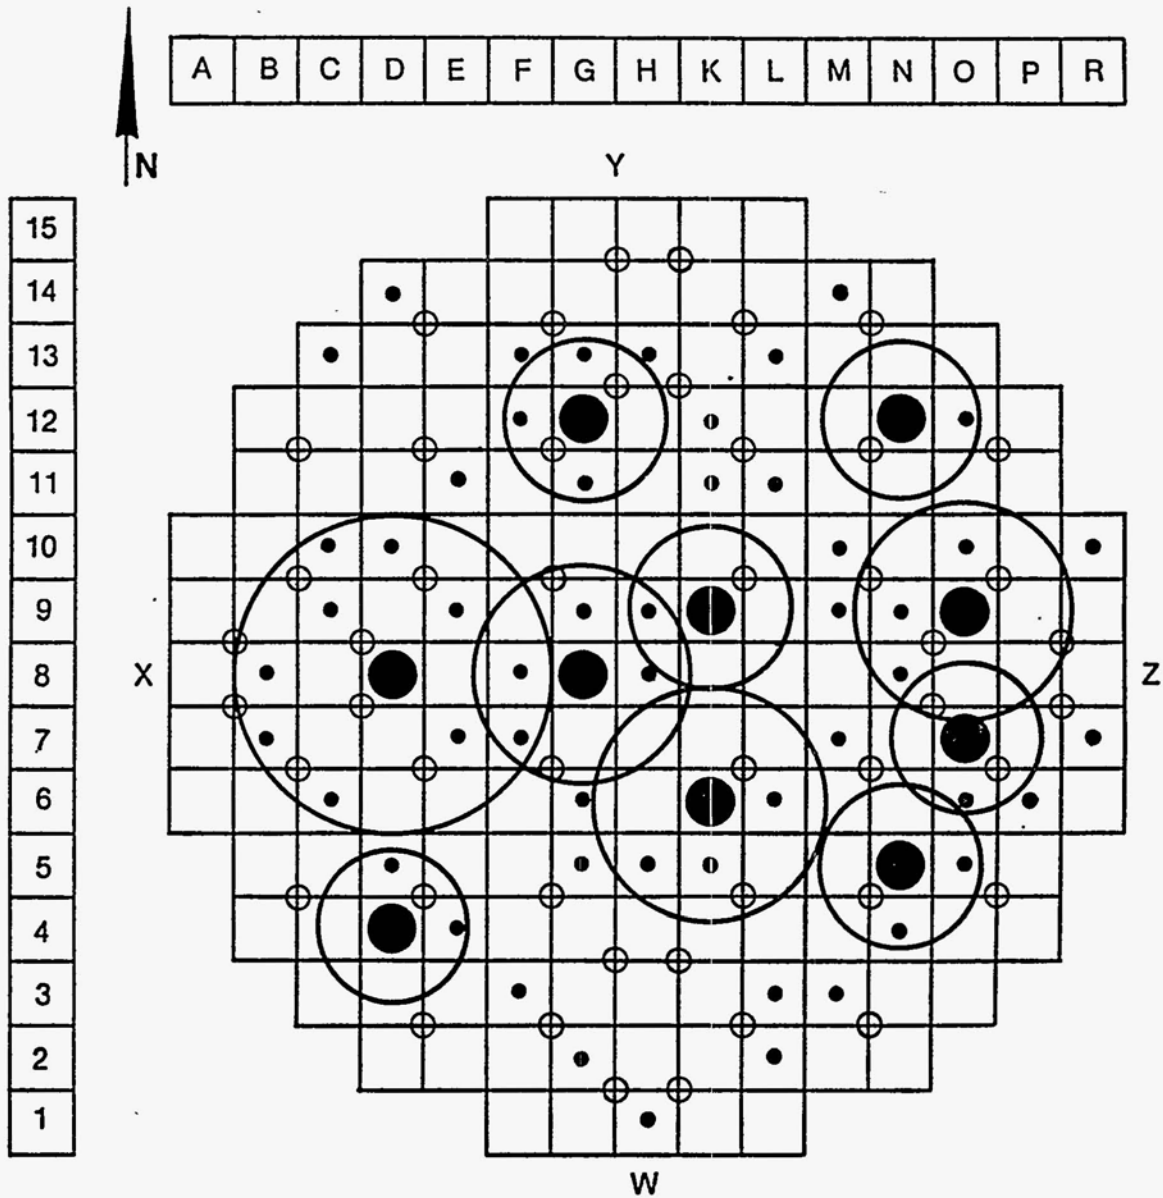
Figure 18. Approximate CSA regions discernible in video data.

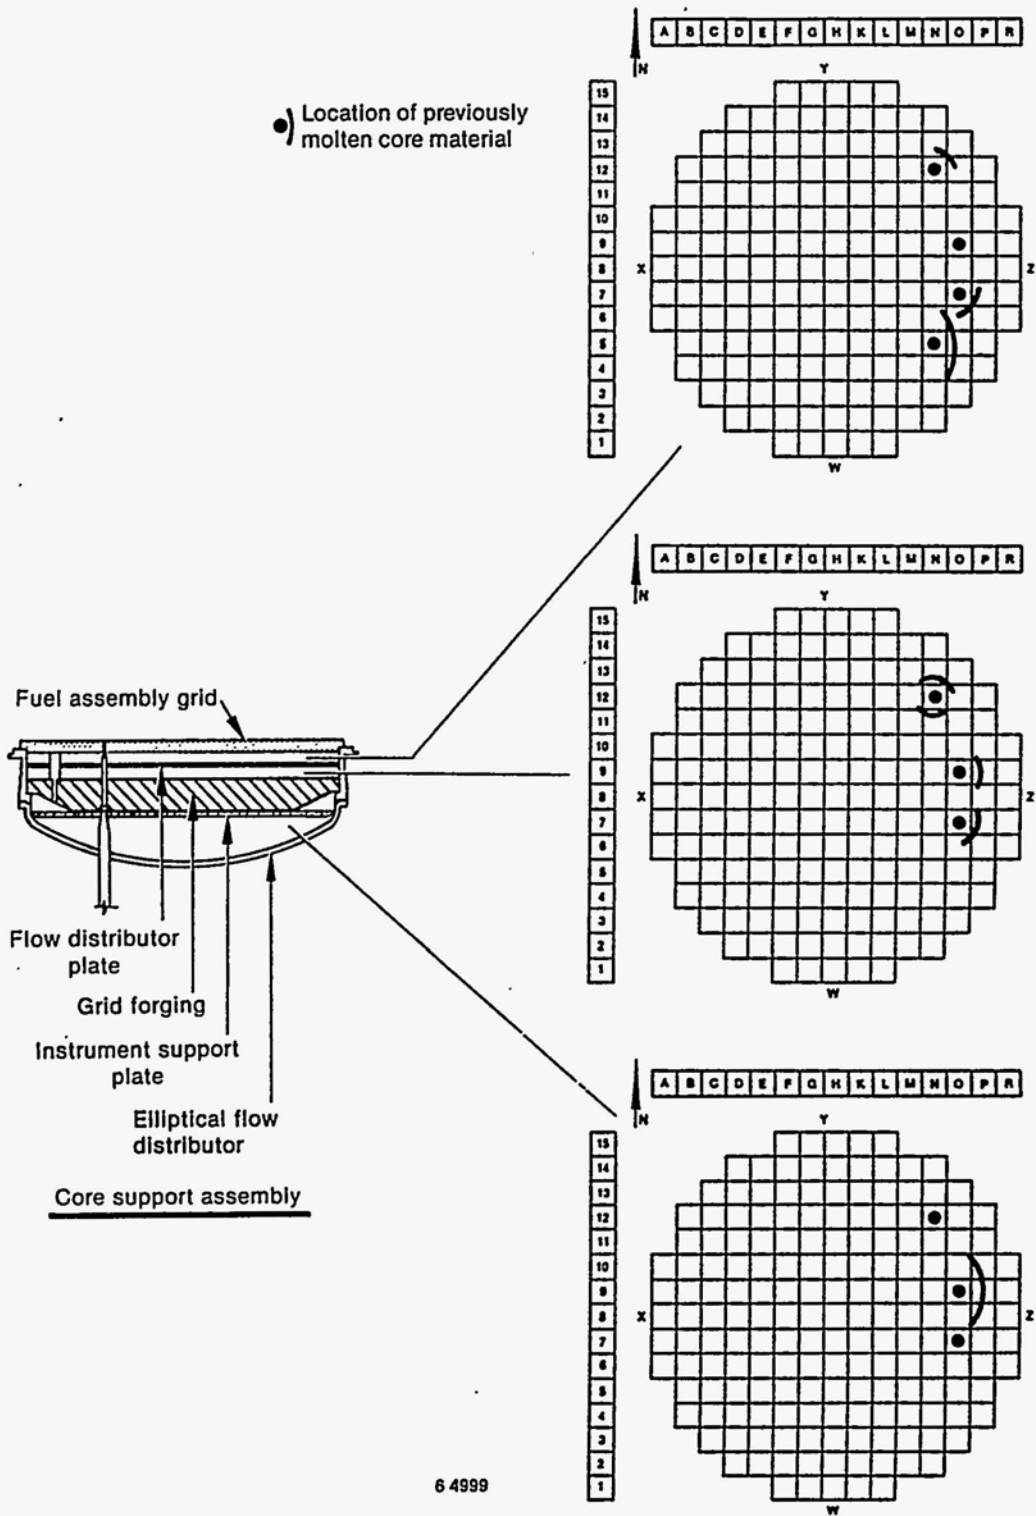
Figure 19. Regions (approximate) of significant fuel relocation in the CSA.

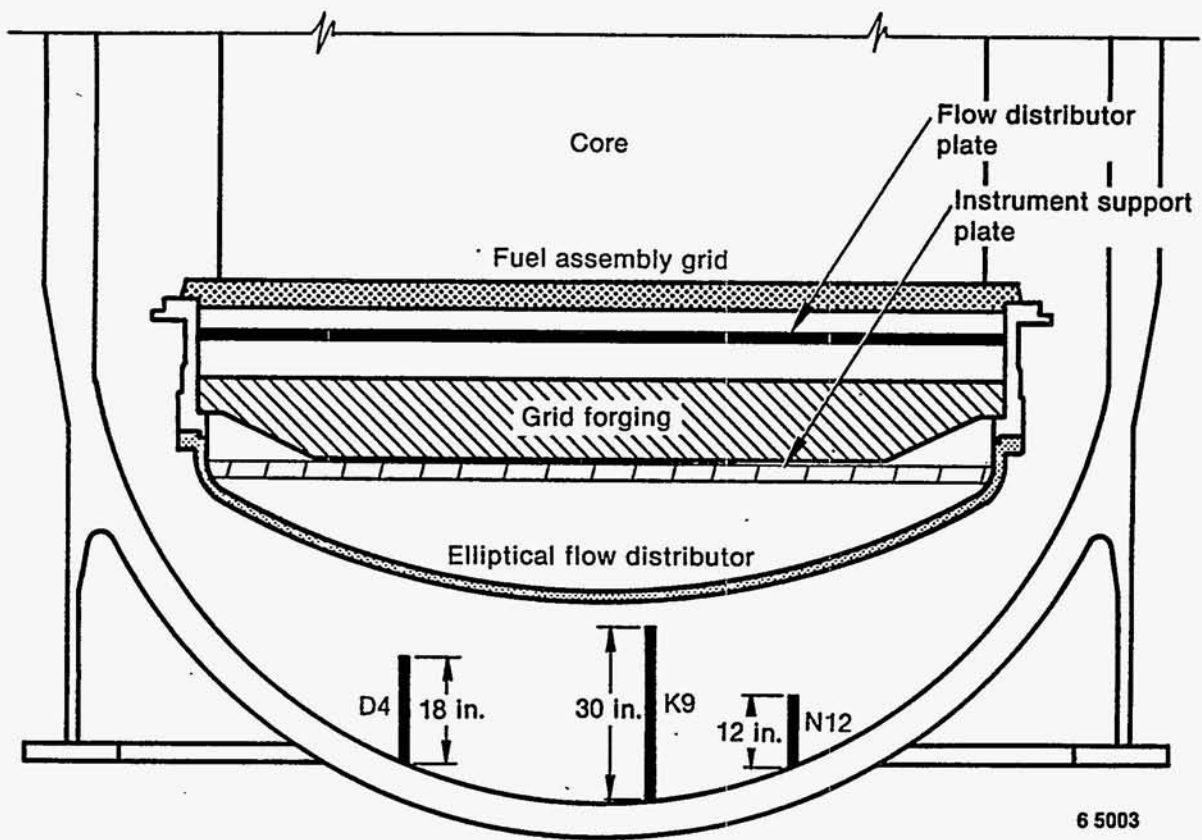
Figure 23. Estimated debris bed heights.

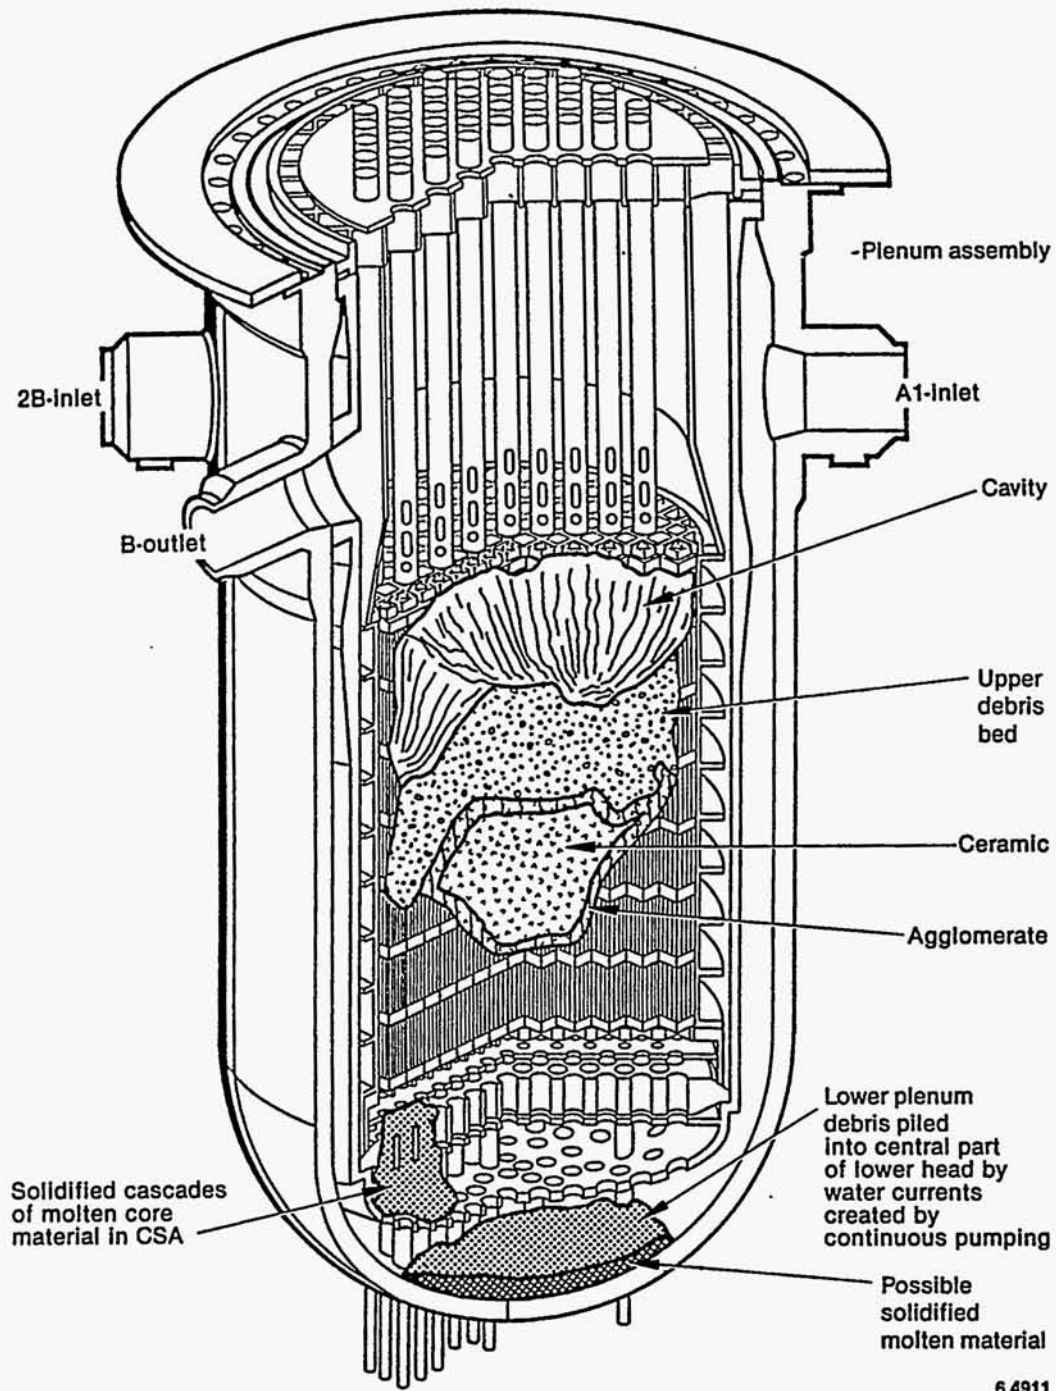
Figure 24. Updated end-state core conditions.

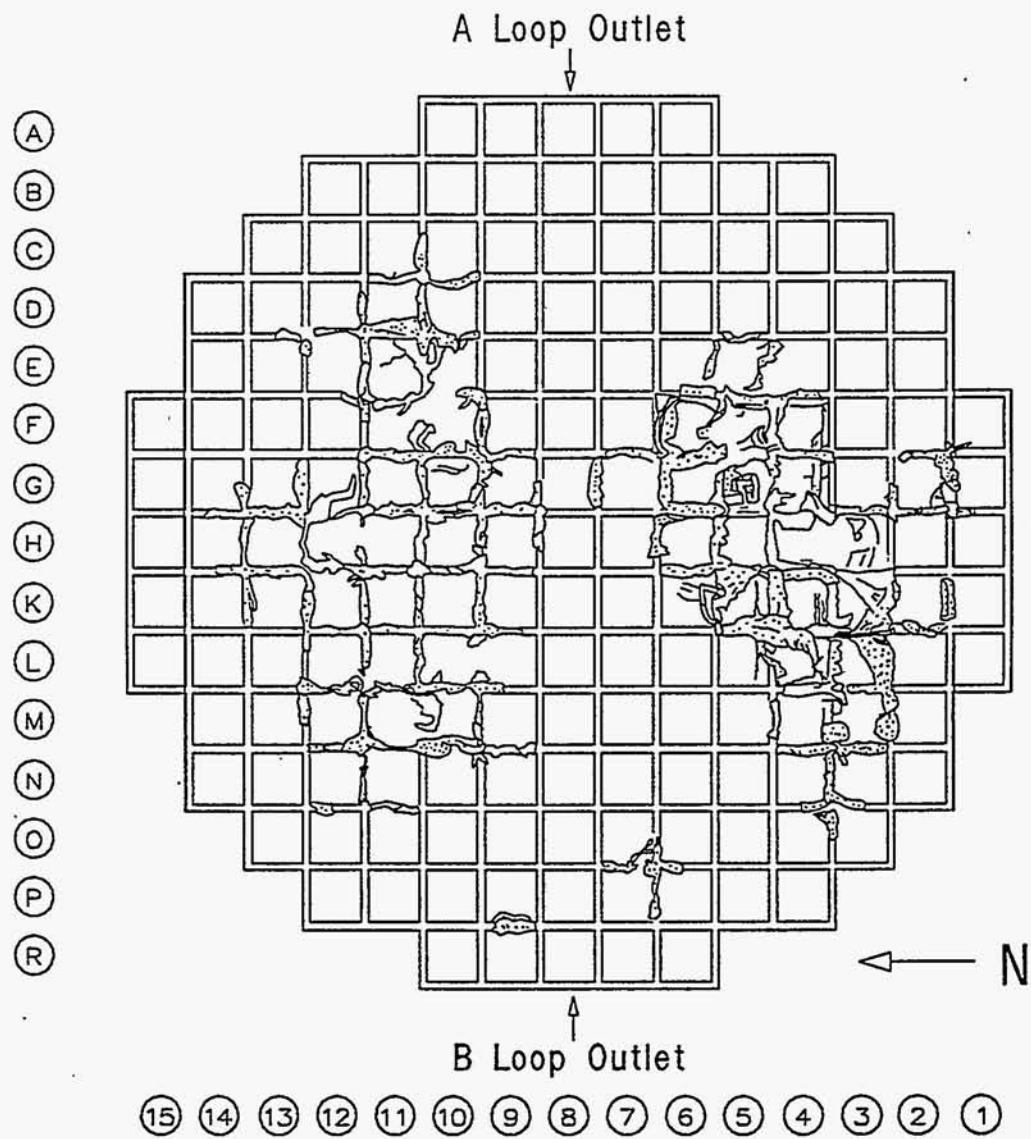
Figure 28. Damage map of the TMI-2 core upper grid structure as viewed from its underside.

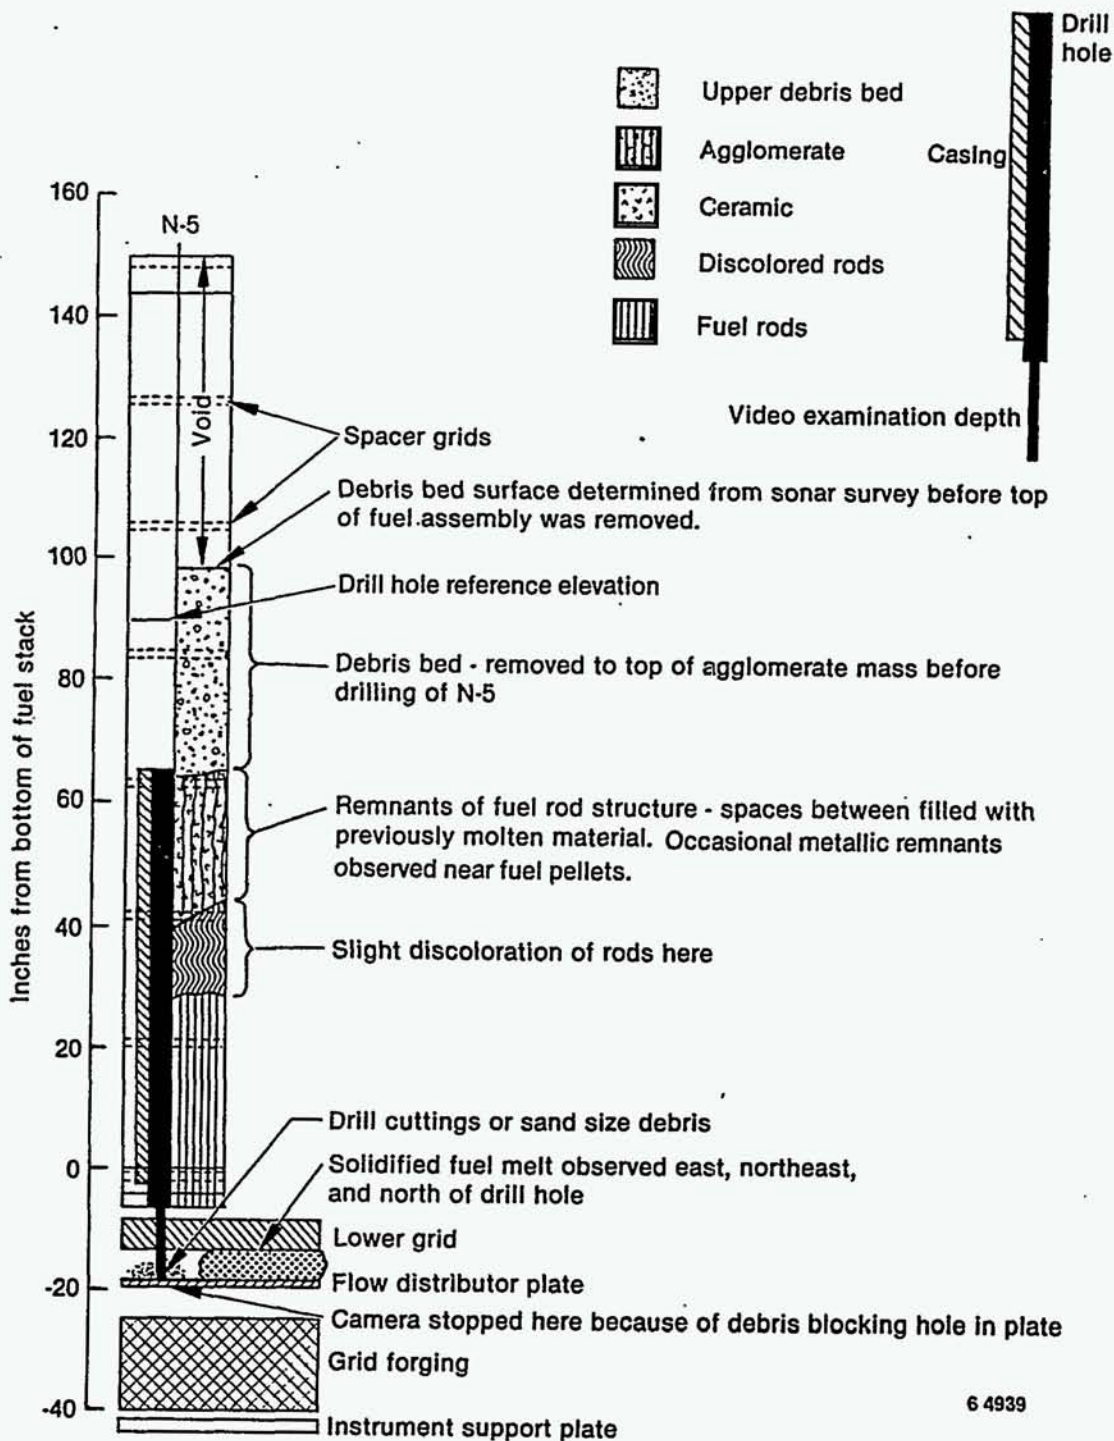
The agglomerate above the third spacer grid extends to at least 50 in. and includes previously molten material. Above about 50 in., no useful video data were recorded. The previously molten material fills most of the spaces between fuel rods. Since some vertical fuel rod structure is

Figure B-1. N5 drill configuration and inspection summary.

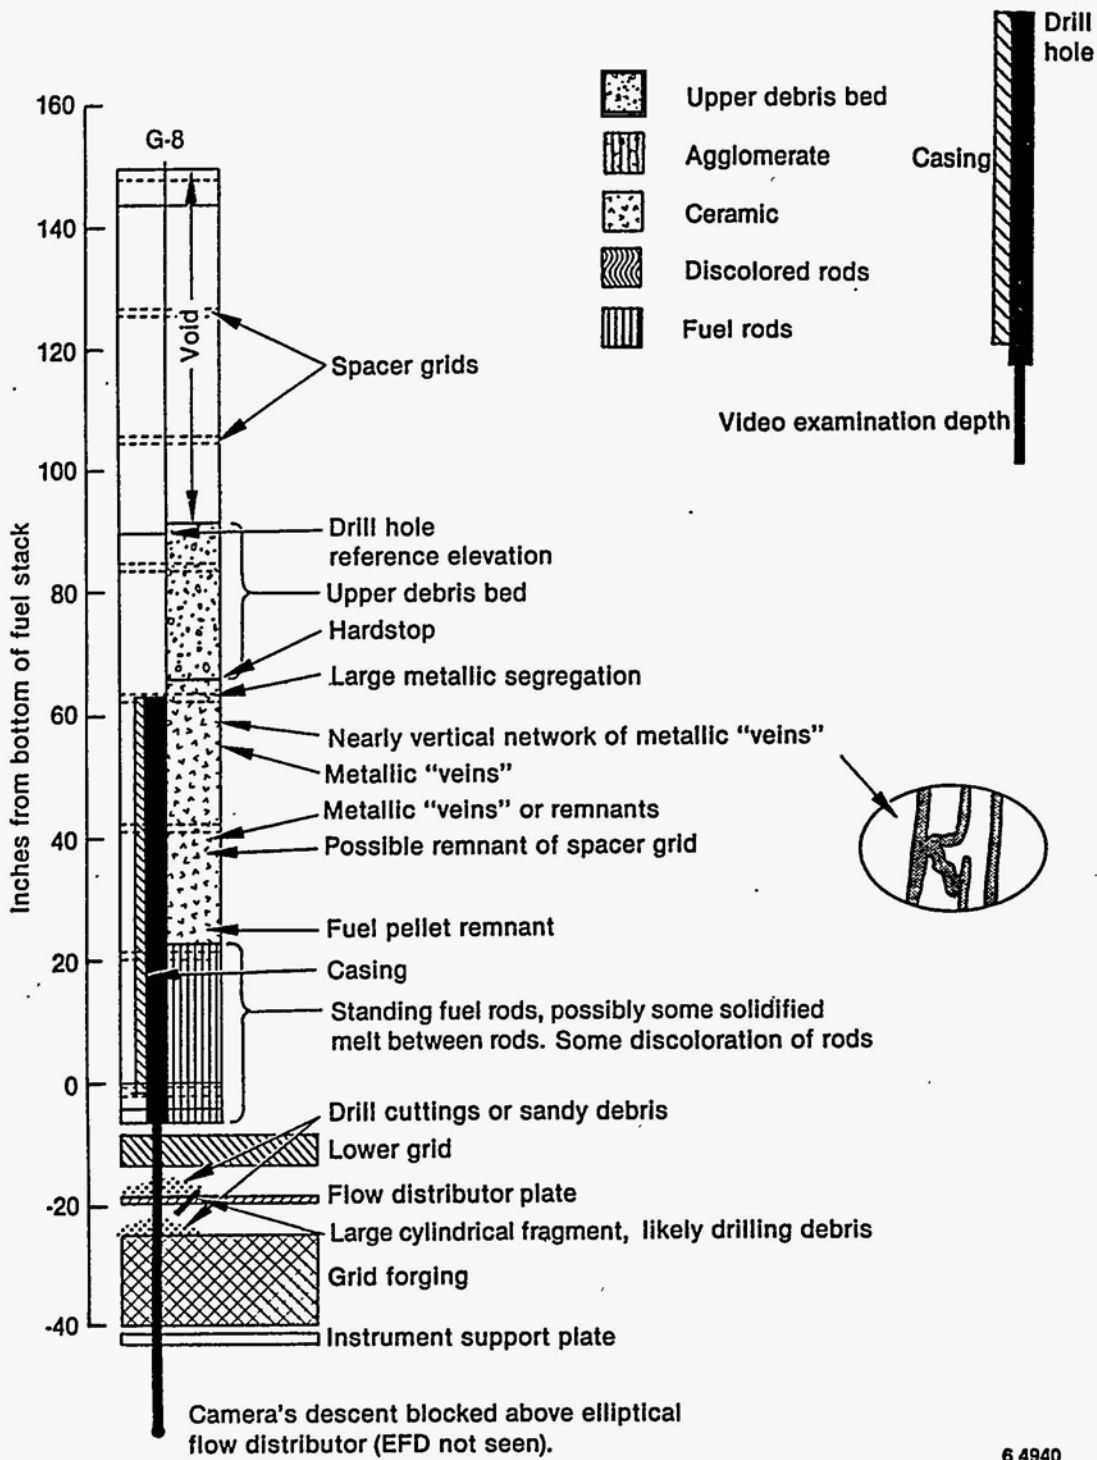
- o The only fuel pellet remnant is within an inch or so of the top of fuel rods.
- o Most of the observed metal-like structure in the ceramic shows evidence of having been melted; i.e., vein-like structure as if the ceramic solidified and fractured, allowing the molten metal to fill the fractures. The only exceptions are (a) a metallic grid-like structure (possibly a spacer grid remnant) and (b) a large metallic segregation near the top of the hole.
- o The bottom 12-14 in. of ceramic is free of metal segregations or veins.

Figure B-7. G8 drill configuration and inspection summary.

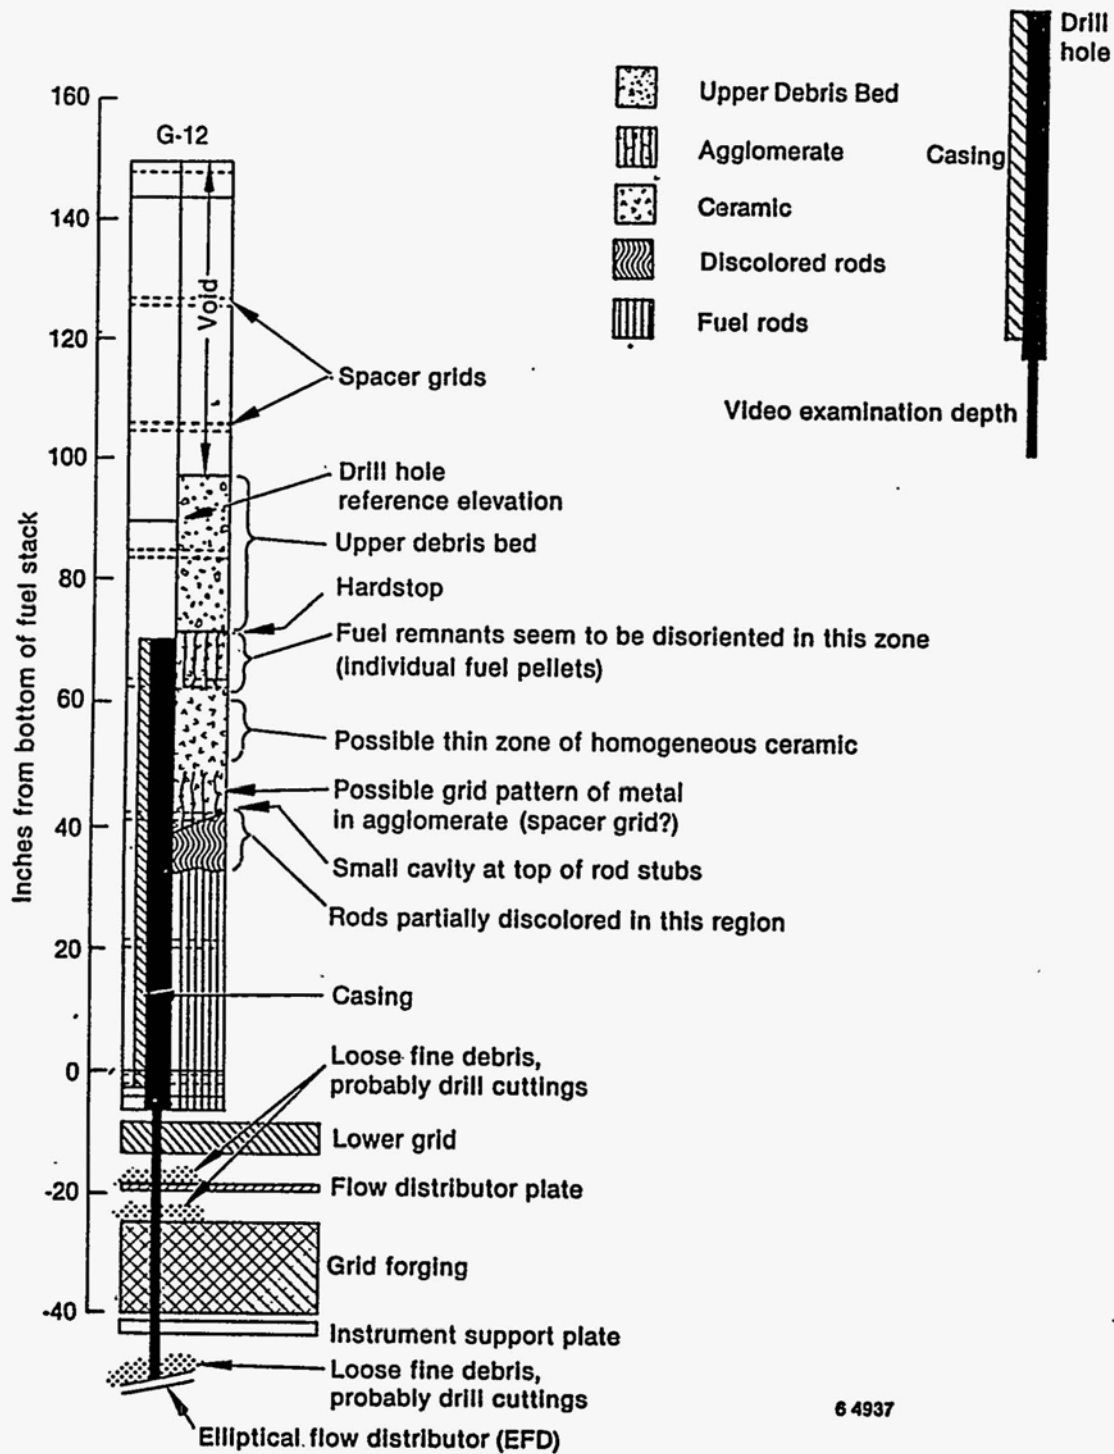
Standing intact fuel rods are observed from the lower fuel assembly endfitting to the third spacer grid. The rods appeared discolored next to

Figure B-9. G12 drill configuration and inspection summary.
