EGG-TMI-7385, Rev. 1
February 1987

TMI-2 CORE BORE ACQUISITION SUMMARY REPORT

Published February 1987

EG&G Idaho, Inc.
Idaho Falls, Idaho 83415

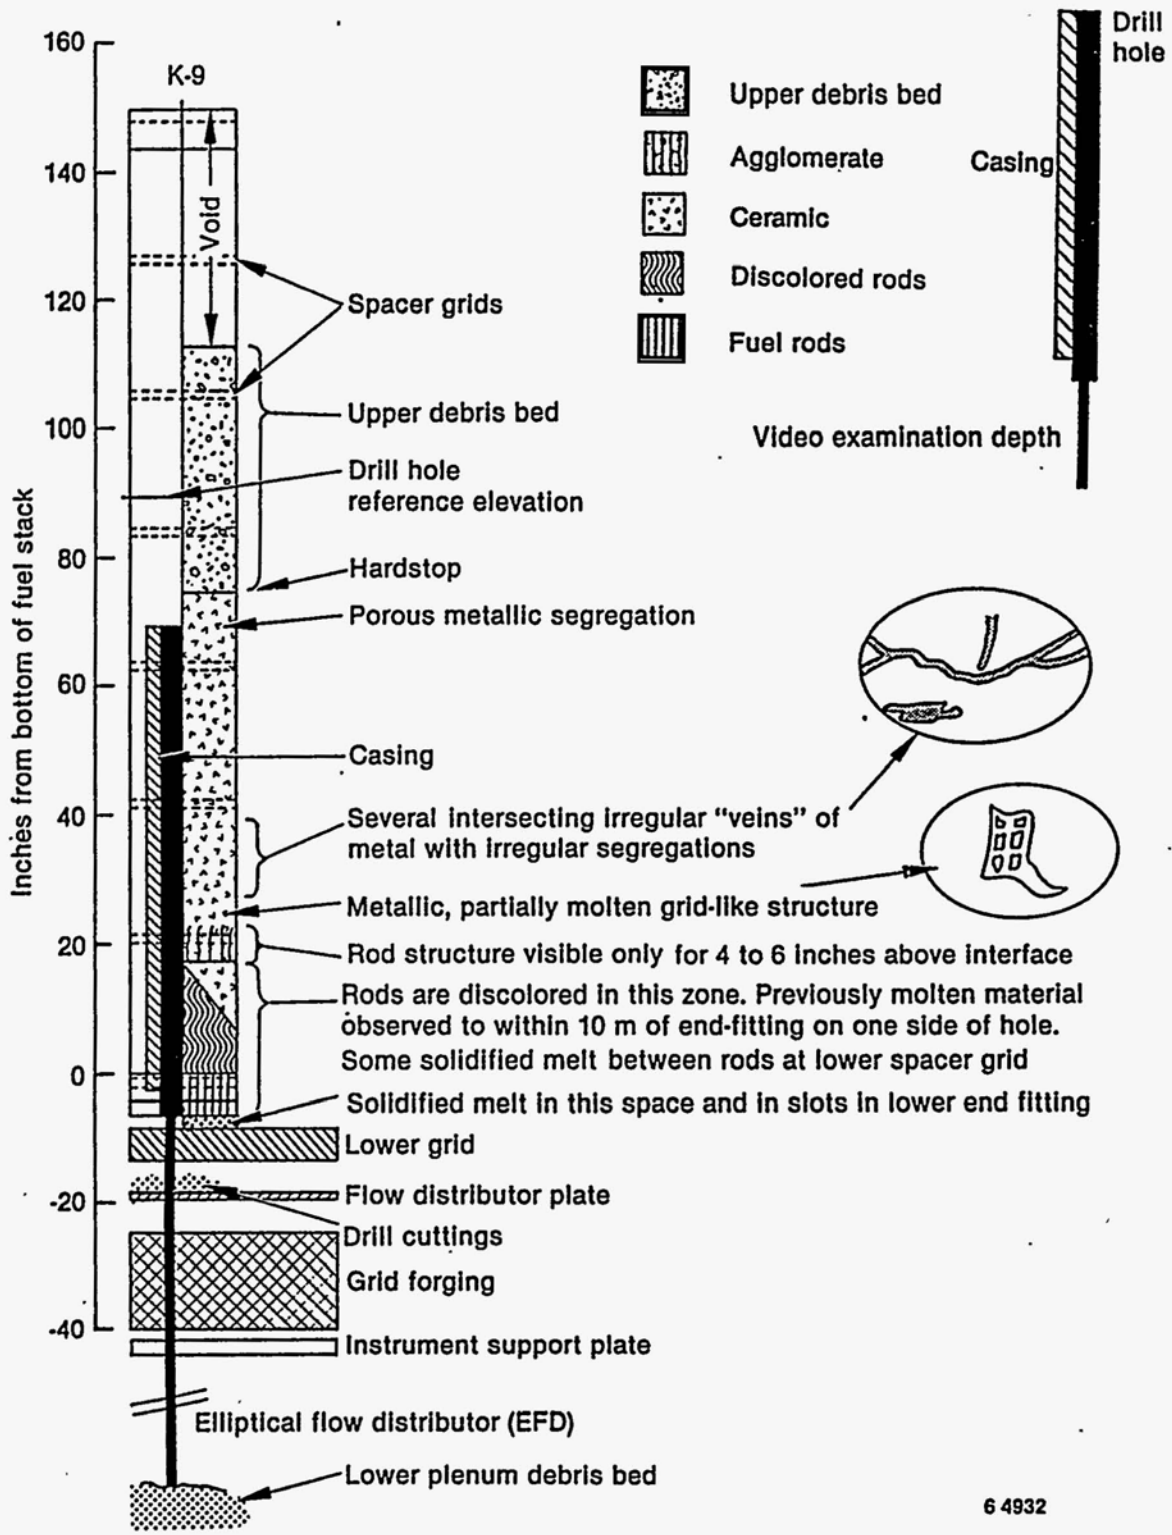
The lower plenum debris appears as a bed of loose pebbles with diameters less than 0.5 in., much the same as observed in N12. Based on the inspection data (obtained after the lower plenum core bore was taken), the upper surface of the debris bed is estimated to be about 8 in. below the elliptical flow distributor. Pieces of fuel rods were observed on the surface of the debris and most likely fell during the drilling operation.

Figure B-12. K9 drill configuration and inspection summary.

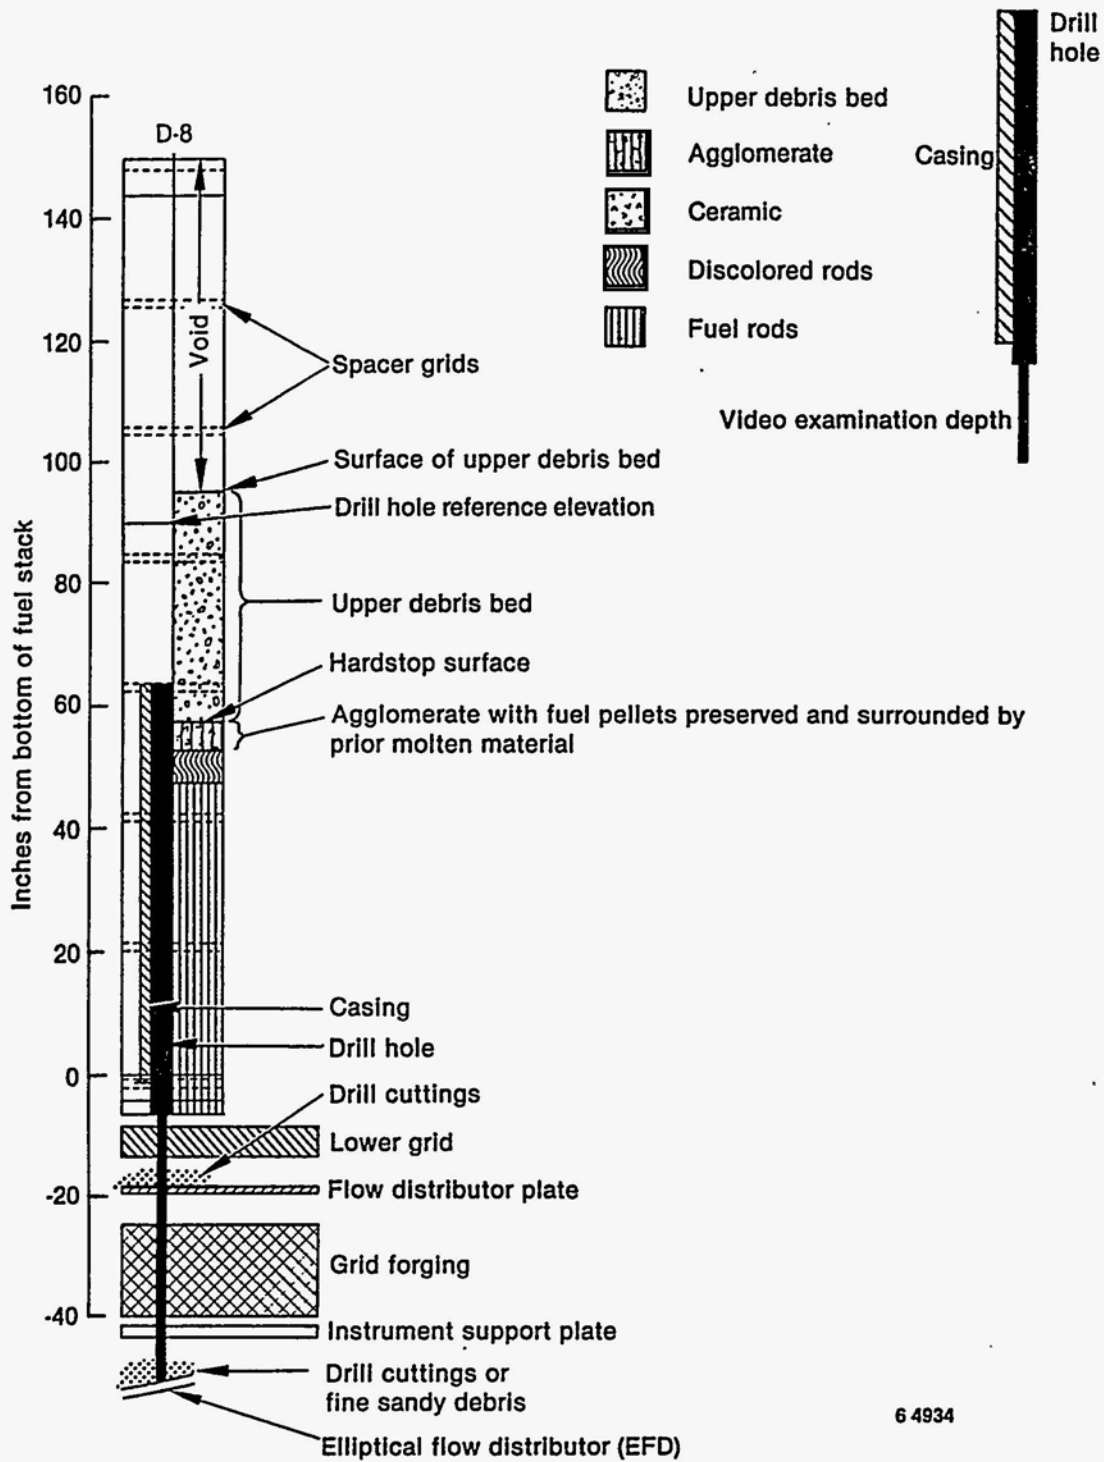
Figure B-15. D8 drill configuration and inspection summary.

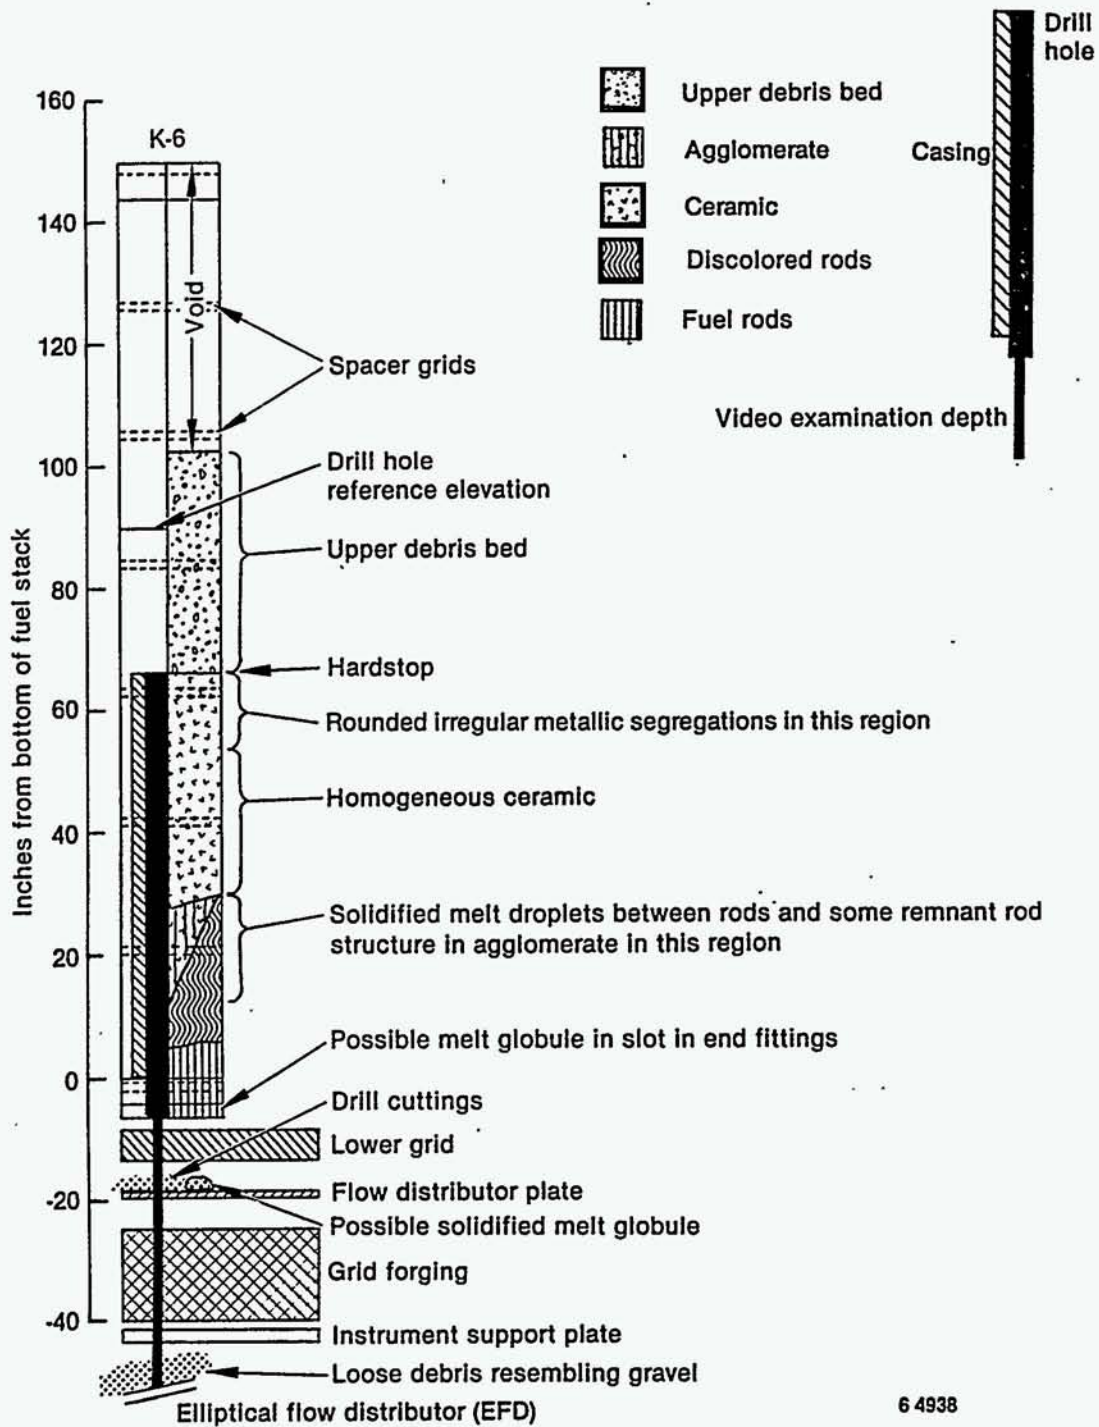
Figure B-18. K6 drill configuration and inspection summary.

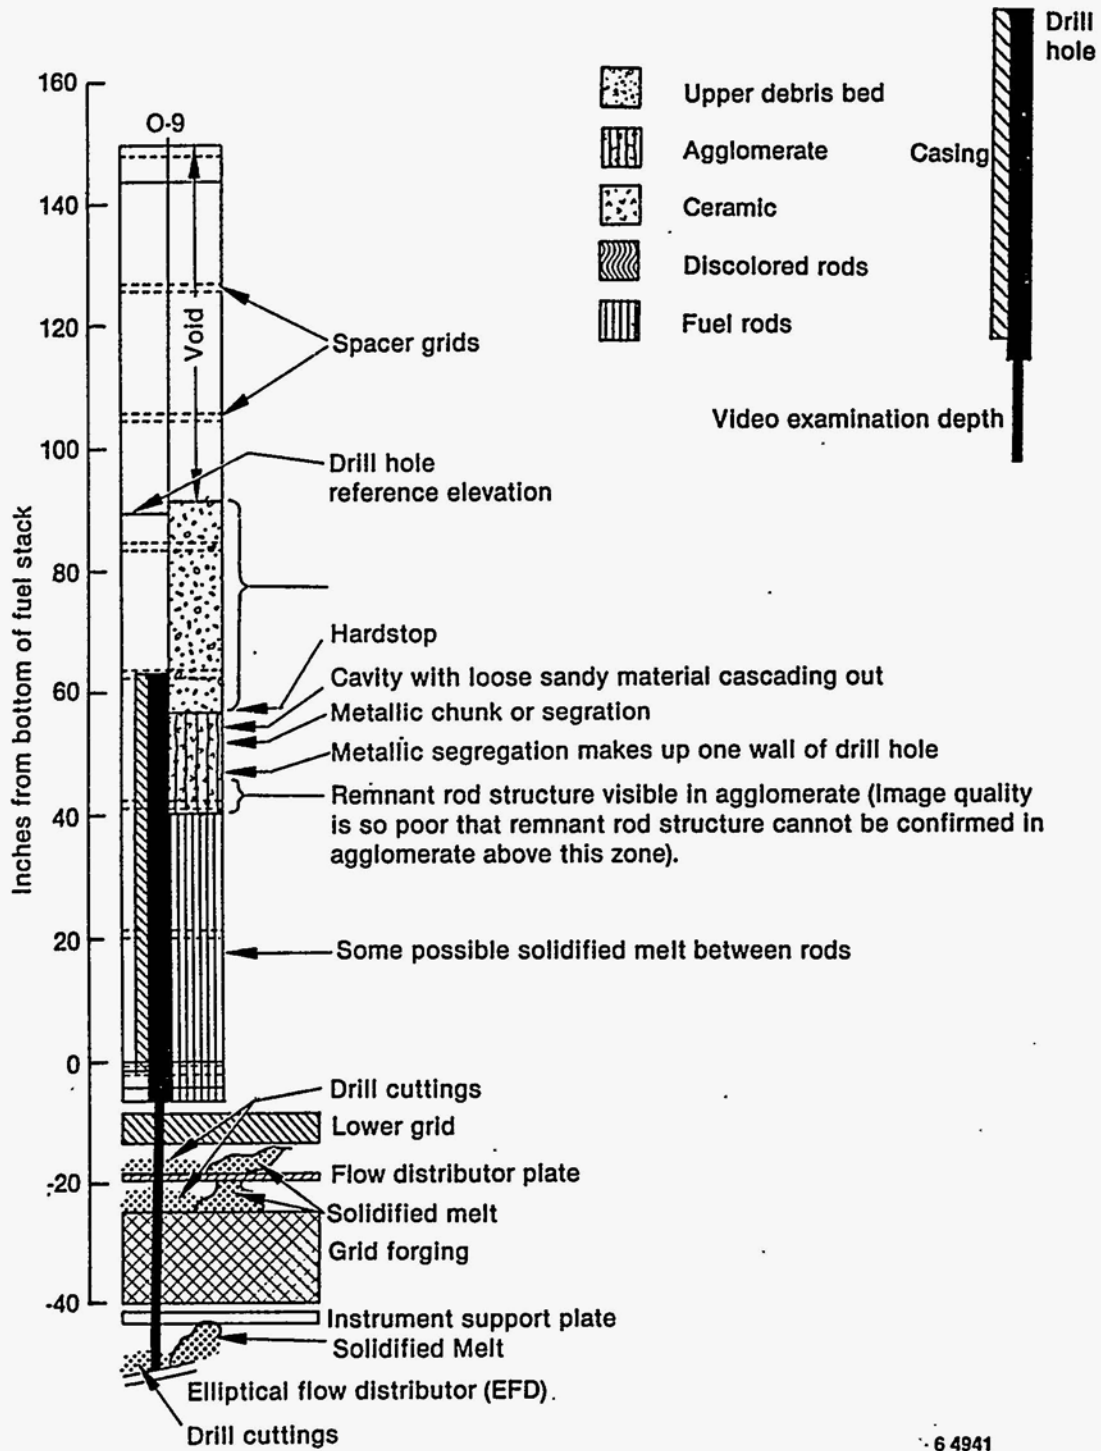
Figure B-27. 09 drill configuration and inspection summary.
