EGG-TMI-7429
July 1987

TMI-2 LOWER PLENUM VIDEO DATA SUMMARY

James P. Adams
Richard P. Smith

Published July 1987

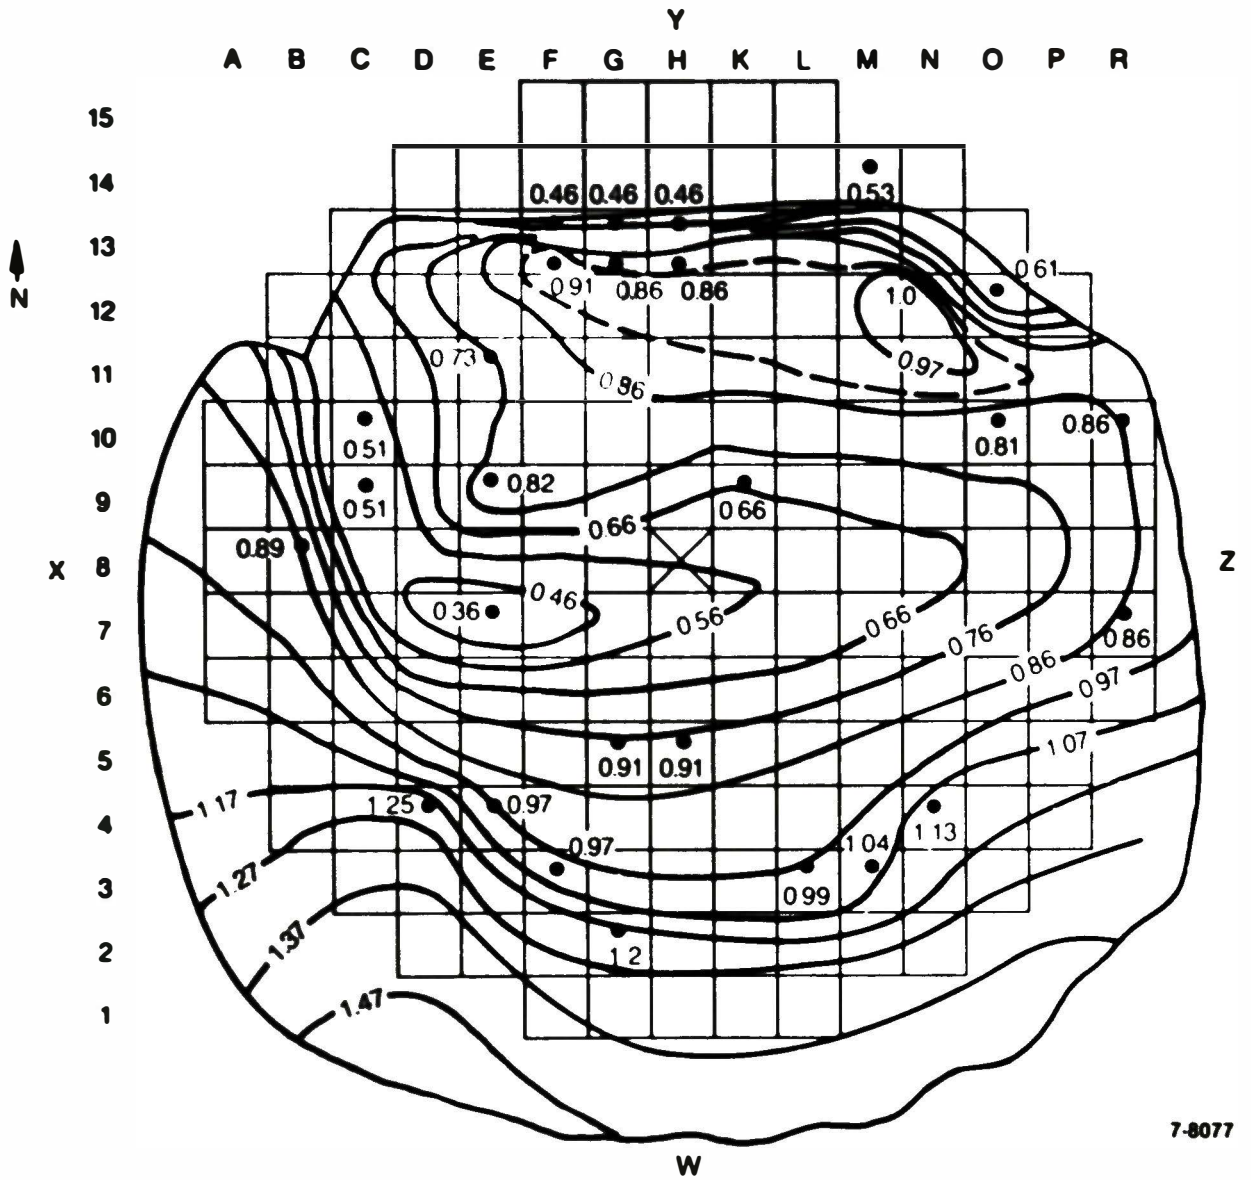
As shown in Figure 6, the rubble bed extends to near the reactor vessel wall along three axes (W, X, and Z) but only to the last row of instrument guide tubes at the Y axis. This is illustrated by Figures 7 and 8, which are photographs of the lower rubble bed at the W and Y axes, respectively. The abrupt "wall" of debris at the Y axis is evident from Figure 8, while the rubble continues to the downcomer wall at the W axis shown in Figure 7. The top surface of the bed slopes from south to north, with a rounded depression extending from west to east in the central zone.

Figure 6. TMI-2 lower plenum debris bed contour map.

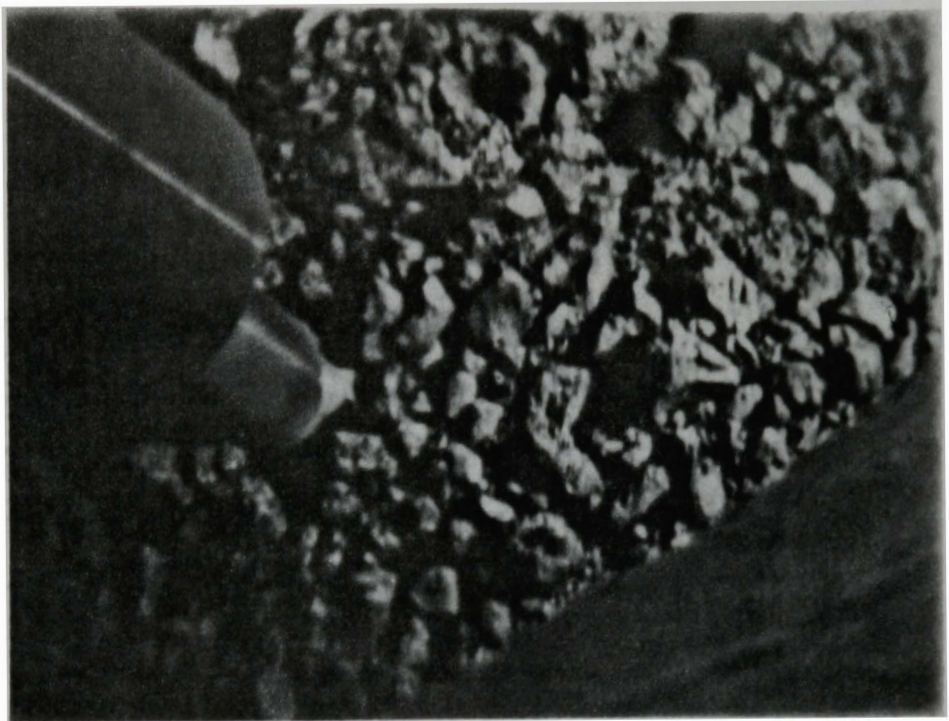
Figure 7. Photograph of TMI-2 lower plenum rubble bed at W axis.

The W axis debris bed looks like a uniform bed of fine to medium-sized debris (see Figure 7). A few larger chunks also exist, but the sizes of these chunks are not determined. There is a transition zone in this region, with a sharp transition between a very uniform and smooth rubble bed and a bed with a large number of medium-sized chunks. The rubble is easily dislodged by the camera and lights. Figures 32 and 33 are photographs of each side of this transition zone.

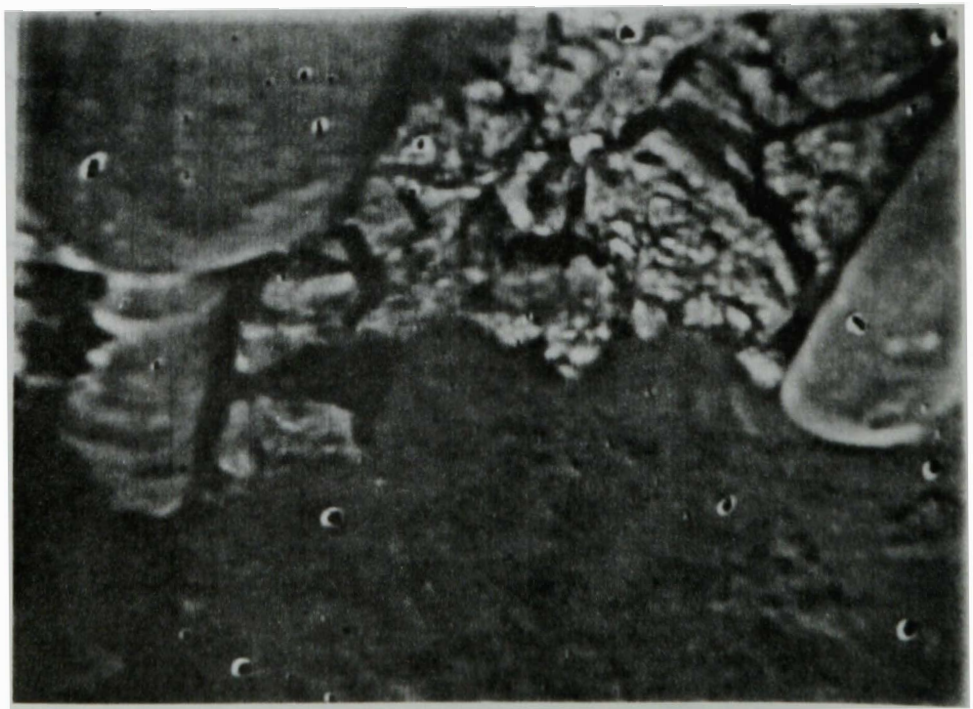
Figure 8. Photograph of TMI-2 lower plenum rubble bed at Y axis.

Large differences in physical appearance exist in the rubble bed. The rubble near the Y axis, as indicated earlier, has the appearance of a large, lava-like cliff which abuts the outermost row of instrument guide tubes (see Figure 8). The region in front of the rubble cliff has almost no debris. In some places, the lower head can be seen, indicating only a light "dusting" of debris at this location. The cliff appears to be solid with a smooth surface interlaced with cracks. There are also some large chunks of previously molten corium which may be loose.

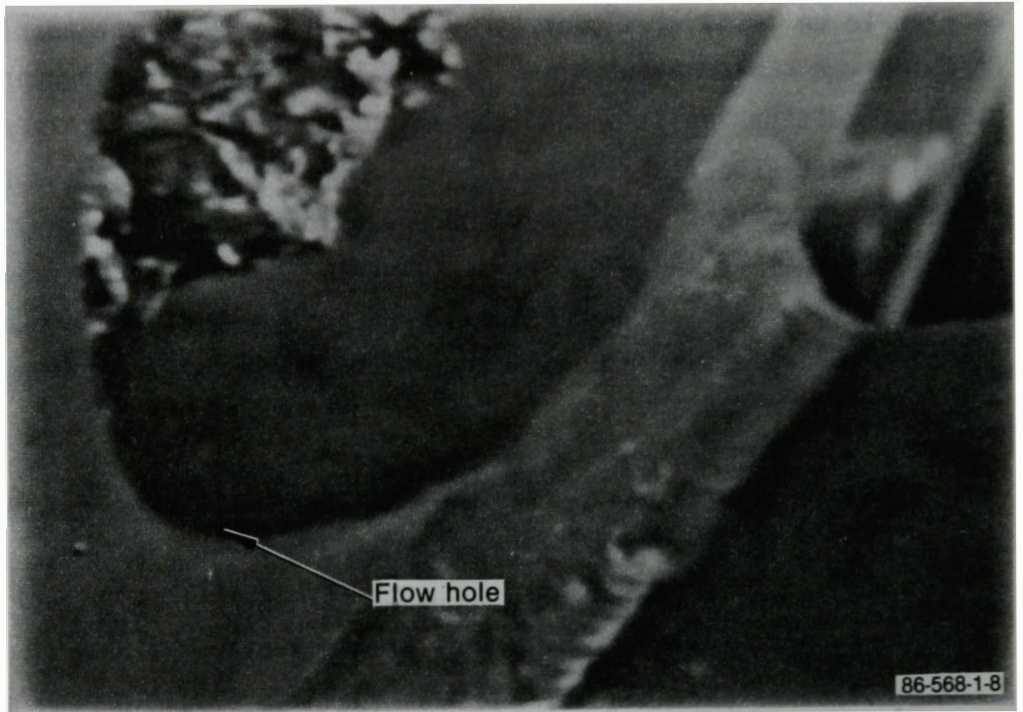
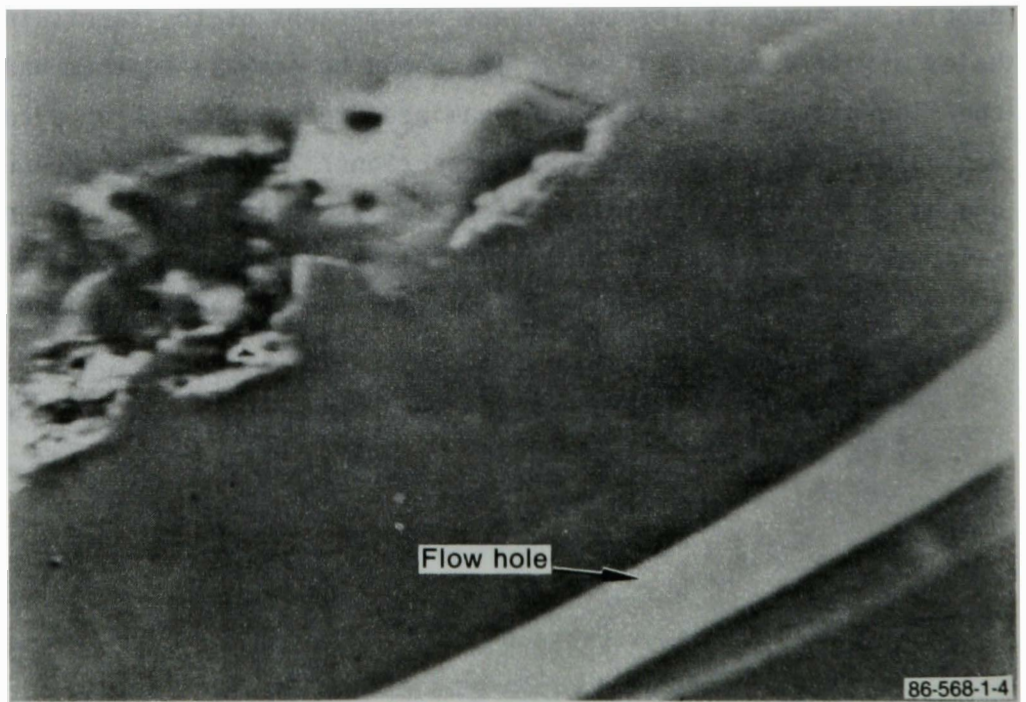
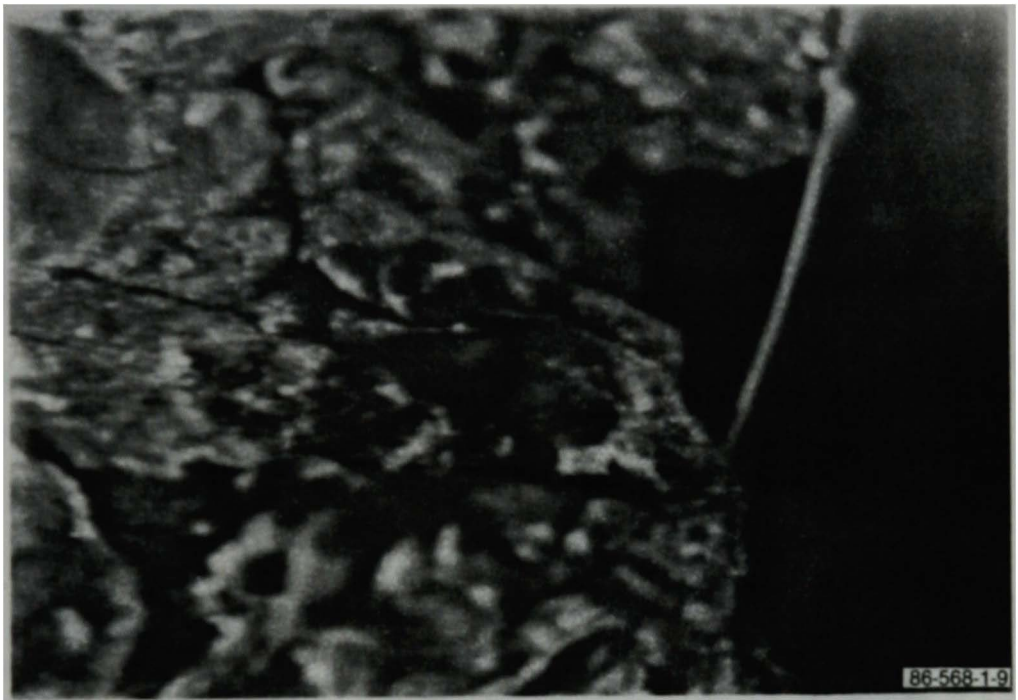
During the lower plenum inspection, debris was observed in some of the holes in the elliptical flow distributor head. The debris in this region was mainly observed during the February 1985 inspection of the Z axis (hole No. 4), the December 1985 inspection of the Y axis (hole No. 14), and the December 1985 inspection of the W axis (hole No. 7). The region of inspection (of the elliptical flow distributor head) was very limited, and no attempt has been made to map the region where debris has been observed. Enhanced photographs were made from the video tapes to illustrate this debris. Figures 26 through 28 are photographs of the debris in the flow holes at different locations. It should be emphasized that only a part of the flow distributor plate was examined due to the lack of a camera manipulator during some of the inspections. Also, since the core was broken up due to the drilling operations, causing additional debris to be relocated to the CSA, it will be difficult, if not impossible, to determine the condition of this head after the accident by additional inspections.

Figure 26. Photographs of TMI-2 debris in flow hole at Z axis.

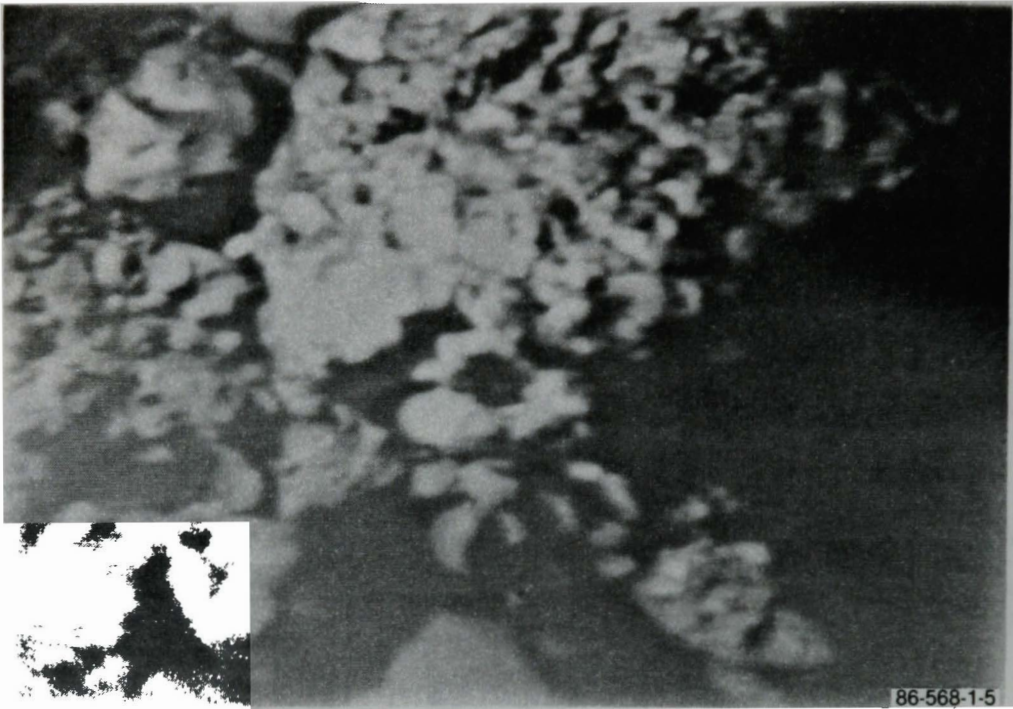
Figure 27. Photograph of TMI-2 debris on top of elliptical flow distributor plate.

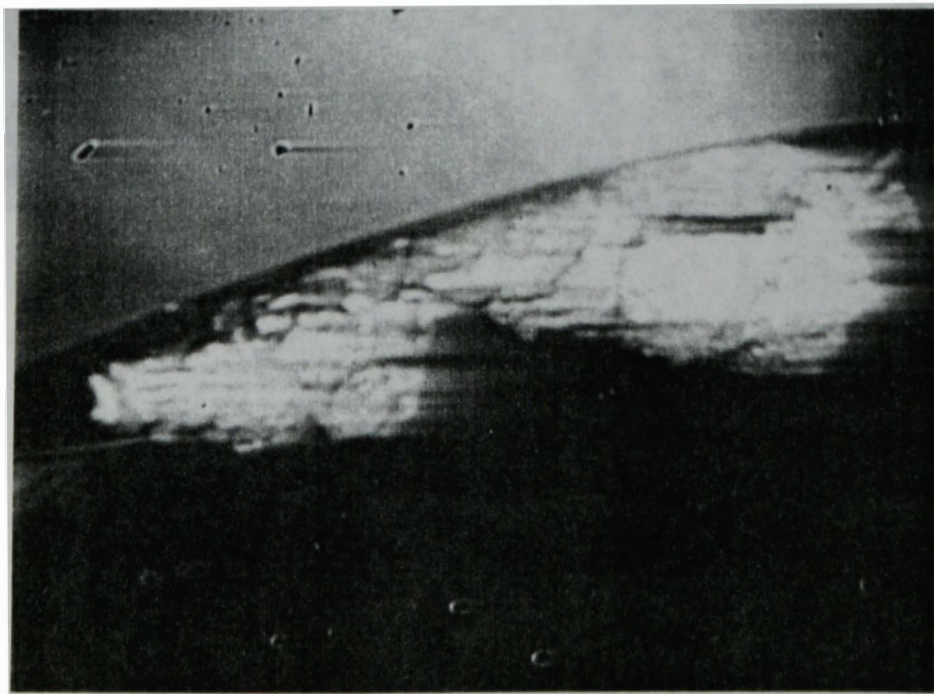
Figure 28. Photograph showing previously molten corium in flow hole at W axis.

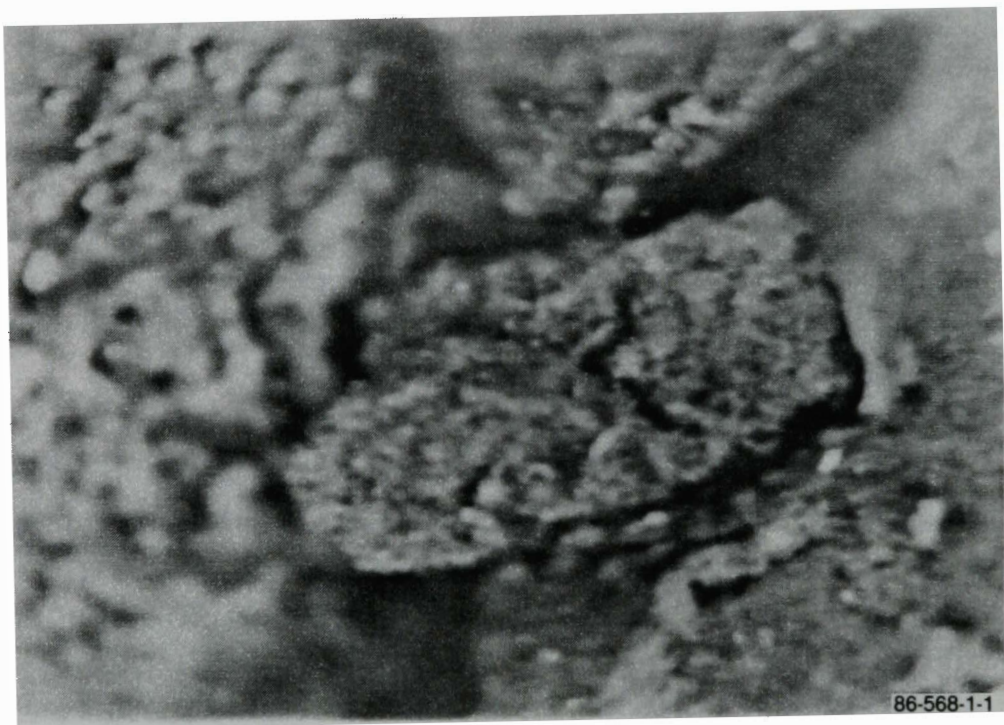
The rubble near the X axis has a large number of 2- to 5-cm-sized chunks interspersed with much finer material. This is illustrated by the photograph of this area shown in Figure 29.

Figure 29. Photograph of large TMI-2 debris chunk at x axis.

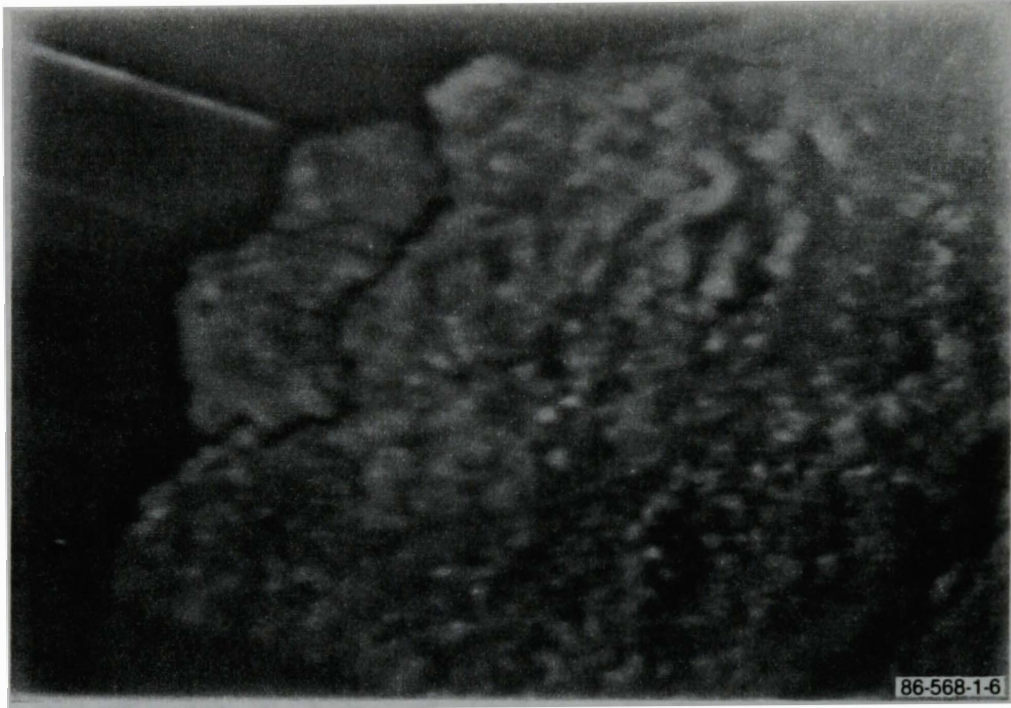
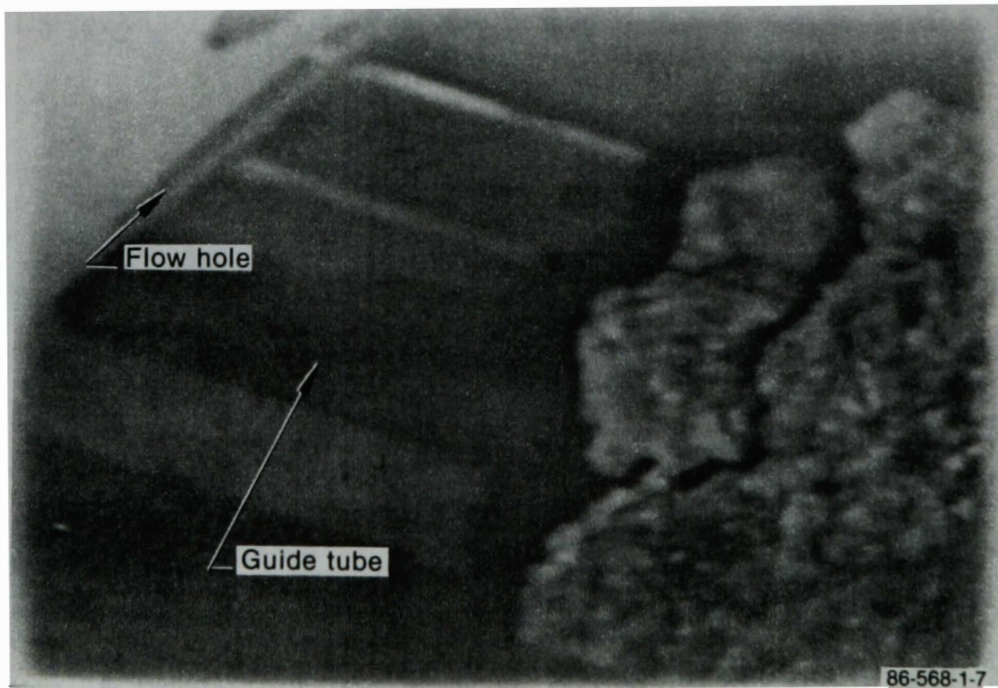
The Z axis appeared to have the largest chunks. At least one chunk is estimated to be 15 to 20 cm in size. Several other large (7 cm or larger) chunks also are present. The larger pieces look porous, with small cracks and smooth surfaces. Figures 30 and 31 illustrate the coarseness of the debris bed in this region.

Figure 31. Photographs showing TMI-2 debris chunks in relation to instrumentation guide tube at Z axis.

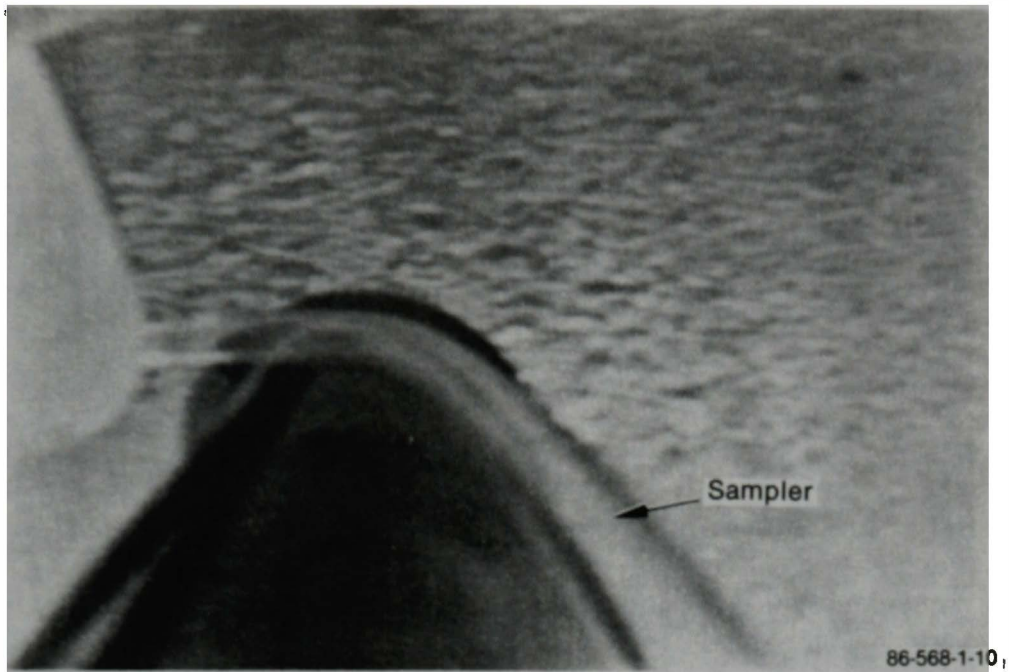
Figure 32. Photograph showing smooth TMI-2 debris surface at W axis.

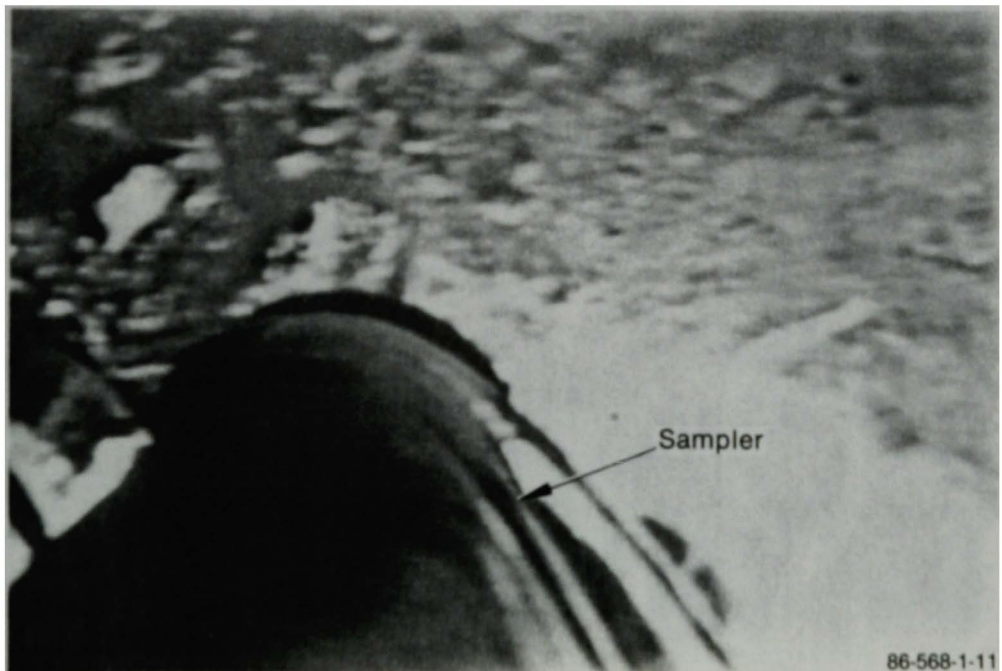
Figure 33. Photograph showing coarse TMI-2 debris on top of smooth surface at W axis.

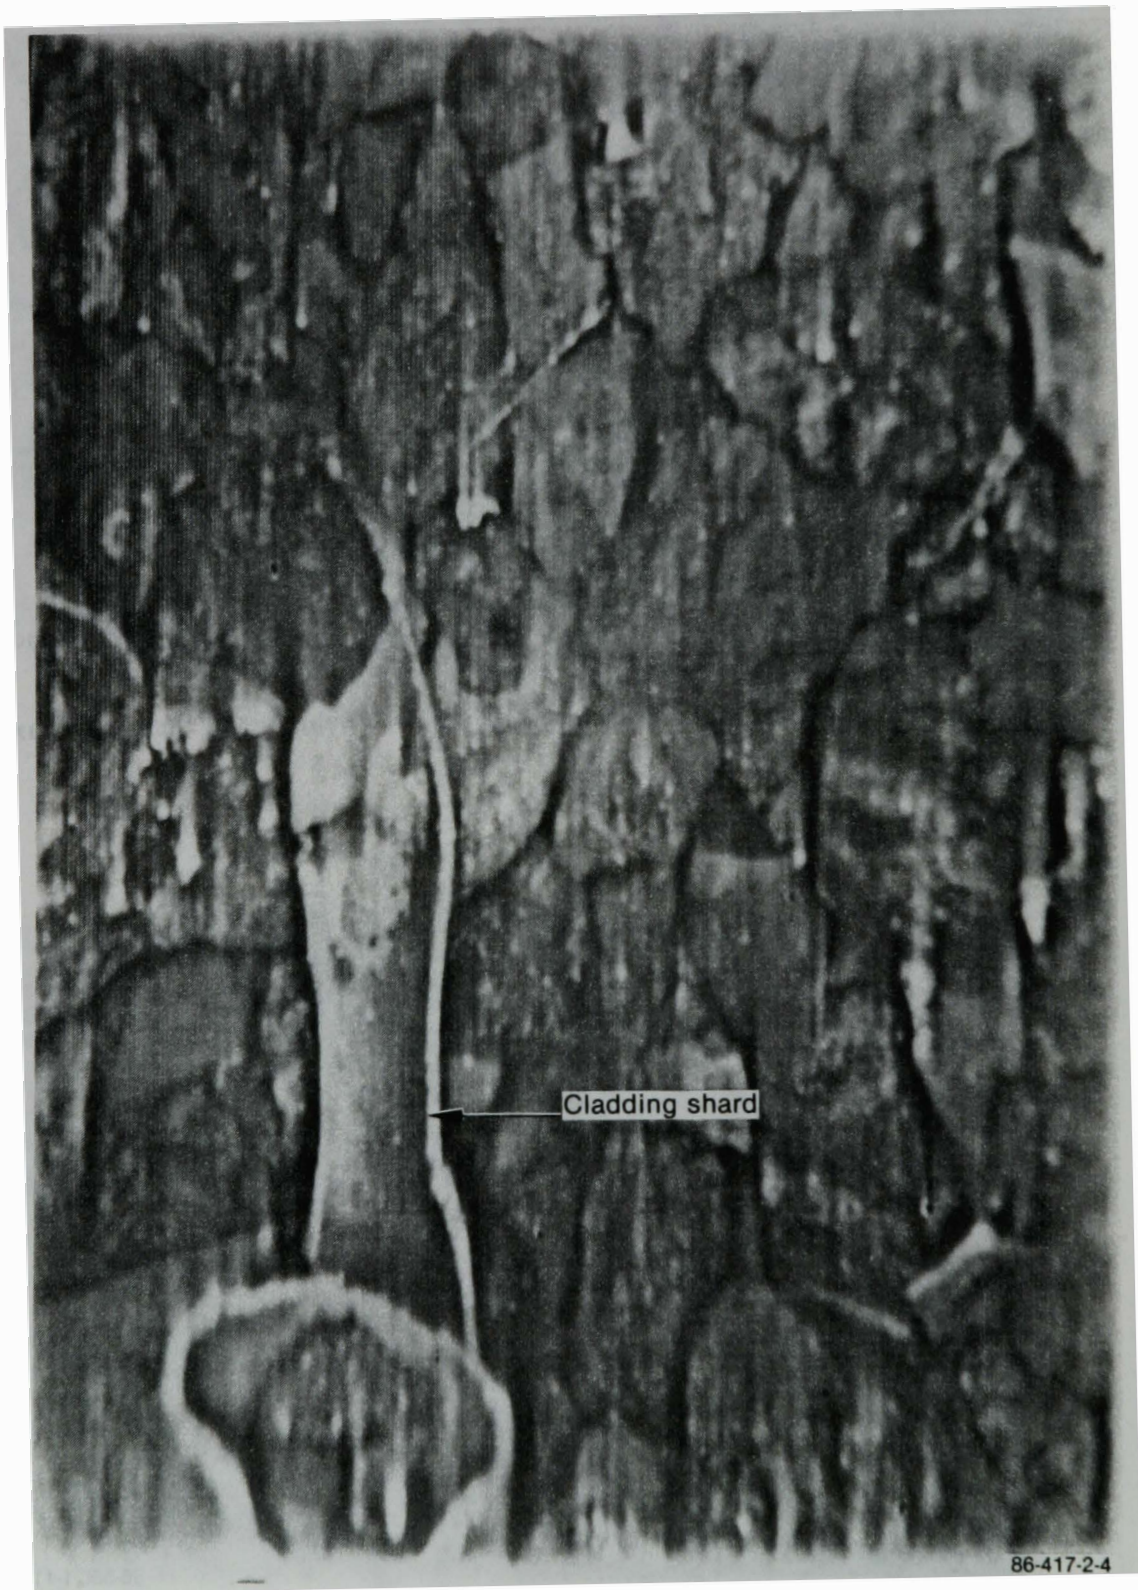
Figure 34. Photograph of TMI-2 lower plenum debris bed at the K-9 location.

the K-9 location and includes cladding shards which most probably relocated there during the operation. An estimate of the relative sizes of the rubble can be made by comparison with the shard which lies atop the bed (diameter approximately 2.5 cm). As was the case at the W axis, the rubble appears to be very loose and is easily dislodged by the camera.

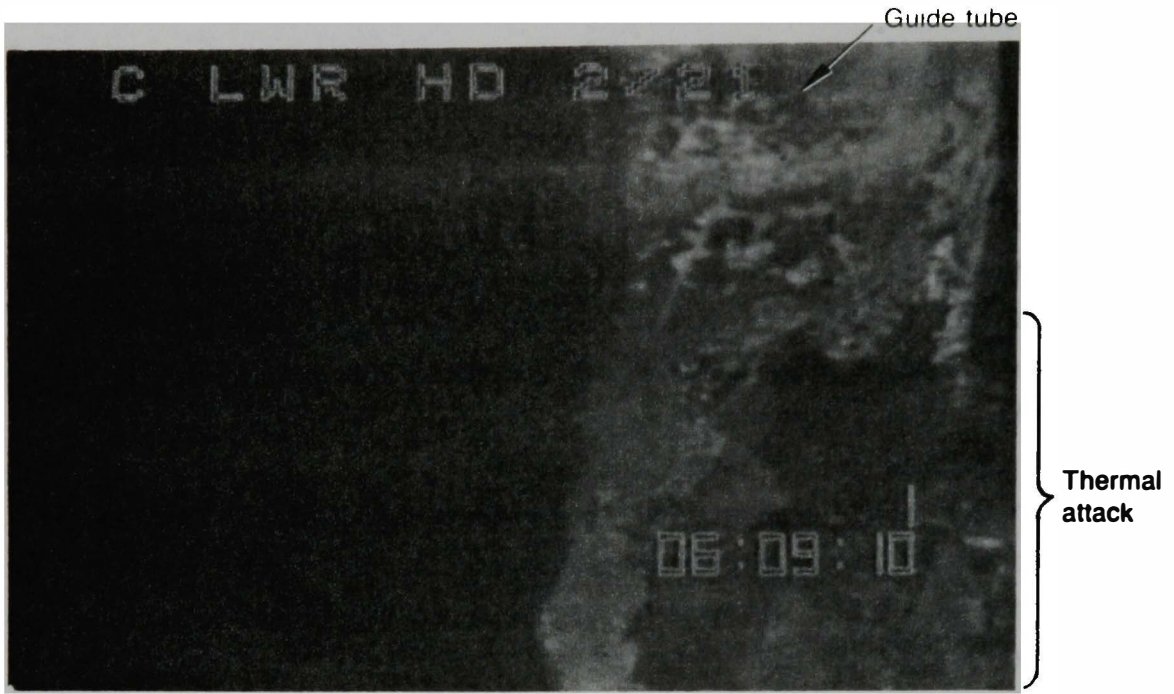
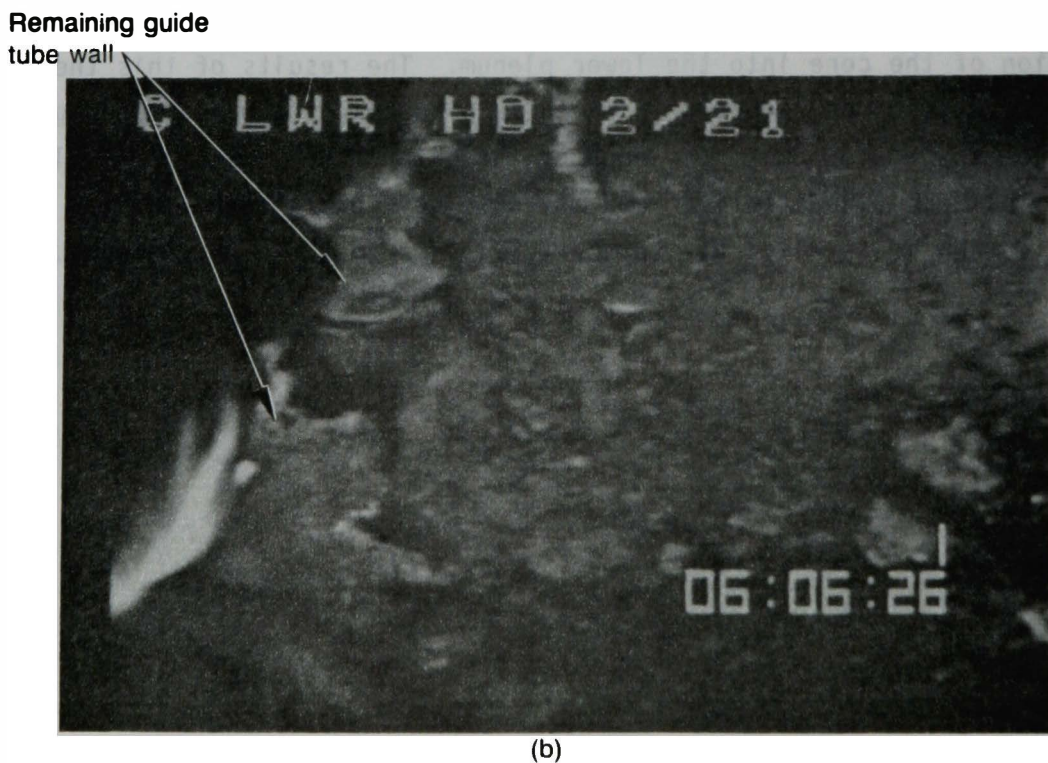
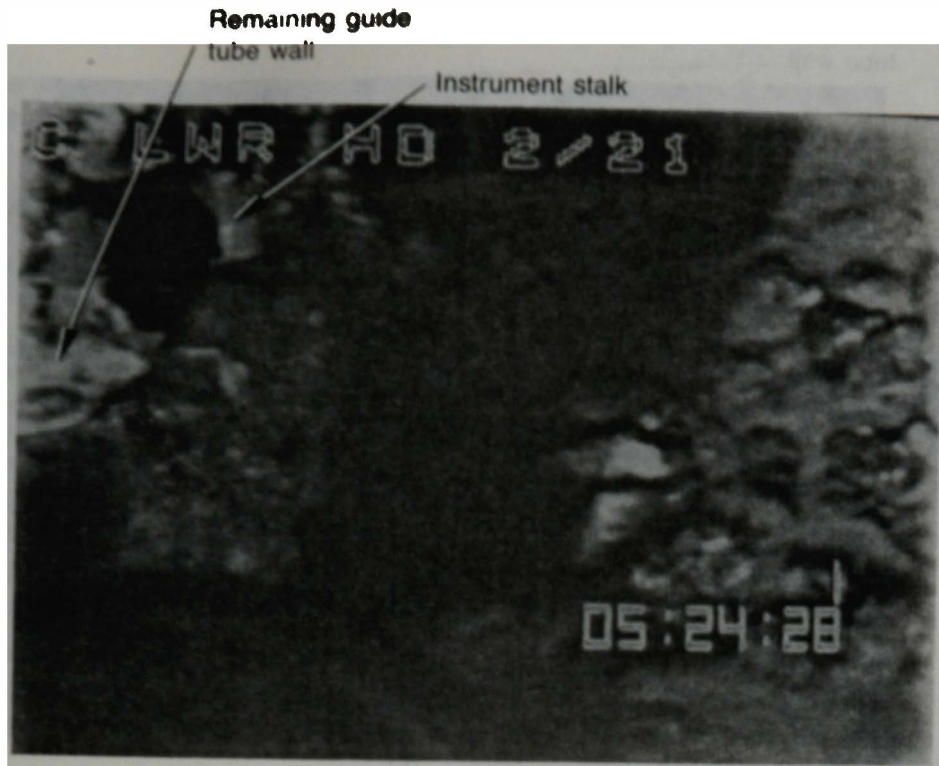
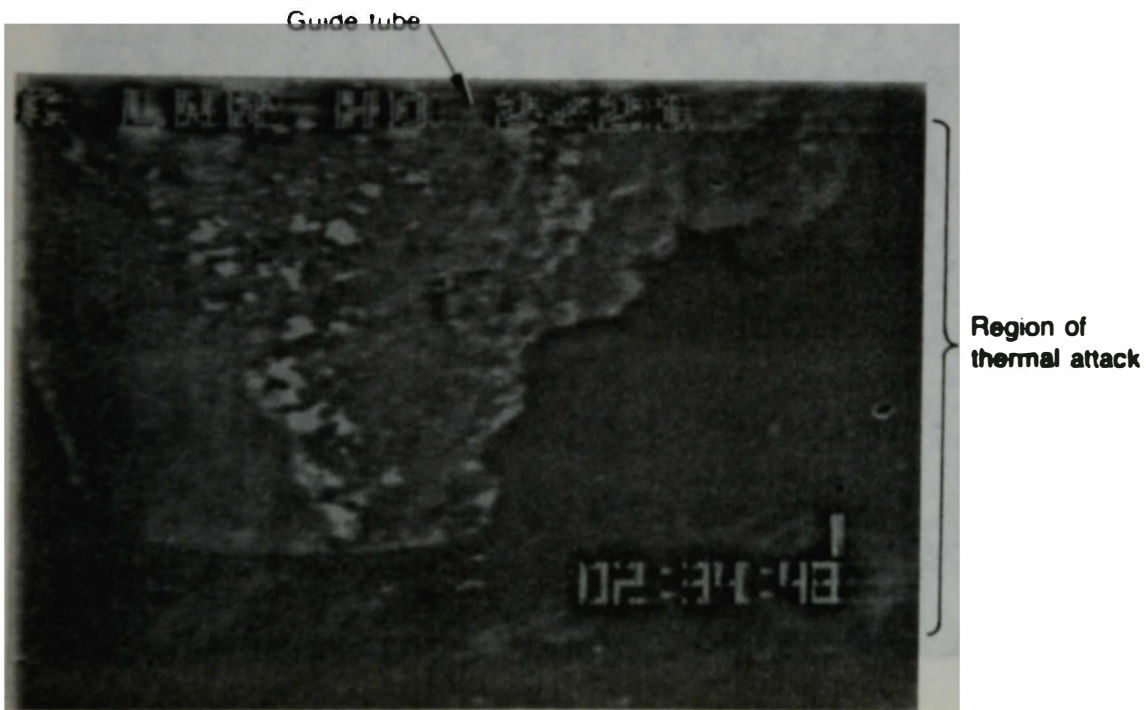
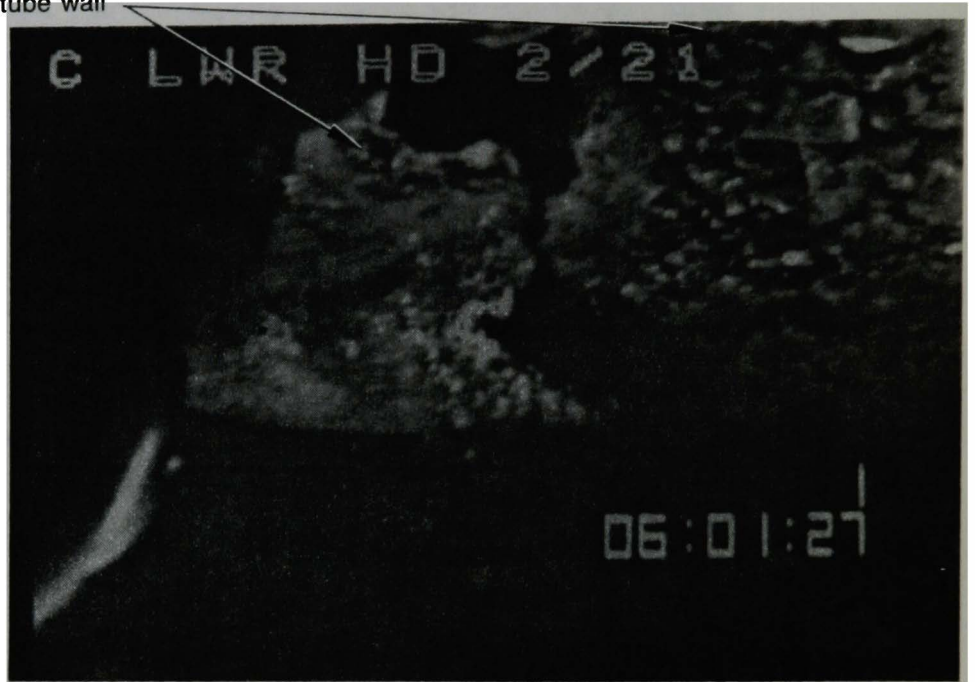
The condition of guide tube 45 was clearly visible during the inspection. This guide tube experienced thermal attack during the relocation of the core into the lower plenum. The results of this thermal attack are evident on figure B-1, which is a series of enhanced photographs taken from the video data. The edge of the guide tube is severely ablated, and the instrument penetration tube may also have experienced thermal attack, though it is difficult to see the latter in these photographs.

Figure B-1. Enhanced photograph of guide tube #45, core position R-7.

Remaining guide
tube wall
