**Quick Look Inspection: Report on the Insertion  
of a Camera into the TMI-2 Reactor Vessel  
through a Leadscrew Opening  
Volume I**

**Bechtel Northern Corporation**

**March 1983**

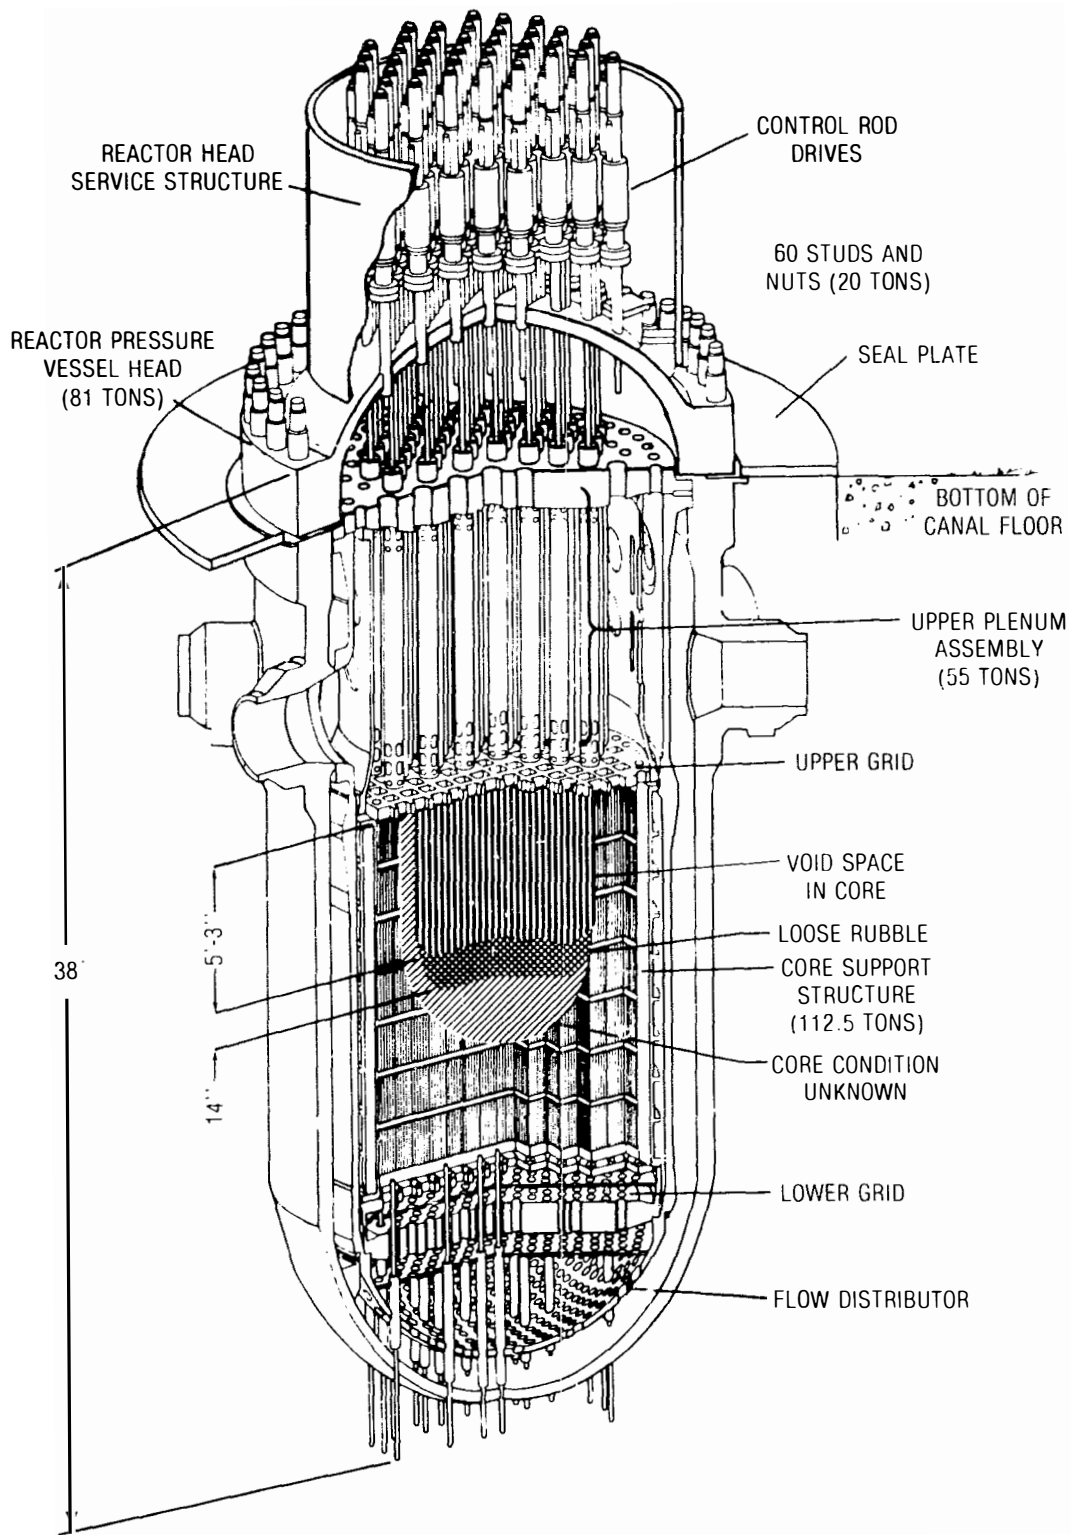
Figure 1-1. Cutaway view of the reactor vessel.

Postulated core damage is shown, which is based on camera inspections and core probes in locations 8H and 9E.

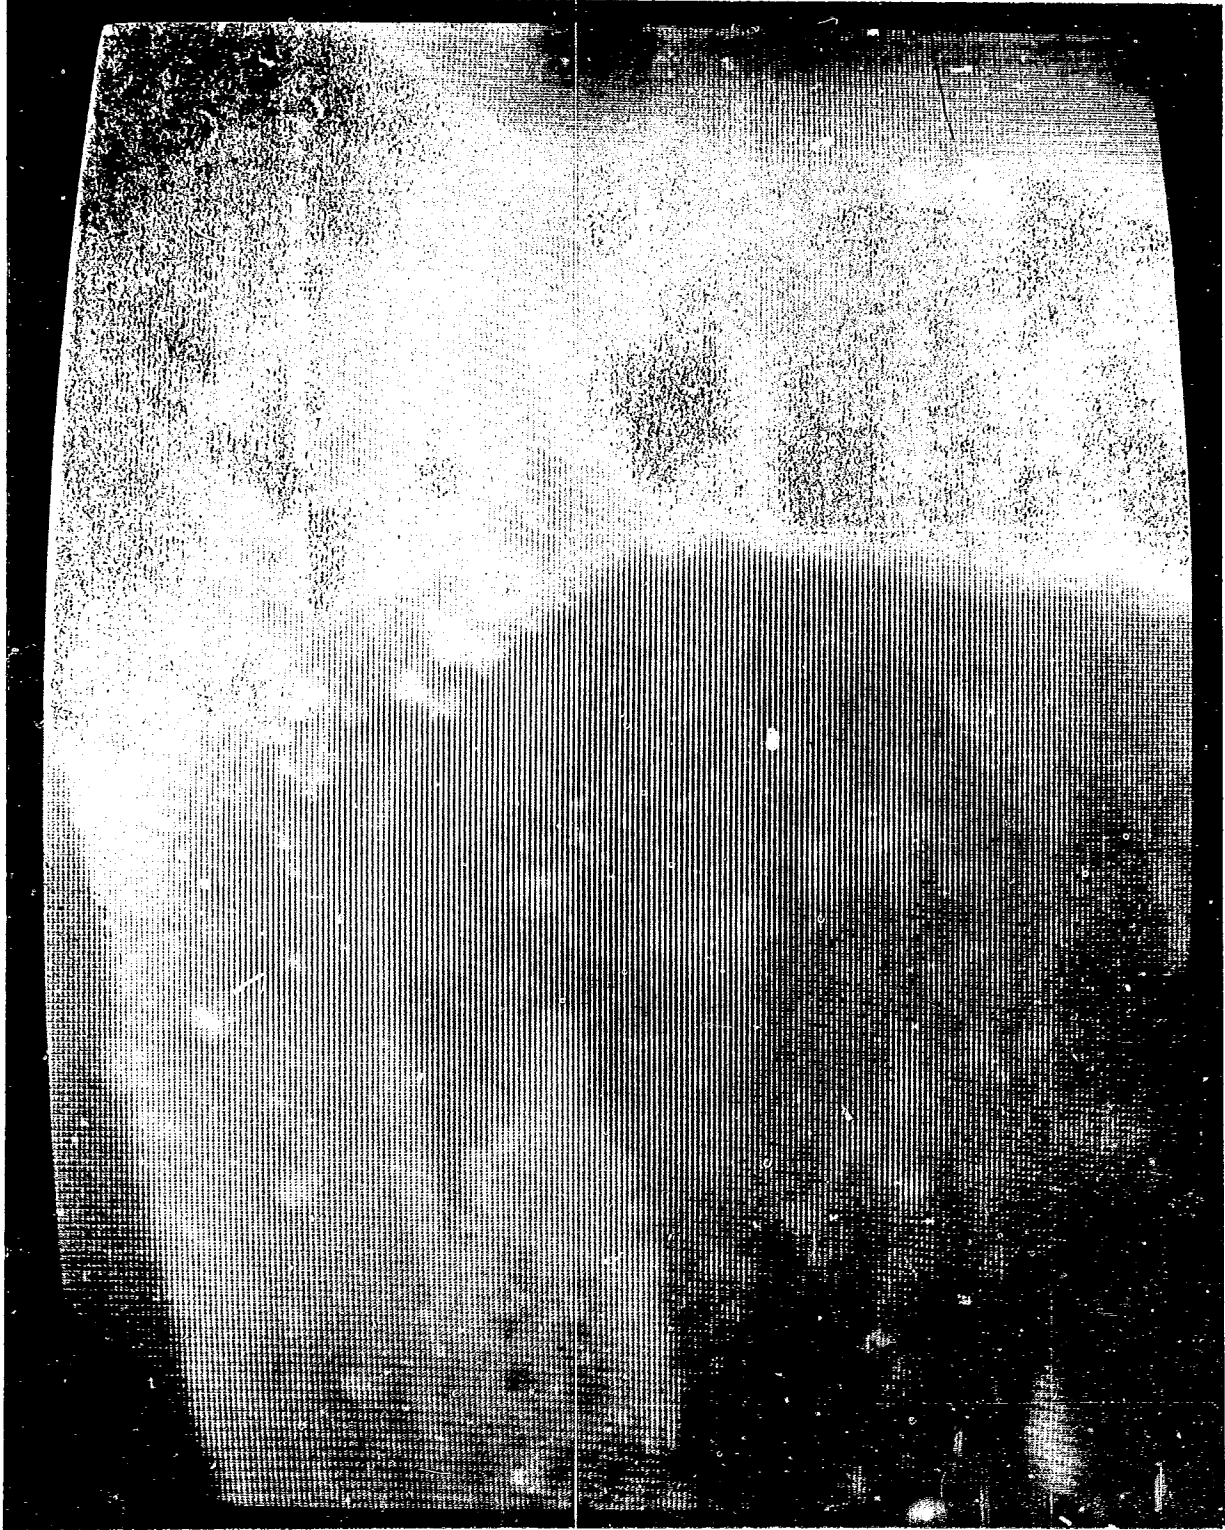
Figure 3-21. Portion of a control assembly spider which was resting on the debris bed near the 8H position.
