TMI-2 CORE CAVITY SIDES AND FLOOR EXAMINATIONS

DECEMBER 1985 AND JANUARY 1986

M. L. Russell

Published February 1987

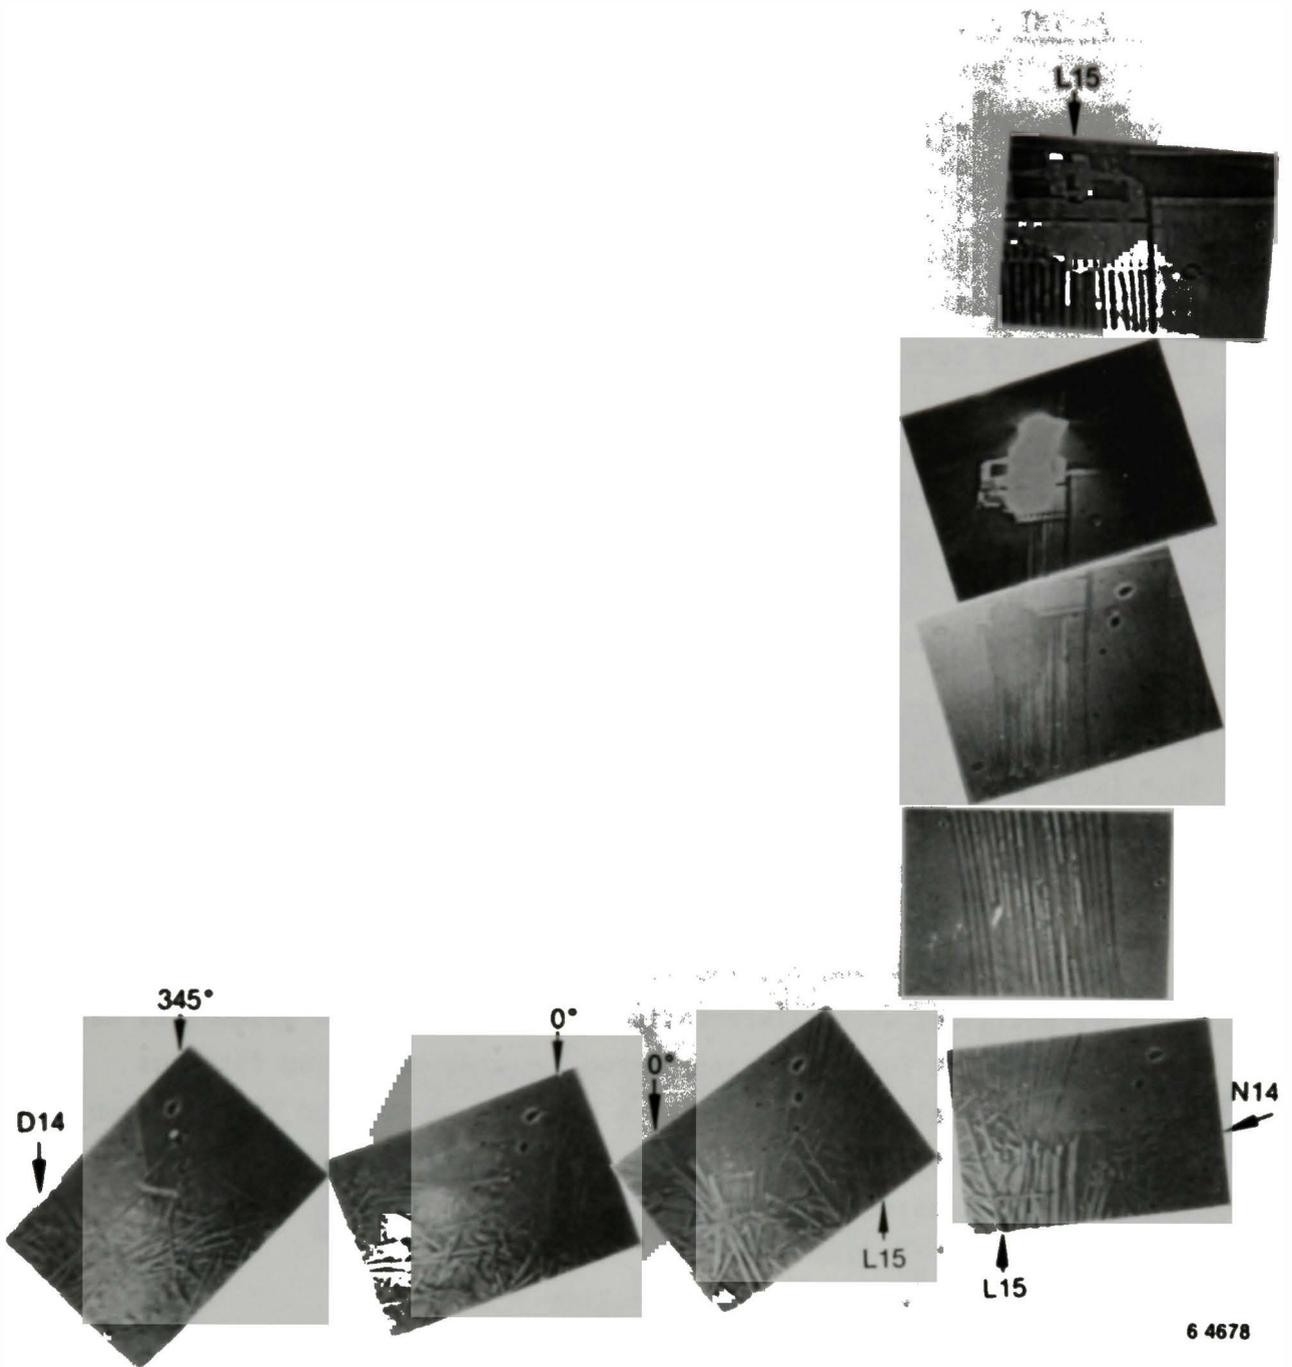
Plate 1. TMI-2 core cavity north side--December 6 through 21, 1985 core position L15 fuel assembly.

The damaged fuel assembly at core position L15 is the only fuel assembly still standing on the North Side. The upper end fitting and fuel bundle damage is consistent with the damage patterns observed on symmetrically located fuel assemblies.

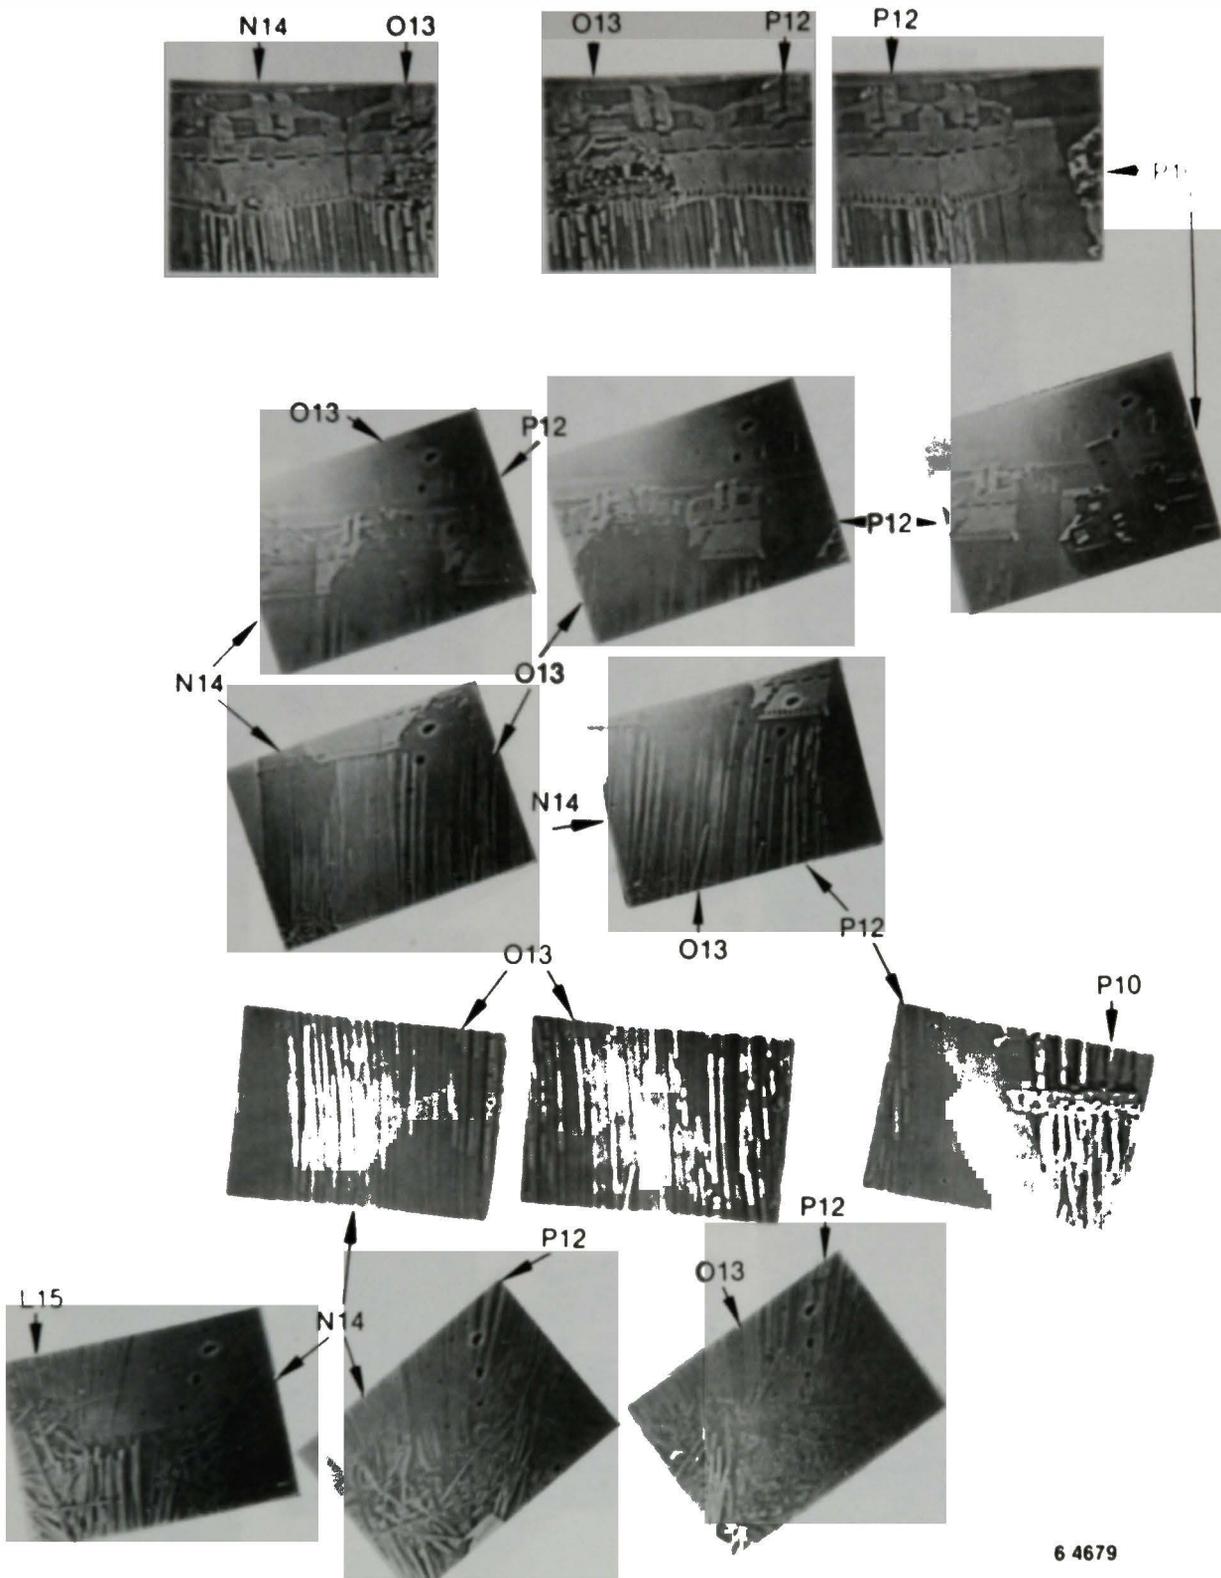
Plate 2. TMI-2 core cavity northeast side--December 6 through 21, 1985 core position N14, O13, and P12 fuel assemblies.

Three core positions (N14, O13, and P12) damaged fuel assemblies were still standing on the Northeast side. The upper end fitting and fuel bundle damage is consistent with the damage patterns observed on symmetrically located fuel assemblies.

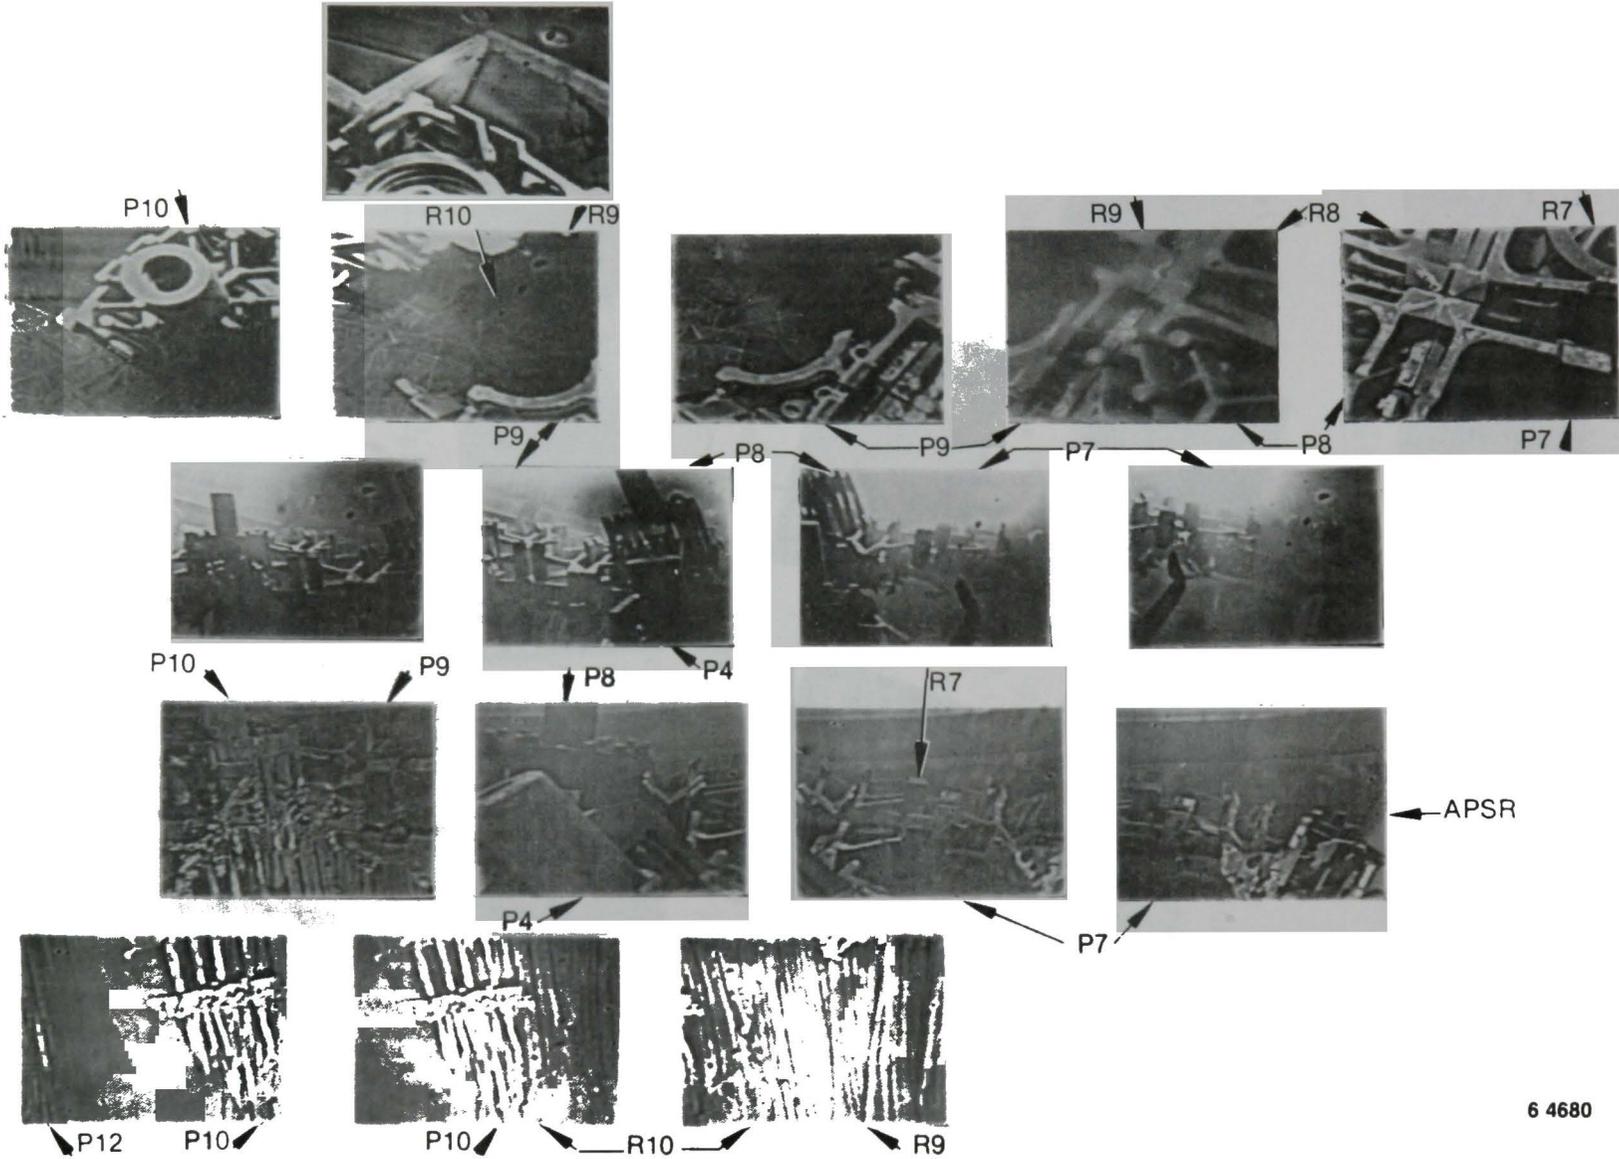
Plate 3. TMI-2 core cavity east side--December 6 through 21, 1985 core position P10, P9, P8, P7, R10, R9, R8, and R7 fuel assemblies.

The Row P upper end fittings are of special interest. Both (P10 and P8) core positions with silver-indium-cadmium poison rod assemblies have relatively intact fuel- and control-rod assembly upper end fittings compared to the alumina-boron-carbide burnable poison rod (BPR) assemblies at core positions P9 and P7, which have completely missing BPR assemblies and gutted fuel assembly upper end fittings.

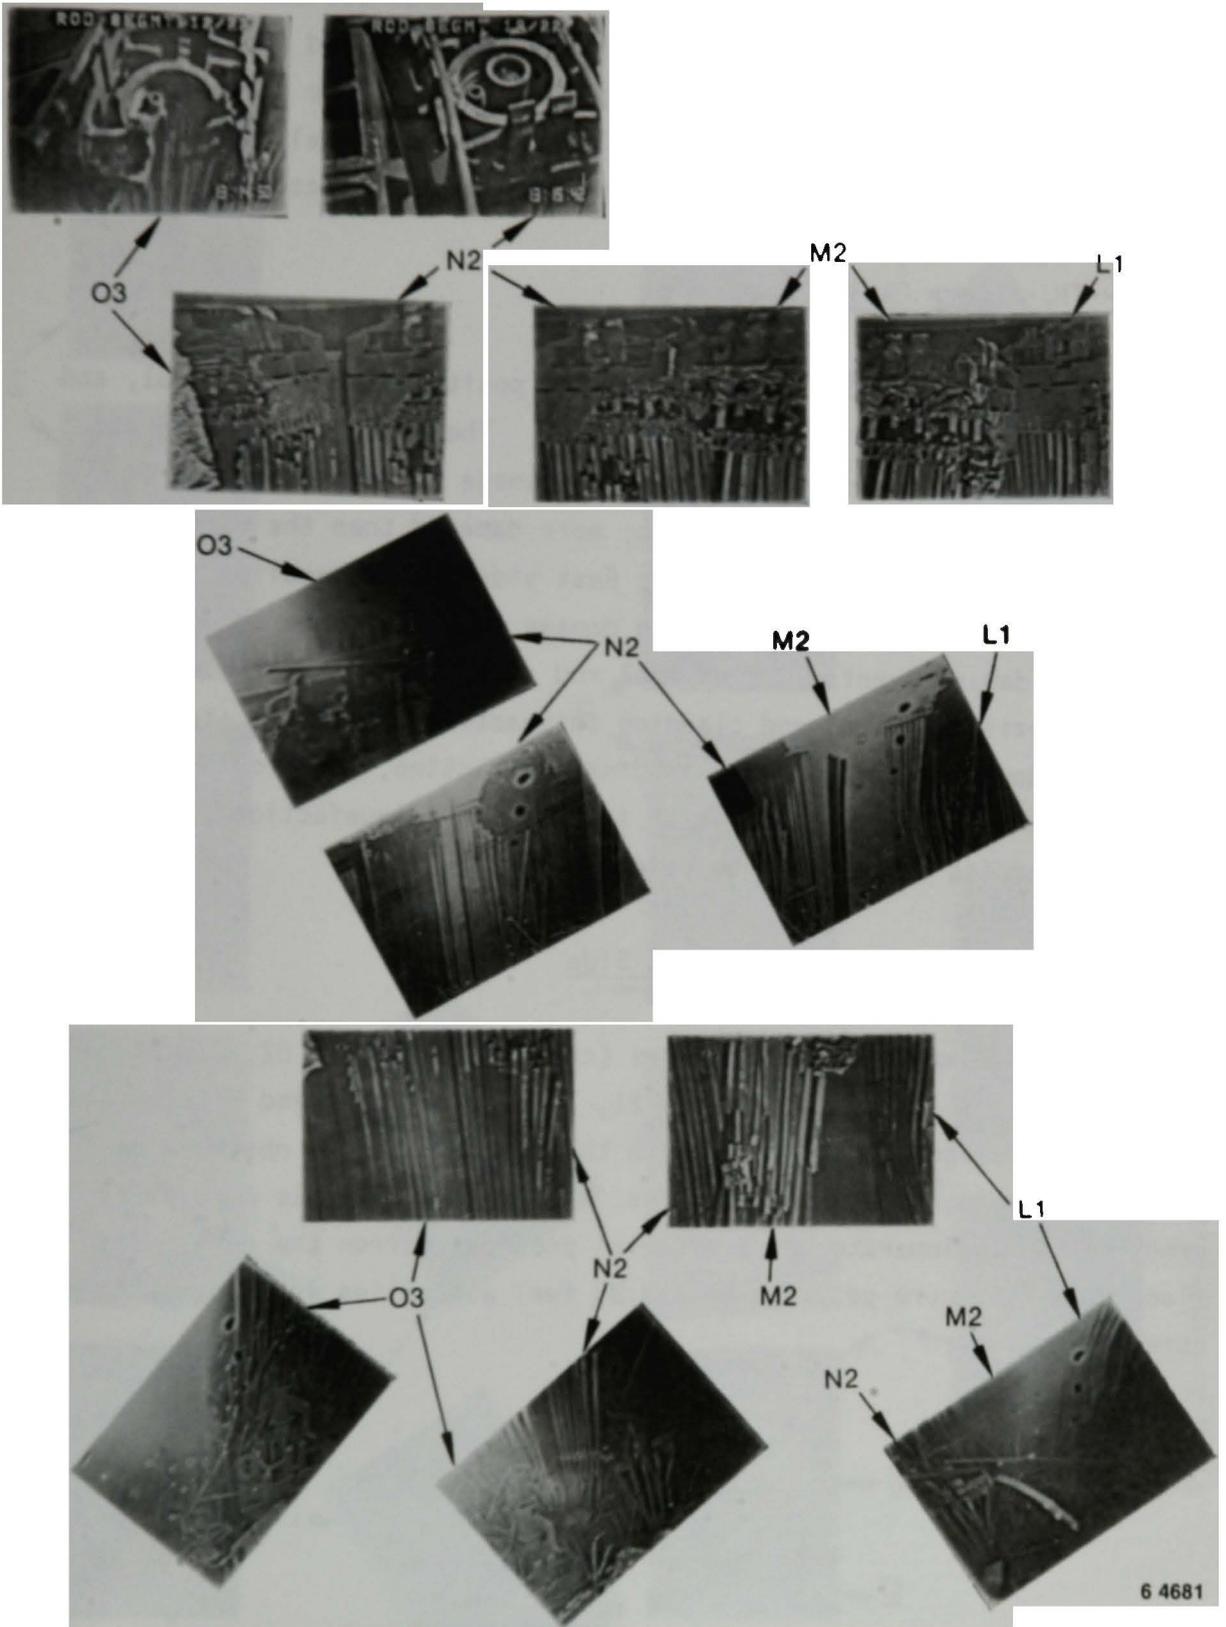
Plate 4. TMI-2 core cavity southeast side--December 6 through 22, 1985 core position O3, N2, and M2 fuel assemblies.

Four damaged fuel assemblies were still standing at core positions P4, O3, N2, and M2 on December 6, 1985, although the P4 core position fuel assembly was leaning into the East side field of view. The M2 core position fuel assembly toppled over before the December 21, 1985, video survey leaving three fuel rods still standing, but leaning inwards. The upper end fitting and fuel bundle damage are consistent with the damage patterns observed on symmetrically located fuel assemblies.

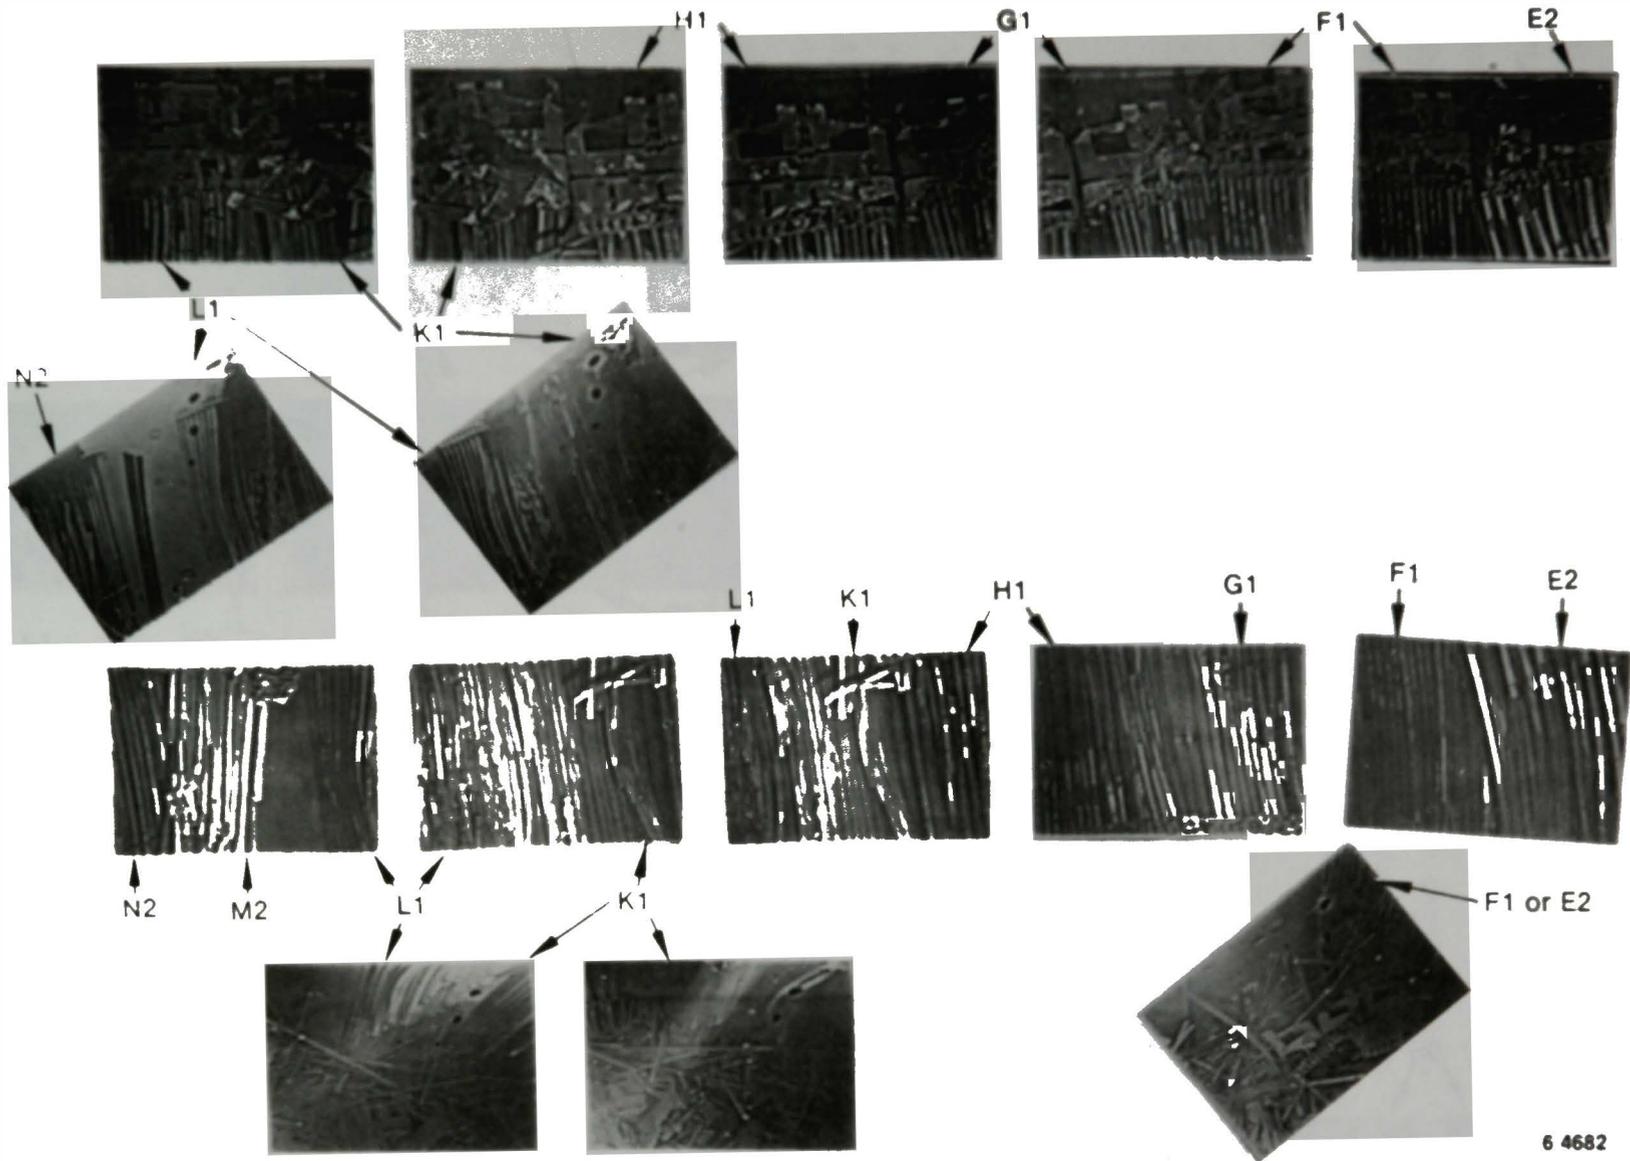
Plate 5. TMI-2 core cavity south side--December 6 through 21, 1985 core position L1, K1, H1, G1, and F1 fuel assemblies.

The five damaged fuel assemblies (core positions L1, K1, H1, G1, and F1) were still standing on December 6, 1985. The upper end fitting and fuel bundle damage is consistent with the damage patterns observed on symmetrically located fuel assemblies; more damaged than the West side fuel assemblies, and less damaged than the East side fuel assemblies. The core position L1 fuel assembly fuel bundle damage shows evidence of a variety of severe fuel damage events such as fuel rod swelling and burst, Inconel spacer grid-zircaloy fuel rod cladding interaction, stainless steel fuel pellet holddown spring-fuel rod cladding interaction, fuel rod cladding-uranium dioxide fuel pellet interaction (liquefaction), and zircaloy cladding and guide tube oxidation.

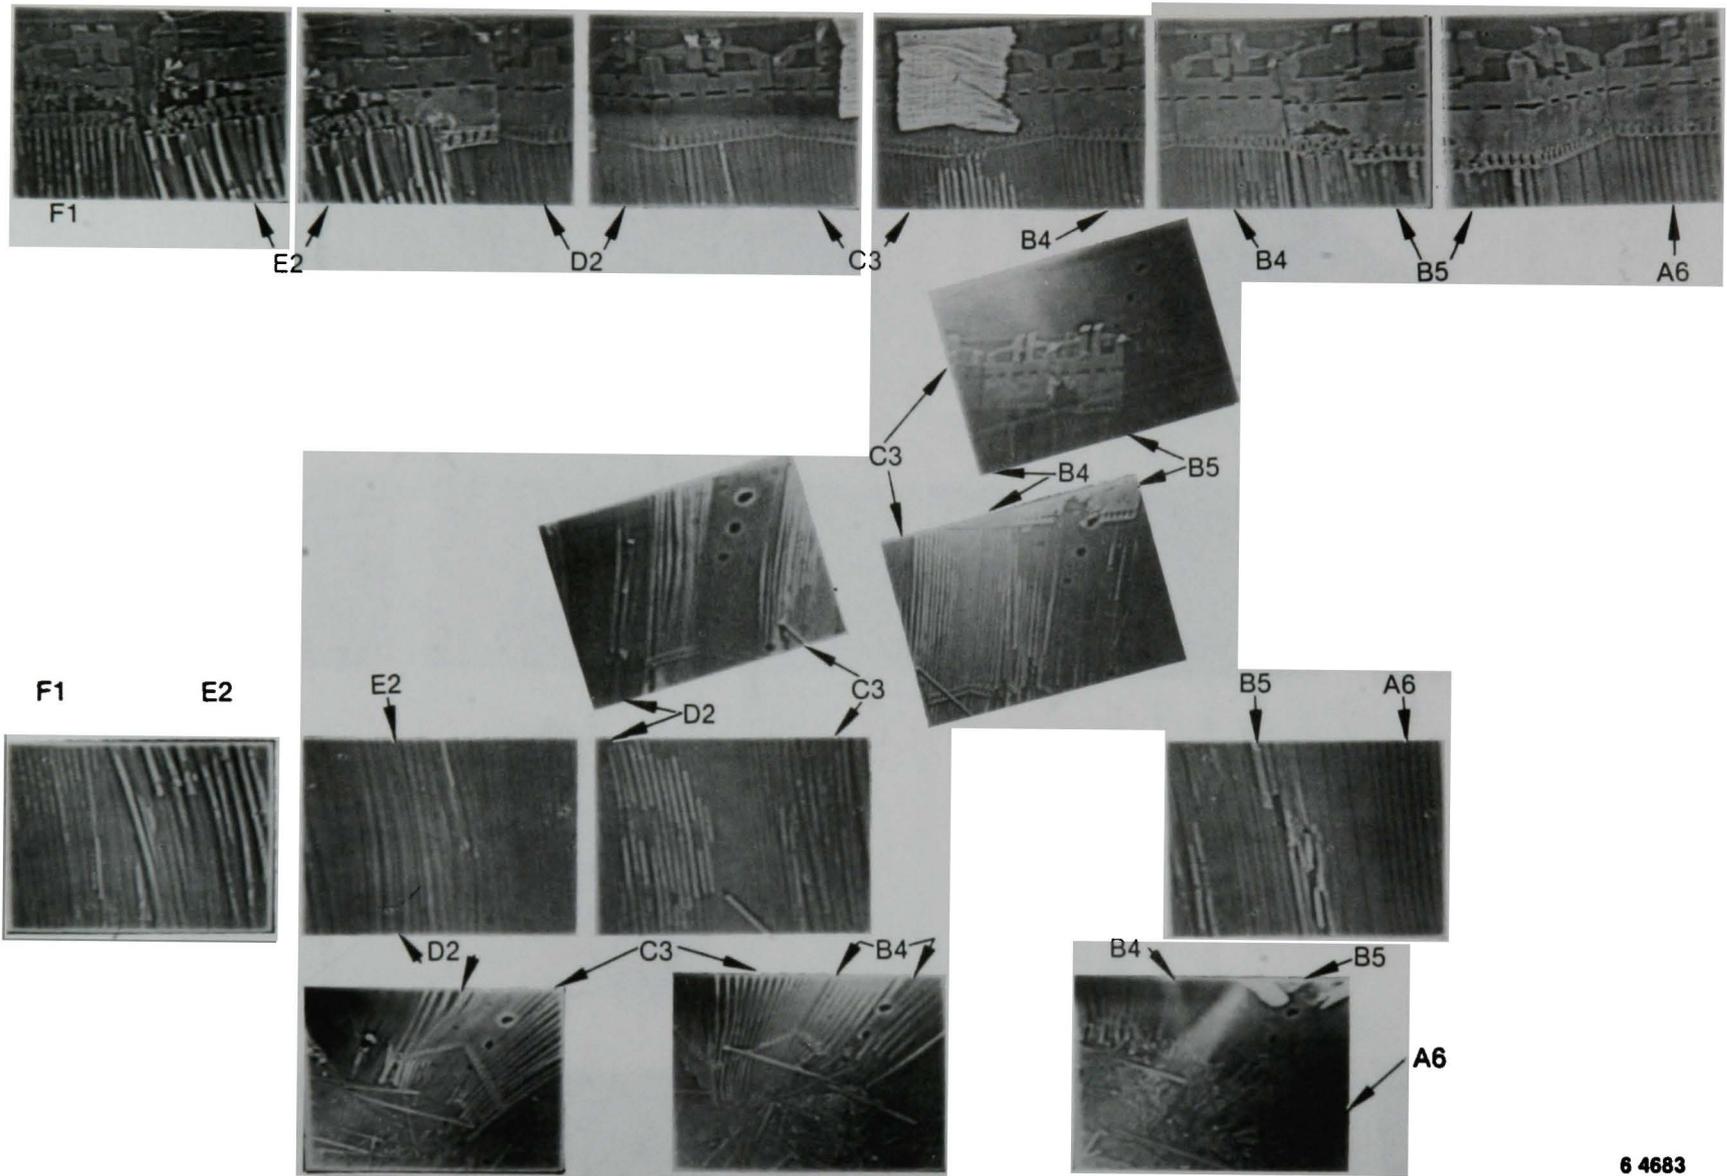
Plate 6. TMI-2 core cavity southwest side--December 6 through 21, 1985 core position E2, D2, C3, B4, and B5 fuel assemblies.

The five damaged fuel assemblies (core positions E2, D2, C3, B4, and B5) were still standing on December 21, 1985. The upper end fitting and fuel bundle damage is consistent with the damage patterns observed on symmetrically located fuel assemblies. There is a possible deposit of prior-molten agglomerated core material protruding from the core cavity floor where the core position B4 and B5 fuel assemblies intersect with the core cavity floor.

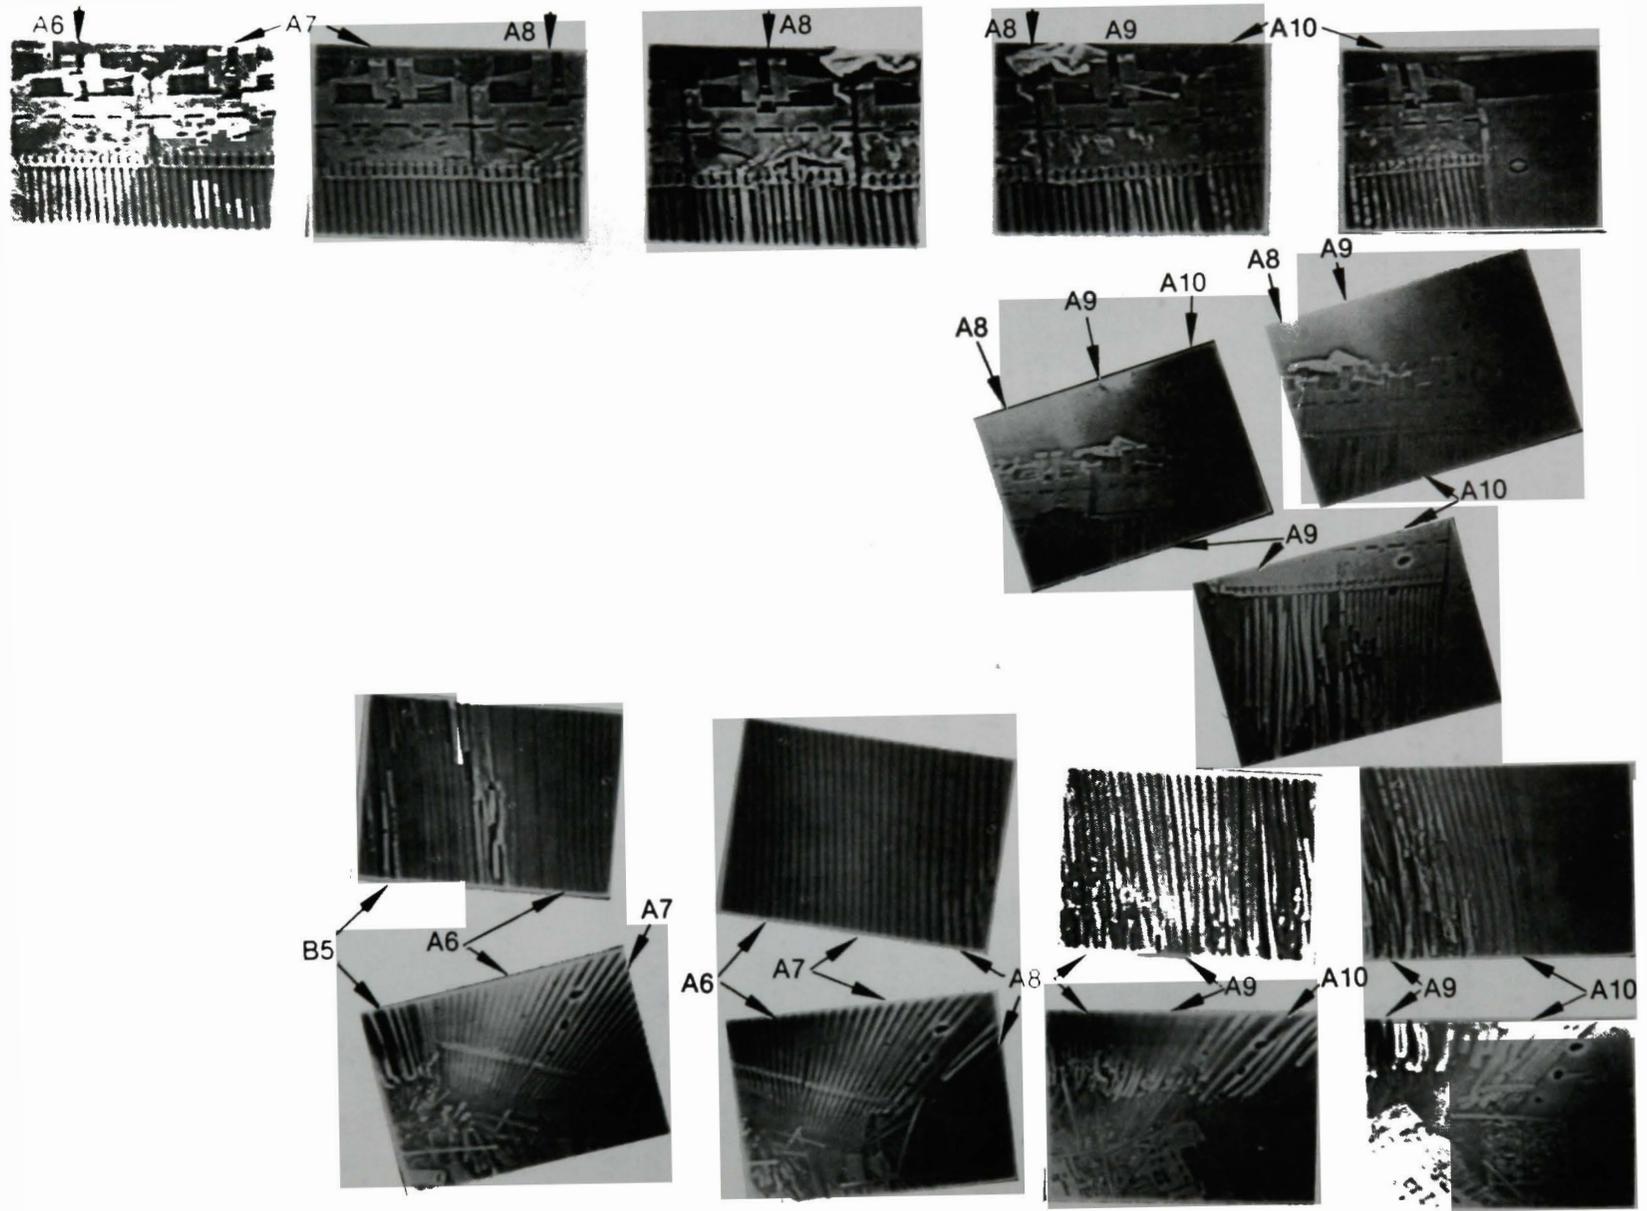
Plate 7. TMI-2 core cavity west side--December 6 through 21, 1985 core position A6, A7, A8, A9, and A10 fuel assemblies.

The five damaged fuel assemblies (core positions A6, A7, A8, A9, and A10) were still standing on December 21, 1985. The upper end fitting and fuel bundle damage represents the least damage of any of the eight sides and ranges from the core position A6 fuel assembly, which appears to have some fuel rod damage (slightly bent) toward the core cavity floor, to the other four fuel assemblies, which have examples of damage (ablated upper end fittings and missing fuel rod regions) similar to other peripheral fuel assemblies.

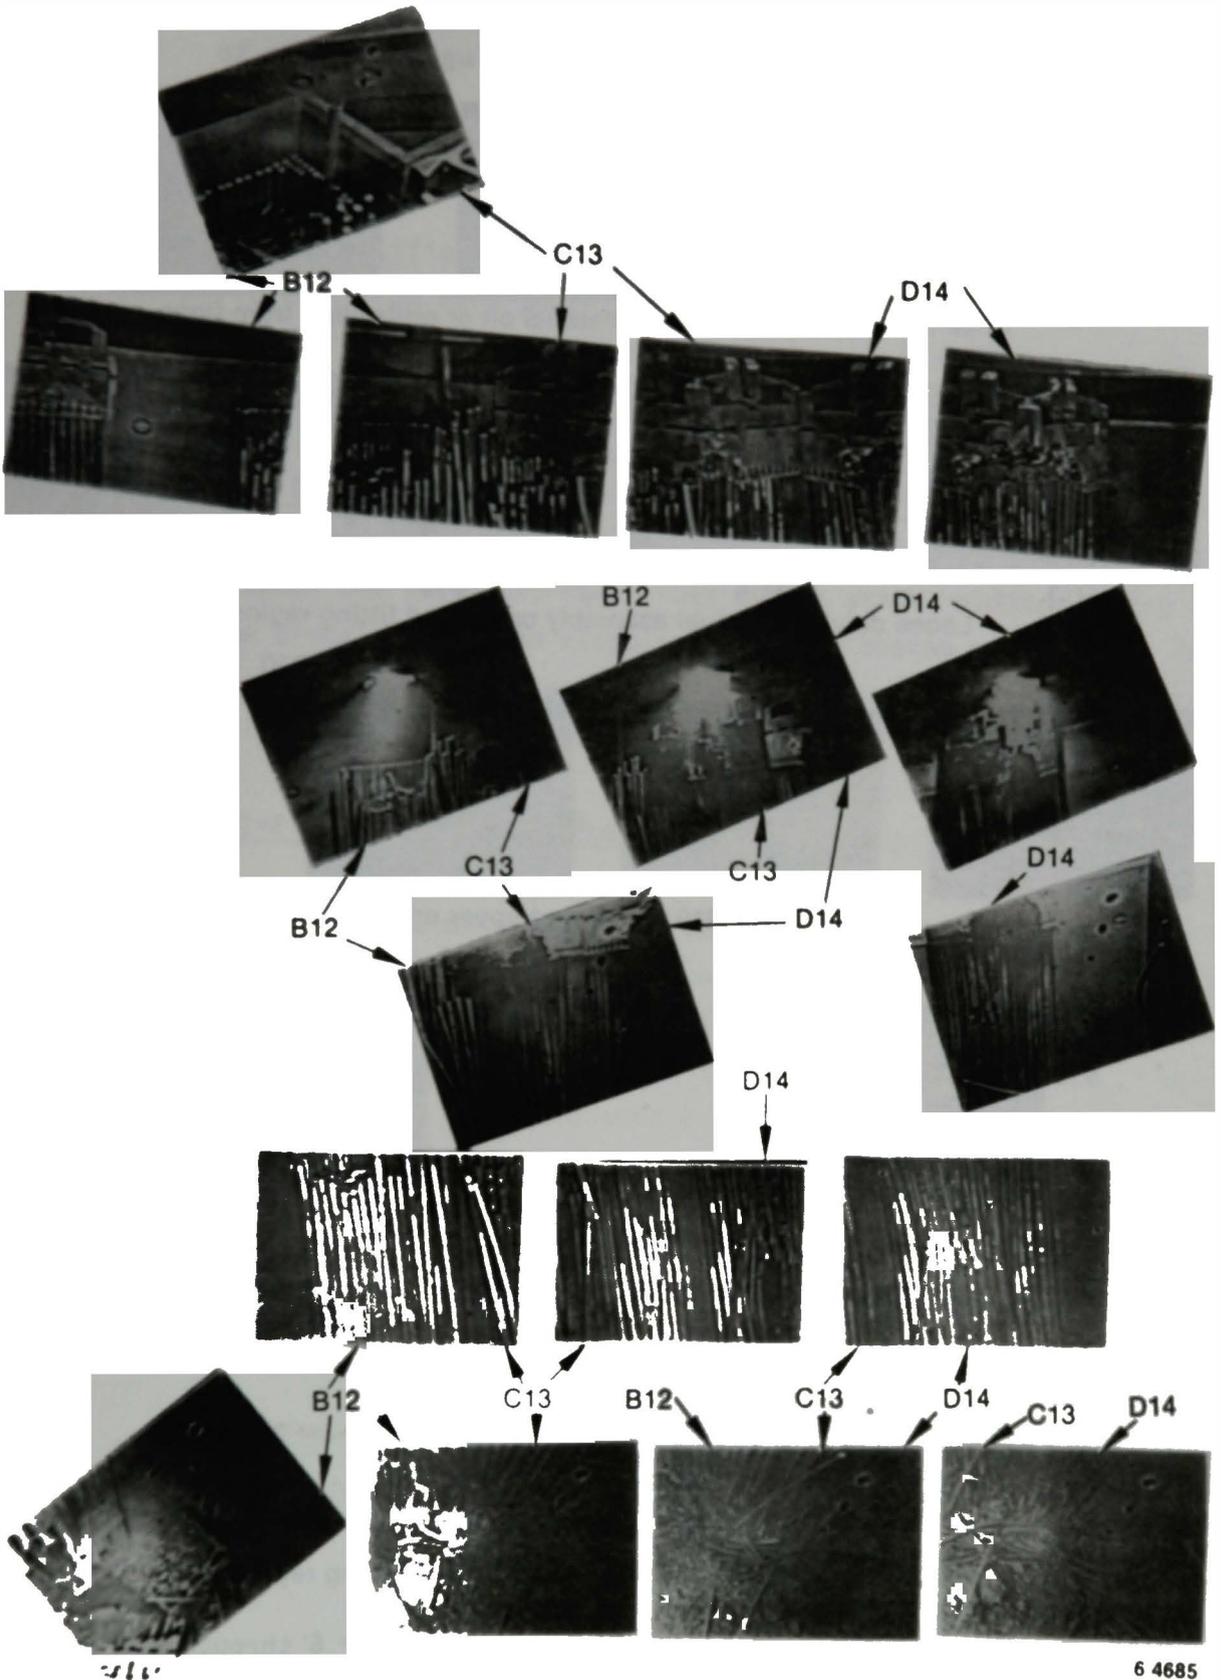
Plate 8. TMI-2 core cavity northwest side--December 6 through 21, 1985 core position B12, C13, and D14 fuel assemblies.

Three damaged fuel assemblies (core positions B12, C13, and D14) were still standing on December 6, 1985. The upper end fitting and fuel bundle damage is consistent with the damage patterns observed on symmetrically located fuel assemblies. The upper end fitting at core position B12 appears to have been separated from the fuel bundle by laterally pulling at the end fitting, which fractured the brittle fuel rods and guide tubes and left the more elastic fuel rods toward the core former intact. There is a possible deposit of prior-molten agglomerated core material protruding from the core cavity floor where the core position D14 fuel assembly intersects with the core-cavity floor.

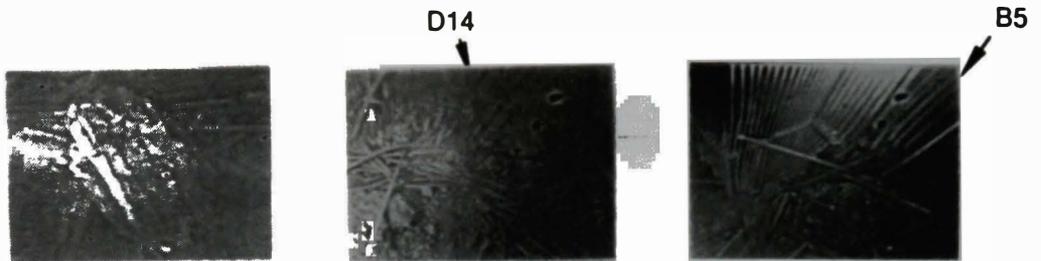
- o Agglomerated Core Material--Possible deposits of agglomerated core material were observed resting on or protruding through the core cavity floor. The rock-size piece resting on the top of fuel rod pieces appears to be decomposed fuel rods cemented together.

Rock size agglomerated core material on or protruding from floor

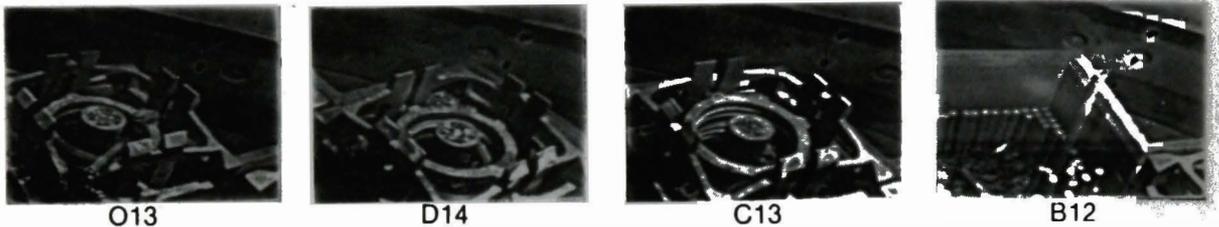
Loose debris on/in fuel assembly upper end fitting region

- o Loose Debris In Fuel Assembly Upper End Fitting Region--Deposits of small, irregular-shaped particles have collected on upward facing surfaces and cup-like areas of the fuel assembly upper rod fittings.
- o Other Identifiable Upper End Fittings--The damaged upper end fittings from core positions B10, C4, C5, D4, and D5 were identified during the video surveys in the loose debris on the core cavity floor.
- o Fuel Rod Damage in Pellet Stack Holddown Spring Region--A still-image photograph of fuel rod damage from interaction between the stainless steel fuel pellet stack holddown spring and the zircaloy fuel rod cladding is at the bottom of Plate 9. The fuel rod bundle section was lying on the core cavity floor; its original core location is unknown.

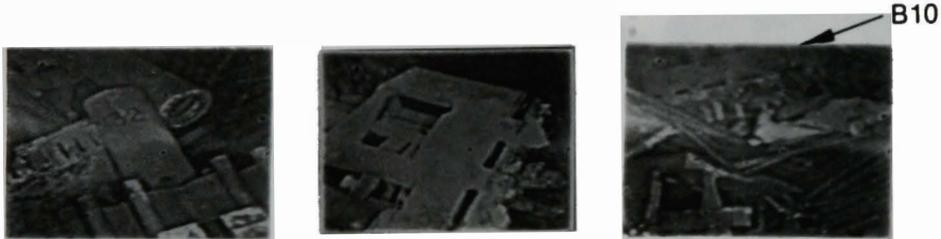
Core position B10 spider and upper end fitting

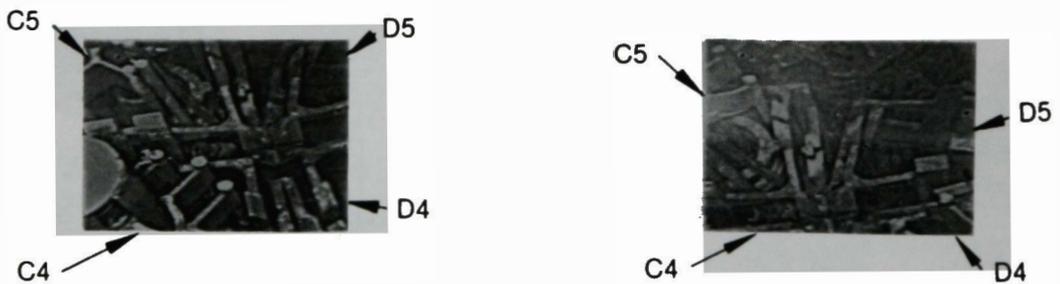
Core position C4, C5, D4 and D5 upper end fitting damage

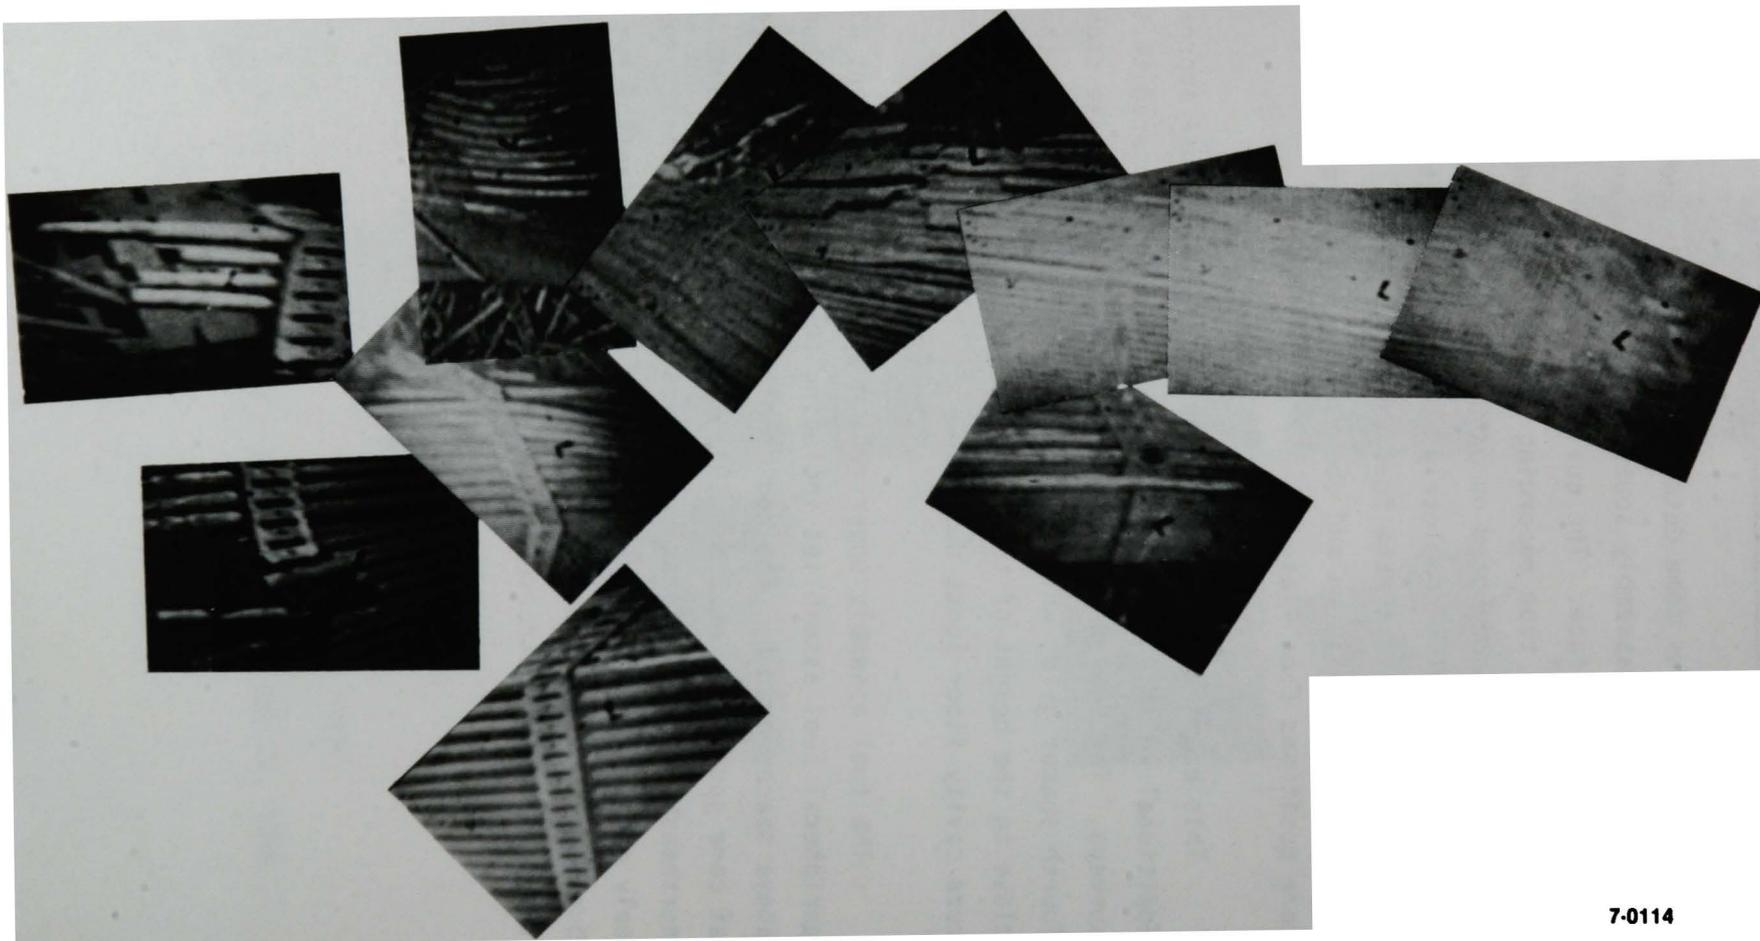
Plate 11. TMI-2 core position P4 fuel assembly.

The core position P4 fuel assembly upper section was subsequently examined by video survey on January 21, 1986, after it had toppled onto the core cavity floor. The upper section appears to extend to the elevation of the fourth spacer grid (approximately 63 in. above the fuel region bottom) and the damage becomes progressively worse towards the bottom of the section.

This examination is of special interest because approximately an additional 40 in. of fuel assembly is exposed compared to the December 1985 surveys. The fuel assembly damage appears to increase significantly at the fourth spacer grid, which is approximately 70 in. above the core bottom and close to the height of the hard crust that has been encountered below the core cavity floor loose debris.

The fuel assembly upper region damage is consistent with other peripheral fuel assemblies including the bow on the rod bundle that exists above spacer grid 5. The rod bundle bowing appears to have occurred also at core south (Plates 5 and 10), southeast (Plate 6), east (Plate 7), and northeast (Plate 8) locations. Because the bow appears to occur between only one set of spacer grids, it may be an artifact of fuel assembly buckling from differential thermal expansion between the fuel assembly and the core support structures during the core heatup.
