EXAMINATION OF THE TMI-2 CORE
DISTINCT COMPONENTS

EXAMINATION OF THE TMI-2 CORE DISTINCT COMPONENTS

**S. M. Jensen
D. W. Akers
R. W. Garner
G. S. Roybal**

September 1987

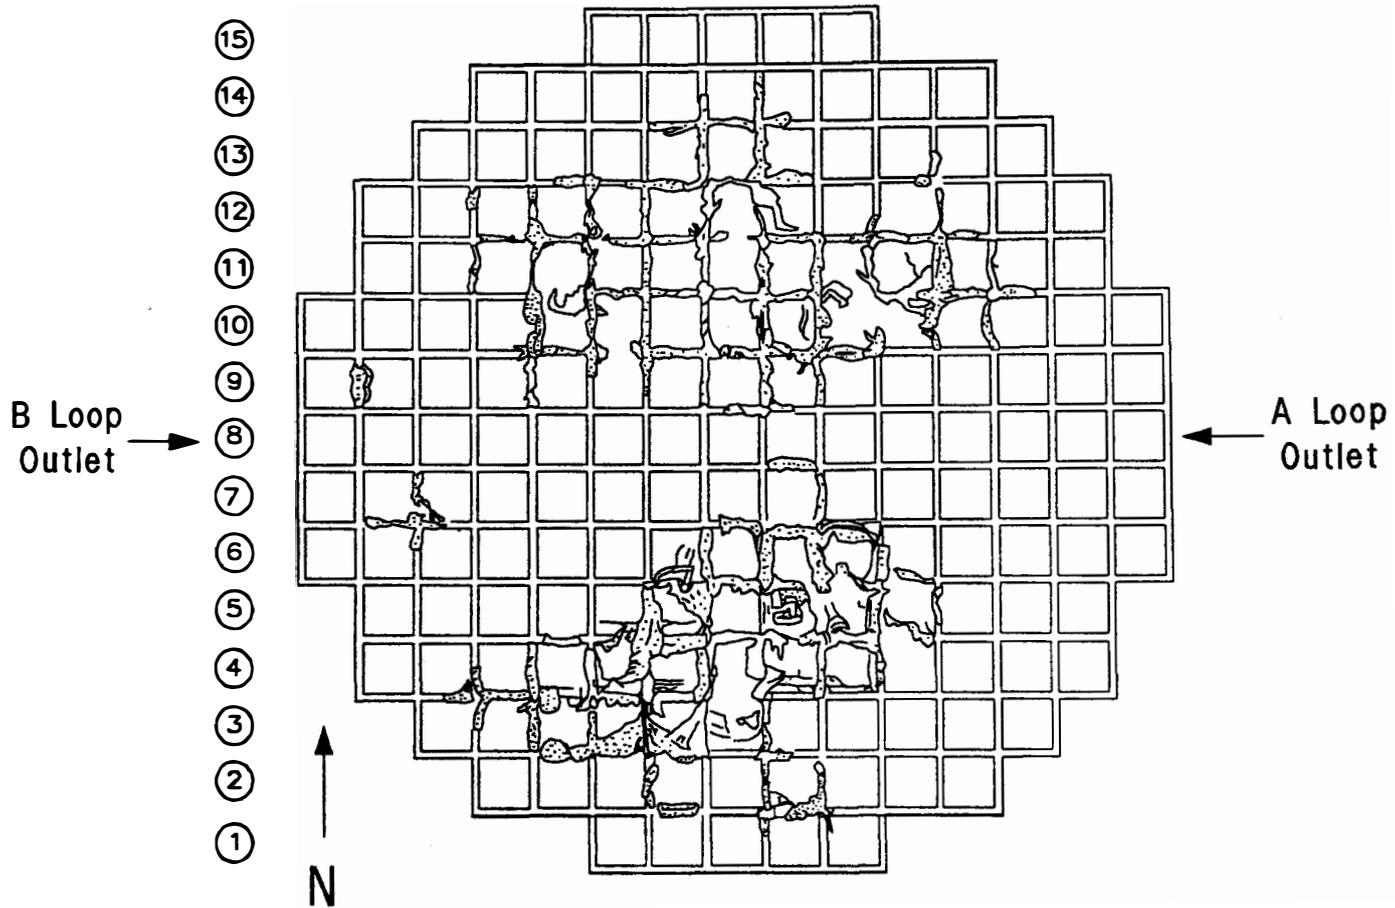
Damage to the plenum assembly bottom surface that was in contact with the fuel assembly upper end fittings is shown in Figure 11. The damage map was determined from video surveys.

Figure 11. Damage map of the TMI-2 fuel assembly upper grid plate.

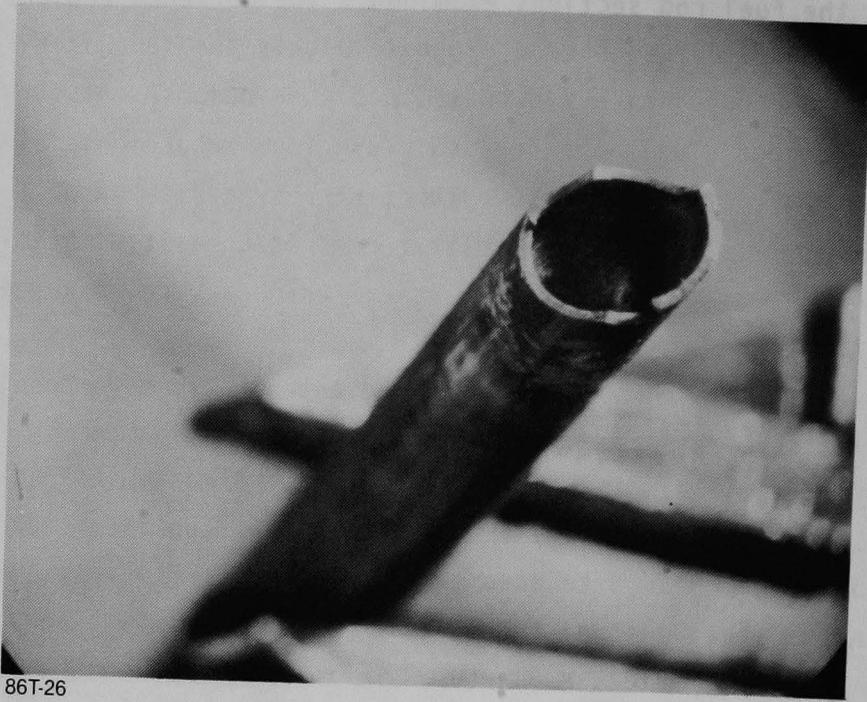
a) Fuel rod 3-35

Figure 20. Typical broken fuel rod endtips.

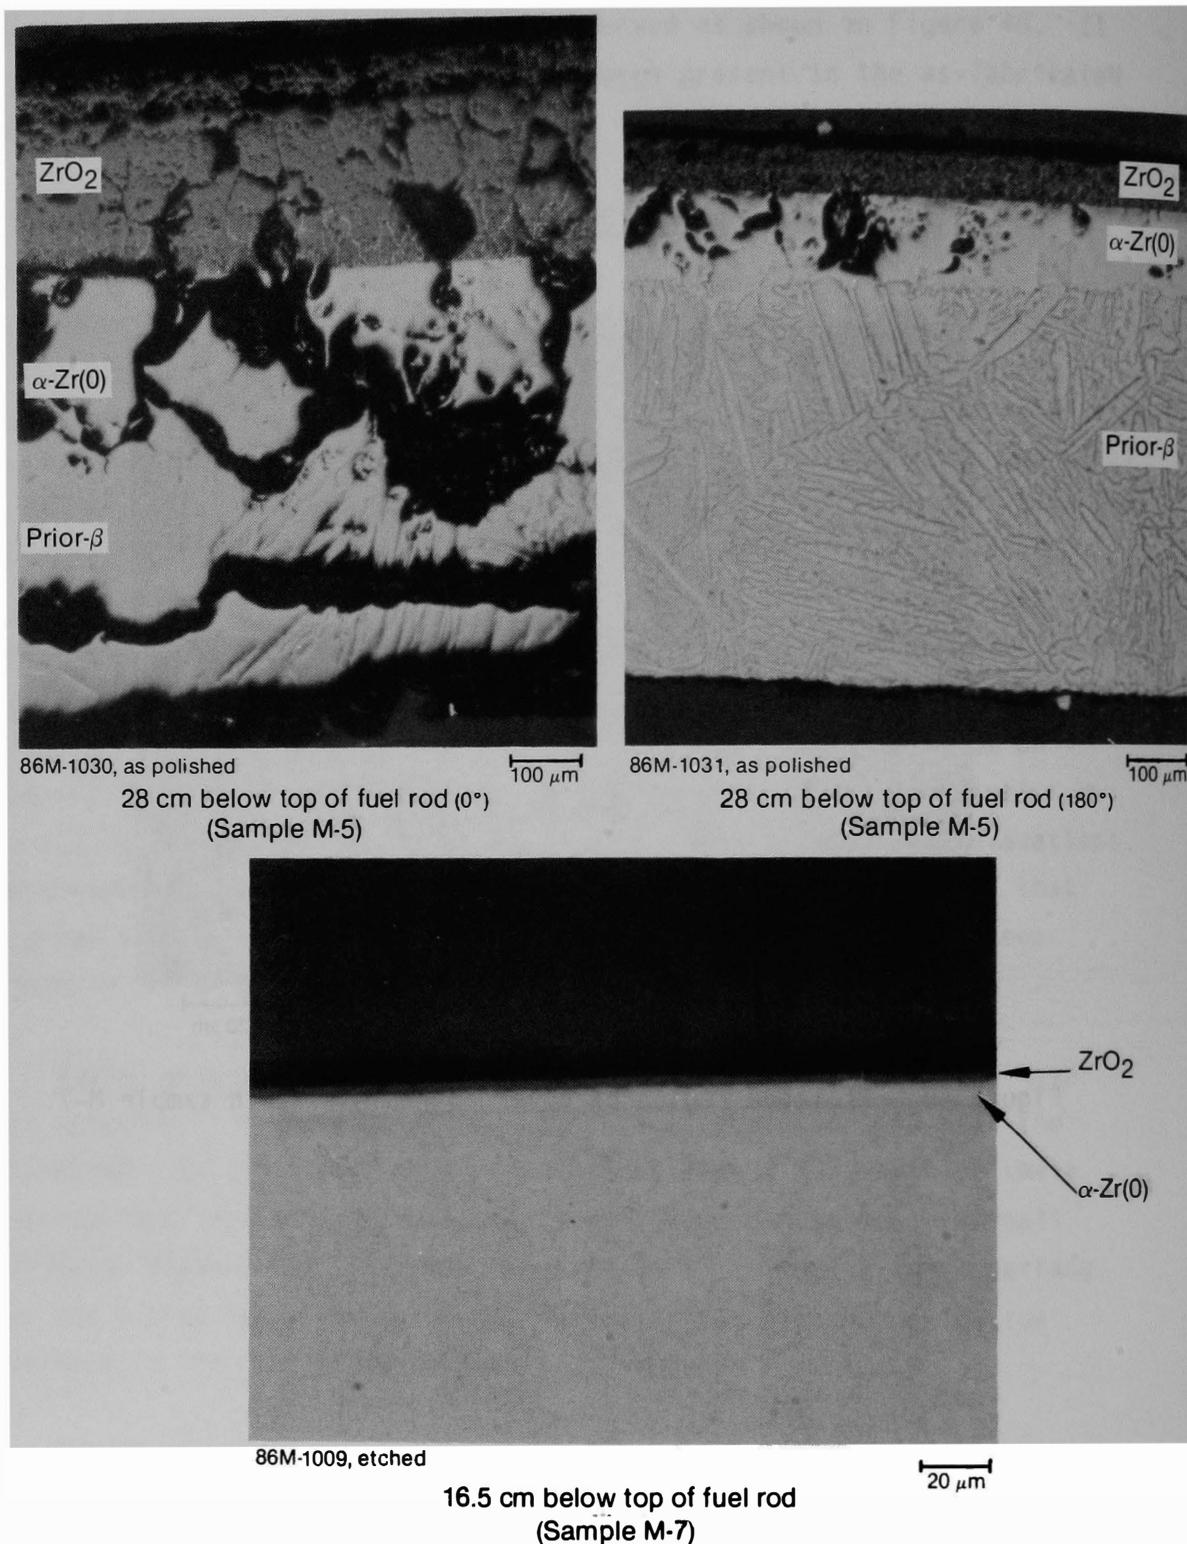
Figure 41. Variations in zircaloy oxidation on fuel rod 3-42.

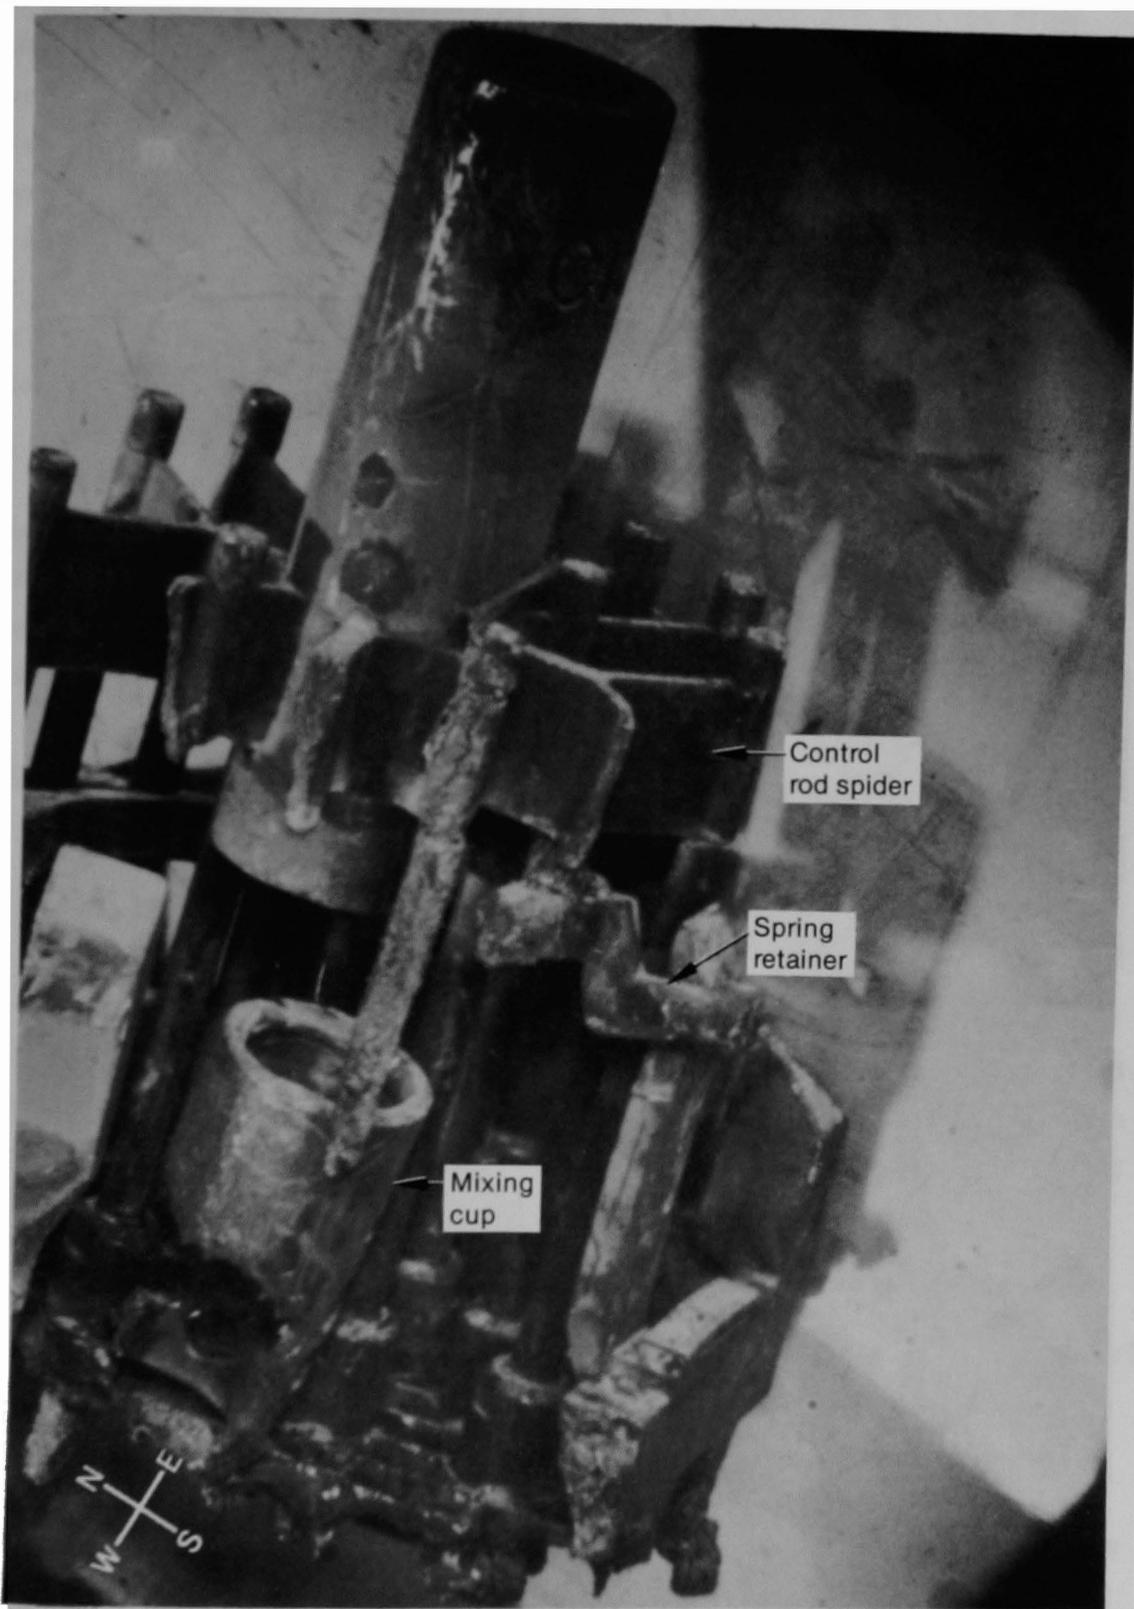
Figure D-1. Southwest corner of component D-141-1. Partially melted end fitting and control rod spider.

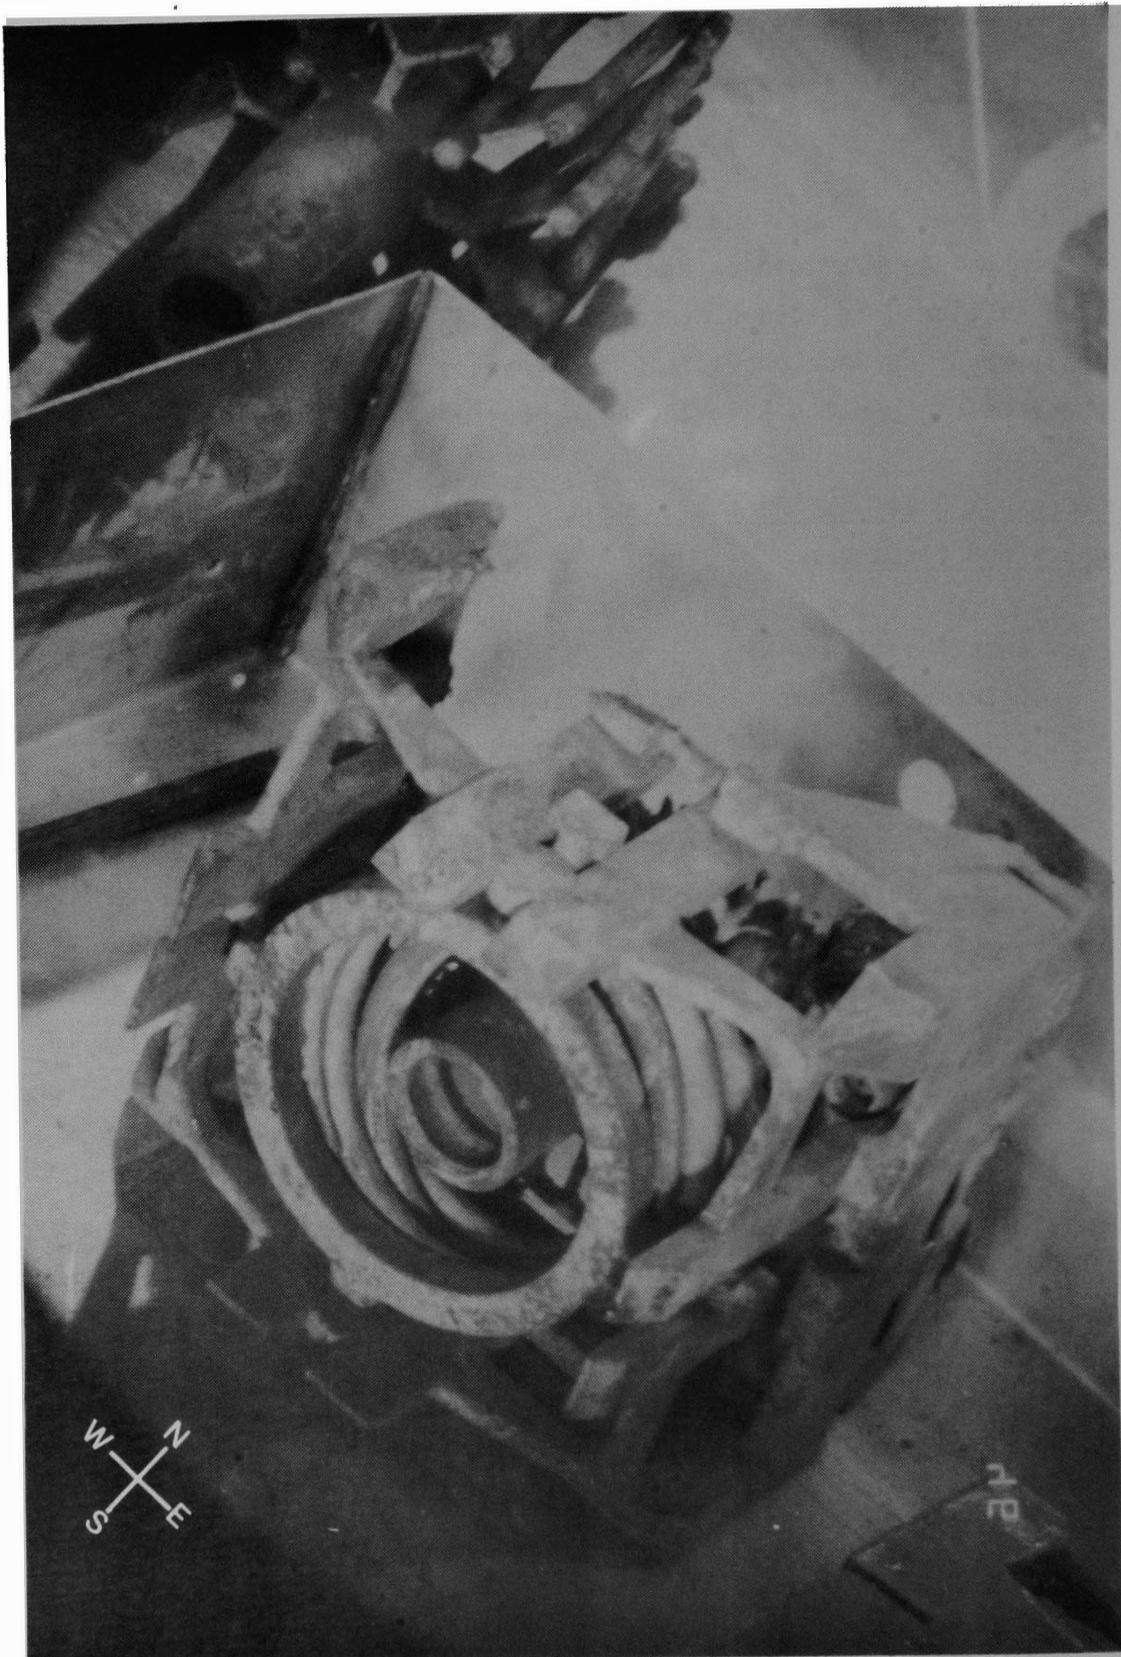
86-384-3-7

Figure D-9. Component D-141-4. Partially melted burnable poison rod fuel assembly upper end fitting.

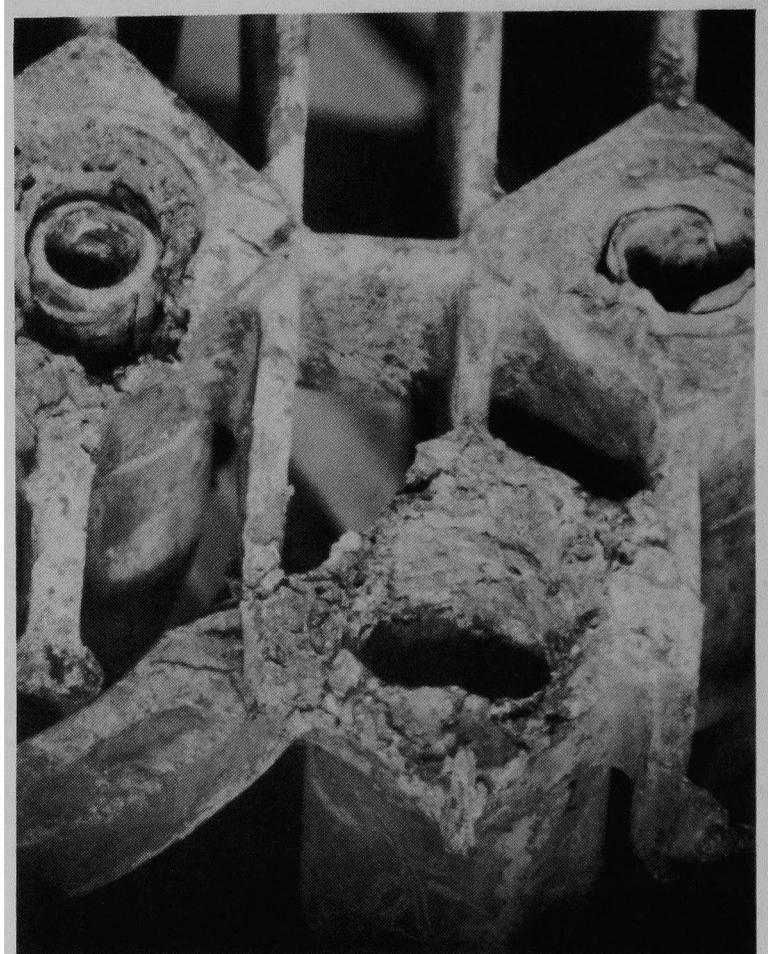
86T-103

Figure D-11. Details of melted transition region around burnable poison rod positions in component D-141-4.

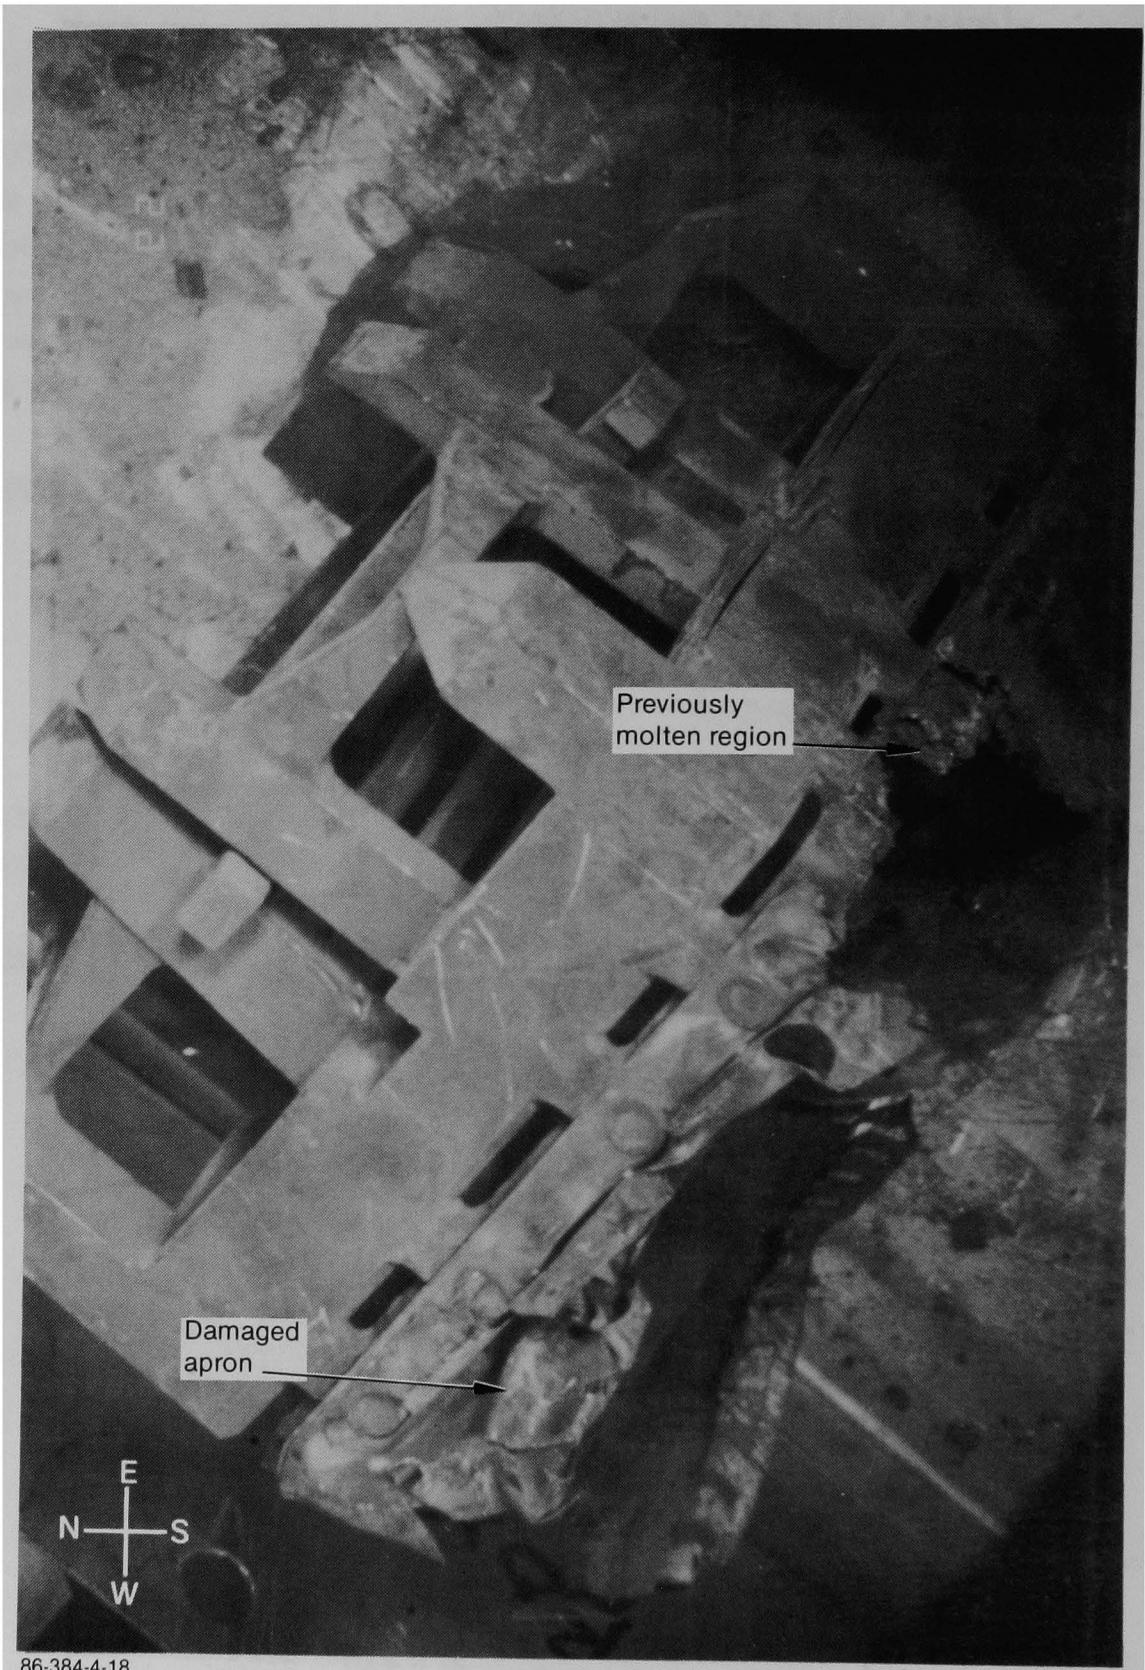
Component D-141-7 was a peripheral fuel assembly which contained empty guide tubes. No rod assembly spider was ever attached. The apron is very bent and torn, probably resulting from a combination of falling to the debris floor in the reactor, and handling damage in inserting and removing the component from the shipping canister. There is one small region of prior-molten tie plate in the southwest corner which could have resulted from a localized Fe-Zr eutectic interaction between the stainless steel tie plate and the zircaloy guide tube sleeves. At the eutectic point (~1220 K), the stainless steel-zircaloy interaction is believed to proceed very slowly; however, at temperatures above 1470 K the reaction approaches

Figure D-14. Component D-141-7. Partial upper end fitting from peripheral fuel assembly.

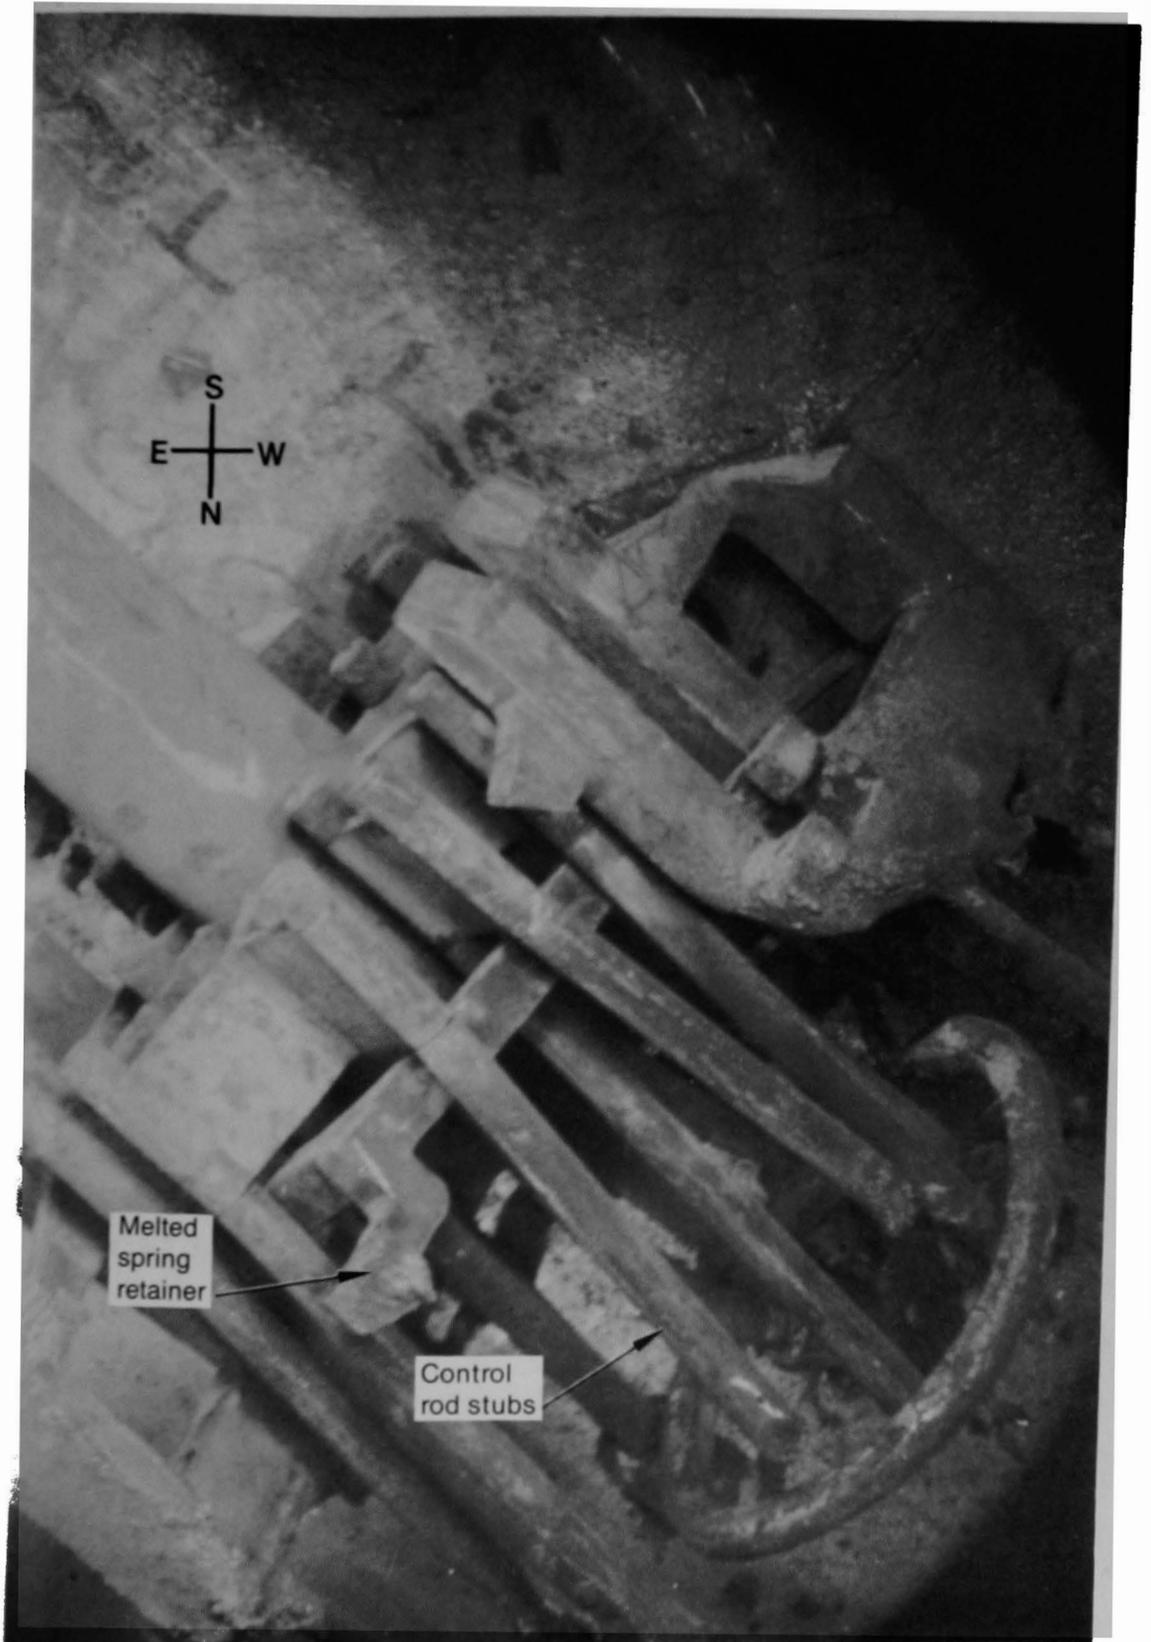
86-384-4-11

Peak temperatures were generally in excess of 1673 K across the entire assembly at the tie plate elevation, and to the top of the end fitting on the north side. Temperatures were also in excess of 1673 K where the spring retainer and mixing cup were melted, and the melted holddown spring indicates temperatures were greater than 1666 K in this region. The distribution of control rod lengths is further evidence that peak temperatures were above 1673 K above the tie plate on the north side, but were slightly cooler on the south side of the assembly.

Figure D-16. Component D-141-8. Control rod spider and partially melted upper end fitting.

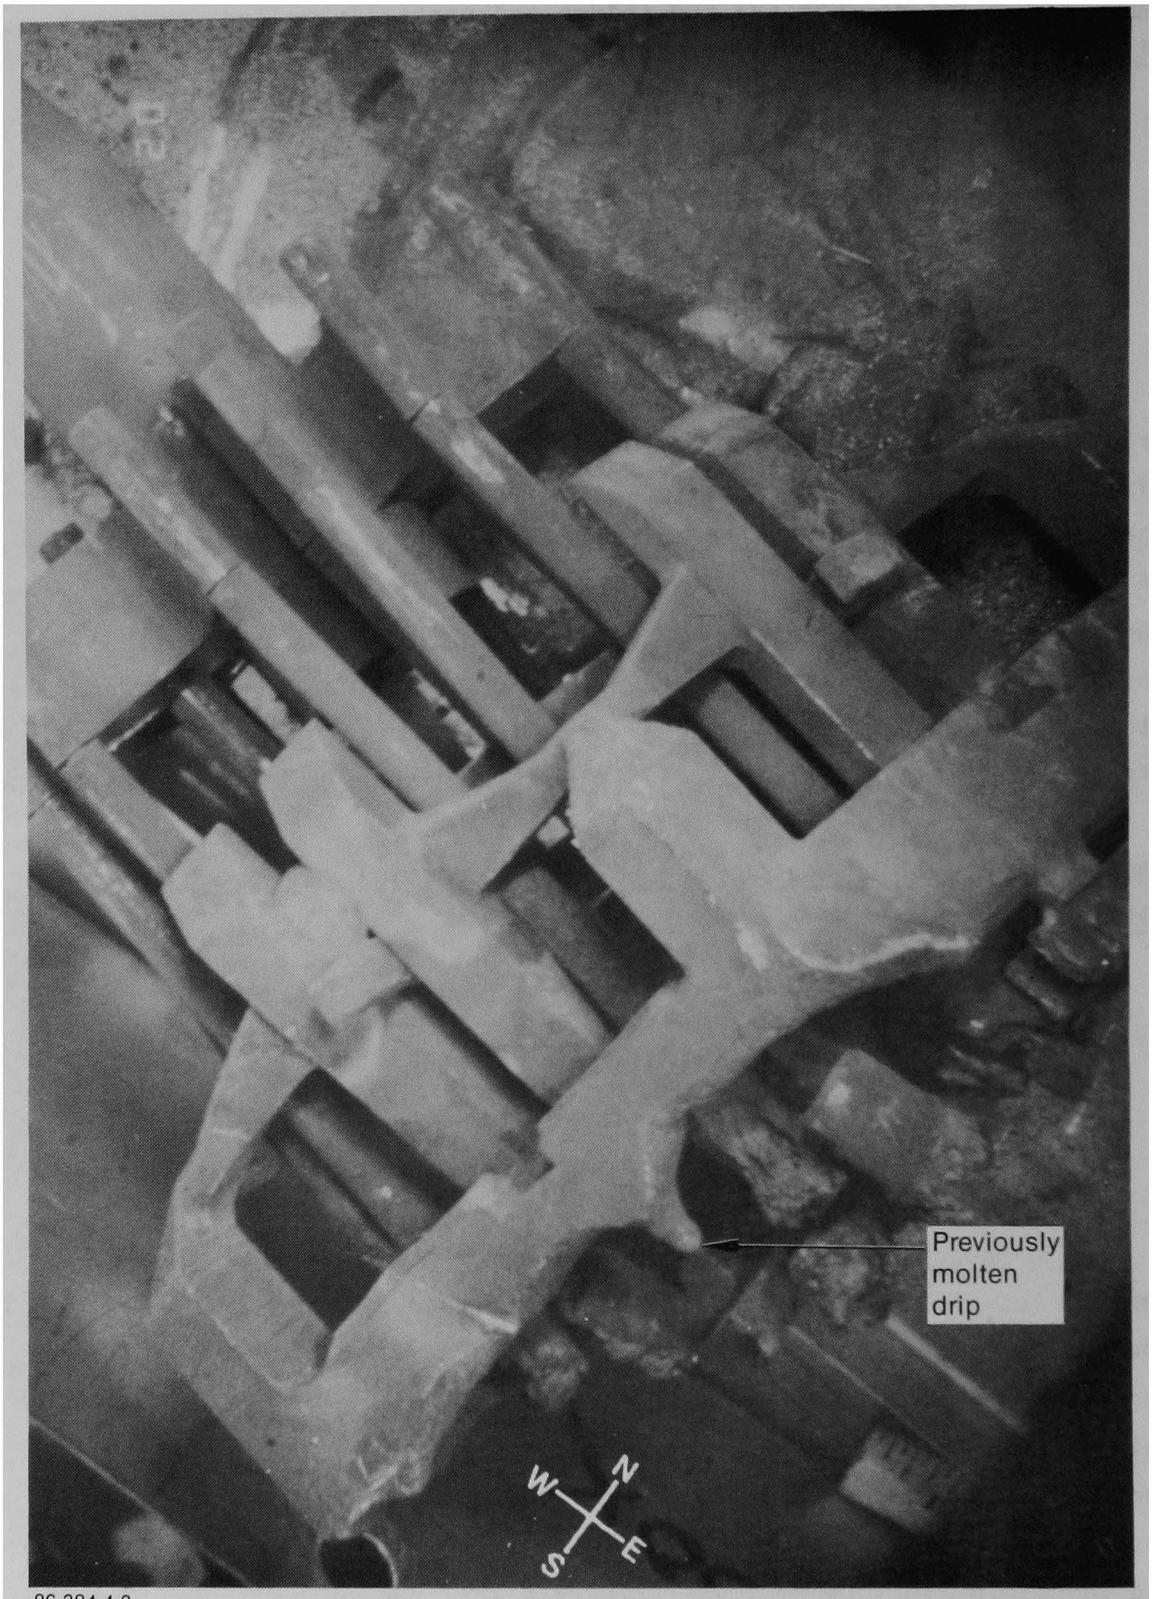
86-384-4-3

Figure D-18. Component D-141-9. Control rod spider and partially melted upper end fitting.

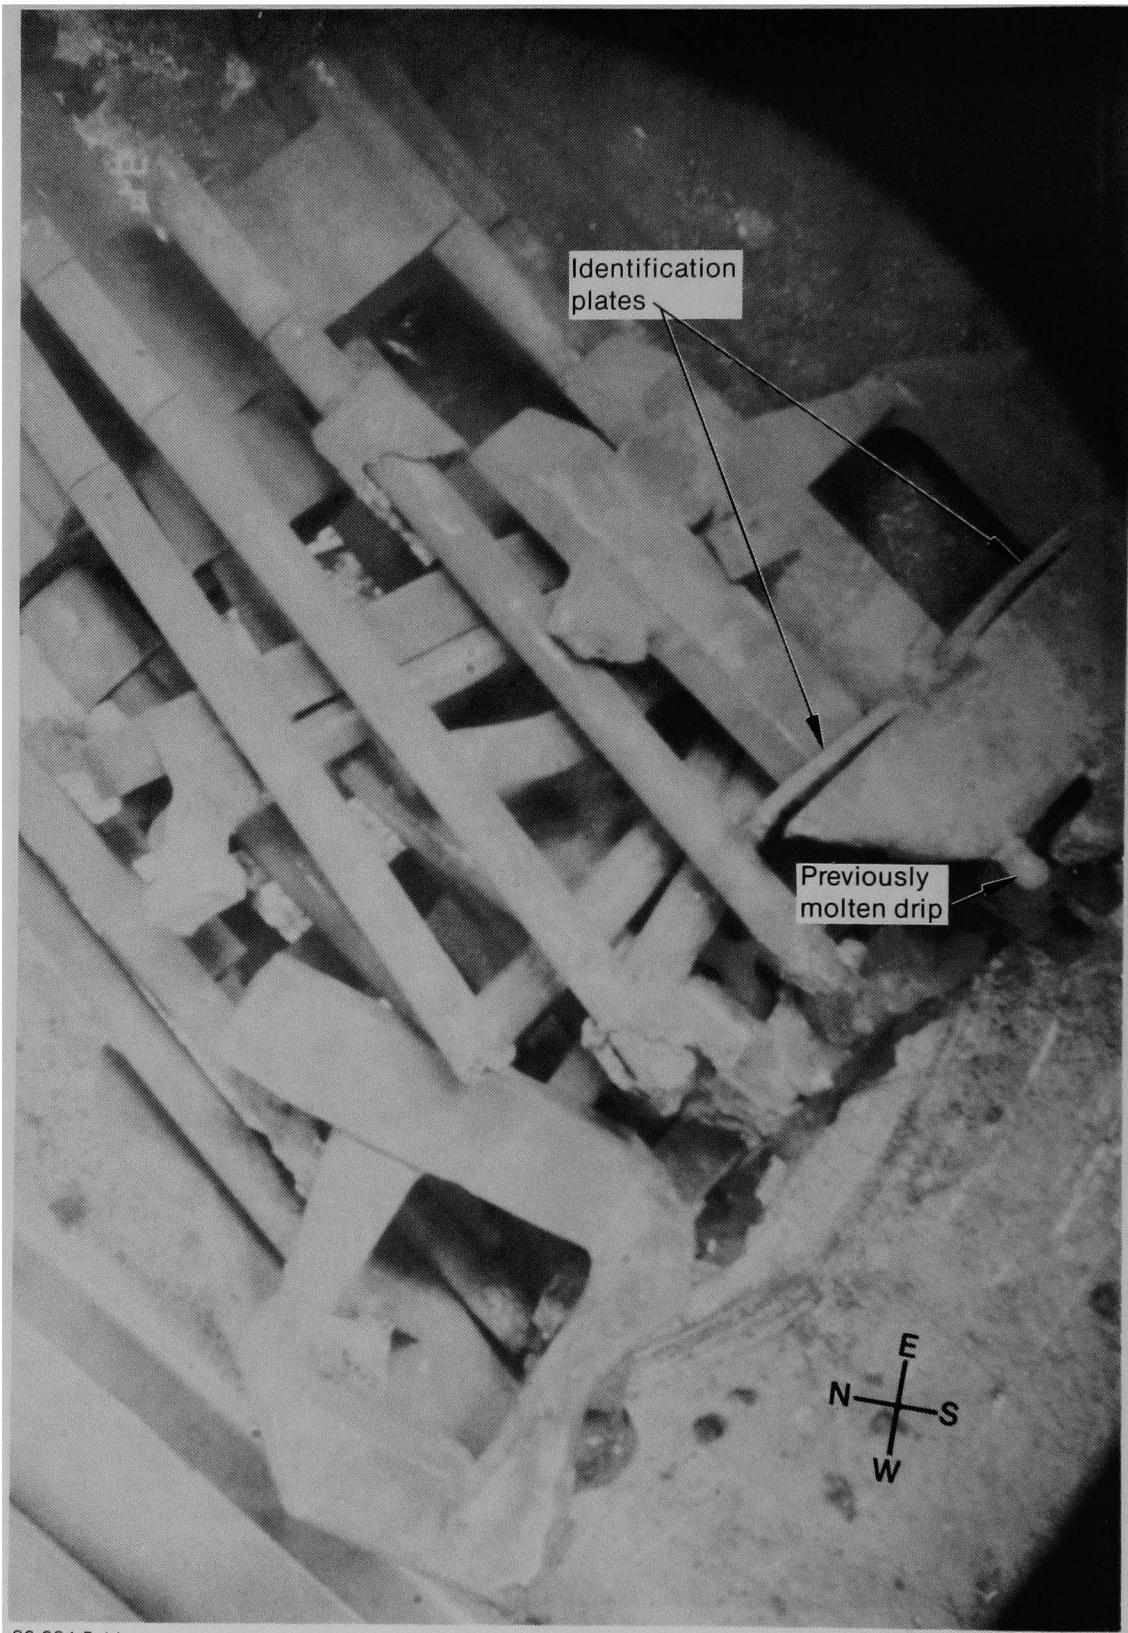
86-384-5-11

In component D-141-10, the tie plate has melted away on the outer peripheries of the north and west sides and has partially melted on the south side. The upper end fitting is completely gone in the southwest corner, and it has slumped in the northwest corner. The arm of the spring retainer has also slumped on the west side, and there is a melted spring endtip just below the slumped spring retainer. There are indications of a possible eutectic interaction zone between the zircaloy guide tube sleeve and the tie plate in some areas (Figure D-22), and many of the zircaloy guide tube nuts were partially melted. Peak temperatures were generally below 1673 K at the tie plate elevation; however, temperatures did exceed

Figure D-20. Component D-141-10. Control rod spider and partially melted upper end fitting.

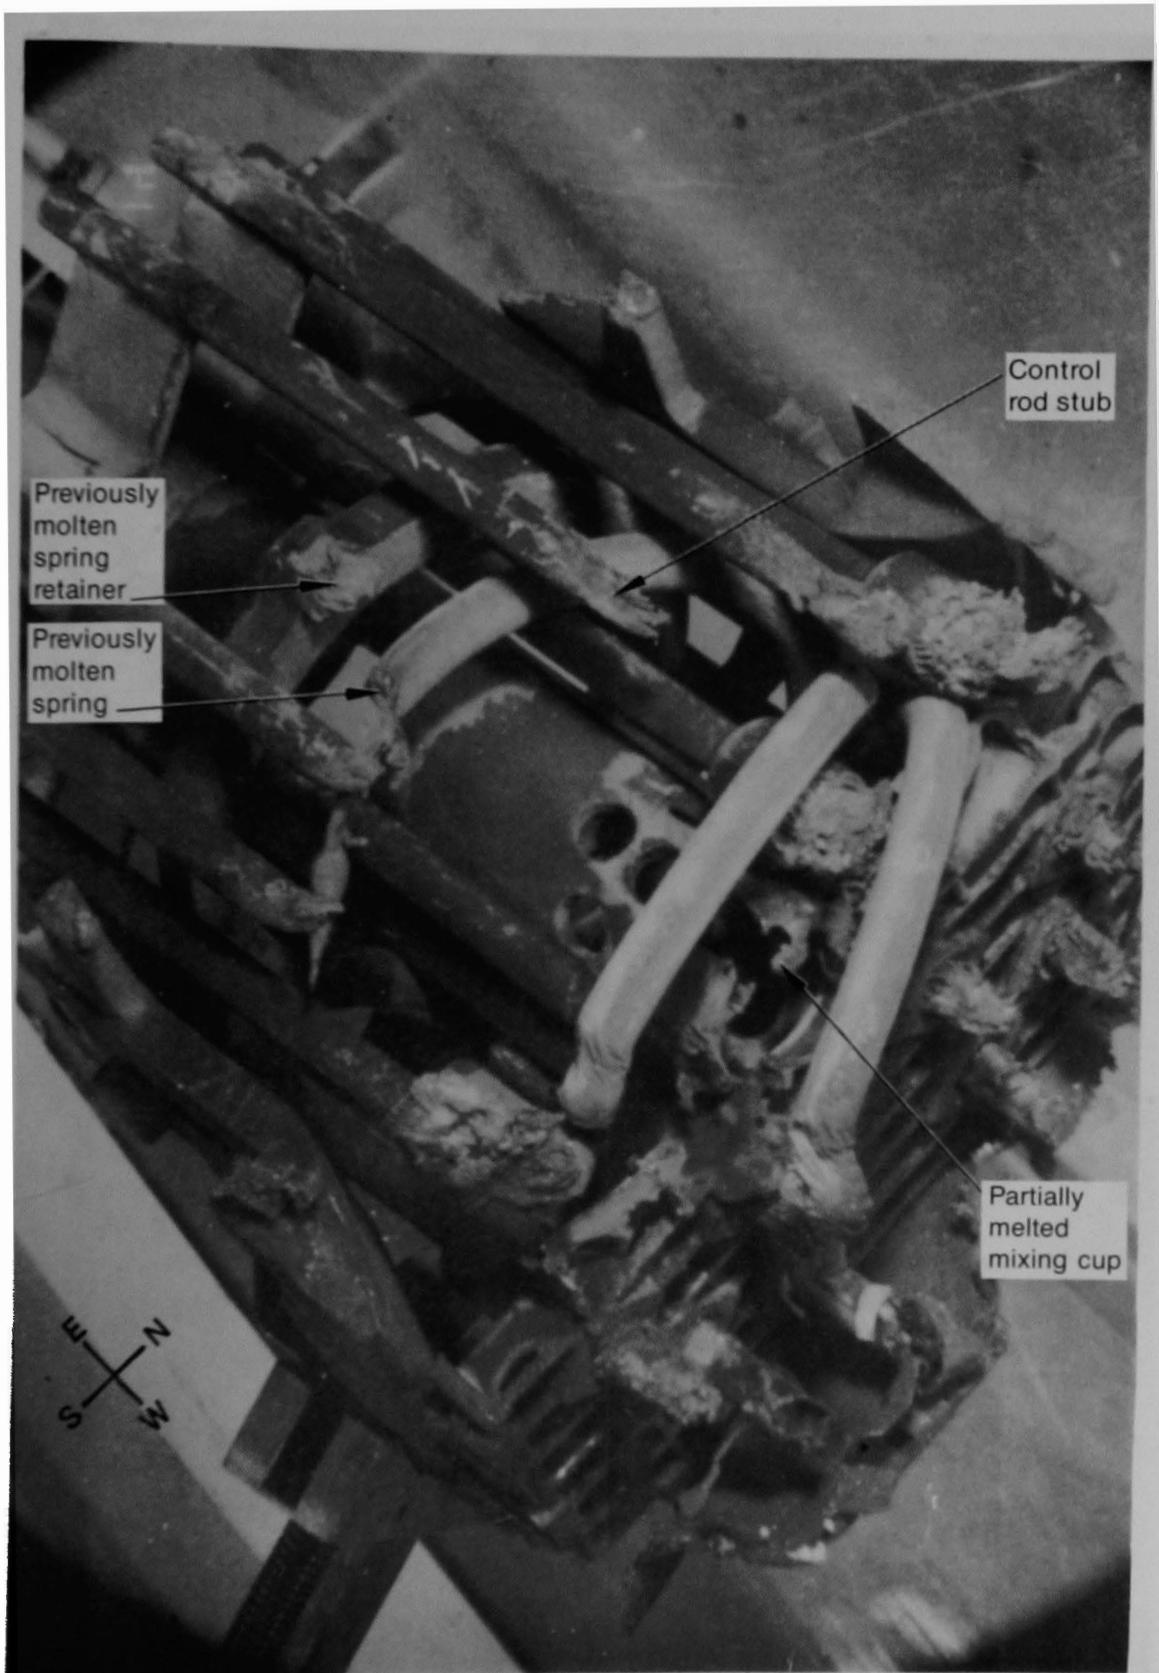
86-384.7.10

Figure D-27. Component D-153-4. End fitting and control rod spider.

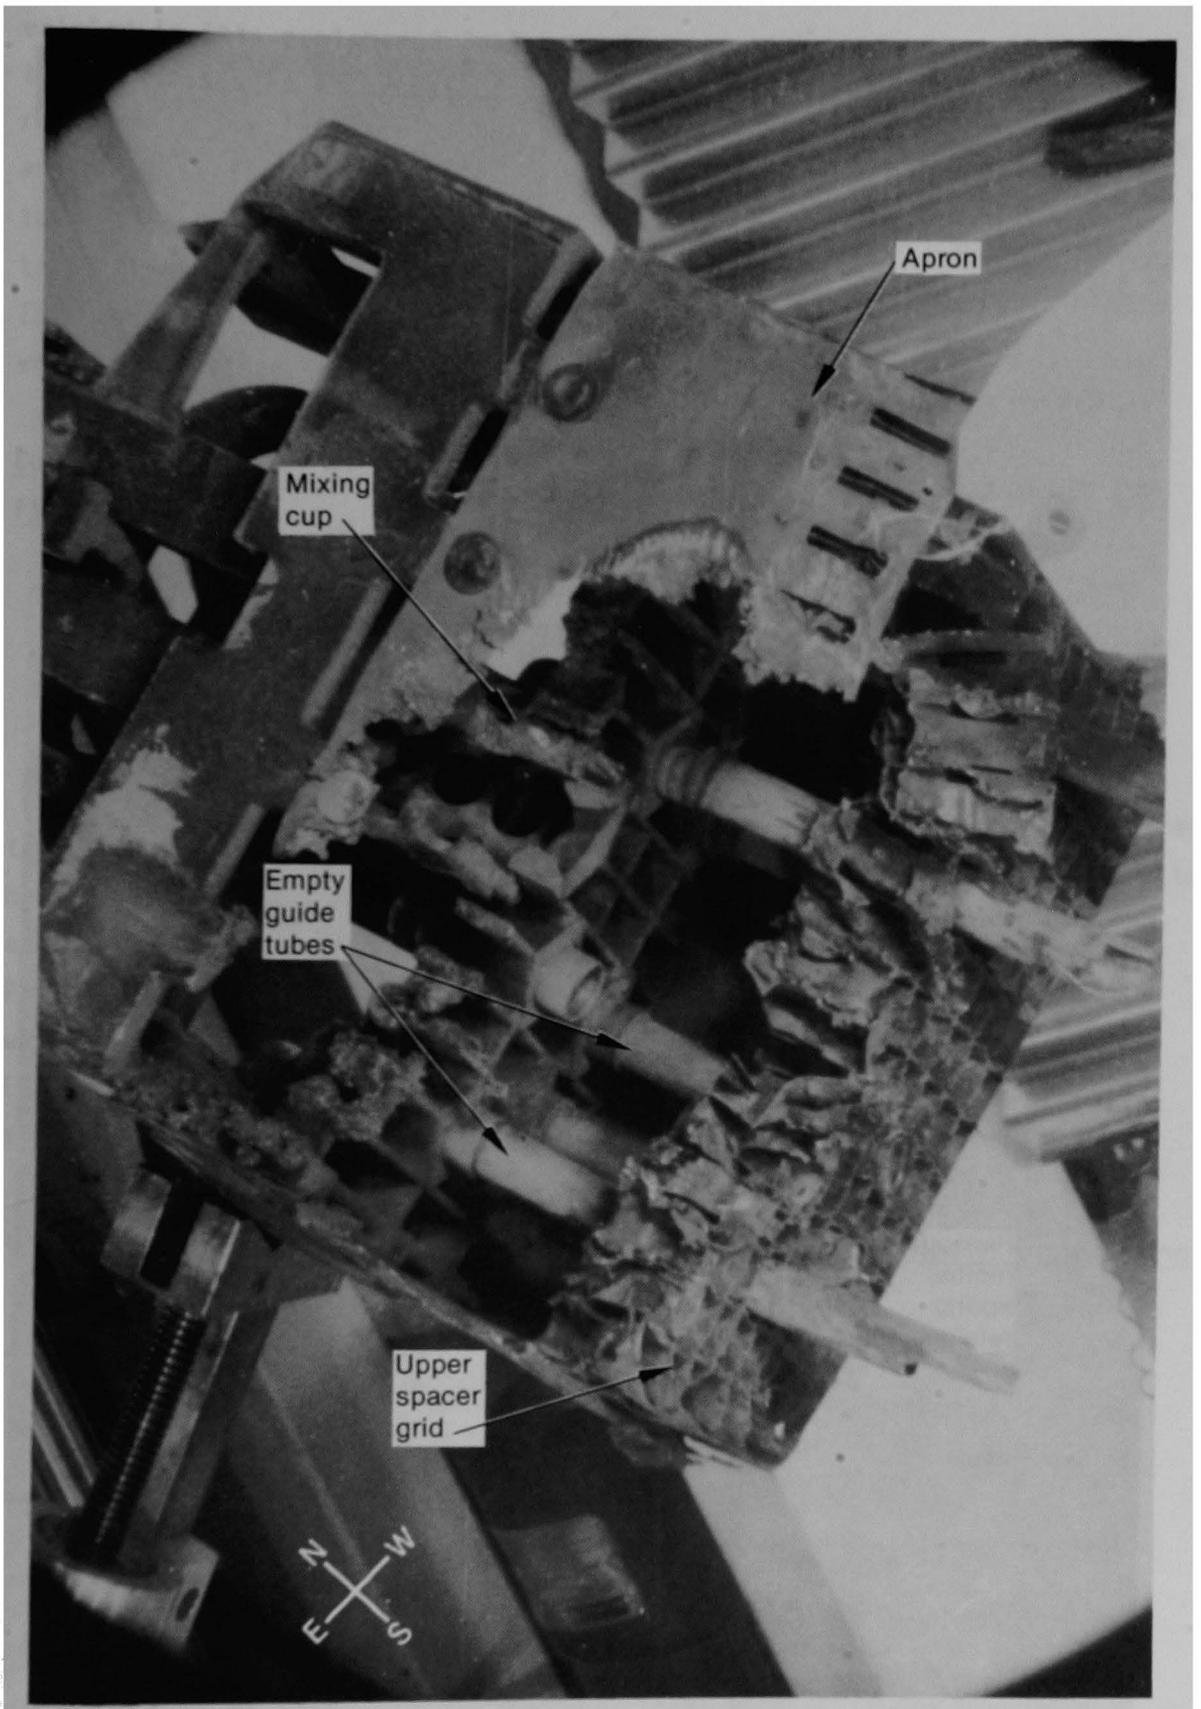
86-384-7-16

Component D-153-5 was a peripheral fuel assembly which contained empty guide tubes and no spider assembly. The greatest damage occurred on the north side where the upper spacer grid, apron, tie plate, and portions of the mixing cup and holddown spring were once melted. There was also an indication of the onset of melting on the underside of the spring retainer on this side. The north side of this assembly faced towards core center, and the postaccident condition indicates steep temperature gradients

Figure D-29. North side of component D-153-5. Peripheral fuel assembly upper end fitting.

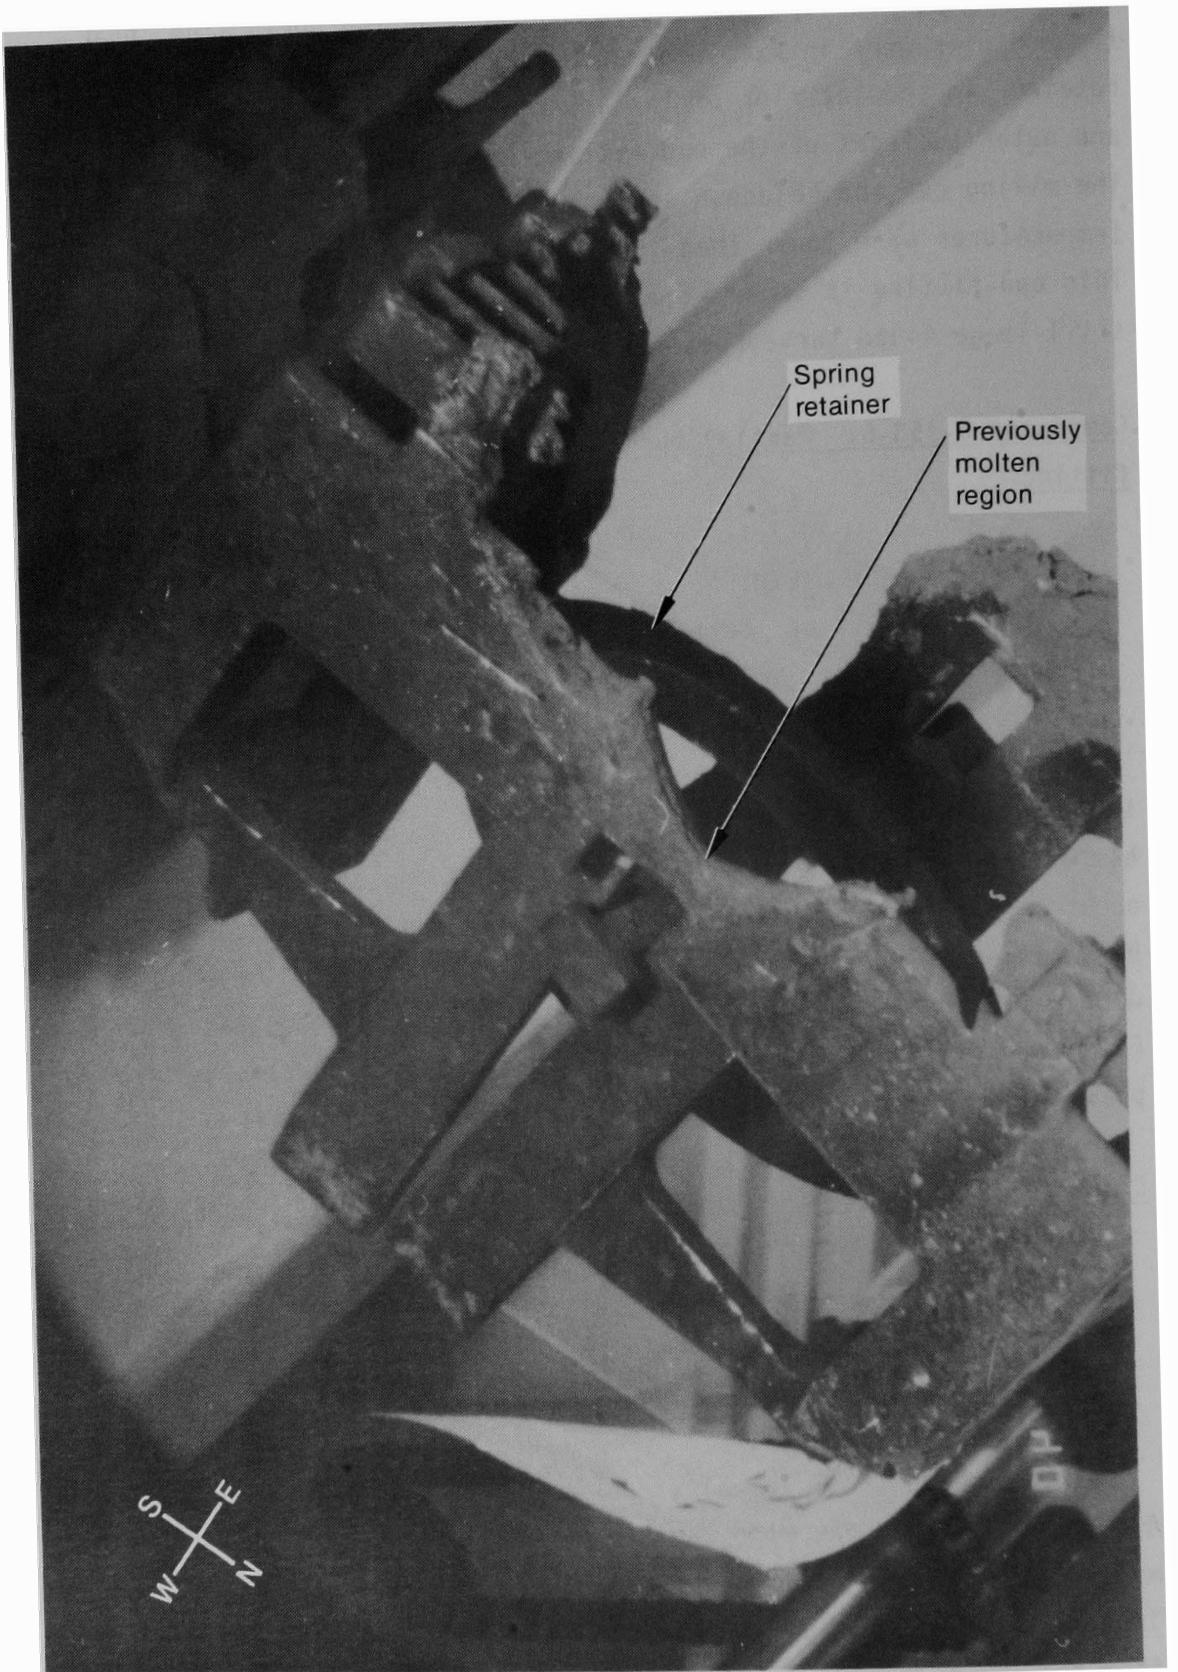
86-384-9-18

Figure D-31. Component D-153-6. Partial burnable poison rod assembly upper end fitting.
