EXAMINATION OF THE TMI-2 CORE
DISTINCT COMPONENTS

EXAMINATION OF THE TMI-2 CORE DISTINCT COMPONENTS

**S. M. Jensen
D. W. Akers
R. W. Garner
G. S. Roybal**

September 1987

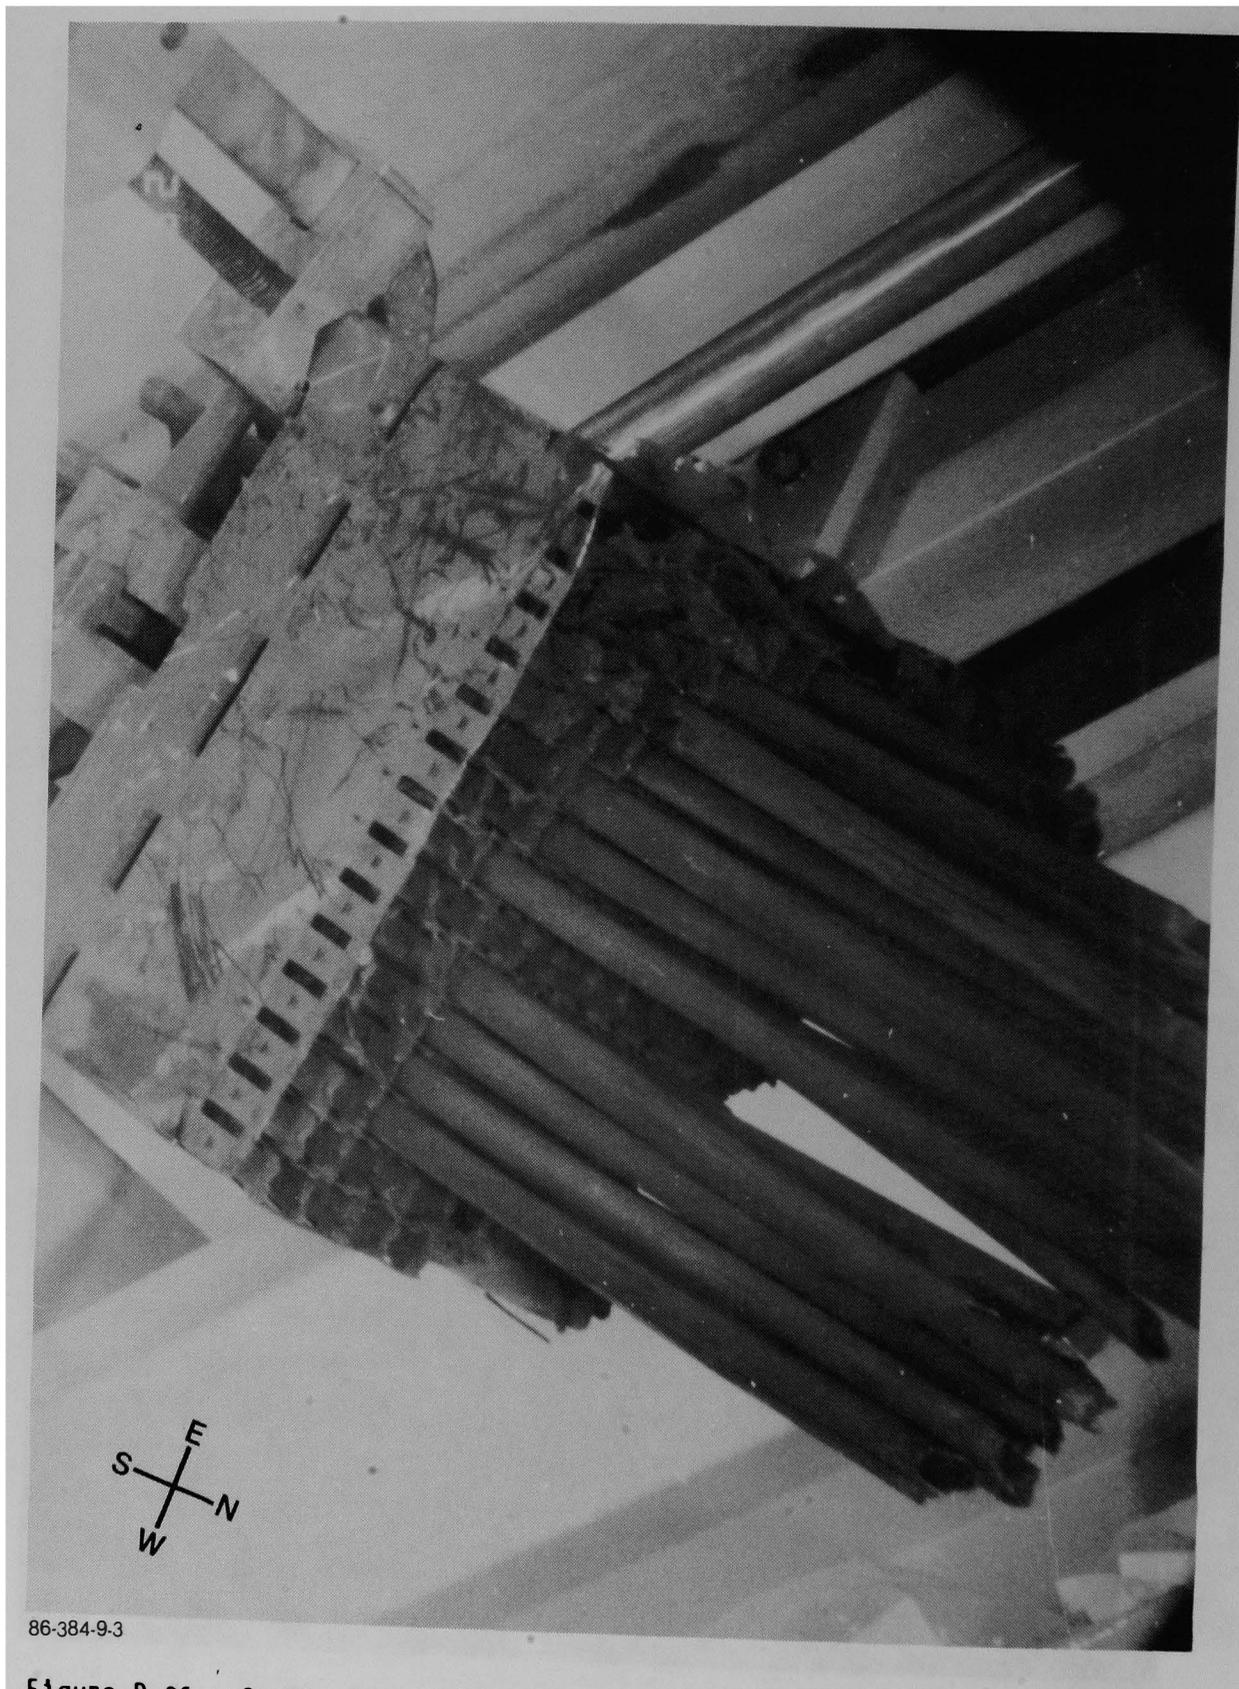
86-384-9.3

The greatest damage to component D-153-9 occurred in the northwest corner of the assembly, and particularly along the north side. The upper spacer grid and tie plate were intact except in this region, with the damage to the tie plate limited to the extreme northwest corner. Portions of the apron were also melted on the north and west sides. Most of the

Figure D-36. South side view of component D-153-9. Control rod spider and partial fuel assembly.

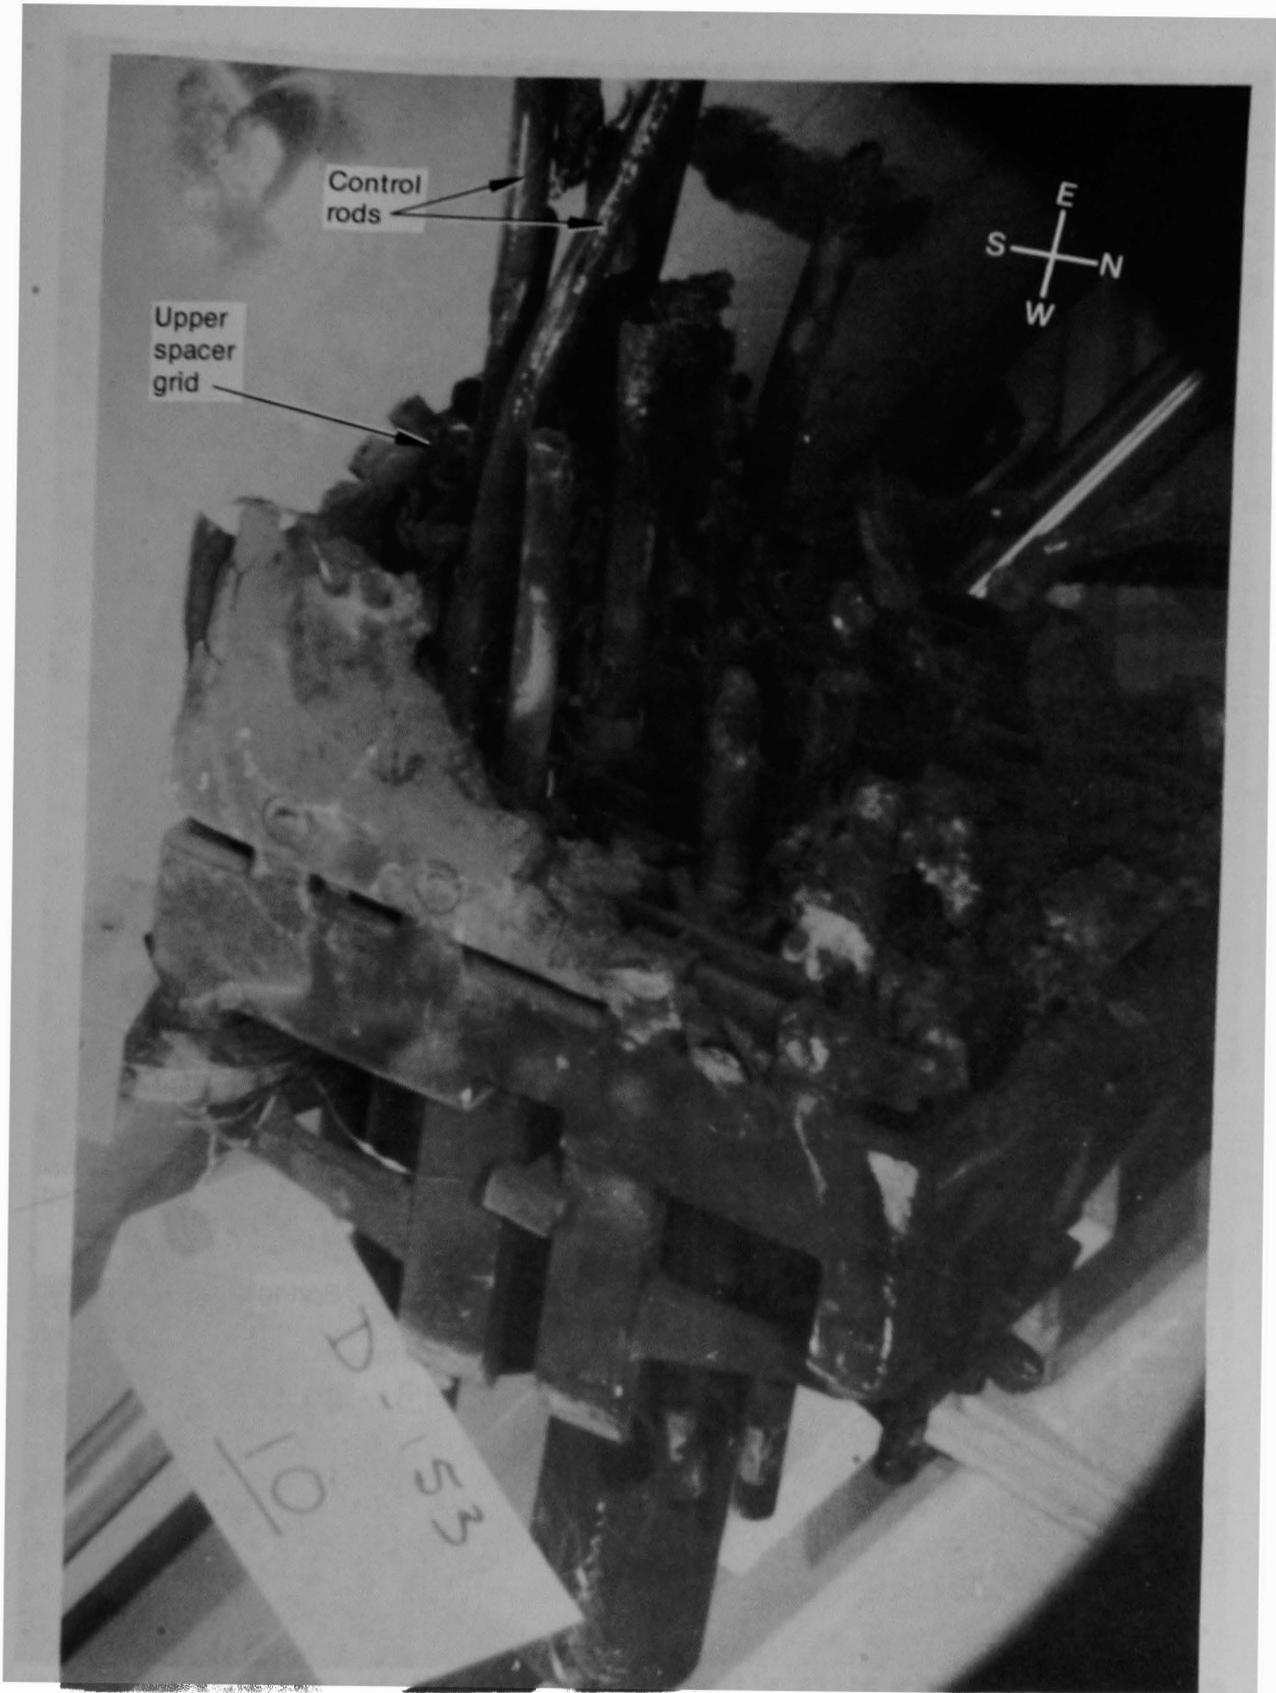
86-384-9-30

In component D-153-10, the tie plate is intact except for a small portion in the northwest corner. The apron is gone except on the south side and in a partially melted area on the west side. The upper spacer grid is gone except for a badly mangled portion on the south side. Control rod stubs extend from just below the tie plate on the north side to well below the crumpled upper spacer grid on the south side. The mixing cup and holddown springs are undamaged. Peak temperatures ranged from lower than 1533 K on the south side at the upper spacer grid elevation to higher than 1673 K in the extreme northwest corner at the tie plate elevation.

Figure D-38. West side view of component D-153-10. Control rod spider and upper end fitting.

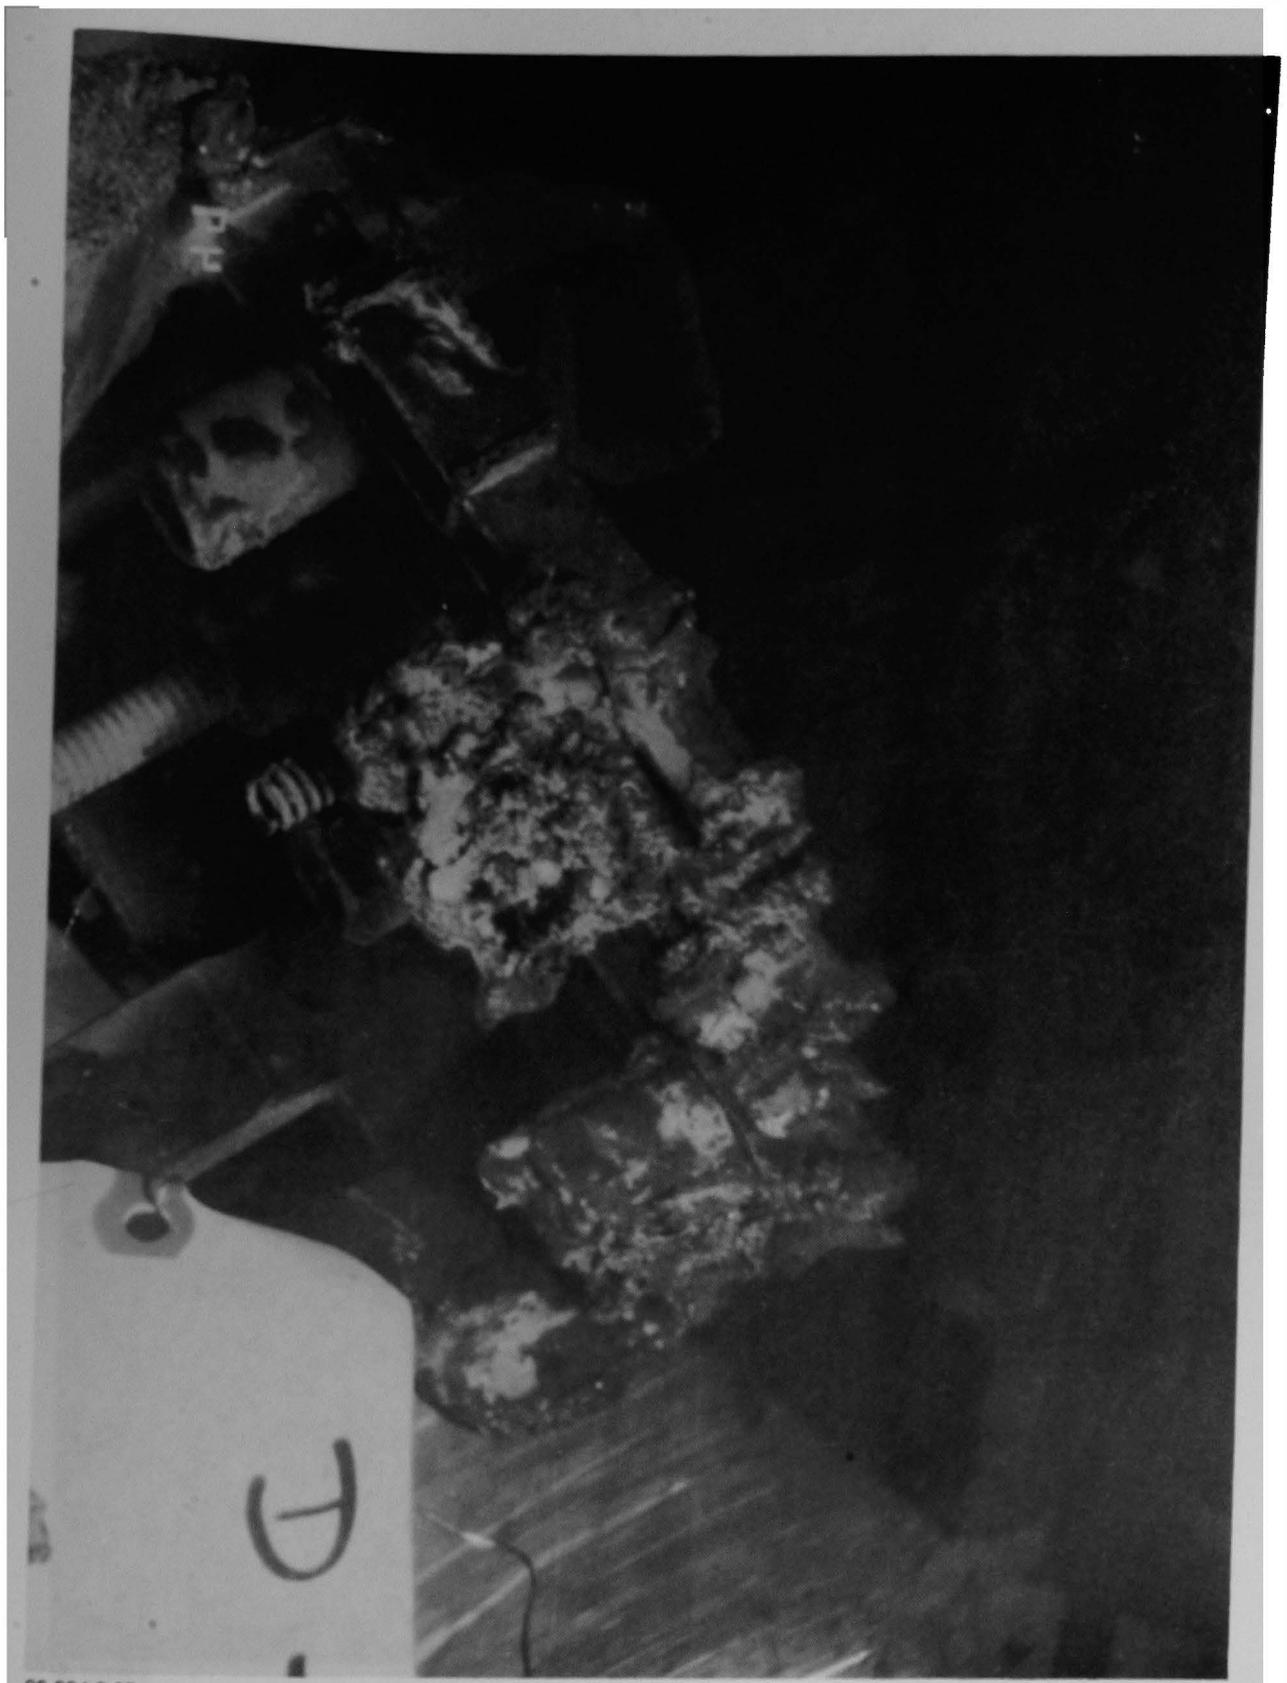
66-384 9-25

Figure D-41. Melted material near mixing cup on component D-153-11.

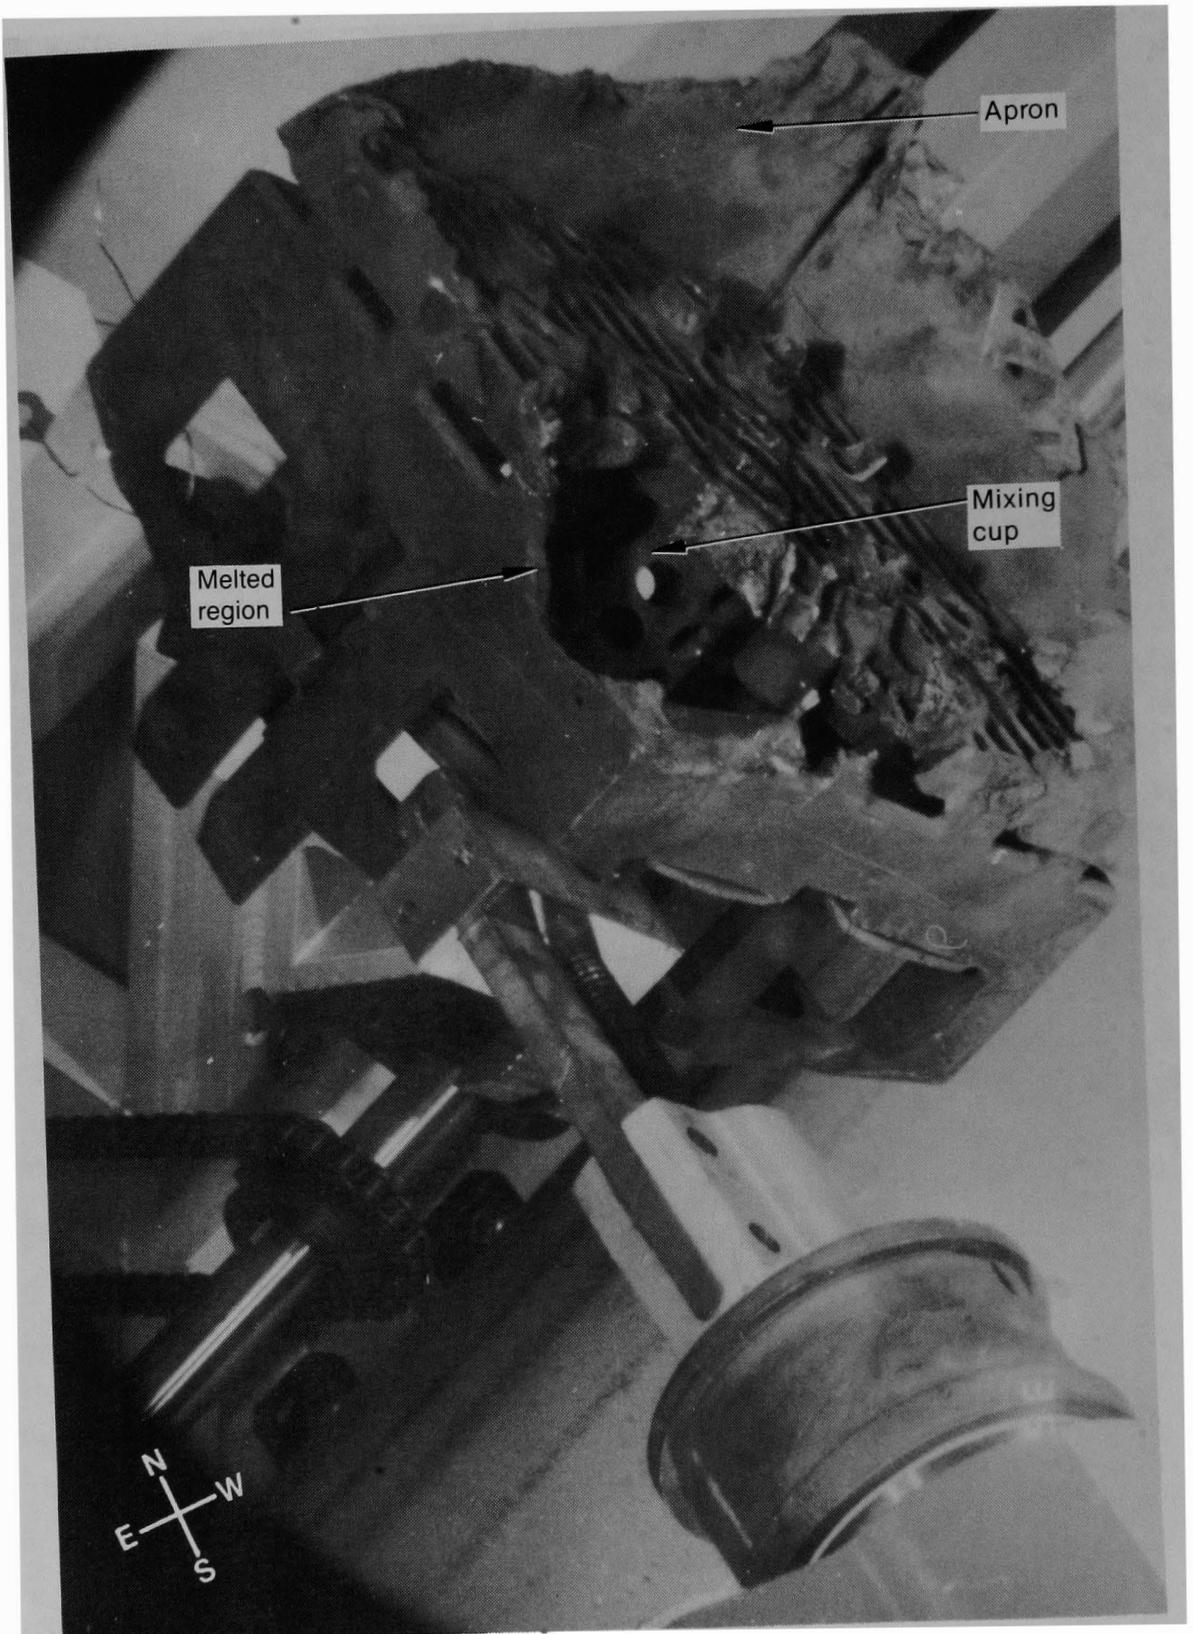
86-384-9-10

Component D-153-12 was most heavily damaged in the southeast corner where the tie plate and portions of the sides of the end fitting above the tie plate elevation were melted. A small portion of the lower part of the holddown spring in the southeast corner was also melted. Portions of the remaining apron on the north and west sides were also melted. Peak temperatures were in excess of 1673 K in the southeast corner at the tie plate elevation and were higher than 1666 K where the holddown spring melted just above the tie plate. Temperatures were lower than 1673 K across the remainder of the assembly at the tie plate elevation.

Figure D-42. Component D-153-12. Axial power shaping rod fuel assembly end fitting.

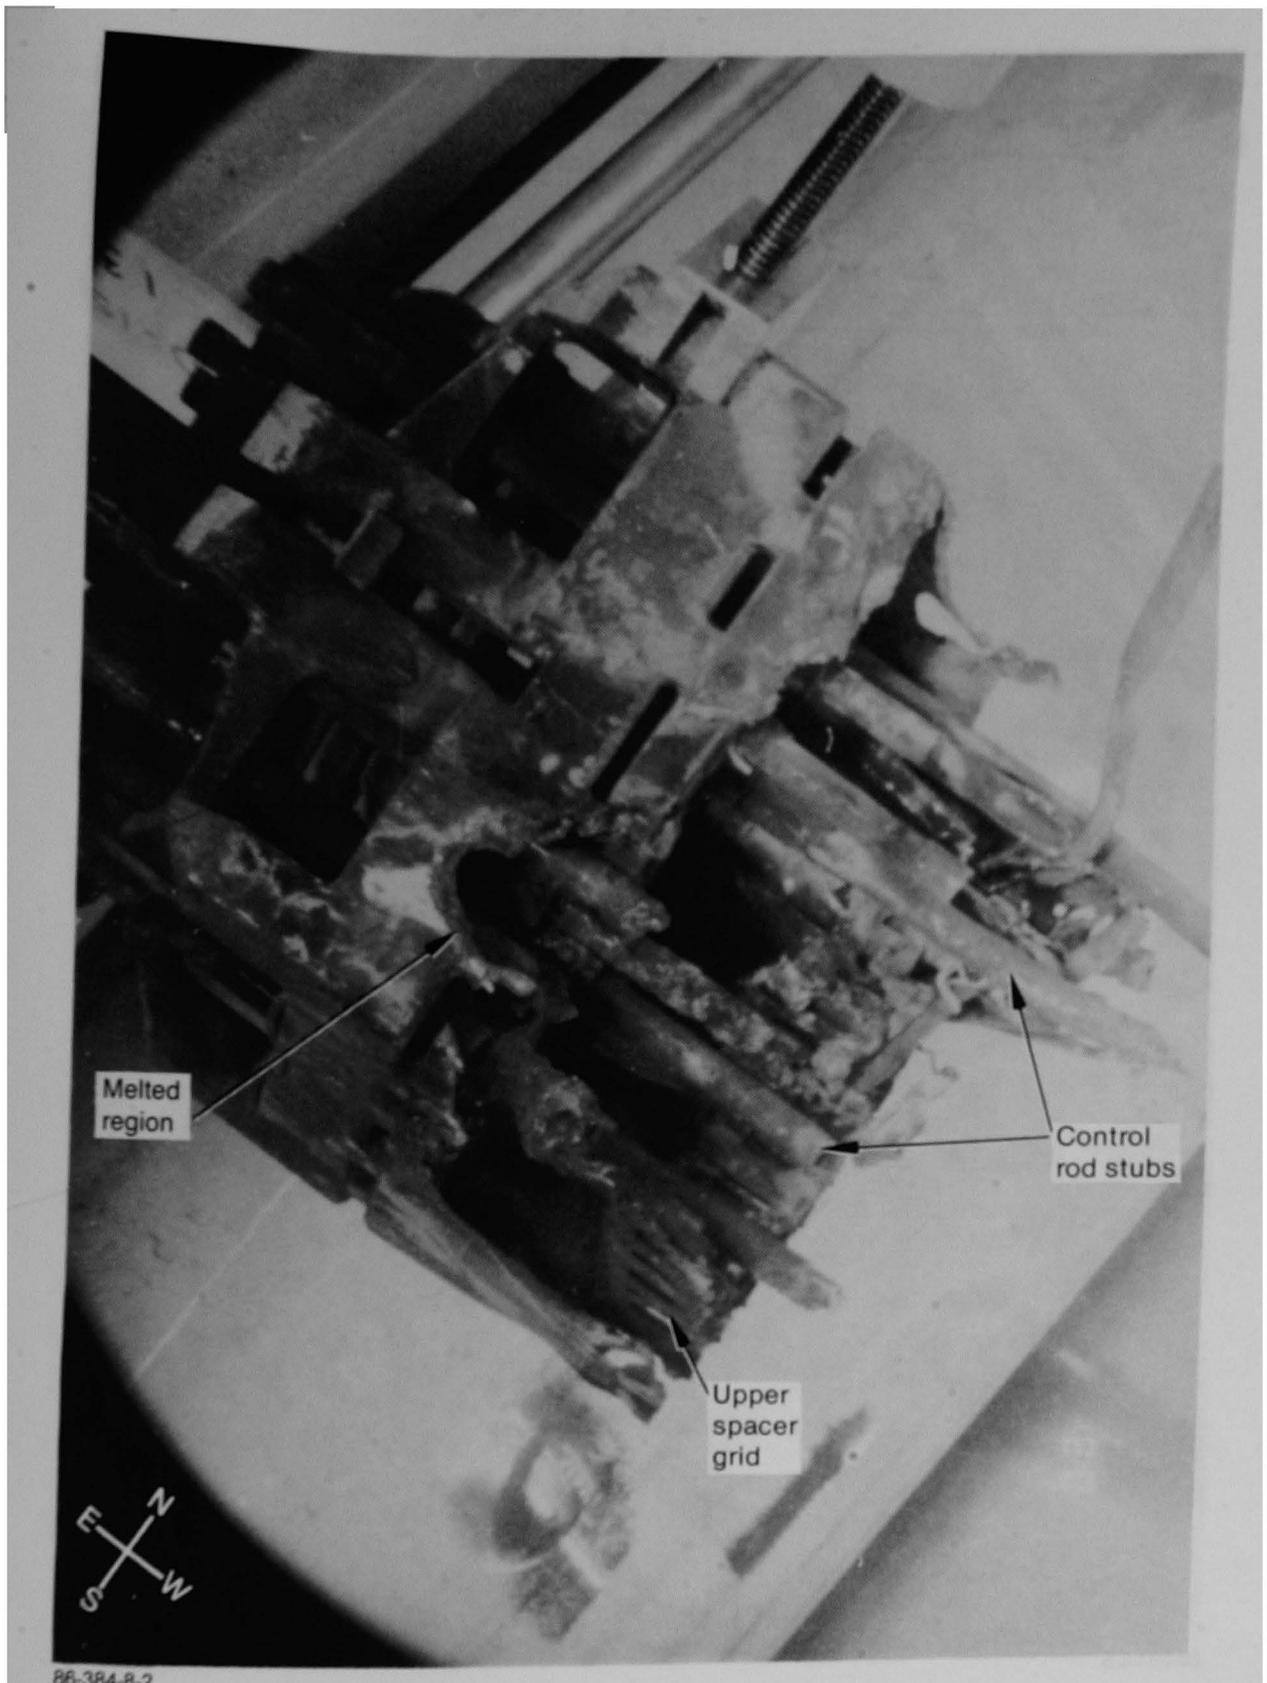
Component D-153-13 was most heavily damaged in the southeast corner where the melted region included the tie plate and portions of the sides of the upper end fitting. This corner faced core center in this peripheral assembly. The least damage occurred on the west side where the upper spacer grid is still present. This side faced a fuel assembly on the edge of the core. The mixing cup and holddown spring were undamaged. Peak temperatures ranged from 1673 K in the southeast corner at the tie plate elevation and slightly above to less than 1533 K at the upper spacer grid elevation on the west side.

Figure D-44. East side view of component D-153-13. Control rod partial fuel assembly and spider.
