TMI-2 CORE HORSESHOE RING EXAMINATIONS

M. L. Russell

Published October 1987

**EG&G Idaho, Inc.
Idaho Falls, Idaho 83415**

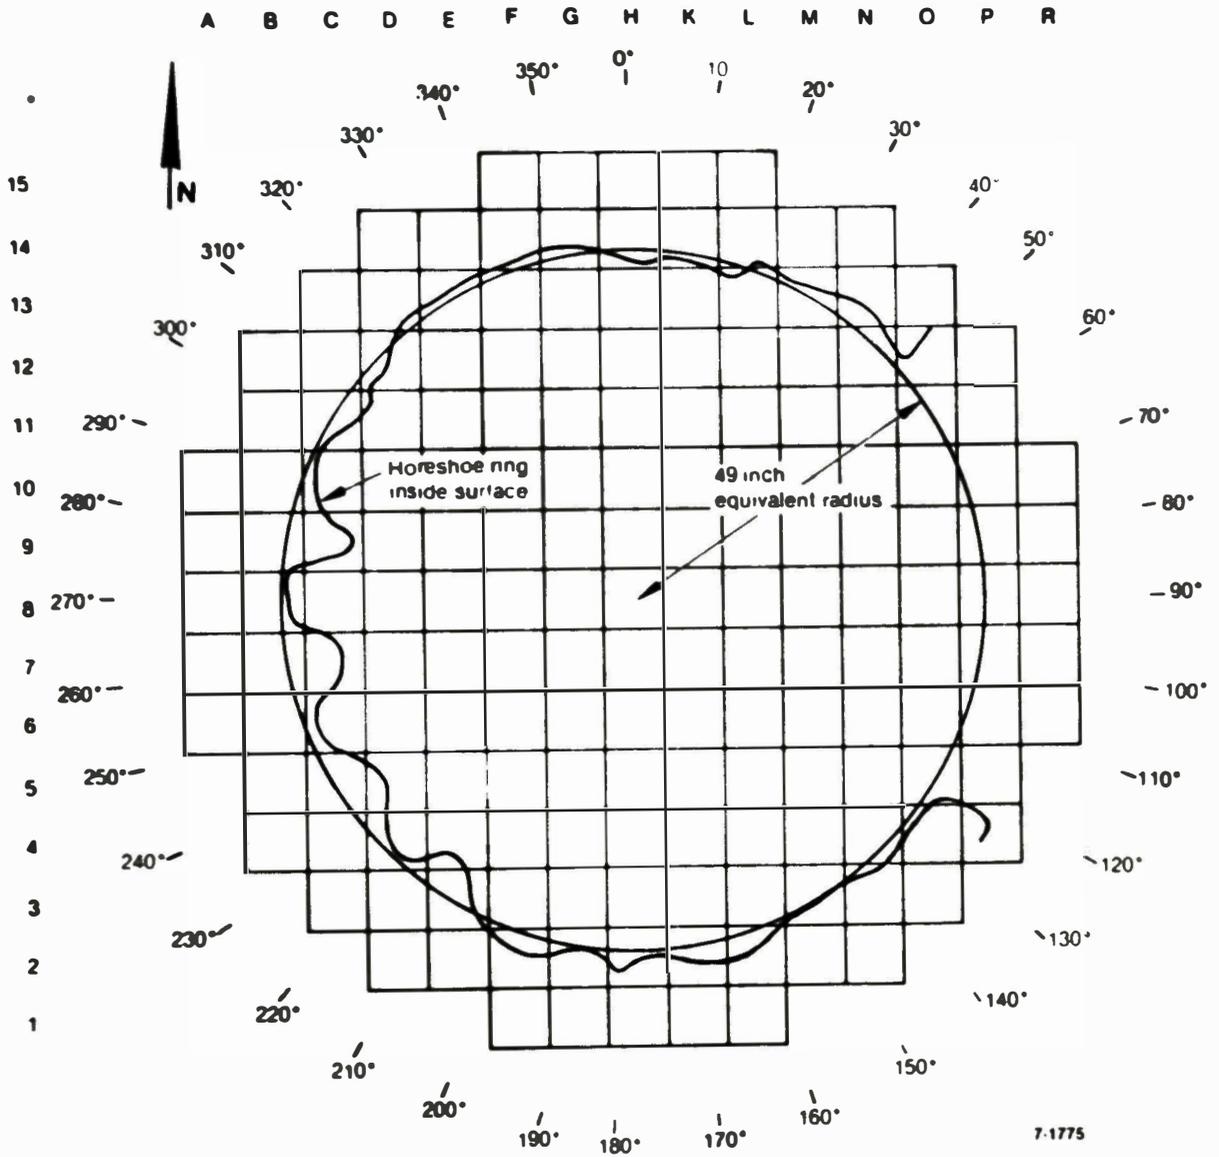
Figure 2. Estimated radial configuration of horseshoe-shaped ring of agglomerate core material.

1. In June, a horseshoe-shaped ring of fused-together core material was observed. It projected inwards from standing rod bundles from 120° to 50° azimuth as shown in Fig. 2. The average inward projection of the ring is estimated to be 49 inches from the core centerline. In several locations, the visible bottom edge of the ring receded, creating a cave-like geometry (see Plates A-2, A-4, A-5, and A-7).

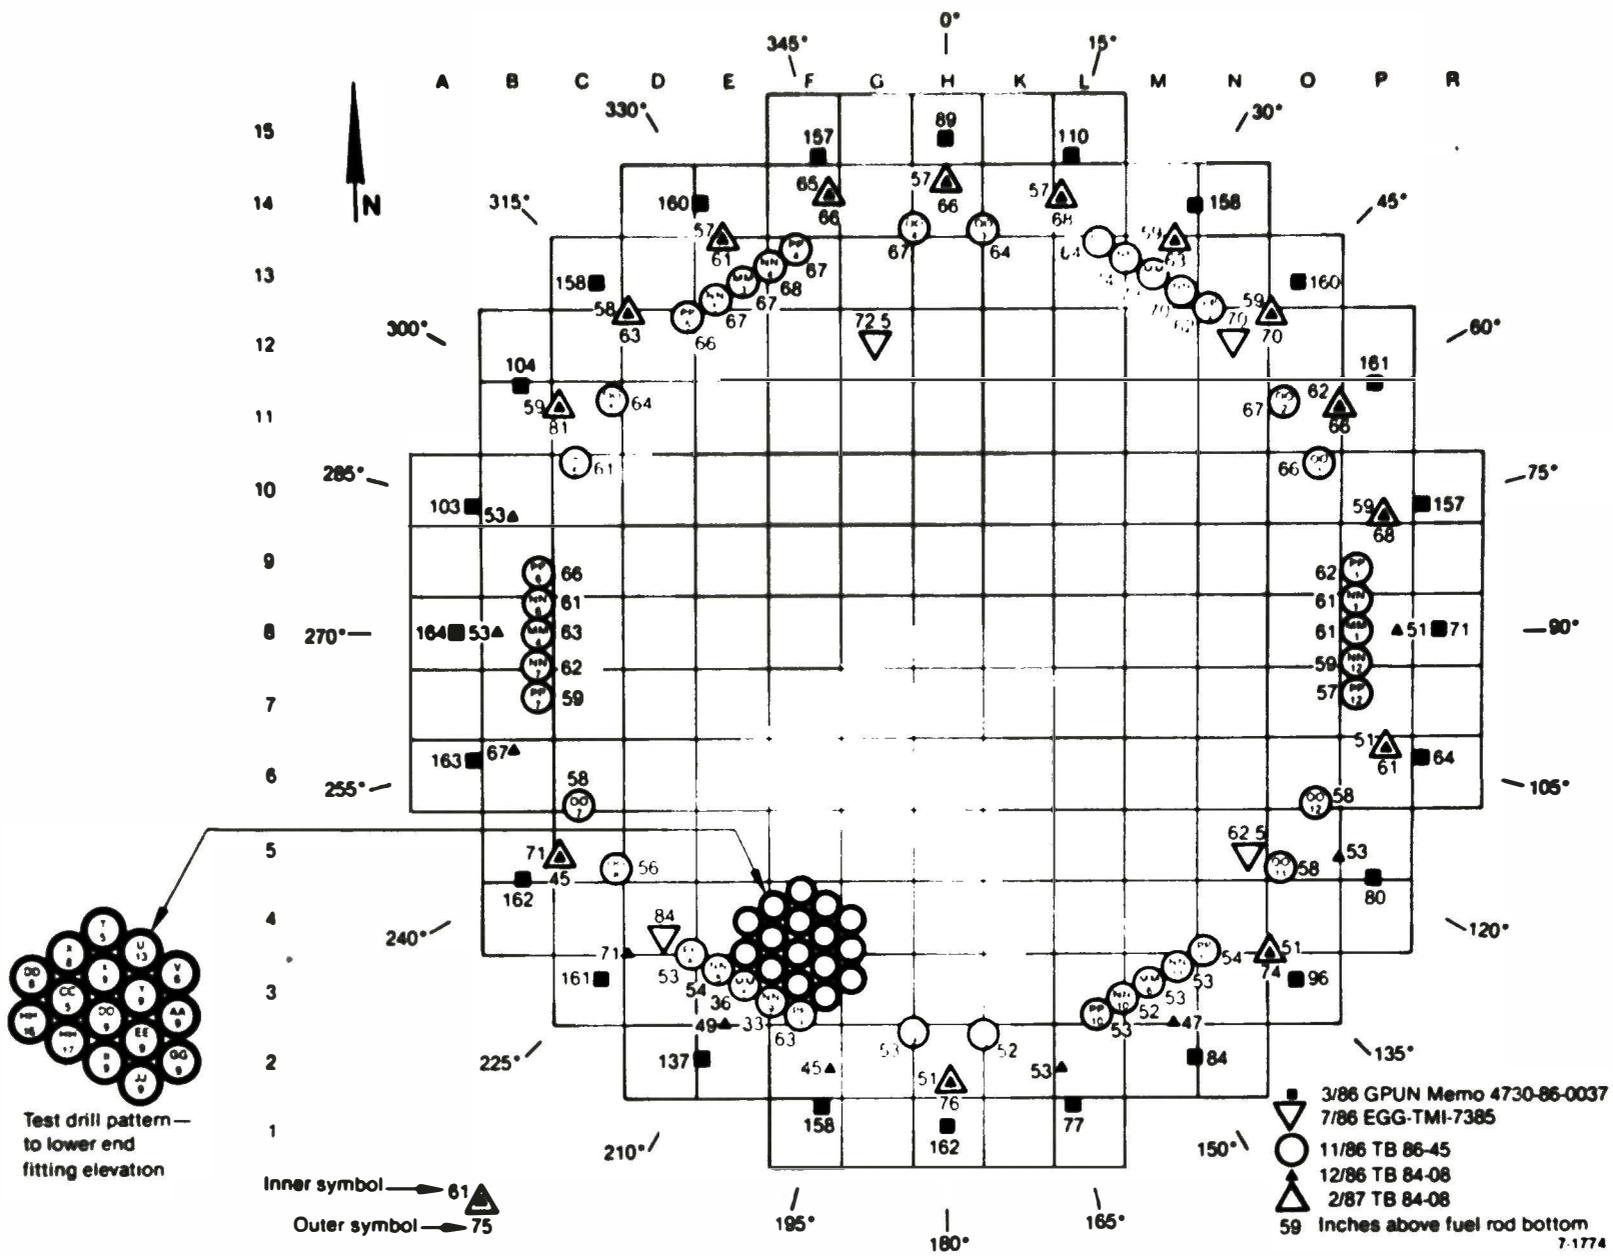
Figure 3. Hard-stop locations from mechanical probing measurements.

1. The July core boring at core position D4 where the hard-crust was first contacted near 84 inches above the fuel rod bottoms.

2. The March 1986 probing data at core positions B10, B11, H15, L1, M2, O3, and P5 that indicate a hard stop at 110 to 77 inches above the fuel rod bottom, which is consistent with some of the video survey data both in elevations and irregularity of the ring upper surface contour.

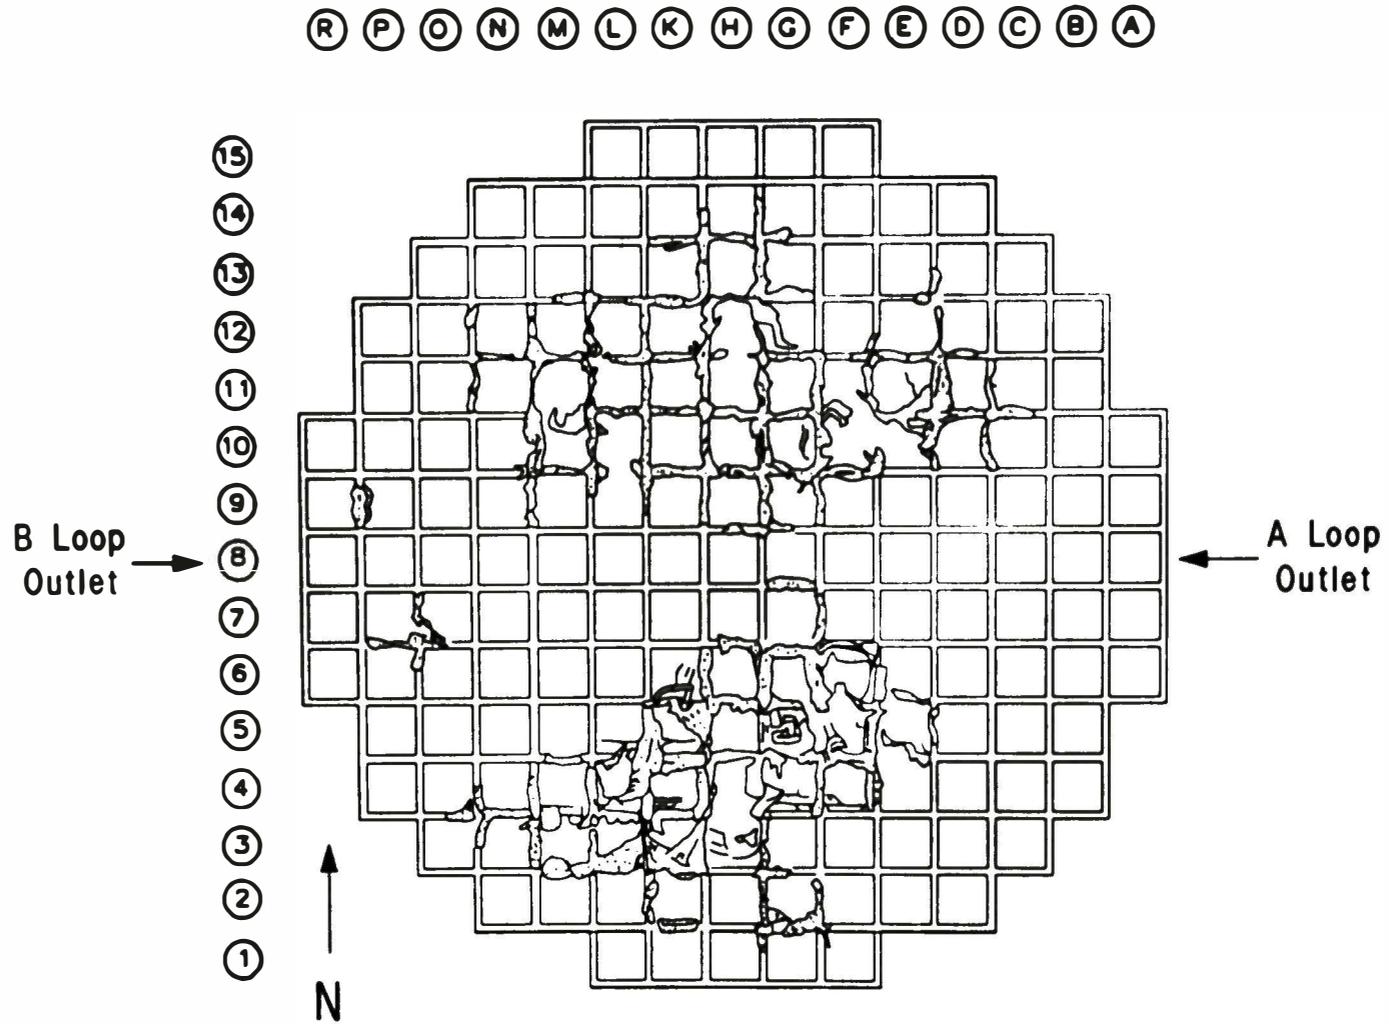
Figure B-10. Damage map of the TMI-2 fuel assembly upper grid plate.

The CCTV examination revealed probable damage to the plenum assembly lower surface as depicted in Fig. B-10.
