PHASE 3 STATUS REPORT

REMOVAL OF TEST SPECIMENS FROM  
THE TMI-2 REACTOR VESSEL  
BOTTOM HEAD

SUMMARY OF WORK DURING 30 DAY IN-VESSEL PERIOD

APRIL 16, 1990

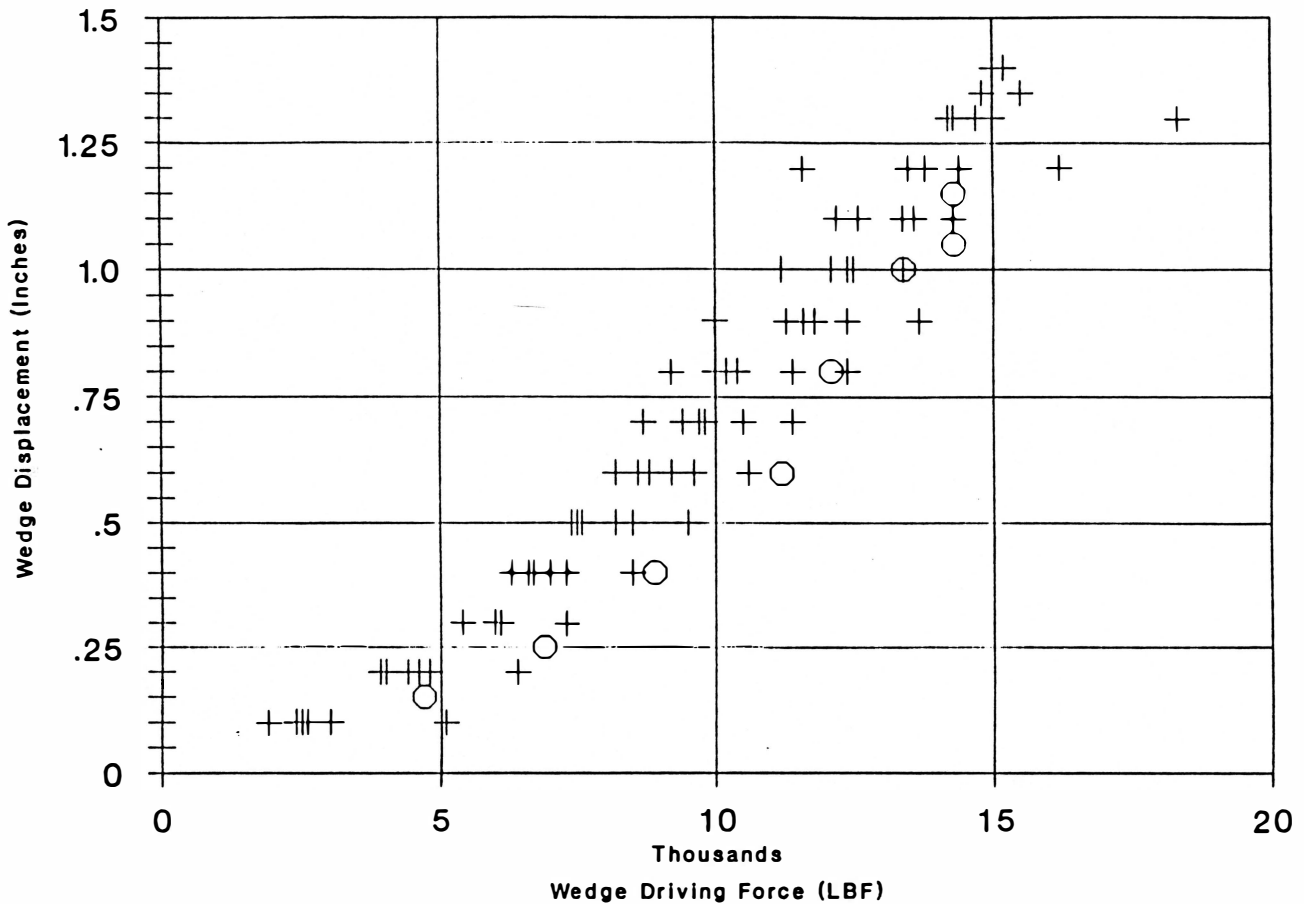
**FIGURE 2-1**

**INSTALLATION OF SEAL PLUG IN PENETRATION  
NOZZLE E-11**

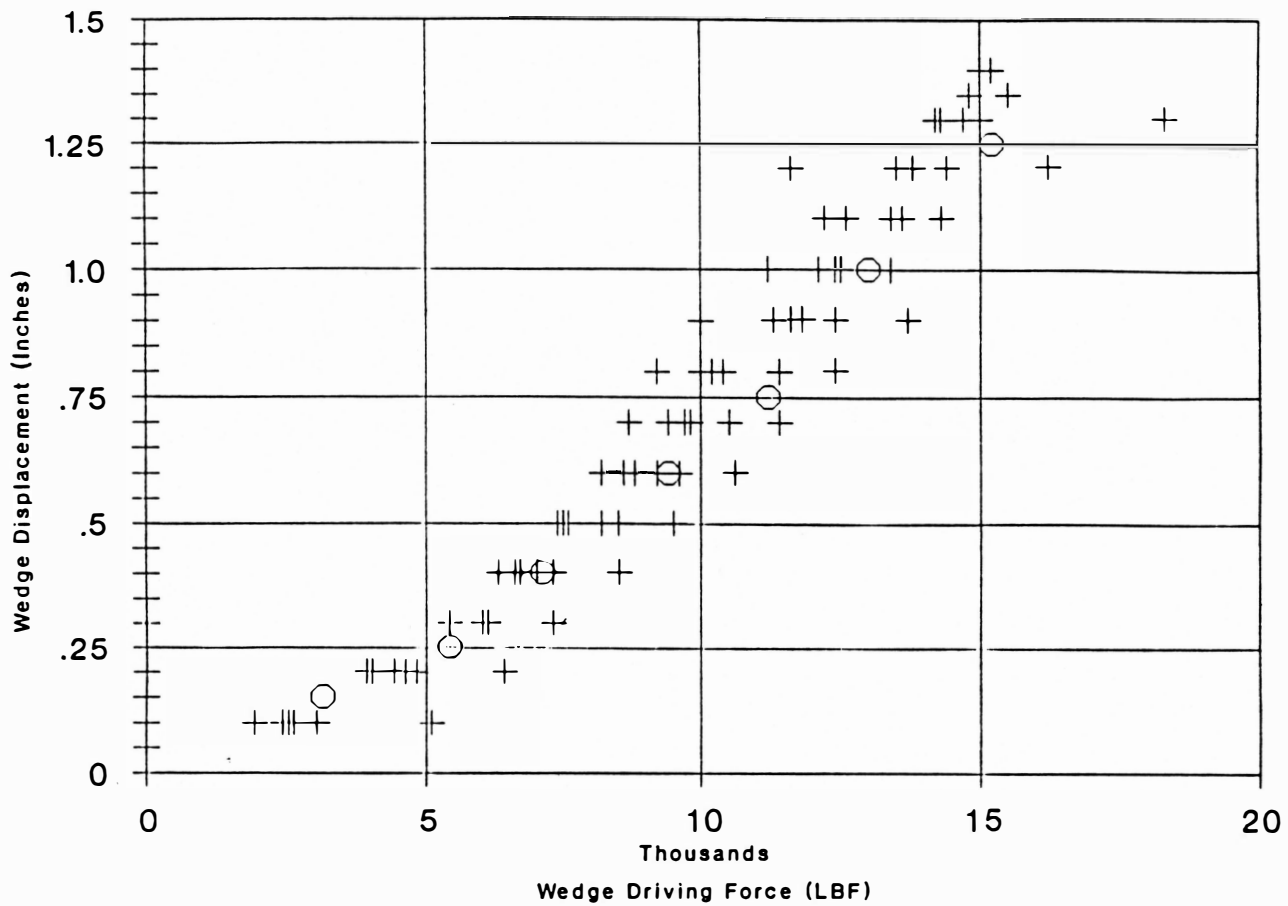
INSTALLATION OF SEAL PLUG IN PENETRATION  
NOZZLE H-8  
FIGURE 2-2

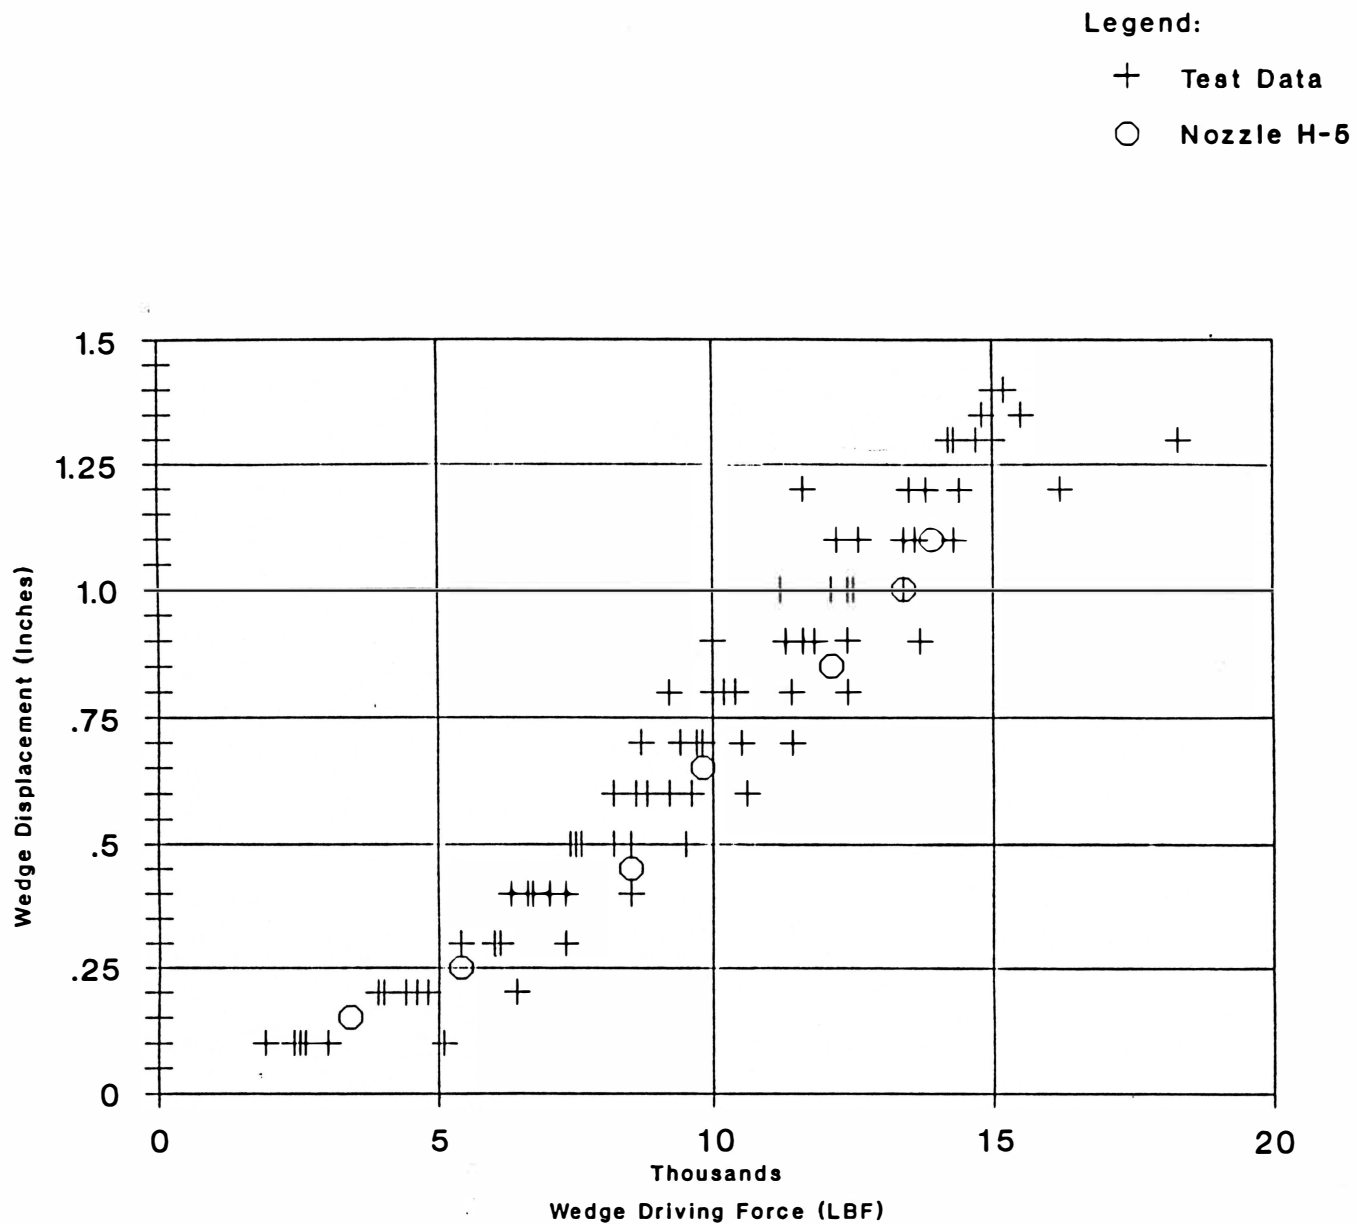
FIGURE 2-3

INSTALLATION OF SEAL PLUG IN PENETRATION  
NOZZLE H-5

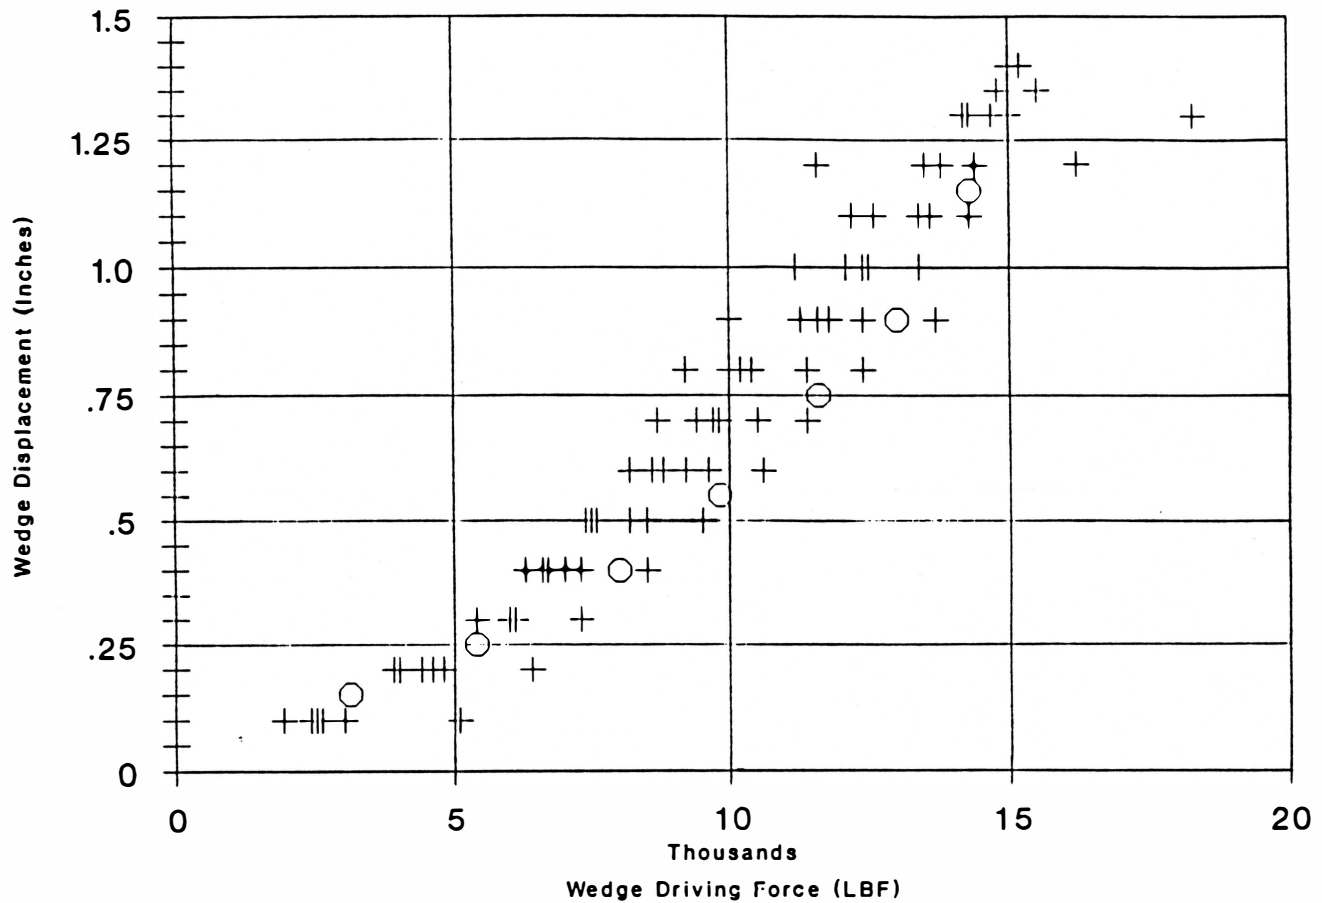
INSTALLATION OF SEAL PLUG IN PENETRATION  
NOZZLE D-10  
FIGURE 2-4

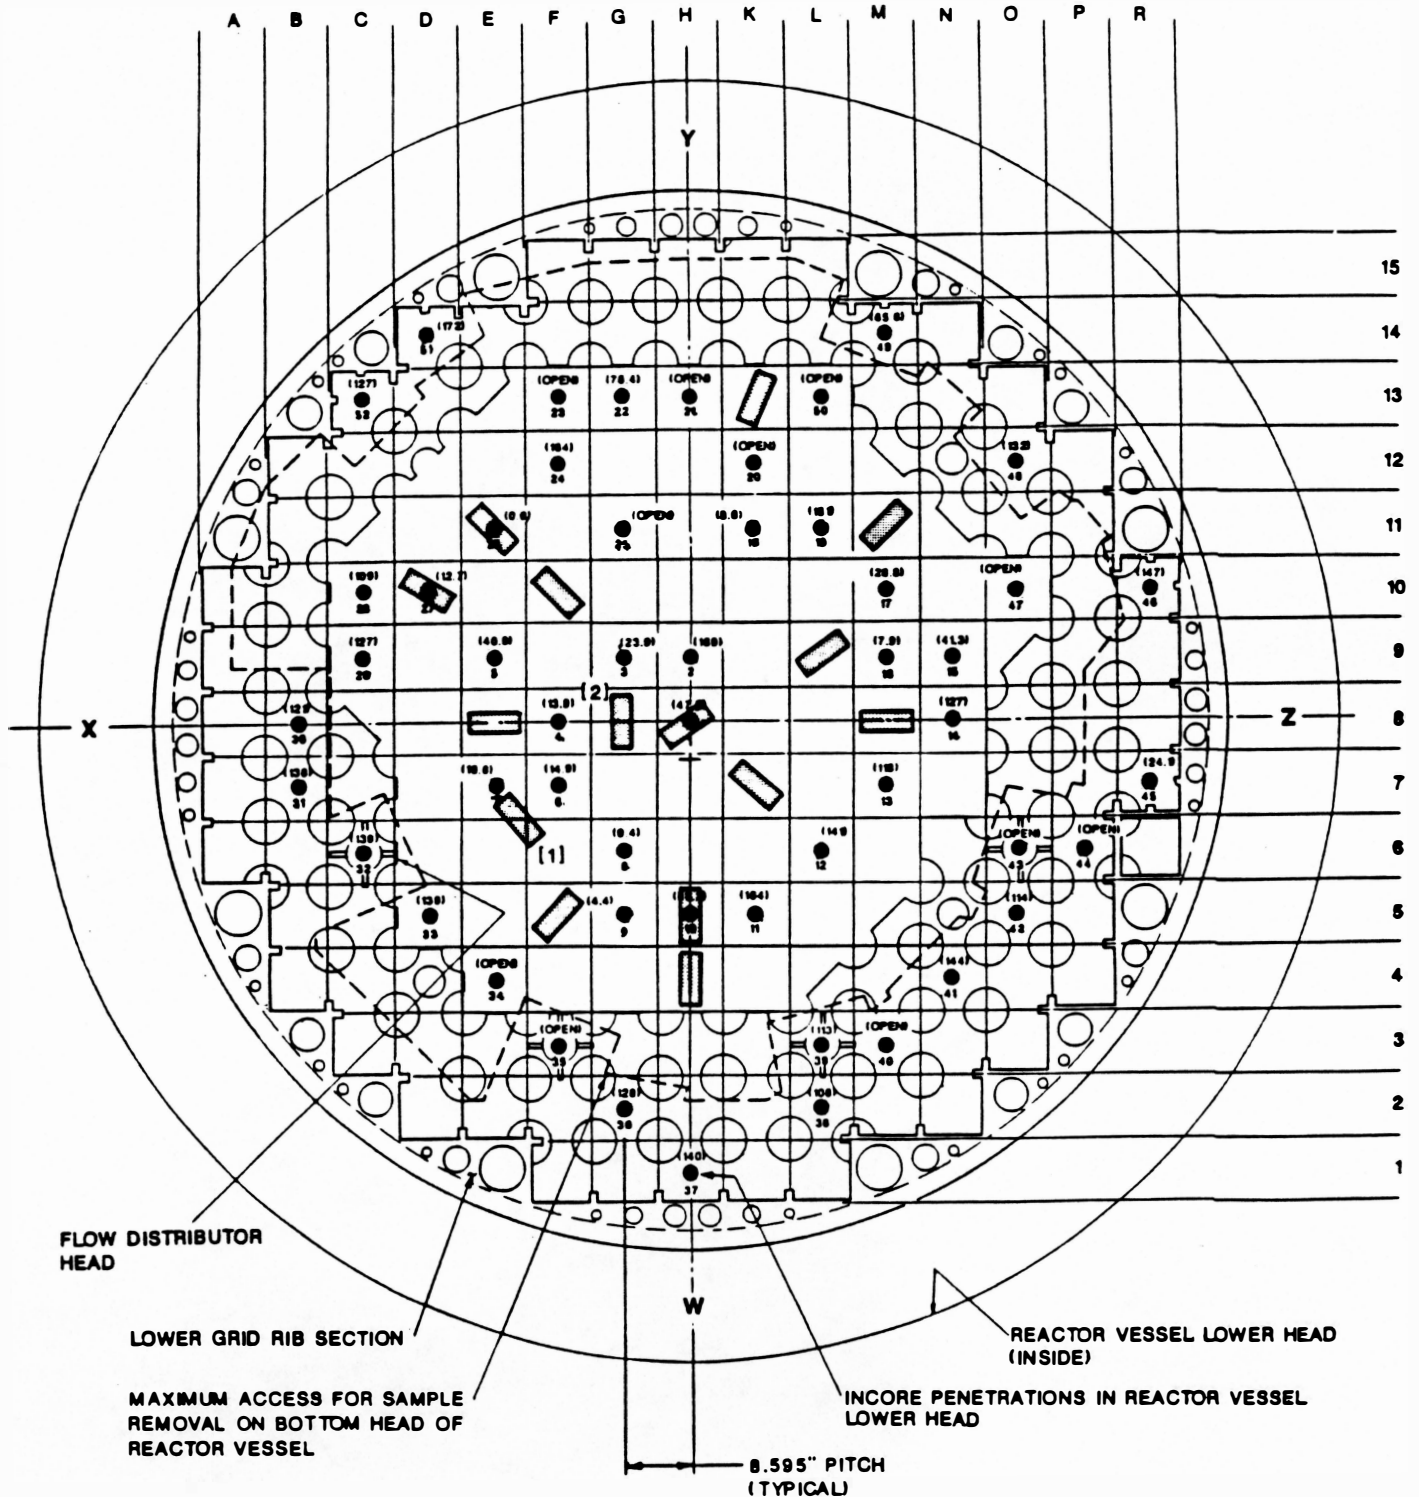
FIGURE 3-1

NOTES: [1] SAMPLE CUT AT E-8 LOCATION WITH MDM HEAD ROTATED 90°  
FROM STANDARD ORIENTATION TO INCLUDE CRACK.

LOCATION AND ORIENTATION OF REACTOR VESSEL SAMPLES

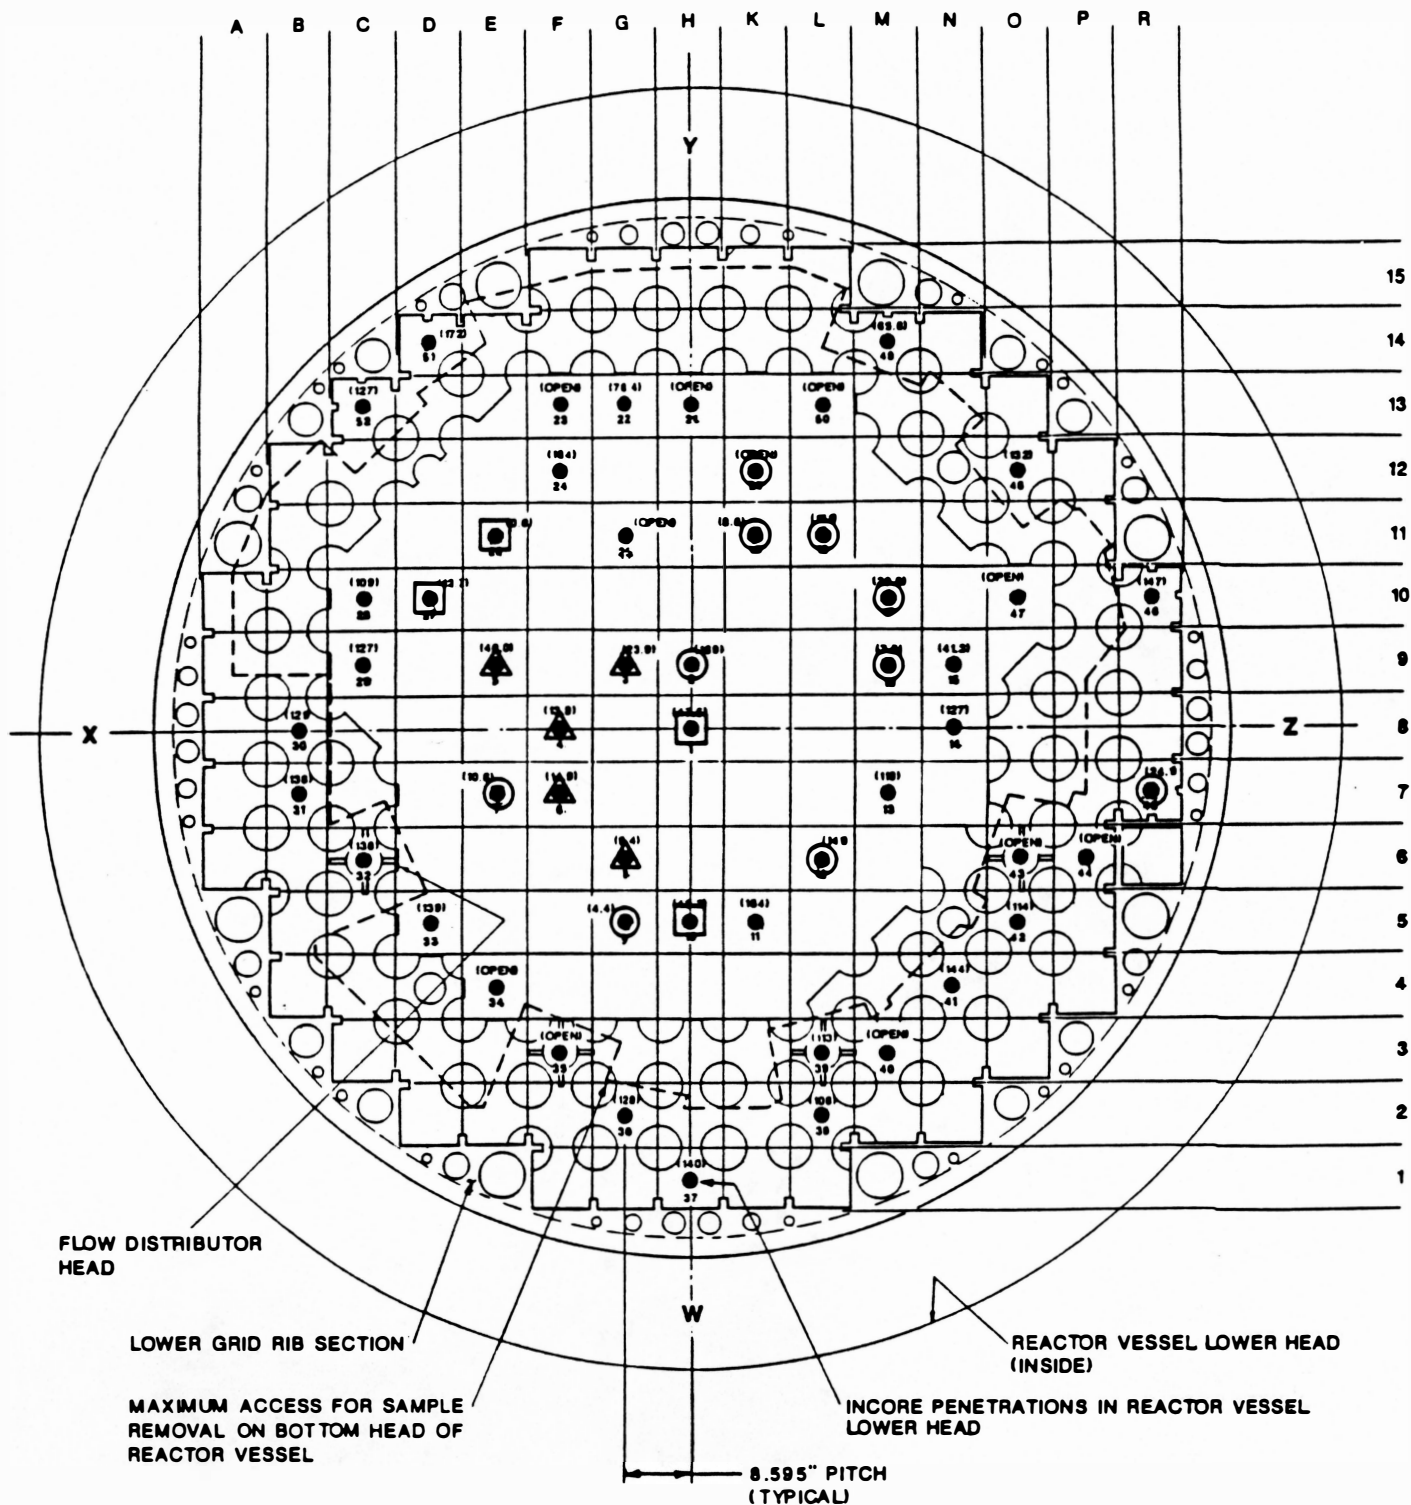
LOCATION OF INCORE NOZZLE SAMPLES  
FIGURE 3-2

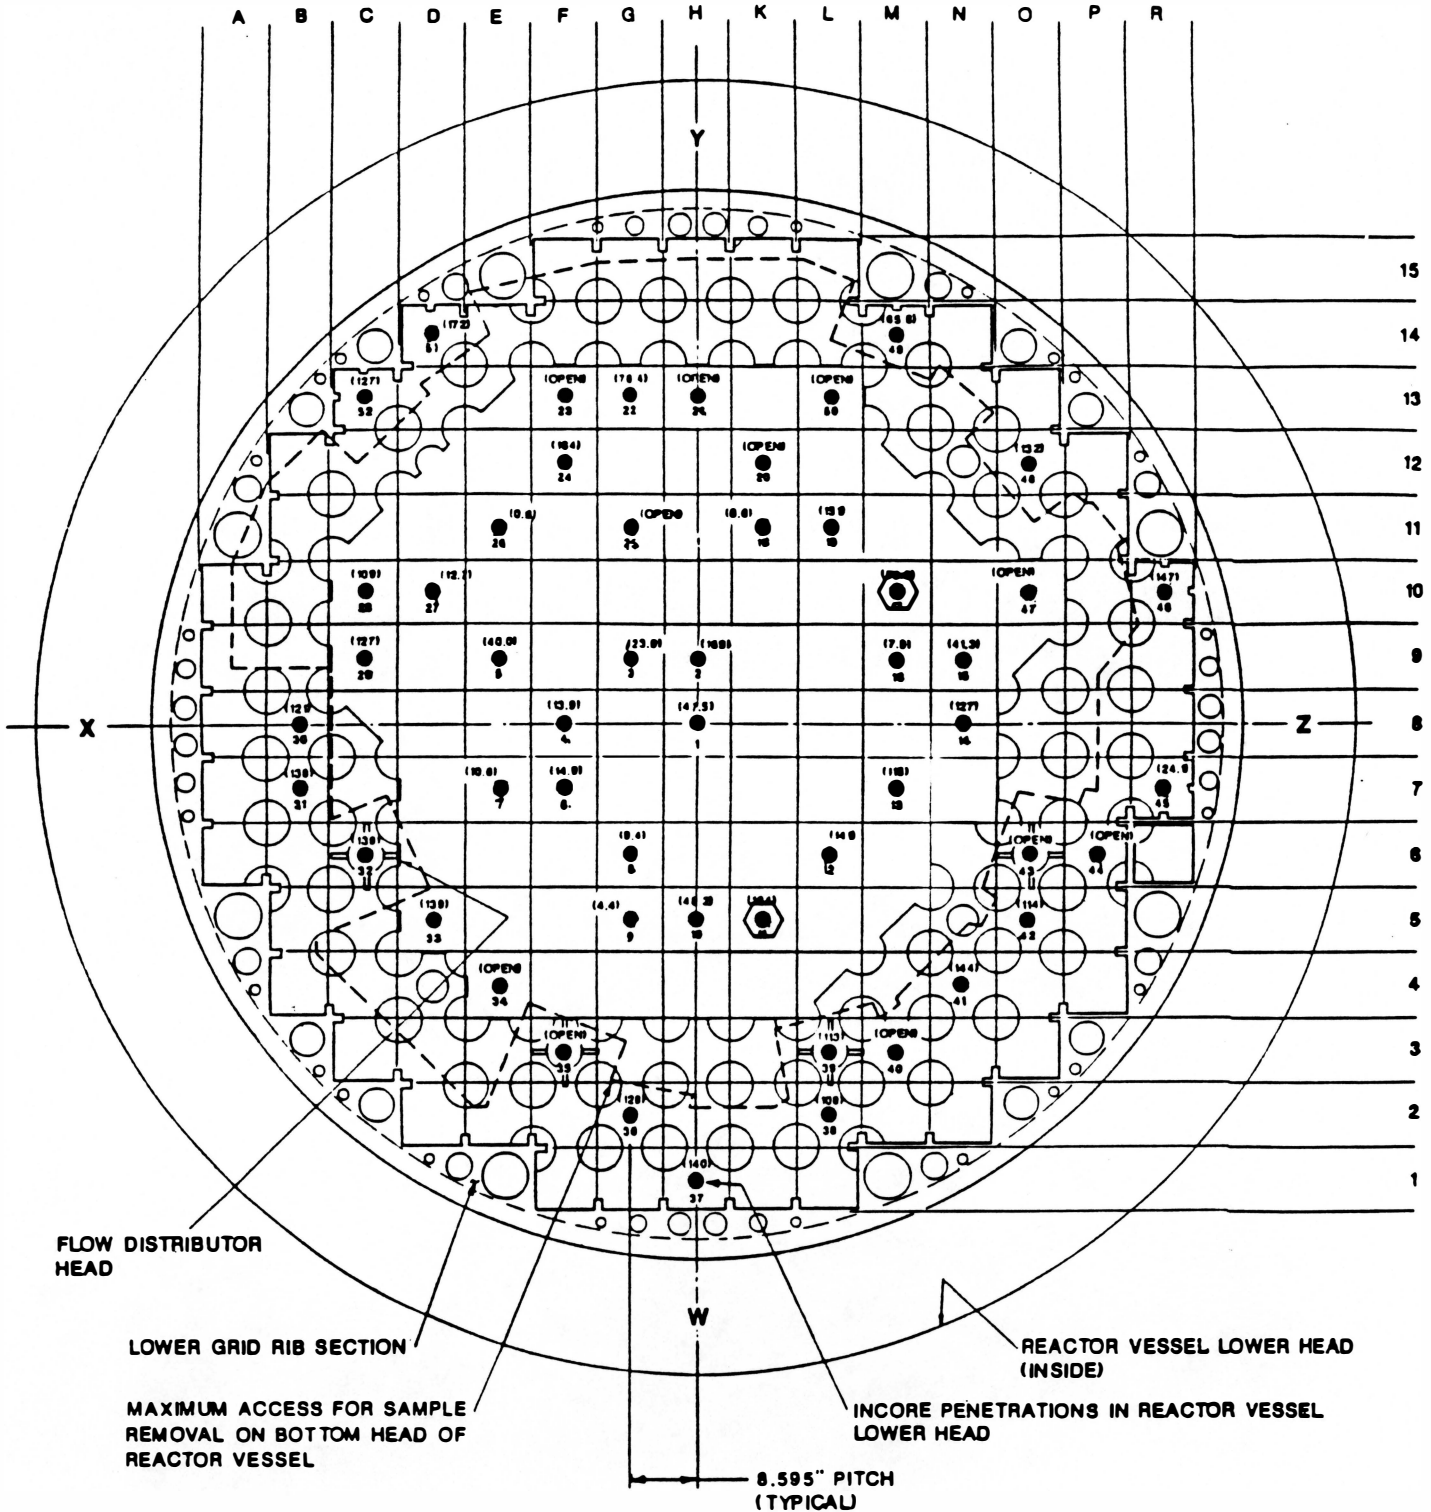
LOCATION OF GUIDE TUBE SAMPLES  
FIGURE 3-3
