GENE-INF-023
Vol. V

ANALYSIS OF THREE MILE ISLAND UNIT 2 REACTOR COOLING SYSTEM TRANSIENTS

Published August 1983

Rockwell International
Rockwell Hanford Operations
Energy Systems Group
Richland, Washington
Idaho Falls, Idaho 83415

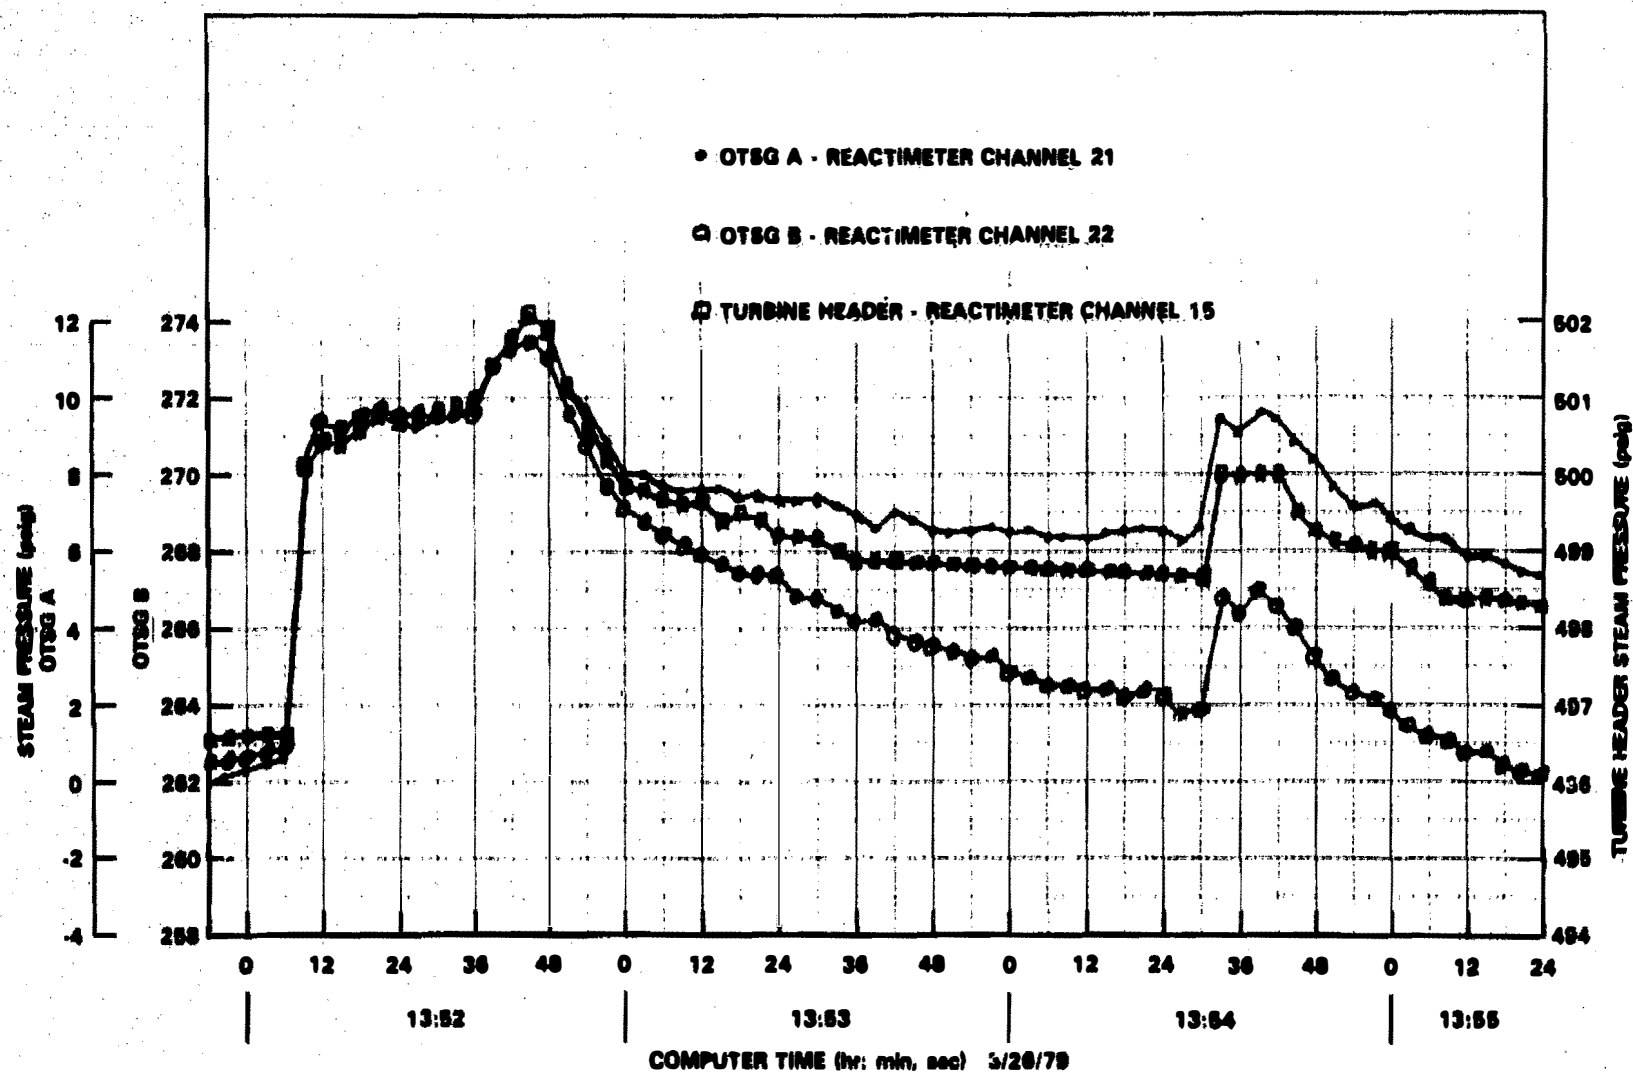
FIGURE 1A. Steam Pressure as Indicated by Reactimeter, 13:52 to 13:55.

1. The steam pressure in steam generator A, as indicated by computer data recorded on the auxiliary printer, did not show any of the pressure pulses that were recorded by the reactimeter between 13:52 and 13:58 (see Figures 1A, 2A, and 3). The computer data is considered to be the more reliable. The computer data shows that the shell of steam generator A, near its upper end, was much hotter than the steam saturation temperature and that it cooled rapidly at the same time as the reactimeter-indicated transient. This rapid cooling was apparently caused by the containment spray wetting the temperature sensor rather than the cooling effect of large quantities of saturated steam in the steam generator. That this temperature sensor could have been cooled by the containment spray should be verified by careful examination including physical arrangement, water marks, water deposited fission products, etc. If the sensor could not have been wetted, further study would be warranted.

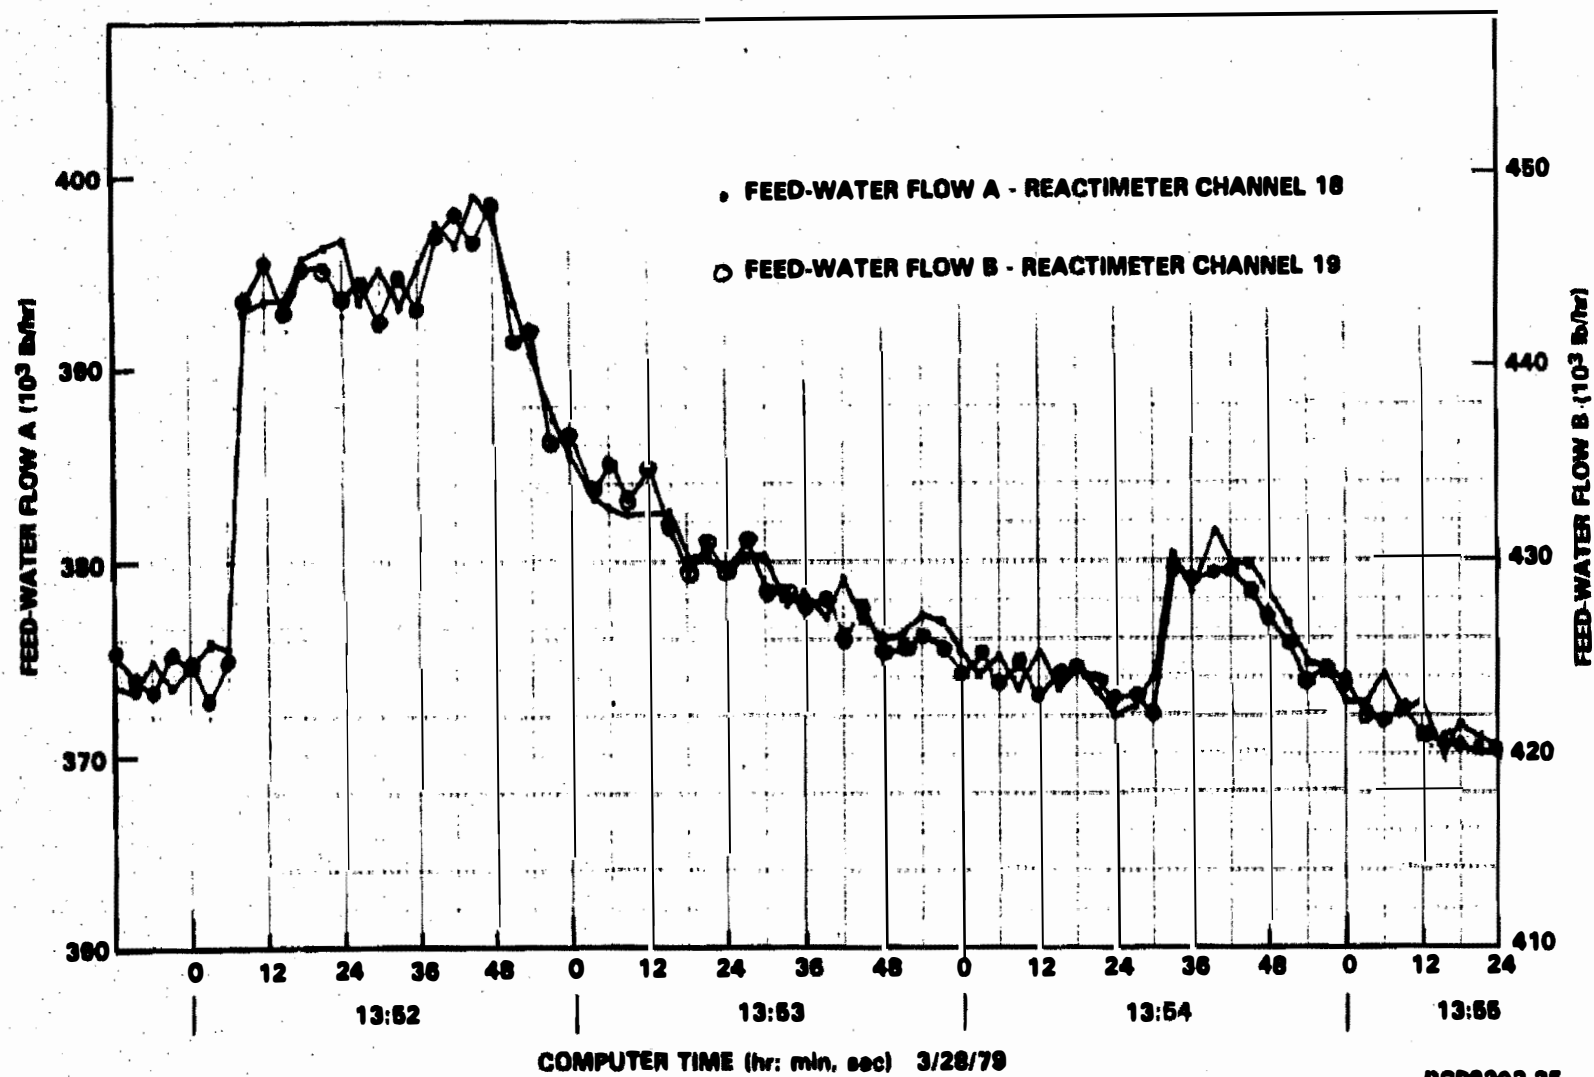
FIGURE 1B. Feed-Water Flow as Indicated by Reactimeter, 13:52 to 13:55.

2. A detailed evaluation of the feed-water flowmeters indicates that their output would not have responded to a pressure pulse. In a differential pressure sensing device of this type, both sides would be exposed to essentially the same pressure at any given time and the net differential would be essentially zero at all times during a pressure pulse. Further, records indicate that the feed-water pumps were not operating during the period of the pulses. Also, feed-water temperature data show less than 1°F change during the period of the pulses, indicating that there was probably no flow surge at that time. Therefore, the increased feed-water flow signal recorded by the reactimeter data (see Fig. 1B and 2B) appears to have been caused by something other than a change in feed-water flow or pressure.

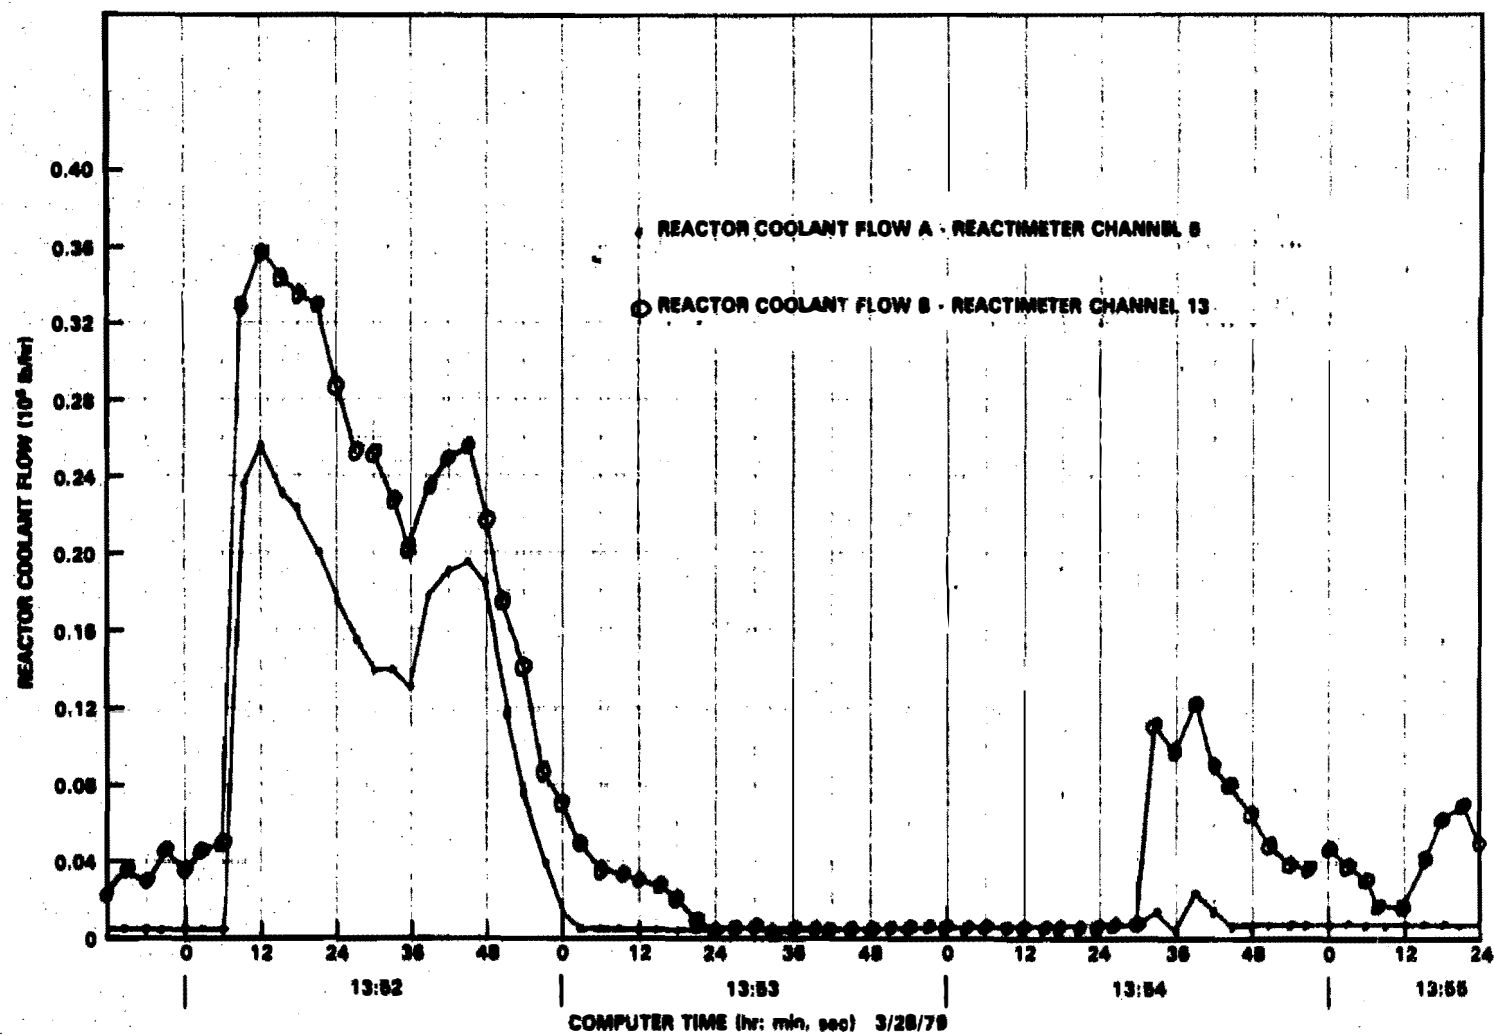
FIGURE 1C. Reactor Coolant Flow as Indicated by Reactimeter, 13:52 to 13:55.

3. An evaluation of the simultaneous increase in reactor coolant flow in loops A and B (see Fig. 1C and 2C) shows that the zero flow indication for loop A is more suppressed than for loop B. This gives an apparently false indication that loop B flow is typically higher than loop A flow during the transients. The significant difference in the shape of the A and B flow signals during the 13:56 transient (see Fig. 2C) could have been caused by an electrical noise signal superimposed on the two flowmeter outputs which were varying quite differently due to some other influence at that time.

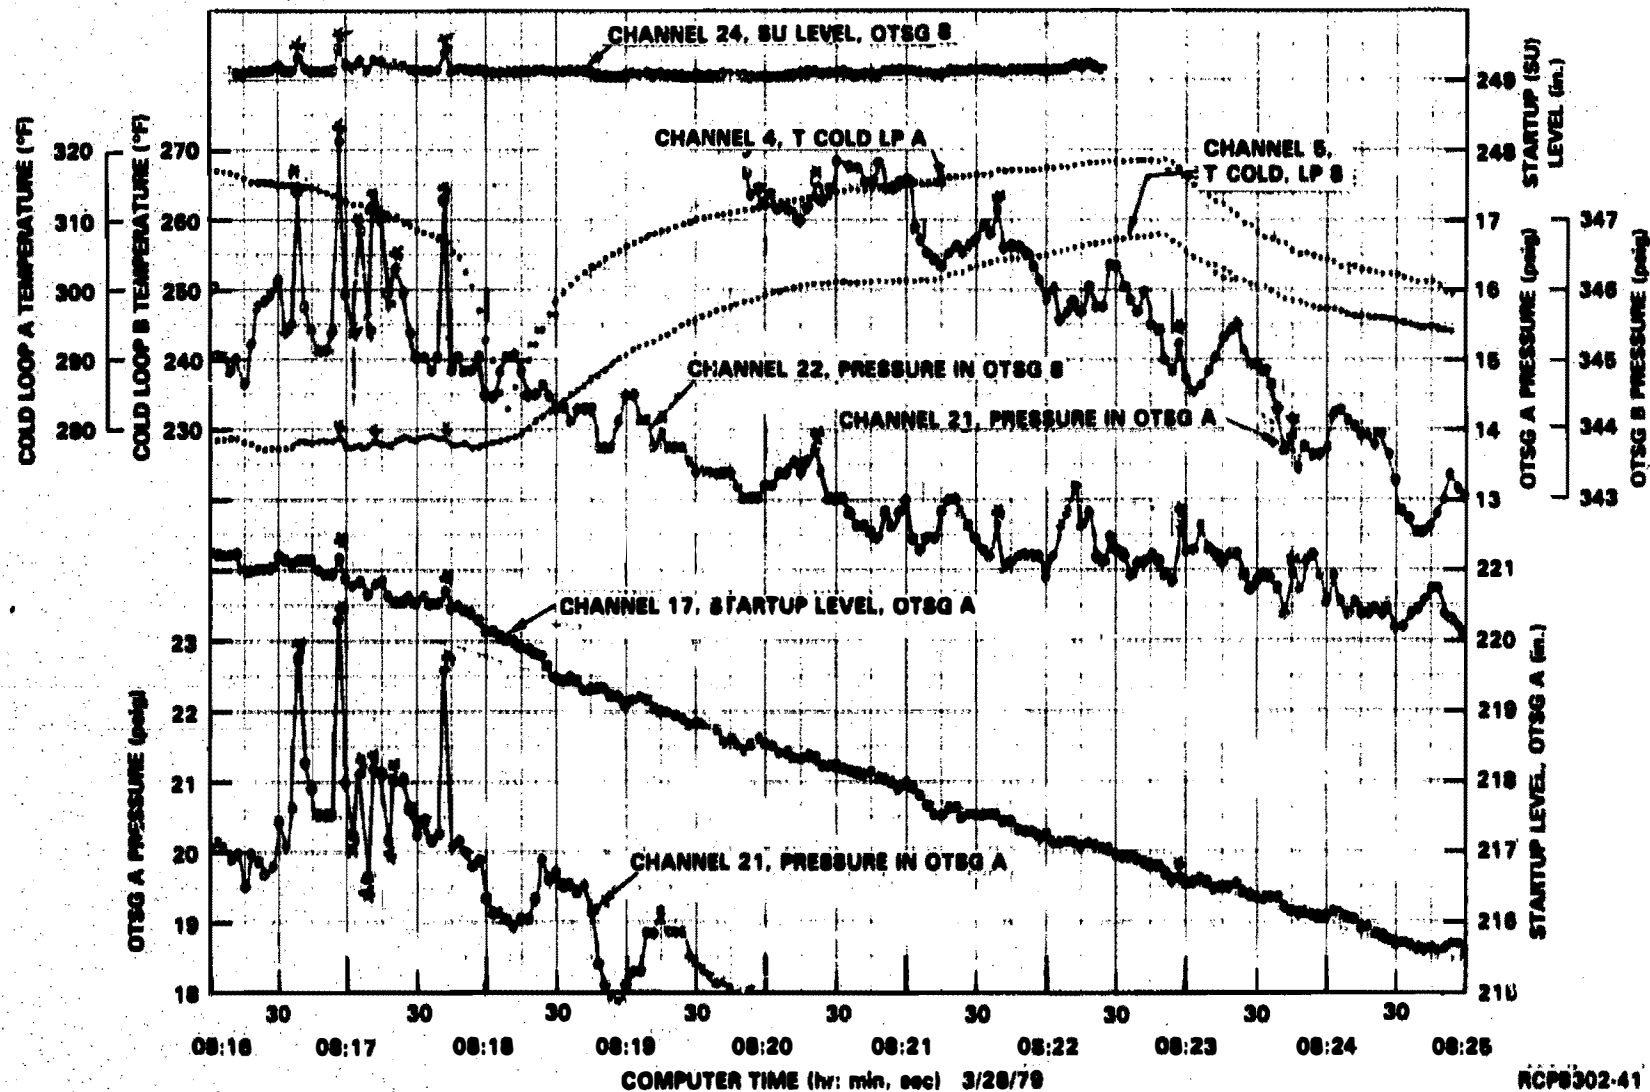
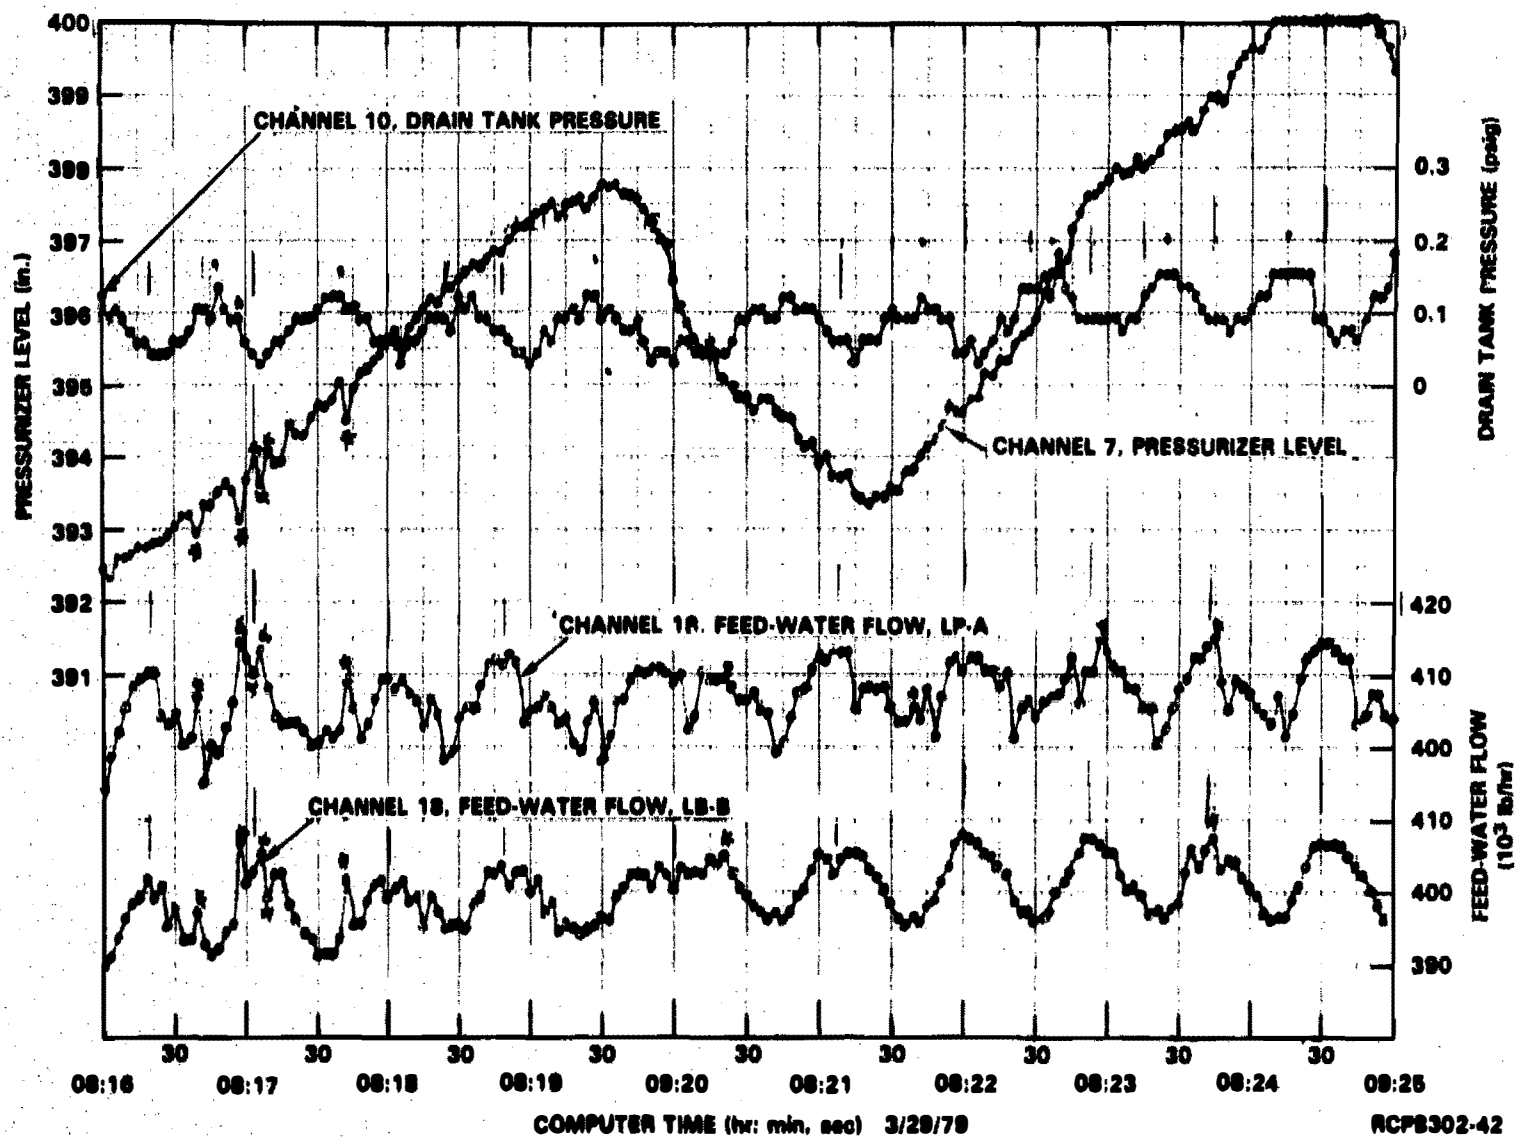
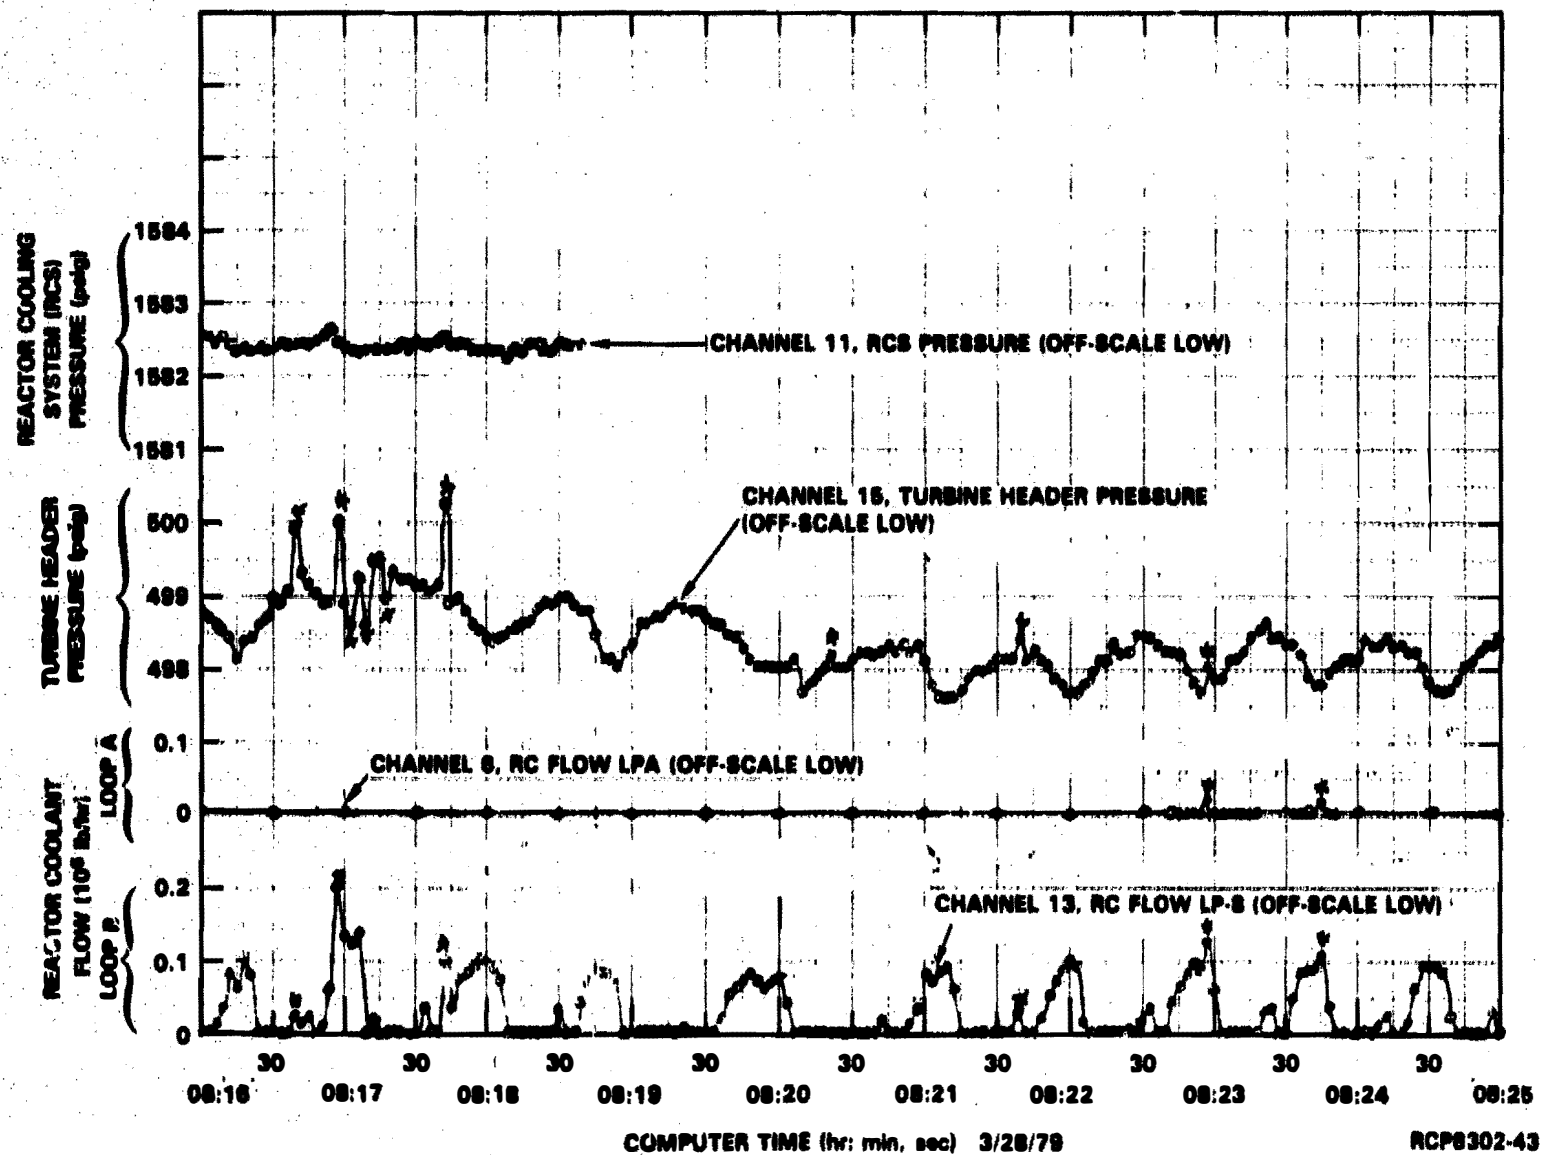
FIGURE 4. System Response as Indicated by Reactimeter. (Sheet 1 of 3.)

A correlation of the reactimeter channels affected by the noise at 08:17 and 08:18 shows that the same channels were affected by the longer pulses that occurred between 13:52 to 13:58 (see

- Table 1). This correlation indicates that these later, longer pulses may also have been caused by superimposed electrical noise, even though the noise characteristics were drastically different.

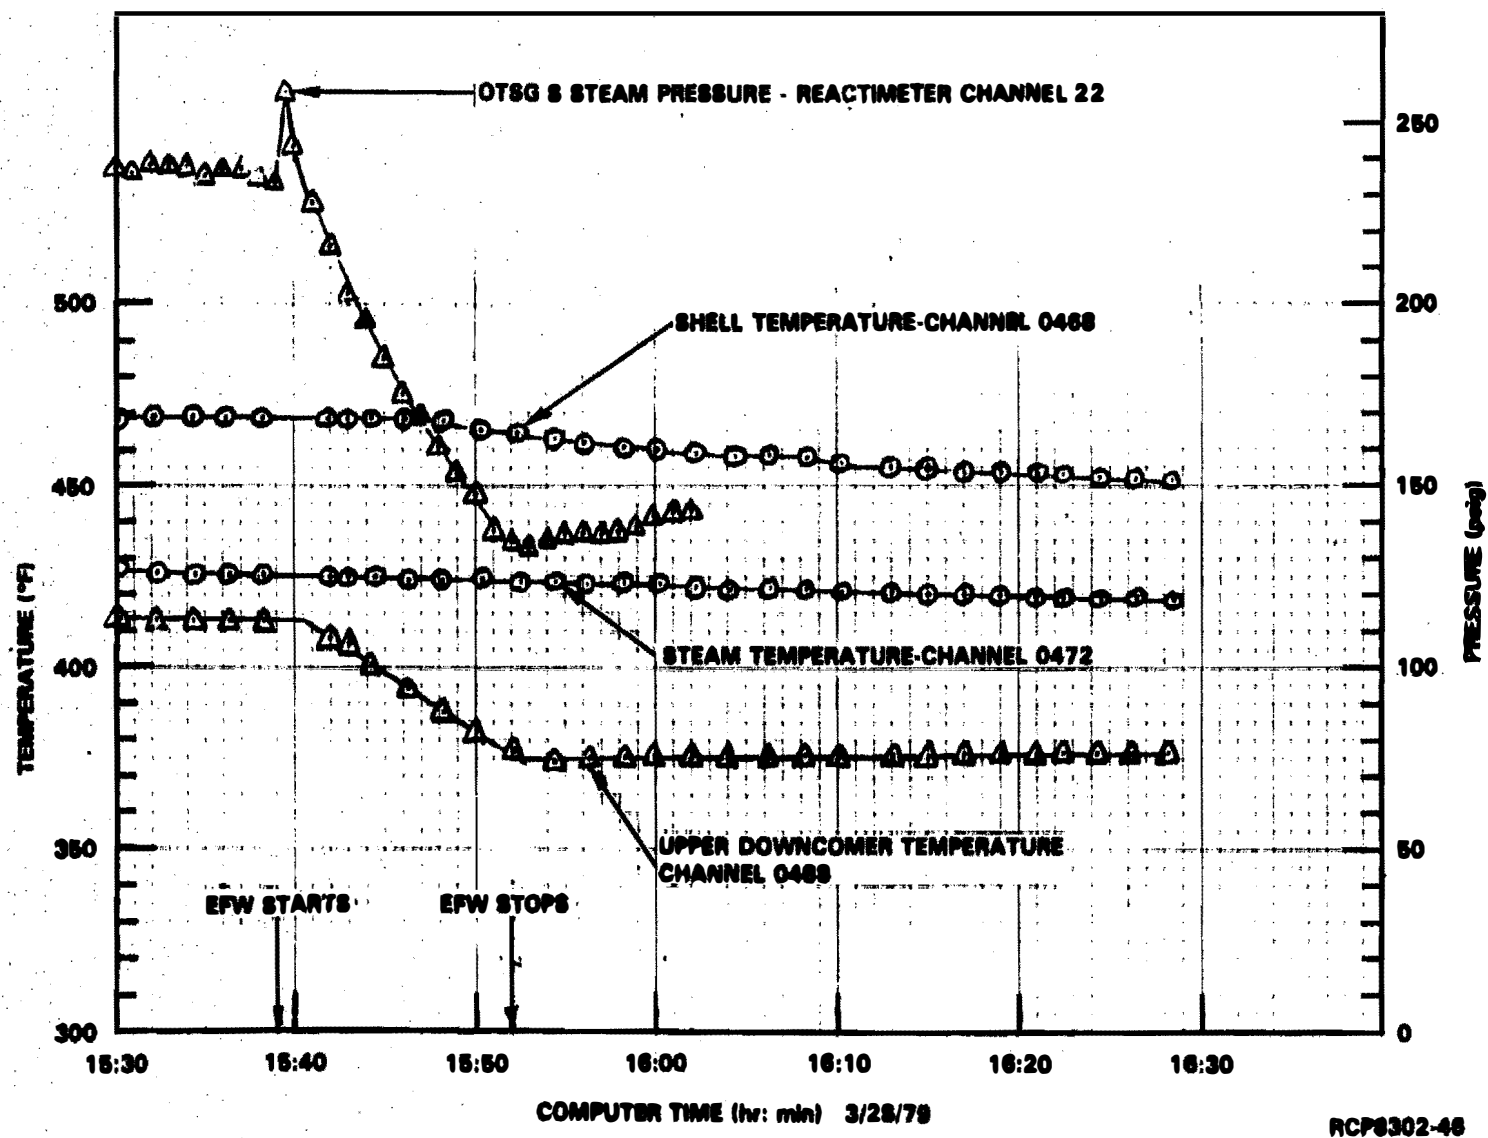
FIGURE 7. Thermal Response of OTSG B to Emergency Feed Water, 15:30 to 16:30.

The thermal response of OTSG B was obtained from data recorded by the utility printer, and is plotted on Figure 7. Steam pressure, obtained from the reactimeter, is also shown on Figure 7.

The data given in Figure 7 indicate that steam pressure first increased, then decreased, until feed-water flow was terminated. Upper downcomer temperature cooled noticeably, from 412°F to 375°F, as a result of feed-water flow. Shell temperature and steam temperature began to cool slowly after feed-water flow had started.

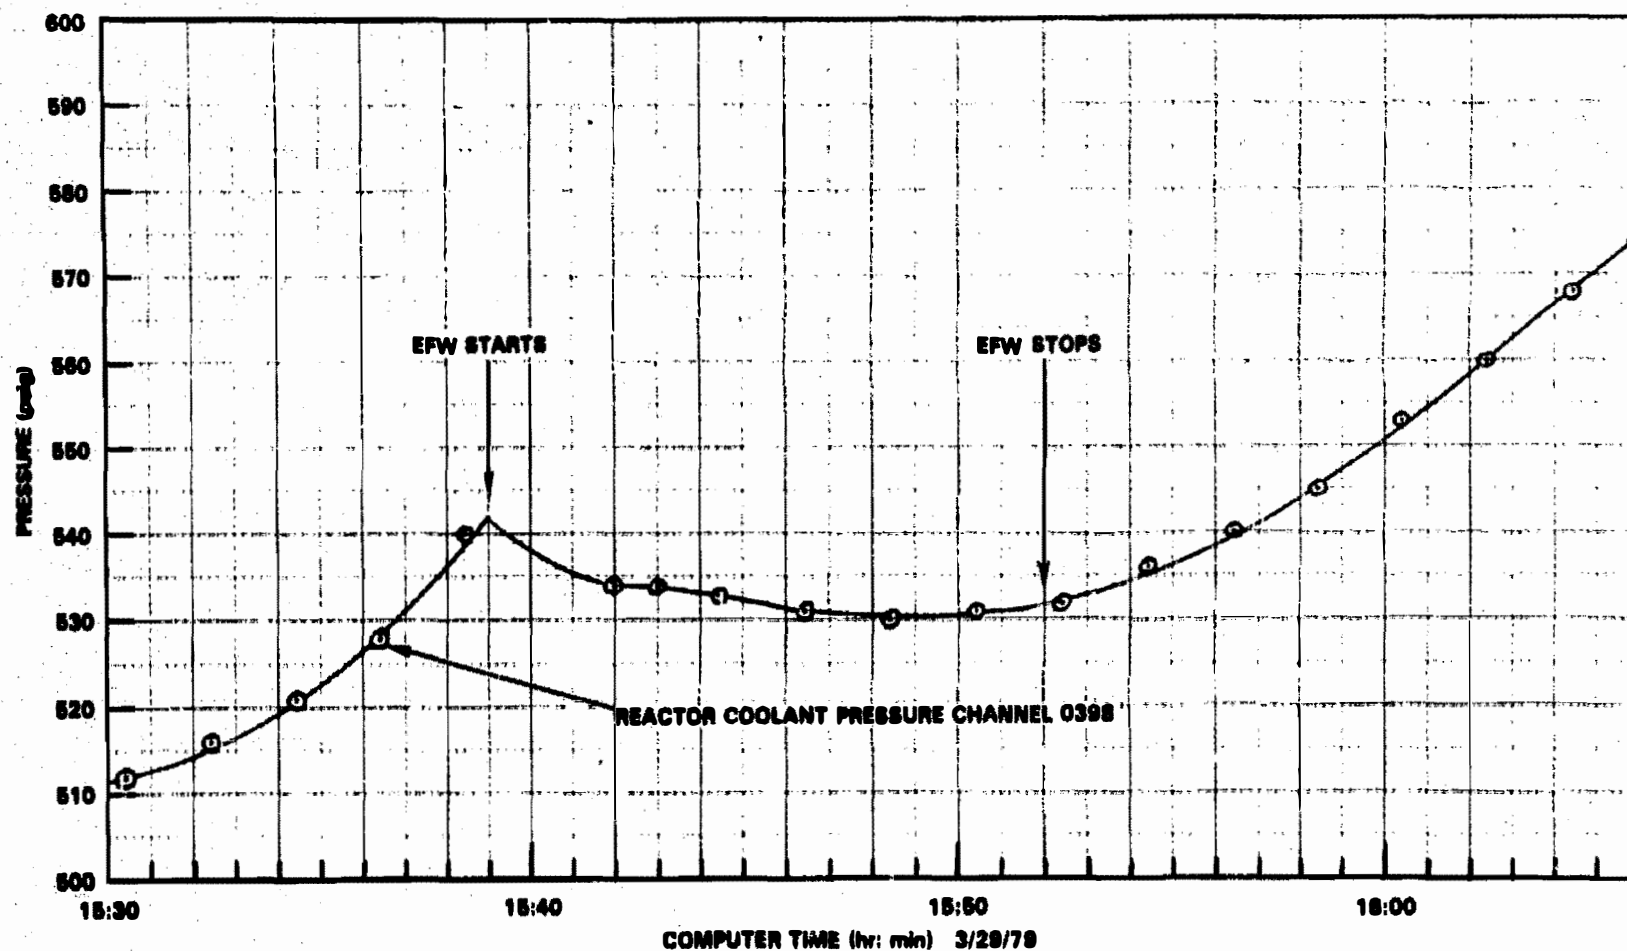
FIGURE 8. Apparent Response of RCS Pressure to Emergency Feed Water at 15:39.

The cooling of the exposed steam generator tubes could be expected to condense steam on the primary side and to possibly affect pressure in the reactor coolant system (RCS). A plot of RCS pressure versus time (Figure 8) shows that RCS pressure was mildly affected; the EFW operation appears to have halted a ramp in pressure. After feed-water flow stopped, the pressure ramp reappeared.

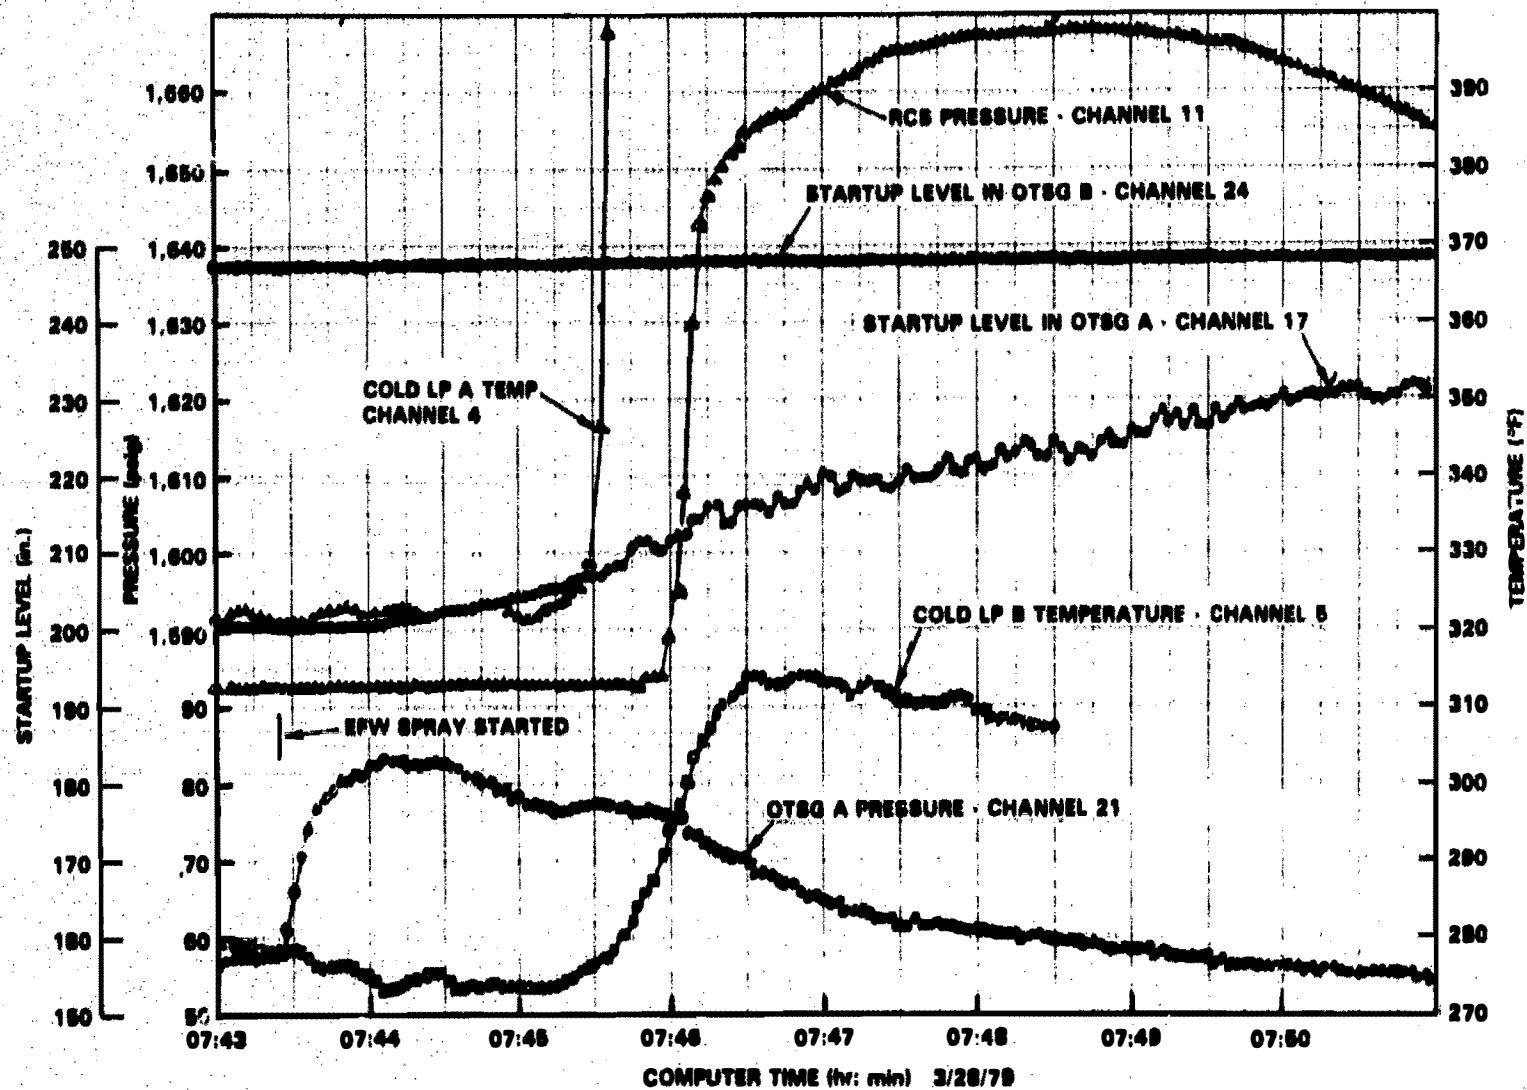
FIGURE 9. Response of System to EFW at 07:43 and Transient at 07:45

Emergency feed-water pump EF-P-2A was started at 07:35:43 and the discharge pressure reached 1,573 psi 6 sec later. These timed events are recorded on the alarm printer record. An abrupt rise in steam pressure at 07:43:24 indicates that water flow to OTSG A began at that time. Water level in the OTSG A steam generator began to increase at 07:43:48. Both steam pressure and water level are plotted versus time on Figure 9.

Feed-water pump EF-P-2A was stopped at 08:42:51 as indicated by the alarm printer. Significant water flow, however, continued only until 07:54; this is indicated by a peak in water level at that time. The rate of water level rise is significantly smaller than for the EFW operation at 15:39, indicating that the EFW flow rate was lower for the 07:43 EFW operation.

At 07:45, an abrupt increase in the temperatures of the cold legs and in the RCS pressure occurred (see Fig 9). The initial RCS pressure of approximately 1,400 psi was not recorded by the narrow-range pressure indicator since it was off-scale low. The cold-leg temperature increases indicate that the cooling water flow reversed, carrying hot water from the reactor vessel to the temperature measuring location in the cold legs.

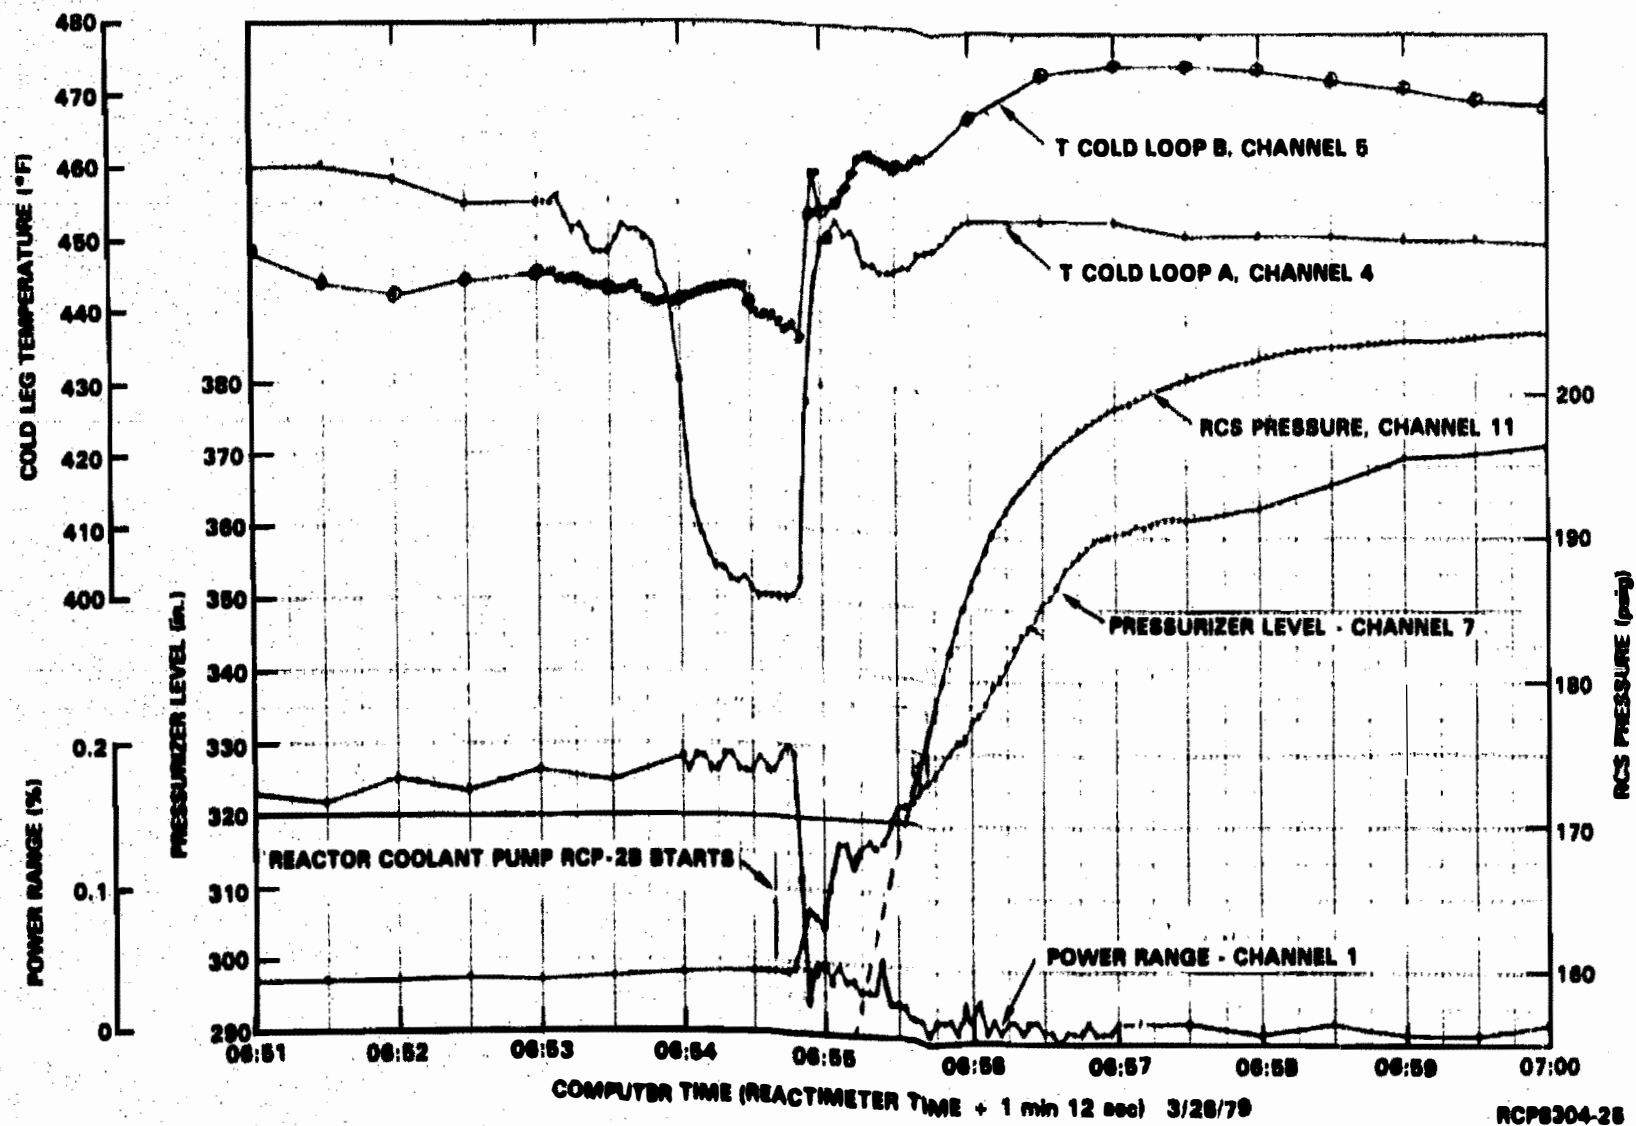
FIGURE 10. Response of Primary System to Operation of Coolant Pump RCP-28 at 06:55.

Changes in primary system parameters are illustrated on Figure 10. Reactor coolant system pressure increased from 1,300 psi (as indicated by the wide range pressure meter) to 2,040 psi. This increase took place over roughly a 5 min period, with most of the change occurring during the first 2 min. Pressurizer level also increased from 300 in. to 370 in. Thermodynamic calculations indicate that for the steam pressure changes experienced in this event, the observed increase in pressurizer level from the condensation of saturated steam is probable. Cold leg temperatures also experienced significant transients.

The indicated power range is also shown on Figure 10. This instrument, a gamma-ray sensor, experienced a sharp drop shortly after cold water was injected into the core. While a part of this drop may be attributable to water shielding, it is probable that a core rearrangement occurred when the overheated fuel and oxidized cladding were quenched with water. Discussions in Section 6.0 provide additional support for a core rearrangement at 06:55.

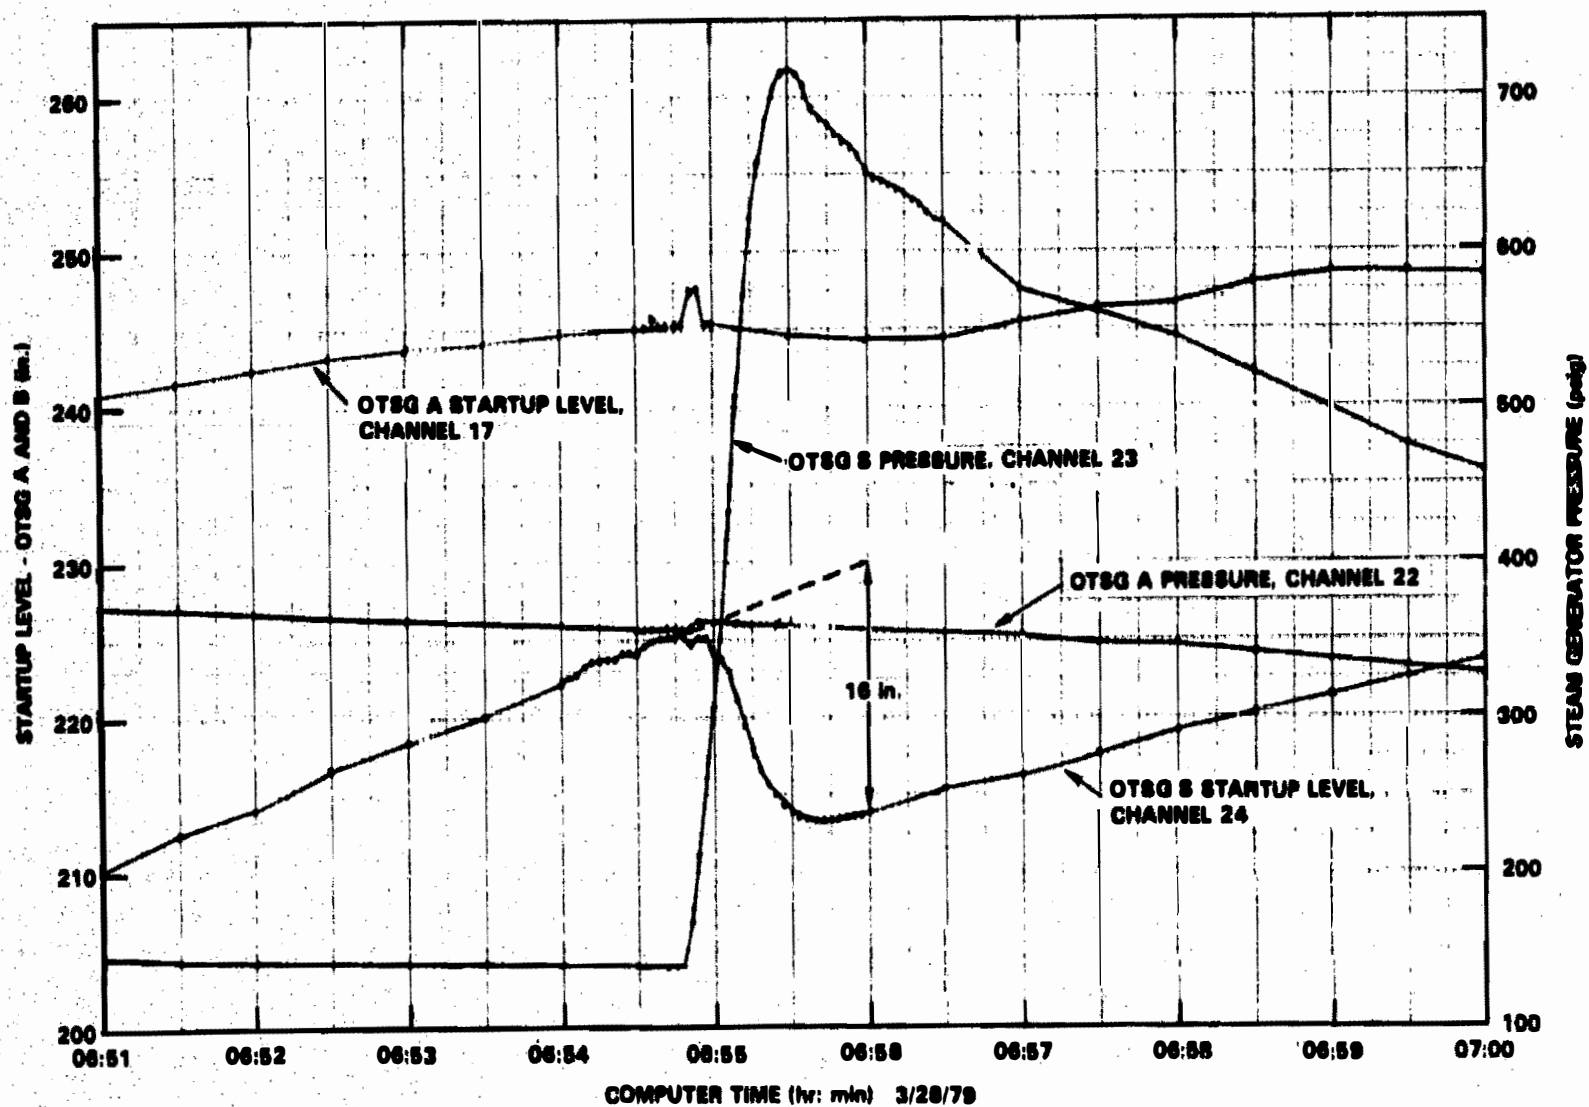
FIGURE 11. Response of Secondary Side to Steam Spike at 06:55.

Response of the secondary side of the steam generators is shown on Figure 11. The data of Figure 11 show that OTSG B experienced a marked steam pressure transient and a corresponding reduction in secondary water level, whereas OTSG A exhibited only minor responses. The response of OTSG B is as expected considering that the water level on the primary side was greatly reduced by the pump operation. The lowered water level caused primary steam to move into the steam generator and to contact the tubes below the secondary water level, thereby boiling the secondary water and generating large amounts of steam. In less than 1 min, OTSG B was again filled with gas (hydrogen). This prevented effective steam refluxing and caused an immediate reduction in secondary steam pressure even though the RCS pressure continued to increase. Steam generator A was not affected by the pump operation, and since it was gas filled, it was not greatly affected by the RCS pressure spike.

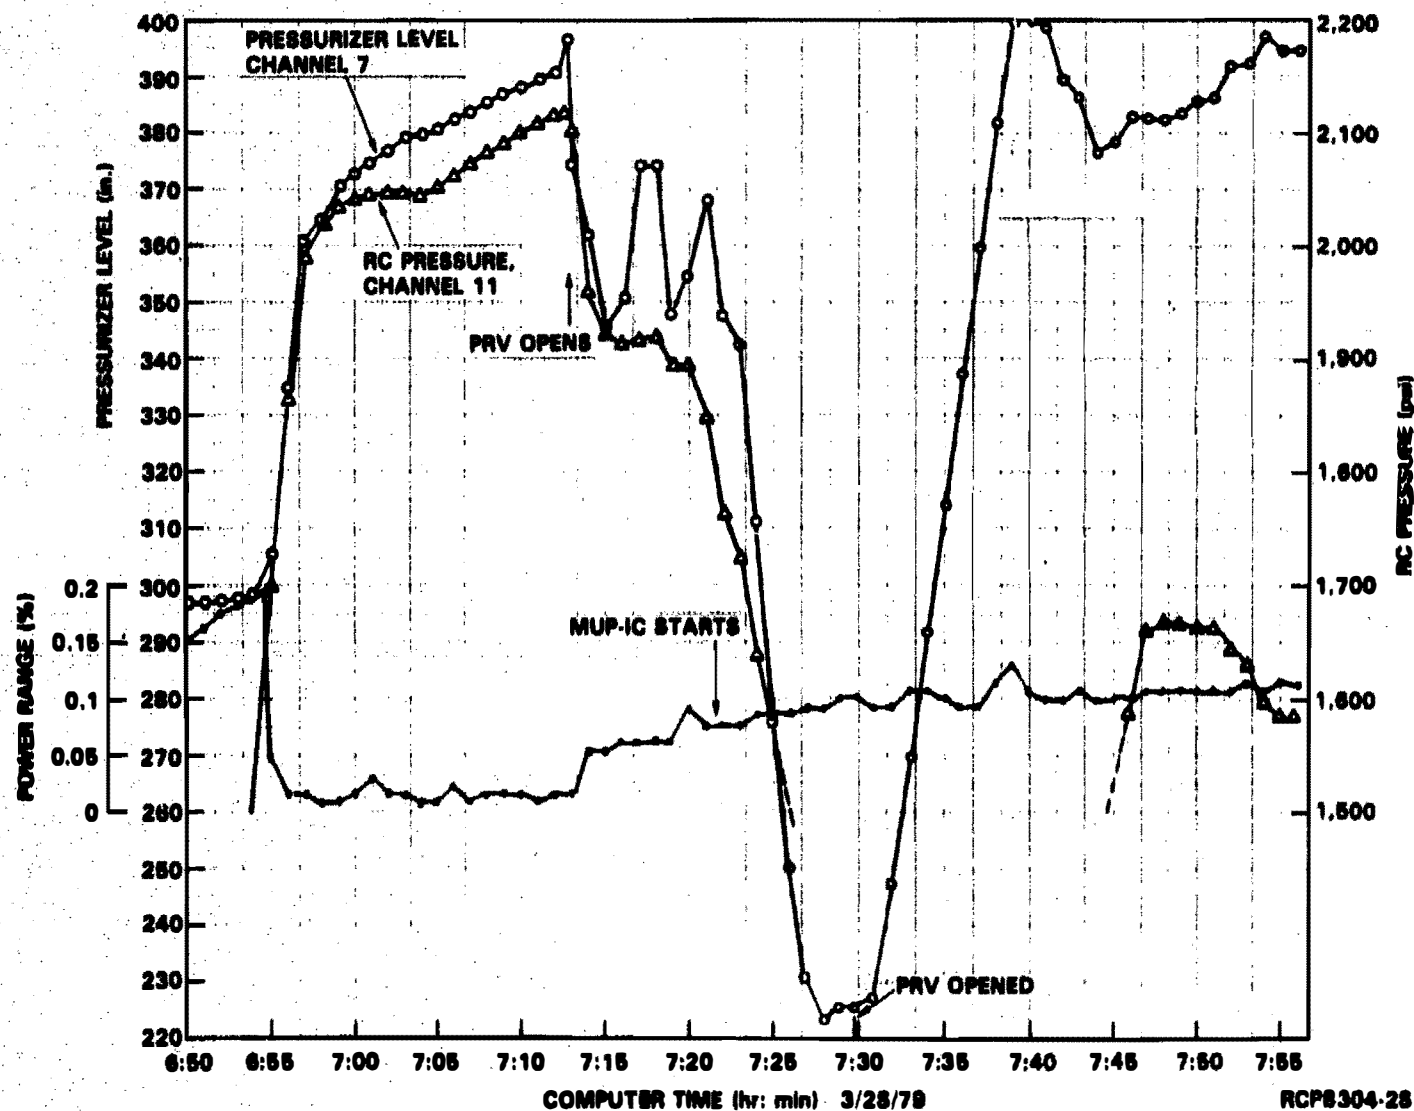
FIGURE 12. Selected Responses to the 6:54, 7:21, and 7:45 Transients.

time when a low water level in the reactor vessel has been suspected is at 07:45 (see Section 4.3). However, note from Figure 12 that the pressurizer level indicator showed that the pressurizer had just refilled at that time it appears that this would have been impossible if the water level in the reactor vessel had not been above the elevation of the reactor coolant nozzles.
