GENE-INF-023
Vol. V

ANALYSIS OF THREE MILE ISLAND UNIT 2 REACTOR COOLING SYSTEM TRANSIENTS

Published August 1983

Rockwell International
Rockwell Hanford Operations
Energy Systems Group
Richland, Washington
Idaho Falls, Idaho 83415

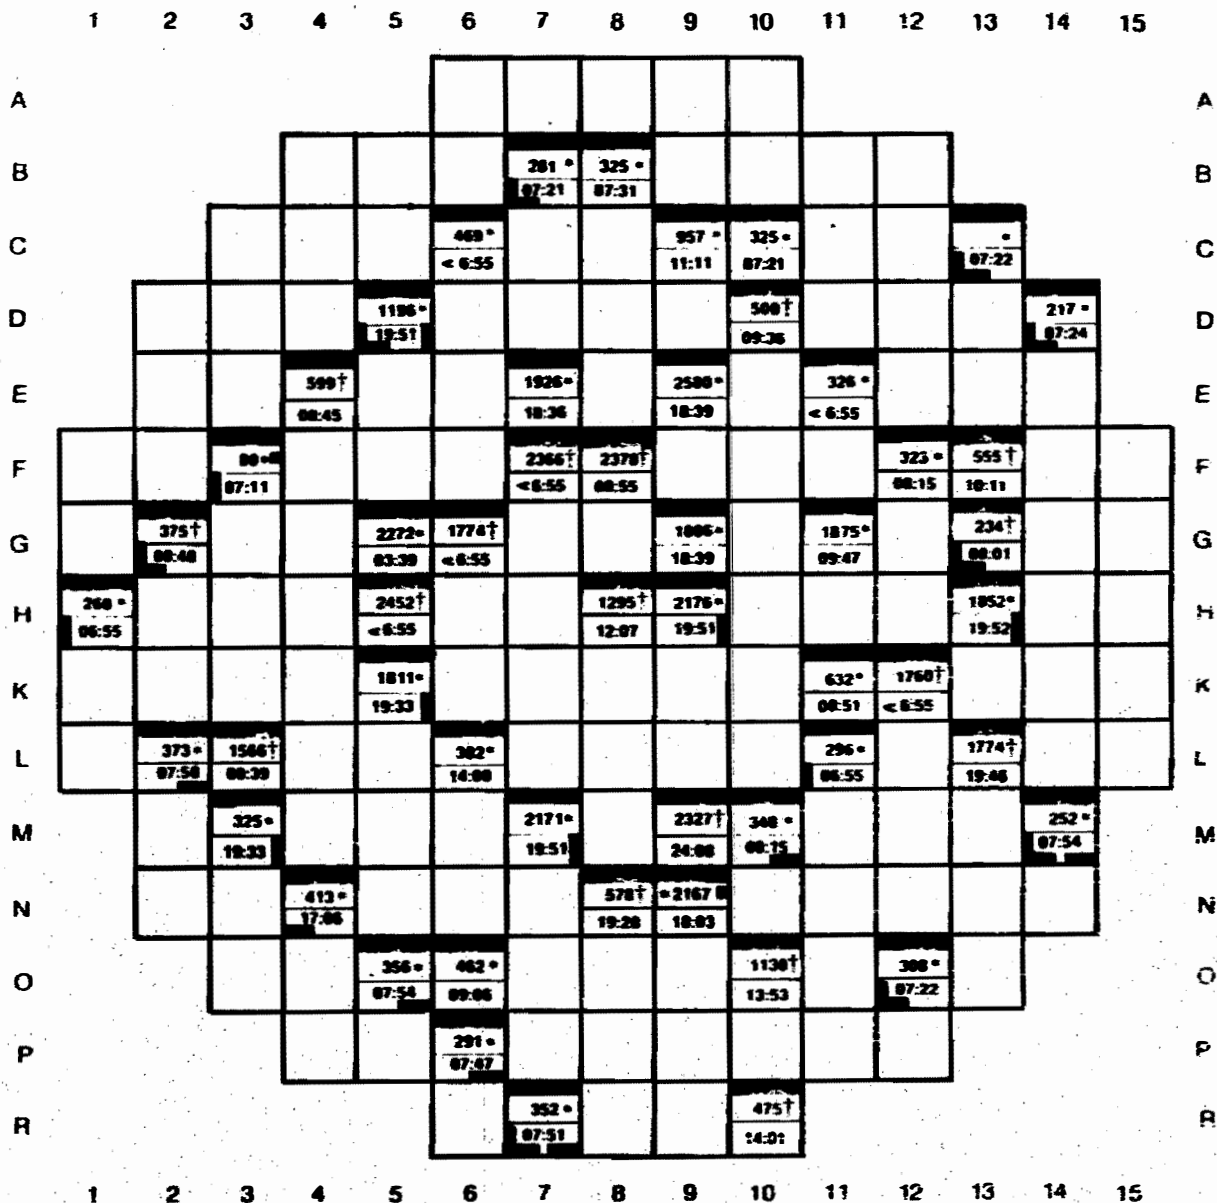
FIGURE 13. Map of Core Temperatures.

A study was made of the alarm printer record of the temperatures of the 52 instrumented fuel assemblies. There are a total of 177 assemblies in the core. The results are summarized in Figure 13. Figure 13 shows a cross section of the core and the 52 instrumented elements. A color bar at the top of each square shows whether the temperature was above or below 700°F at the end of the day. The last time during the day when the temperature changed above or below 700°F is also shown for each element. The fuel elements that cooled below 700°F during (or shortly after) four identified transients are shown by black bars. Further, the temperature measured between the hours of 08:00 and 09:30 is shown. The study shows that at least 17 of the 52 assemblies (33%) were still at temperatures hotter than 700°F in the areas of the thermocouple junctions (some newly formed) 23 hr after the start of the accident. This hot condition existed even though one reactor coolant pump was operating, coolant temperatures were ~250°F, and the RCS pressure was about 1,000 psi. Note that only the peripheral fuel elements cooled as water was added to the core at 6:55 and 7:21. This shows that coolant paths in the central section of the core were blocked at or prior to 6:55. Temperatures in many of the fuel channels, particularly those in the H through R half of the core, dropped shortly after the 7:45 transient and after the reactor coolant pump started. The "hot spots" and "cold channels" are widely scattered and continued to change all day. Therefore, the solidified melt slab (agglomerate) below the rubble in the core is probably highly irregular and not continuous. Also, even though the core was apparently water covered all day after about 7:25, the central section of the core was so badly plugged and overheated that the metal-water reaction probably continued to progress in and below the flow restriction. The steam surge which started at about 7:45 was probably caused by the rapid quenching of a steam bubble that had developed below the flow restriction. This damaged area should become evident as the reactor is defueled.
