INVESTIGATION OF HYDROGEN-BURN DAMAGE IN
THE THREE MILE ISLAND UNIT 2 REACTOR BUILDING

N. J. Alvares and D. G. Beason
Lawrence Livermore National Laboratory
and
G. R. Eidam
EG&G Idaho, Inc.

Published June 1982

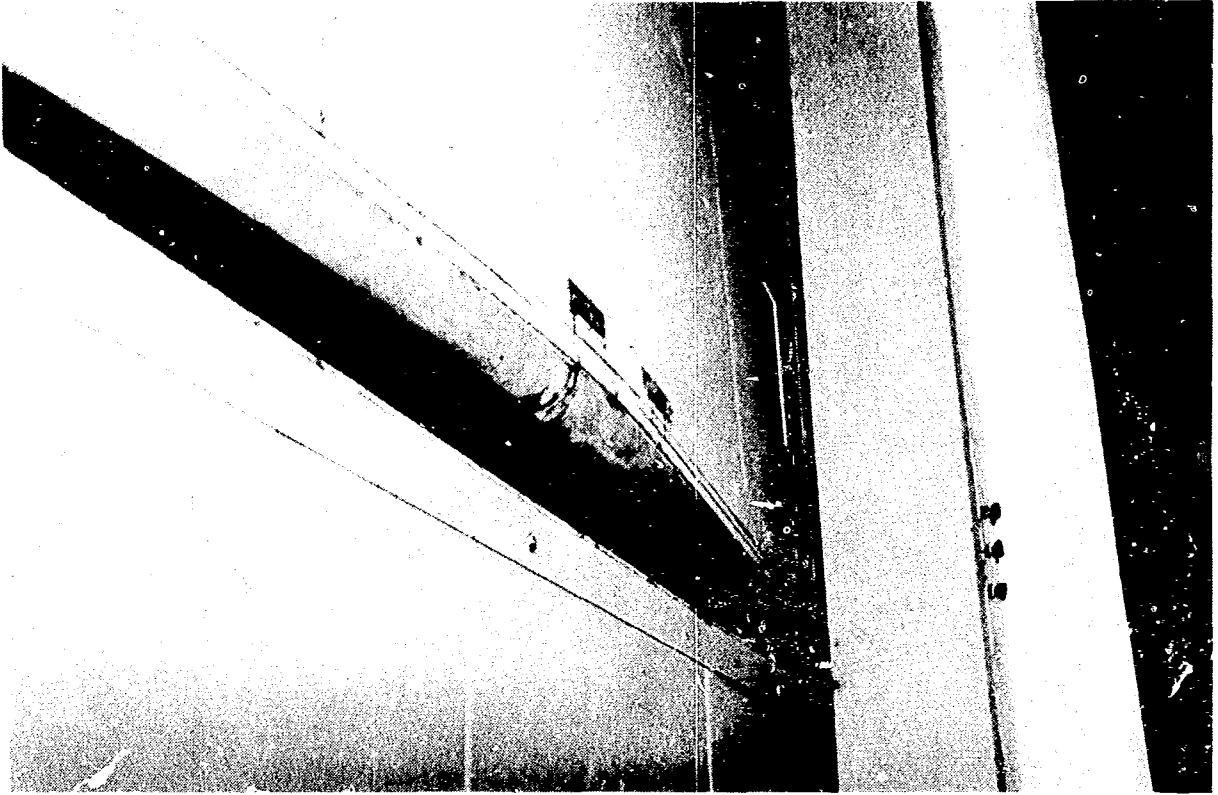
Figure 2. Elevator door on the 347-foot elevation indicating overpressure damage.

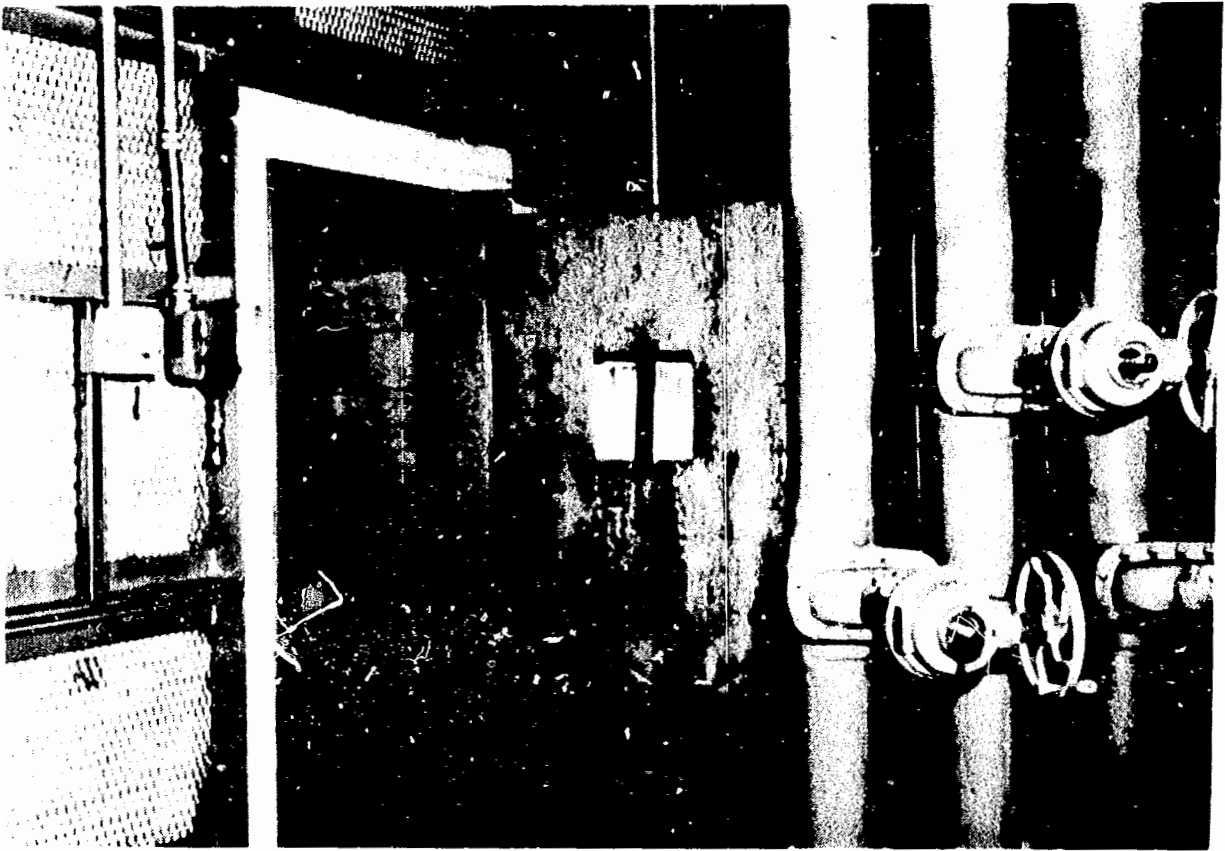
Figure 3. Enclosed stairwell door on the 305-foot elevation indicating overpressure damage.

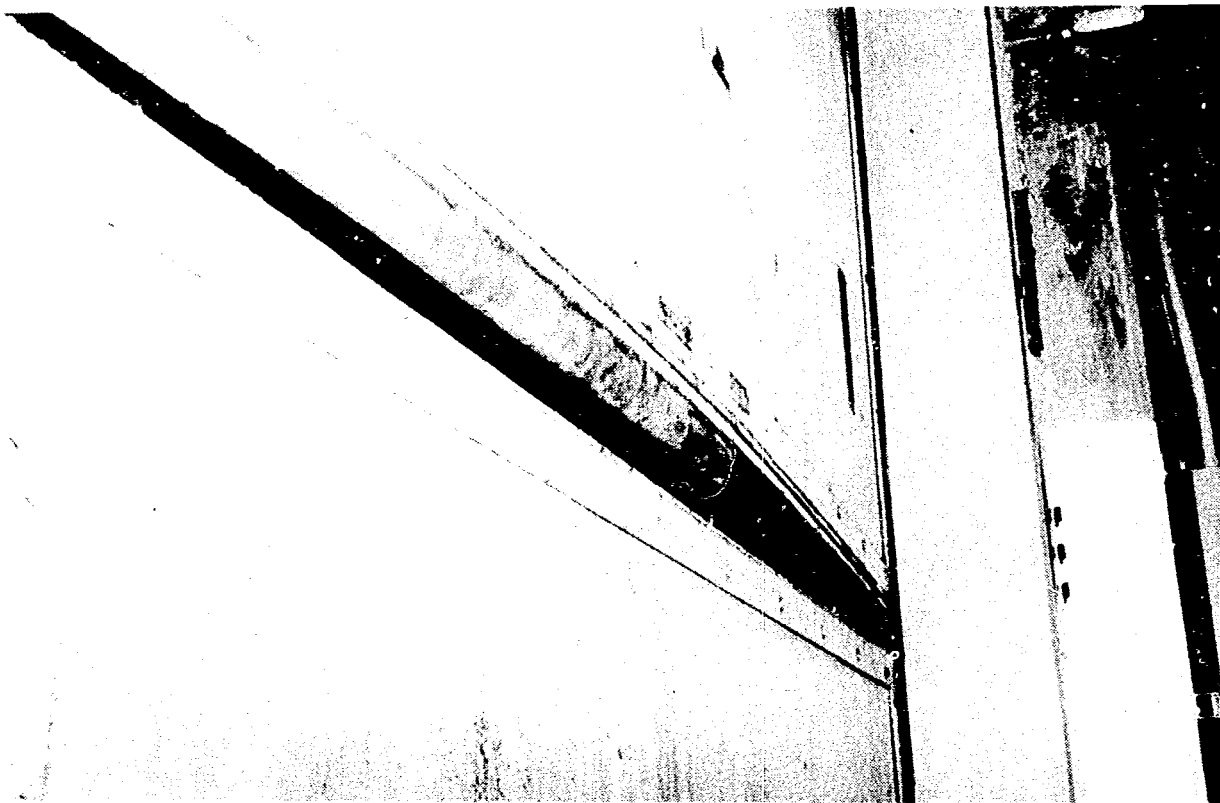
Figure 4. Elevator door on the 305-foot elevation indicating overpressure damage.

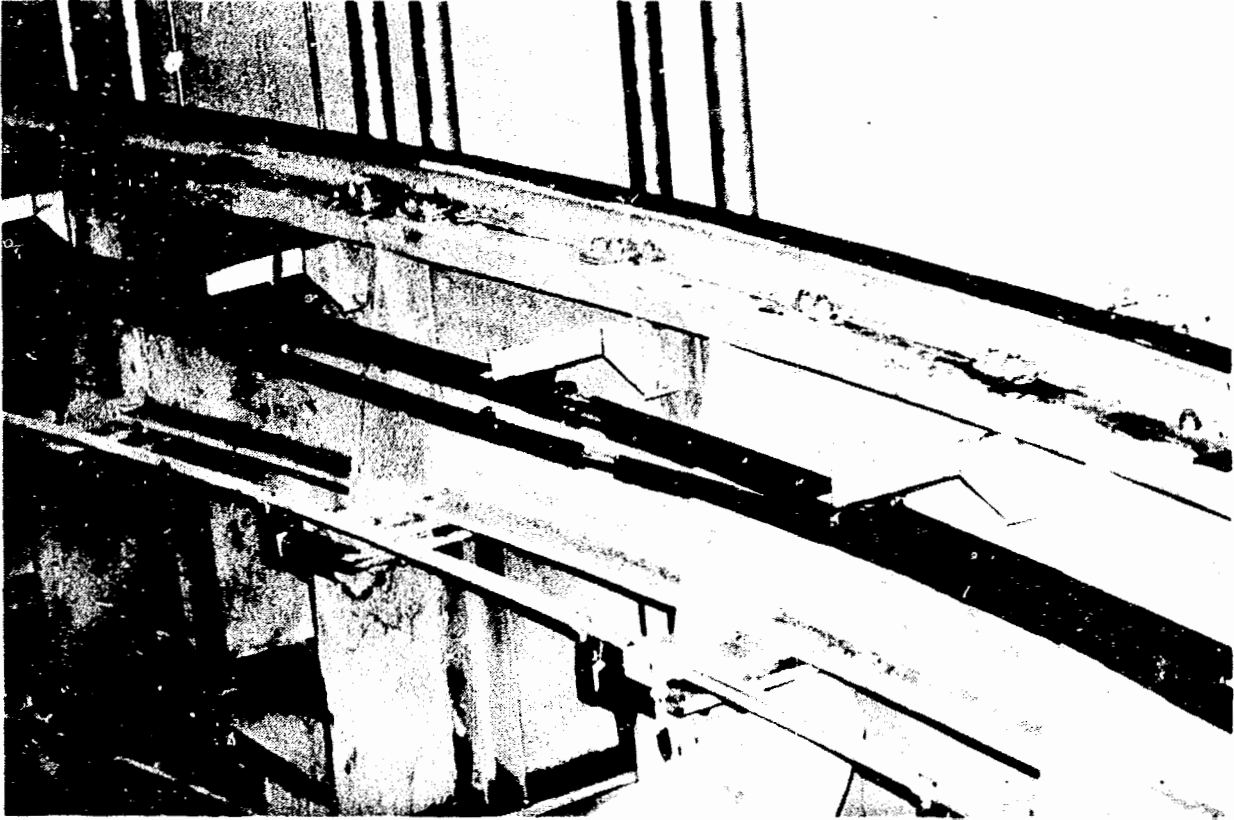
Figure 7. Charred insulation on the containment bus.

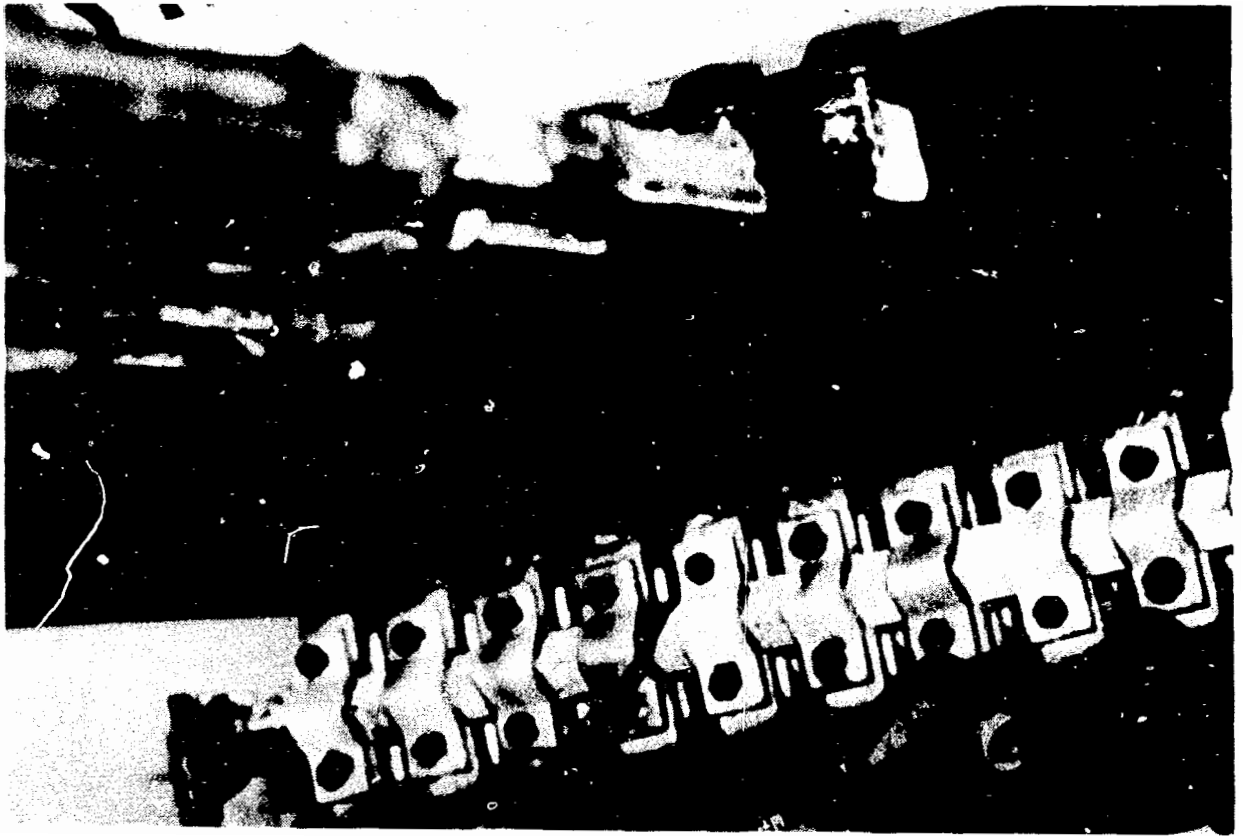
Figure 8. Damage to polar crane bus insulation.

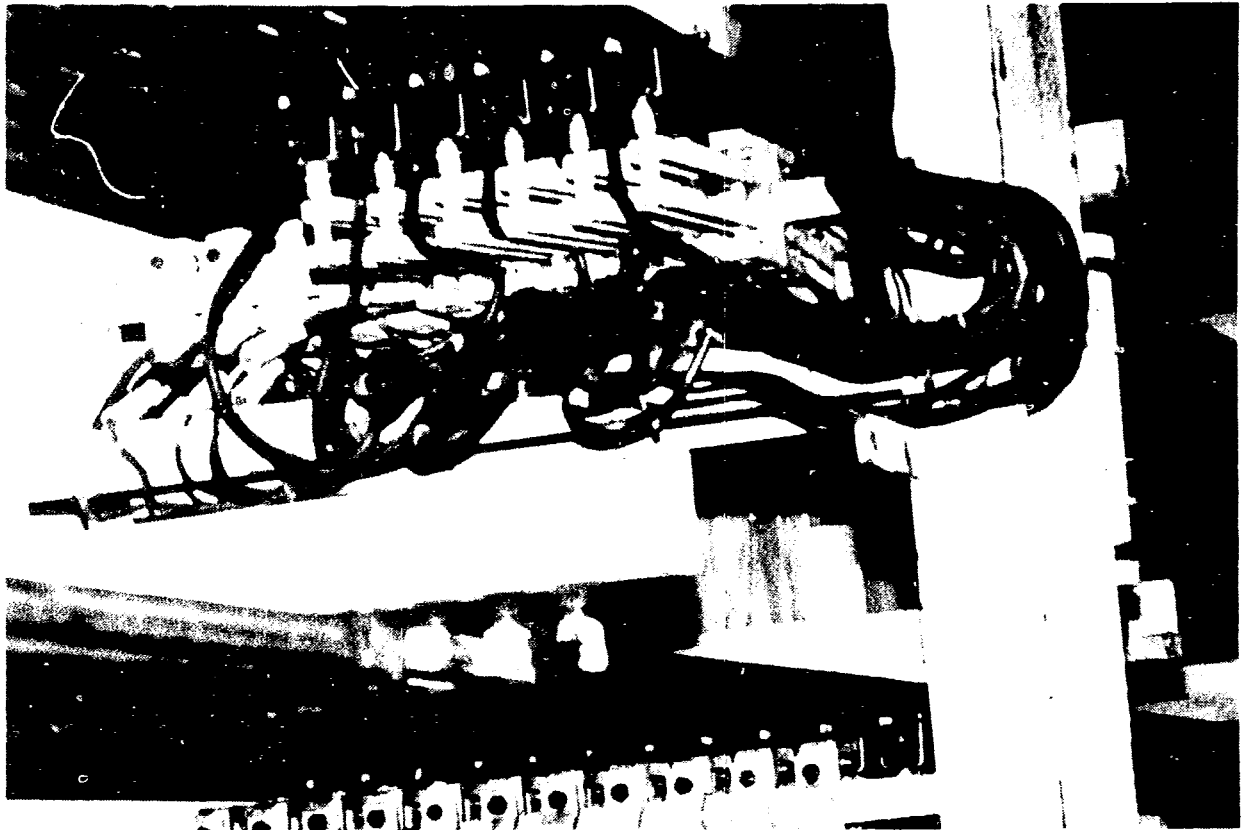
Figure 9. "Scalloped" damage to polar crane bus insulation; appears to decrease close to crane.

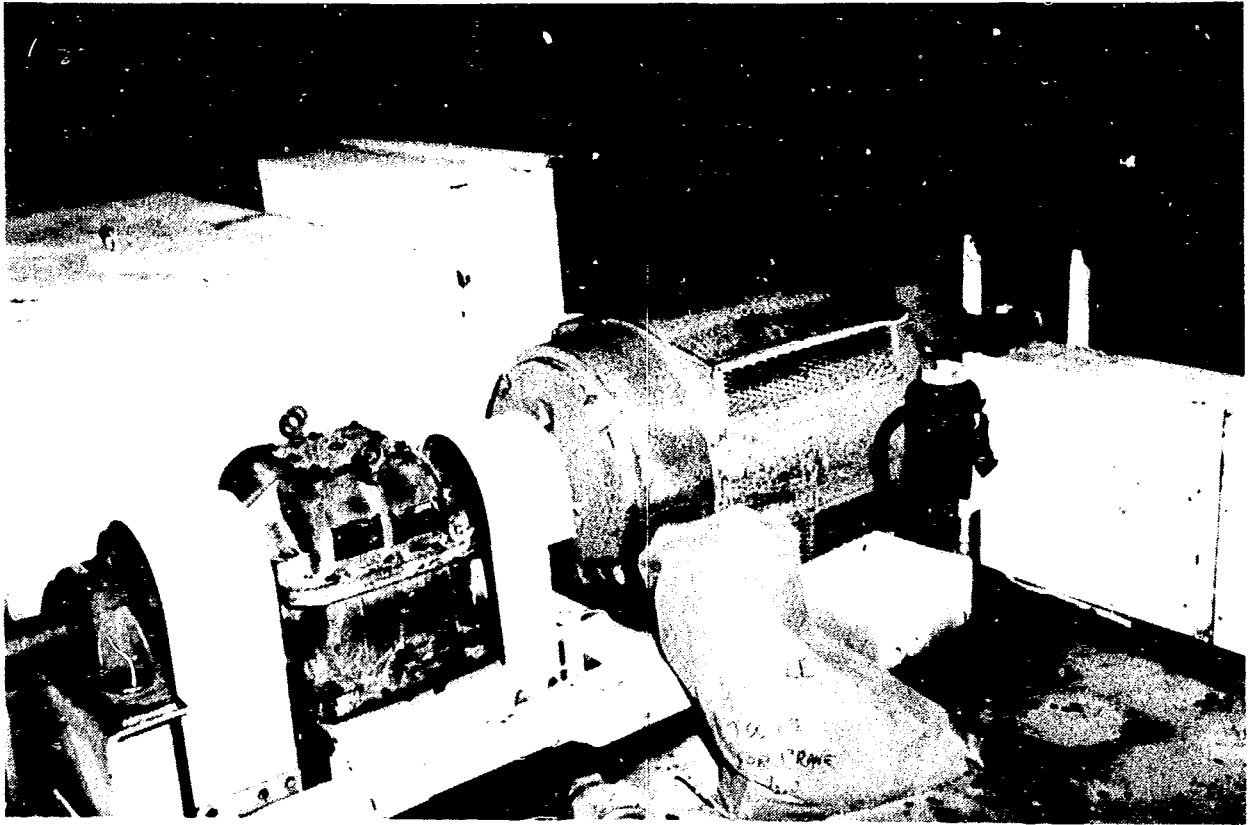
Figure 10. Charred hose and charred label on fire extinguisher.

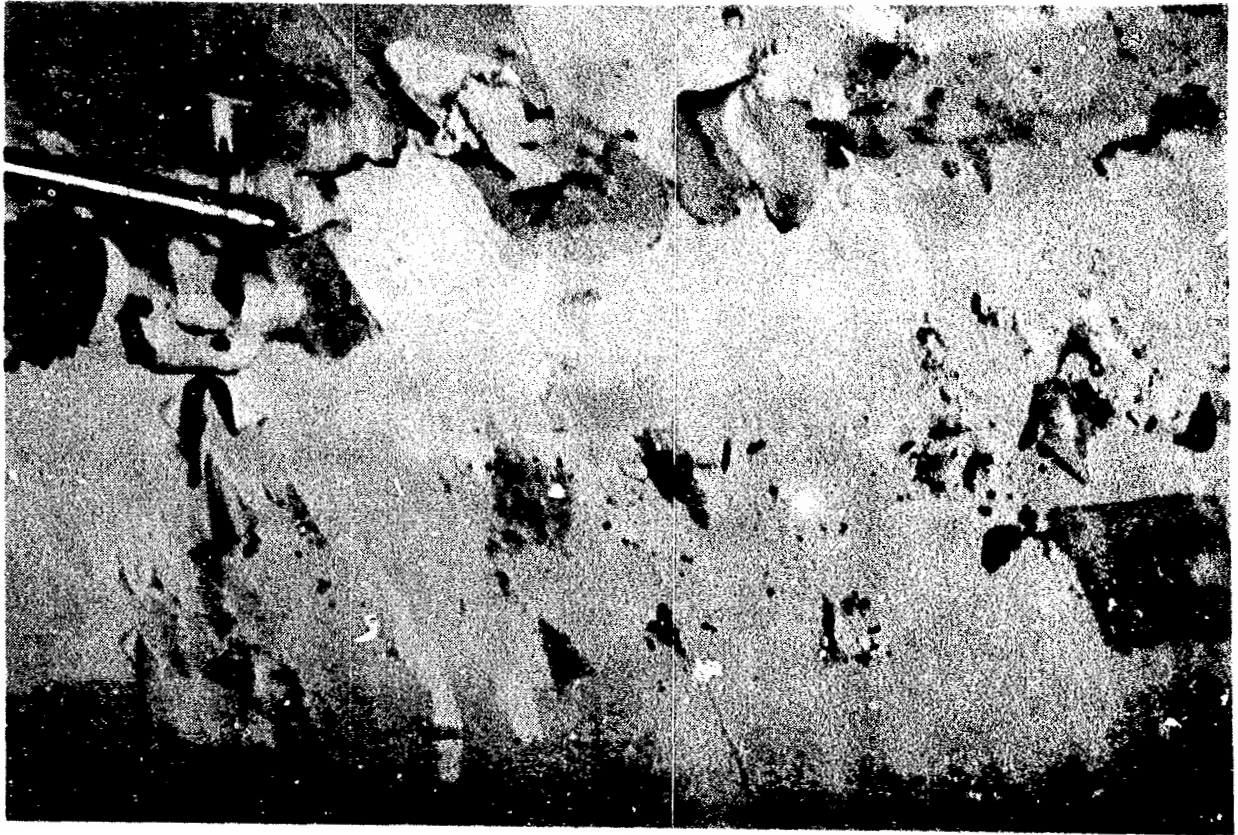
Figure 12. Stripped, charred, and blistered paint in the polar crane region.

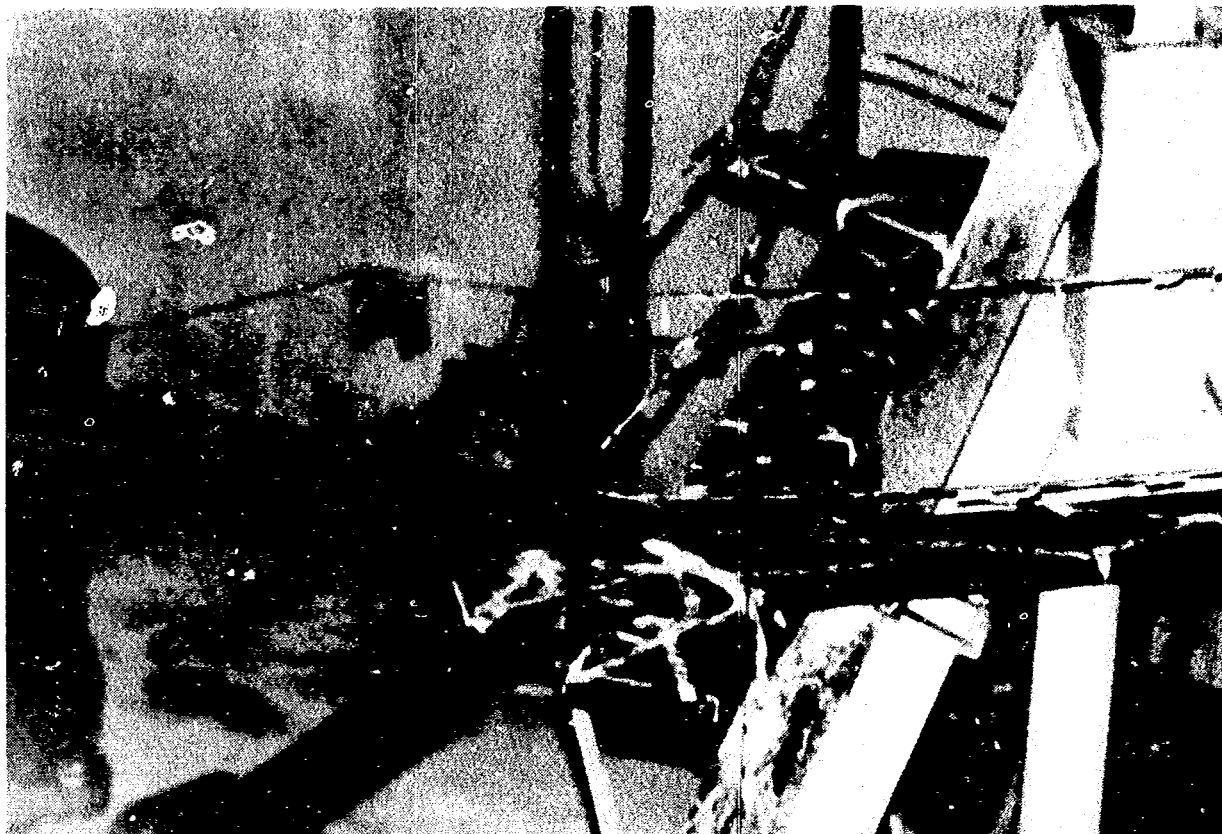
Our preliminary estimates lead us to believe that in at least one area of the reactor building, the total surface heat exposure or heat flux during the accident was greater than 3 W/cm^2 (9500 BTU/hr-ft^2). In estimating possible total surface heat exposures we studied the charred scaffolding shown in Figures 14 and 15. The minimum charring temperature for such wood is around 300°C , and the minimum total surface heat exposure, or heat flux, required to produce the charring is 3 W/cm^2 . We assumed that the scaffolding was probably covered with polyethylene film (an assumption based on the patterns of the variations in the char and the presence of adhesive tape), so the polyethylene had to melt before the wood could char. At a minimum heat flux of 3 W/cm^2 , this polyethylene-covered board would take hundreds of seconds to char. However, since accident records indicate the hydrogen burn did not last for hundreds of seconds, but rather for tens of seconds, total heat flux near the charred scaffolding had to be greater than 3 W/cm^2 in order to produce the observed damage.

Figure 14. Top view of charred scaffolding with tape shields showing and polyethylene cover melted off. Note phone table in background: front surface of plywood backing against south wall is charred.

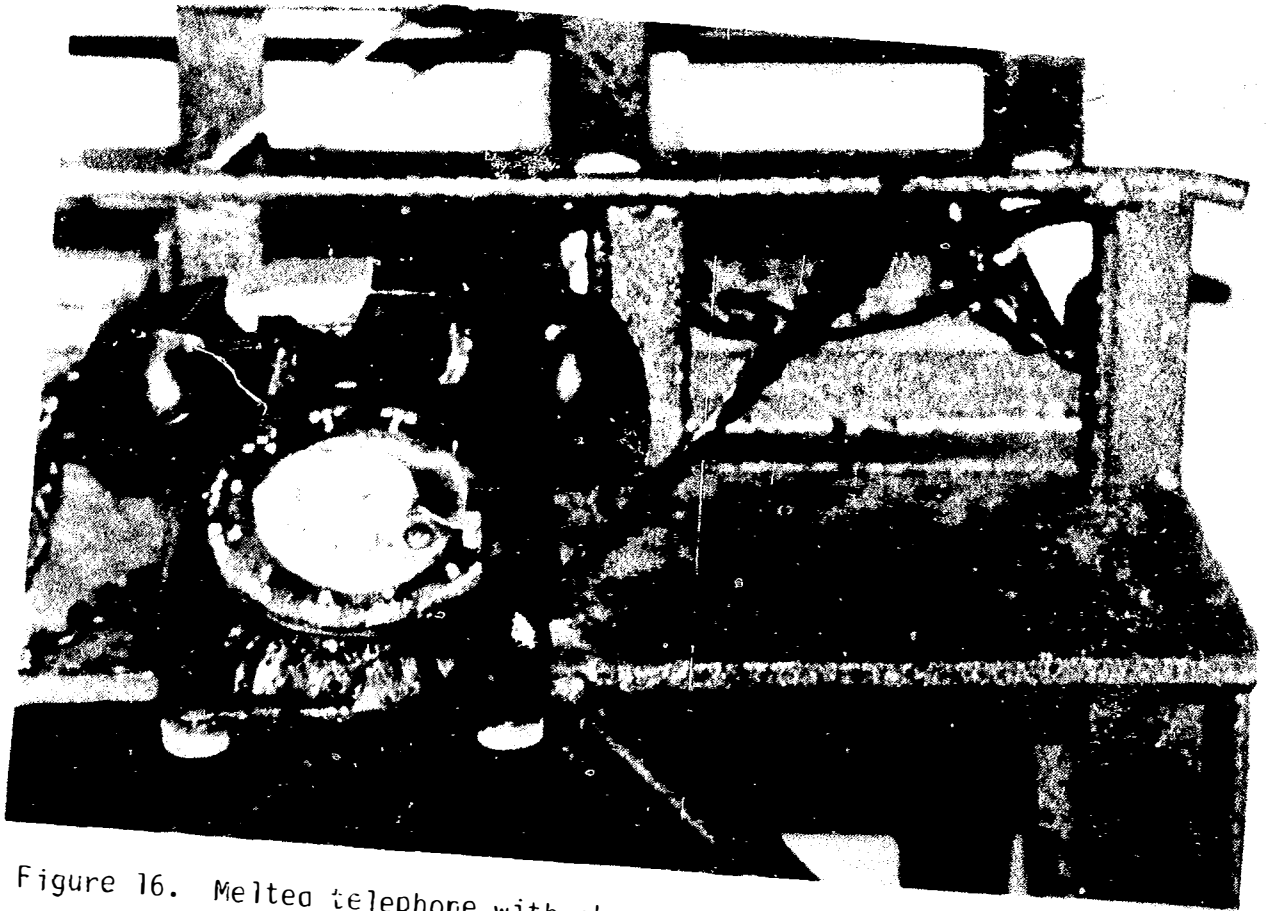
Figure 16. Melted telephone with charred cord along the south wall of the 347-foot elevation.

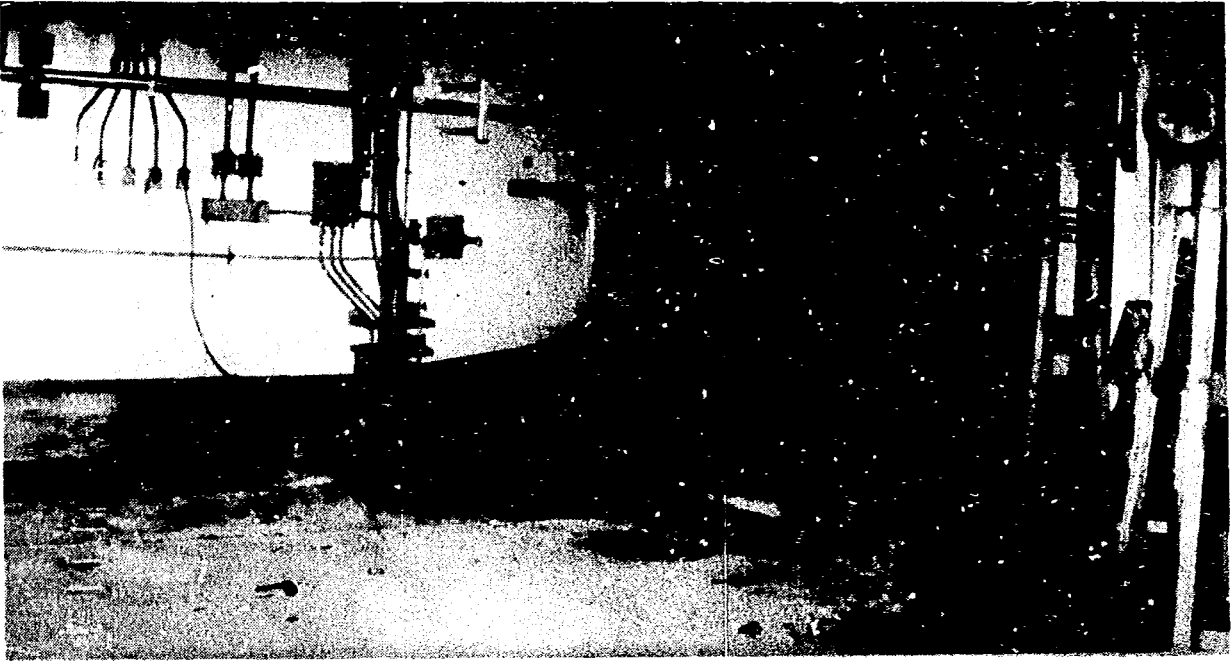
Figure 18. Uniformly charred plywood box against D-ring wall in the southeast area of the 347-foot elevation.

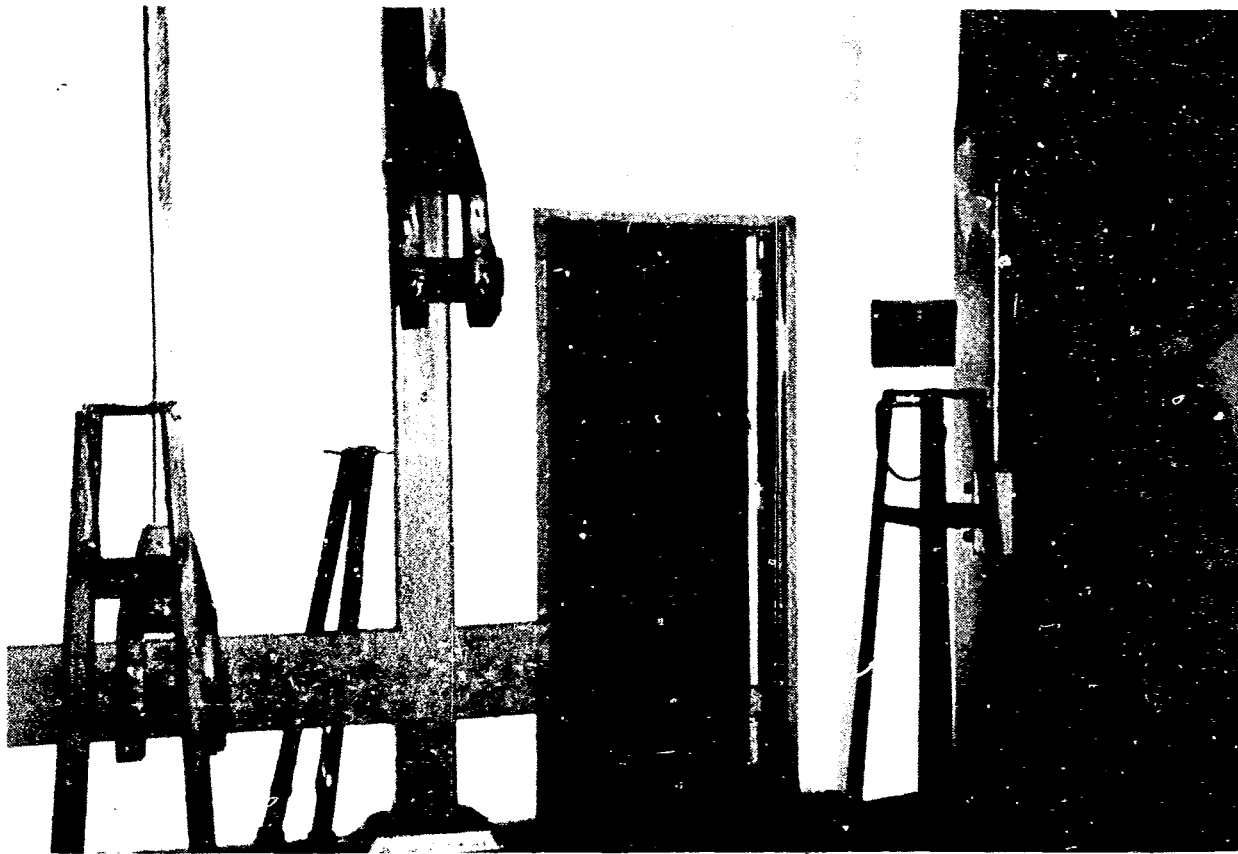
Figure 19. Discolored exit sign, burned in right top corner; located in the southeast area of the 347-foot elevation.

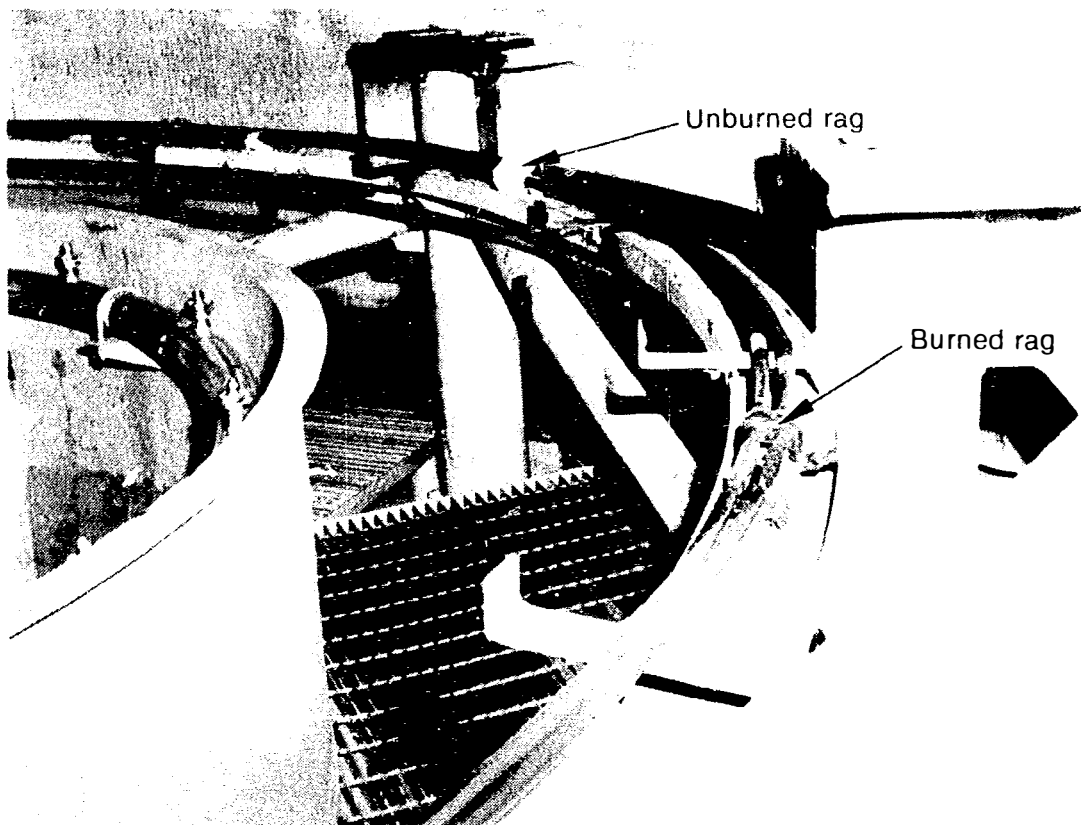
Figure 20. Random fabric char inside the head storage stand on the 347-foot elevation.

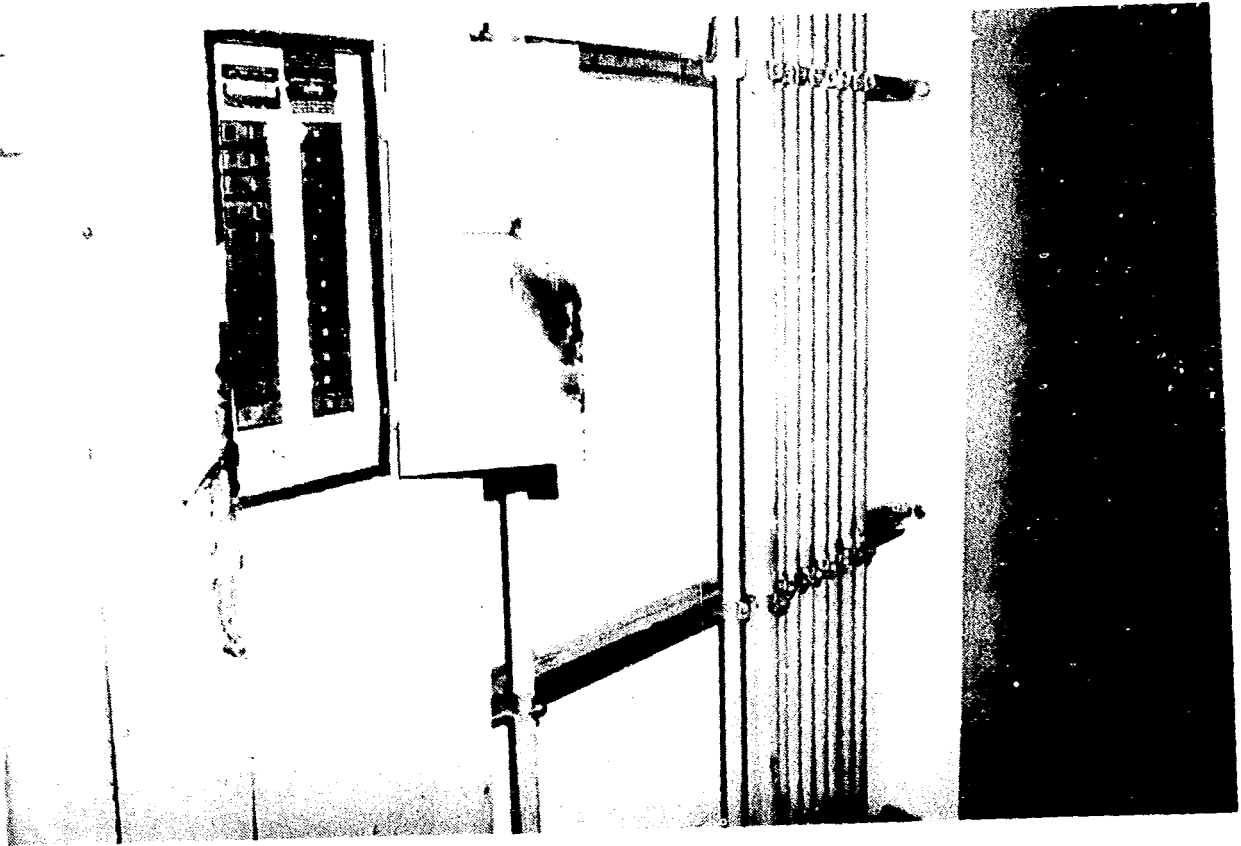
Figure 22. Charring and melted door seal material on electrical panel in southeast area of the 347-foot elevation.

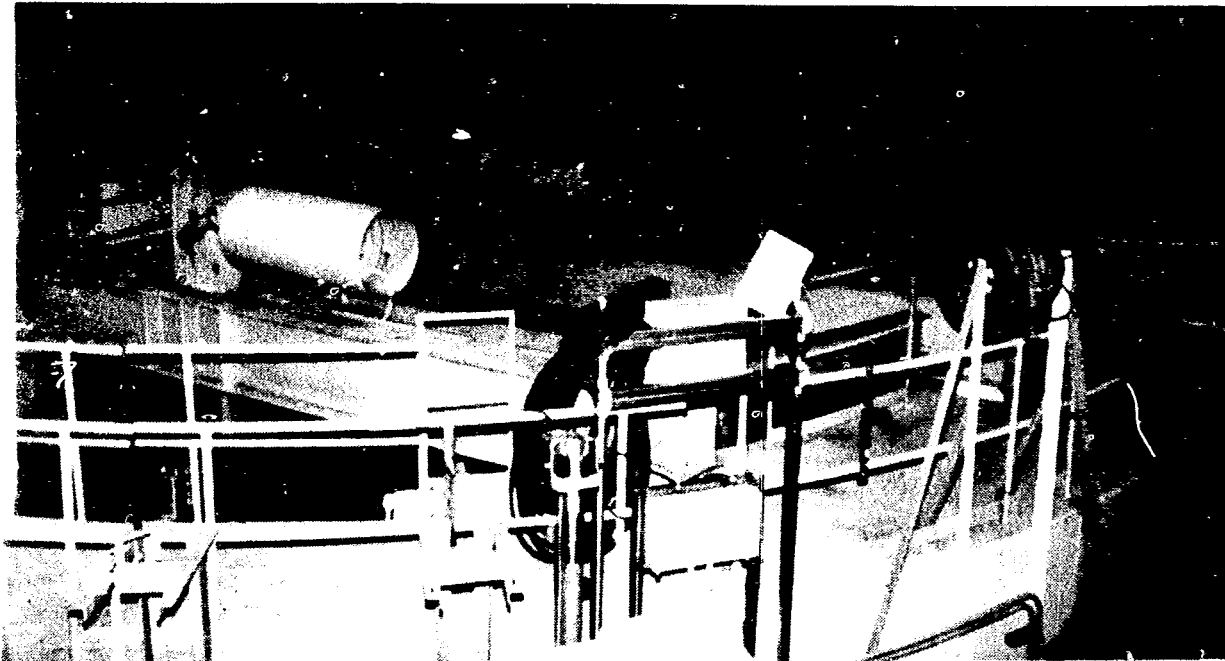
Figure 23. Charred paper in metal box in the east D-ring on the 347-foot elevation.

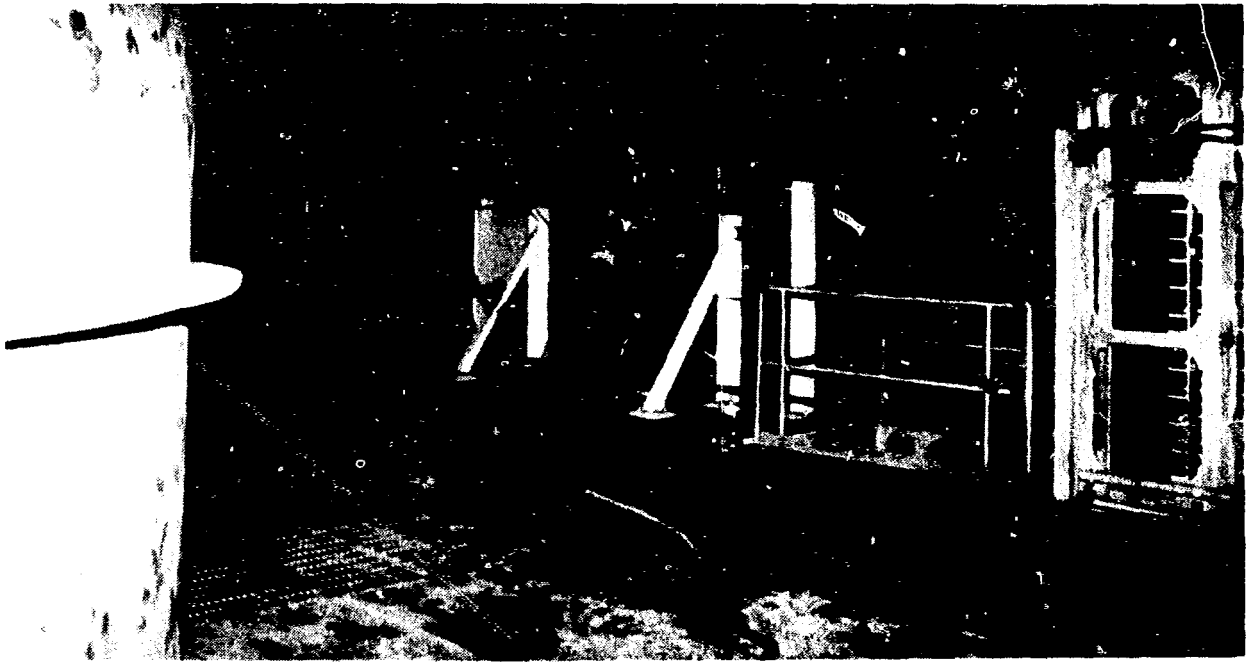
Figure 24. View towards the refueling canal on 347-foot elevation showing fallen bus bar from polar crane and charred electrical insulation.

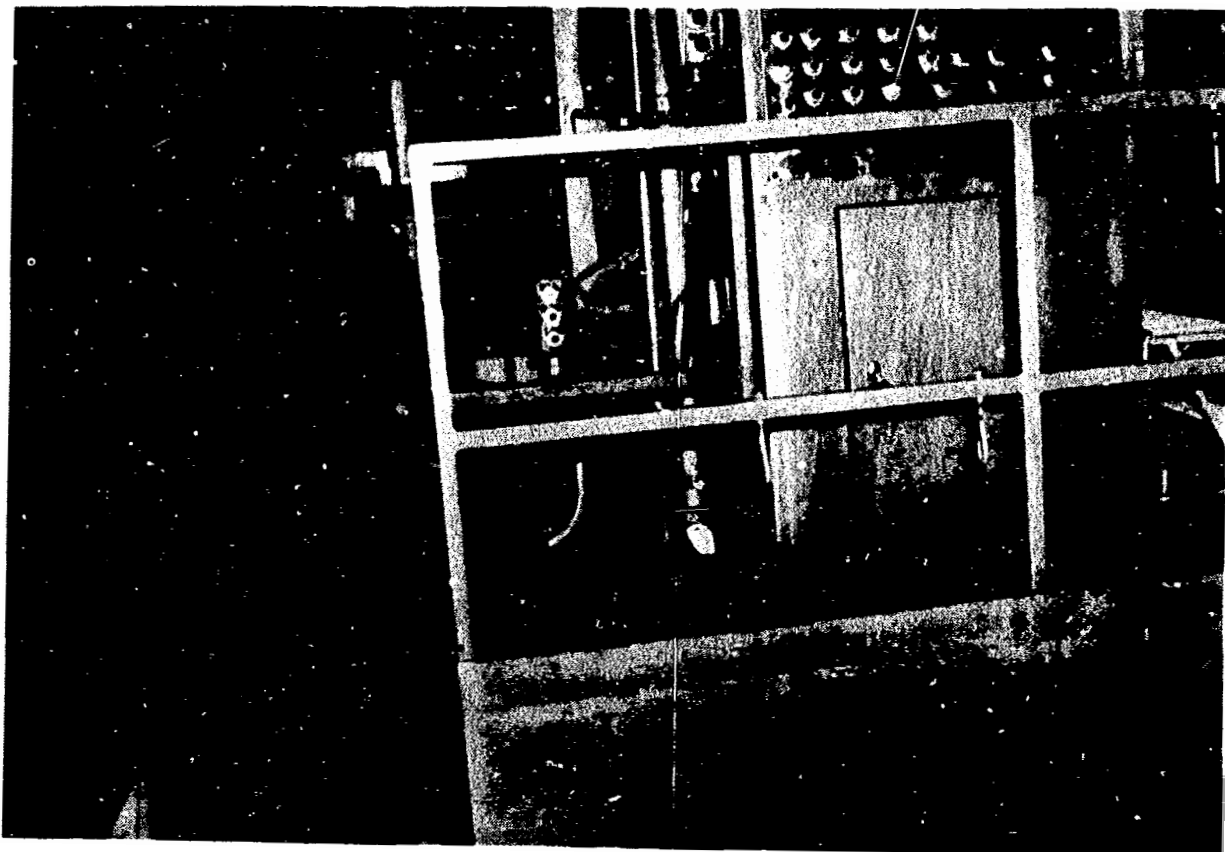
Figure 26. Burned manual and melted earphones on the auxiliary fuel handling bridge on the 347-foot elevation; just below view in Figure 25.

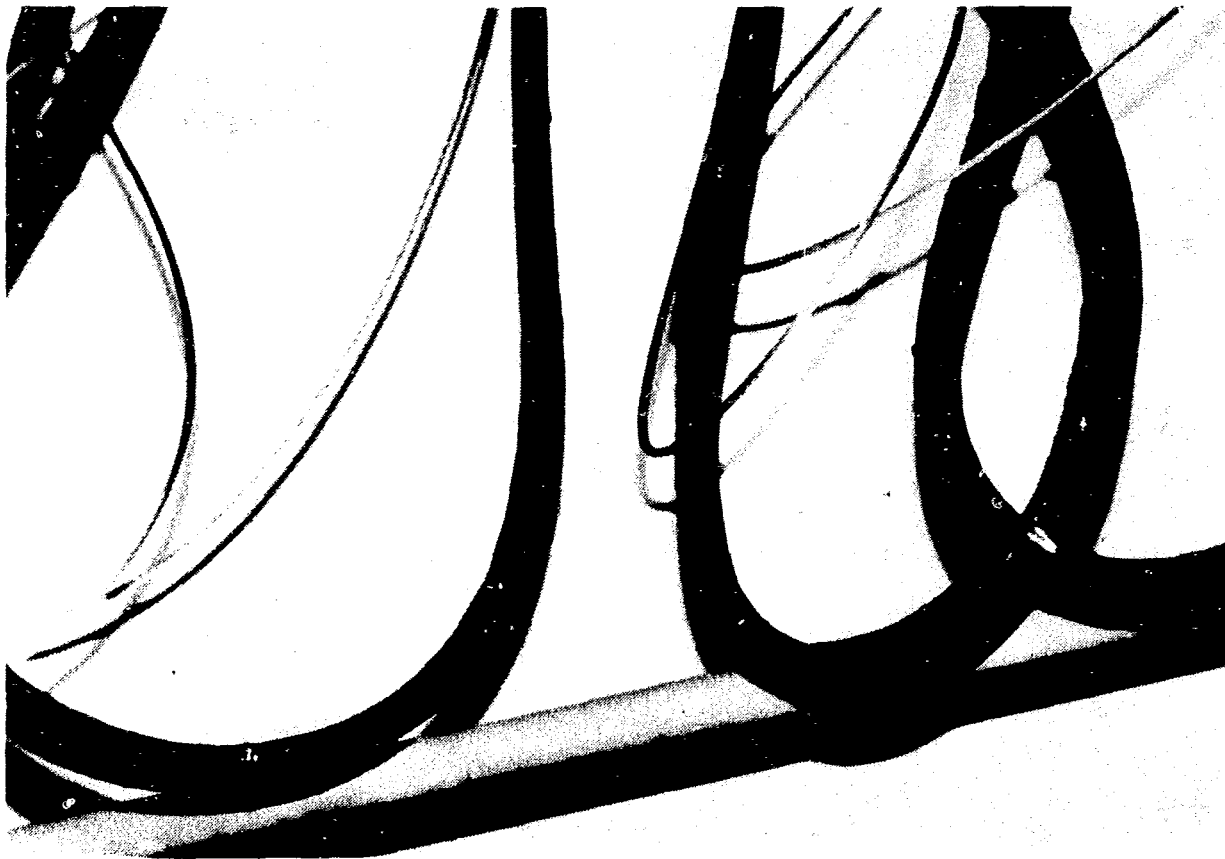
Figures 25 through 28 show thermal damage and burning of auxiliary fuel handling bridge control buttons, and burning of manuals on the deck next to the north side of the control panel. Thermal intensity appears to be similar to that of the south reactor building area. The control and power cable festoon exhibit thermal damage to insulation on the side away from the wall (Figure 27), indicating a relatively uniform exposure in the region between the D-rings.

Figure 27. Electrical festoon for fuel handling bridge, on the 347-foot elevation; charred on the exposed surface.

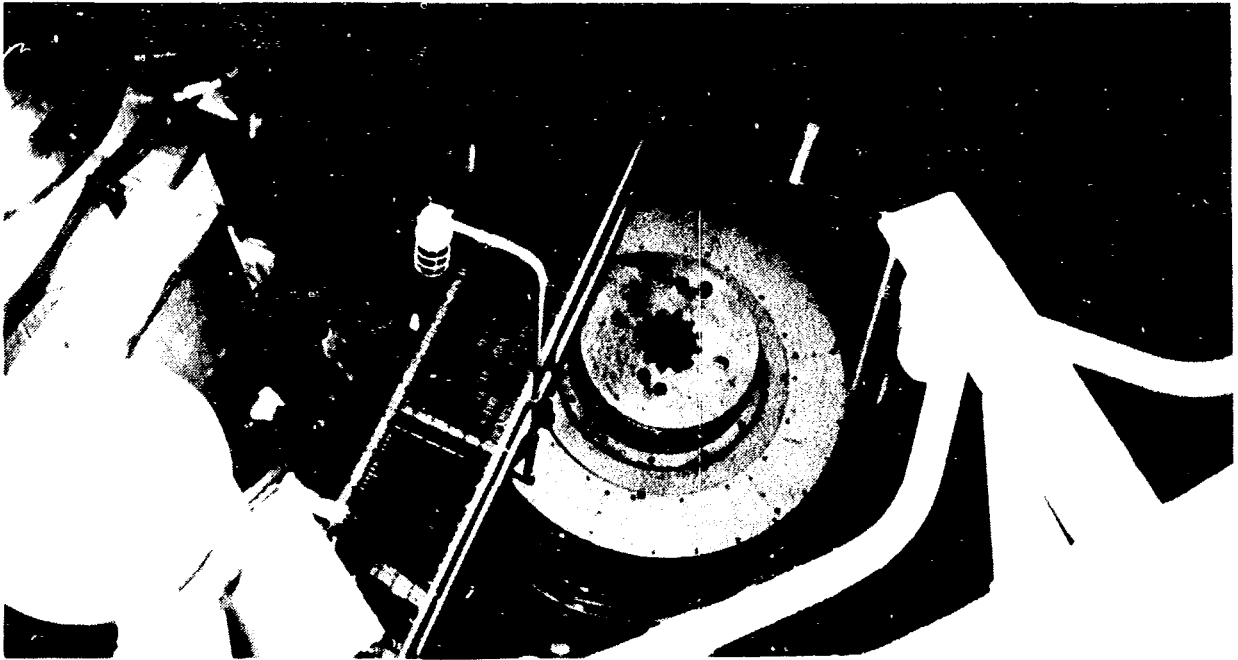
Figure 28. Darkened edge of junction box inside east side of west D-ring.

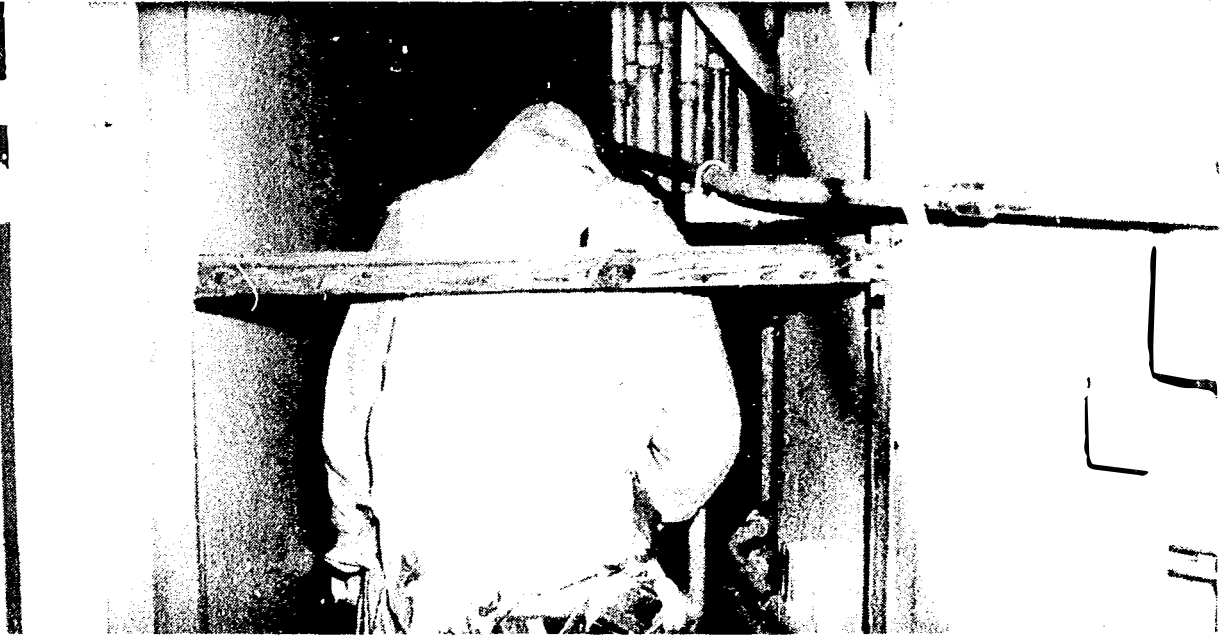
Figure 30. Undamaged wood shoring on 305-foot elevation.
