## ASSESSMENT OF EXTENT AND DEGREE OF THERMAL DAMAGE TO POLYMERIC MATERIALS IN THE THREE MILE ISLAND UNIT 2 REACTOR BUILDING

GEND-INF--023-Vol.6

Published February 1984

Lawrence Livermore National Laboratory  
Livermore, California

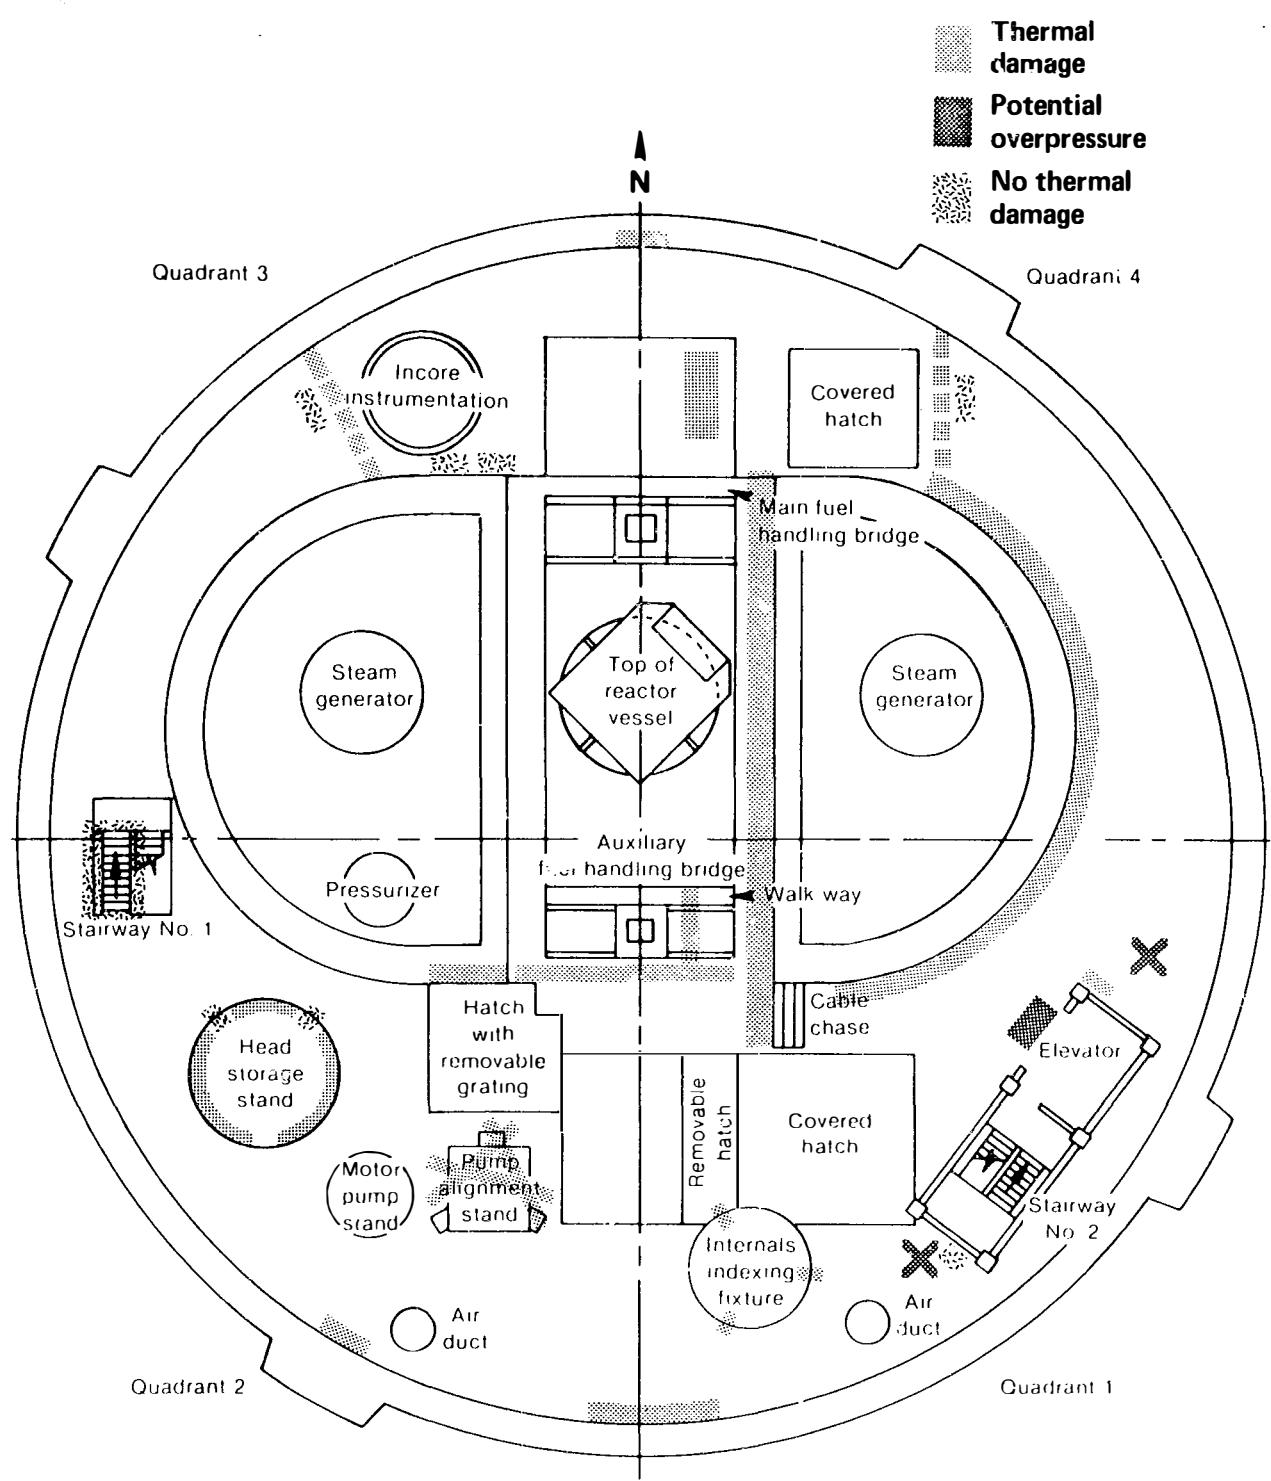
Figure 4. Thermal damage and potential overpressure on the 347-ft level.

Damage to the elevator and stairwell doors indicates internal pressurization of both the stairwell and the elevator. Moreover, the metal floor plate in front of the elevator door on the 305-ft level was displaced. On the 347-ft level to the east and west side of the enclosed elevator, barrels containing unknown levels of oil were distorted to various degrees.

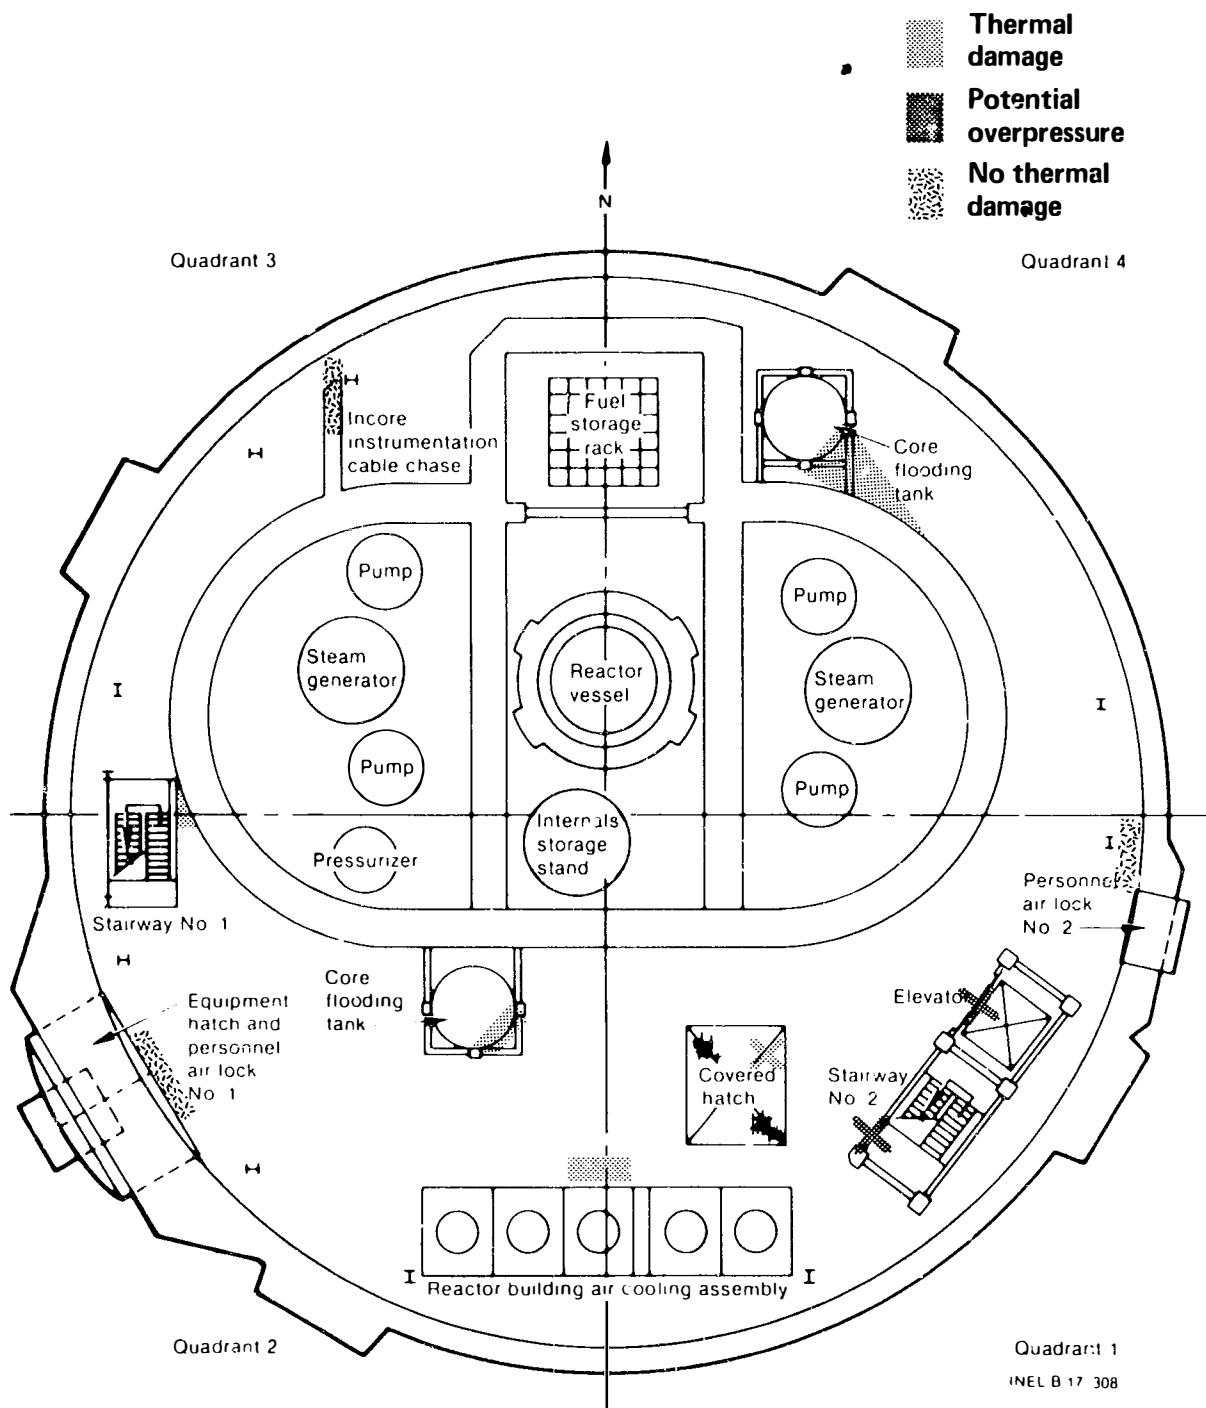
Figure 5. Thermal damage and potential overpressure on the 305-ft level.

Most items susceptible to thermal degradation on and above the 347-ft level suffered some photographically apparent thermal damage. On the 305-ft level evidence of burn damage was not extensive. Yet close scrutiny by personnel interested in such observations has found adequate charred and melted items to confirm the presence of a combustion front at most locations on this level.<sup>7</sup> Insufficient photographic or video data is available to

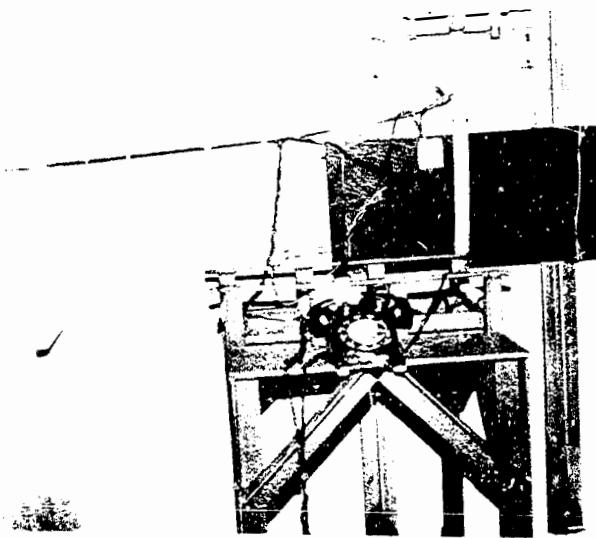
Figure 6 shows photographs of plywood on the reactor building south wall and remains of an instruction or maintenance manual located on the reactor building north wall, both ignited by fire propagation through the seismic gap. Note in Fig. 6a that wires along the wall also exhibit burn trauma. Figures 6c and 6d show the front and rear surface of the plywood panel after it was extracted from the reactor building. Both sides are charred, as are edges and holes through which wire ties penetrate. Surface char condition indicates that the panel ignited to flaming combustion for a short period before self-extinguishing or being quenched by the reactor spray system.

8. The total burn pattern of the plywood board back for the south-wall telephone on the 347-ft level indicates flame propagation through the seismic gap.

Figure 6. Hydrogen-burned in-containment materials: (a) Bell telephone. (b) Charred manual on electrical box. (c) Back of plywood panel. (d) Front of plywood panel.

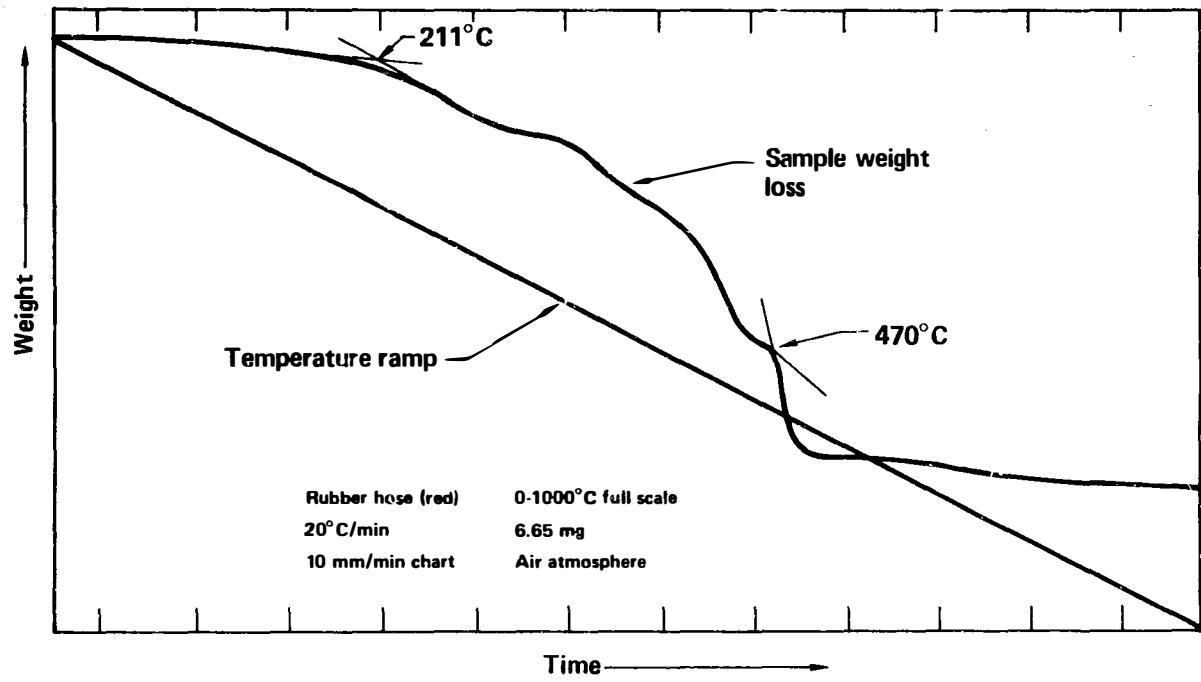
Figure 9 illustrates the thermal degradation pattern for red rubber fire hose. This material begins slow degradation at 211<sup>0</sup>C, ultimately forming an inert char at 470<sup>0</sup>C. We would expect that this material would be difficult to ignite because of low pyrolyzate production.

Figure 9. Thermogram of red rubber fire hose.

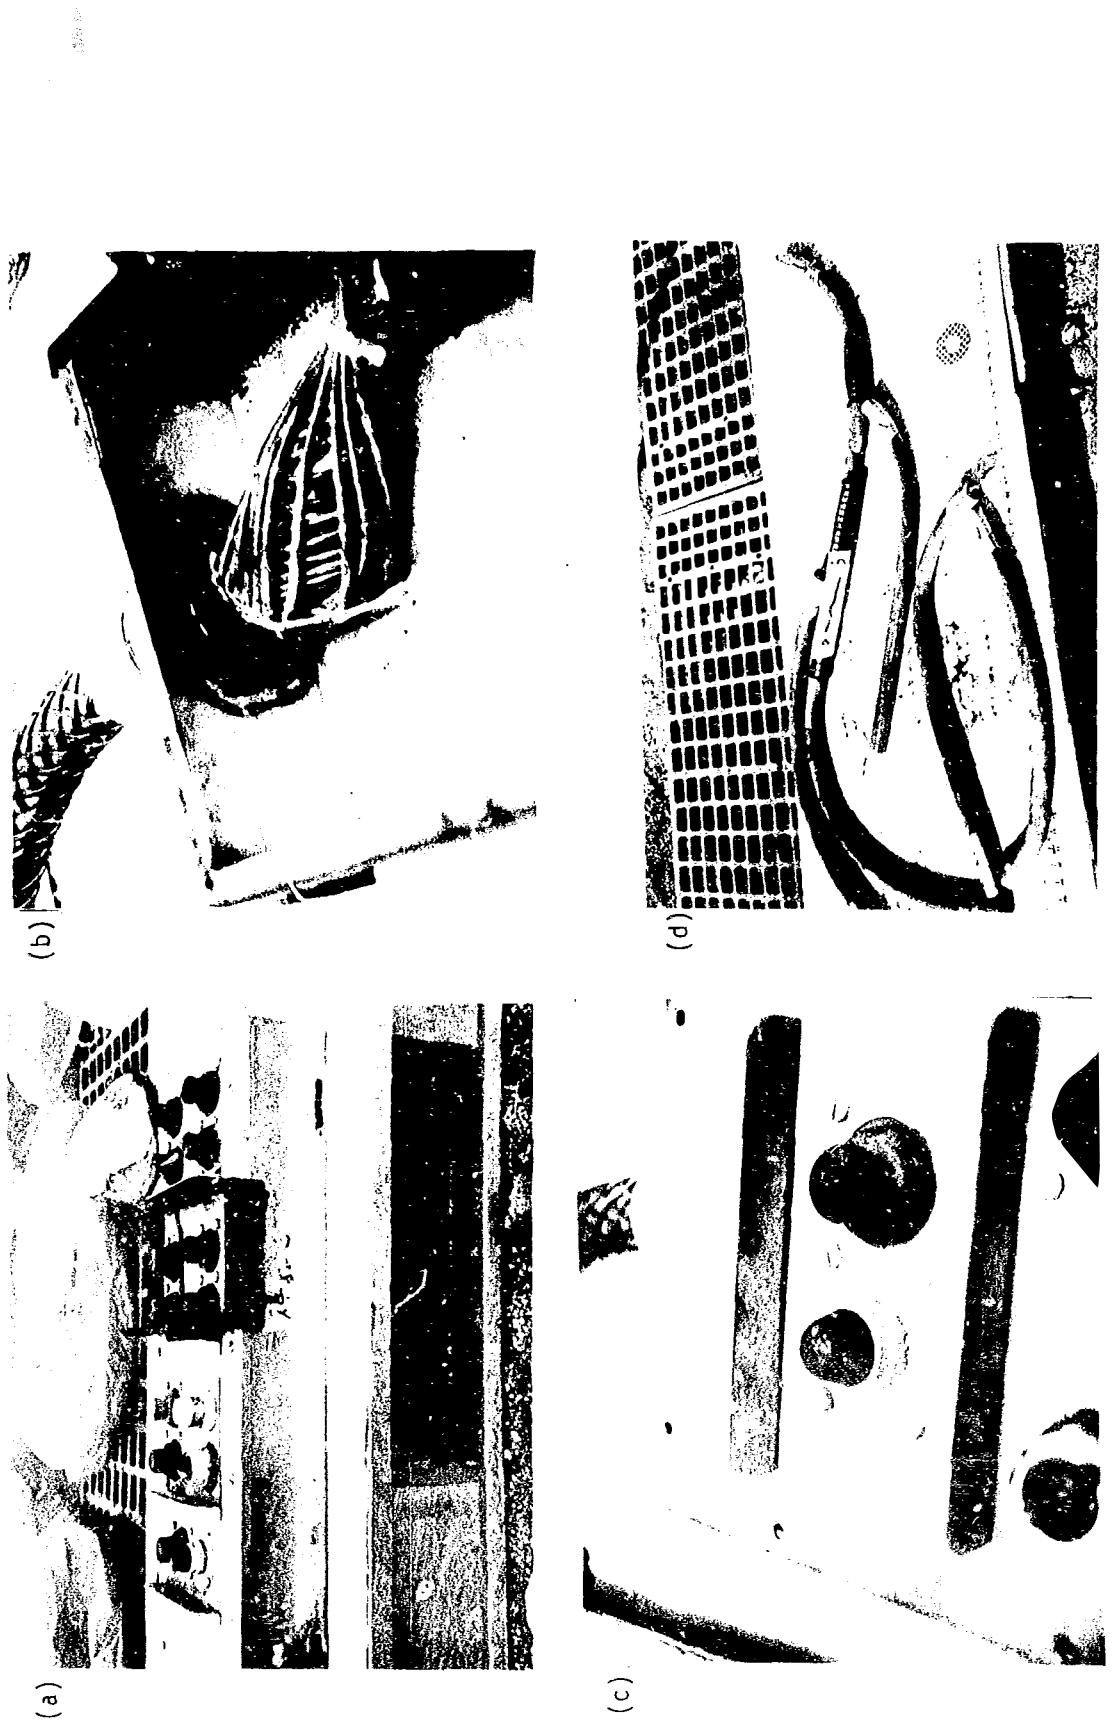
One item that possibly received the most intense energy exposure was the pendant and festoon for the polar crane. Figures 10a and 10b show the lower polar crane pendant, and upper polar crane pendant and festoon along the A girder in the reactor building. Figures 10c and 10d, and all plates in Figs. 11, 12, and 13, show the relative thermal damage of cable sections extracted from the reactor building.\* These are illustrative photographs starting from the festoon support of the polar crane and extending to the position of the control box resting on the east side of the west D-shield. A detailed description of thermal damage on each section is contained in Table 3. The figures and tables show that all sections received thermal exposure, including those coiled on the D-shield catwalk. The degree of thermal degradation decreased from the polar crane level to the D-shield top, and, in fact, was only apparent on the bottom pieces where cuts in insulation projected free surfaces of poor heat transfer. Thermal degradation is also apparent on light lenses of the pendant control box (Fig. 13c).

Figure 13. Details of control box and proximate cable.

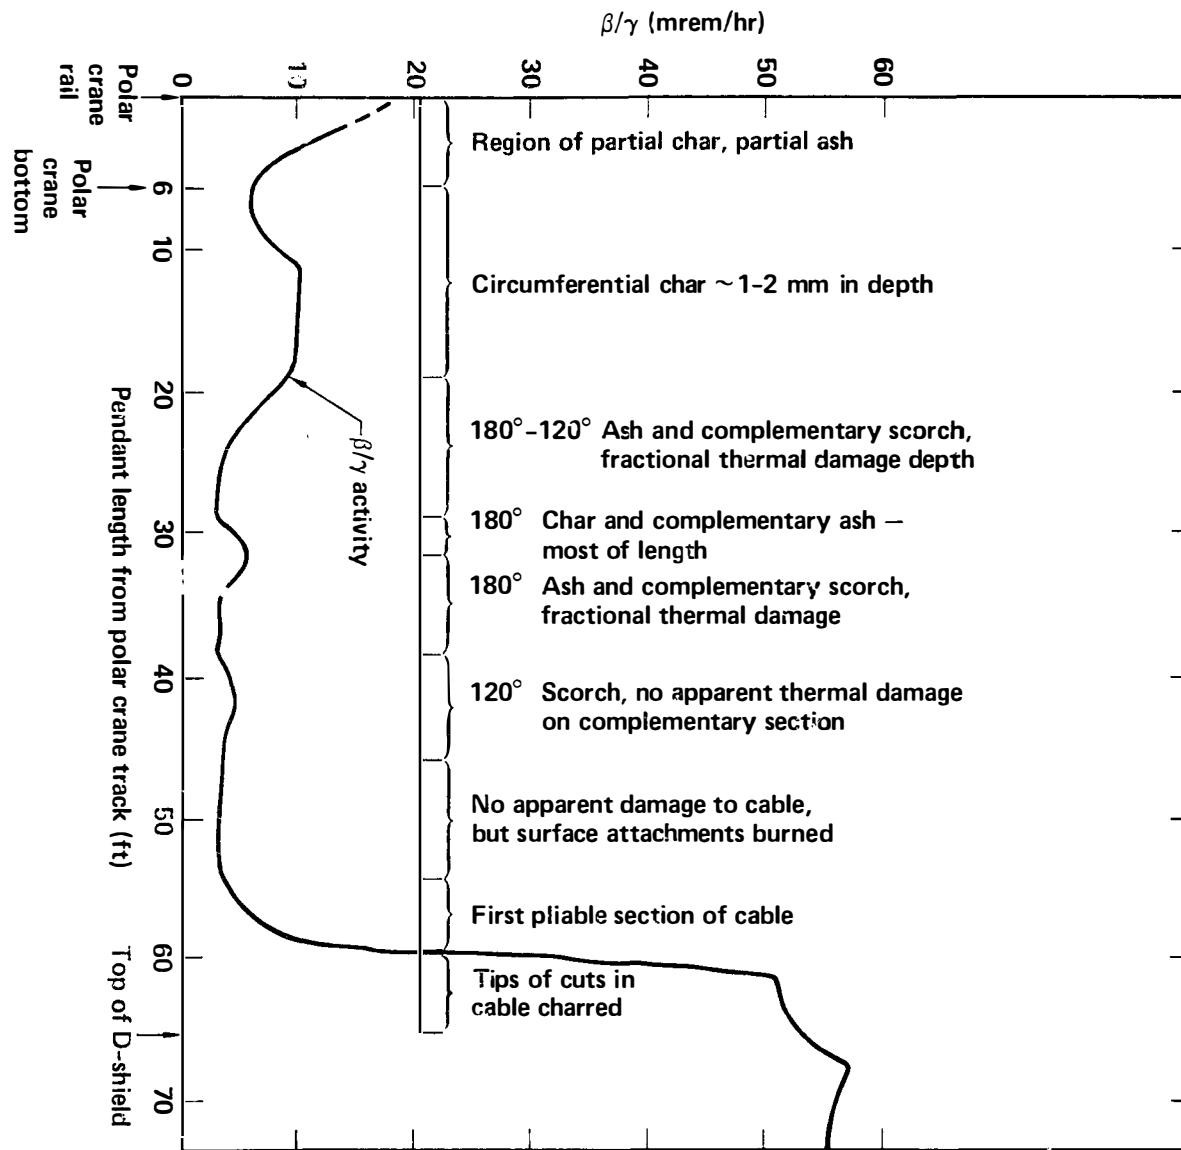
Figure 14 plots thermal damage with pendant length from polar crane level to the top of the D-shield level. Superimposed is the level of  $\beta/\gamma$  radiation (as determined and constructed by Mr. Trujillo). Maximum thermal damage occurs in the region from 6 to 10 ft below the polar crane girder (from about the 420-ft level down to about the 406-ft level). This region shows locally high  $\beta/\gamma$  activity, which may correlate to physical absorption by porous, charred insulation. Thermal damage is severe and circumferentially equal in this region. Char depth on the polymer surface averages 1 to 2 mm. We have no clue as to the composition of the insulating cover for the pendant, so we cannot define the intensity of exposure. However, it was definitely intense and uniform, an indication that this region was bathed for a substantial period in an intense combustion zone.

of the insulation circumference exhibited a heavier degree of damage, ranging from char at the 406-ft level to no perceptible insulation degradation just above the D-shield plane. Unfortunately, the direction of exposure is not established, either by cable geometry or by observation. Because of the extent of thermal damage to available polymers in the south and southeast regions of the reactor building, it might be feasible to assume that plume dimensions encompassed that region. Moreover, since all containment gases above the 347-ft level were convected to the air-cooler intake plenums in the southern sector just below the 347-ft level, some preferential fire propagation path may have occurred in this area. However, because there were fewer thermally susceptible materials in the north reactor building regions we cannot contrast the south and north experience to define the center of fire intensity. Had there been either minimal thermal experience or other patterns in susceptible polymers in any other region, we may have had better opportunity to define fire plume geometry. Only one cause for asymmetry of the burn pattern below the 406-ft level can be conjectured: that the cable at this height was exposed to radiation and convection from a hydrogen plume centered to one side (logically the south side) of the reactor building. The exposed surface would sustain flame more readily from the shadowed surface, thus producing the observed pattern.

Figure 14. Distribution of residual radiation and burn damage along pendant length from the polar crane track.

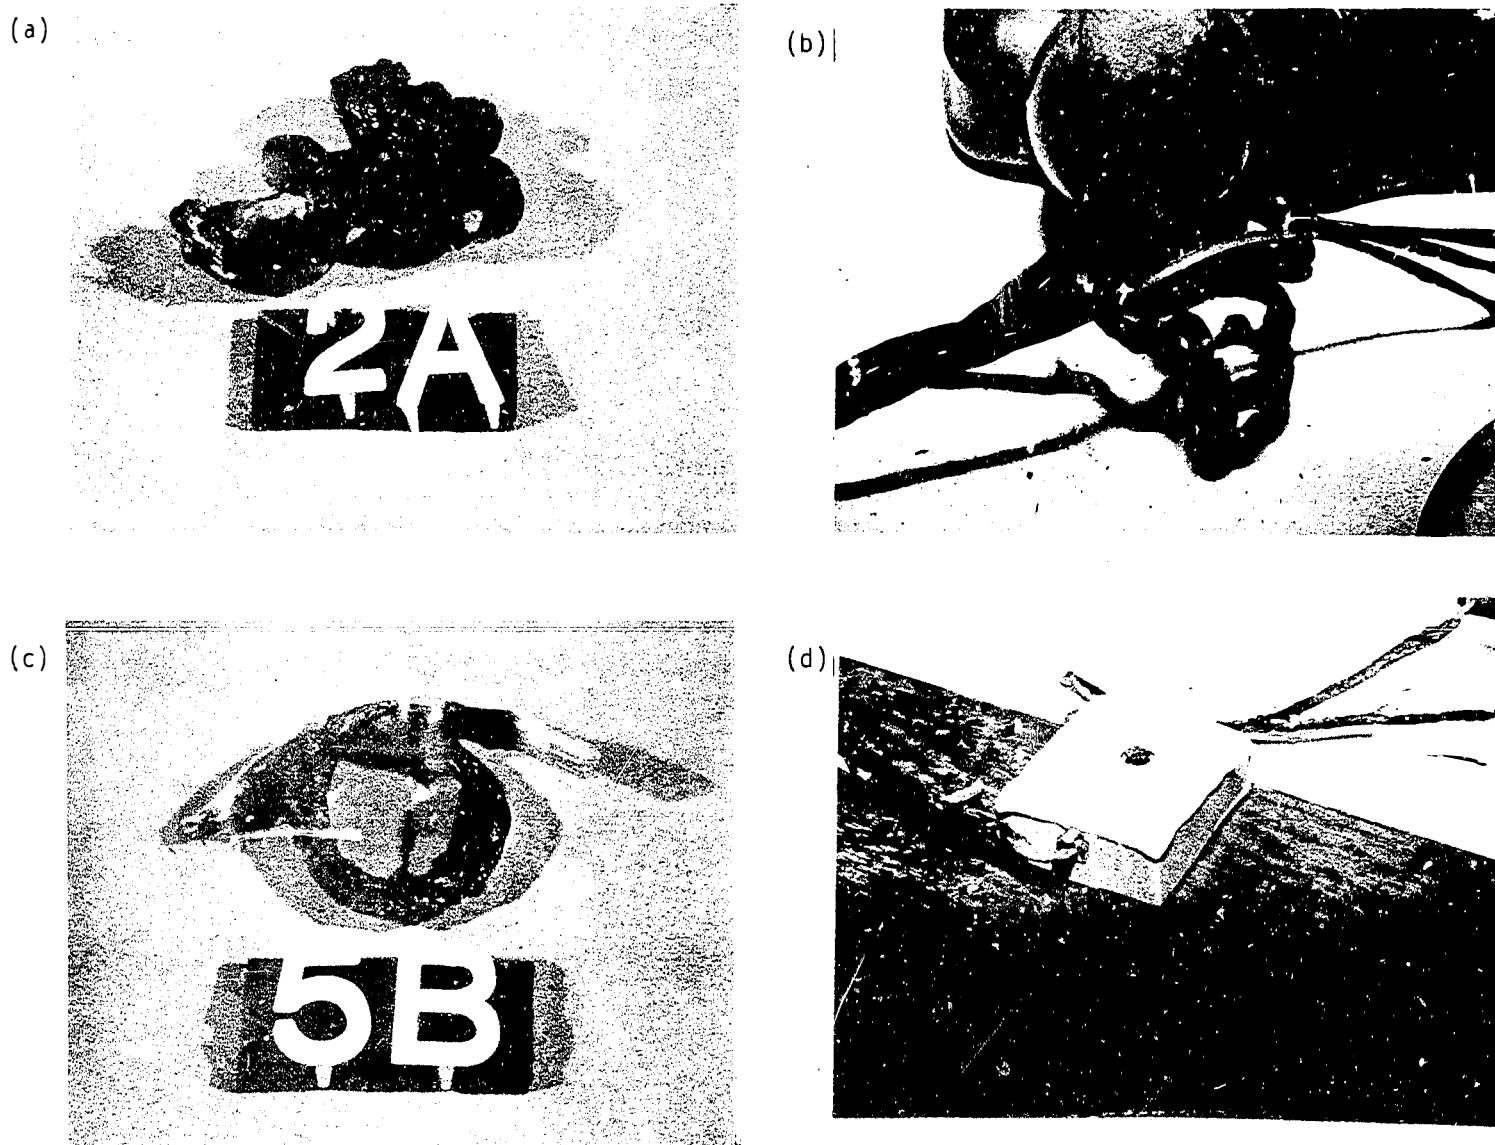
Figures 17 through 21 illustrate the correlation between the damage to exemplar and TMI materials of the south-wall telephone stand on the 347-ft level. The similarity of thermal damage is encouraging and the duration and intensity of thermal exposure is in the range of estimated thermal fluxes attained during the reactor building burn. Note that these are very simplistic tests. No attempt was made to refine temperature or thermal energy measurement. Moreover, we had no illusions as to the distribution of convective or radiative contribution from the test burner. However, the results give data trends which are intuitively acceptable. Description of other materials' responses are contained in Table 4.

Figure 17. Comparison of exemplars exposed to  $180 \text{ J/cm}^2$  for 30 s and TMI materials: (a) Exemplar telephone receiver cord. (b) TMI receiver cord. (c) Exemplar extension cord. (d) TMI extension cord.

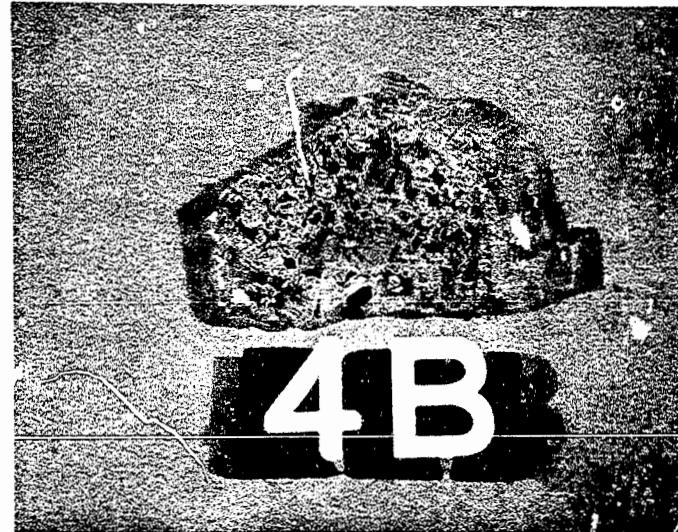
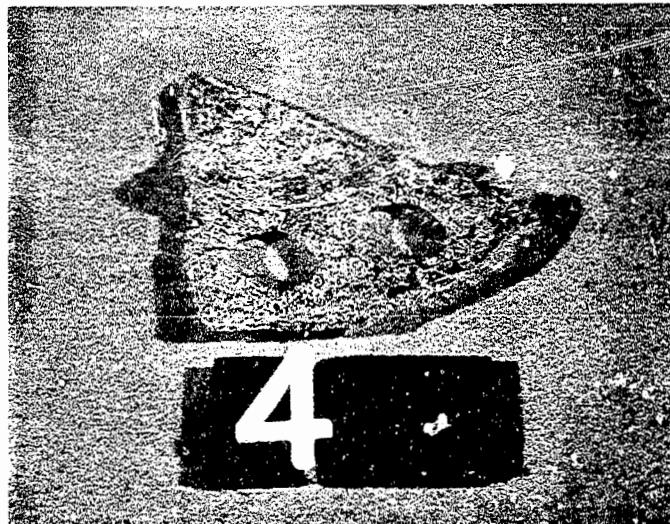
Figure 18. Comparison of exemplar acrylic exposed to  $180 \text{ J/cm}^2$  for 30 s (left) and TMI-2 telephone dial.

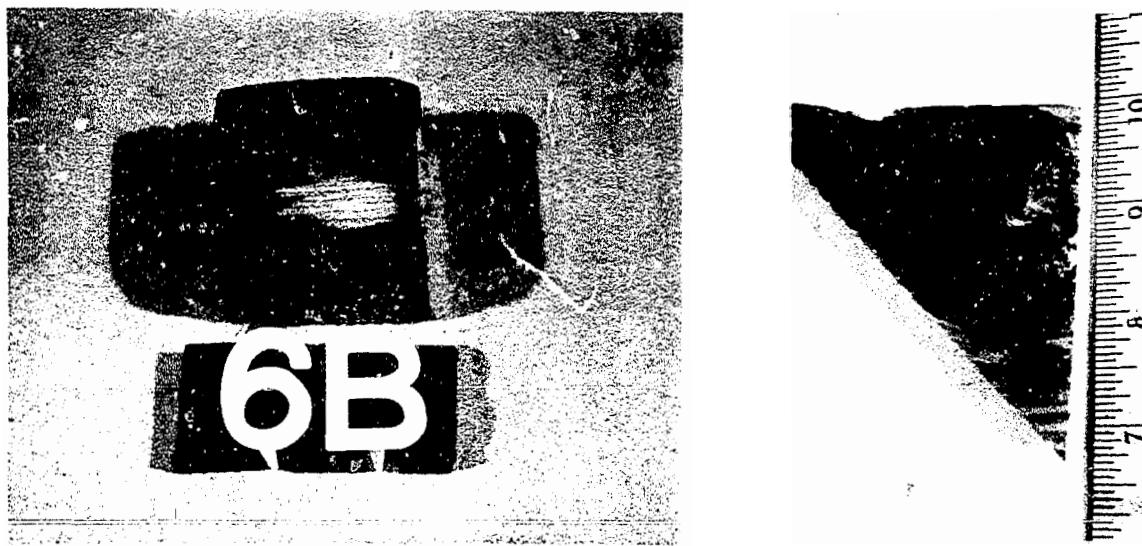
Figure 19. Comparison of exemplar plywood (fir) exposed to  $180 \text{ J/cm}^2$  for 30 s (left) and plywood from TMI.

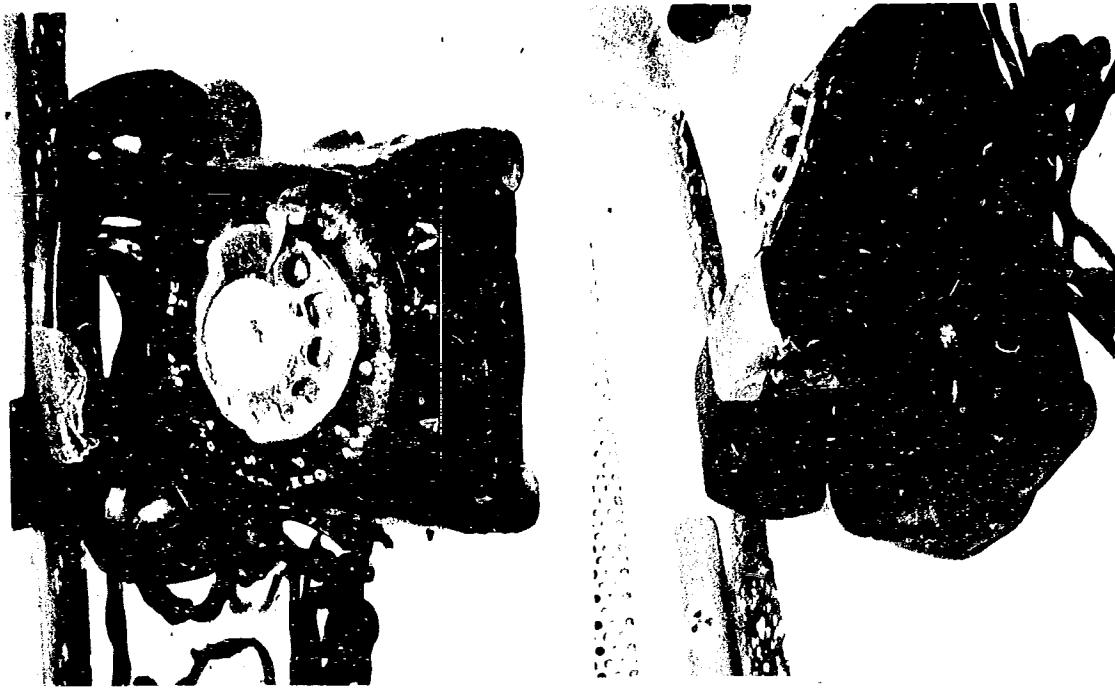
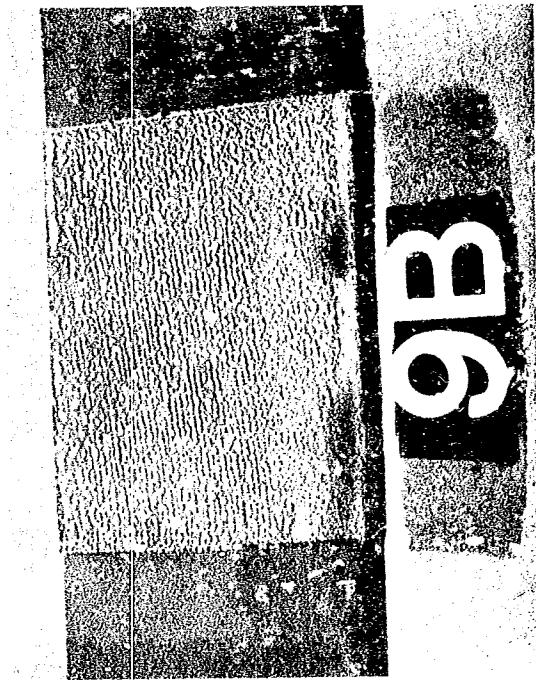
Figure 20. Comparison of exemplar duct tape exposed to  $120 \text{ J/cm}^2$  for 20 s (left) and TMI-2 duct tape.

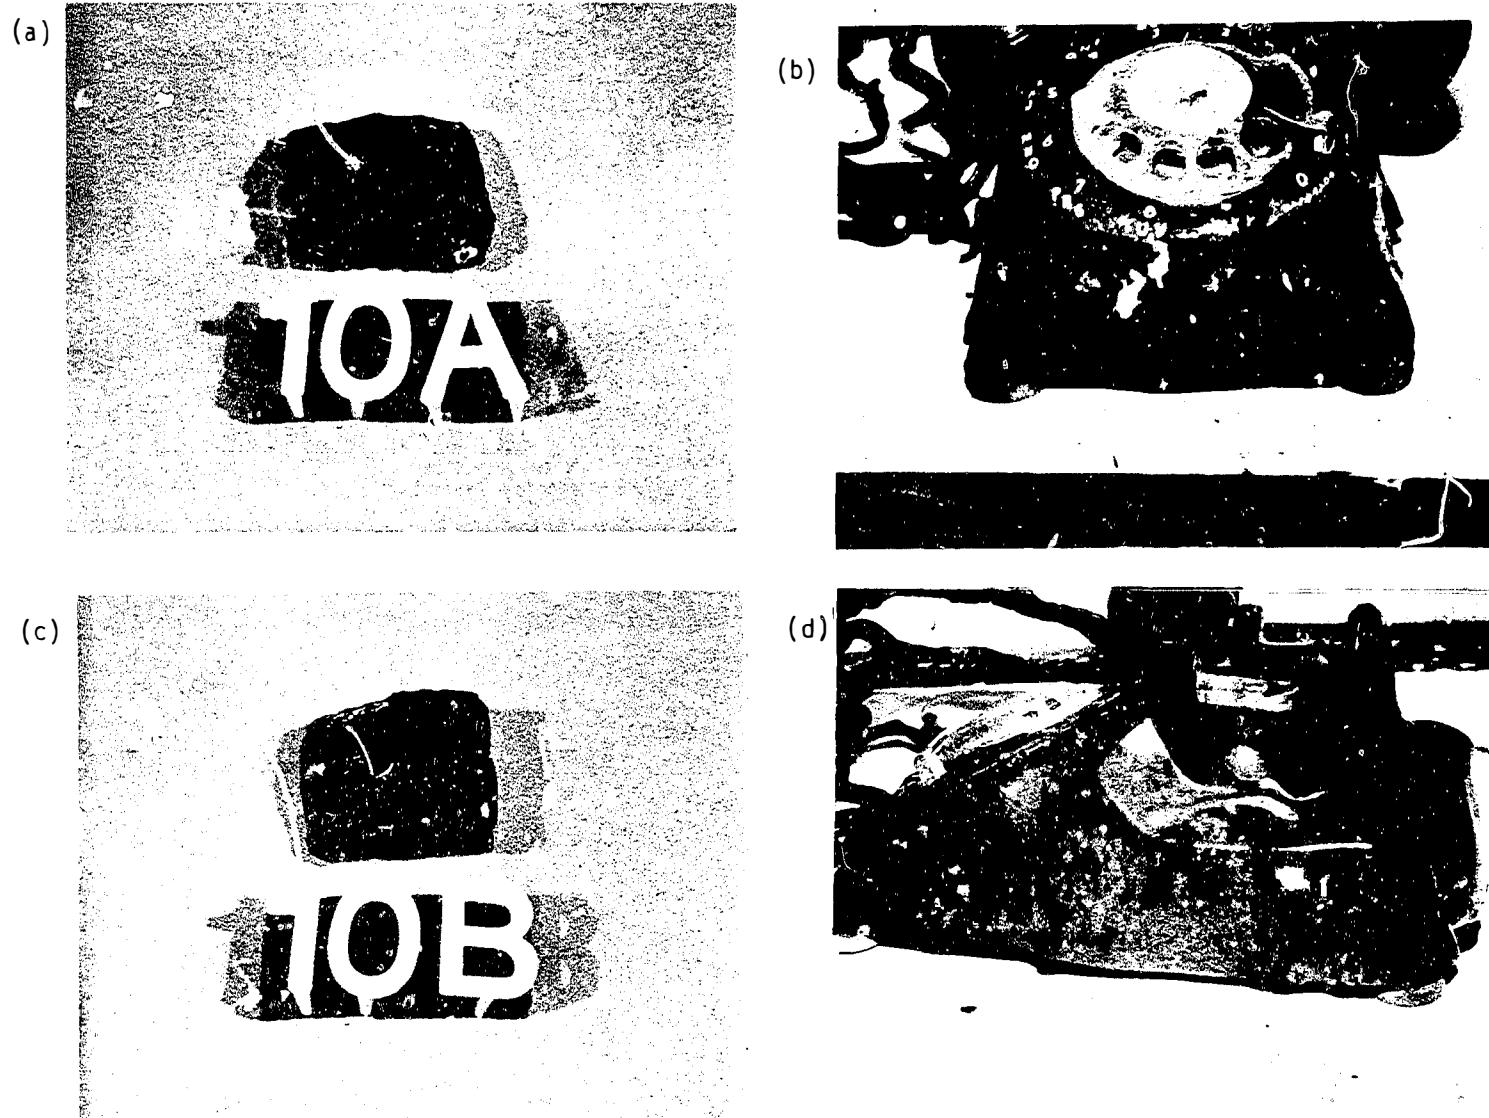
Figure 21. Comparison of exemplar telephone body pieces and TMI-2 ABS telephone body: (a) Exemplar exposed to  $120 \text{ J/cm}^2$  for 20 s. (b) Telephone from TMI. (c) Exemplar exposed to  $72 \text{ J/cm}^2$  for 12 s. (d) Telephone from TMI.

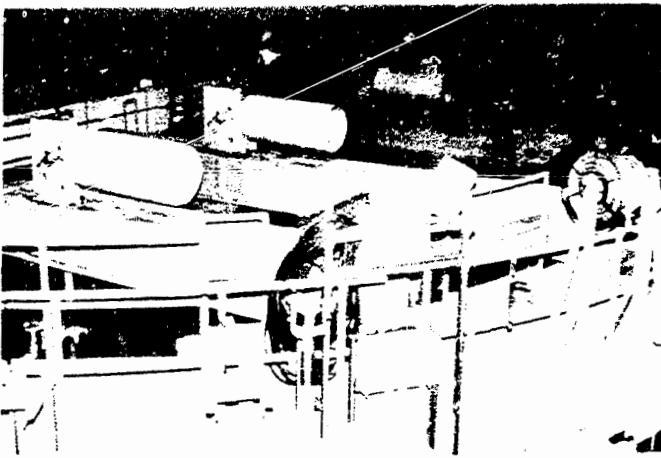
Figure 24. Exemplar red rubber fire hose exposed to  $360 \text{ J/cm}^2$  for 1 min (left) and fire hose at TMI (right).
