NUREG/CR-6194 TMI V(92)EG01 EGG-2731

Metallographic and Hardness Examinations of TMI-2 Lower Pressure Vessel Head Samples

Prepared by G. E. Korth

Idaho National Engineering Laboratory EG&G Idaho, Inc.

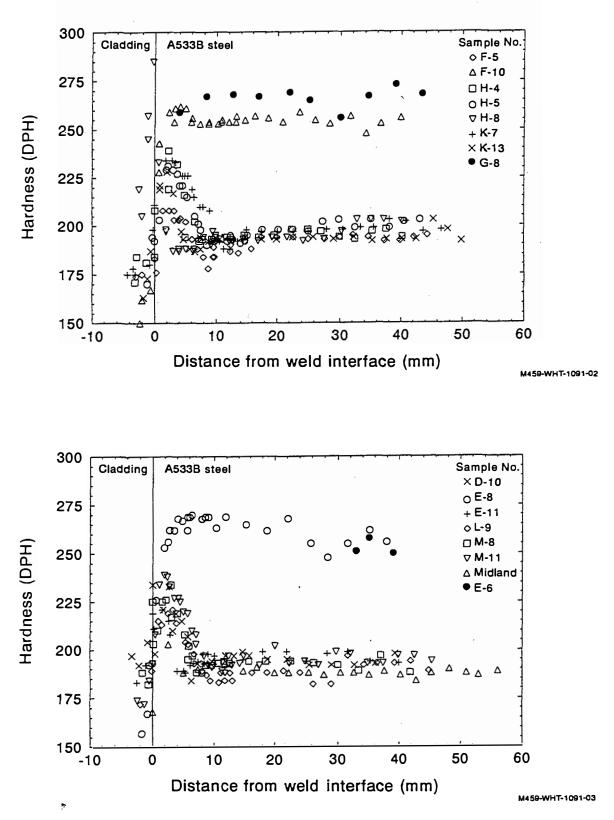
Figure 3. Composite hardness profiles of lower pressure vessel head metallographic samples. Data for eight samples are shown in upper figure; data for remaining seven samples plus Midland archive material are shown in lower figure.

The final hardness of the TMI-2 samples is a strong indicator that the A533B steel transformation temperature of 727°C (1,000 K) was exceeded during the accident, and the discussion to follow shows that the cooling rate back through the phase change was $\geq 10^{\circ}$ C/minute. Figure 5 compares the final hardnesses of Samples E-8(m-3), F-10(m-3), G-8(m-1), and E-6(m-1) with the results of the cooling rate studies of the Midland archive material. Assuming the Midland material is representative of the TMI-2 lower head material, this figure shows that if the cooling rate had been in the vicinity of 1°C/minute or less, then the final hardness would have been approximately the same as that of the as-fabricated parent metal. Therefore, hardness measurements would not have been very helpful in determining the thermal history due to the accident - they would only reveal that the hardness peak from the heat-affected band from the weld cladding was eliminated. However, the final hardness values for E-8(m-3), F-10(m-3), G-8(m-1), and E-6(m-1) are consistent with cooling rates of $\geq 10^{\circ}$ C/minute and any peak temperature

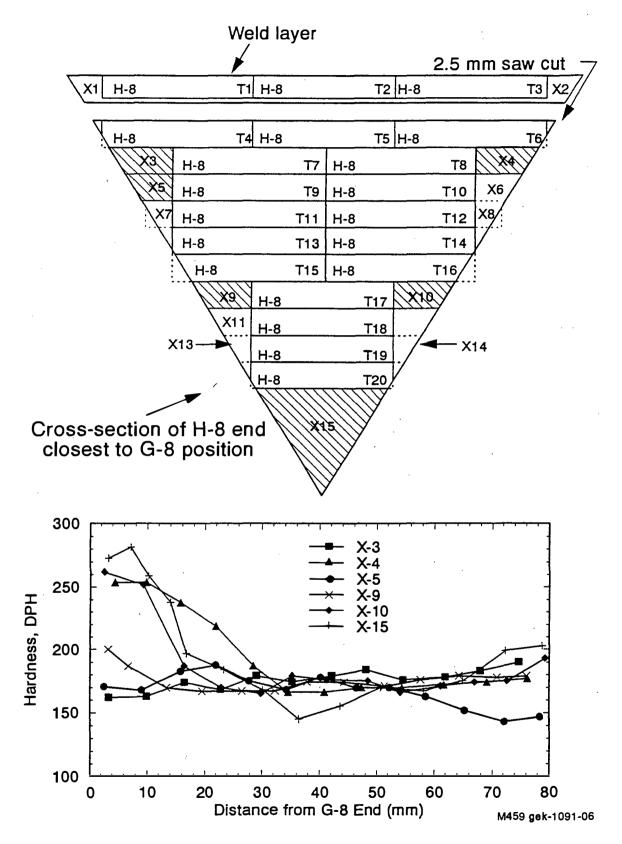
Figure 4. Longitudinal hardness profiles taken from the H-8 (x-series) strips.

The hardnesses of the H-8(x-series) strips were measured in a longitudinal direction on the several pieces that were large enough to obtain a good reading. The results of these measurements are shown in Figure 4. A hardness increase is evident as the end closest to G-8 is approached. This observation indicates that the ferrite/austenite transformation temperature was reached on the end of H-8 nearest to G-8.

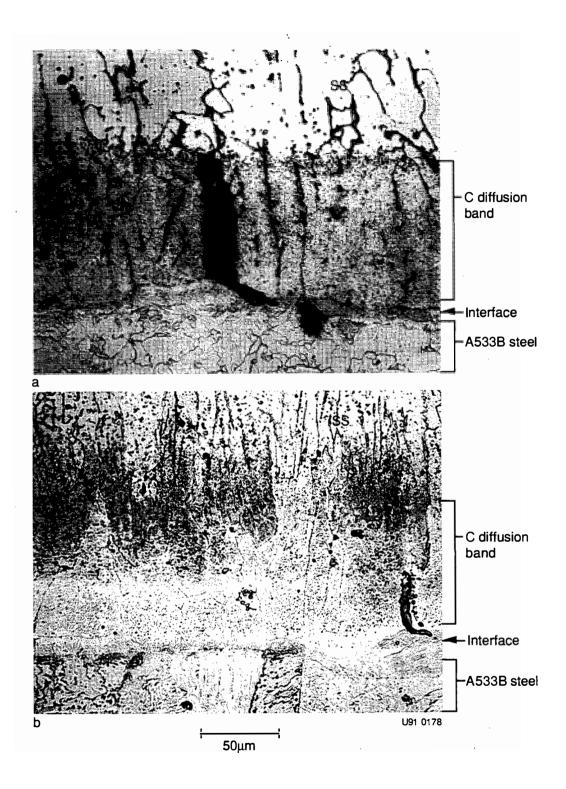
Figure 6. Stainless steel/low alloy steel interface of Samples F-10(m-3) (a) and E-8(m-3) (b) illustrating the band of carbon diffusion into the stainless steel.

Carbon diffusion from the pressure vessel steel (0.2% C) into the stainless steel (0.03% C) is evident, and this phenomenon is another possible indicator of thermal history. Figure 6 shows the band of carbon diffusion into the weld cladding for Samples F-10(m-3) and E-8(m-3), known heataffected samples from the accident. The 0.10 to 0.15 mm band in the stainless steel at the interface has been determined by scanning electron microscopy (SEM) microchemical analysis to be due to carbon diffusion. Figure 7 shows more details of the band of F-10(m-3). Microhardness measurements reveal that the band is very hard (up to 500 DPH) and microcracks, seen in Figures 6a and 7, show that the band is brittle. Although TMI-2 samples believed to not have been affected by the accident exhibited some evidence of carbon diffusion (by microhardness

measurements only, not revealed by metallography) into the stainless steel from the welding operation, it is not so prominent nor as deep as observed in F-10(m-3) and E-8(m-3). Figure 8 illustrates the time/temperature/distance relationship of carbon diffusion into austenite based on theoretical calculations using diffusion coefficients found in the literature.³ This figure shows that the 0.10 to 0.15 mm diffusion distance observed on Samples F-10(m-3) and E-8(m-3) could have resulted from conditions ranging from 2 minutes at 1,100°C to 90 minutes at 800°C. Thus, the carbon diffusion distance by itself is not conclusive in determining peak temperatures of the lower head, but it is of value in confirming other indications.

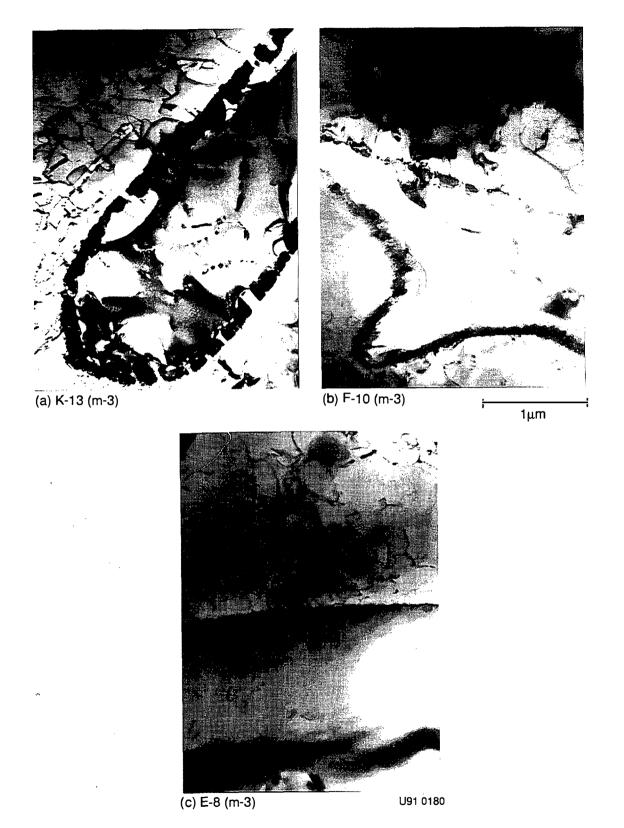
and F-10(m-3), but none were observed at an austenite/ferrite boundary for E-8(m-3). The carbides shown in Figure 10 for Sample F-10(m-3) appear to be partially dissolved when compared to those in K-13(m-3). The presence or absence of carbides correlates well with the spheroidizing of the δ -ferrite islands.

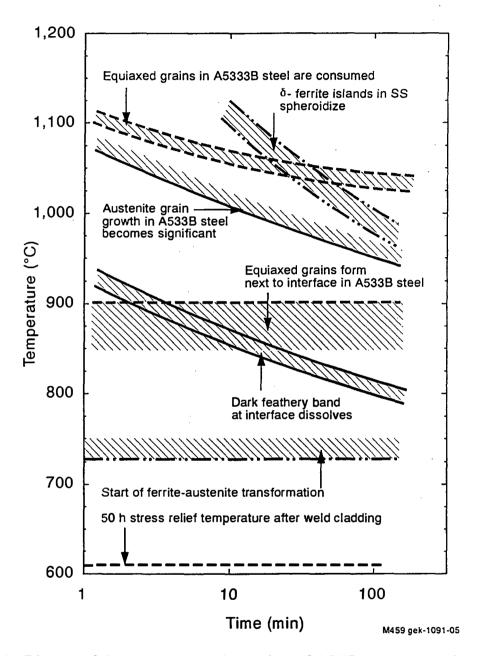
Figure 11. Diagram of time/temperature observations of A533B pressure vessel steel clad with Type 308L stainless steel.

In an attempt to illustrate the various metallurgical observations from the prepared standards of Midland archive material and the heat treated TMI-2 material, the diagram shown in Figure 11 was constructed. Since the vessel was stress relieved at 610°C after the weld cladding, no thermal effects from the accident could be detected at or below this temperature and, therefore, the diagram only shows metallurgical observations for temperatures above this point. The lowest temperature indicator, above the stress relief temperature, was the ferrite-austenite transformation, which starts at 727°C and is complete by 810°C. Variations in hardness will be evident when this threshold is exceeded. The next indicator is the dissolution of the dark feathery band at the interface; this occurs between 800 and 925°C, depending on the time. The next indicator of increasing temperature is the appearance of small equiaxed grains in the A533B steel adjacent to the interface that form between 850 and 900°C and disappear between 1,025 and 1,100°C as they are consumed by grain growth in the low alloy steel. The dissolution of the dark feathery band and the formation of the equiaxed grains are believed to be associated with carbon diffusion into the stainless steel cladding. The dark feathery band appears to be some sort of carbide that disperses as the carbon diffuses into the stainless steel. The equiaxed grains, which are not typical for a low alloy steel, appear to be devoid of cementite, undoubtedly due to a loss of carbon into the stainless steel. Grain growth in the A533B steel becomes significant above approximately 950 to 1,075°C, depending on the time involved. The highest temperature indicator shown on the diagram is the spheroidizing of the δ -ferrite islands in the stainless steel cladding, which occurs in the approximate range of 975 to 1,000°C at 100 minutes or 1,100 to 1,125°C at 10 minutes.

The thermal histories were determined by applying the above observations to microstructural examinations of areas near the stainless steel/low alloy steel interface (within 2.5 mm). The temperature gradient through the thickness of the lower vessel head wall was estimated by two methods. First, since the high level of hardness of the four affected samples persisted to the full depth of the boat samples (50 mm from the inside surface, 45 mm from the weld clad interface, see Figure 3), it could be concluded that the temperature at that depth was greater than the 727°C transformation temperature. Secondly, since it had been established that the thermal excursion on the lower head due to the accident was of the order of 30 minutes, prior austenite grain size at the bottom-most tip of the heat-affected samples was compared with the prepared standards given the 30-minute heat treatments. The results of this rough analysis indicated that the temperature 50 mm from the inside surface (45 mm from the stainless steel/low alloy steel interface) was approximately 50 to 150°C lower than the peak temperatures determined previously for the region near the interface. There is a fair amount of uncertainty in the gradient estimate since only average prior austenite grain size was used for the determination and that measurement cannot be made with precision. Also, the assumption that 30 minutes was the actual time at peak temperatures 50 mm into the thickness may be in error.
