Examination Results of the Three Mile Island Radiation Detector HP-R-211

October 1981

EXAMINATION RESULTS OF THE THREE MILE ISLAND RADIATION DETECTOR HP-R-211

Sandia National Laboratories
Albuquerque, New Mexico 87185
and
Livermore, California 94550

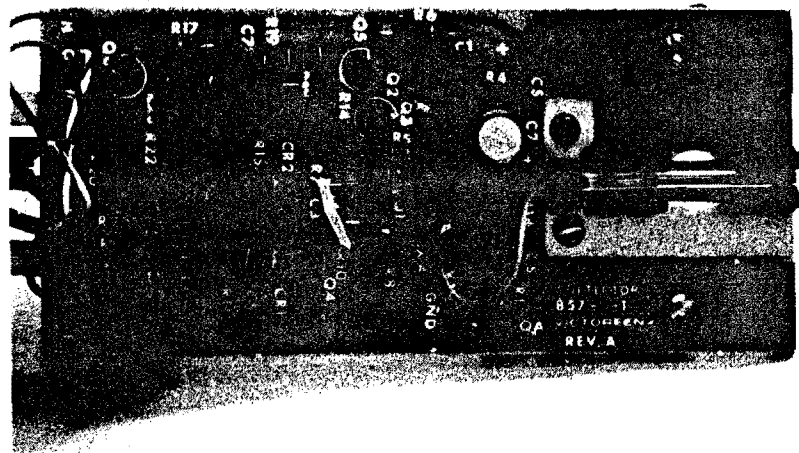
FIGURE 7. HP-R-211 Circuit Board. This picture shows the actual circuit board as removed from the housing. Notice the clean, uncorroded appearance. The GM tube is shown on the right end.

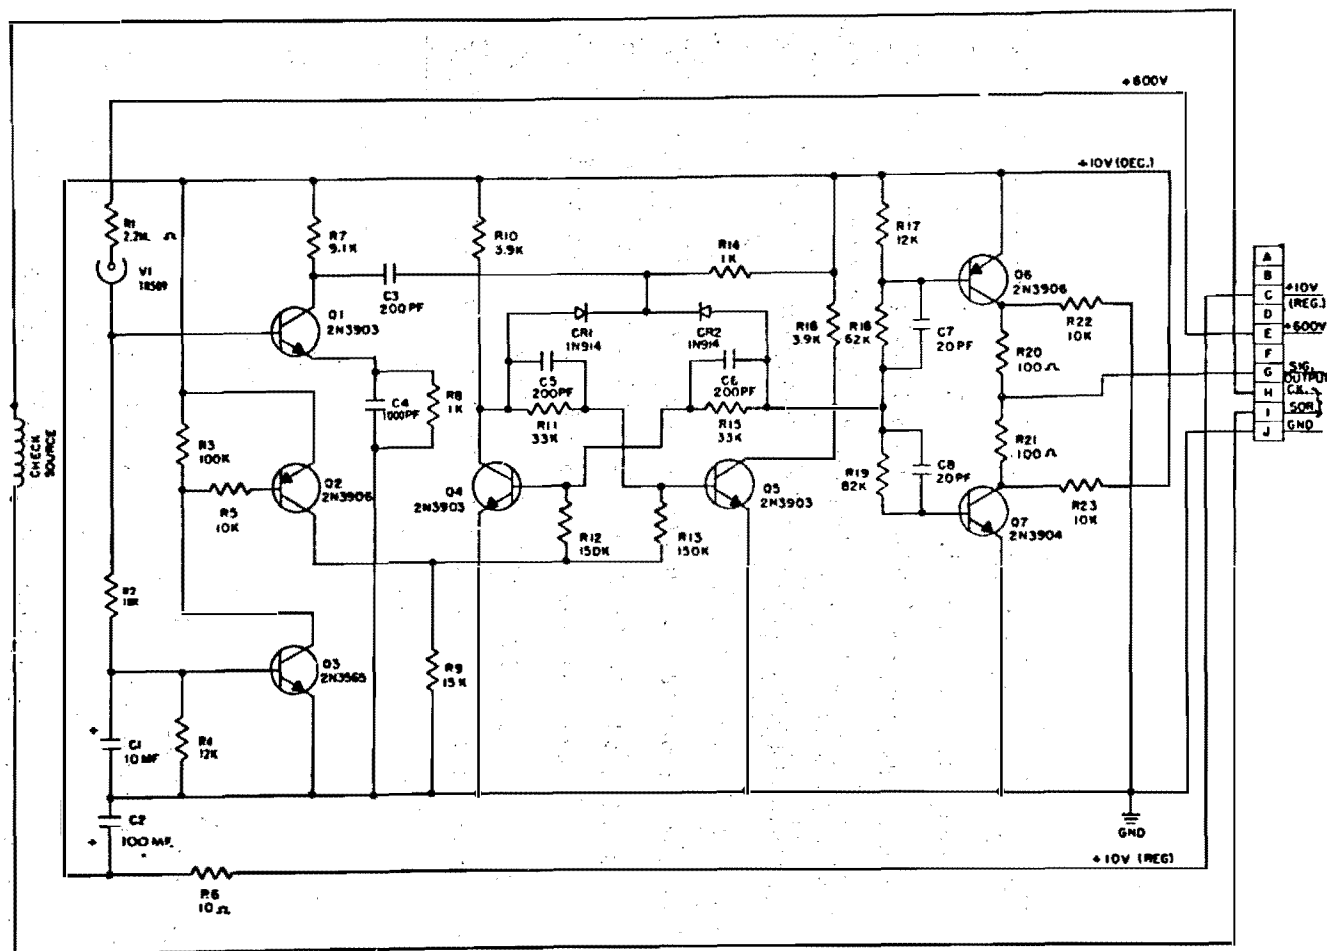
FIGURE 9. Detector Schematic. The GM tube and antijam circuits are on the left, the flip-flop is in the center and the output driver is on the right side of the schematic. Transistor Q6 failed.

Following tests at the Sandia gamma range facility, the detector was opened, node voltages were measured, and the failure was diagnosed. Transistor Q6, a Motorola 2N-3906, was removed and found to exhibit a 163 ohm collector-to-emitter shunt resistance. No other circuit abnormalities were found. Figure 12 shows several of the more important transistor Q6 characteristics as measured on a curve tracer. The collector current characteristics show the presence of an approximate 160 ohm slope on any given base current curve. The transistor gain and the base-emitter junction characteristics are all proper. The presence of this apparent shunt resistance is consistent with the passive tests due to the nominal 100 ohm current-limiting resistor R20 in series with the collector of Q6. The Motorola 2N-3906 is a general purpose 350 mW, epoxy encapsulated PNP transistor which is designed to operate with a maximum collector current of 200 ma. The collector to emitter breakdown voltage is rated at 40 V. The epoxy case was removed by grinding the surface away until the semiconductor chip cavity was exposed; normal solvents were ineffective. The chip shown in Figure 13 has a large amount of foreign material on the surface (not due to the grinding operation, since an additional coating of RTV-like material had to be removed). The metallization is shown removed in Figure 14, and a punch-through defect exists under the center emitter finger. Probes were in fact made of each finger, and the failure was electrically isolated to the middle finger. This type of failure is typically caused by high voltage breakdown from collector to emitter and a subsequent transient surge current. The energy deposited is enough to destroy the normal lattice structure and actually diffuse aluminum metallization into the lattice to cause a resistive path. Had the transistor been overheated through high power dissipation over a long period of time, much of the metallization would probably have been melted. As it is, however, the defect points to a rapid transient.

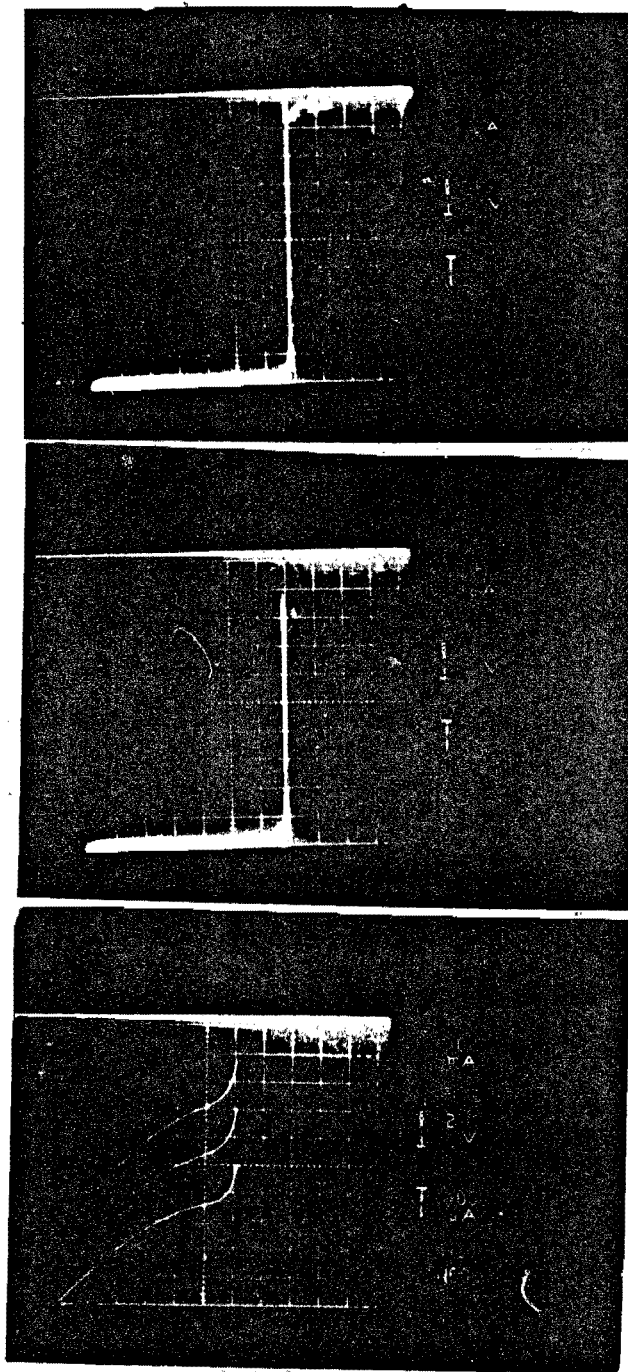
FIGURE 12. Transistor Q6 Characteristics. The top curve is BVCBO, middle curve is BVEBO and lower curve is collector current characteristics. The effect of the 163 ohm anomaly is seen as the slope of the collector current characteristics for any particular base current of the family.

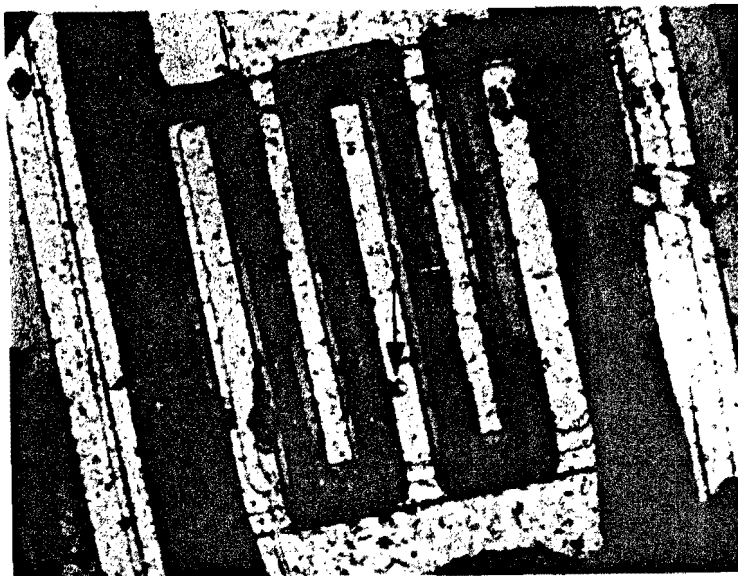
FIGURE 13. Q6 metalization. The punch through defect is apparent even through the emitter metalization (three fingers). This photograph was taken after chip probe but before the metalization was stripped. Notice the large amount of foreign material present.

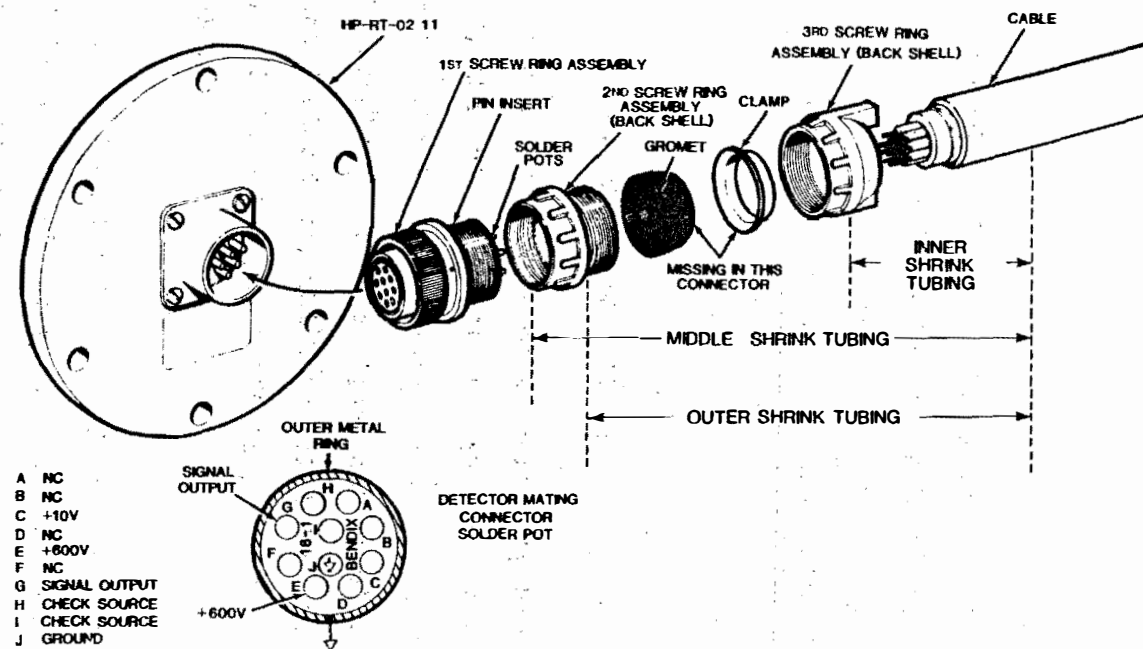
While we cannot say with absolute certainty how and when transistor Q6 failed, the evidence indicates that the failure was caused either by a transient short in the detector connector backshell; from the 600 Volt GM tube supply pin to the signal output pin, or by a high voltage pulse generated elsewhere, which traveled down the cable on the signal output line. Of these two possibilities, the former appears to be much more probable.

During the removal of the detector from the containment building, the GPU technician was unable to unscrew the connector from the detector, even with the aid of channel-lock pliers. While attempting to loosen the connector, he applied downward pressure on the detector, and it broke free of the cable. The detector, connector first screw-ring assembly, and pin insert were removed as one piece. Figure 15 gives an exploded view of the connector assembly and pin connections. Later examination of the free cable end after its removal revealed the second and third connector screw-ring assemblies to be mated and encased along with the cable end in Raychem WCSF heat-shrink tubing. This tubing was tightly molded to the connector part and covered at least the lower 20 cm of cable. In fact, three layers of heat-shrink tubing were used as shown in Figure 15 to produce what appears to be a good, watertight seal between the connector and cable. Since he did not attempt to rotate the detector to unscrew it when he could not turn the connector, apparently the second screw-ring was not mated or mated by less than one thread to the threaded insert. Corrosion on the connector insert and inside the second connector screw-ring indicates exposure to steam or liquid. Scanning electron microscope (SEM) and energy dispersive spectroscopy (EDS) studies made on the insert around the solder pots were inconclusive in the search for sodium there (because of instrument limitations on the detection of low Z elements).

FIGURE 15. HP-R-211 Connector Assembly. The second screw-ring assembly was apparently not screwed onto the pin insert.

A chemical analysis was not performed. We believe that steam and/or NaOH/B spray entered the connector backshell through the loose-fitting insert-to-second screw-ring junction.

the accident. Spray and/or steam apparently entered the connector assembly where the detector and cable mated and caused the 600 volt GM tube power line to short, momentarily, to the signal output line. The connector backshell does not look as though it was properly mated to the connector insert. This, and the orientation in which the detector was mounted provided an entryway for the moisture. To prevent this from occurring in the future, we recommend that Victoreen detectors of this and similar types be mounted with the connector below the housing and that the connector backshells be potted. Even more fundamentally we question the need for having anything other than a sensor inside the containment building. Wherever possible, active electronics should be located outside containment.

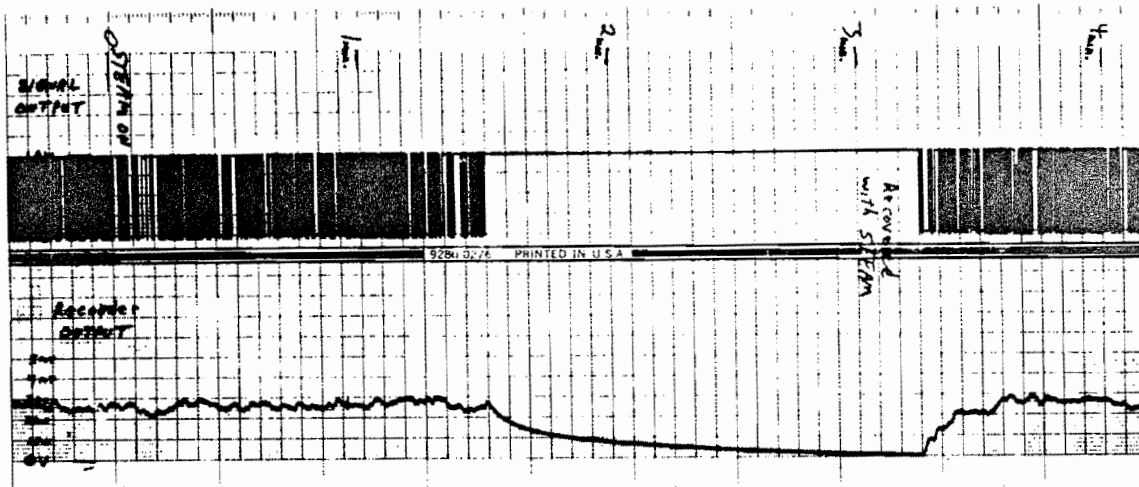
tive paths between pins can form quite abruptly and disappear as fast. Interestingly, even in the presence of steam, the path can open quickly and remain open. This is illustrated in Figure 17a. Here, using the test detector and its connector, we deposited NaOH of PH 12.7 on the surface and allowed the water to evaporate. We then directed steam onto the surface, and after 100 seconds the signal output dropped to zero indicating a reduction in the 600 Volt to somewhere below 380 Volts. A minute and a half later the detector recovered and did not fail again even in the presence of steam. What happened was that the sodium ions were attracted to a more negative terminal, the surface near the 600 Volt pin was depleted, and conduction terminated. In fact, water ceased to wet this area and even to form droplets there. Figure 17b shows the 600 Volt line in the test where a large droplet of NaOH had been introduced between pins. The 600 Volts decreased abruptly then rapidly increased time-after-time (the 0.01 μ F capacitor was used to supply energy). Tiny arcs could be seen around the 600 Volt pin. Each one of these delivered energy to ground or to ground through another pin.

FIGURE 17a. Steam on a Contaminated Backshell. A detector connector backshell was exposed to steam after the backshell was first contaminated with NaOH. NaOH was introduced and then allowed to dry before steam was applied. The top trace is the signal output, and the lower trace is the ratemeter output. The detector failed after about 1.5 minutes of steam, but recovered even though steam was still being applied.

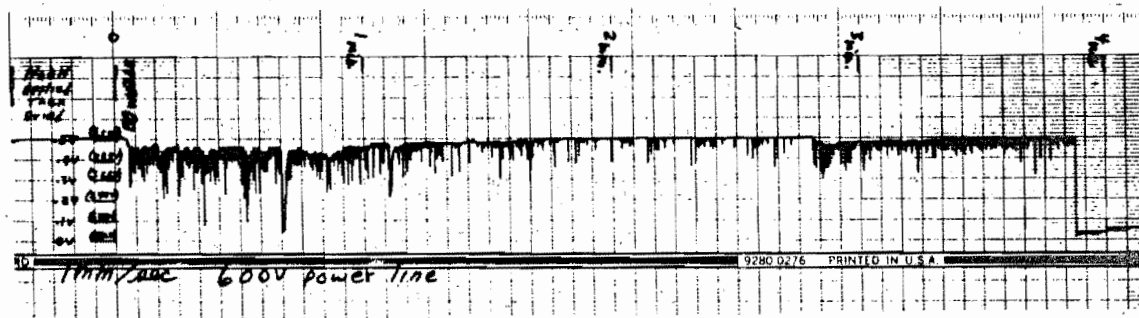
We conclude from these tests that a large droplet of water or spray was not in the connector shell due to the absence in the strip-chart recording of any long duration short or repeated signal irregularities. A highly contaminated connector, introduced abruptly to only a small puff of steam, is sufficient to produce the single drop-out noted. The presence of sodium is indicated, and it is possible that even though a single discontinuity was observed other short duration discontinuities could have occurred without being registered on the stripchart recording.

FIGURE 17b. Large Droplet Formation. A similar experiment to that shown in Figure 17a was conducted, except that here all of the detector pins are covered with a water droplet. The 600 Volt power line is plotted versus time. Repeated surges are delivered to a load during each breakdown.

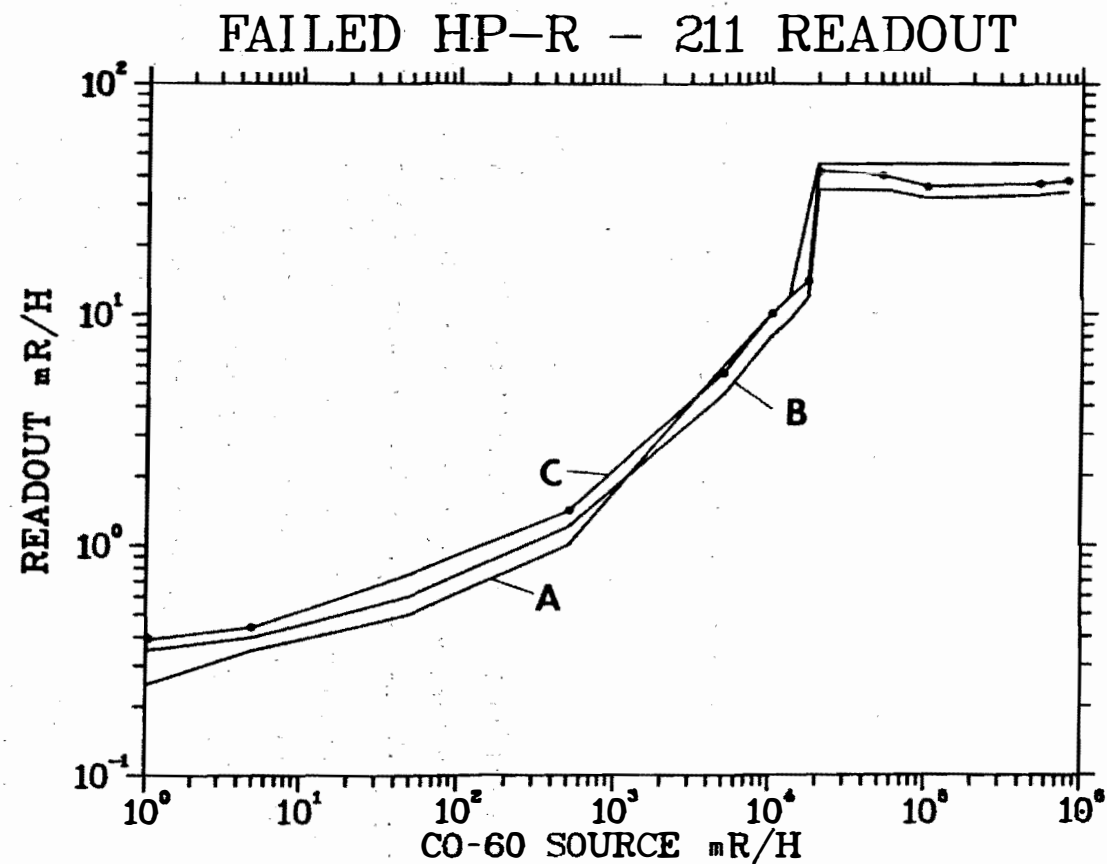
FIGURE 18. HP-R-211 Characteristics. The detector was exposed to a Co-60 source upon arrival at Sandia and produced the output shown. Curve A is for the condition of nominal detector supply voltages, Curve B is for low voltages, and Curve C is low-voltage, ratemeter corrected. These data were taken without 152 m cables or line capacitance equivalents used.

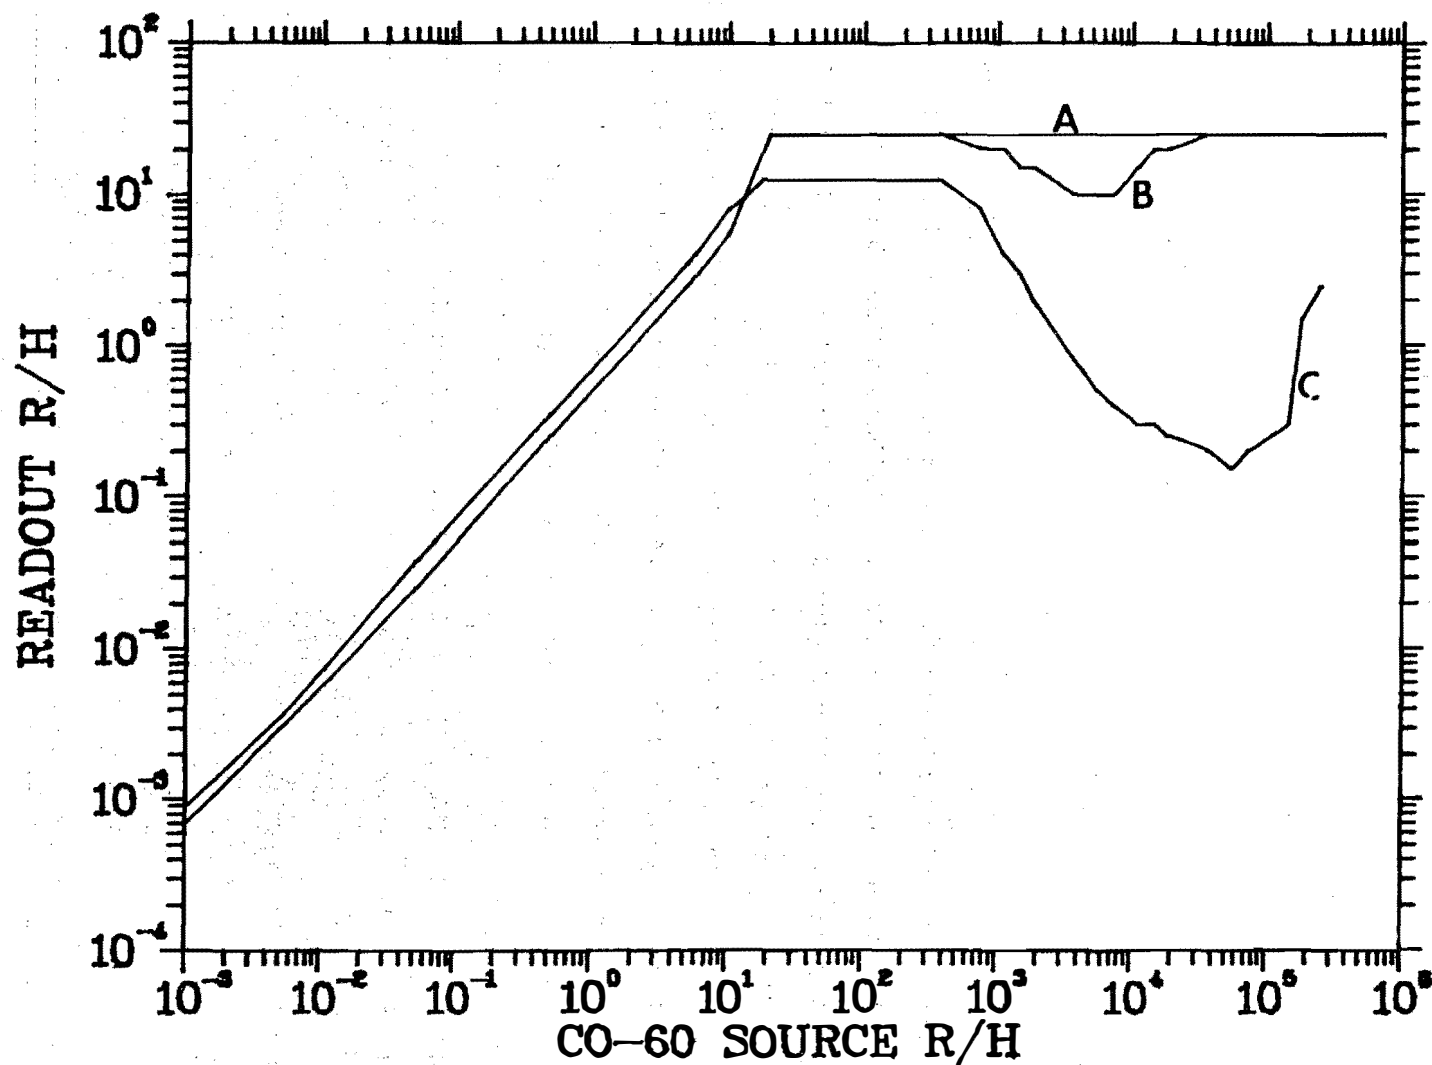
2. The repaired, but degraded, detector exhibits a radiation level indication which becomes multivalued when it is exposed to radiation levels in the 10^3 to 10^6 R/H range. Instead of remaining pegged at its maximum 10^4 mR/H indication in this range, the readout begins to decrease at 10^3 R/H, reaches a minimum at approximately 50×10^3 R/H, and then begins to increase thereafter. This characteristic is caused by detector to cable impedance mismatches and is accentuated by long cable lengths and radiation degradation of detector transistors and the GM tube. This could present a hazardous situation in a reactor LOCA wherein radiation degraded detectors may indicate radiation levels to be significantly lower than they actually are. Changes in circuit design and/or the use of more radiation tolerant transistors can correct this problem.

FIGURE 21. Multivalued Readout. Curve A shows the Test detector response to the Co-60 source when a short cable is used to connect the detector to the ratemeter. Curve B gives the response when 152m of coaxial interconnect cable are used. Curve C gives the HP-R-211 response using 152m interconnect cable. The response is seen to be multi-valued when long cables are used, especially for the degraded detector.

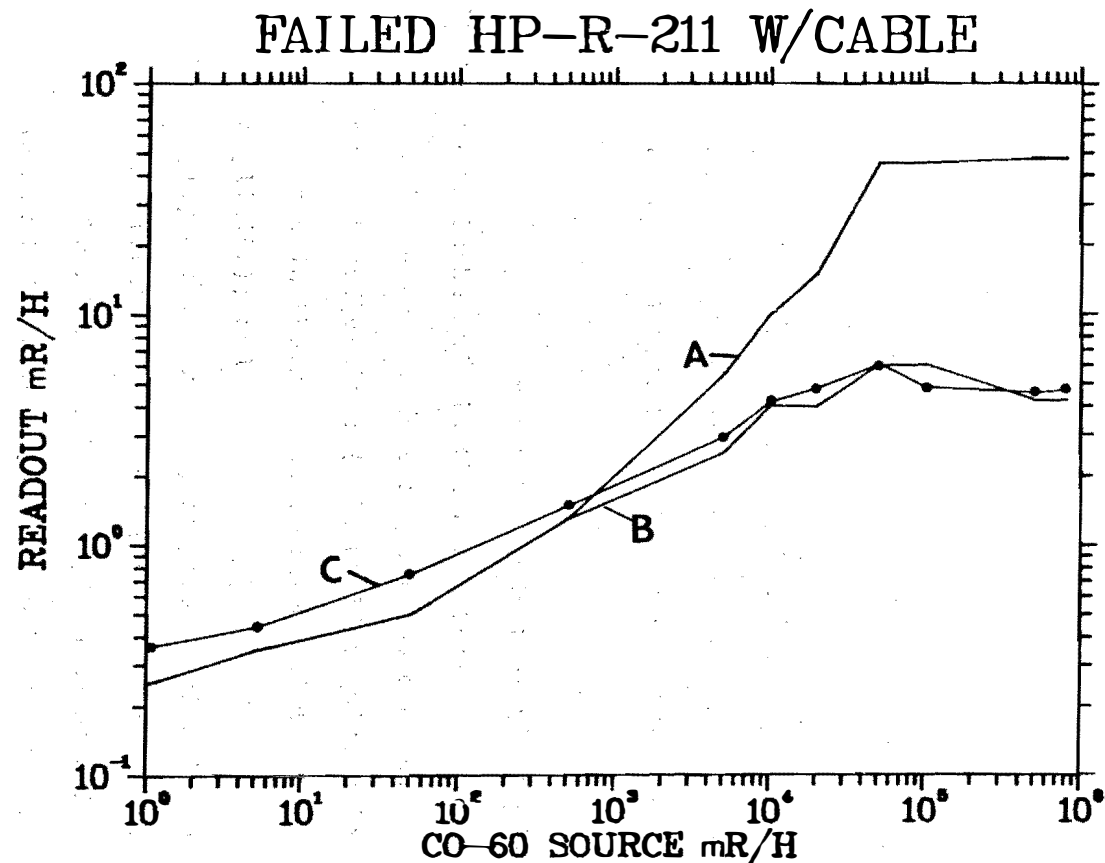
FIGURE 24. Failed HP-R-211 characteristics with 152 m of Coaxial Cable. A new 2N 3906 transistor with a parallel 250 ohm resistor was substituted in place of the failed transistor Q6. RG 58 Cable was used to connect the signal output line from the detector to the ratemeter. Curve A is the nominal-voltage characteristic with a short (3 m) coaxial cable. Curve B is the nominal-voltage characteristic using a long (152 m) coaxial cable. Curve C is the low-voltage, ratemeter corrected, characteristic, using a long cable.

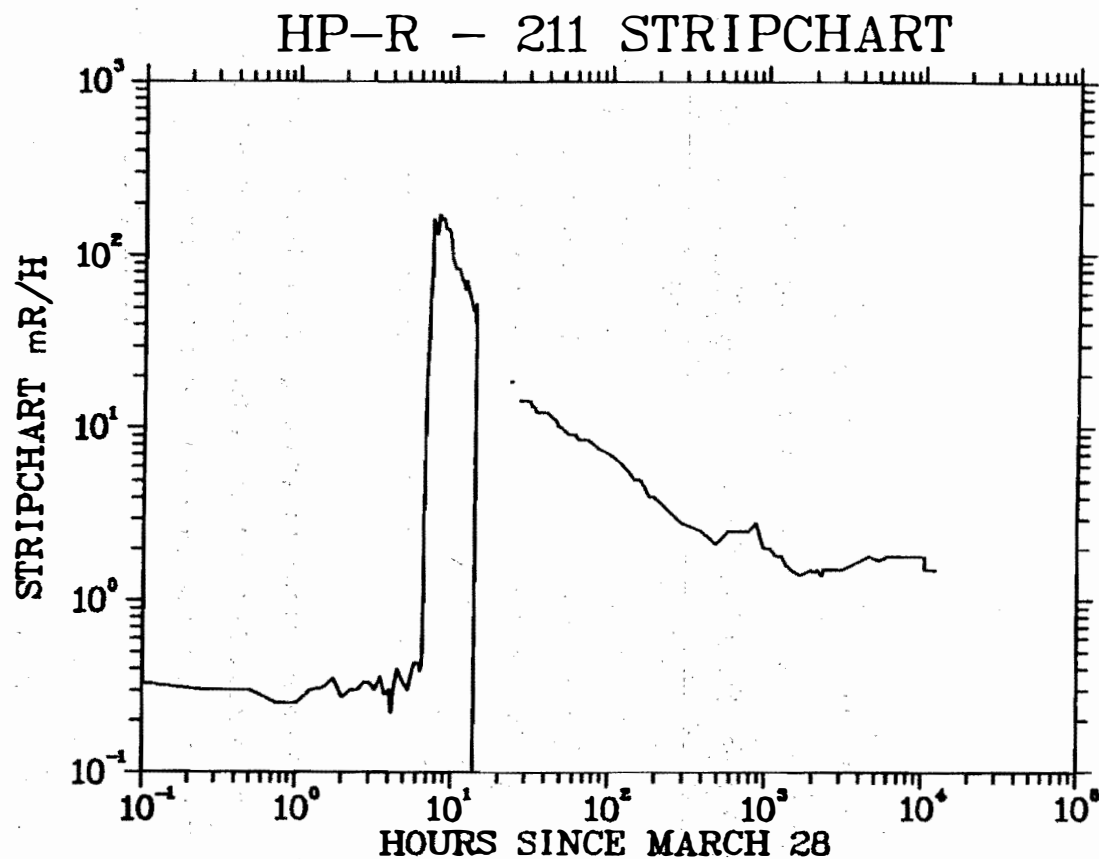
The HP-R-211 stripchart recording (Figures 25a and 25b) exhibits only a single observable discontinuity. This occurs at approximately 1350 hours during the time of either the hydrogen burn or five minutes of building spray. The signal first rises, drops to zero for approximately two minutes, and then steps back up abruptly to a level somewhat lower than it was prior to the transient. This five minute perturbation suggests a point in time at which the failure could have occurred.

FIGURE 25a. HP-R-211 Composite Stripchart. All 506 days of stripchart and operator logs are shown. The detector output peaks at 170 mR/H at about 0800 on March 28, 1979. When removed on August 15, 1980, the detector registered only 1.5 mR/H.

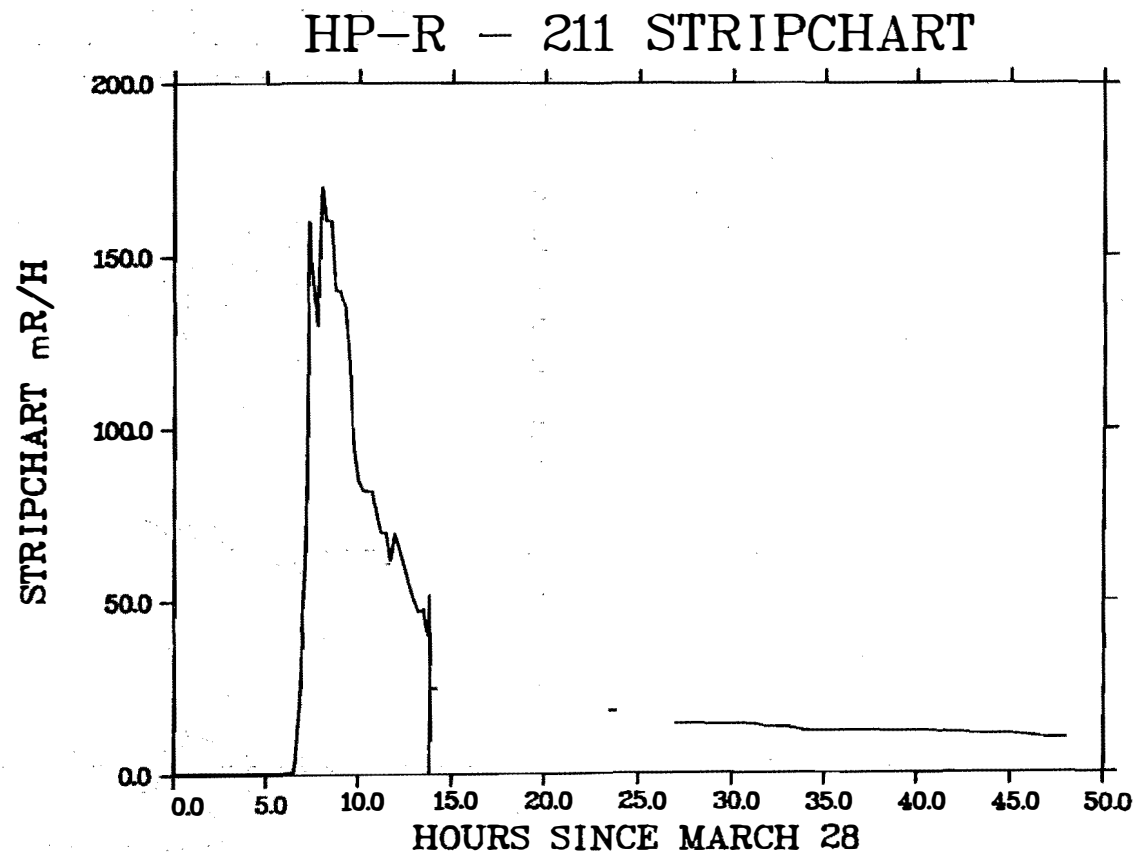
FIGURE 25b. HP-R-211 Short Term Stripchart. Only the first two days of the accident are shown on a linear scale. The ESF actuation occurred some 9 hours and 50 minutes into the accident (1350 hr). Several data points were taken just after this before the recorder printed in place. A few more points were taken at about 2400 hr.

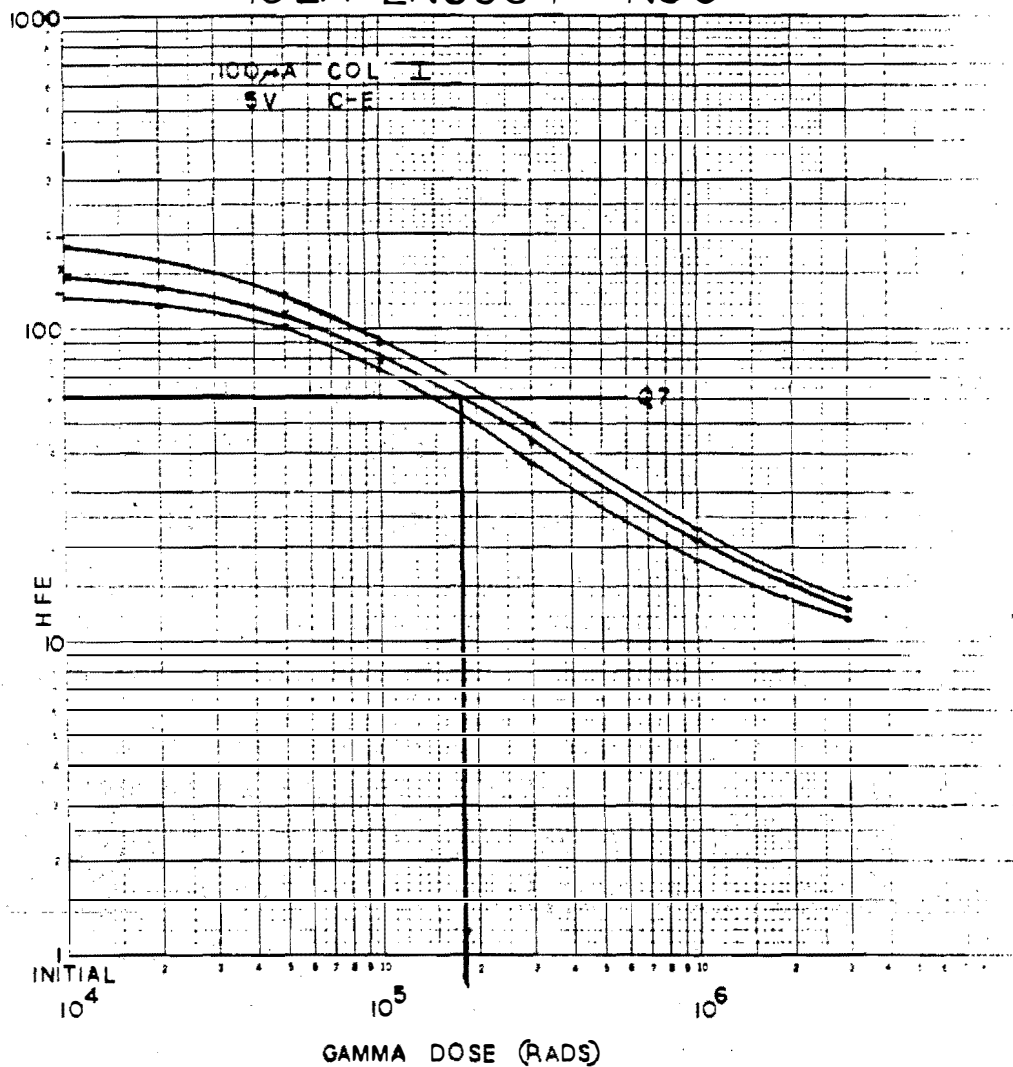
FIGURE 26. Transistor Gain Degradation. The measured gain of transistor Q7 was 61 at a collector current of 100 μ a. This corresponds to a nominal gamma dose of 1.6×10^5 rads using National Semiconductor 2N 3904 data.

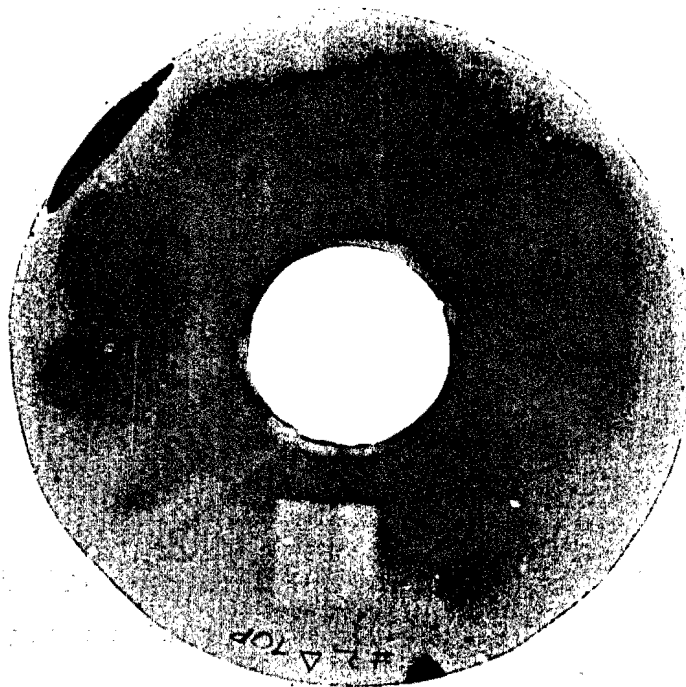
FIGURE 29. Film Negative of Detector Lid.
Illustration of the variation in beta activity.
Dark area was over the Victoreen label and light
rectangular area was a position tag.

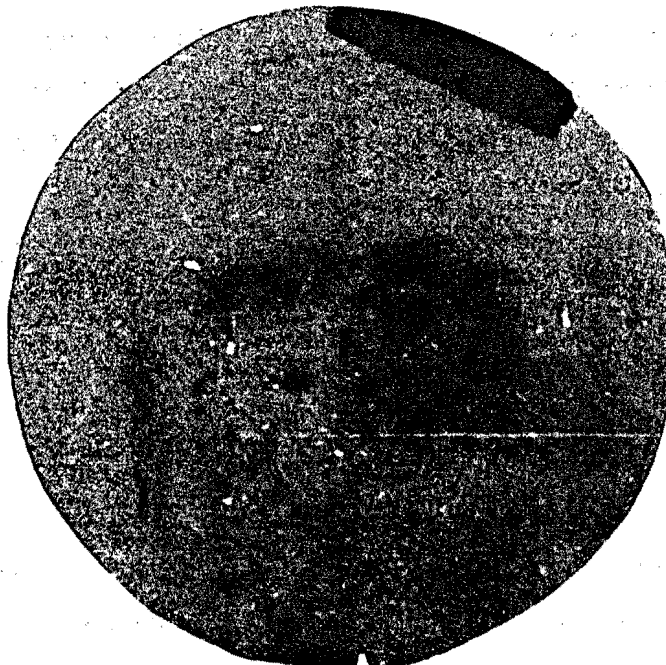
FIGURE 30. Film Negative of Detector Bottom.
The dark spots identify areas where contaminated
liquids probably concentrated and dried.
